RE: 222 Polaco Street Status Review Buildings A, B, C

# Historic Cultural Properties Inventory (HCPI) Base Form (FORM 1)

# Historic Cultural Properties Inventory (HCPI) Detail Form (FORM 2)

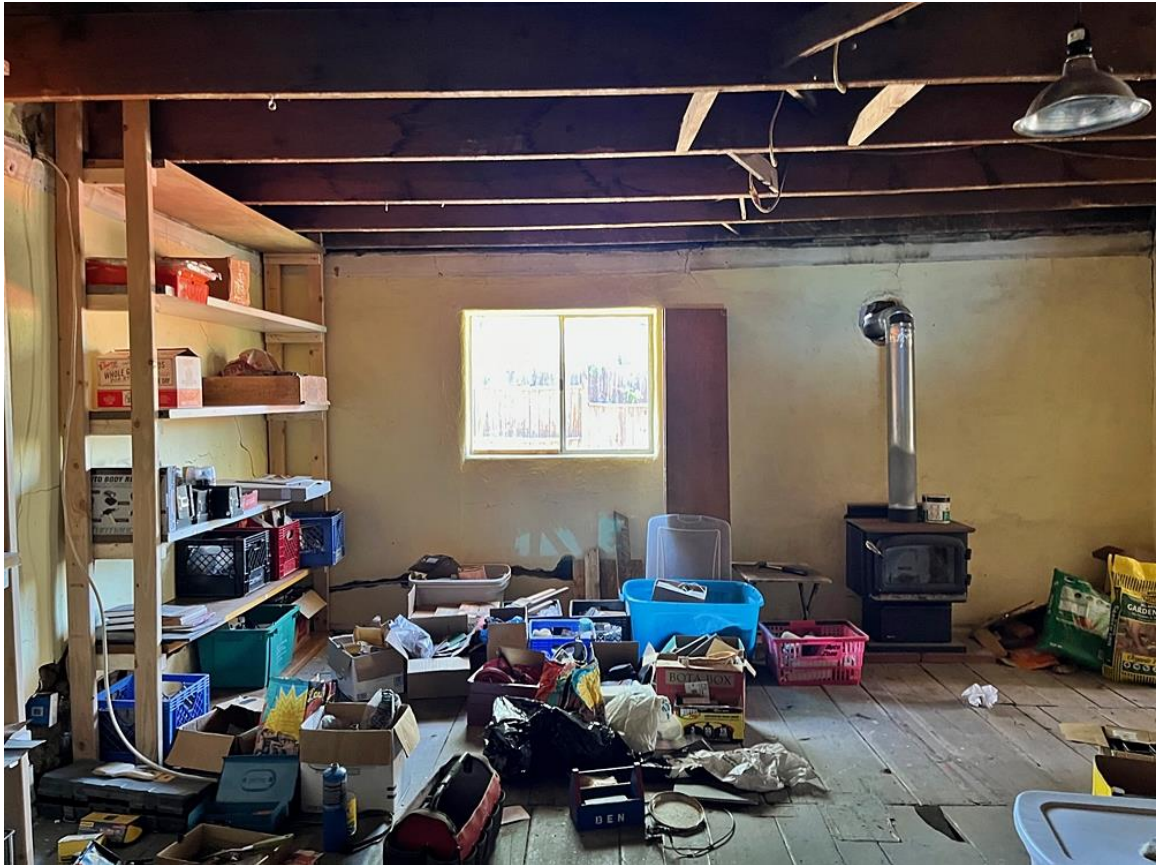
**Photo 17: Building #1. Interior of southwest room. Camera facing west.**

The entry vestibule represents the enclosed porch, which is evident by surviving windows which were once located on the exterior (Photo 16). There are several large rooms with exposed wood decking. A large 16' 10" x 17' 6" room at the southwest corner (Photo 17) reveals its adobe construction. It has a plank board floor with a few areas patched using homemade mending plates (Photo 18). A nicho is carved into the south wall (Photo 19). The bump-out containing the bathroom addition is nine inches above the adjacent room (Photo 19). It has a plywood floor painted yellow (Photo 20).

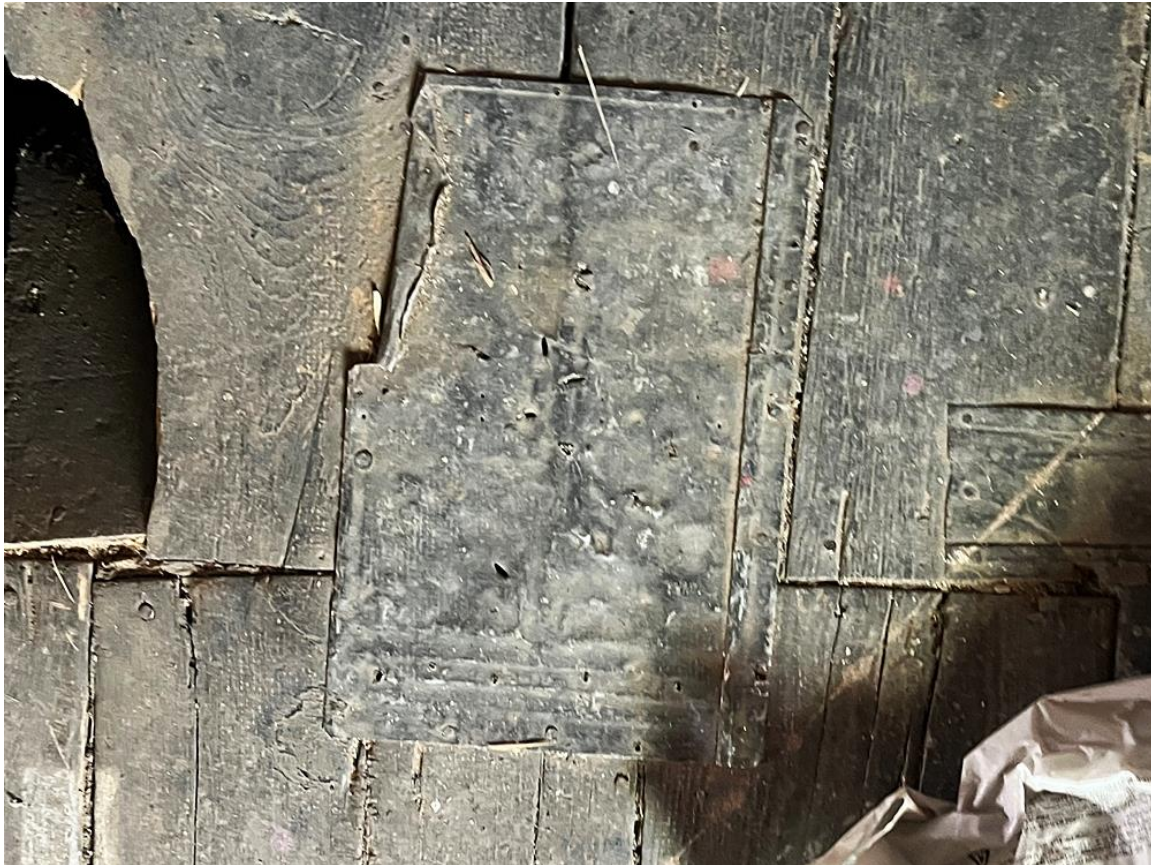
**Photo 18: Building #1. Interior of southwest room. Homemade mending plate.  
Camera facing down.**

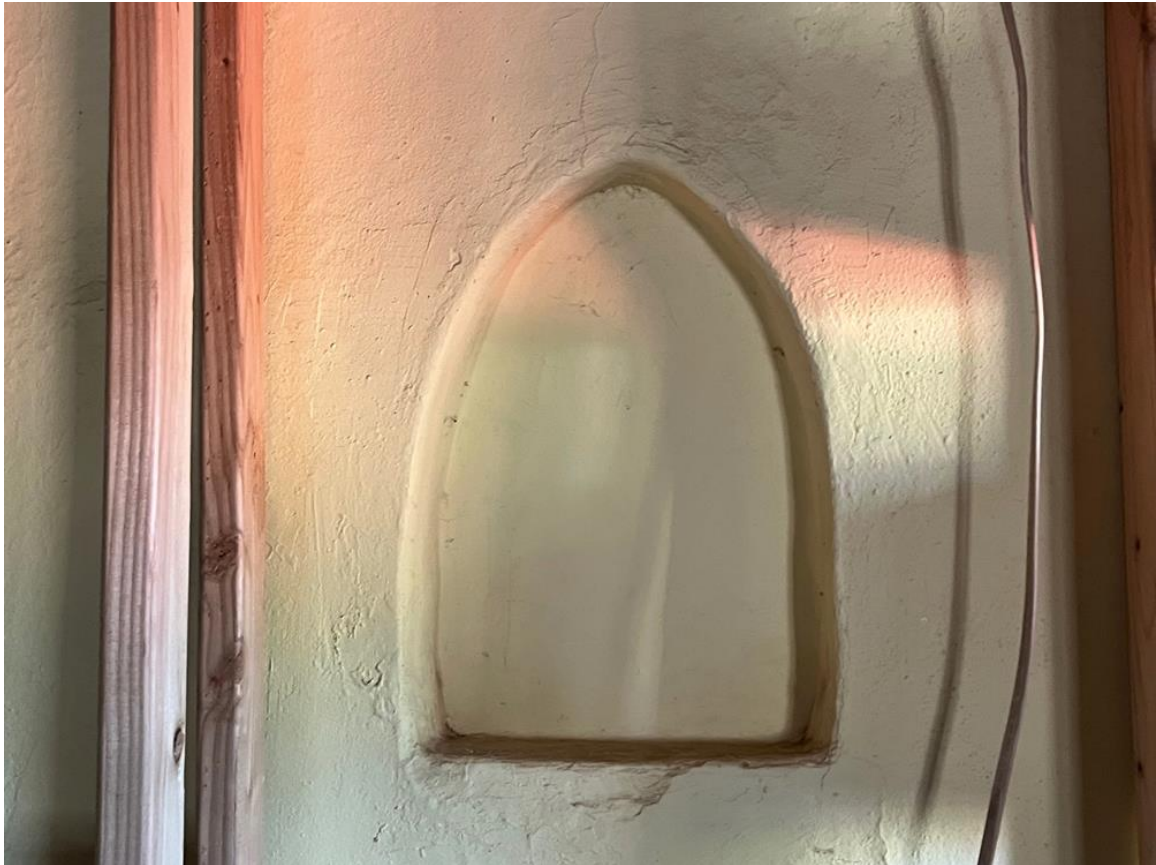
**Photo 19: Building #1. Interior of southwest room. Nicho. Camera facing south.**

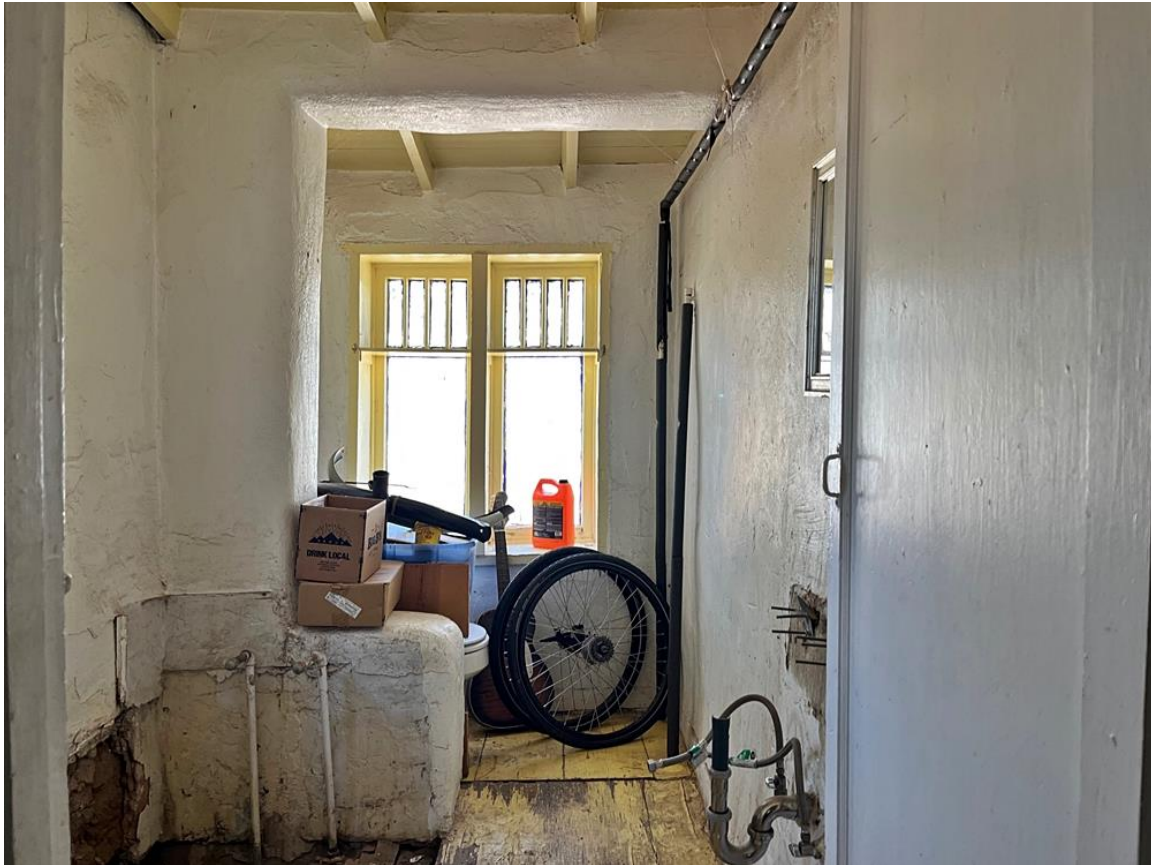
**Photo 20: Building #1. Interior of bathroom hall. Camera facing north.**

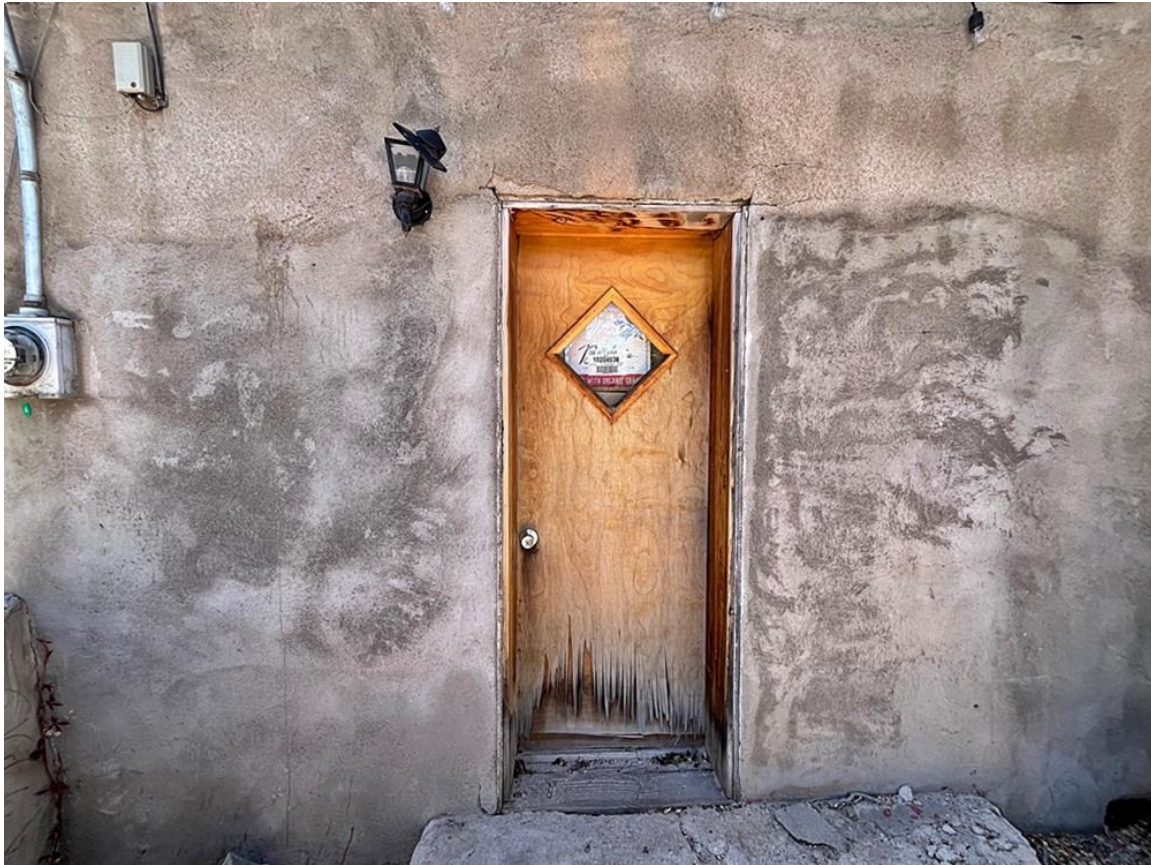
This elevation has a single opening containing the street-facing entry door (Photo 21). The door, a wood veneer unit with a “diamond” vision light, is now partially obscured by a non-historic walled patio, which includes a raised oven and surrounding bancos (Photo 22). This facade presents the basic vocabulary of the building: gray-coat stucco walls, flat surfaces, and a mix of historic and replacement fenestration. Reflecting the building’s vernacular character, the electrical meter box is mounted matter-of-factly next to the door. There is no invitation to approach this house.

**Photo 21: Building #2. East elevation. Camera facing west.**

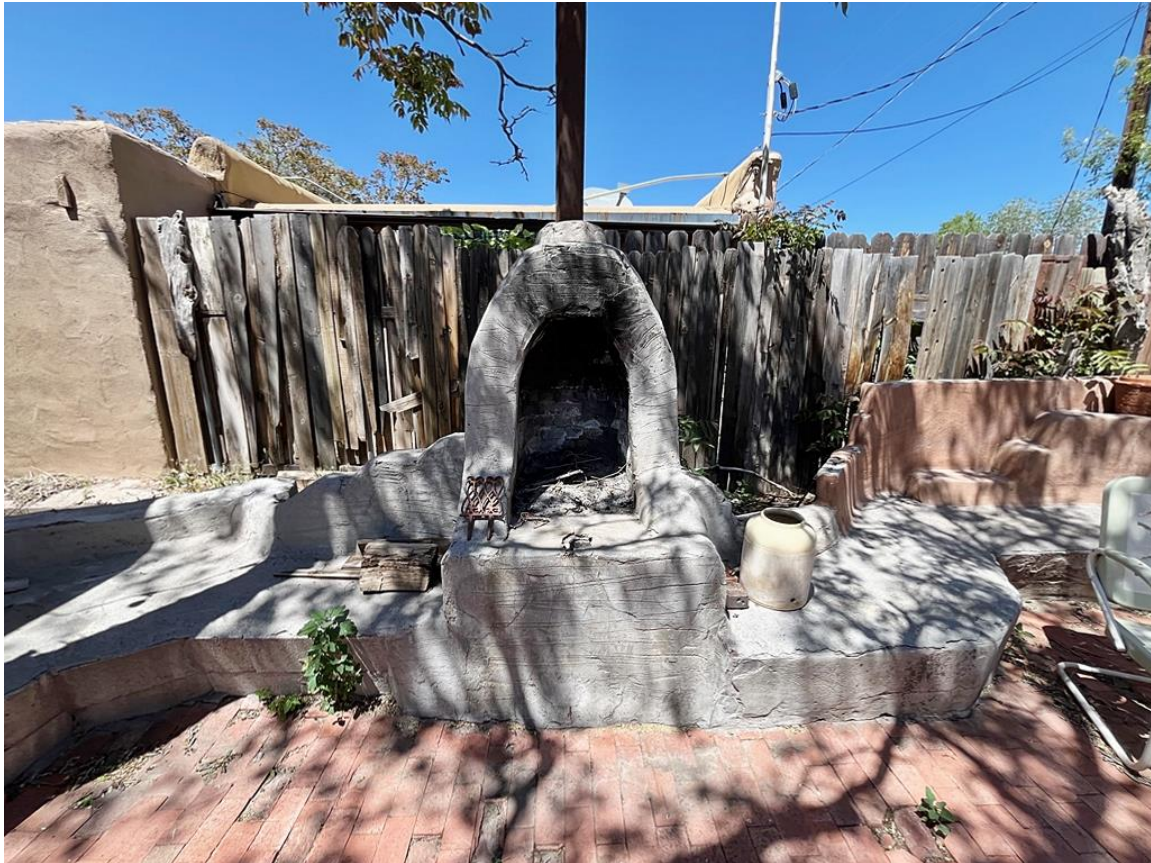
**Photo 22: Building #2. Front yard. Camera facing north.**

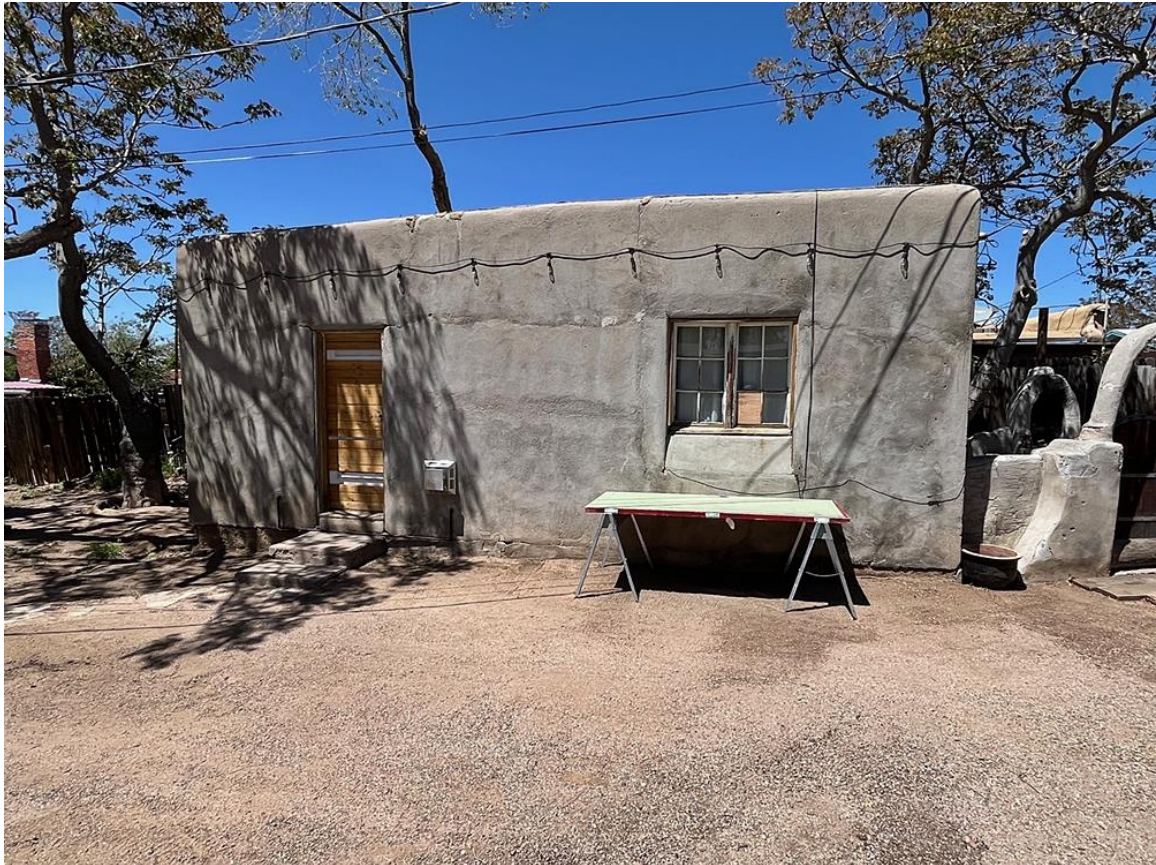
This façade serves as the everyday-use entry with one door and one window (Photo 23). The entry, situated near the west end, holds a non-historic wood panel unit approached by rough concrete steps. The window consists of two six-light wood sash divided by a mullion bar. The sash, like other units around the property, is in poor condition, with a light missing and weathering down to bare wood (Photo 24).

**Photo 23: Building #2. South elevation. Camera facing north.**

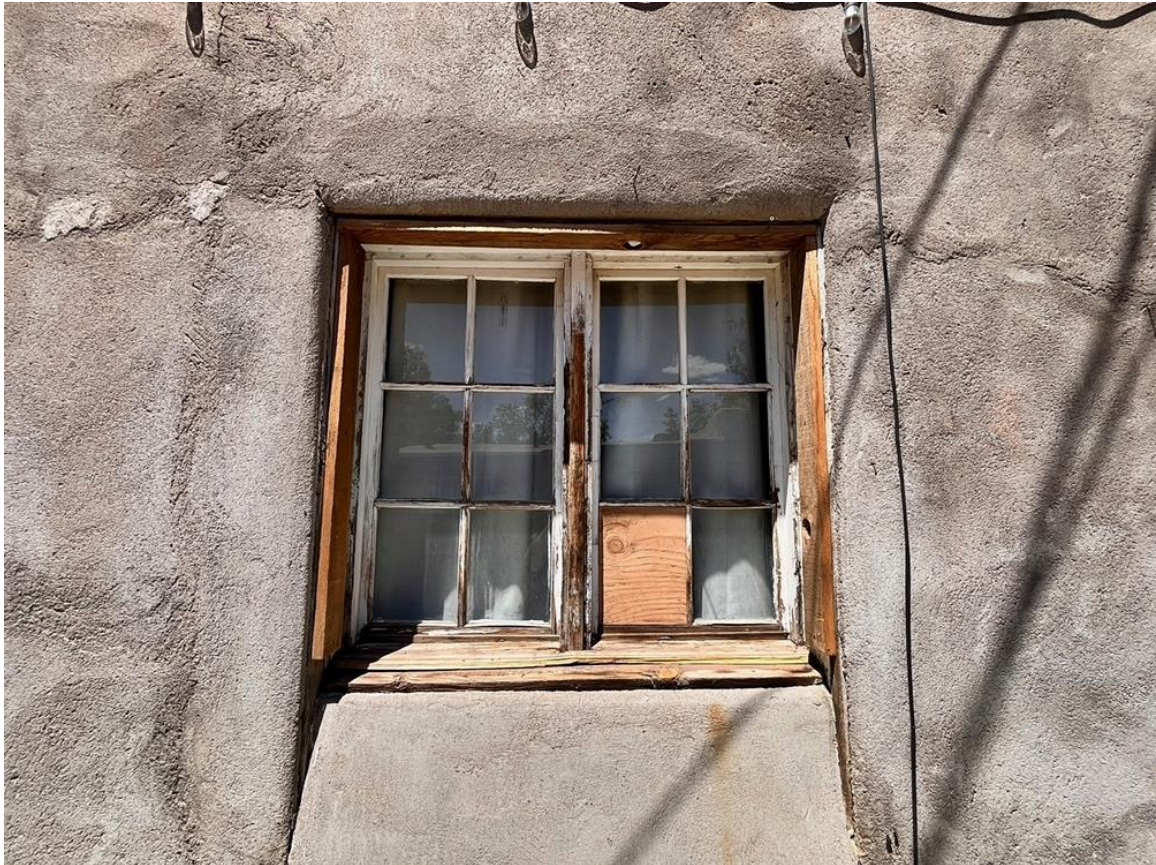
**Photo 24: Building #2. South elevation. Window. Camera facing north.**

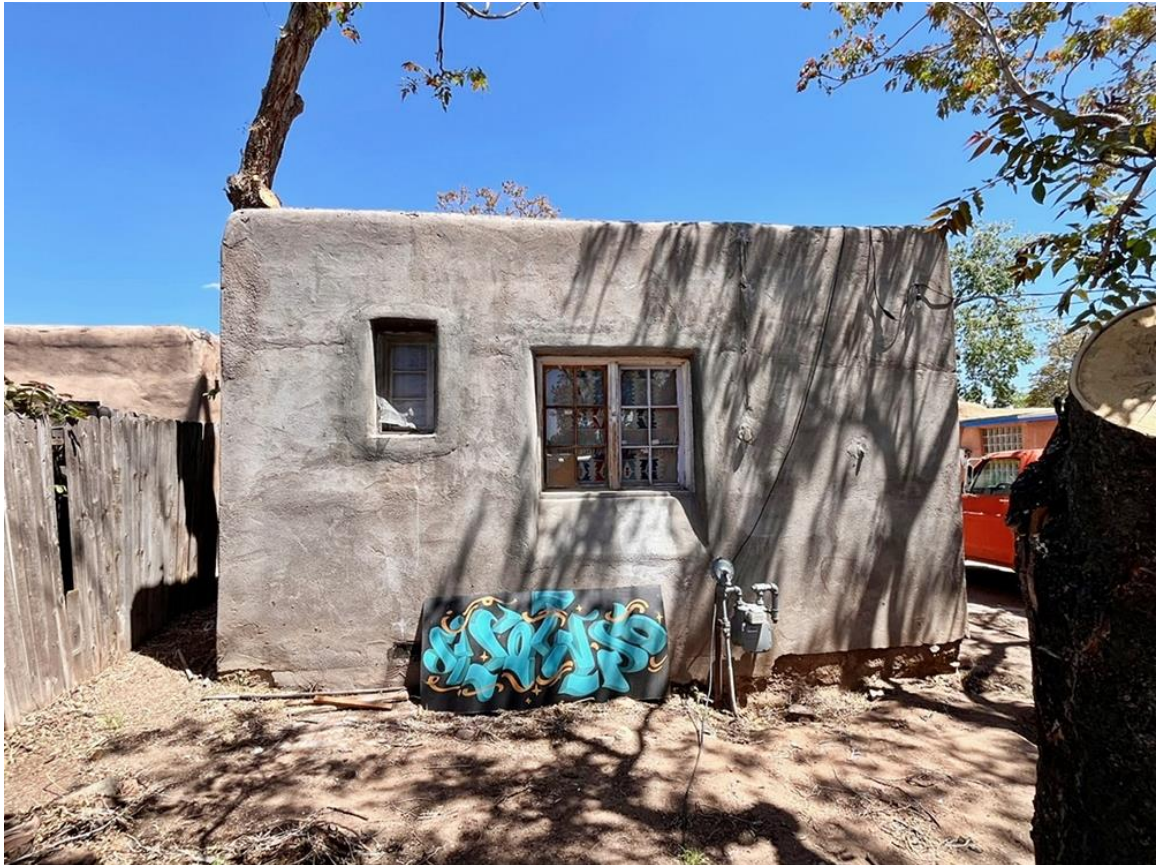
The short west façade has the most windows of the house (Photo 25). At the northwest corner is a three-light wood sash buried deeply into the wall at the bathroom (Photo 26). Sitting at a lower position are two six-light wood sash with a mullion (Photo 27). One light is cracked and blocked with a piece of wood.

**Photo 25: Building #2. West elevation. Camera facing east.**

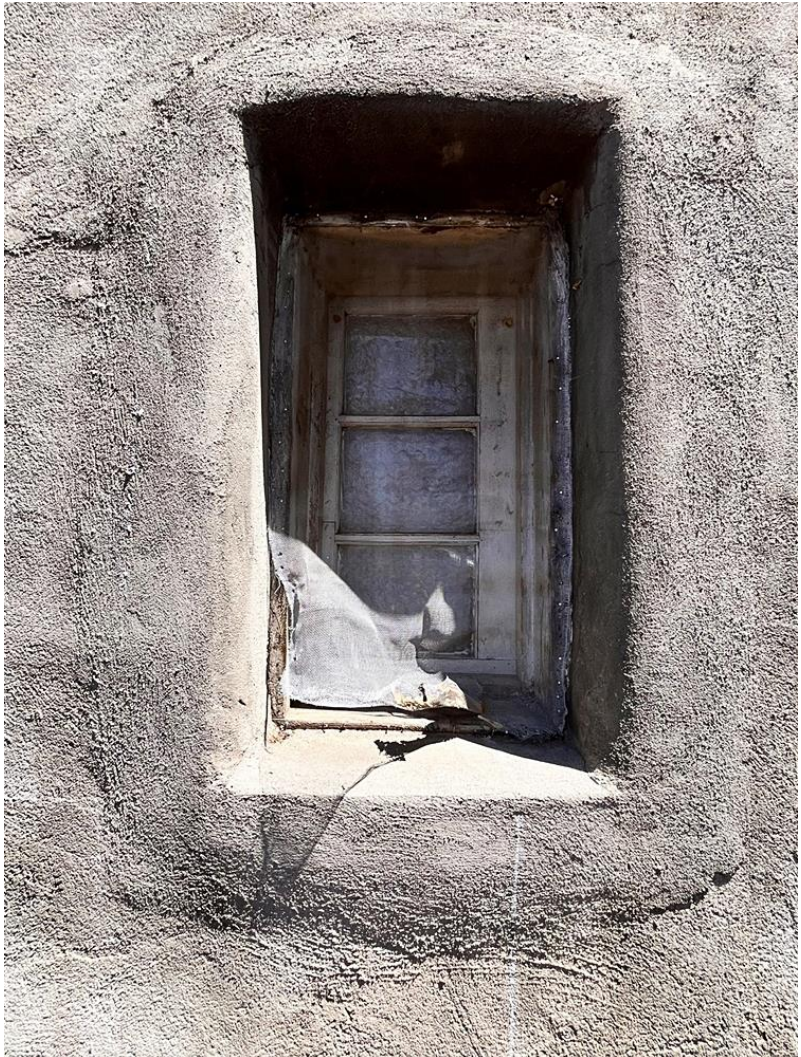
**Photo 26: Building #2. West elevation. North window. Camera facing east.**

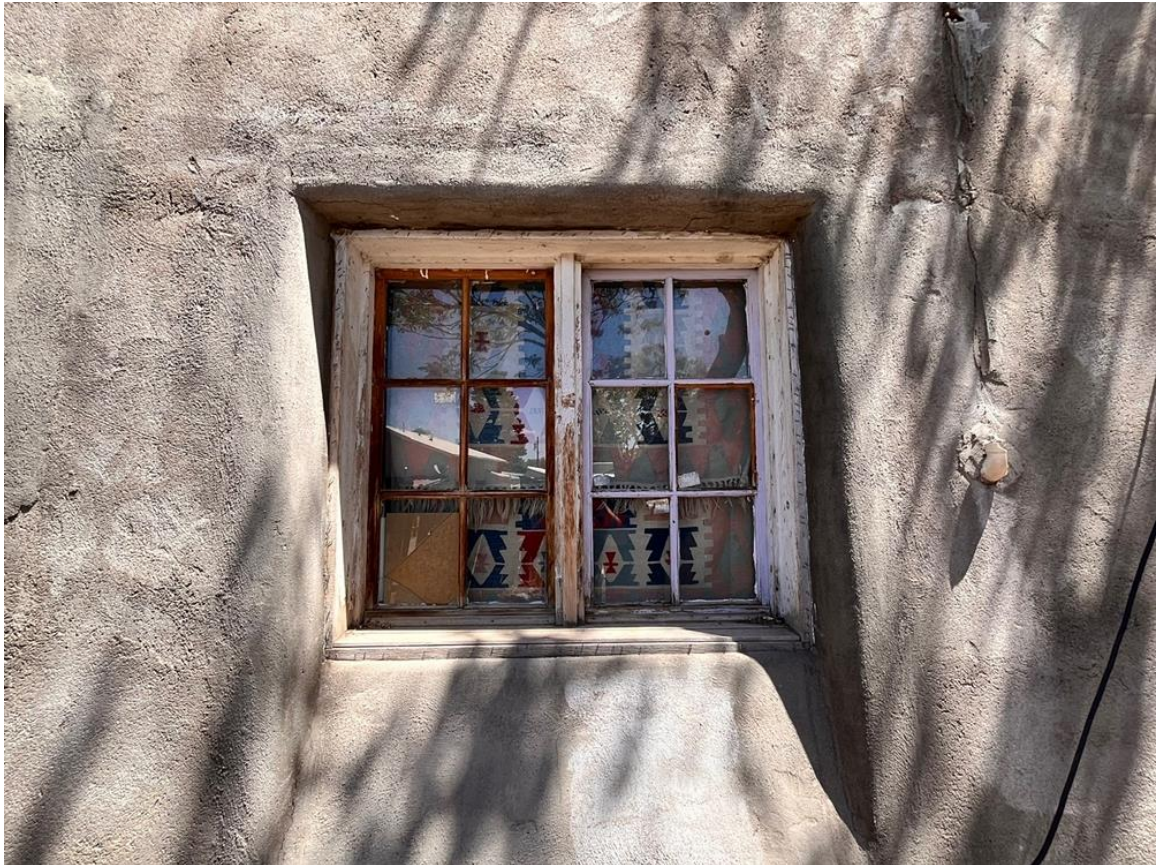
**Photo 27: Building #2. West elevation. South window. Camera facing east.**

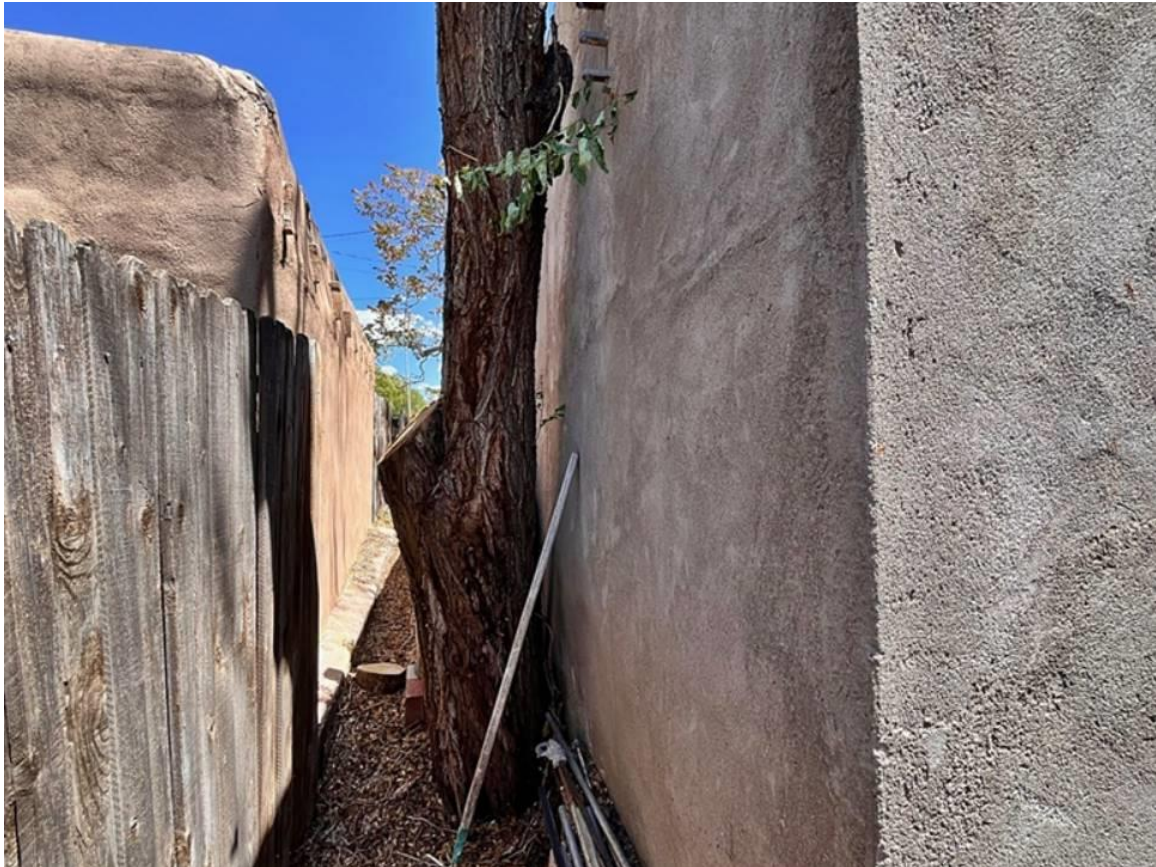
The north side of the building has no fenestration (Photo 28).

**Photo 28: Building #2. North elevation. Camera facing east.**

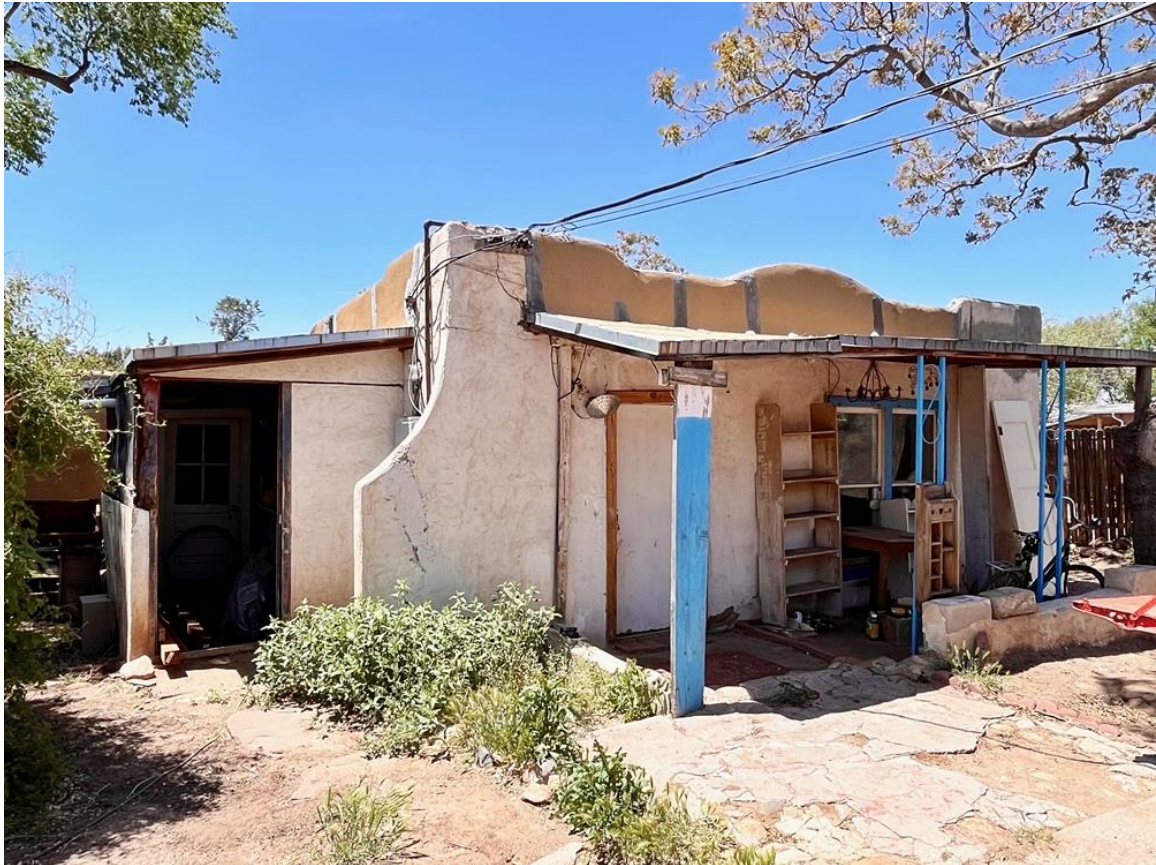
**Photo 29: Building #3. East elevation. Camera facing northwest.**

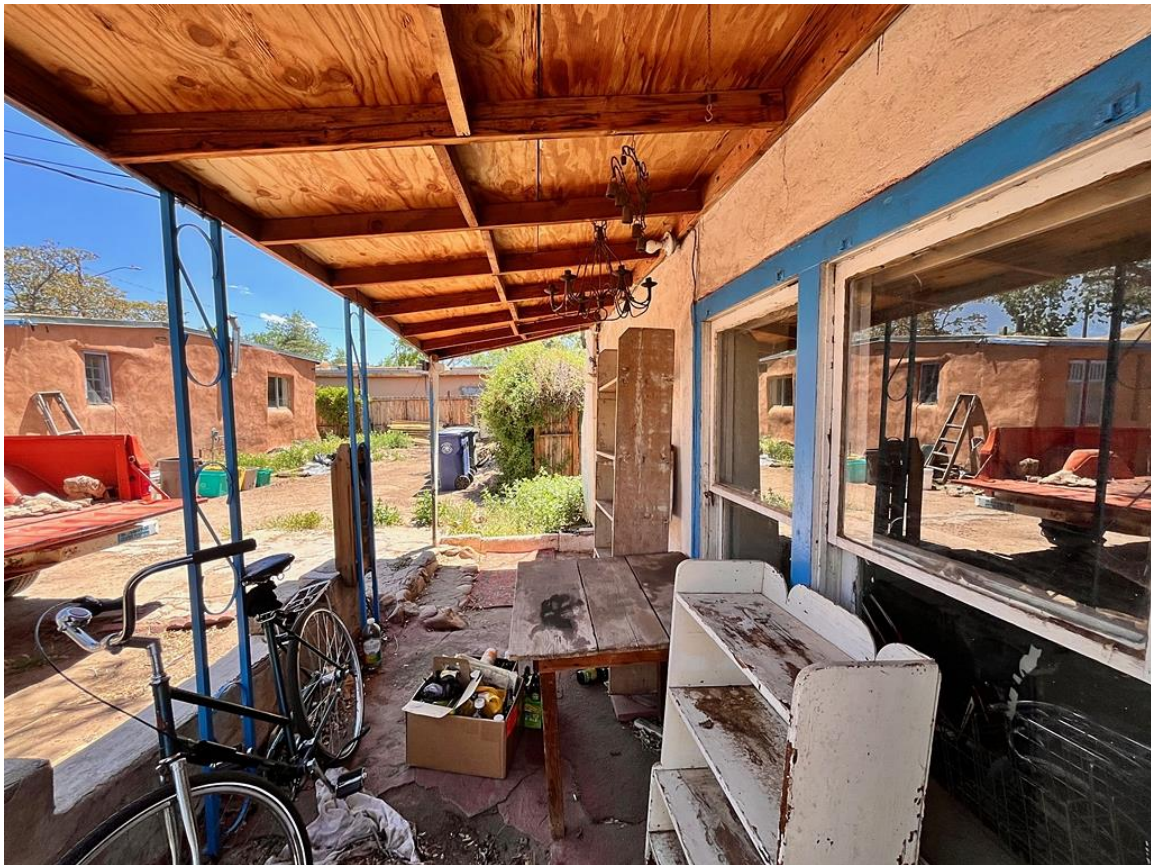
**Photo 30: Building #3. East elevation. Porch. Camera facing south.**

The rest of the façade is characterized by replaced fenestration and poor repairs. A non-historic shed-roof porch spans the façade, constructed of plywood and 2x4s and supported by wobbly posts incorporating pieces of metal scroll columns (Photo 30). The entrance holds a modern hollow-core wood door framed by rough casings (Photo 31). To the north are two 1/1 wood sash windows, which appear to be repurposed and are installed upside down (Photo 32).

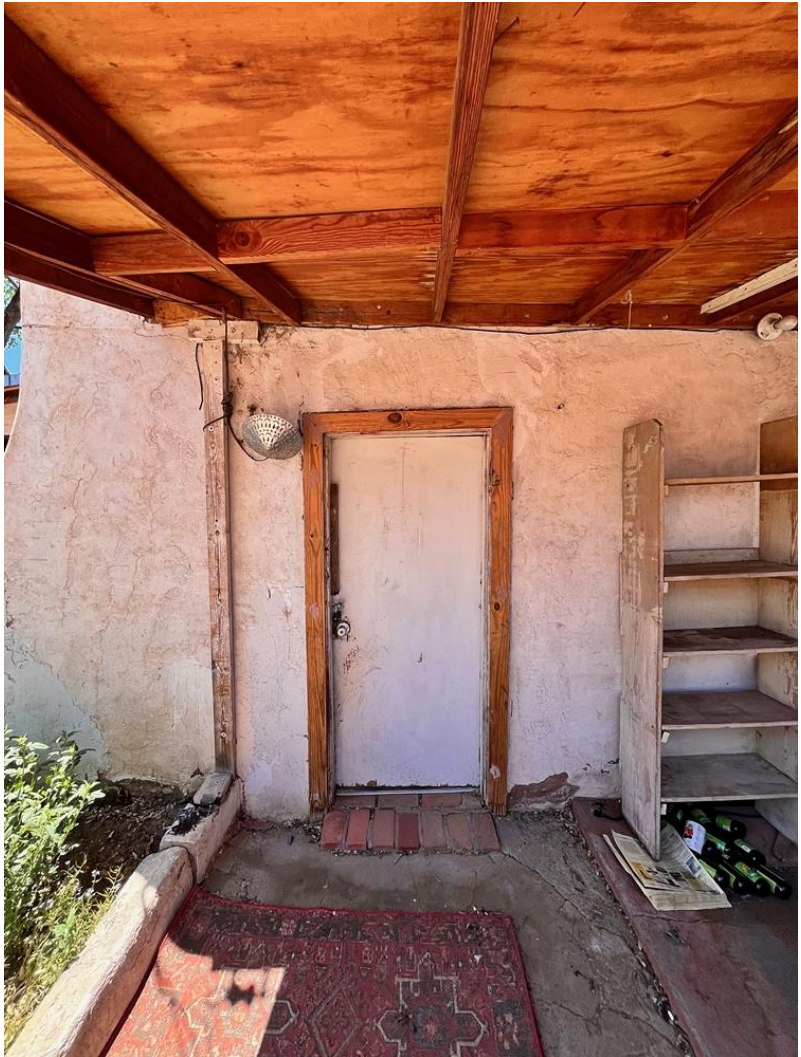
**Photo 31: Building #3. East elevation. Entry door. Camera facing west.**

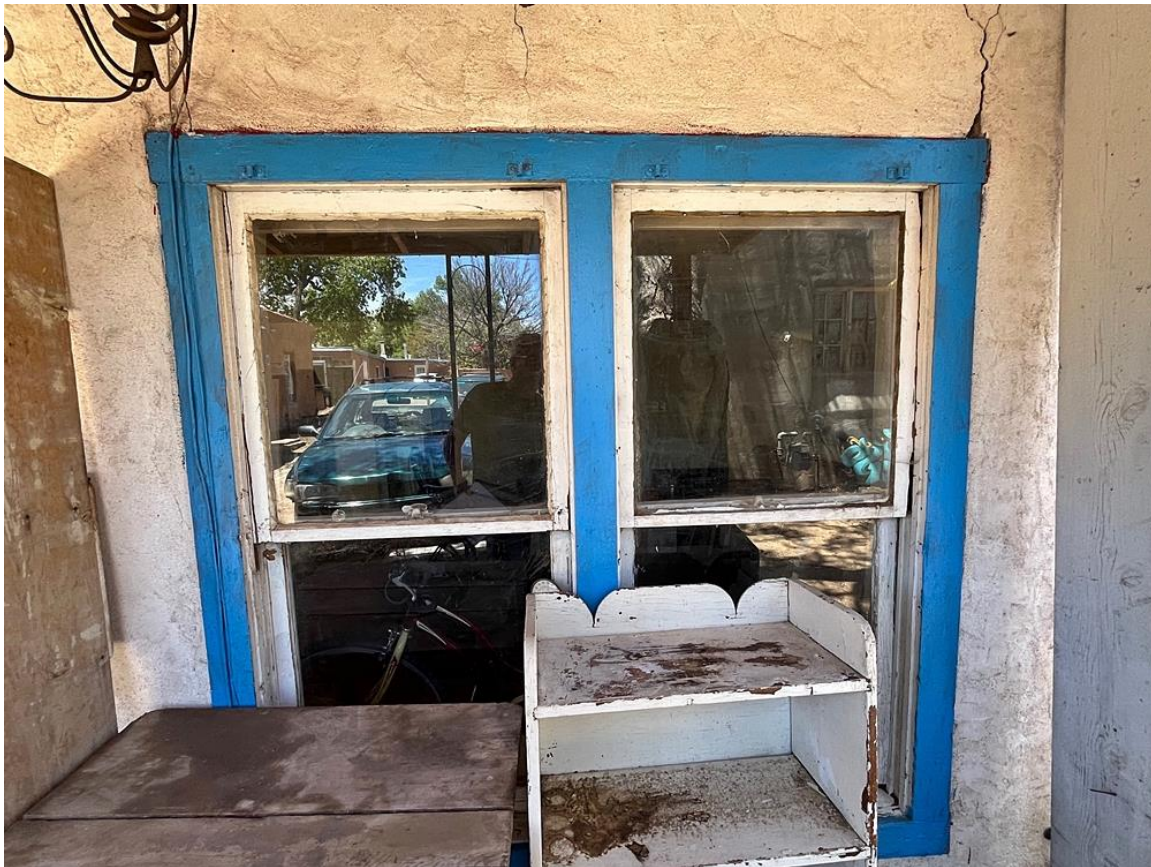
**Photo 32: Building #3. East elevation. Window. Camera facing west.**

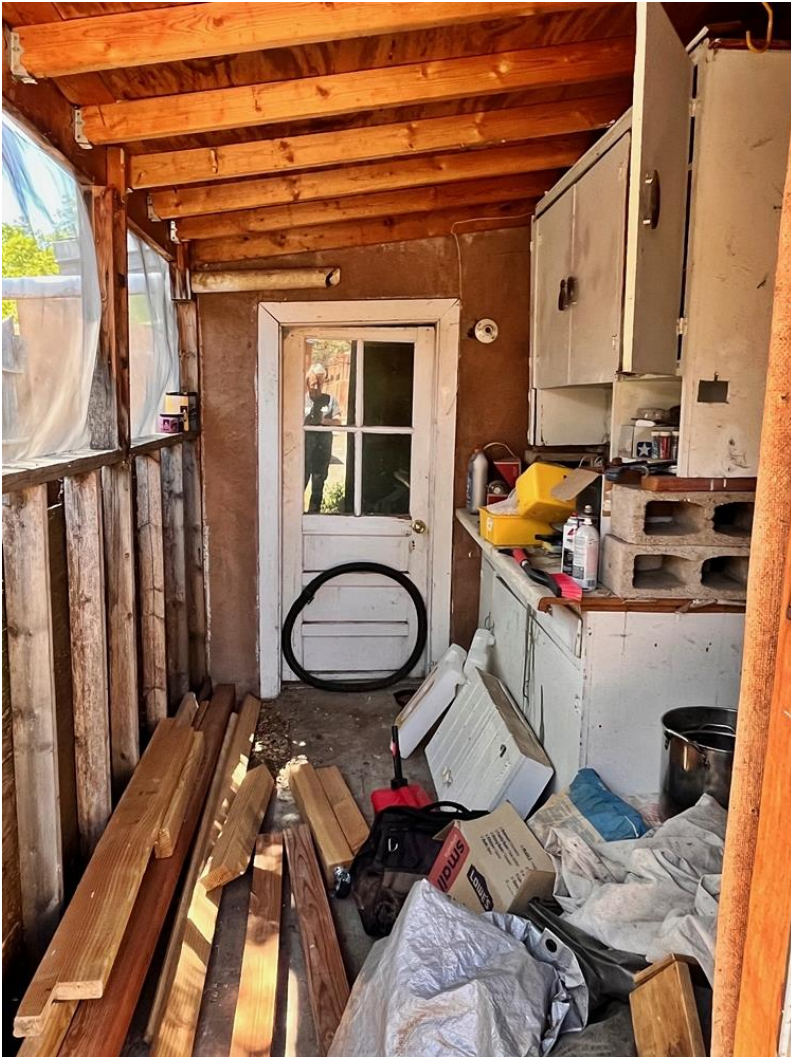
**Photo 33: Building #3. East elevation. Outdoor kitchen addition. Camera facing west.**

Attached to the south is a shed-roof extension functioning as an outdoor kitchen (Photo 33).

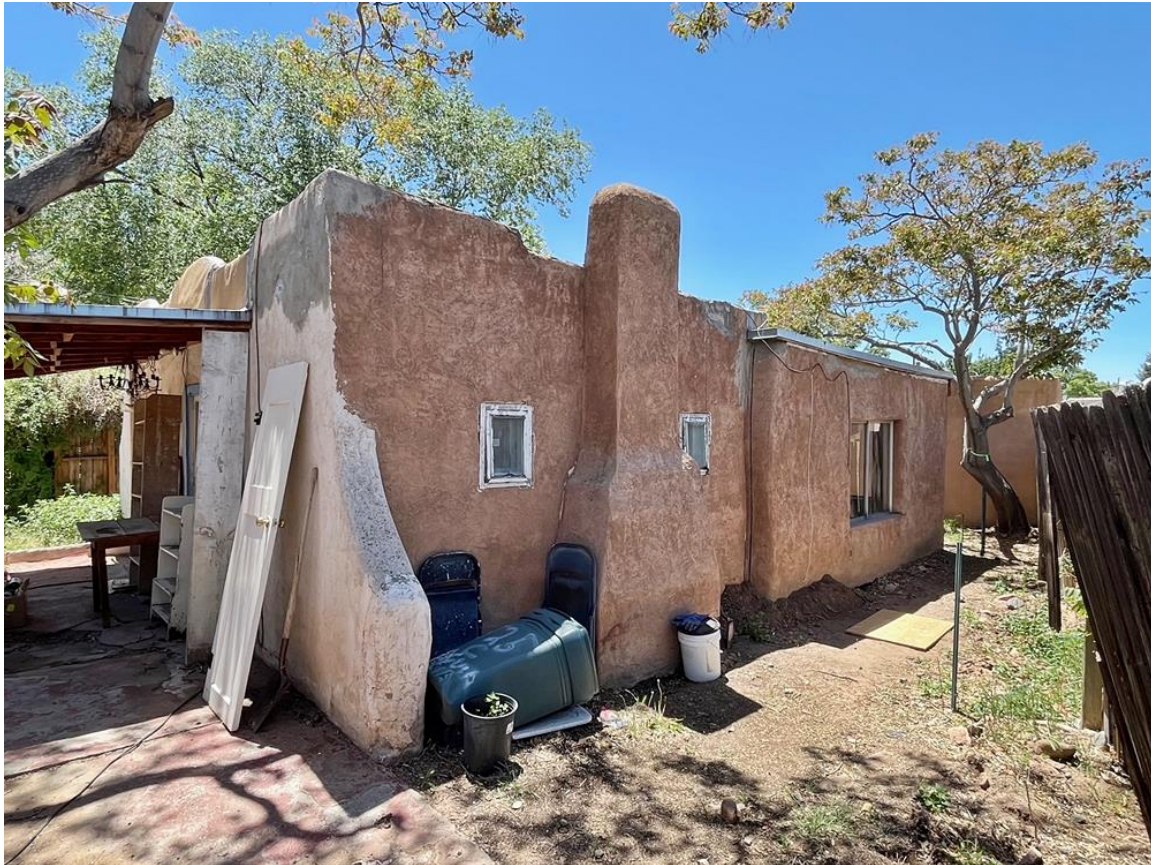
**Photo 34: Building #3. North elevation. Camera facing southeast.**

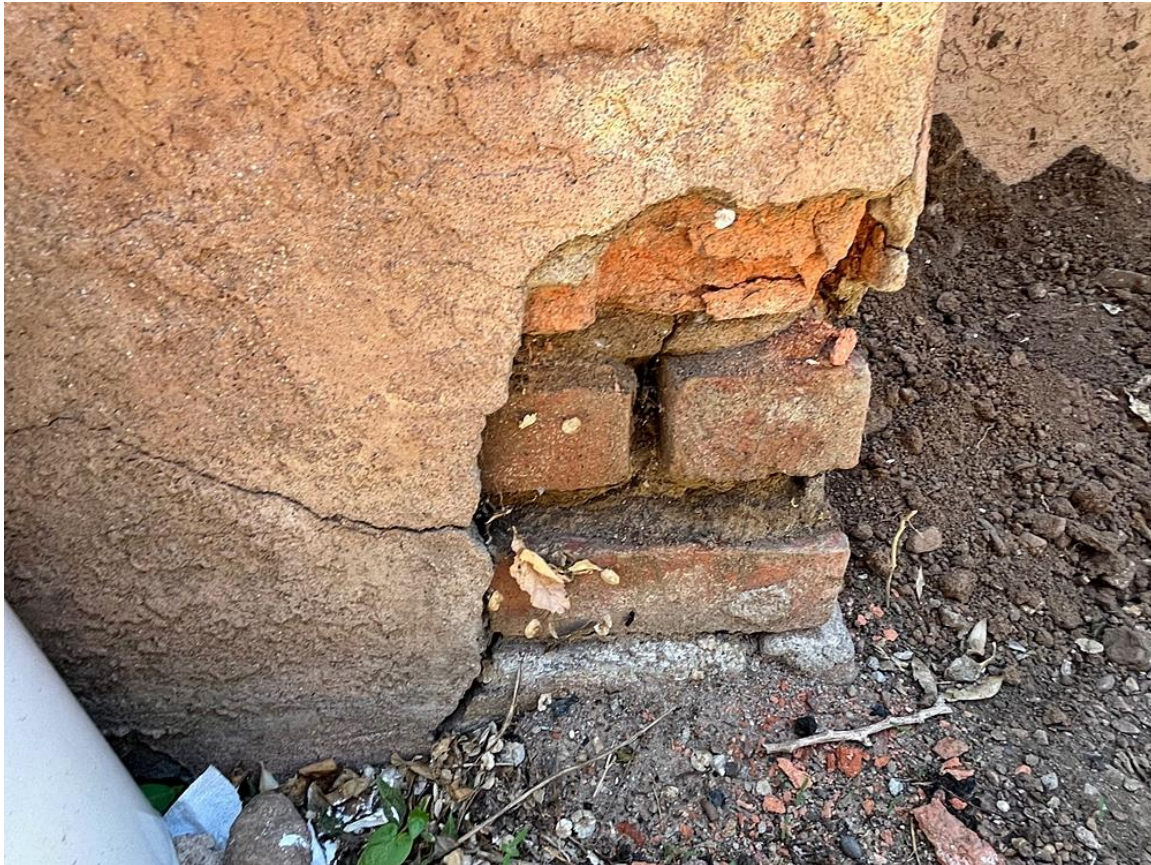
**Photo 35: Building #3. North elevation. Exposed brick at chimney. Camera facing down.**

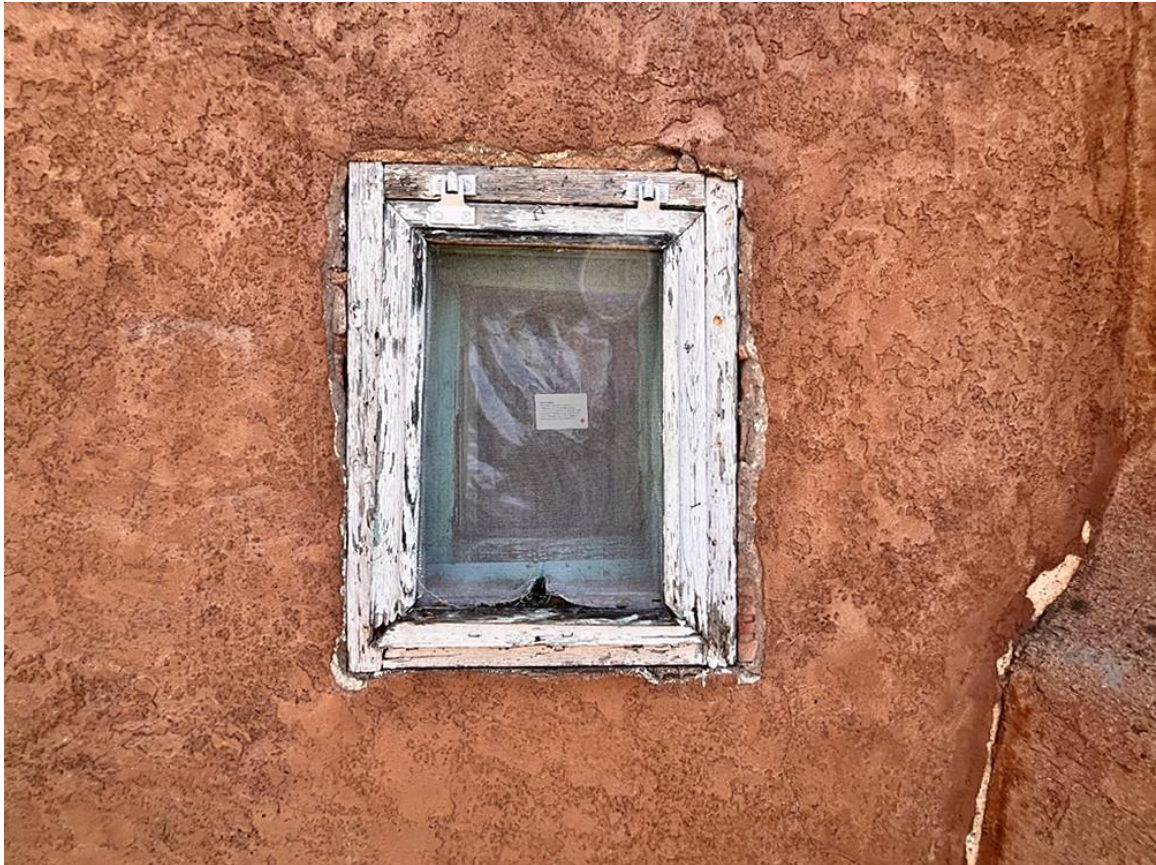
The north elevation presents a traditional fireplace façade, with a centered chimney flanked by small windows (Photo 34). Removed stucco reveals that the chimney is constructed of soft bricks (Photo 35). The flanking windows measure 17½ x 22½ inches and are single-light casements (Photo 36). In a more developed home, these would typically be multi-light units. A piece of hollow clay tile is exposed at one of the windows, suggesting that the original core of the building is constructed of this material (Photo 37).

**Photo 36: Building #3. North elevation. Window east of chimney. Camera facing south.**

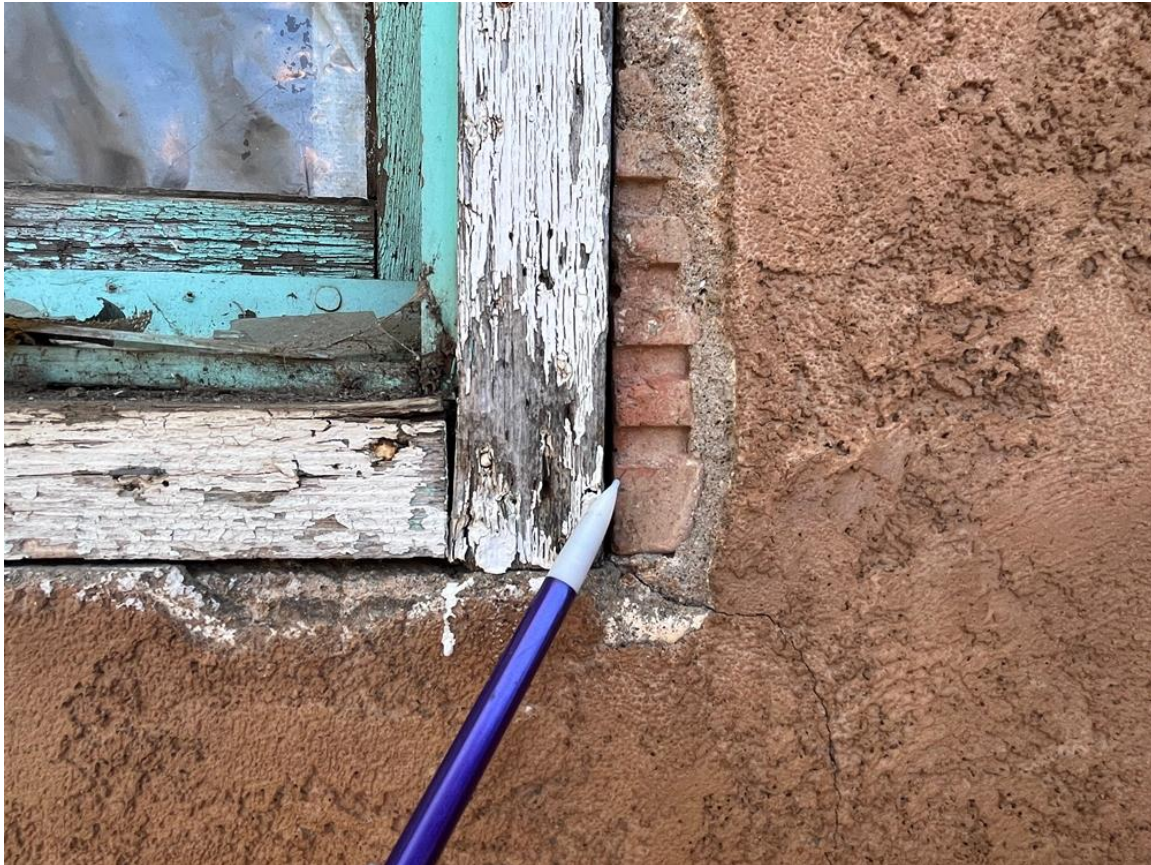
**Photo 37: Building #3. North elevation. Window east of chimney. Clay tile block construction exposed. Camera facing south.**

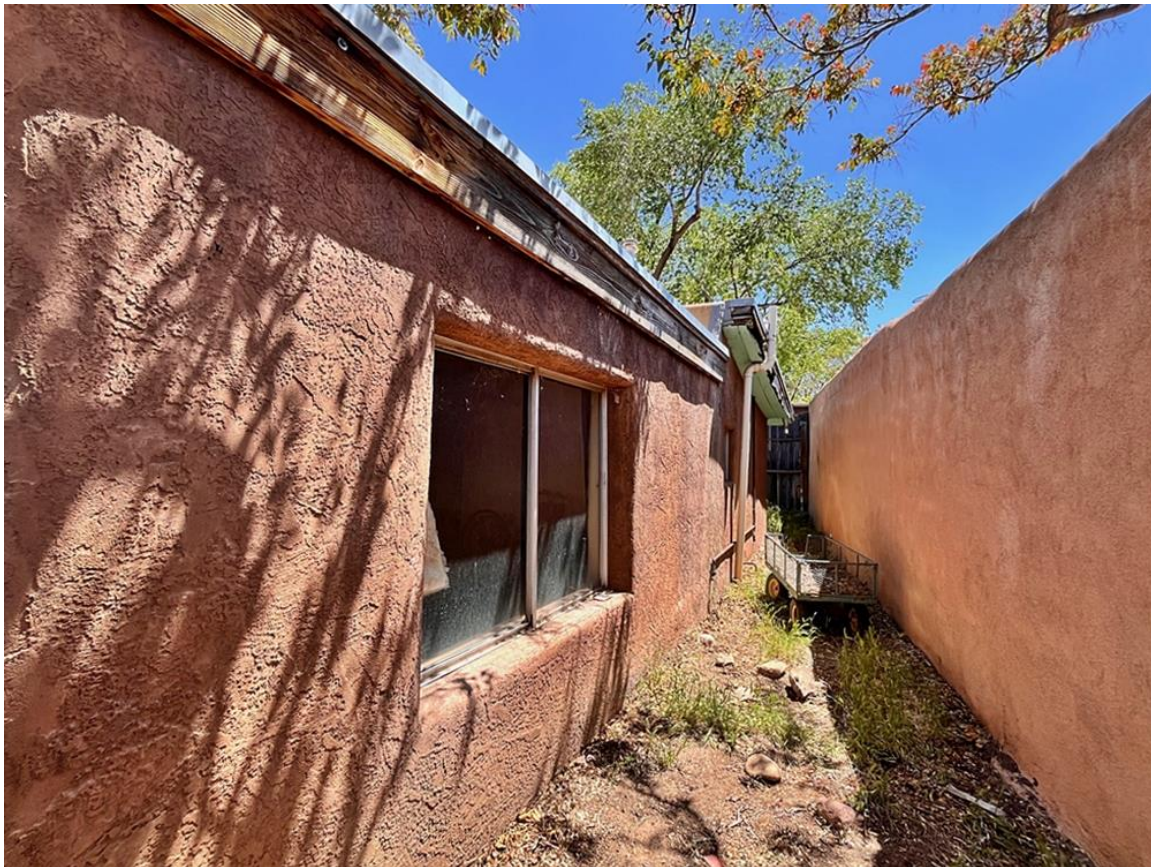
The west elevation sits close to the rear side of a house on Closson Street. It consists of two additions with different roof heights, each containing a sliding aluminum window (Photo 38). The southern addition has a roof that slopes to the south.

**Photo 38: Building #3. West elevation. Camera facing south.**
