RE: 222 Polaco Street Status Review Buildings A, B, C

# Historic Cultural Properties Inventory (HCPI) Base Form (FORM 1)

# Historic Cultural Properties Inventory (HCPI) Detail Form (FORM 2)

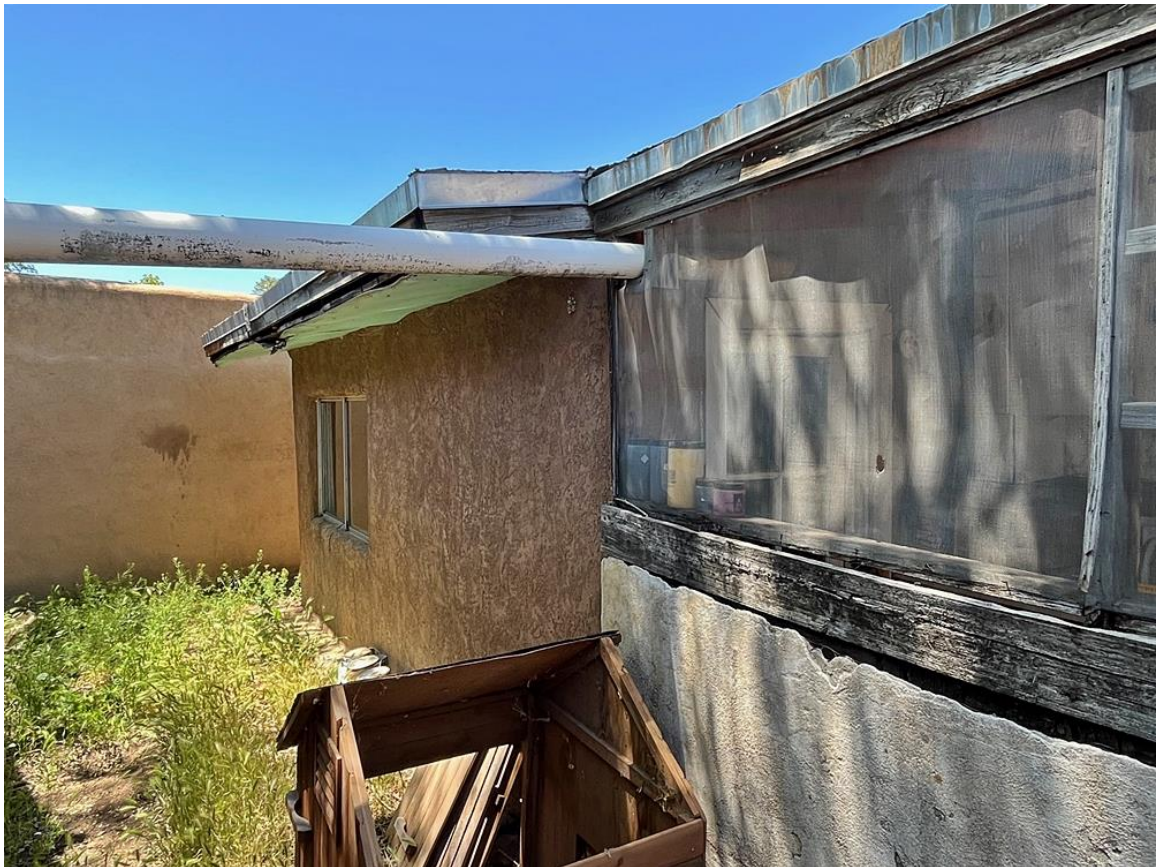
This elevation comprises the sloped-roof addition and the extension forming the outdoor kitchen (Photo 39). The former has a pronounced overhang with a rotting plywood soffit painted green. Like the other additions to the dwelling, it contains a sliding aluminum window. The kitchen lean-to includes a pony wall topped by an opening filled in with screen.

**Photo 39: Building #3. South elevation. Camera facing northwest.**

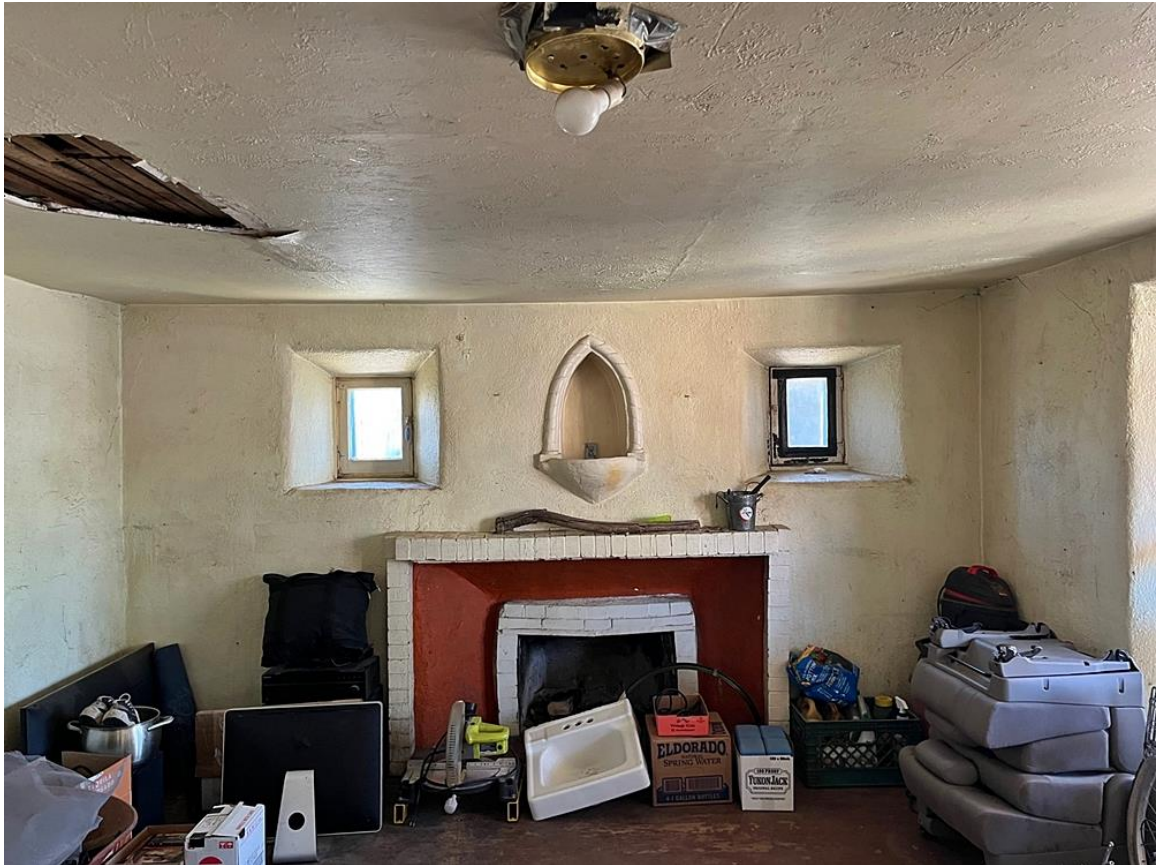
The interior, enclosing four rooms, is a mixture of design and materials. They reflect the various construction phases and the modest—likely owner-built—approach. The front door opens to a 13' 8" x 18' 11" living room with a traditional layout featuring a centered fireplace bookended by the previously mentioned windows (Photo 40). The economical character of the house is evident in the painted brick mantel and surround. A nicho with twisted rope-molded columns is located above the mantel, though it is not exactly centered. The ceiling has a textured plaster finish with areas of exposed lath.

**Photo 40: Building #3. Interior of living room. Camera facing north.**

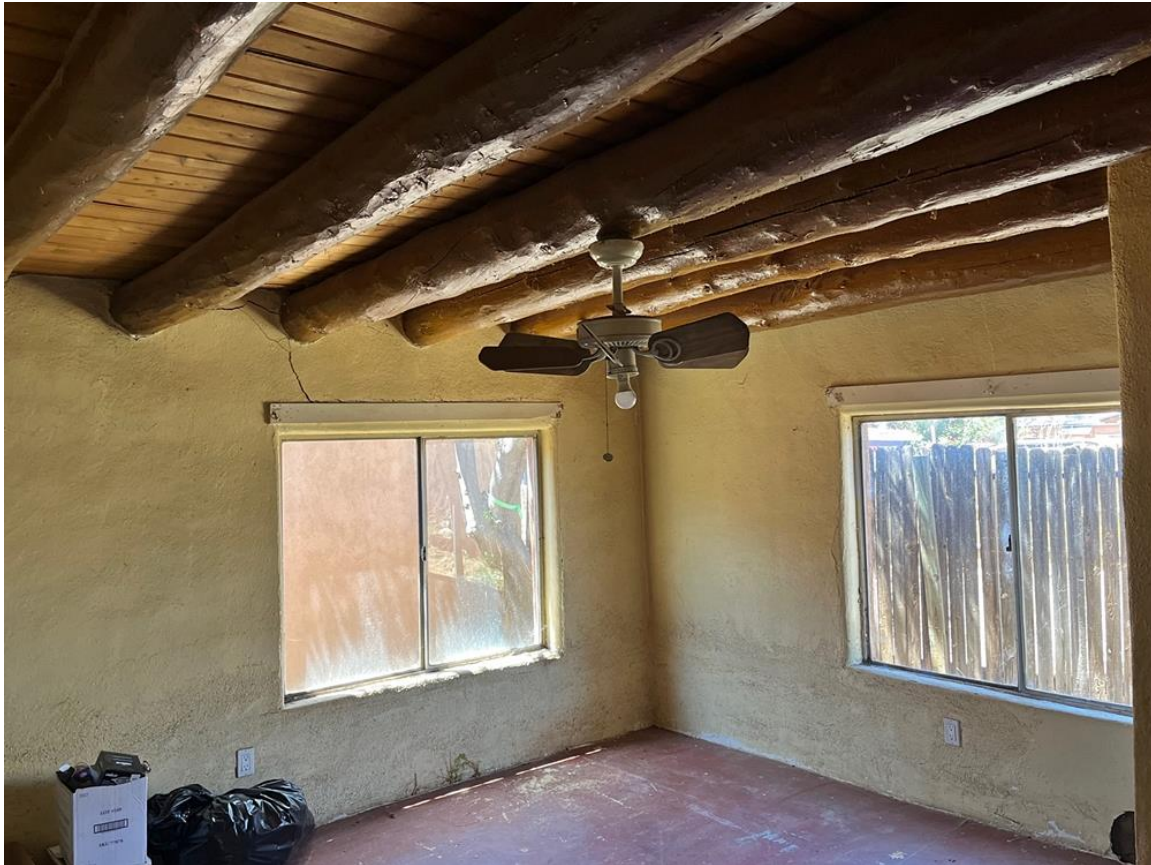
The bedroom at the northwest corner displays large vigas finished with a clear varnish or polyurethane coating (Photo 41). The kitchen and bathroom are of different design and further illustrate the economical construction, with rough textured walls and tacked-on cabinetry (Photos 42 & 43).

**Photo 41: Building #3. Interior of bedroom. Camera facing northwest.**

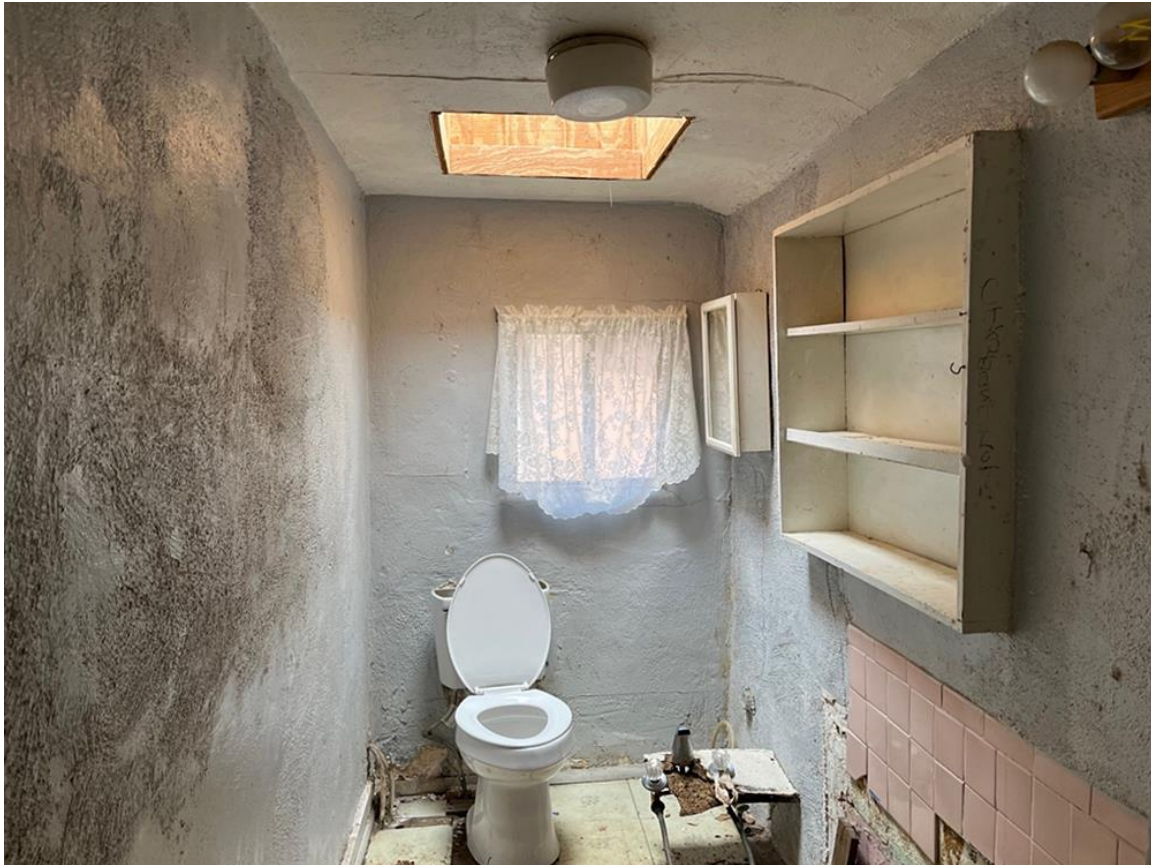
**Photo 42: Building #3. Interior of bathroom. Camera facing west.**

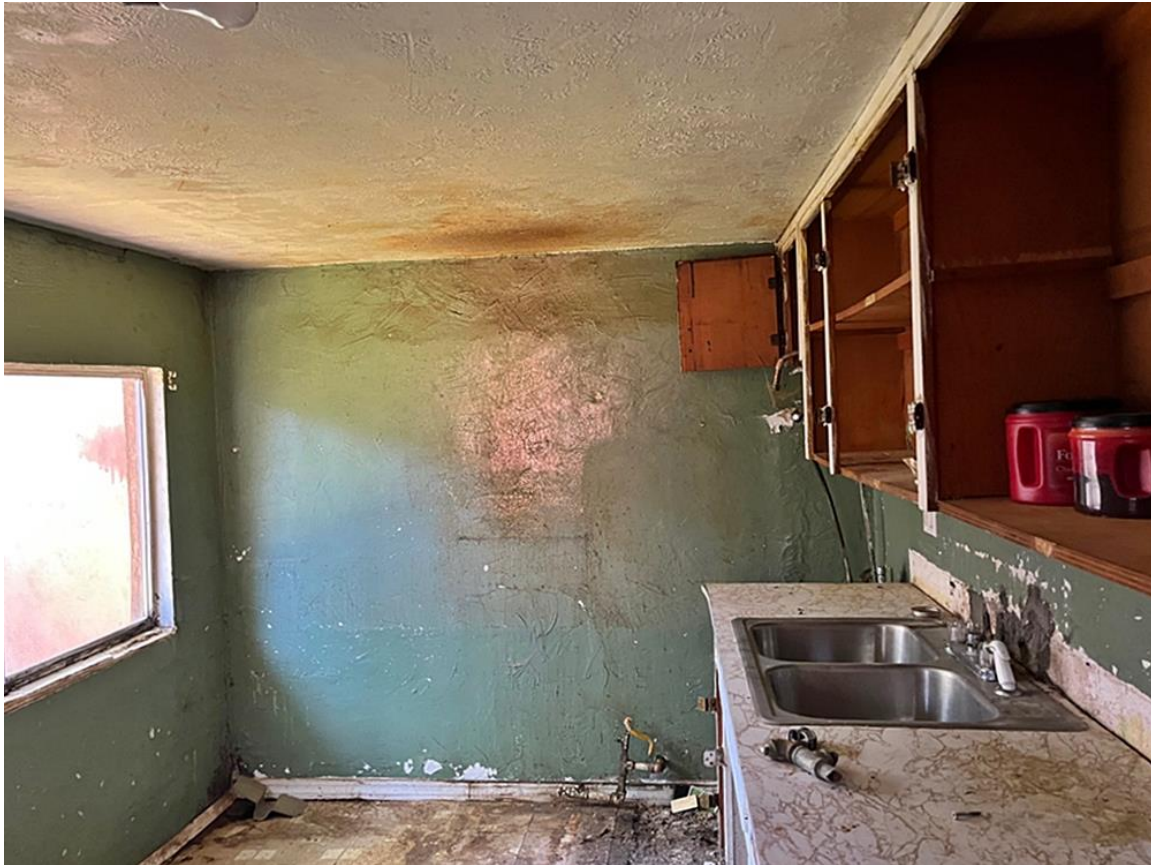
**Photo 43: Building #3. Interior of kitchen. Camera facing west.**
