# Historic Cultural Properties Inventory (HCPI) Base Form (FORM 1)

| For HPD Office use only: | | District No. | | NRHP | SRCP | Criteria | A | B | C | D |
|---|--|---|--|---|---|---|---|---|---|---|
| Plaza del Monte<br>Residence 24<br>& Garage/Carport | | 126 Camino Santiago<br>Downtown and Eastside Historic District | | Santa Fe ID #: N/A<br>Plaza del Monte Inventory | | | | | | |

# PLAZA DEL MONTE

## Historic Resources Evaluation

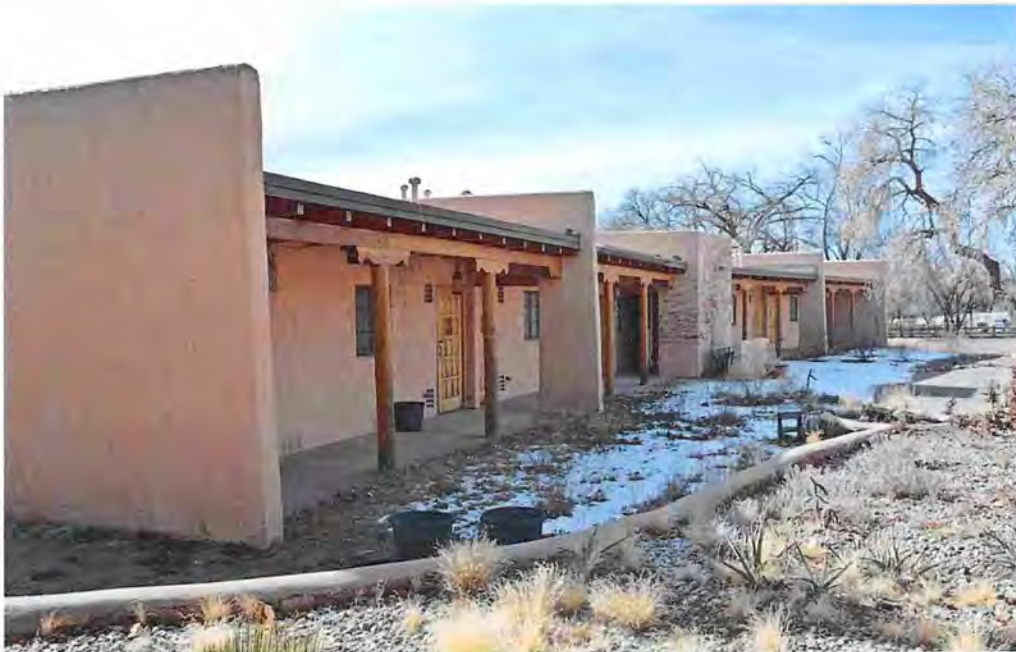
**Photo 1: North elevation, facing southwest.  
Low wall in foreground.**

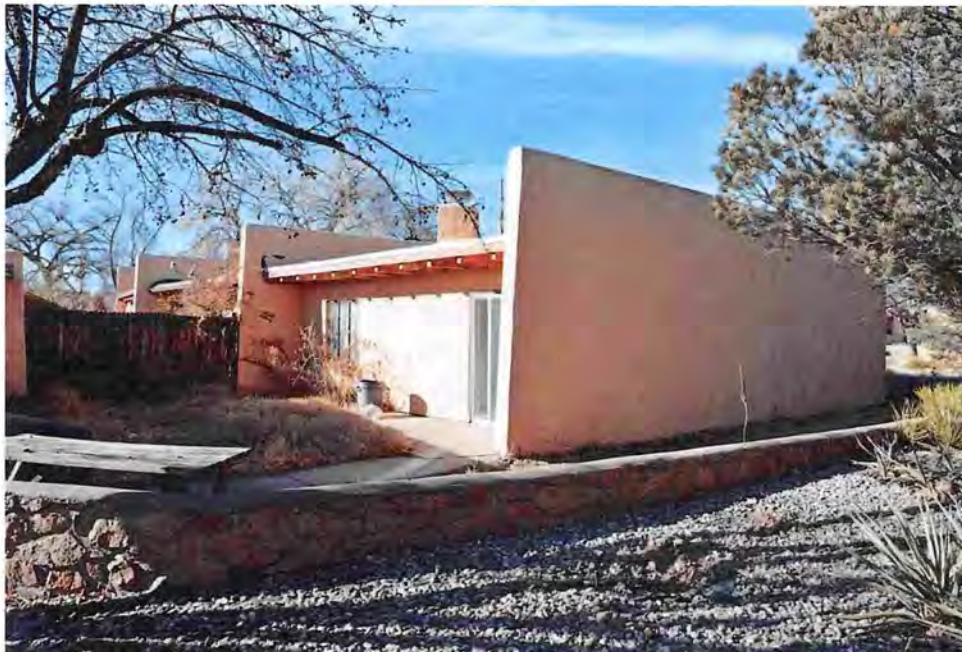
**Photo 2: East and south elevations, facing northwest.  
Low wall in foreground.**

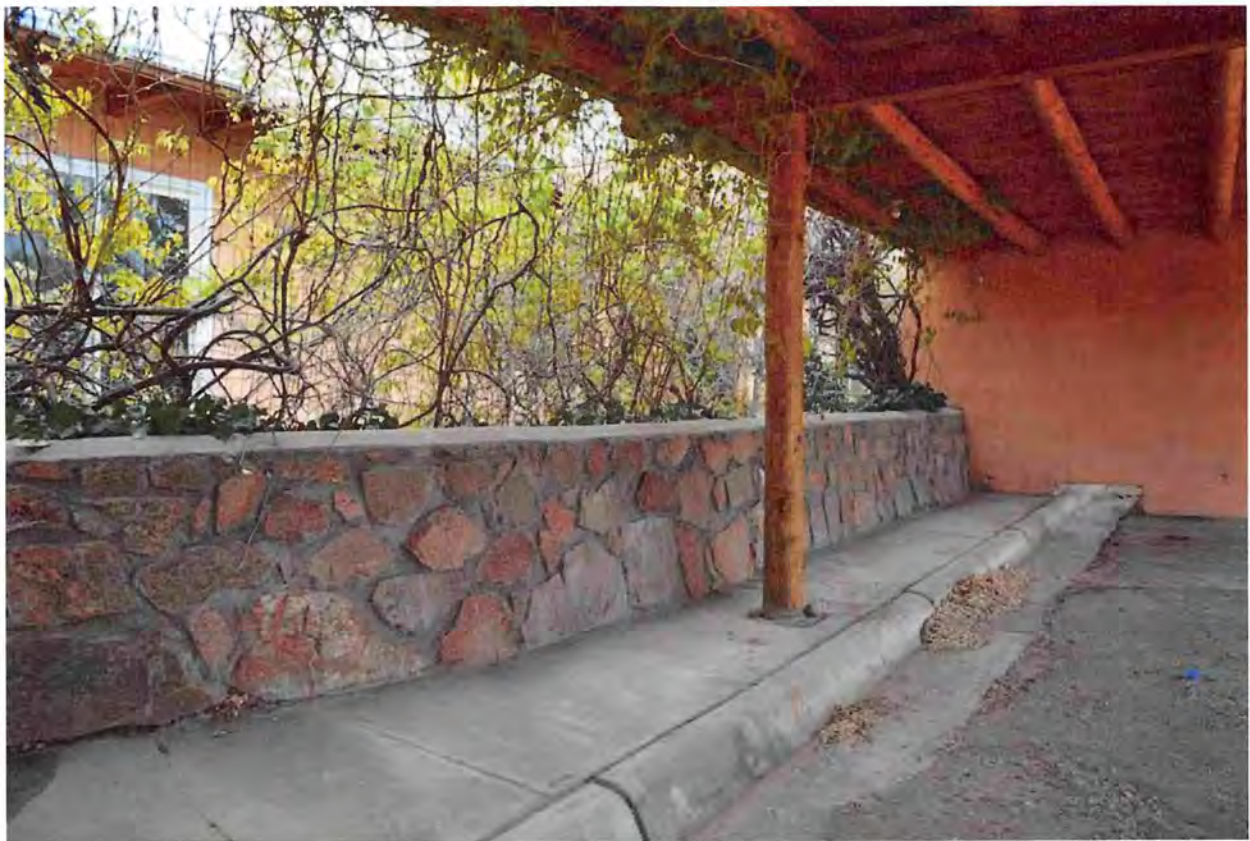
**Photo 4: Retaining wall between apartment and parking structure, facing northeast.  
May 3, 2018.**

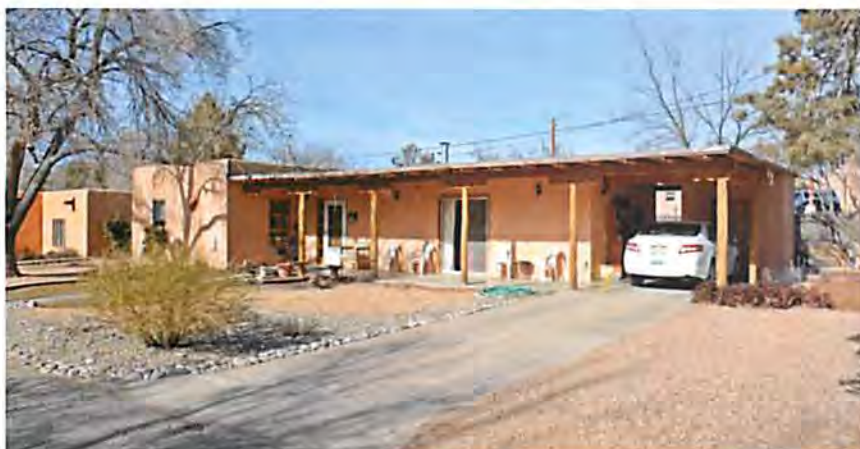
Surviving drawings show Register pushing beyond the traditional plan of the earlier Clark and Register designs. While previous elevation and floor plans were recycled for subsequent houses, Register opted to add large areas of glass across the front façade, primarily by inserting sliding doors under the portal (103 and 111 Camino Santiago) (Figure 7). While retaining the basic roomblock bedroom wing, Register often attenuated the stem of the "L" with a more contemporary, one-room-wide Ranch house plan.

Figure 7: 111 Camino Santiago, an example of Philippe Register's transitional work.

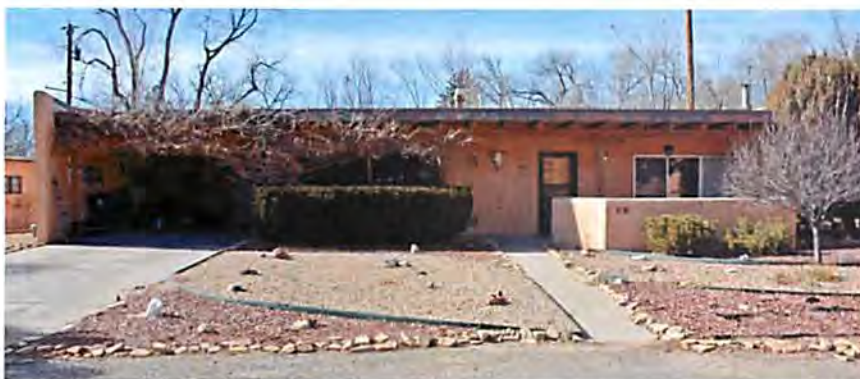
The contemporary influence later moved to the exterior, as elevations became longer and leaner. Many reveal a then-popular horizontal emphasis. This emphasis was furthered with overhangs arranged across front, back, and sometimes side elevations (117, 119, 121 Camino Santiago) (Figure 8). In this way, many of the units constructed in the mid-to-late 1960s are examples of the Contemporary flat-roof house form.

Figure 8: 119 Camino Santiago, an example of a Contemporary flat-roof form.

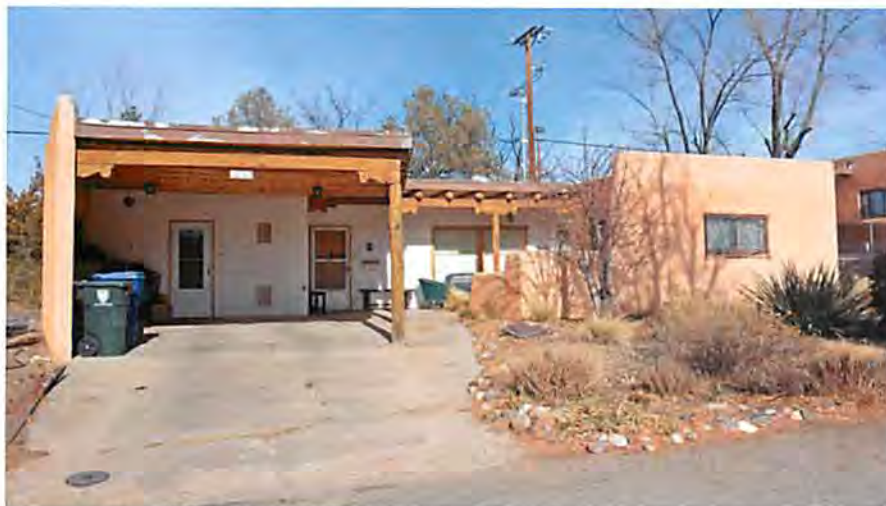
The design of each unit, however, was totally driven by economy. While not particularly well-suited for the climate, carports were employed as an economical method to shelter automobiles. Prominent carports emerged as almost a design motif in the drawings produced in Register's shop. Framed by either vigas or square beams, the structures were often placed in front of the dwelling, sometimes marring the balance of composition (109, 120, 121, 122 Camino Santiago and 111 Camino Matias) (Figure 10). The use of carports further ushered the houses into the contemporary context.

Figure 10: Example of carport dominated front façade, 109 Camino Santiago.

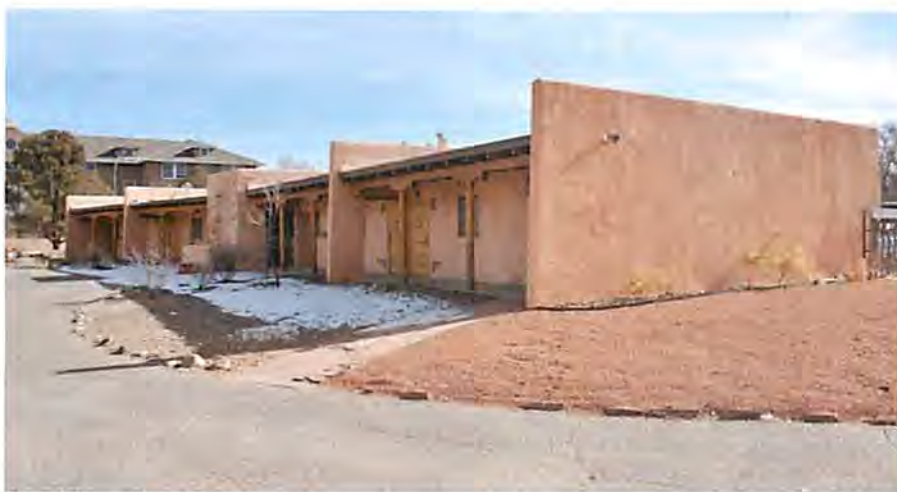
Figure 11: 126 Camino Santiago.

The quad apartment block terminating Camino Santiago (126) represents the most radical plan of the development. For its design, the architects removed the roomblock massing from the ends, moving it to the center to act as hood over the laundry. Raised triangular party walls divide the sections and bookend the building (Figure 11). Despite its avant-garde appearance, a viga portal was tacked on to the front façade.

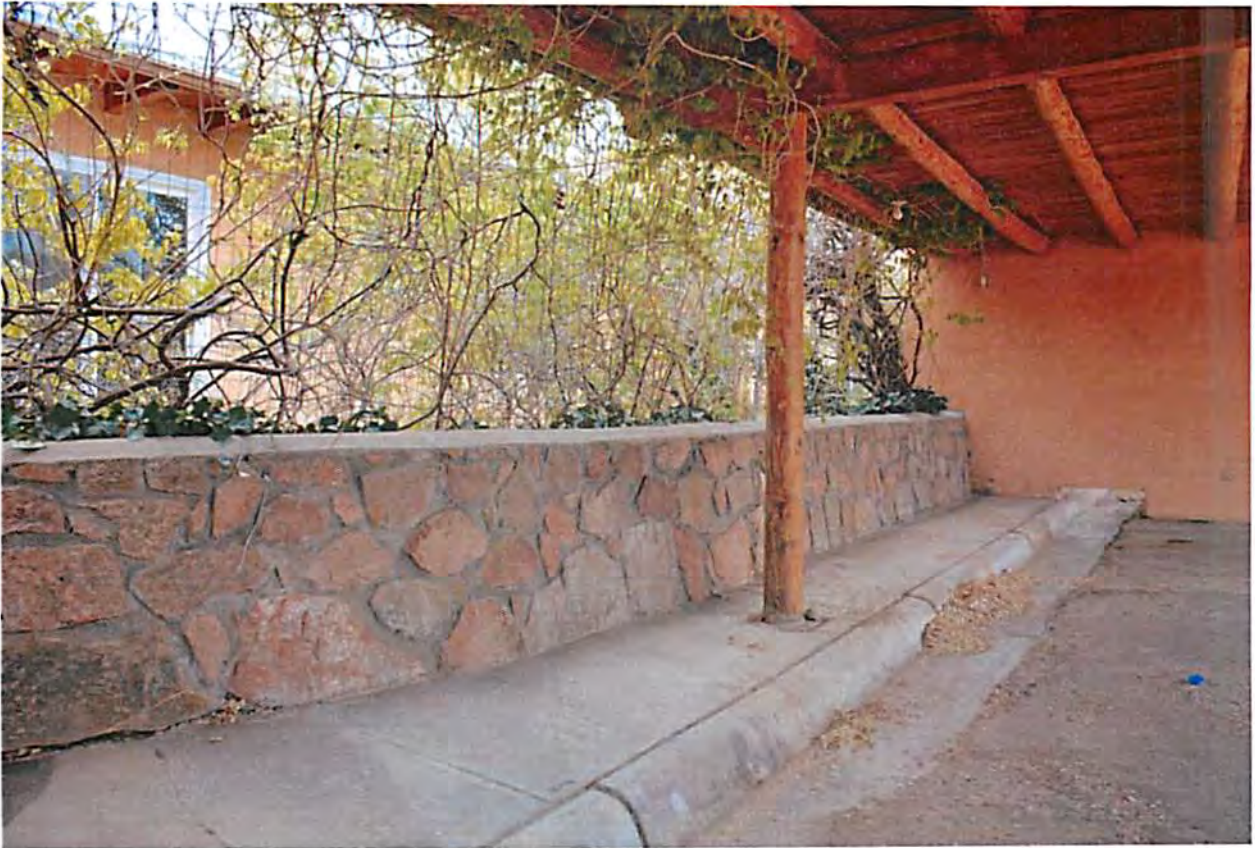
Given their low architectural value, and assumed c.1968+ construction date, neither is recommended for Contributing Structure status to the Downtown and Eastside Historic District.

Figure 1: 126 A Camino Santiago, Garage/Carport Structure, retaining wall, May 3, 2018.

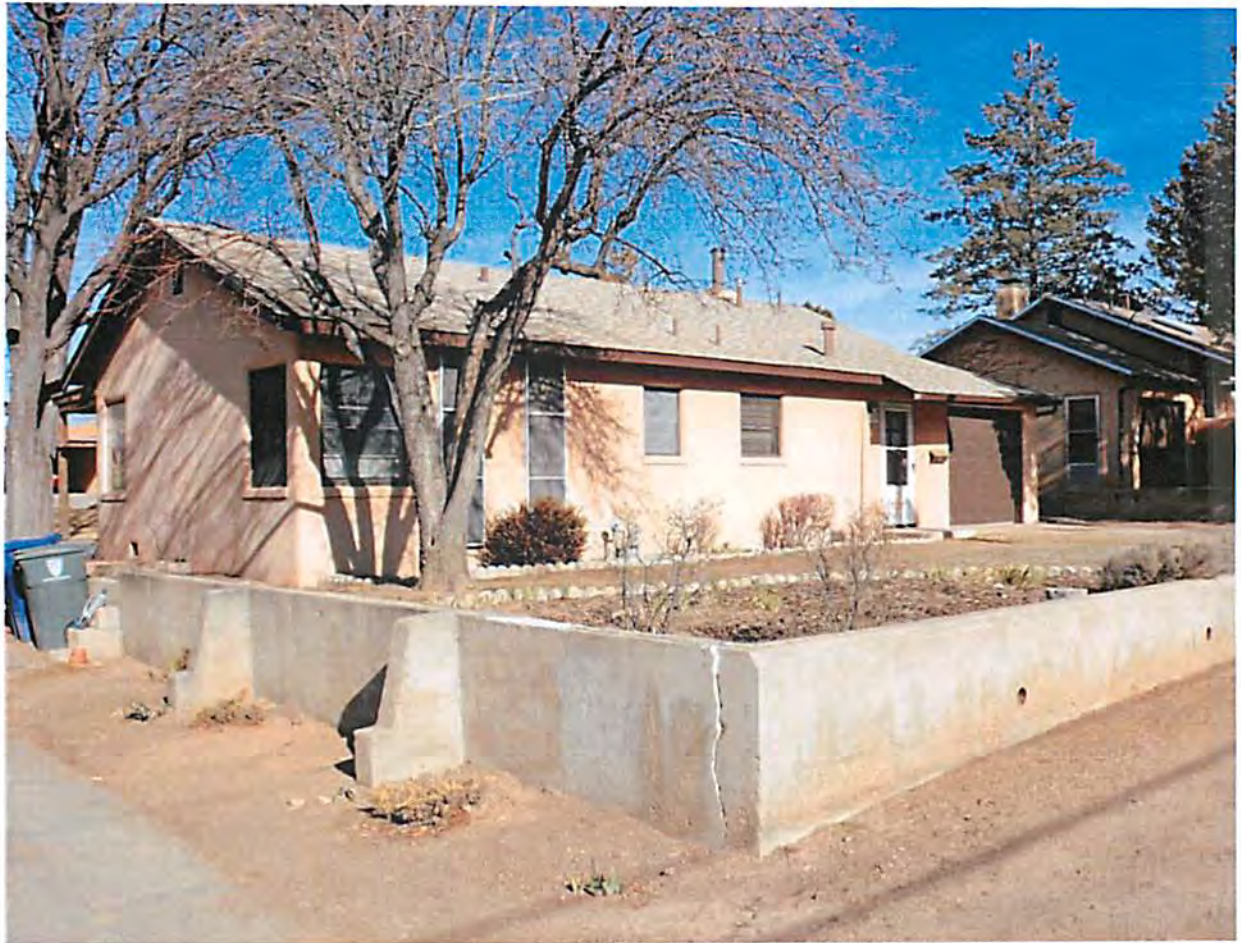
Figure 3: c.1950 concrete retaining in front of 107 Camino Matias. January 18, 2018.

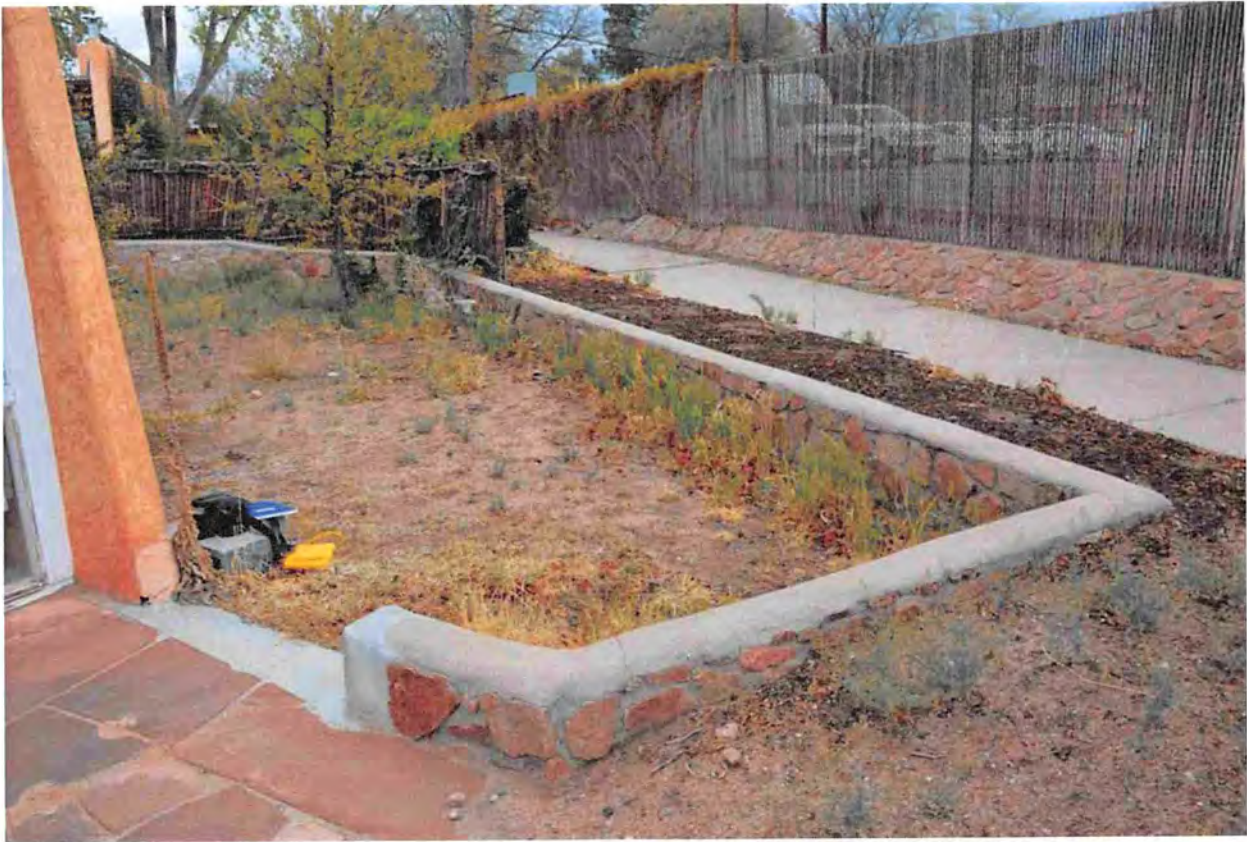
Given their recent date of construction and utilitarian quality, the retaining and property walls are not recommended for individual or collective Contributing Structure status to the Downtown and Eastside Historic District.

**Figure 2: 124 Camino Santiago, rear retaining wall, May 3, 2018.**

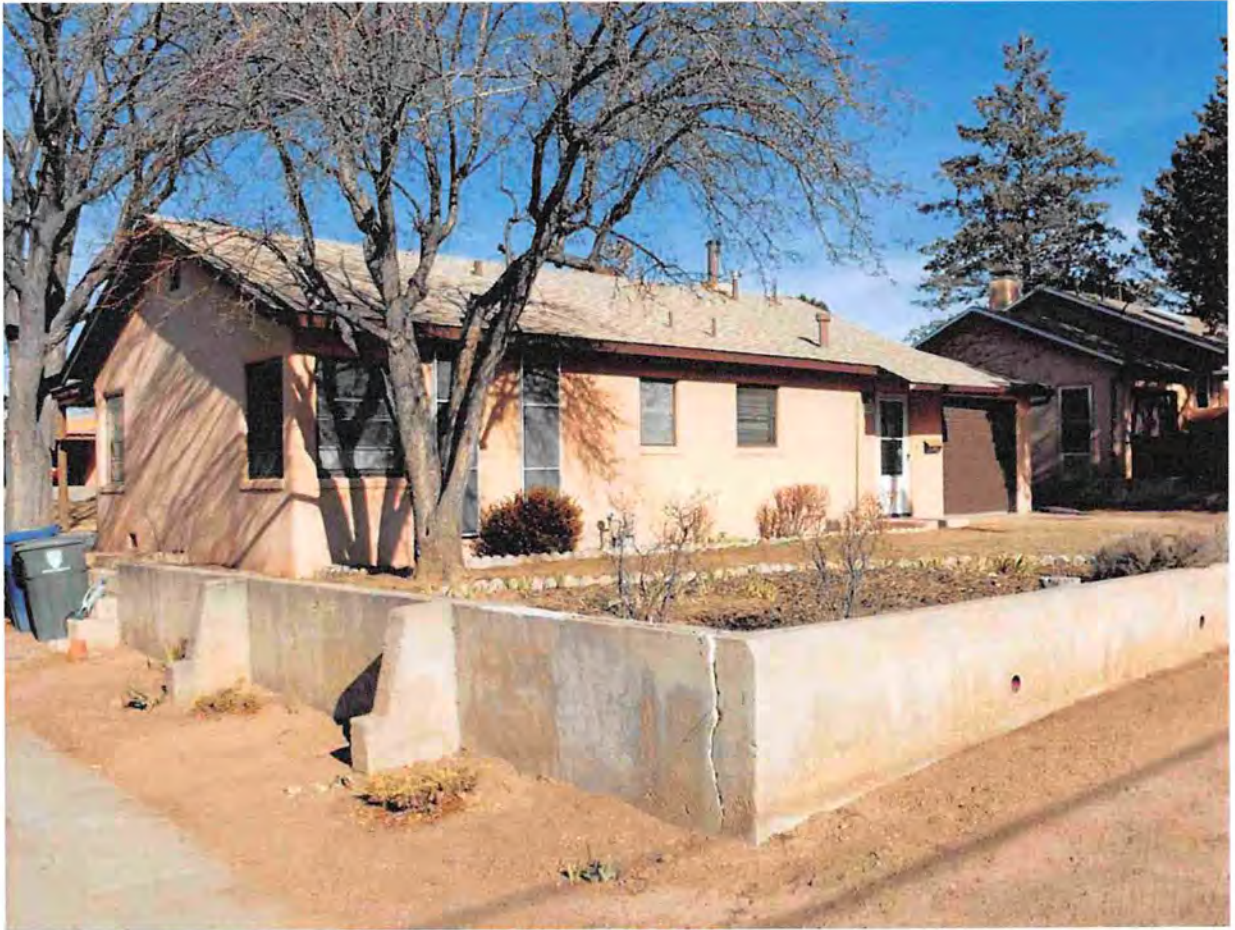
**Figure 3: c.1950 concrete retaining in front of 107 Camino Matias. January 18, 2018.**

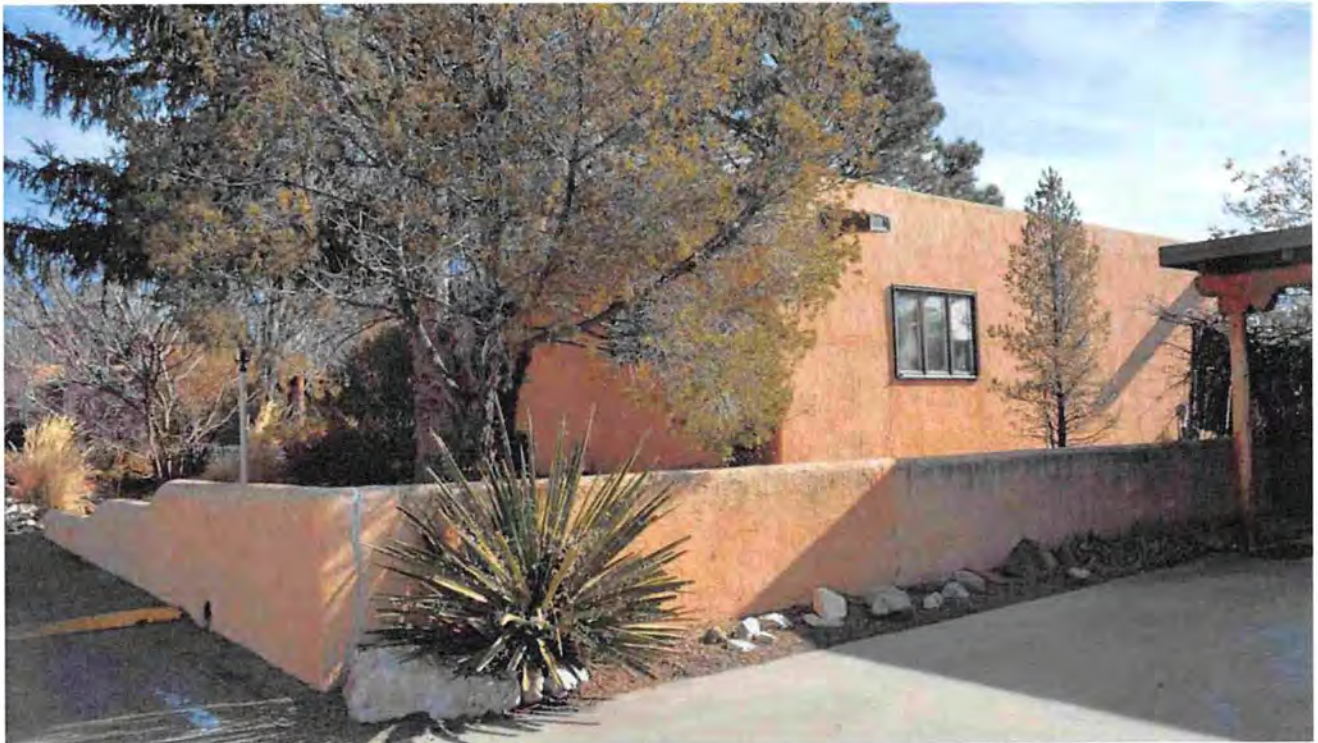
**Figure 4: Stucco-on-block property wall between 114 and 118 Camino Santiago, January 18, 2018.**
