Re: 121 EAST SANTA FE AVE, SANTA FE, NM 87505

This proposal covers the property at 121 E Santa Fe Ave. This is a two-part proposal that requests a clarification on work already completed (the "Exception") for which we believed we received approval and a second proposal for which we received partial approval. In reference to the second proposal, we will only be applying for those items that were not approved in the first submission. From this point forward, we reference P1 for proposal one (the Exception), P2 for proposal 2 and P2a if referencing those items that were already administratively approved.

Re: 121 EAST SANTA FE AVE, SANTA FE, NM 87505. (1) Clarification of finish work for approved roof replacement (2) re-request approval of safety items

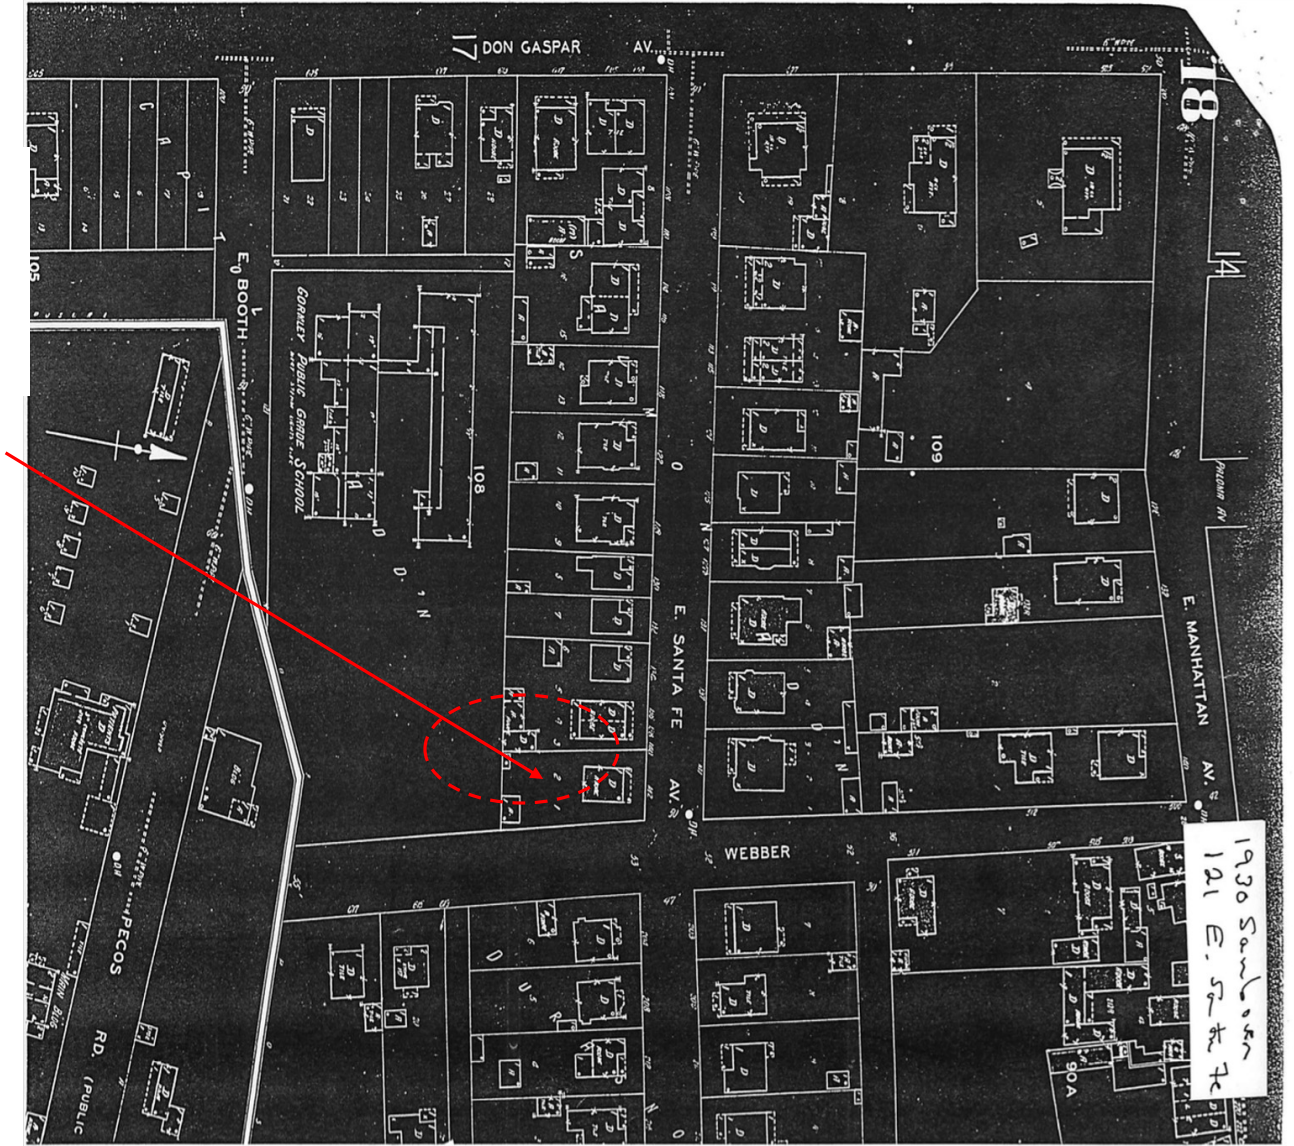
Original site plan.
Added in
correction of roof
line: 18" at back
of main house

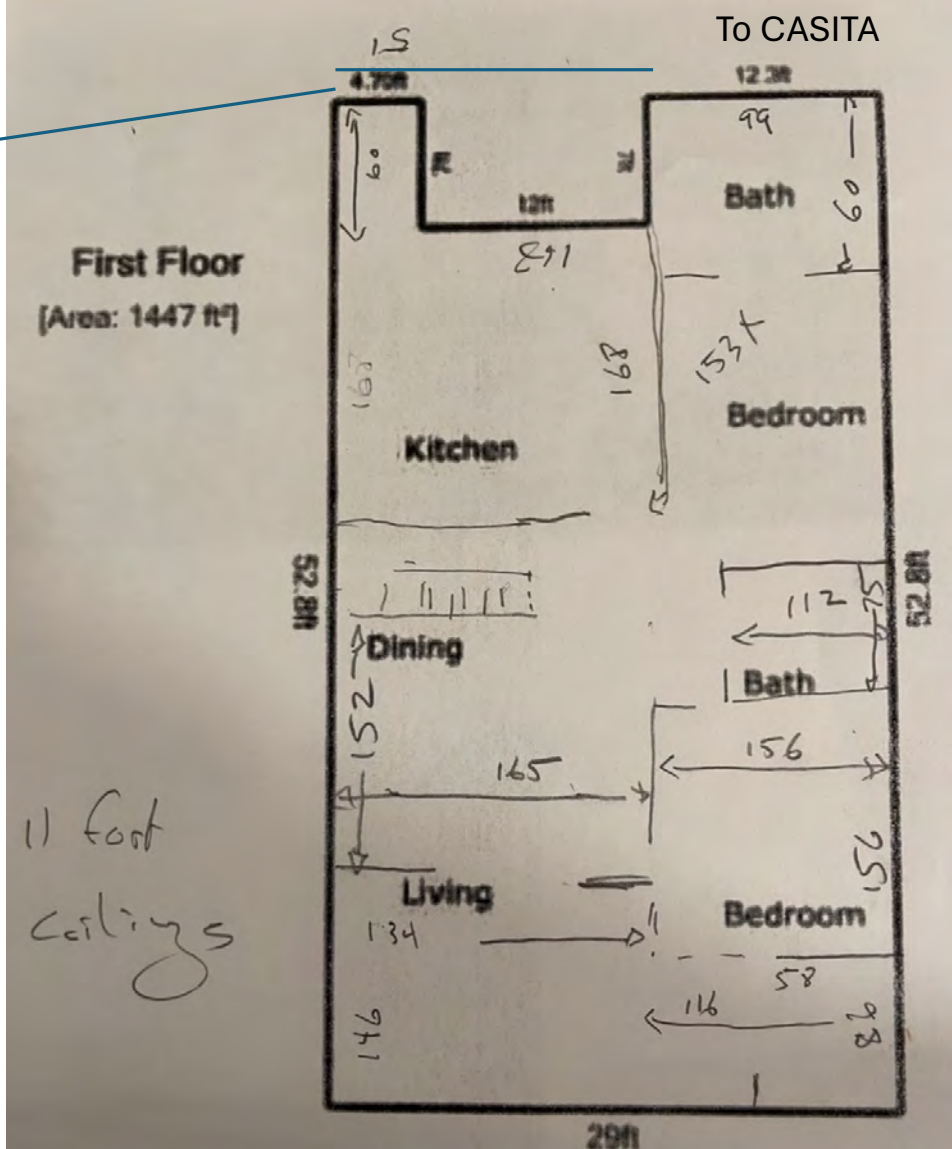
1st floor Current floor plan.
 Extended 18" from back of
 utility room to correct original
 roofline that caused the leaks,
 rot, and housed rodent feces.

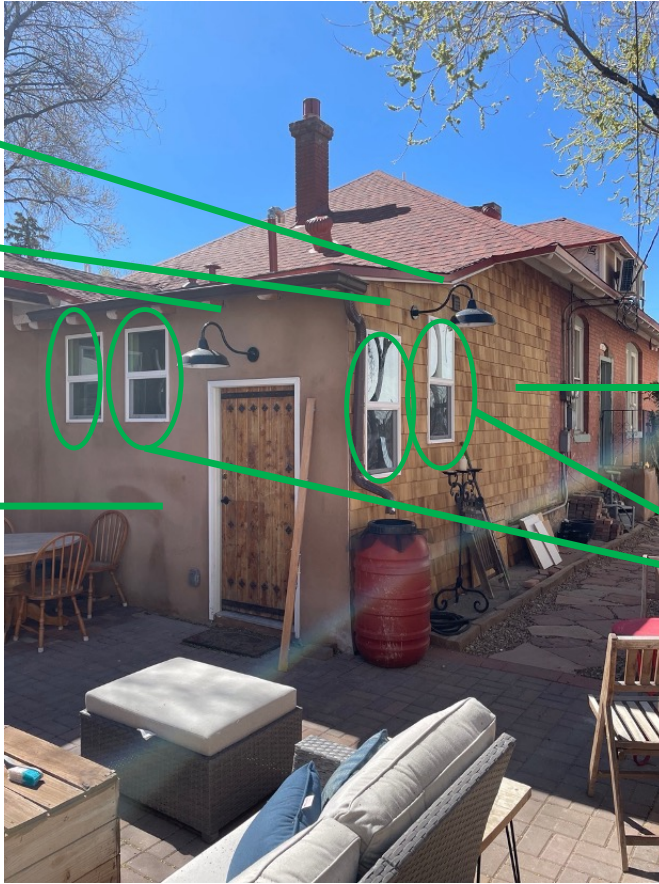
**Approved Roof Replacement
and related replacement of support walls (back of house, north and west walls)**

Area of where roofers corrected angle (remedy of leaks, rot, rodent feces)

Walls replaced in correcting roof angle

Stucco on North wall replaced in correcting roof angle

Shakes on west supporting wall replaced in correcting roof angle

4 Windows replaced

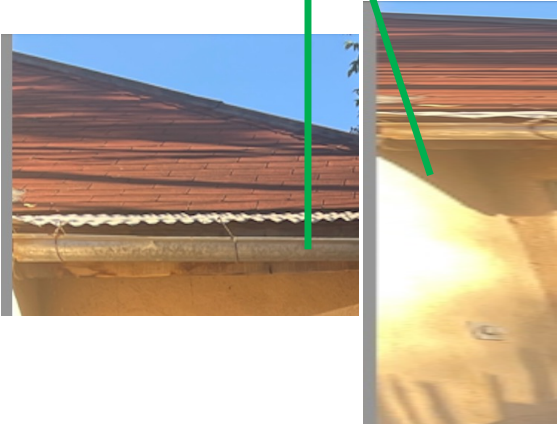
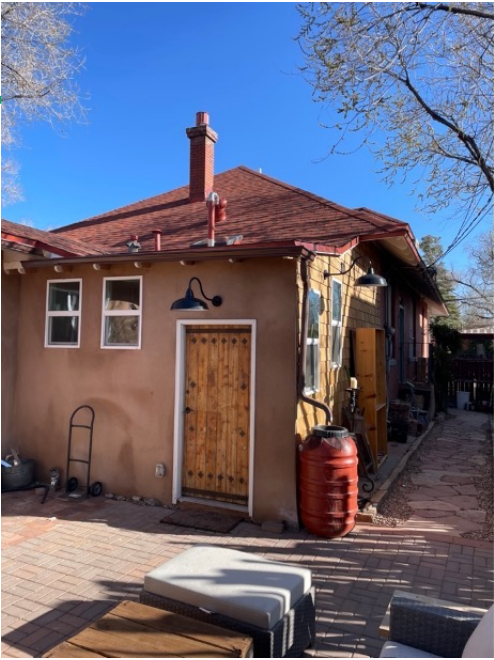
North wall replaced.
Replaced surface with
the similar stucco as
original (in shade so
looks darker)

North and west walls
before replacement.
Original stucco (pic in
bright sunlight so looks
lighter)

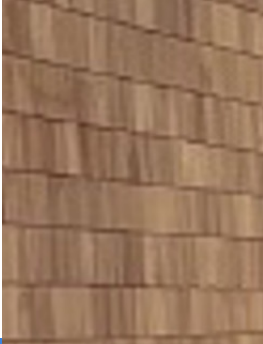
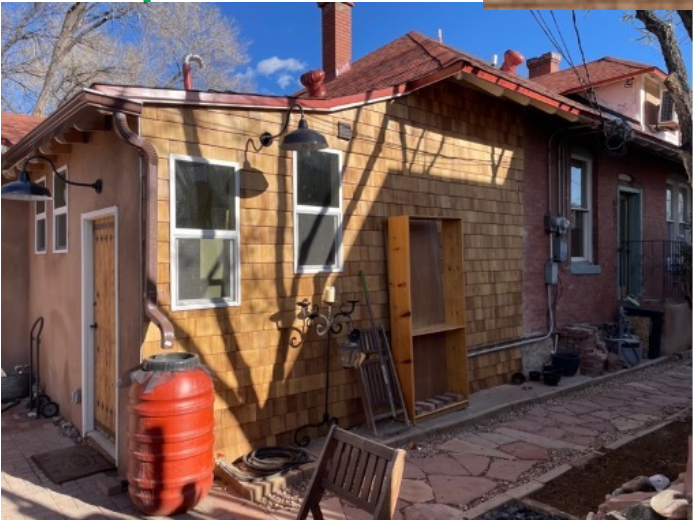
West wall replaced.
Covered with shakes to
match the 3 dormers

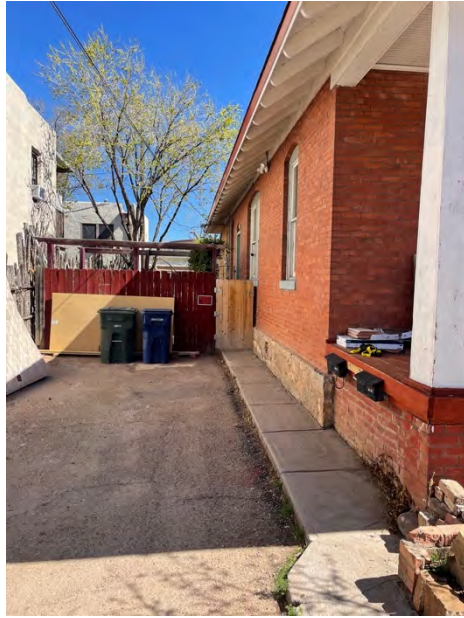
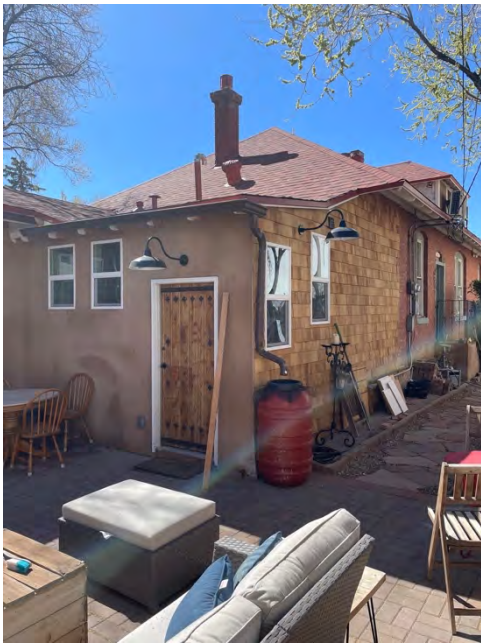
West front

West back elevation, from the North, inside the north wall

Note: this shows the work completed to remedy the angle of the roof that had caused the leaking and rotted walls in previous roof

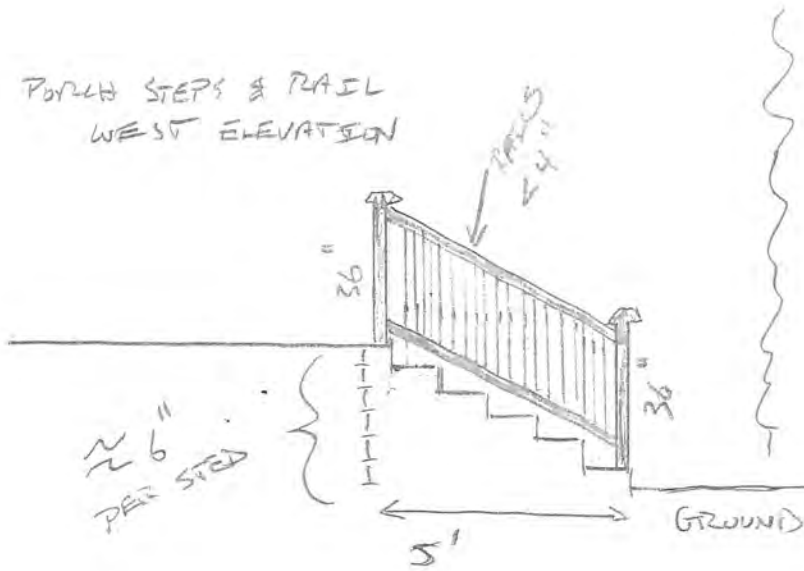
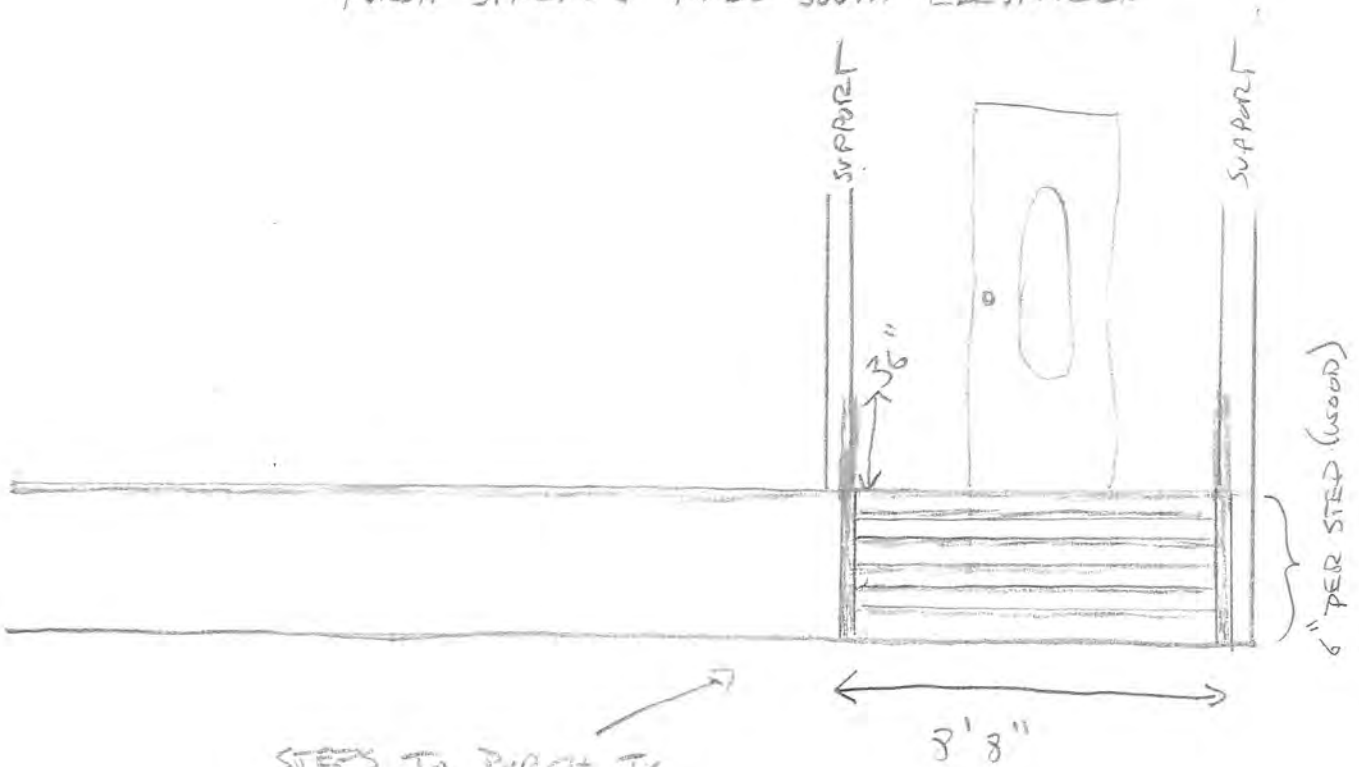
PORCH STEPS & RAIL
WEST ELEVATION

PORCH STEPS & RAIL
EAST ELEVATION

PORCH STAIRS & RAIL SOUTH ELEVATION

STEPS TO PORCH TO
BE WOOD @ 6" PER
CODE REQ

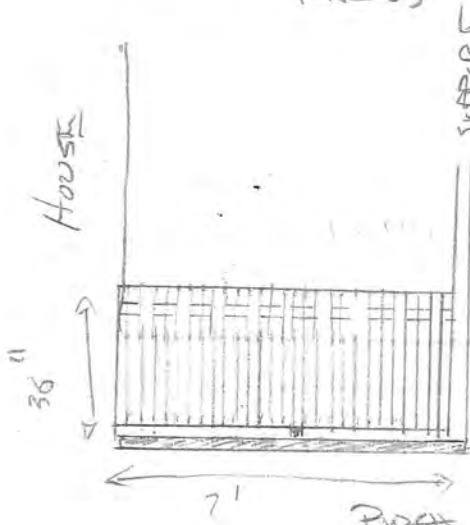
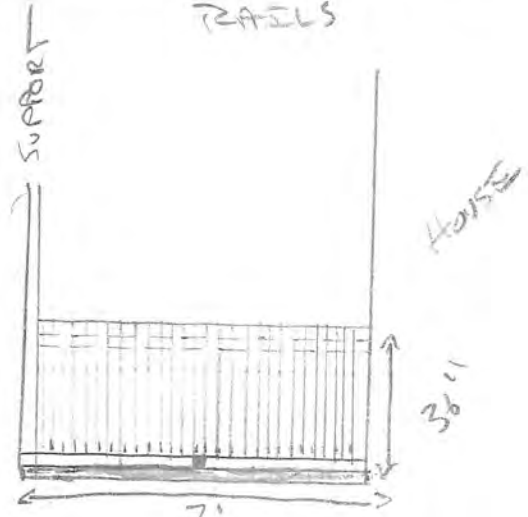
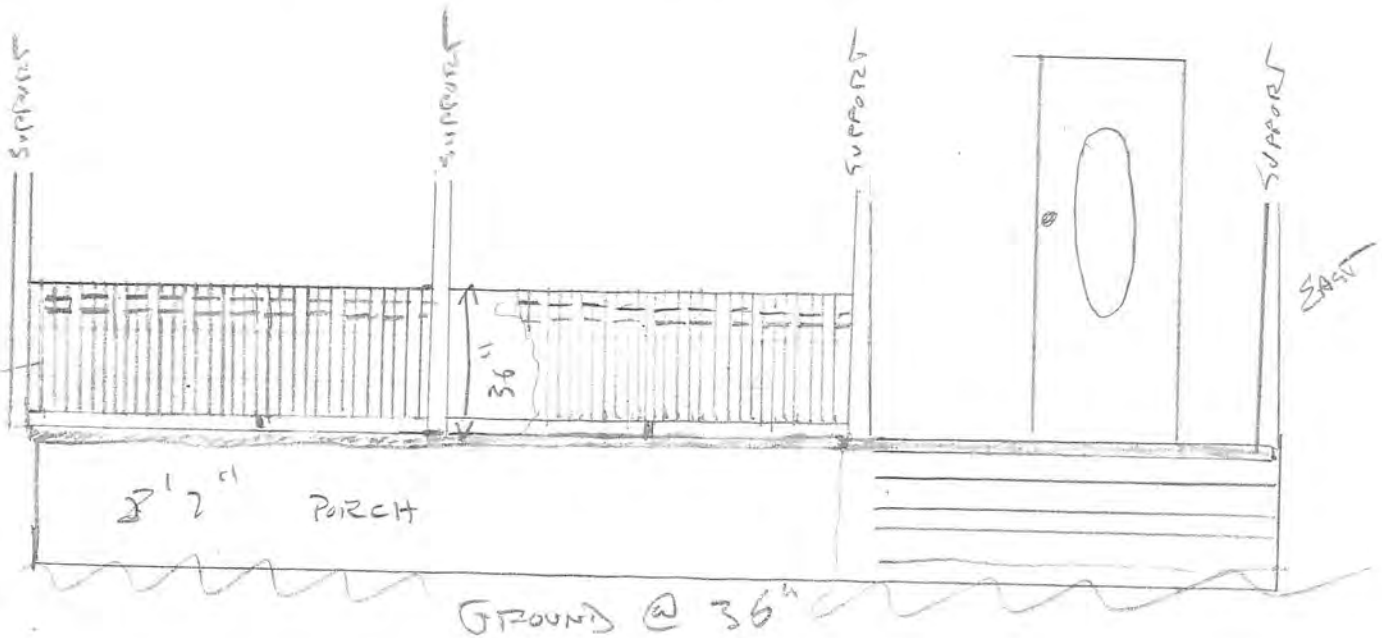
PORCH WEST ELEVATION
RAILS

PORCH EAST ELEVATION
RAILS

PORCH SOUTH ELEVATION
RAILS

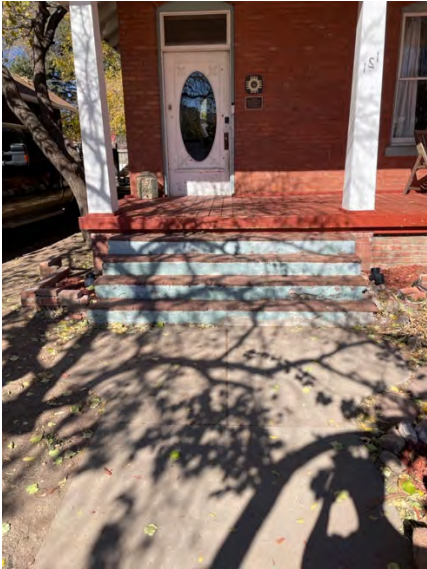
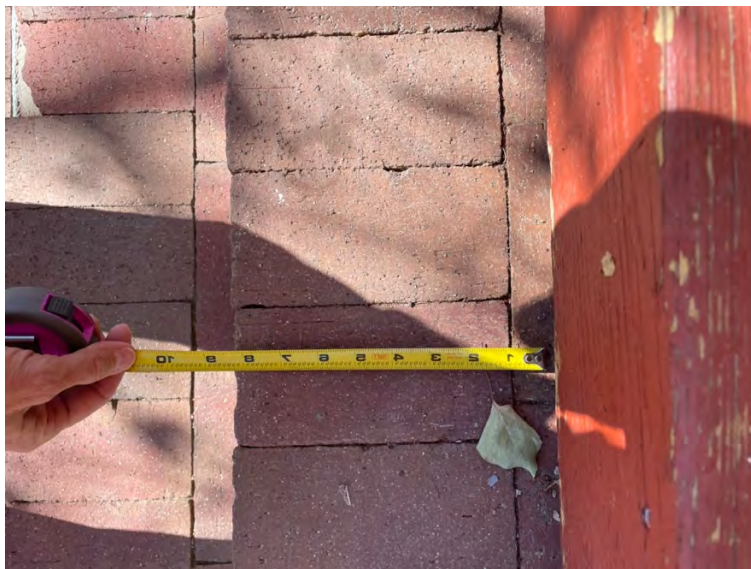
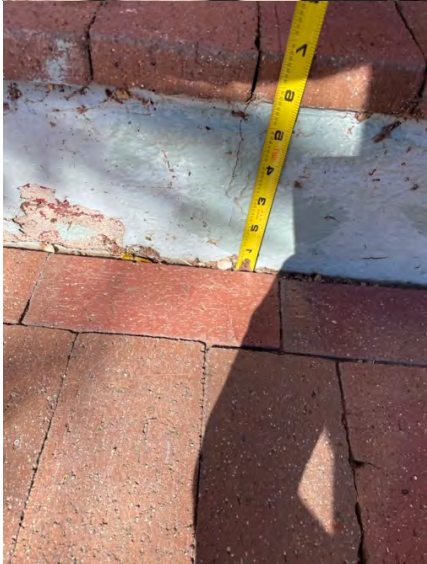
For item #2 – safety of stairs. Exhibit 2A, 2B, 2C, and 2D

- 2. The steps from the front patio are concrete and brick. The concrete has deteriorated significantly and the rise and run of the existing steps are not consistent with existing code. Additionally, someone put new lumber on top of rotted old lumber creating a “lip” that has tripped and injured several people. There have not yet been any personal injury lawsuits.**

The national building code reads: “Treads must be at least 10 inches deep, measuring from front to back. Stair treads must sustain a weight of at least 300 pounds in an area no more than four inches square. The rise, or the vertical distance from one tread to the next, can be no more than 7 1/4 inches high.”

The current steps ARE HAZARDOUS, and several guests have tripped on them. Because they added a deck on top of a deck, there is a “lip” at the top of the steps that creates a significant tripping hazard. Additionally, there are no handrails, which would be added when the stairs are replaced. We propose replacing the concrete steps with Messmers (<https://www.messmers.com/>) over cedar. Since the existing deck is painted red, we feel that cedar and its natural red tone would be sufficiently similar in color. Therefore, natural cedar would be the primary request, (see deck request at item 3). Photos of current steps are attached. Exhibit 2A, 2B, 2C, and 2D. *This was not administratively approved even though it is a significant safety hazard.*

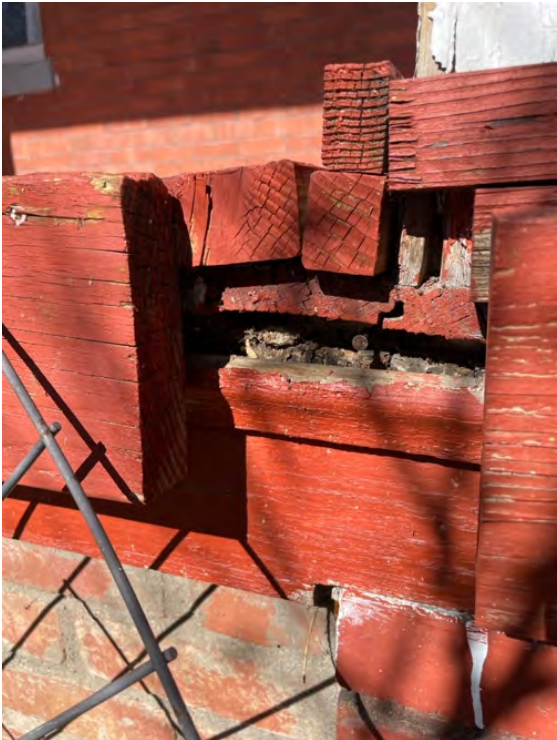
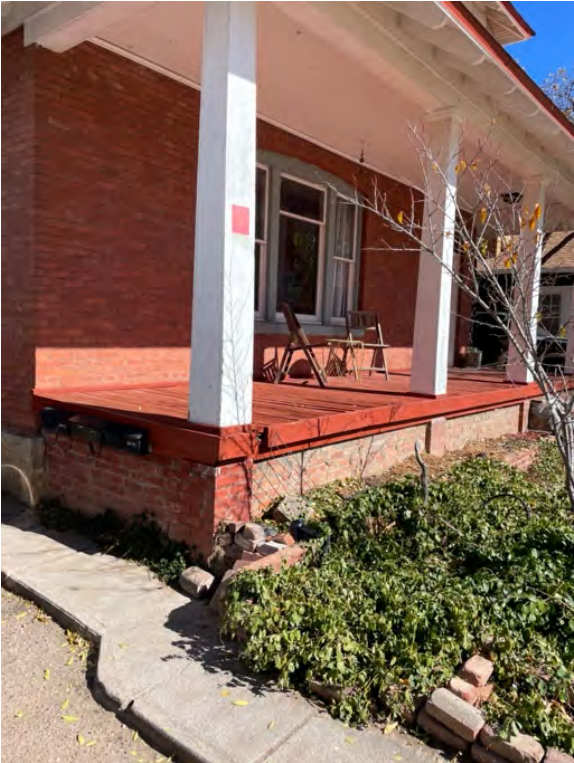
Item #3: safety replacement of deck. Exhibit 3A and 3B

- 3. Replacement of front patio deck is needed as previous owners “decked over” an existing rotted deck and evidence of rotting under the second deck is showing. We are requesting that we be allowed to use cedar as decking material to be coated with Messmers. Note that the deck is currently painted red, so moving to a natural cedar with a red tinted stain would not significantly change the look and would better match the natural brick of the house. Neighbors have indicated that the “second” porch was added to the first porch several years ago by a tenant (not owner). He also advised them it was not permitted and that he warned them that putting new wood on rotten wood would only result in the top deck rotting within a few years. Note that this was done without historic or permits. Photos attached exhibit 3A and 3B. *This was not administratively approved even though it is a significant safety hazard.***

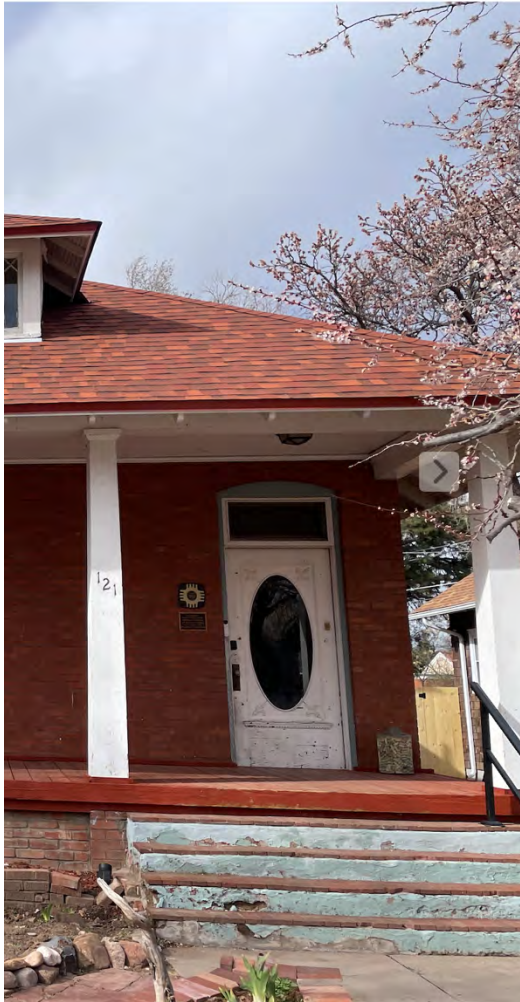
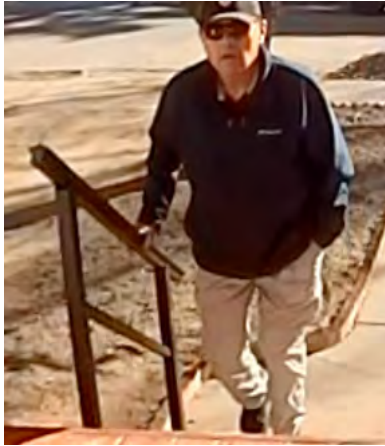
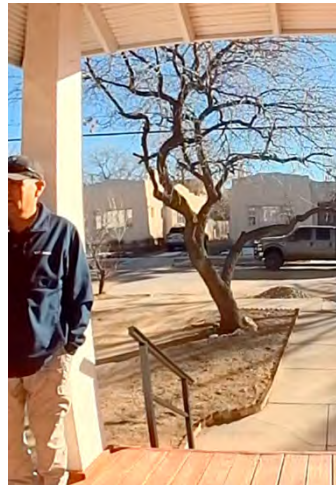
#5 safety railing for front steps

5. The front deck does not, nor may have never had a railing, however the deck is 30 to 38 inches above ground. Given the height above ground, that is not within code guidelines which require “Decks higher than 30” off the ground have guardrails to satisfy a majority of local building codes. Most U.S. guidelines require railings at least 36” tall between the decking and top rail, though this varies by location. California and Washington require 42” or taller railings for decks.” We have had two people fall off the patio without injury but feel this is just luck that serious injuries have not happened yet.

Being actively used

This proposal asks permission to install railings consistent in height with the Santa Fe code. I could not locate the height requirements but will build consistent with code.

This is a safety hazard, and we request immediate approval to mitigate this problem. Photos attached Exhibit 5A and 5B. Also, see elevations for railing. They would be consistent with craftsman style homes as found on several Internet sites (see attached in file). Once again, we are open to suggestions for style should the committee make a recommendation. *This was not approved even though it is a significant safety hazard.*

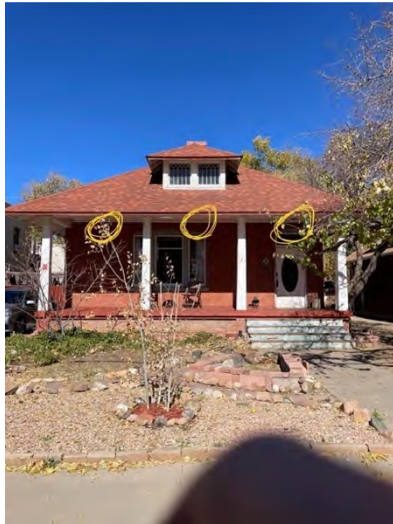
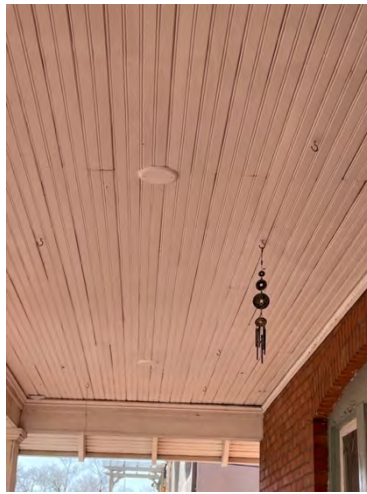
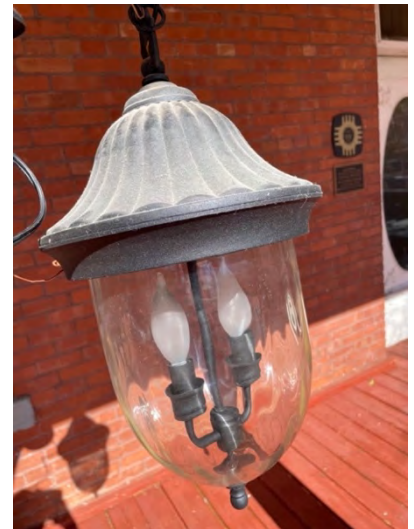
Item #6: Exhibit 6A, 6B, 6C and 6D
Adding lights for safety of front porch and 2 walkways

Site of lights

site of lights

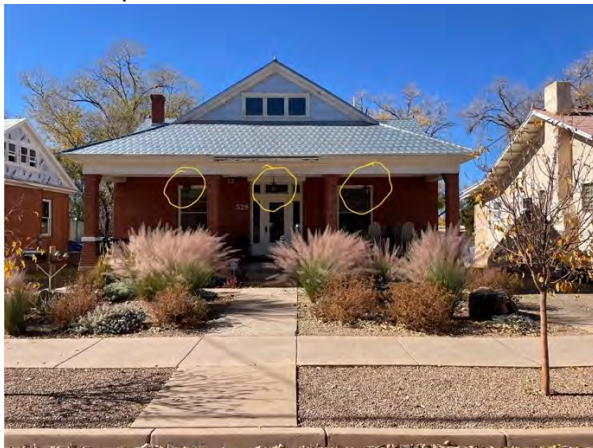
proposed light

3 pendant lights at 528 Don Gaspar (5 houses from 121 E Santa Fe), and similar to other local homes of the same period
