Historic Cultural Properties Inventory (HCPI) Base Form (FORM 1)

1. Name of property: Blas Jr. and Lucia M. Sanchez House/ Phillip R. and Nell L. Sanchez House	2. Location: 815 Dunlap Street Westside-Guadalupe Historic District – Santa Fe	3. Local Reference Number: Santa Fe ID: Old # 051613417 4. County: Santa Fe Parcel # 12422016

8. Name of Project: HDRB Status Evaluation		
9. Lat/Long: 35.6861507,-105.9561845		
10. Photo Information: Giulia Caporuscio, photographer. Photo 1: View of front, south elevation. February 1, 2025.

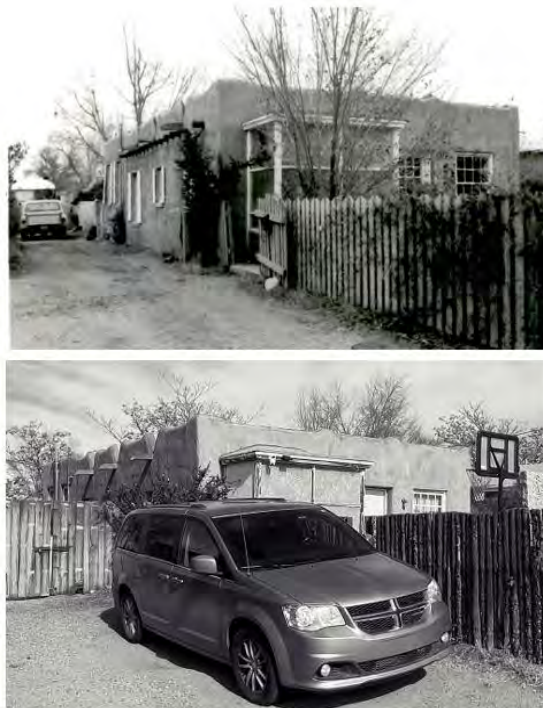
Figure 1: Comparison of 1985 (above) and current conditions (below).

Looking over the driveway, the west elevation has an almost comical undulating parapet, cut with deep openings to hold canales (Photos 6 & 7). The elevation presents a motley array of windows, most of which are older wood units. They are positioned at varying heights. With the exception of a sliding unit in the bathroom, they all are 6/6 wood hung sash (Photo 8). They sit in the same position as the front window and have similar strip-wood muntins and concrete lug sills. A sliding vinyl unit at the center has been added since 1985. The last 16’ of the elevation holds the mudroom addition (Photo 9). The vigas of the original portion of the house have been shorn off since 1985 (Fig. 1).

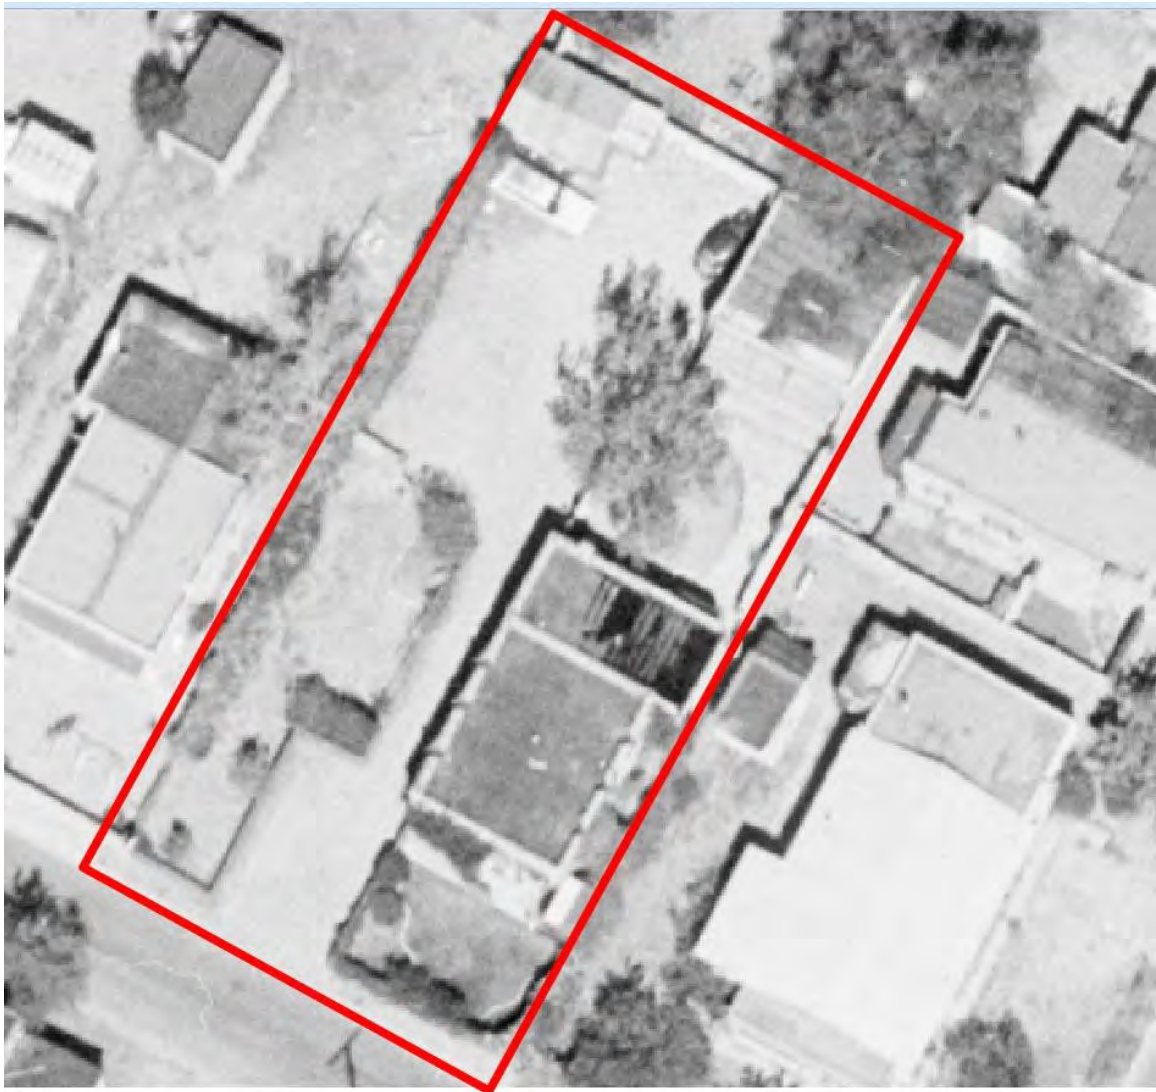
Figure 9: September 11, 1978, aerial photograph.
Note attached solar greenhouse is not present.

The highway divided the community into two distinct neighborhoods. Those fronting or adjacent to St. Francis were subject to noise levels that exceeded the allowable decibel limits for commercially zoned areas. This safety hazard, along with the fracturing of land, led to depressed property values and the call for rezoning in the late 1970s. A 1978 flyover captures this period (Fig. 9).

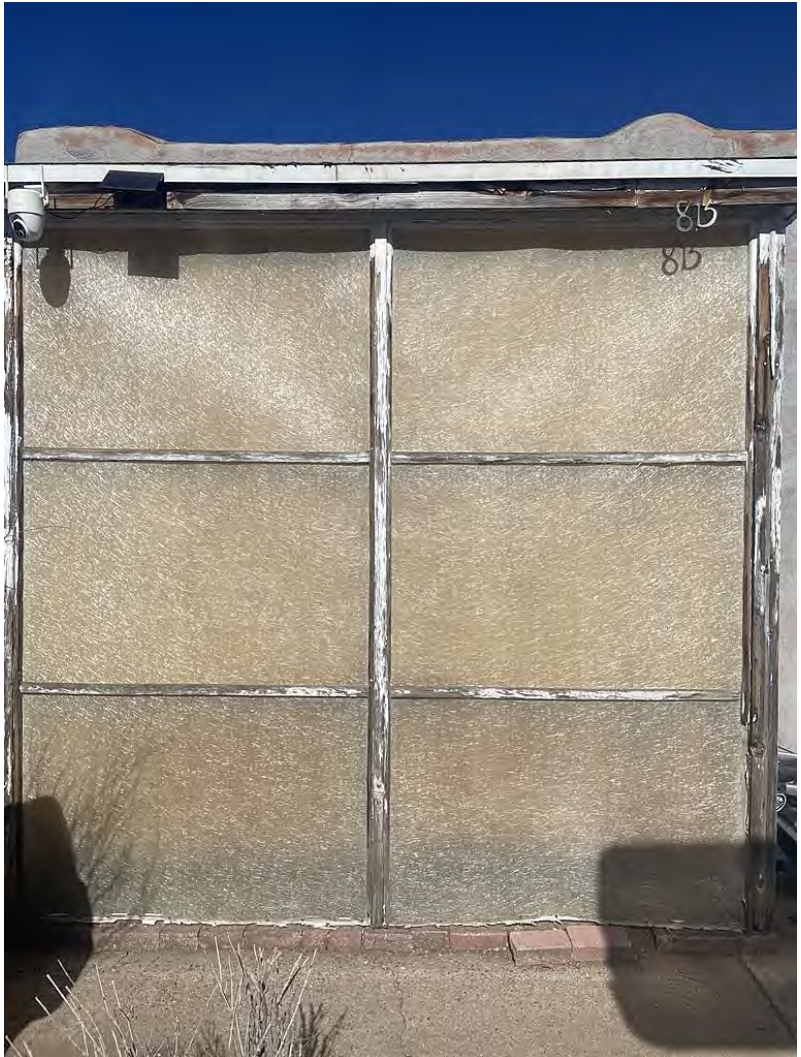
Photo 3: South (front) façade. Attached solar greenhouse. Camera facing north.

What first catches the eye is the bulky attached greenhouse. Measuring 50 square feet, this c.1970-80s addition disrupts the modest composition and balance of the building’s façade (Photo 2). Built for growing food, its fiberglass panels are now clouded with a color reminiscent of aged parmesan (Photo 3). Behind the greenhouse and visible only from the interior is a 12-light door, which may have been relocated from the front entry (Photo 4)(Fig. 1). Based on the façade’s assumed symmetry this opening likely started as window.¹

Given these considerations, the recommendation is to maintain Non-Contributing status for the house. If the assumed original window opening behind the greenhouse is restored using historical or forensic evidence, the house may be reconsidered for Contributing status.

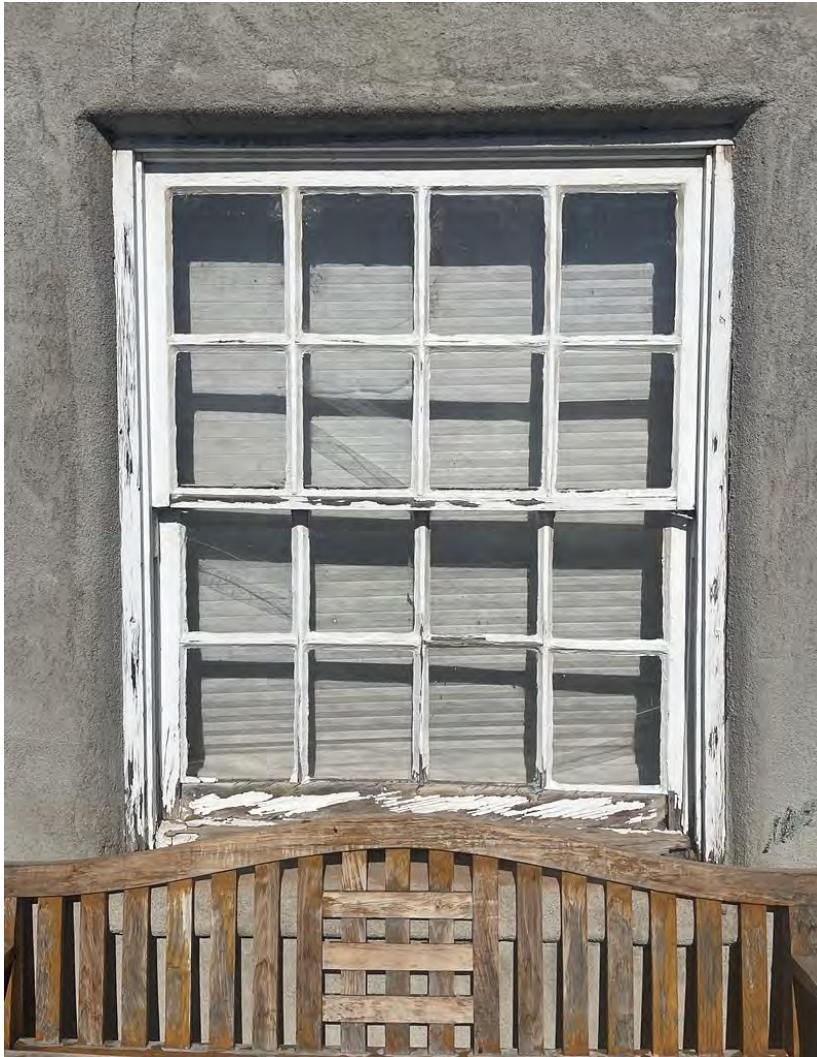
Photo 5: South (front) façade. Detail of east window. Camera facing north.

The current front entry is fitted with a modern six-panel metal door. A large 8/8 hung-sash wood window completes the façade’s composition (Photo 5). The window has simple strip wood muntins and putty-glazed lights. Like all the other wood windows along the house, it is in poor condition, with paint deteriorating to reveal bare wood. A heavy concrete lug sill terminates its opening.

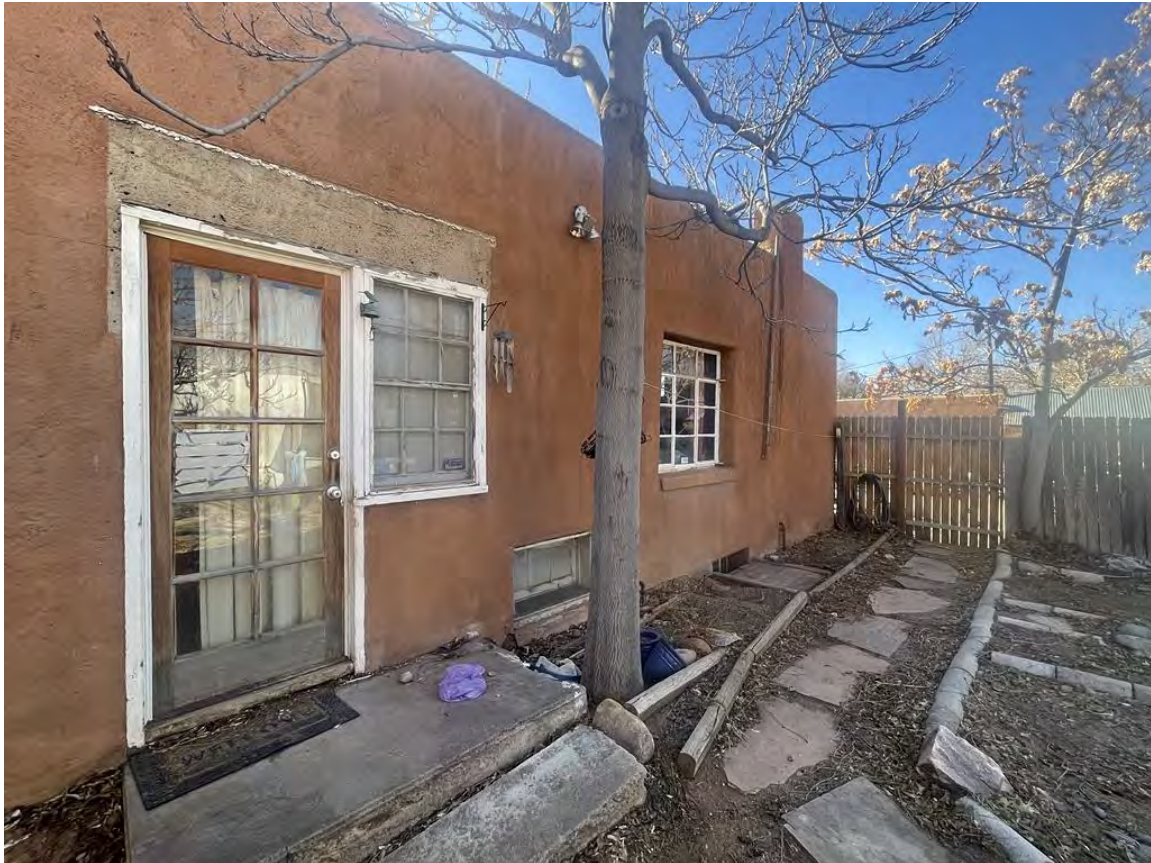
Photo 10: North elevation oblique. Camera facing southwest.

This side of the building represents the mudroom extension. Built before 1948, it consists of one large room which provides access to the basement. Its openings are concentrated toward the east end (Photo 10). They comprise a more recent 10-light wood door with an adjacent 6/6 hung-sash window. These units are almost flush with the outside wall, suggesting a more recent installation. This aligns with the 1985 survey, which highlighted the mudroom’s northeast corner as an “exposed shed.” A 1950-’60s steel combination window sits near the center of the façade. It has the same type of lug sill as the older windows. At the ground level, a few cellar windows give light to the basement.

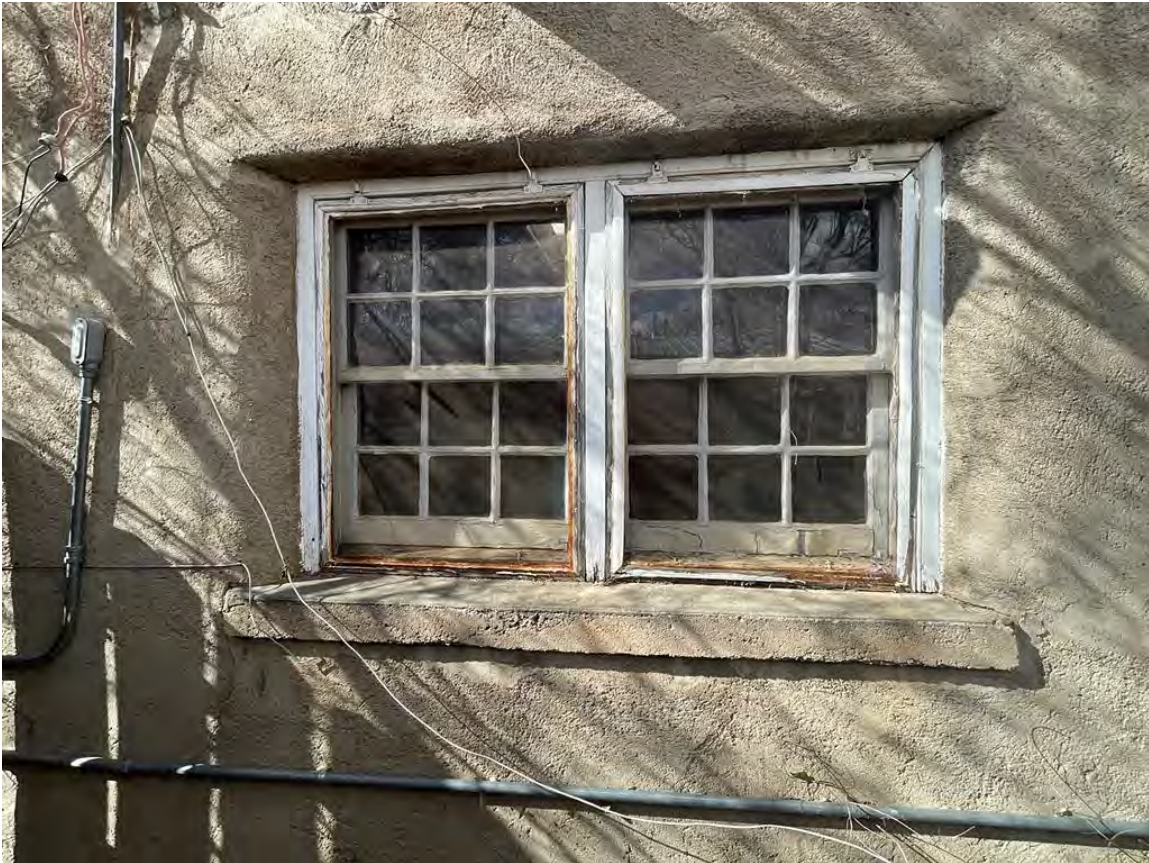
Photo 13: East elevation. Windows at middle of elevation. Camera facing southwest. Michael Zimmer, January 29, 2025.

The east elevation once faced a home (813 Dunlap) associated with the property. Since the 1950s, the properties have gone under separate ownership. A vine-covered fence separates them and obscures this side of the house from public view (Photo 11). The elevation begins at the south with three 8-light wood casements arranged in the living room (Photo 12). Beyond this to the north are two 6/6 hung sash windows with the same construction details as the others in the house (Photo 13). Both sets of windows have concrete lug sills.

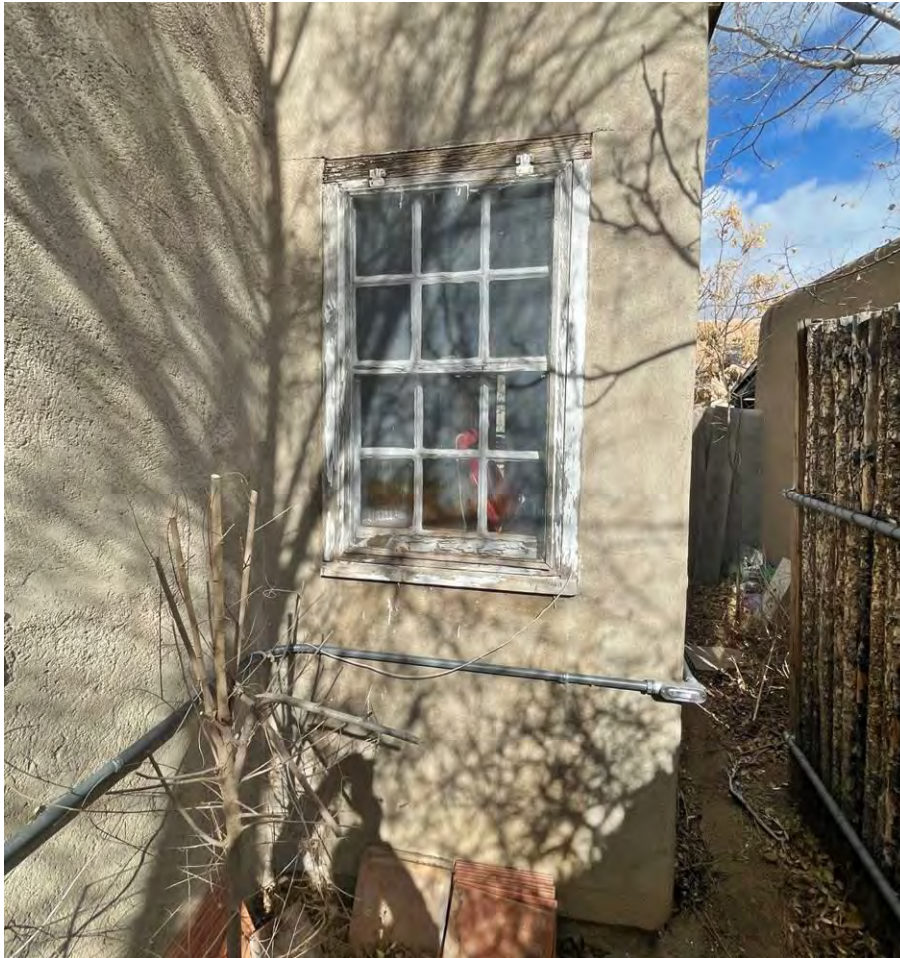
**Photo 14: East elevation. Window at south side of mudroom addition.
Camera facing northwest. Michael Zimber, January 29, 2025.**

Bumping out four feet is the beginning of the mudroom. A 6/6 sash window topped with a wooden header penetrates its short south wall. The window is placed flush to the surface, suggesting later installation (Photo 14). The remainder of the east elevation holds three 6/6 hung sash windows divided by mullions (Photo 15). The window’s location near the wall surface indicates a different construction period than the main part of the house. The 1985 survey states this part of the building had aluminum windows.

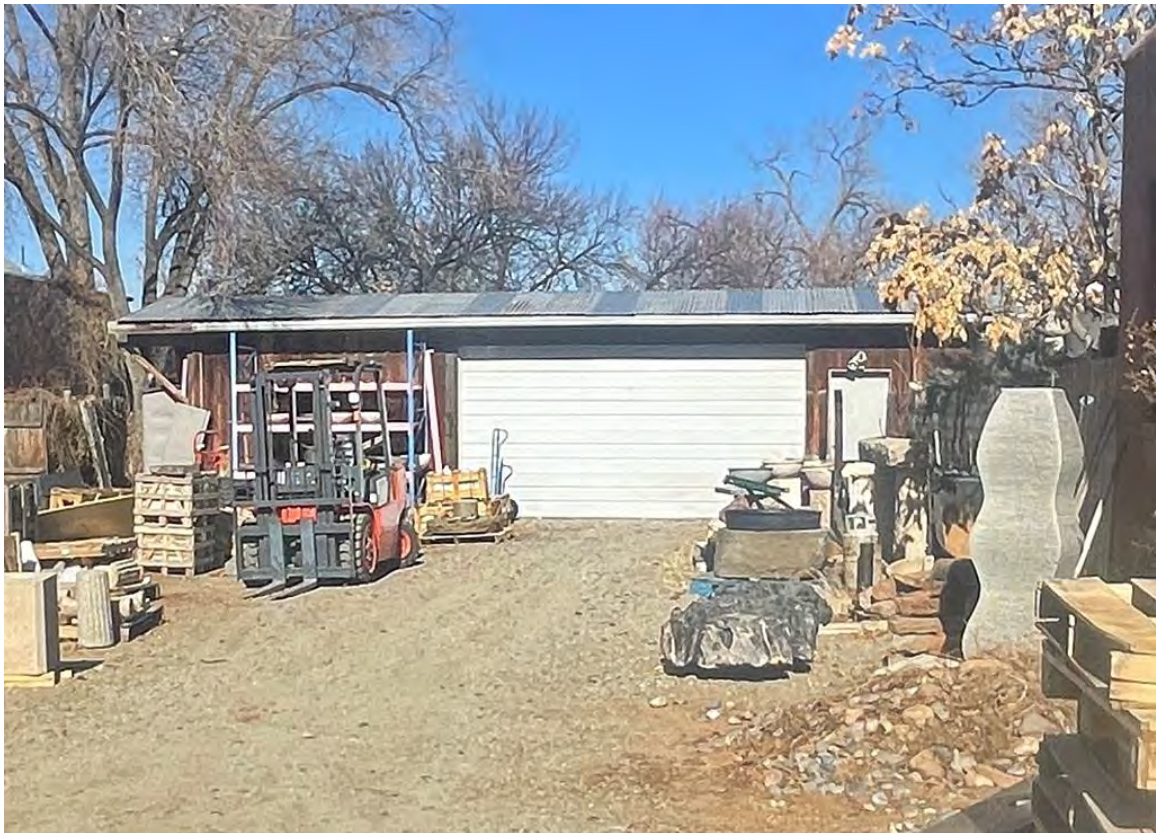
Photo 16: Garage/storage area. Camera facing north.

Taking up the northwest corner is a wood frame structure capped with a corrugated metal roof (Photo 16). Weathered vertical boards sheath its south elevation. A wide roll-up metal door provides vehicular entry. Adjacent to the east is a modern pedestrian door. This structure may have started as the gabled roof building shown in a 1950s aerial (Fig. 8), which was described in the 1985 survey as an “old garage.”

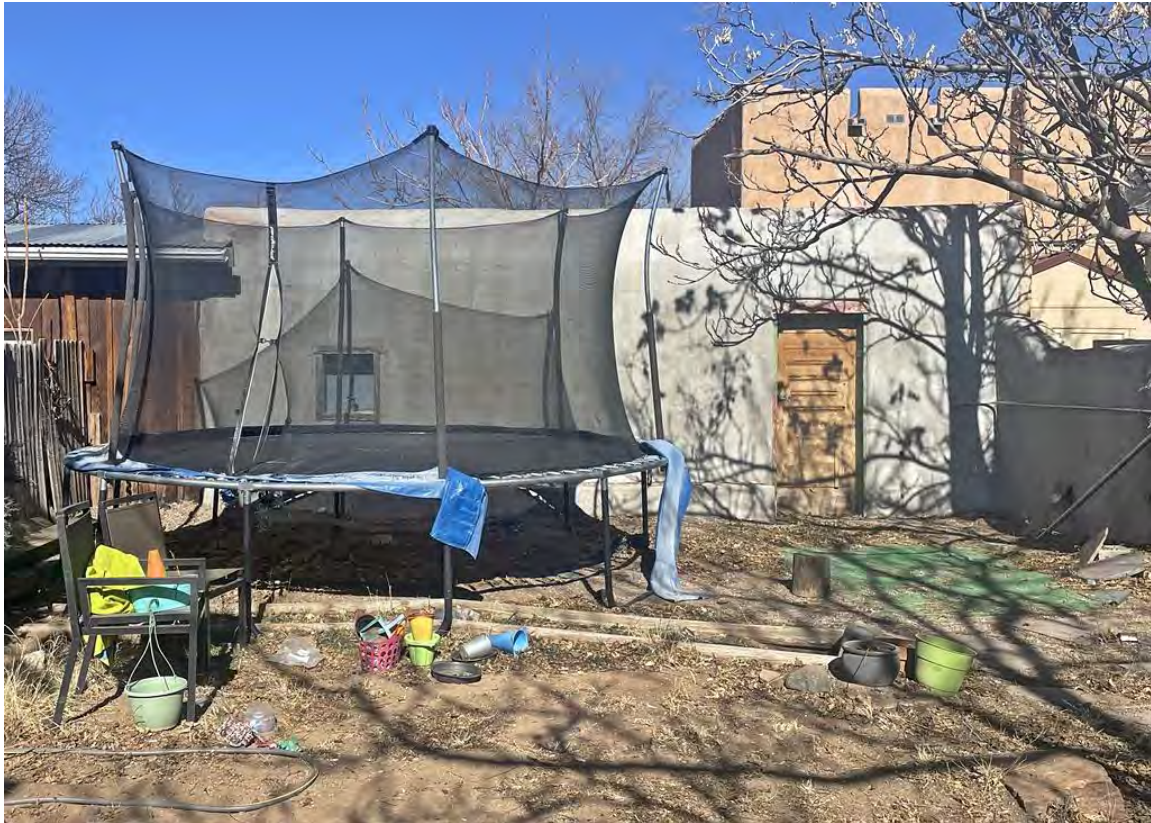
Photo 17: Outbuilding. Camera facing north.

A flat-roofed, square-plan adobe building stands at the opposite corner (Photo 17). The building is covered with a gray coat of stucco and features a plywood door along with a small single-light window on its south elevation. Its original purpose is unclear; the 1985 survey describes it as “storage.” Aerial photographs from the 1950s (Fig. 8) show that the structure has retained its overall ground plan into the present day.

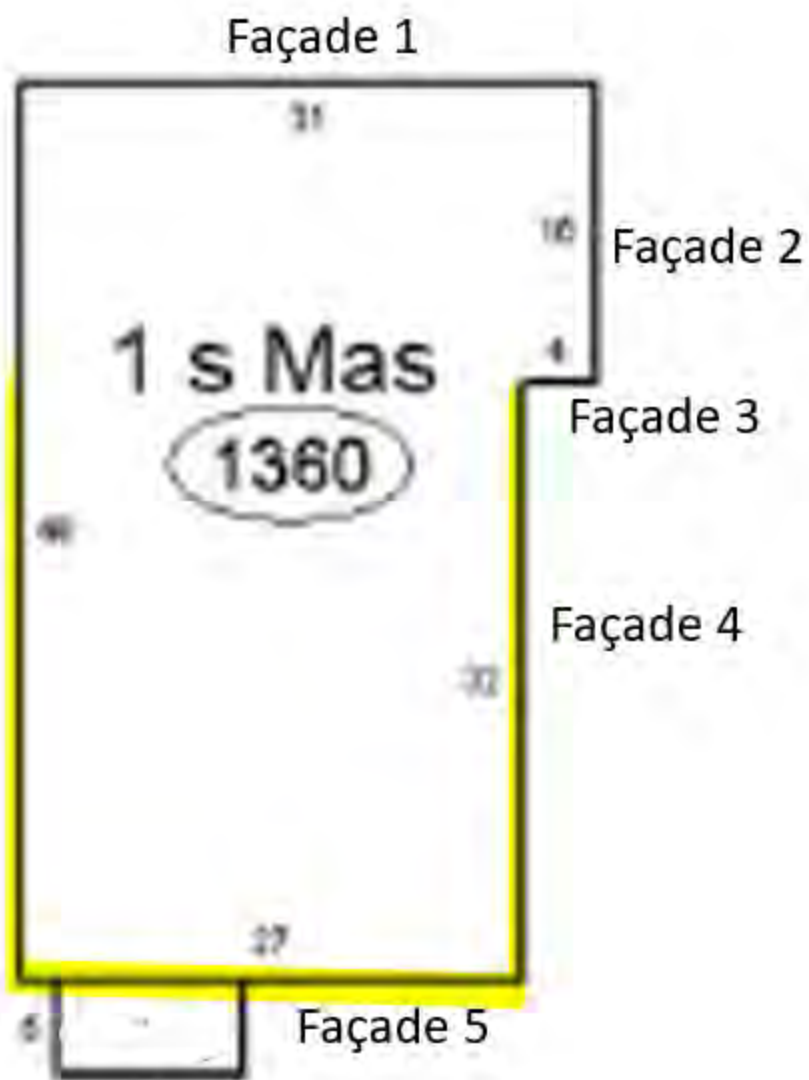
Façade 6

South (5), west(6) and east(4) facades of the original residence as primary , excluding the non-historic materials and excluding the greenhouse
