Extend the Living River
Reduce Flood Risk
Improve Acequia Flows
Preserve Wildlife Habitat

NEIL WILLIAMS, PE
FEBRUARY 6, 2024

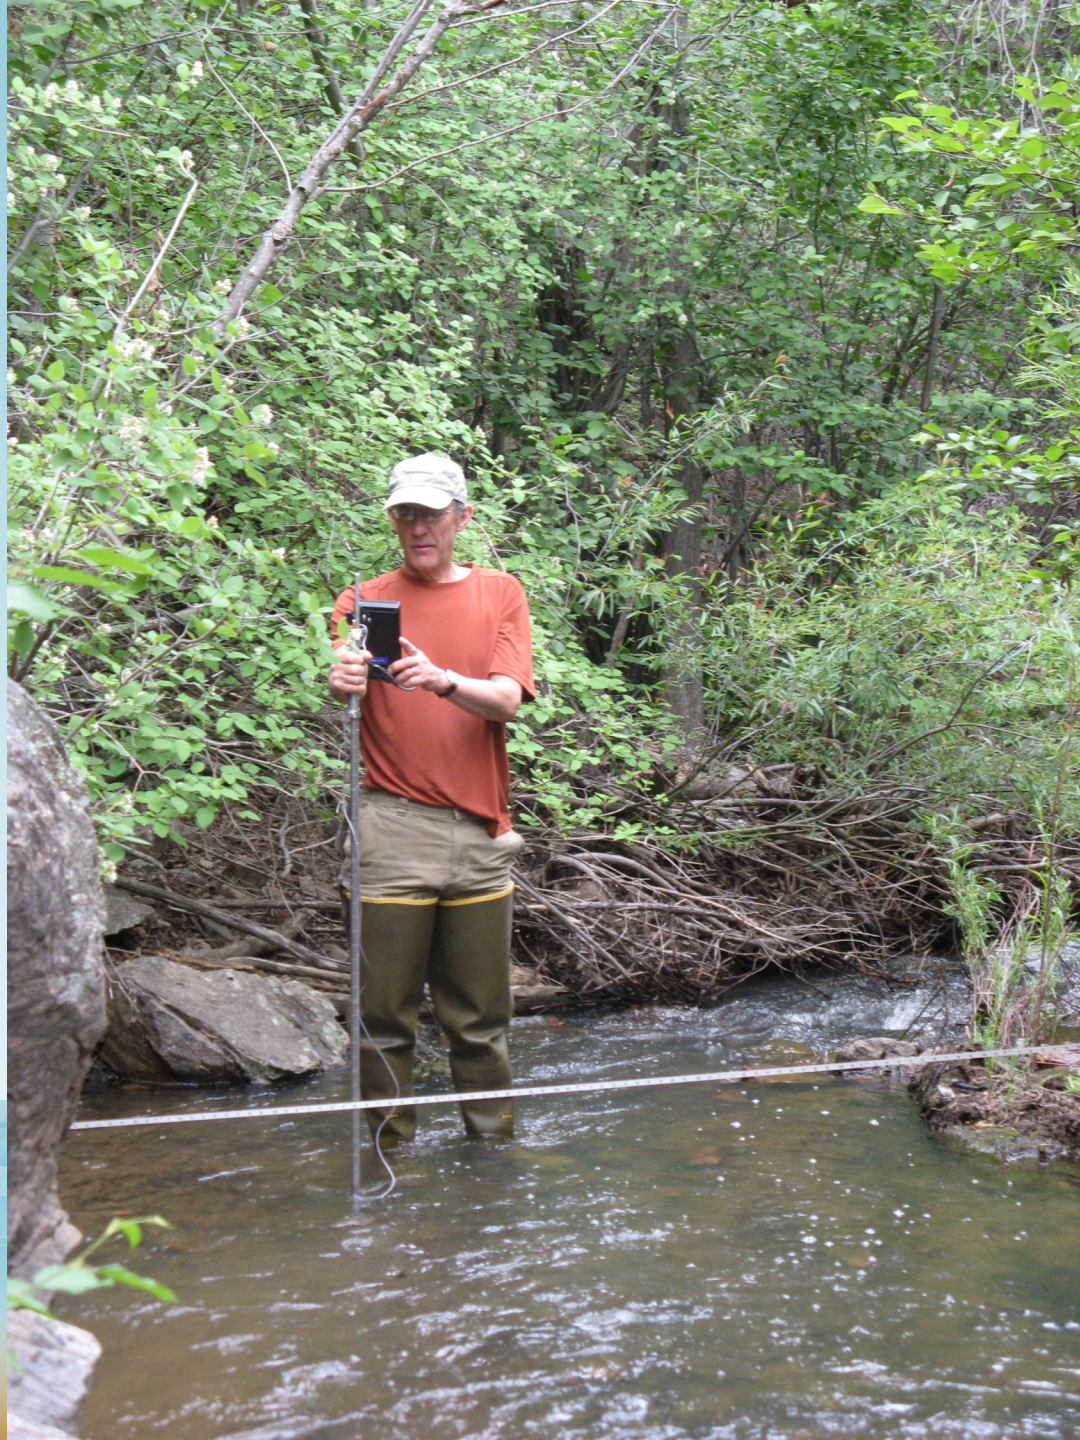
WADING DISCHARGE MEASUREMENTS

Gage Below
Nichols Reservoir

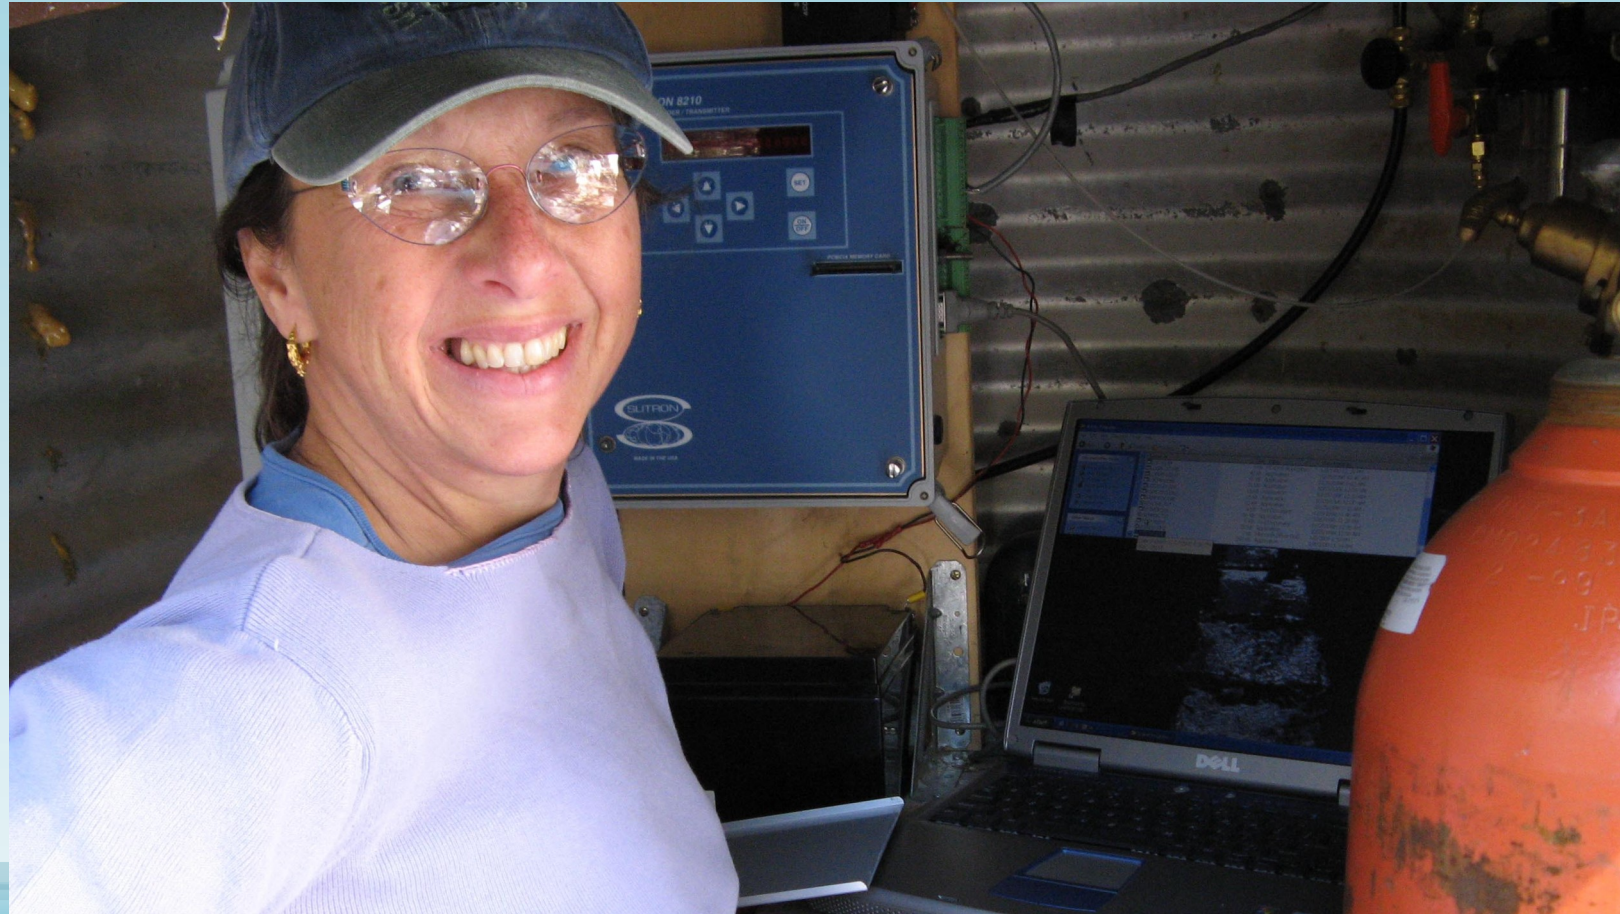
Stream Gaging

Paige Grant
Downloading
Data
at Gage Below
Nichols Reservoir

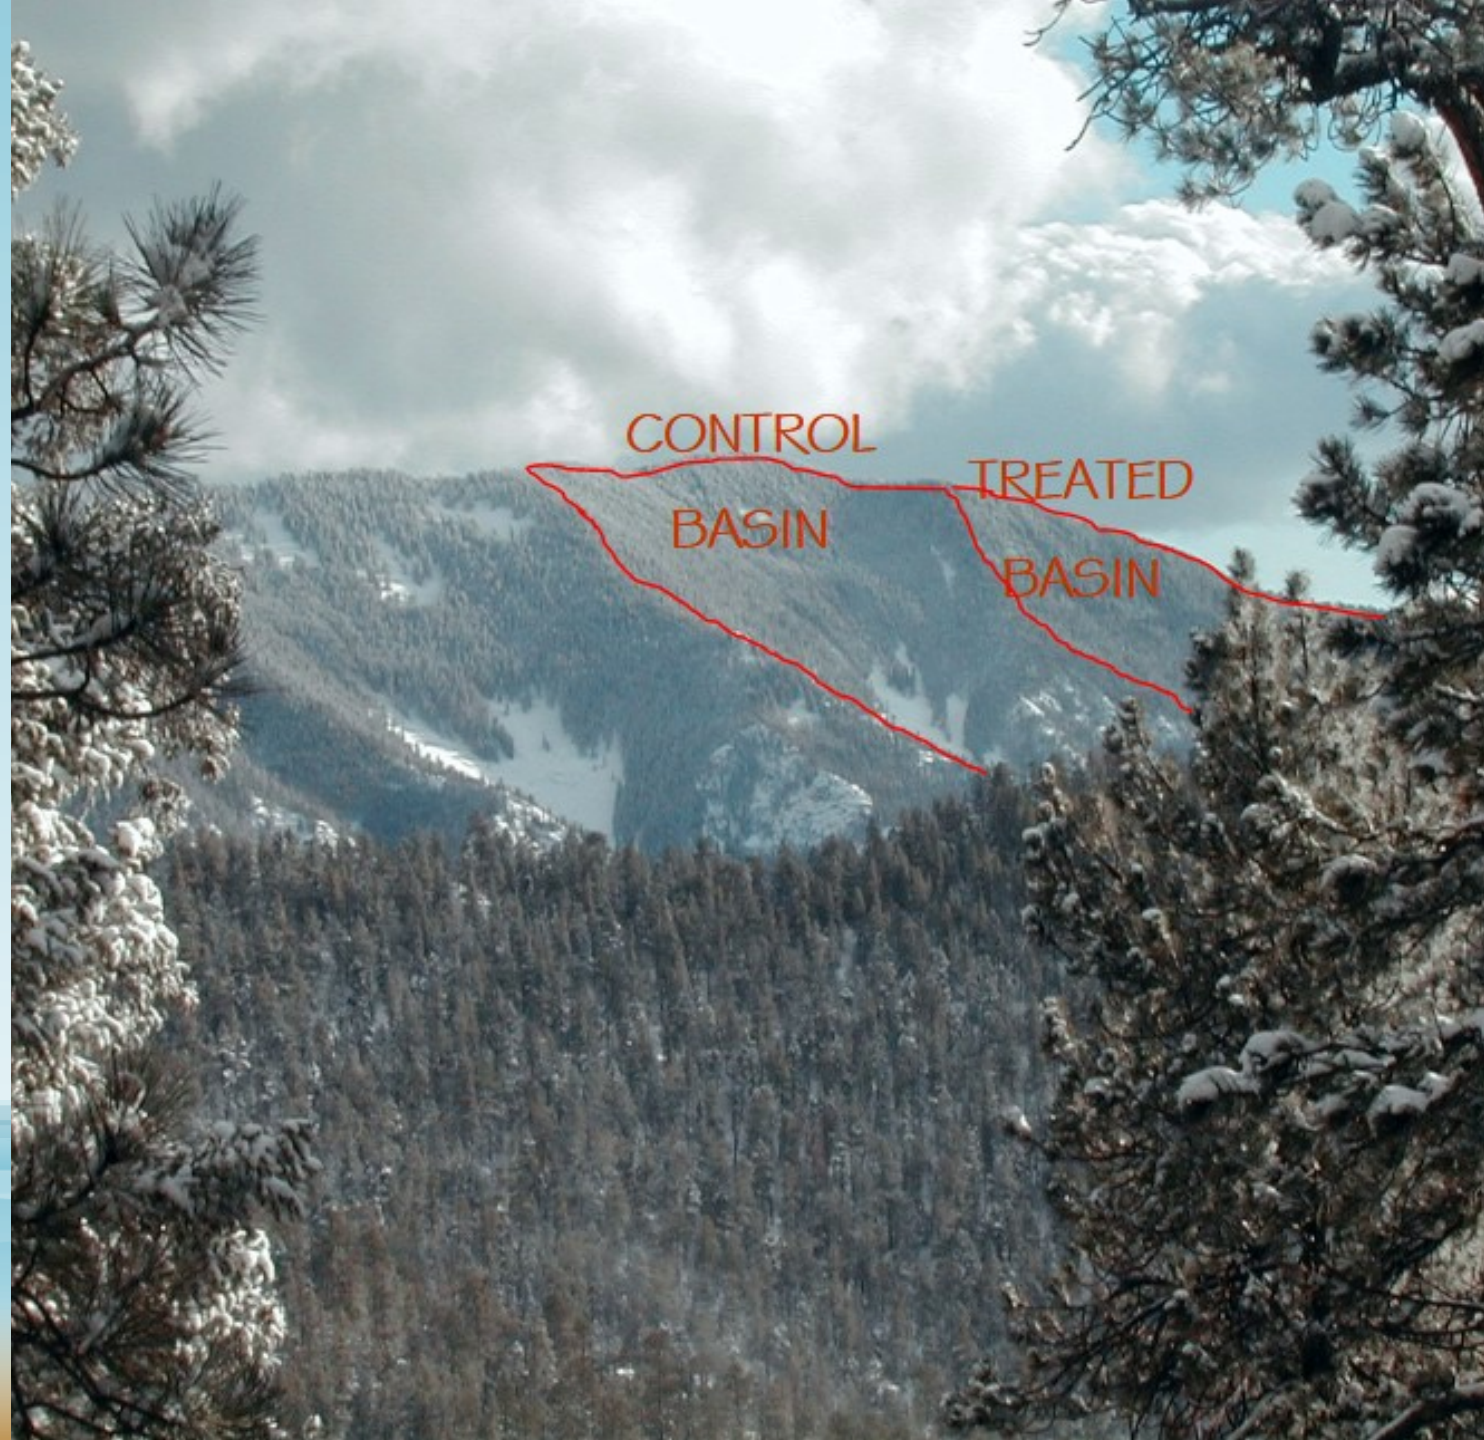
PAIRED BASIN STUDY
2001 - 2006

CREEK RESPONSES TO THINNING AND
BURNING

FLOWS
TURBIDITY
TEMPERATURE
CONDUCTIVITY
RAINFALL

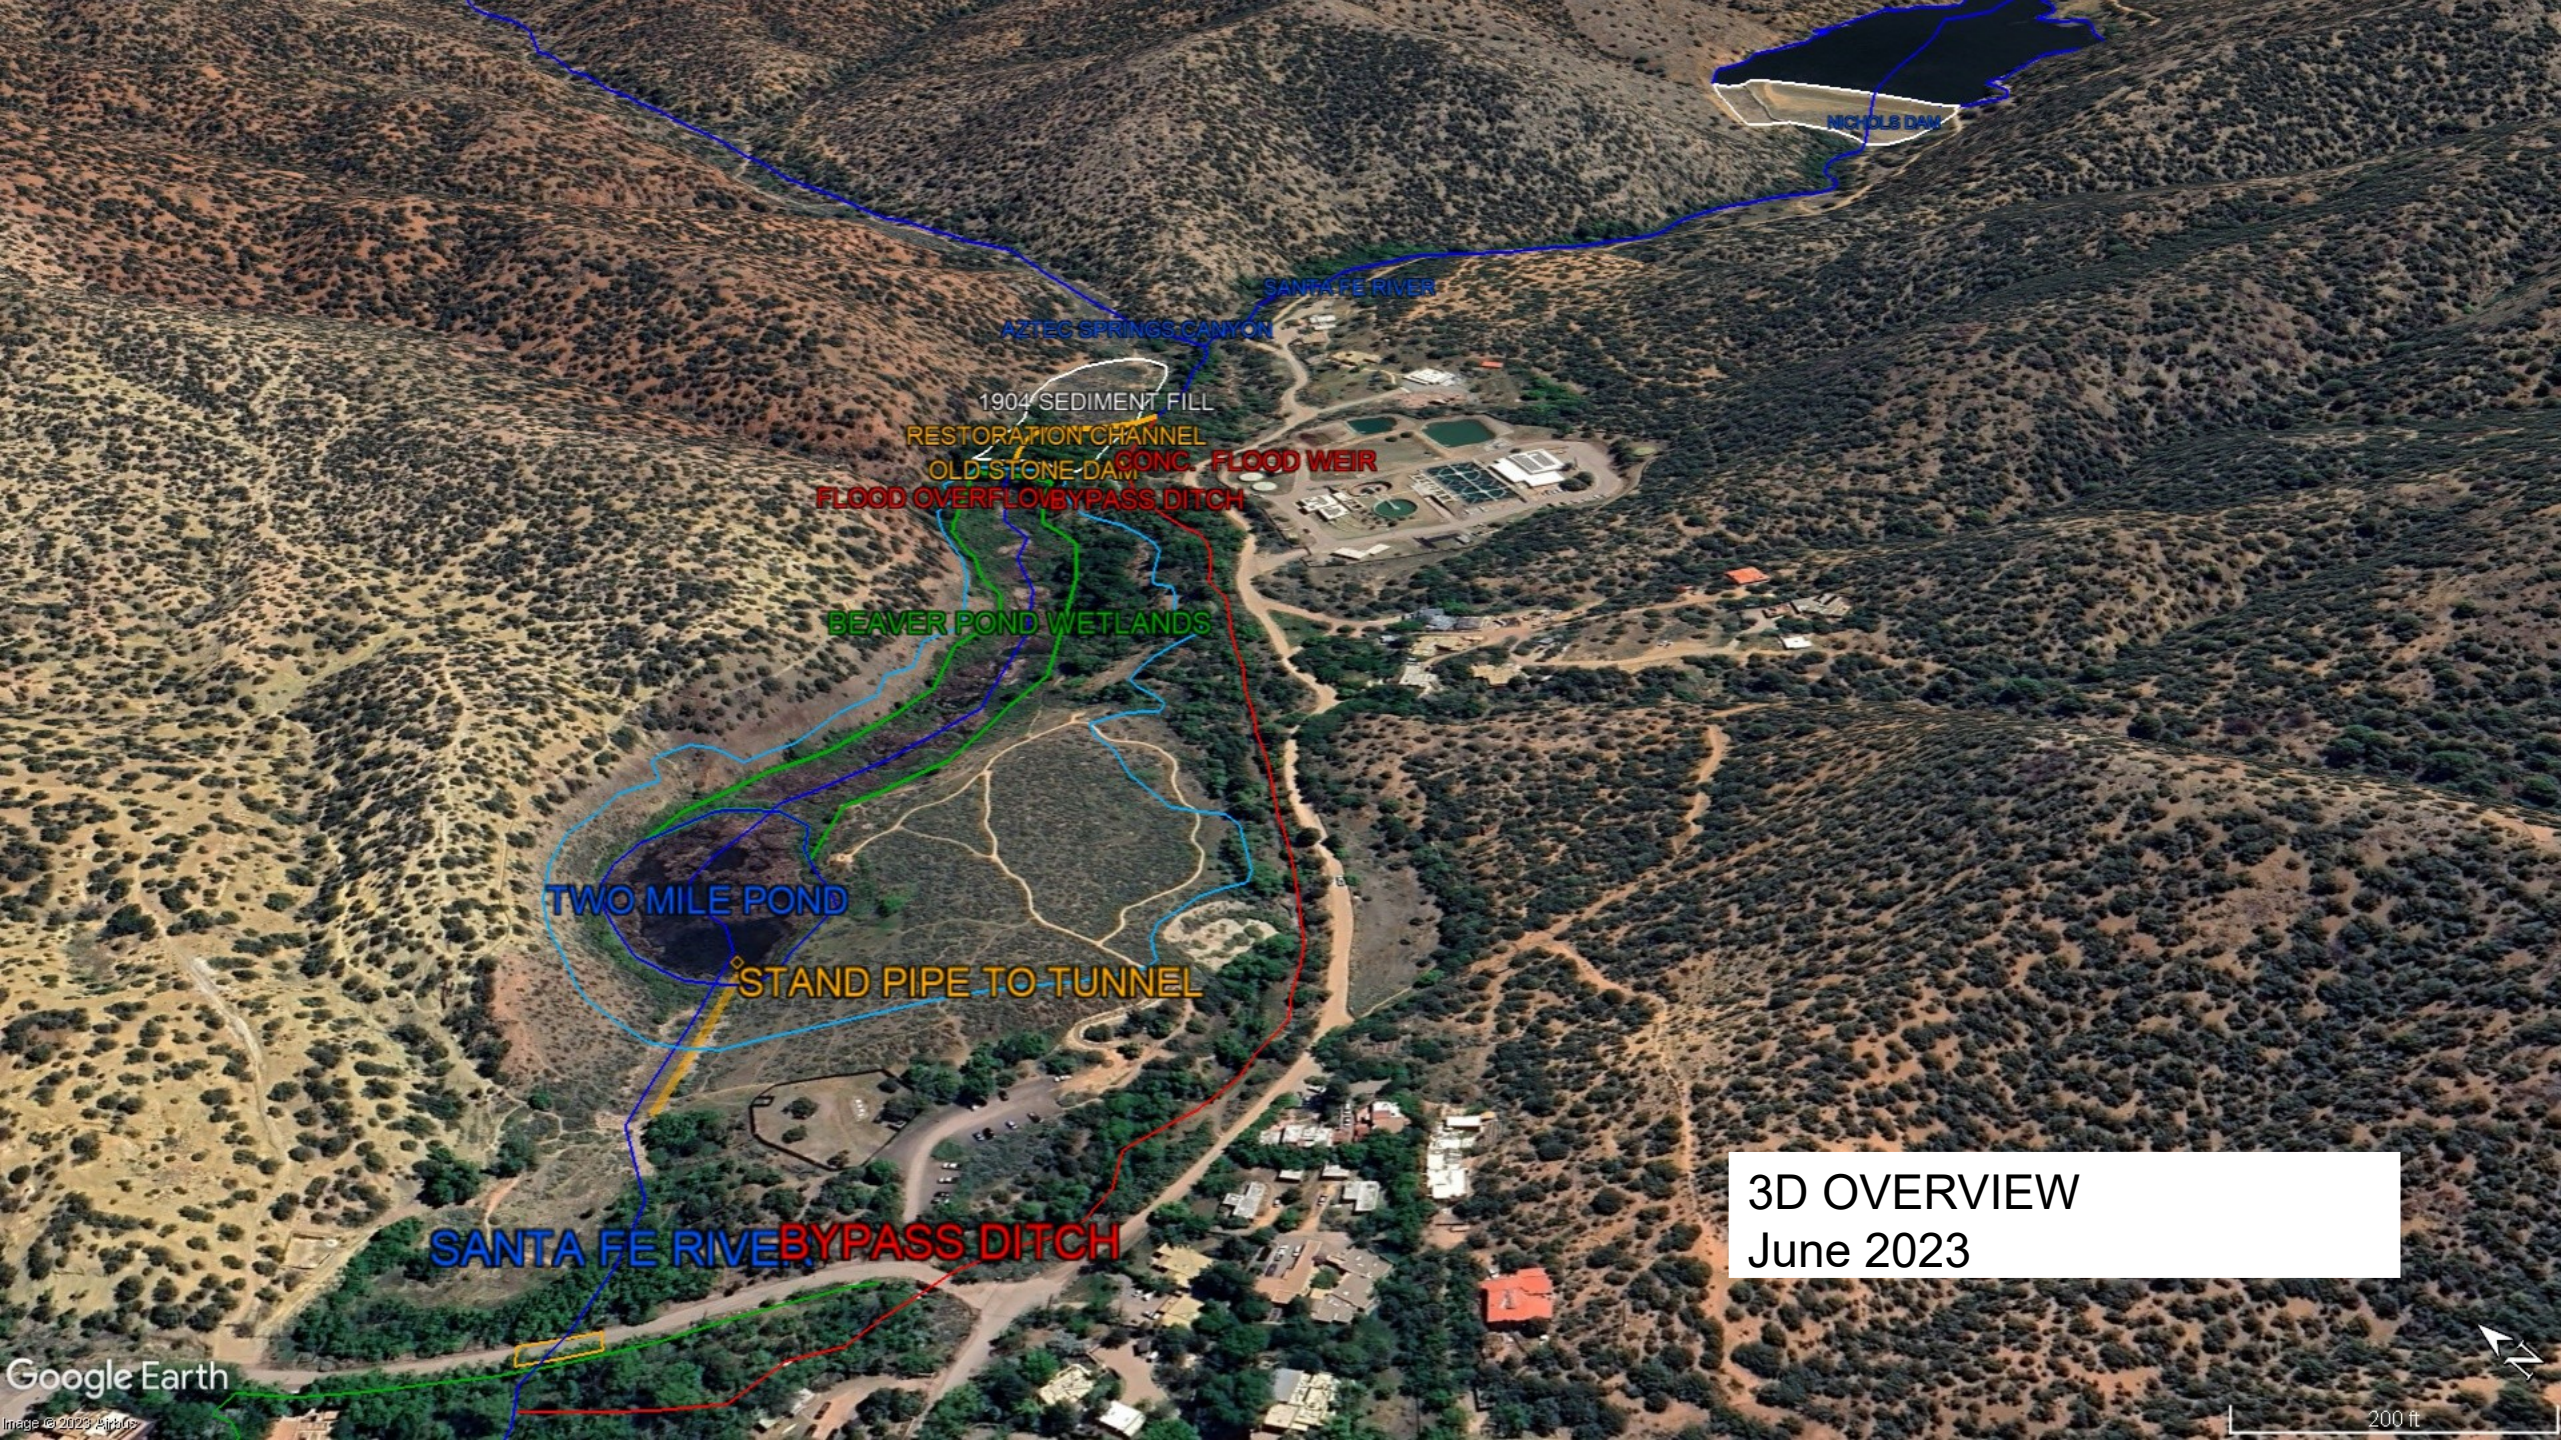
3D OVERVIEW
June 2023

NICHOLS DAM

RESTORATION CHANNEL

OLD STONE DAM

CONG. FLOOD WEIR

FLOOD OVERFLOW BYPASS DITCH

BEAVER POND WETLANDS

TWO MILE POND

STAND PIPE TO TUNNEL

SANTA FE RIVER BYPASS DITCH

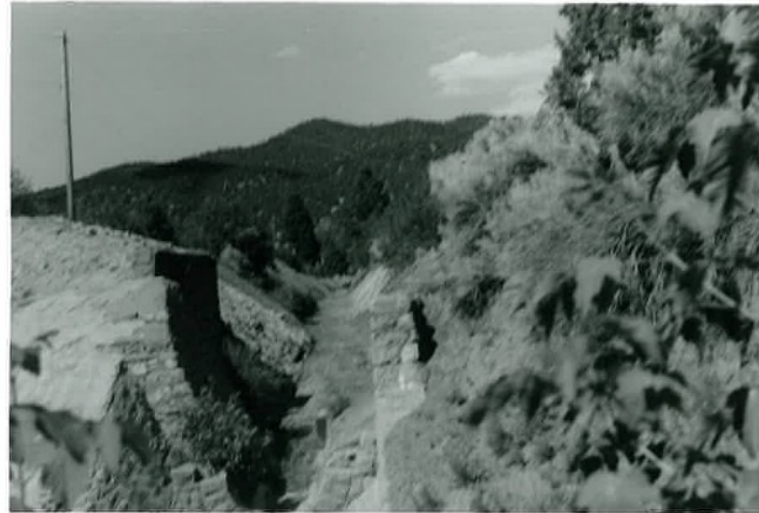
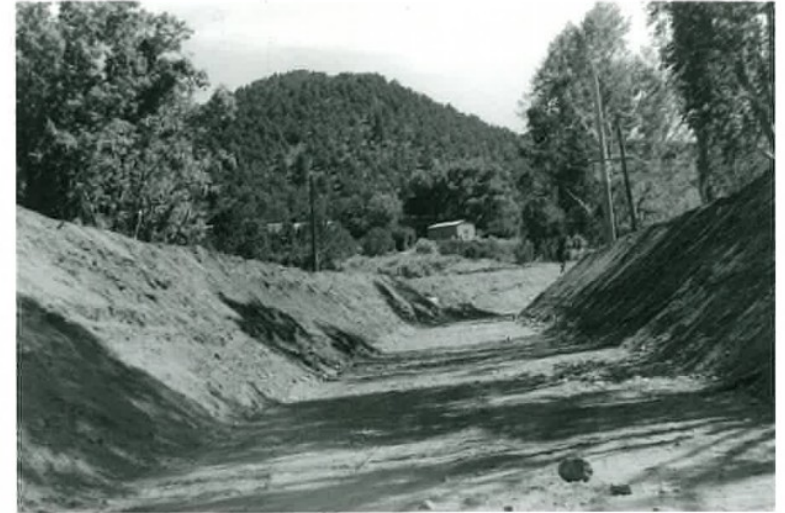
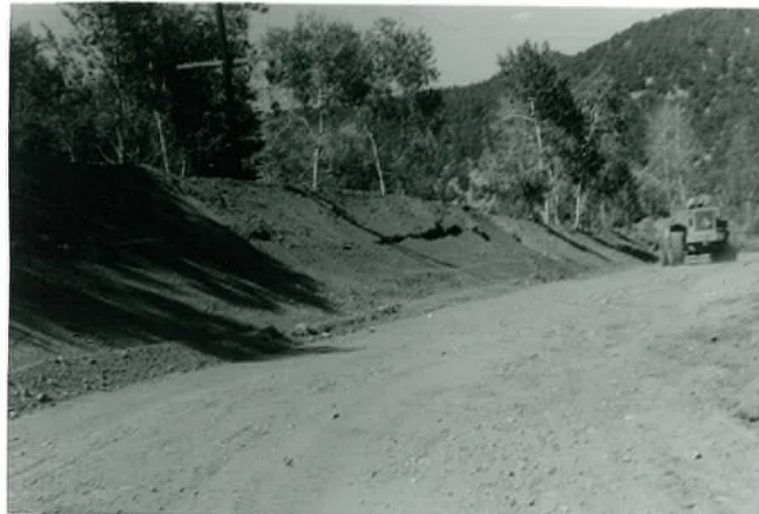
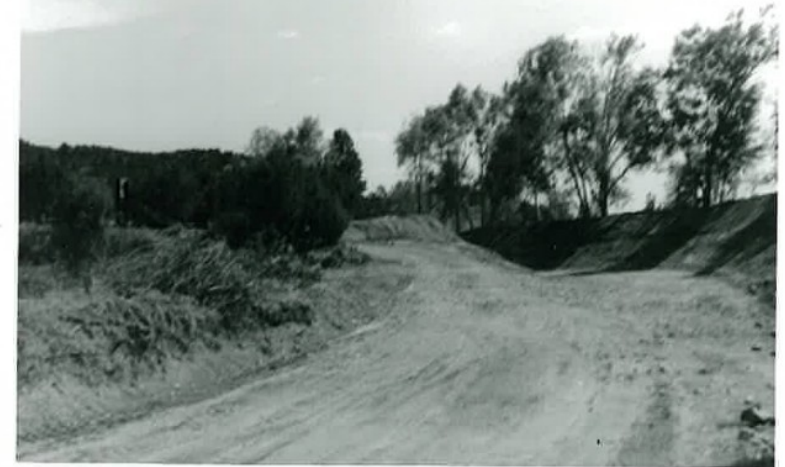
Bypass Ditch Cleaning in 1972

An Efficient Channel for Acequia Delivery

Narrow,
Clear of
vegetation

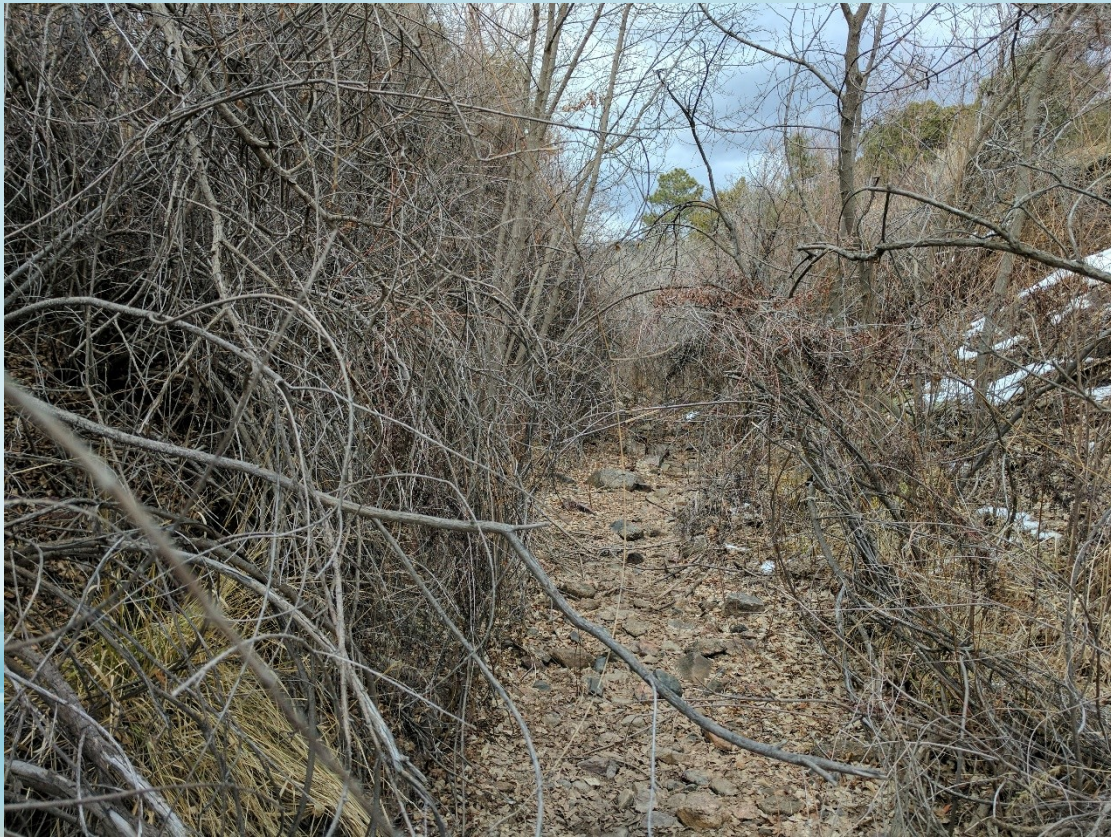
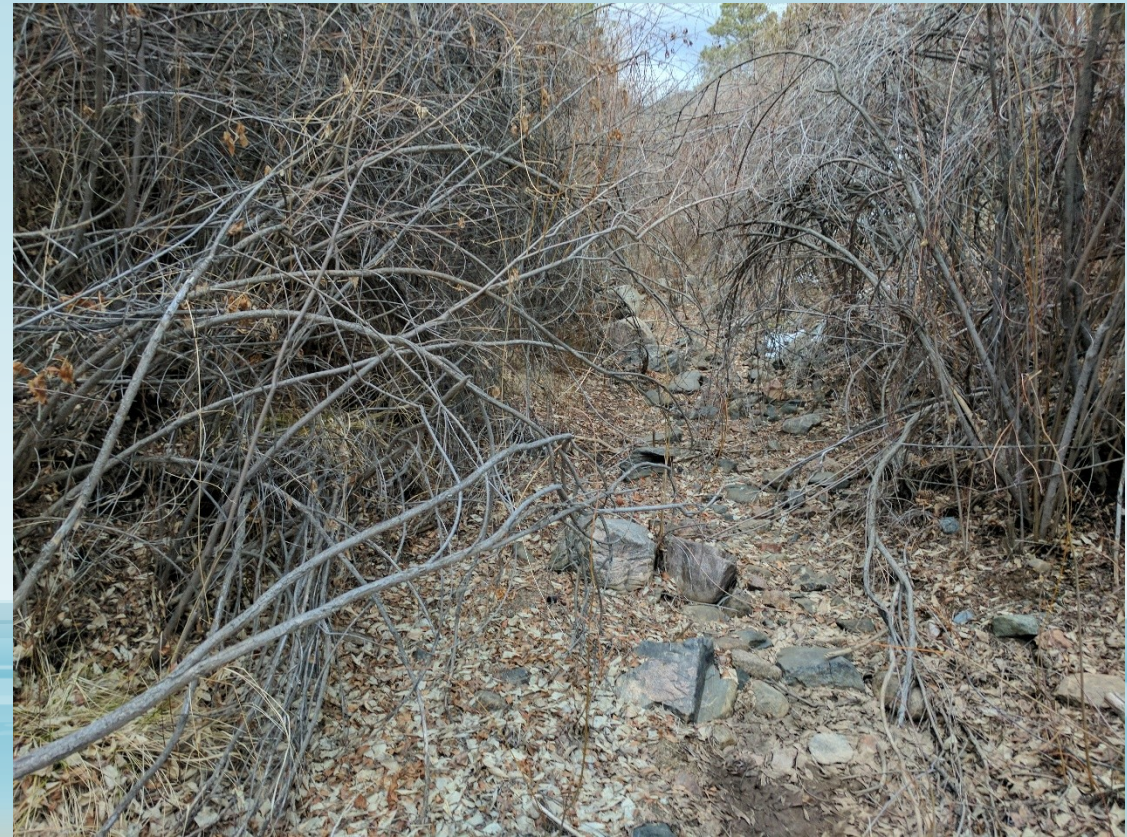
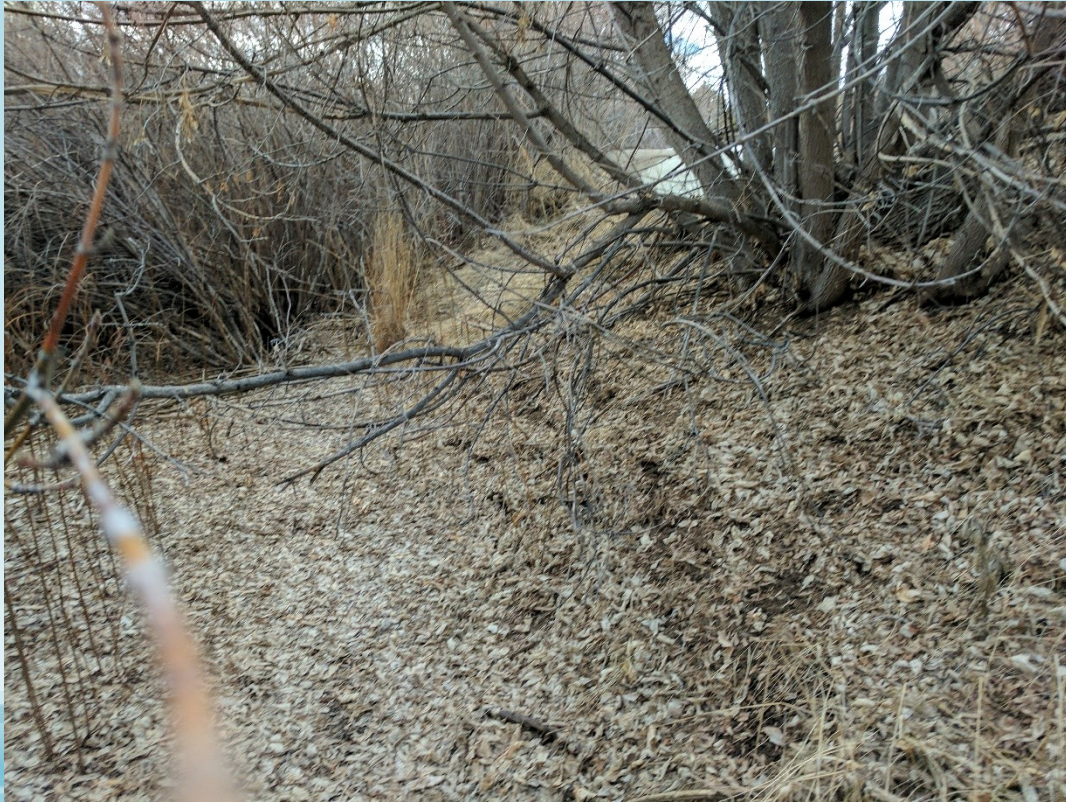
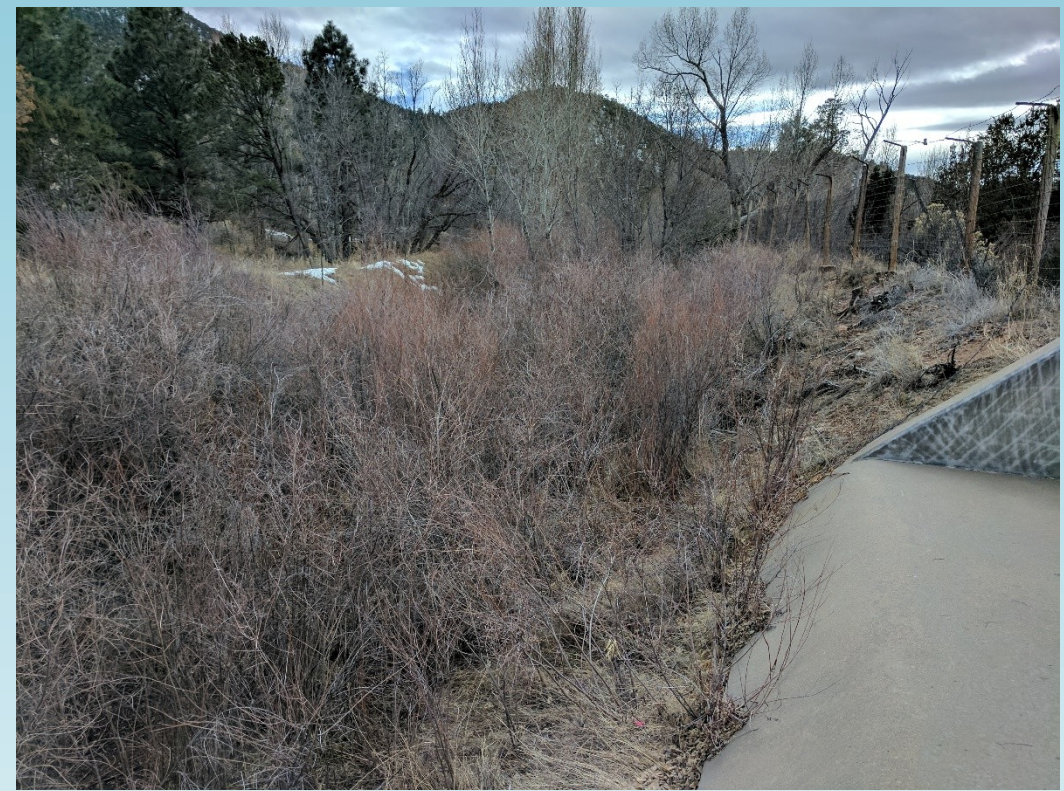
The Bypass Channel Today

Tree growth clogs the Bypass and will cause major flood water to spill over the concrete weir here.

- *It had* an engineering purpose 113 years ago, but now it's a **Public Works Liability**
- The Bypass is now overgrown and clogged with trees.
- A major storm will cause the spillway to dump uncontrolled flood water upstream of Cerro Gordo Rd
- When the flood spillway overflows (as designed) it will likely flood and destroy Cerro Gordo Road and damage properties through downtown Santa Fe
- PNM and the City did not completed the bridge and other flood work recommended in their 1994 purchase agreement
- No one is responsible for Bypass maintenance - and most of it is now TNC land.
- The Bypass loses water continuously. Retiring it will save drinking water.

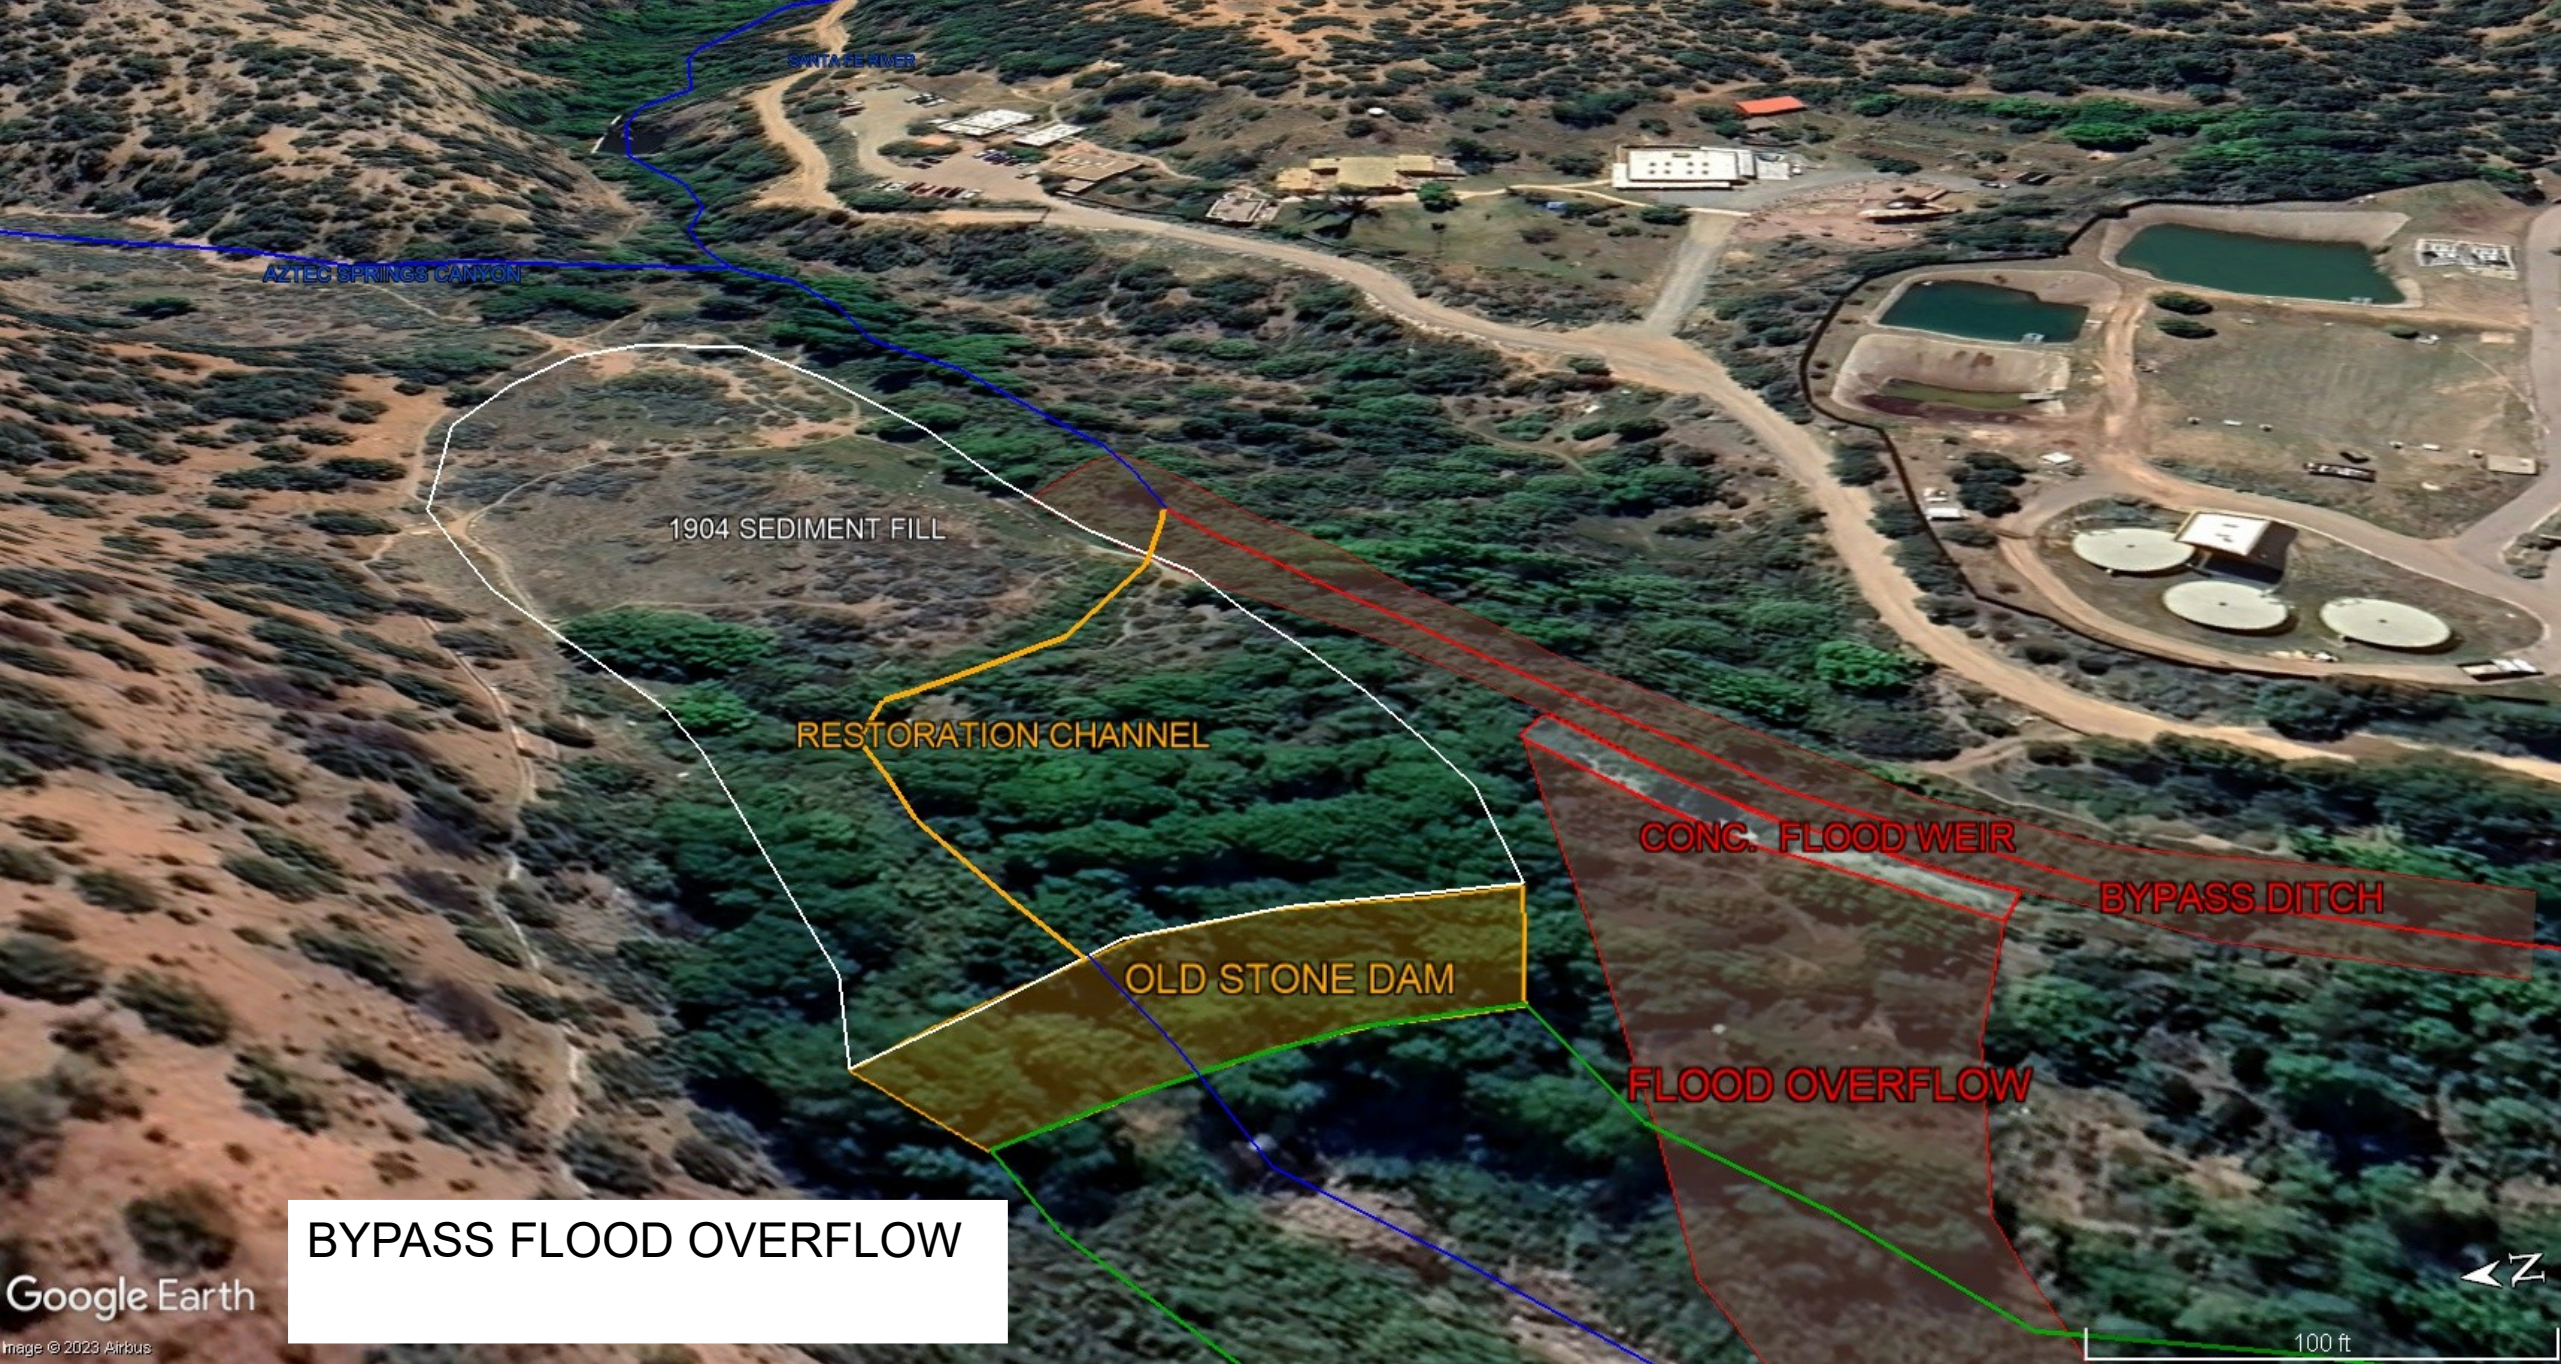
FLOOD ZONES - Nichols to Cerro Gordo Rd

SANTA FE RIVER

RESTORATION CHANNEL

OLD STONE DAM

CONC. FLOOD WEIR

BYPASS DITCH

FLOOD OVERFLOW

BYPASS FLOOD OVERFLOW

Santa Fe County
GIS Flood Zone
Mapping 2023

Note: TM Reservoir
area still shows 30
years after breach.

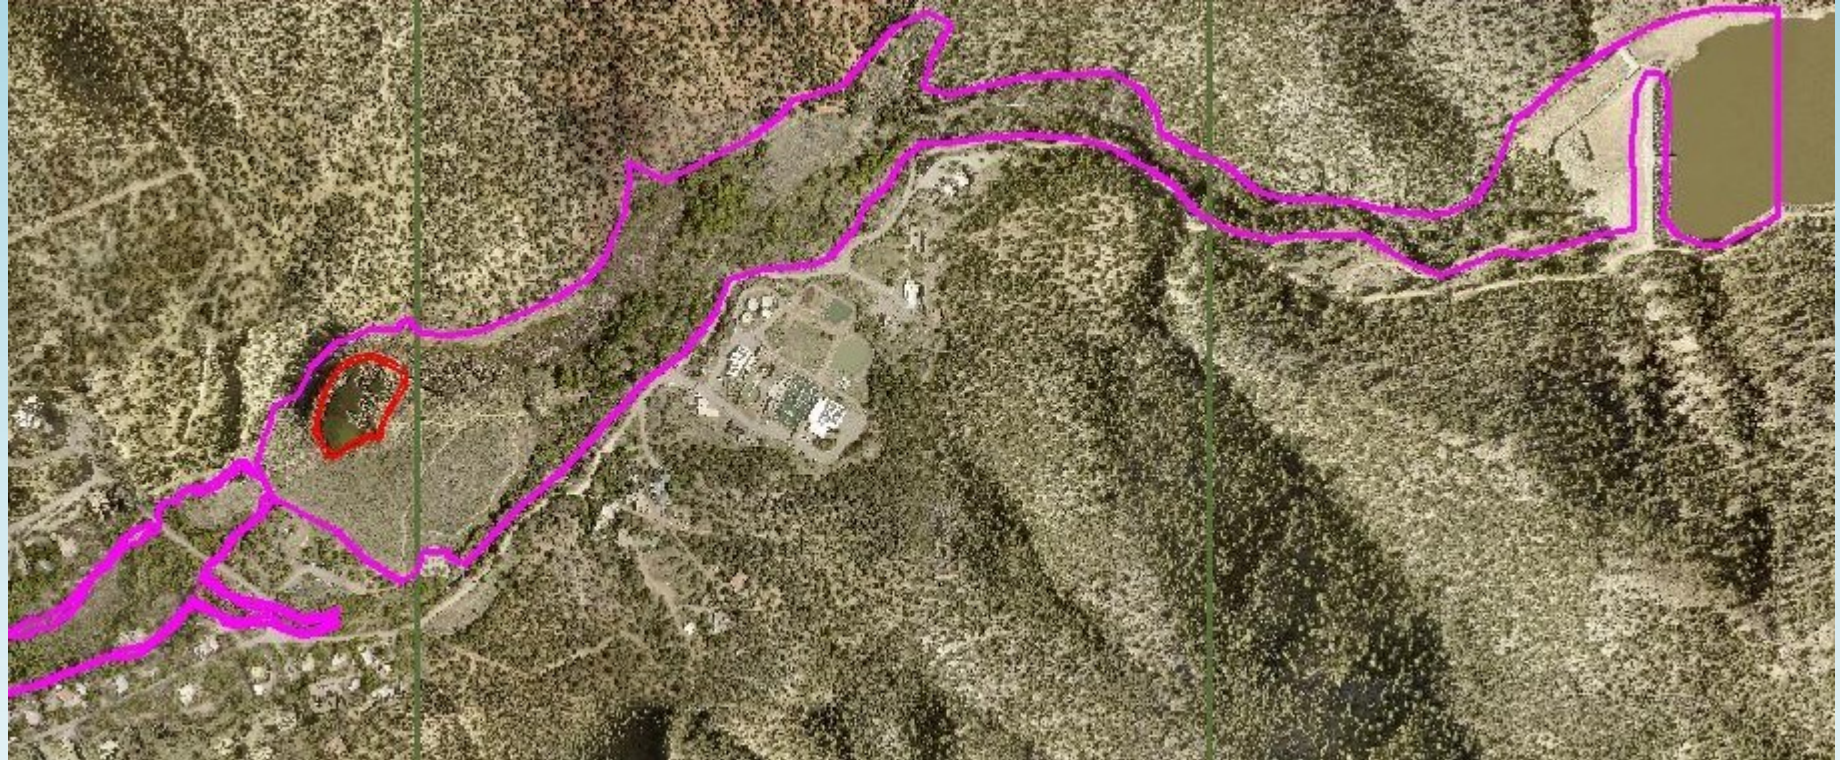
THE BYPASS DITCH LEAKS

Bypass seepage ranged from -0.5 cfs at base flow up to -1.75 cfs during acequia deliveries

Average Measured Loss - 0.304 cfs

THE NATURAL CHANNEL GAINS

Natural channel below Two Mile pond flowed from +0.3 to +0.5cfs from infiltration without any river input

Average Measured Gain+ 0.320 cfs

All loss occurs in Bypass Channel

Table 6. Water budget for the Santa Fe River from below Nichols Reservoir to below Two Mile Pond, July 23, 2018 to March 16, 2019

component	station	average flow (cfs)
inflow	below Nichols river station	0.527
midpoint	Stilling Well A bypass station	0.458
outflow	Stilling Well B bypass station	0.154
outflow	TNC Restoration Channel return below Two Mile Pond	0.320
net loss		0.053

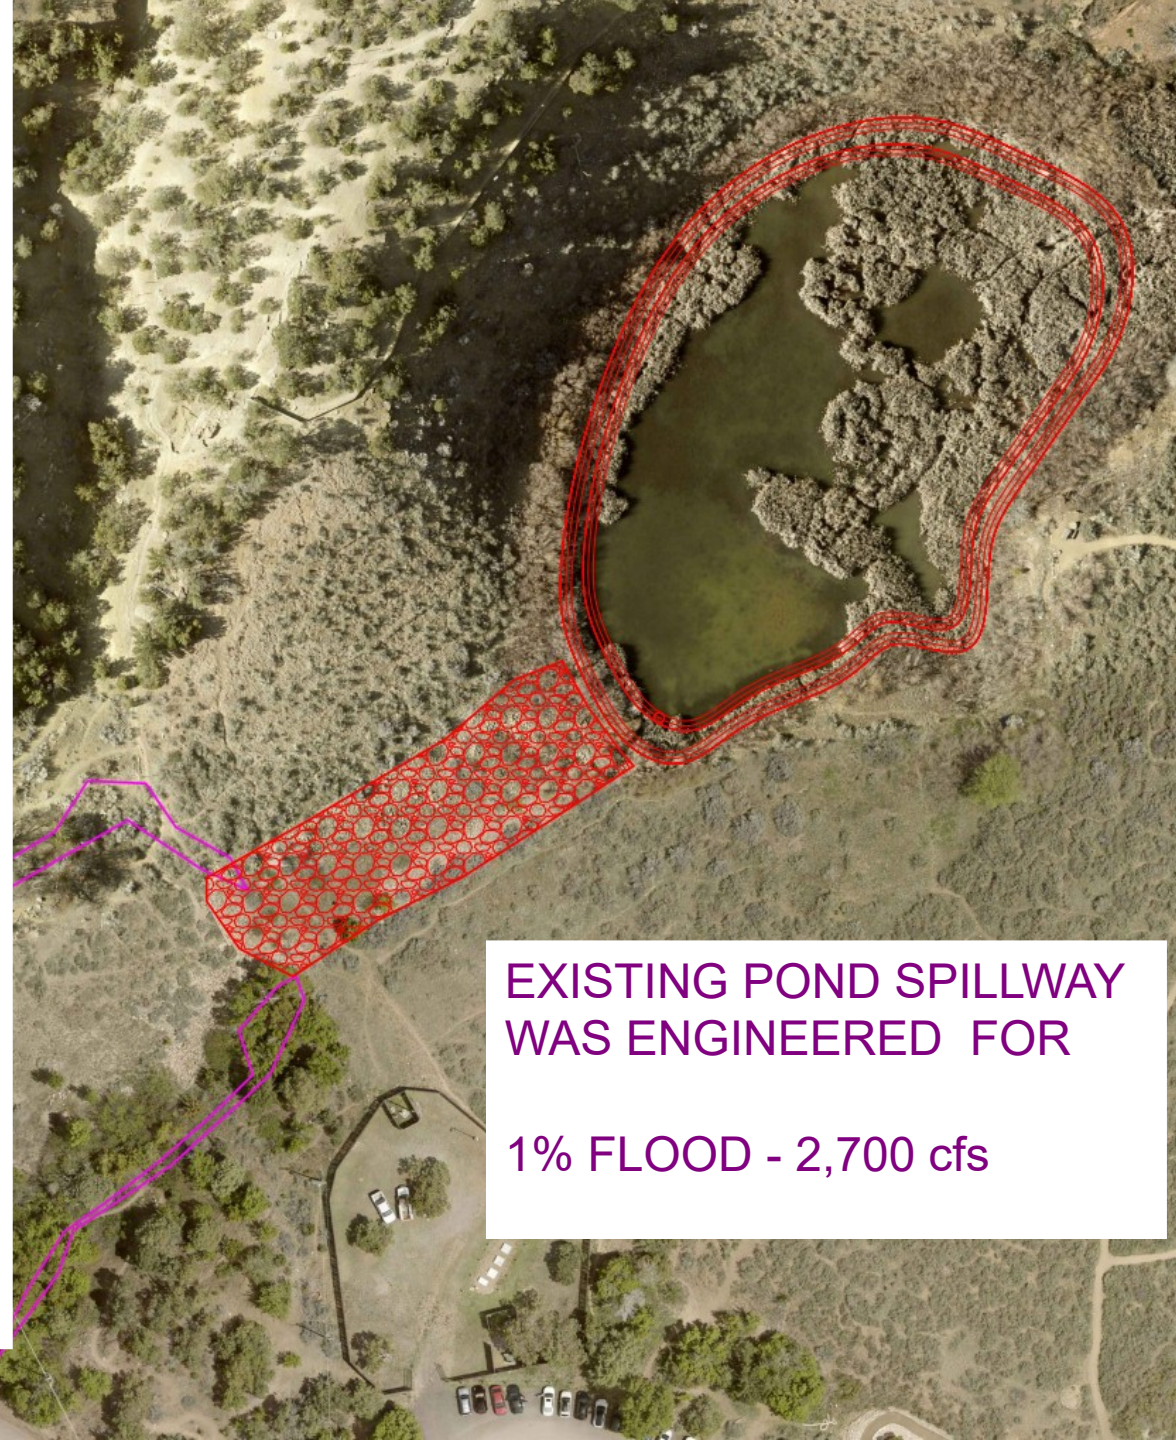
POND SIZING: IF POND IS EXCAVATED TO A UNIFORM 6 FEET DEEP

1.6 ACRE MAX WATER SURFACE

6 FEET DEEP, 3:1 SIDE SLOPES

8.5 ACRE FEET TOTAL VOLUME

ACEQUIA RELEASES :

ACEQUIA DELIVERY = APPROX. 3.5 ACRE FEET/ WEEK
(99 AF/Y, 28 WK SEASON)

DRAWDOWN ON ACEQUIA RELEASE DAYS - APPROX. 2.5 FT

POND INFLOWS :

NICHOLS ACEQUIA TRANSFERS = APPROX. 3.5 ACRE FEET/ WEEK

NATURAL INFLOW = APPROX. 4.2 ACRE FEET / WEEK (0.3 CFS)

LIVING RIVER INFLOW = VARIES

EXISTING POND SPILLWAY
WAS ENGINEERED FOR
1% FLOOD - 2,700 cfs
