Historic Cultural Properties Inventory (HCPI) Base Form (FORM 1)

1. Name of property: 127 Duran Street, Rear House Guadalupe and Simonia Chavez House Martha J. Baca House	2. Location: 127 Duran Street (Rear) Westside-Guadalupe Historic District – Santa Fe	3. Local Reference Number: Santa Fe ID: Old # 051613057 4. County: Santa Fe Parcel # 10446175

8. Name of Project: HDRB Status Evaluation		
9. Lat/Long: 35.690543, -105.946678		
10. Photo Information: John W. Murphey, photographer. Photo 1: North (front) elevation. Camera facing southeast, November 25, 2024

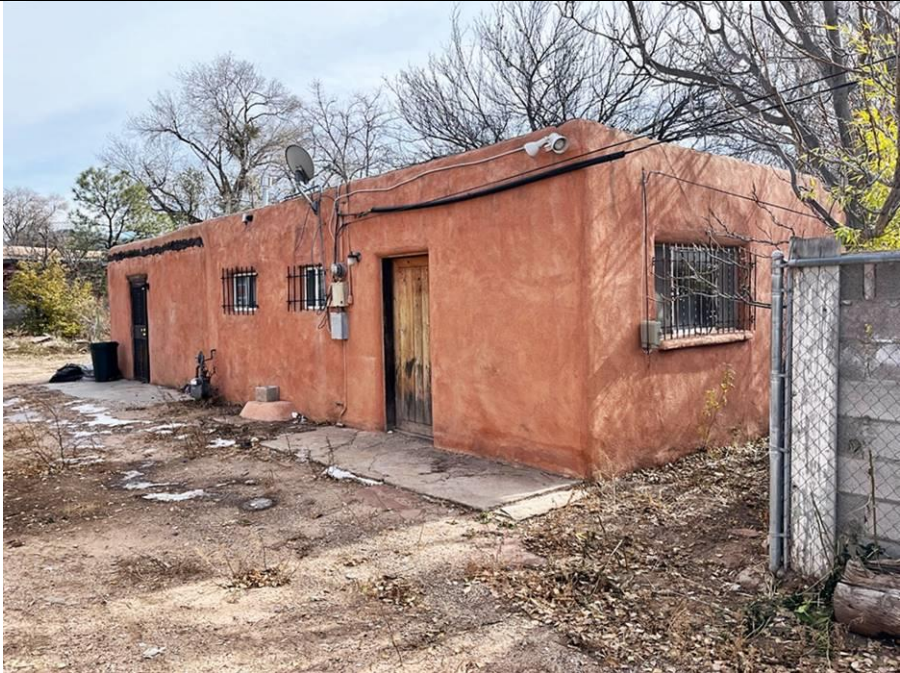
The building faces north with mostly a blank façade (Photos 1 & 5). The west half is the earlier constructed dwelling, consisting of four rooms. Separated by an expansion joint is the 1980s addition holding a dining room and living room (Photo 5). The west side is constructed of adobe and rests on a low foundation, though it is too low to be considered a crawl space. Its walls are roughly 12" thick. The construction of the addition is unclear.

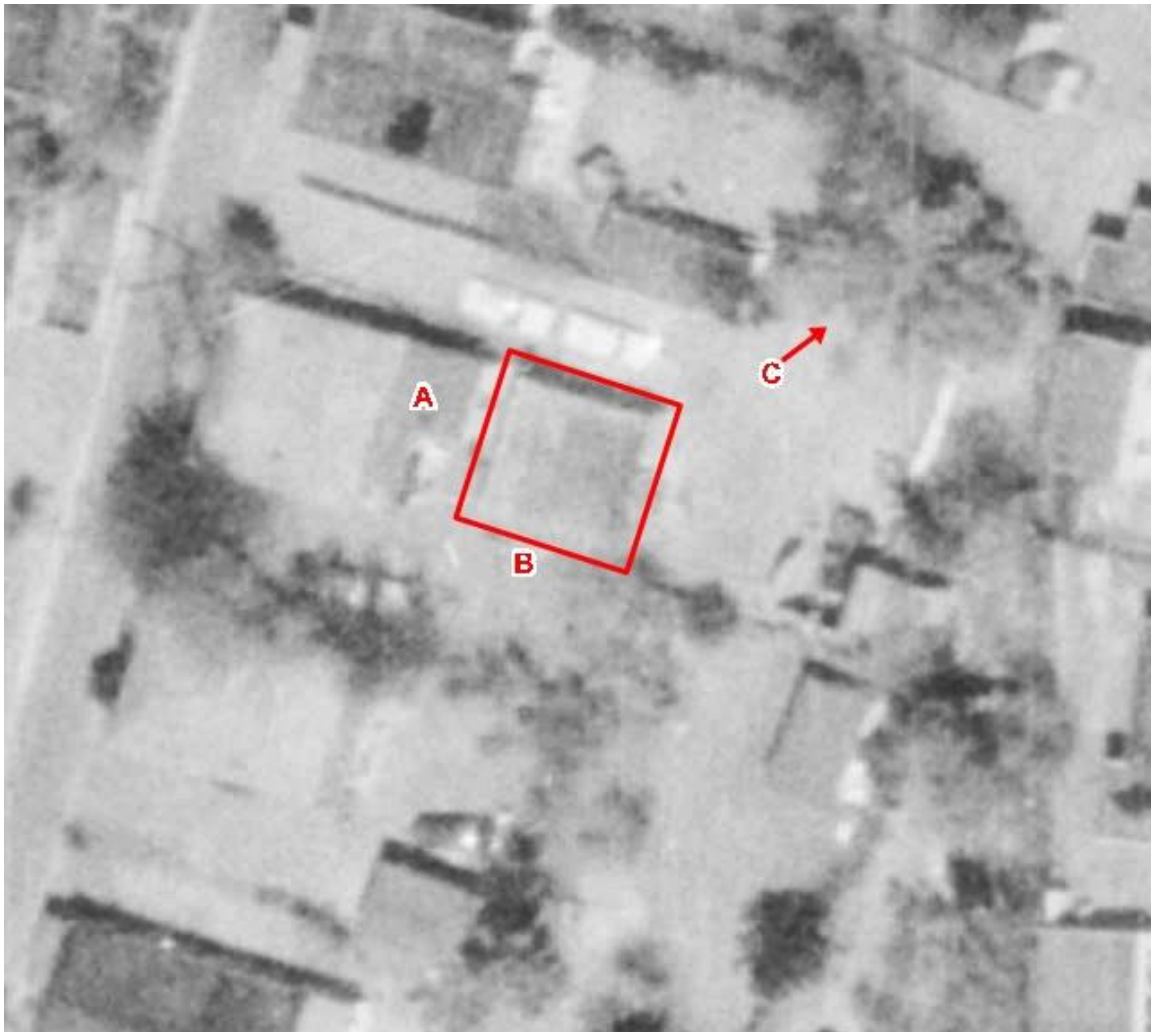
Figure 3: May 6, 1966, aerial photograph.
A. Structure located between front house and subject house; B. subject house, note square footprint; C. note absence of shop.

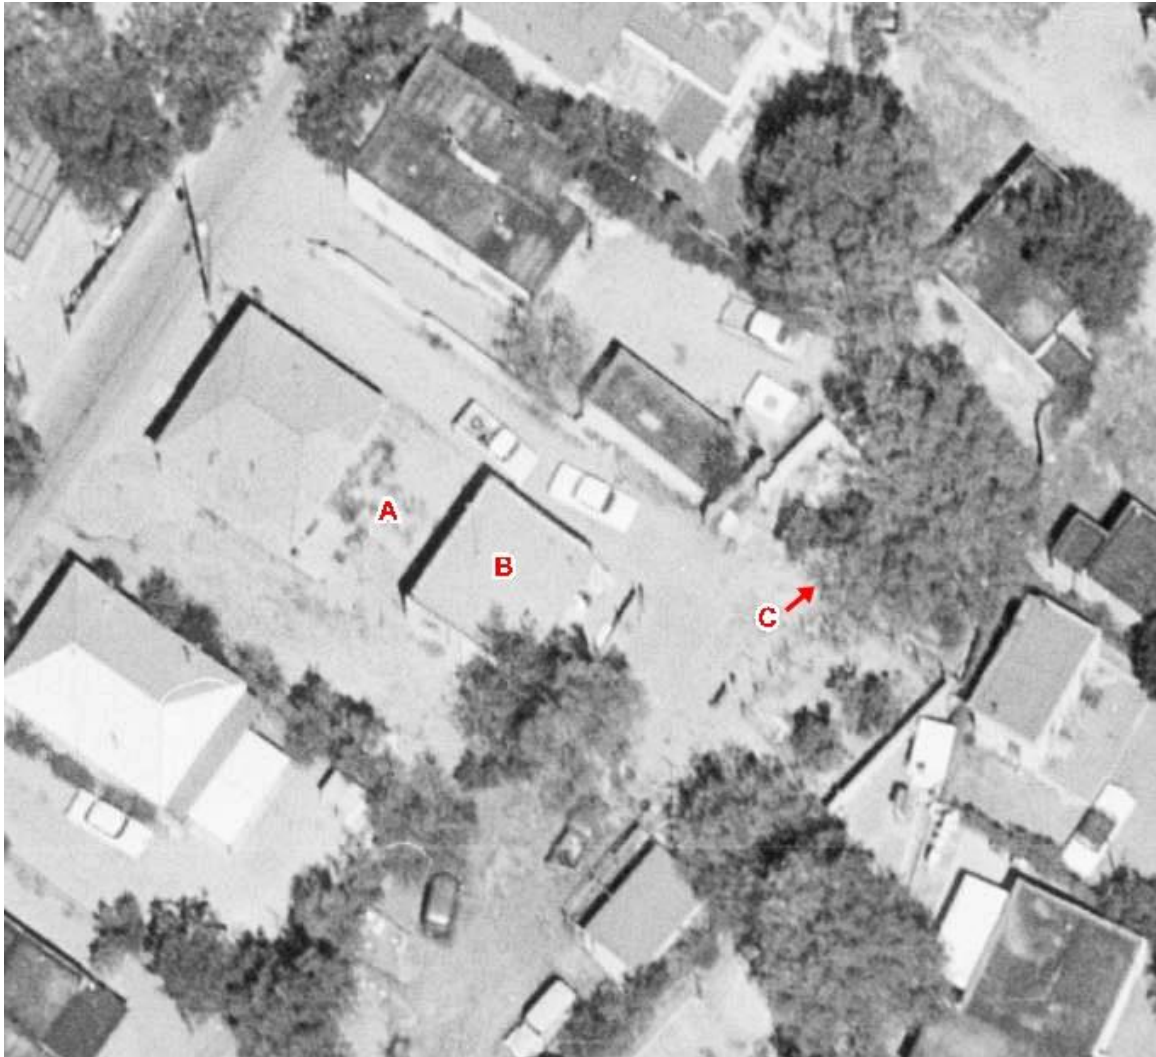
Figure 4: September 11, 1978, aerial photograph.
A. Structure located between front house and subject house has been demolished; B. subject house, note square footprint; C. note absence of shop.

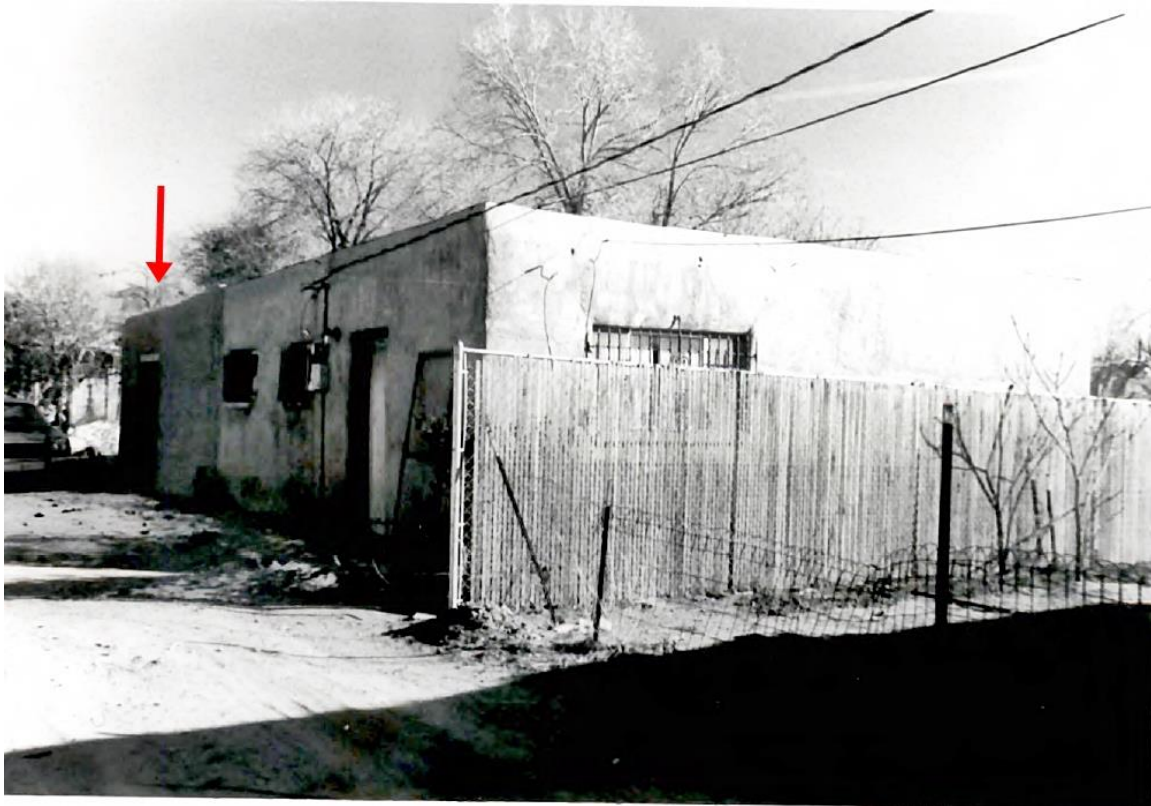
Figure 5: August 1985 HBI survey. The arrow indicates 1980s east addition. Susan Lopez, photographer. Courtesy of NMCRIIS.

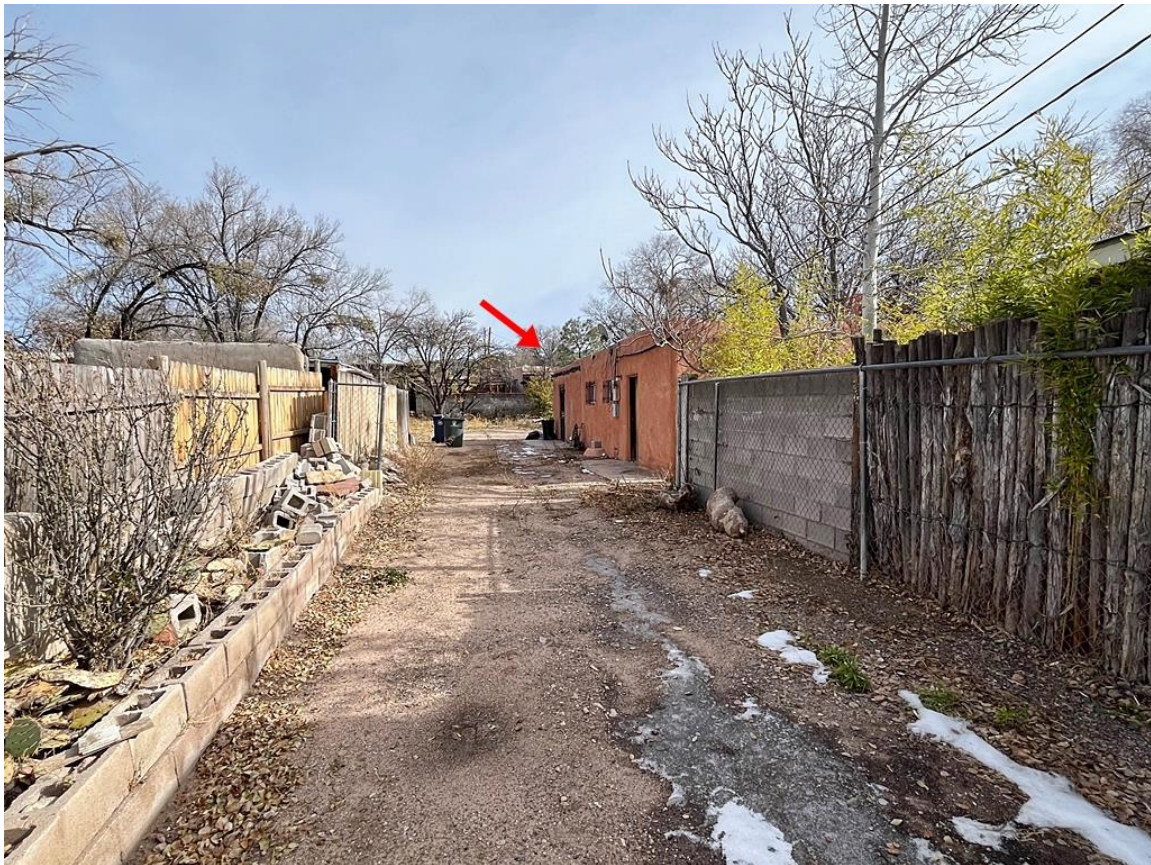
11. Brief Description of the Property: Potentially erected in the late 1930s, 127 Duran Street (Rear) is a roughly 1,189-square-foot adobe box. The building sits approximately 70' from the street (Photo 2) on a 0.15-acre flag lot created from the property west of it at 127 Duran Unit A. The subject house has a rectangular ground plan and faces north. The building began as a square footprint, evident in a 1966 aerial photograph (Fig. 3). In c.1985, a 406-square-foot addition was added across the east elevation. All windows and doors have been replaced. The house is designated Non-Contributing to the Westside-Guadalupe Historic District.		
<i>Continued on Page 5.</i>

Photo 2: View of property from near the west end of the driveway. Subject house highlighted by arrow. Camera facing east.

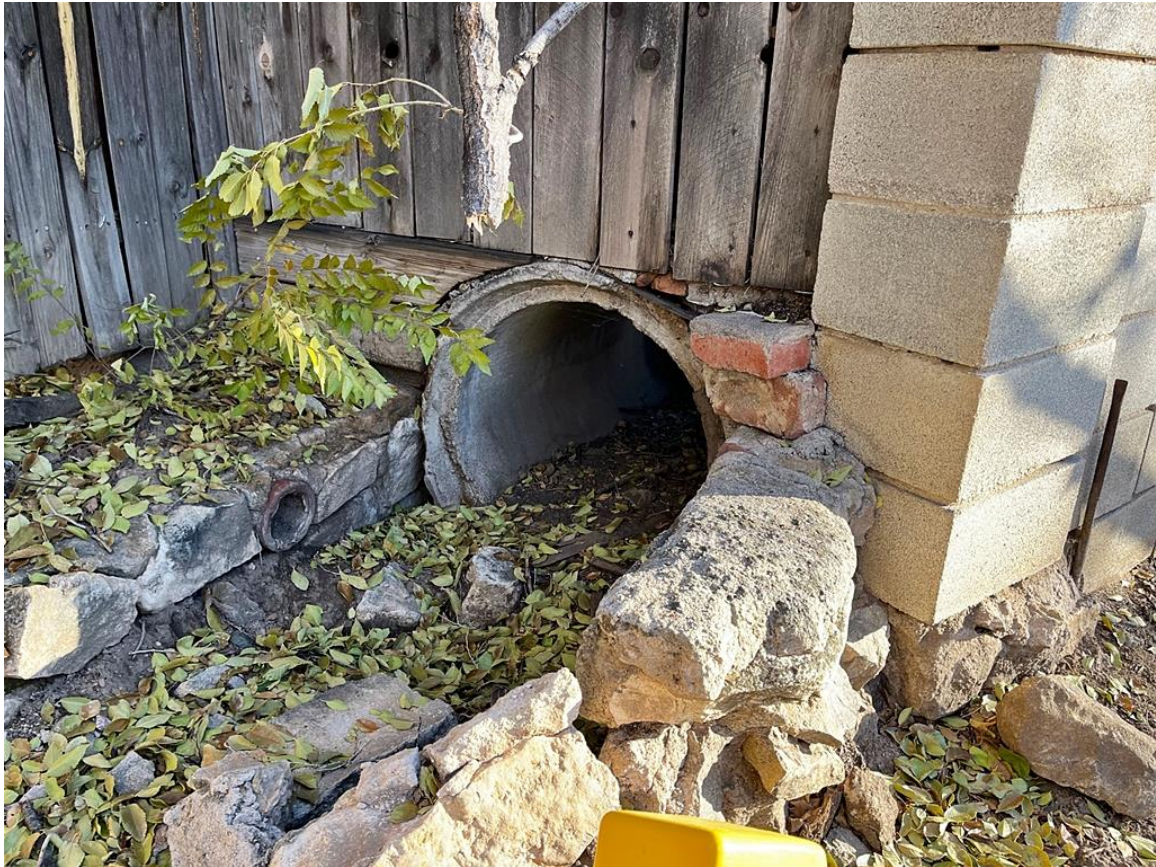
The property includes a post-1978 concrete block shop and storage room, both of which are of substandard construction. Once used for farming, the level lot has two mature apricot trees and several invasive ailanthuses. There is no formal landscaping. A relict acequia, thought to be part of the *Acequia Publica*, courses across the east edge of the property (Photo 4).

Photo 4: Assumed acequia segment tracing east side of property. Camera facing southeast.

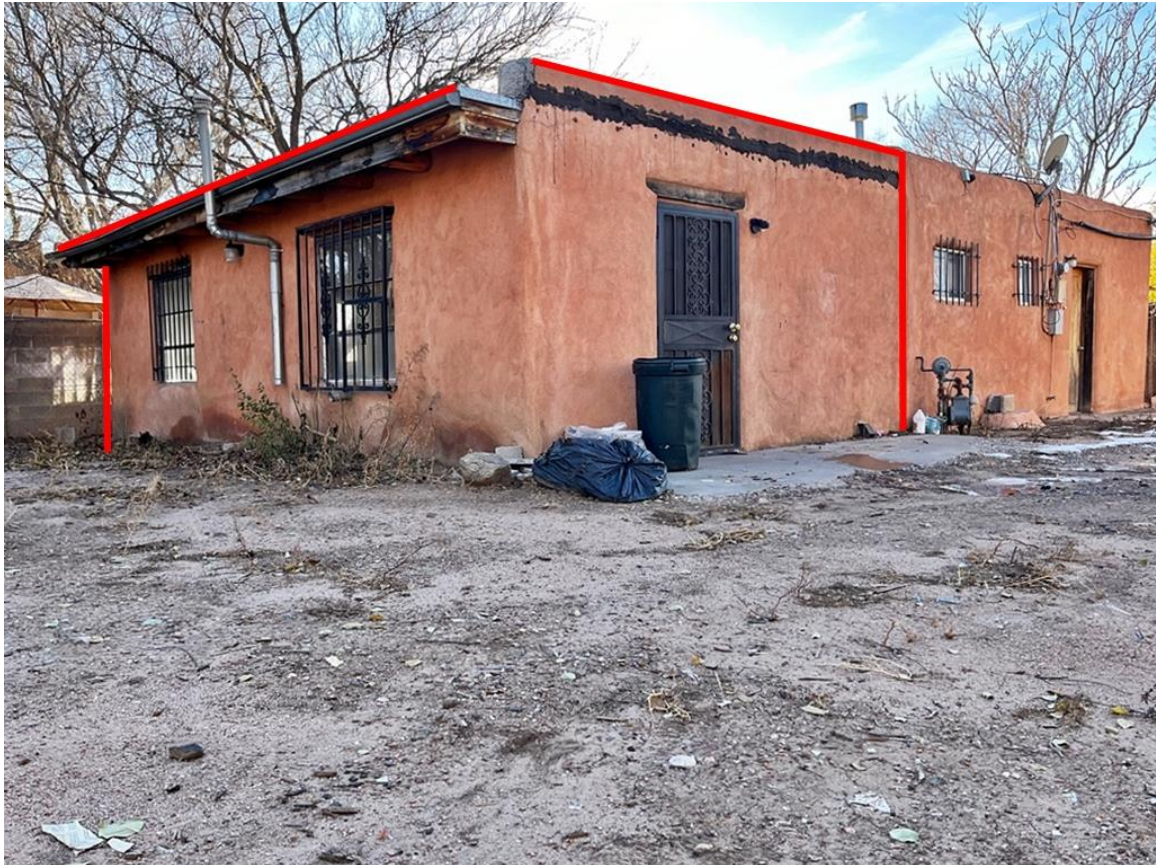
Photo 5: East and north elevations. 1980s addition outlined in red. Camera facing southwest.

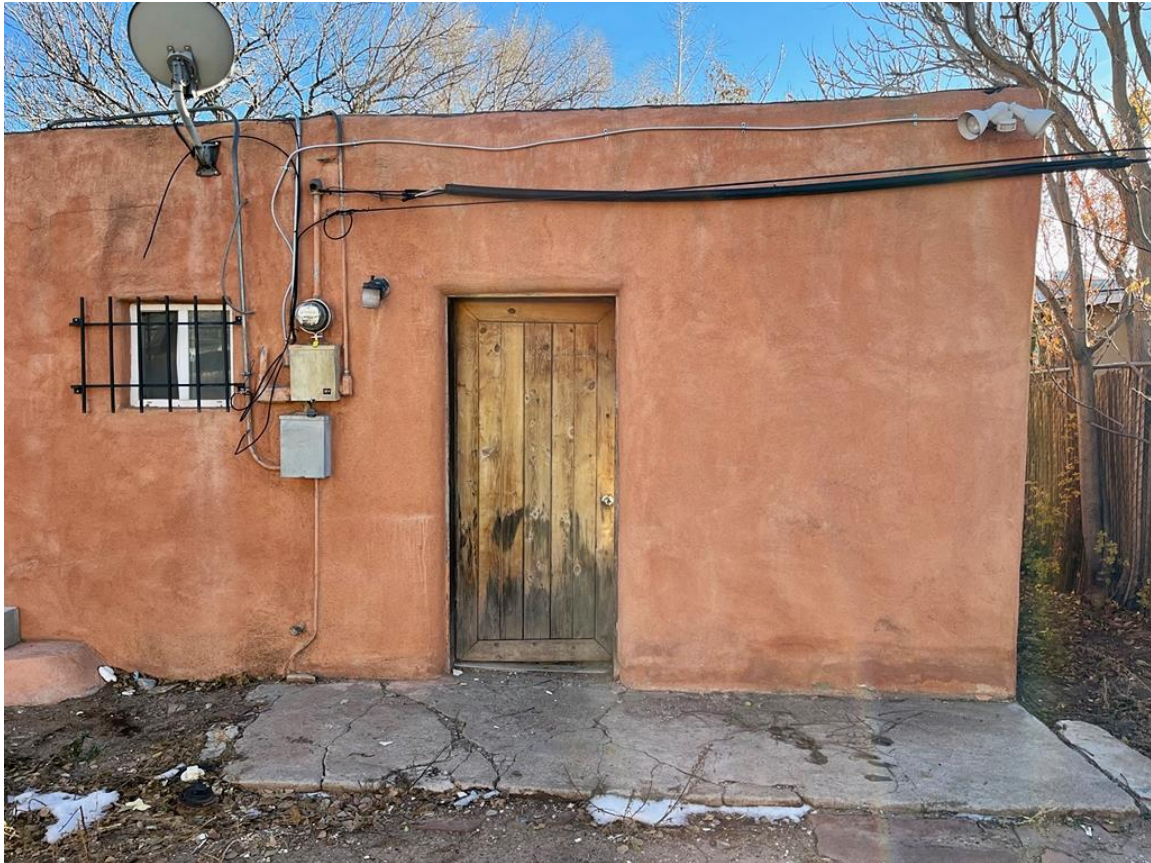
Beginning at the west end is a non-historic faux plank door (Photo 6). Next, still representing the original core, are sliding vinyl windows at the bathroom and kitchen (Photo 7). These windows, like the rest of the units along the portion of the building, are set 3½" to 4½" deep into the wall.

Photo 6: North elevation representing the northwest room of the original core. Camera facing south.

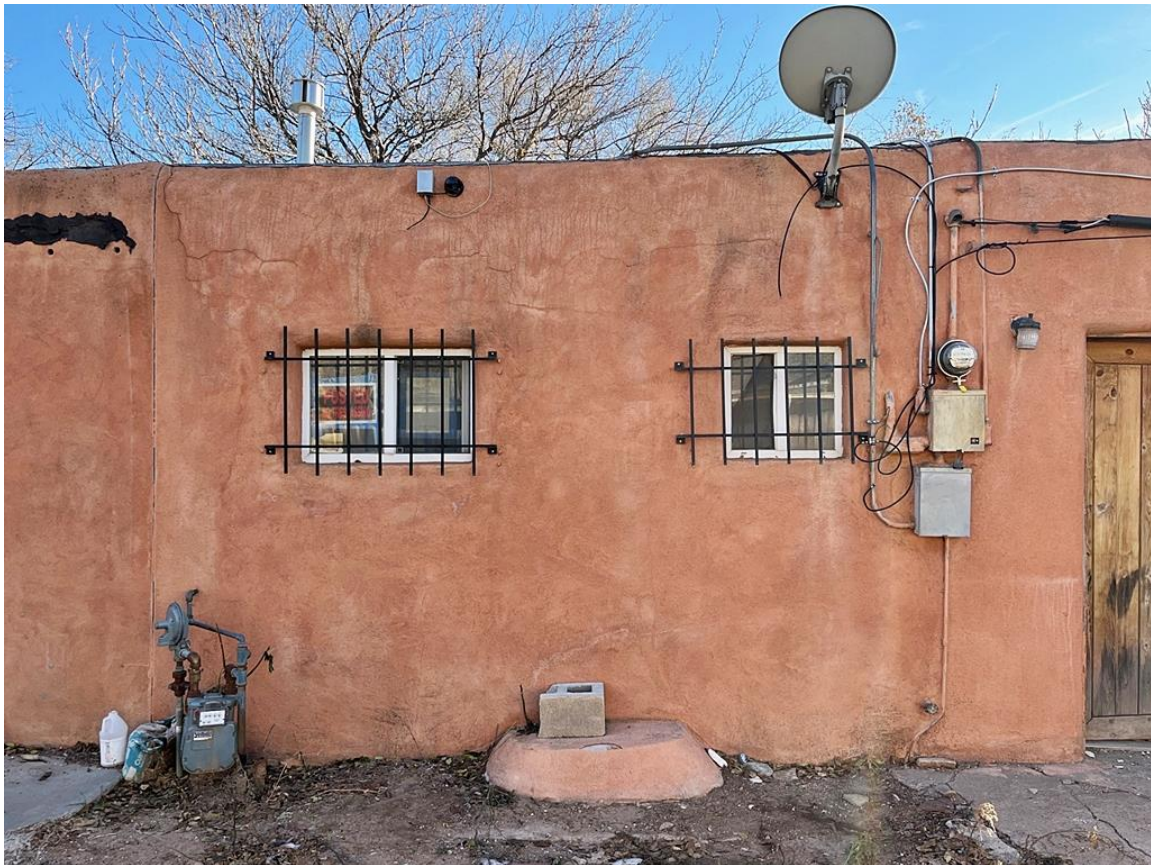
Photo 7: North elevation fenestration representing the kitchen (left) and bathroom (right) of the northeast room of the original core. Camera facing south.

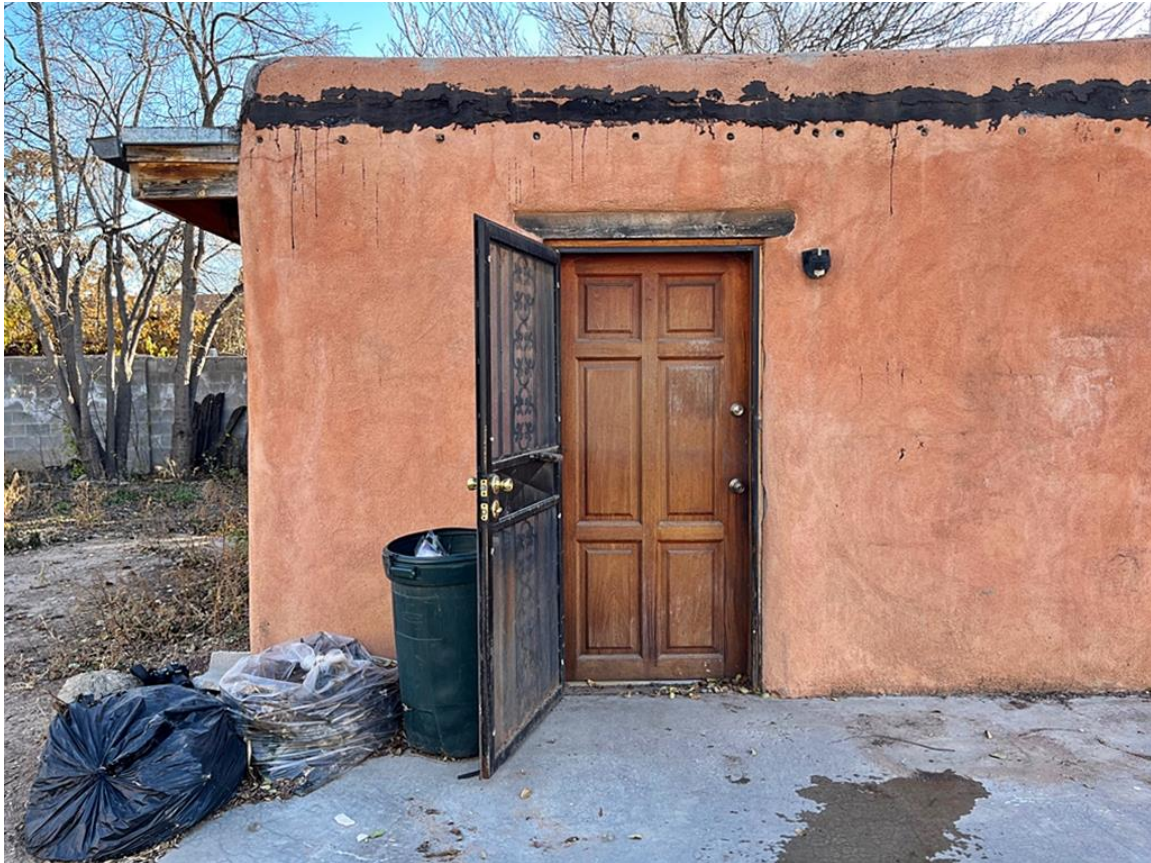
The remaining 14' of the façade represents the non-historic addition, which is entered by a six-panel wood door (Photo 8). Tar stains above the doorway indicate the presence of a porch that was recently removed.

Photo 8: North elevation at east end addition. Camera facing south.

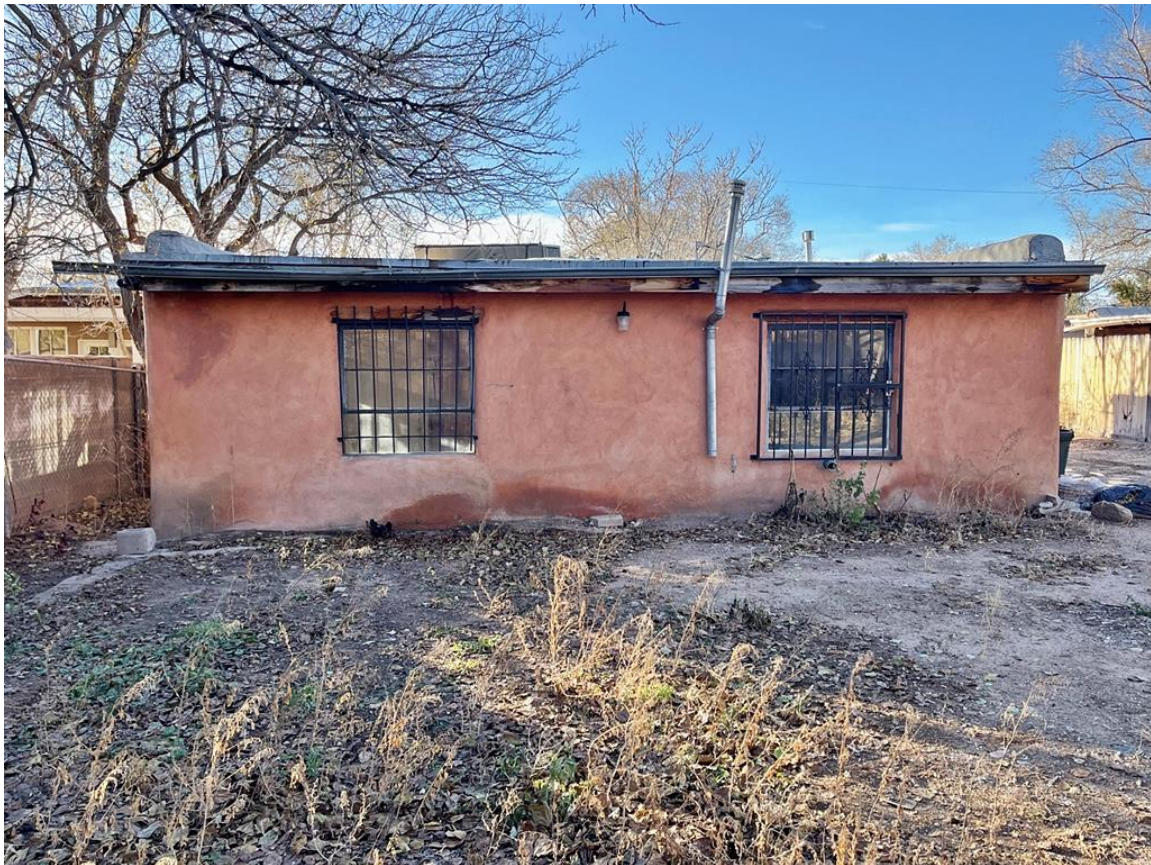
An overhang, which helps drain the roof, traces the east elevation (Photo 9). This portion of the building represents the addition and encloses a large room which is divided into living and dining spaces. The windows on this and the west elevation of the addition are metal fixed units (Photo 10). They are placed nearly flush with the wall.

Photo 9: East elevation representing 1980s addition. Camera facing west.

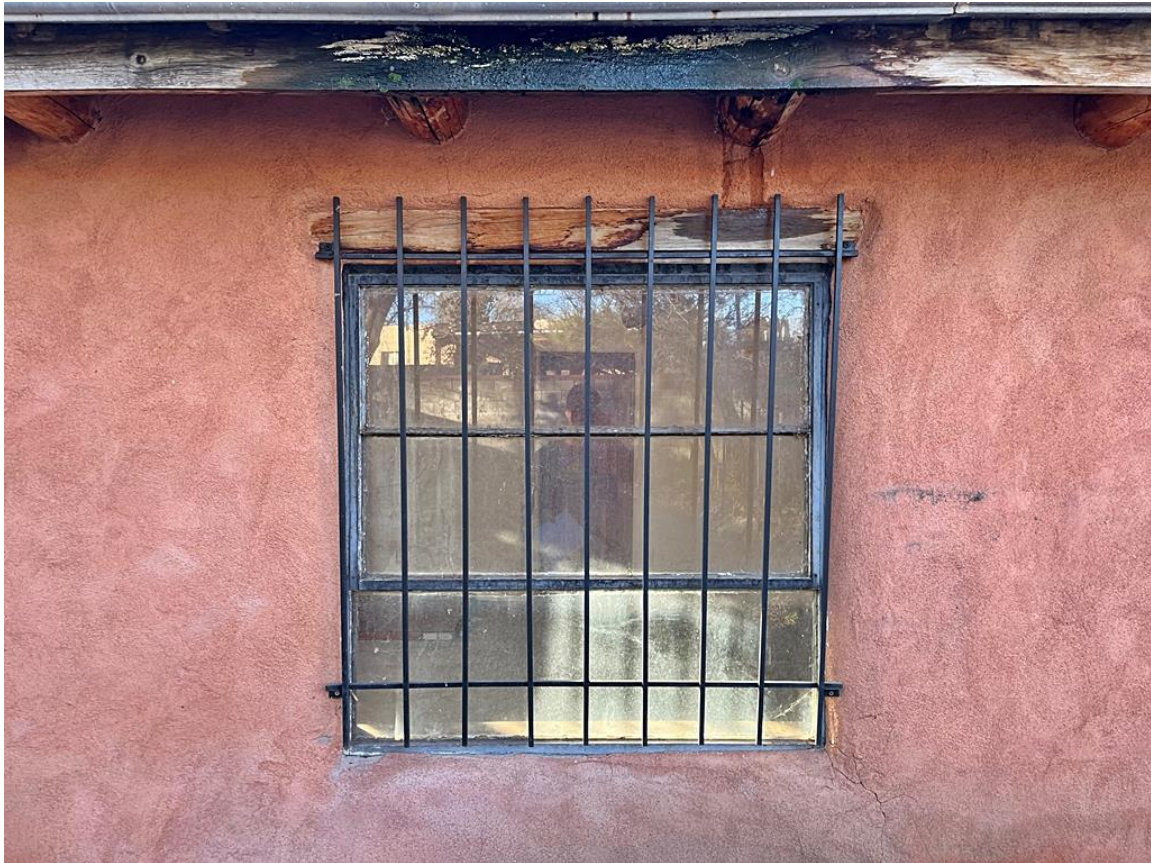
Photo 10: East elevation at 1980s addition. Window detail. Camera facing west.

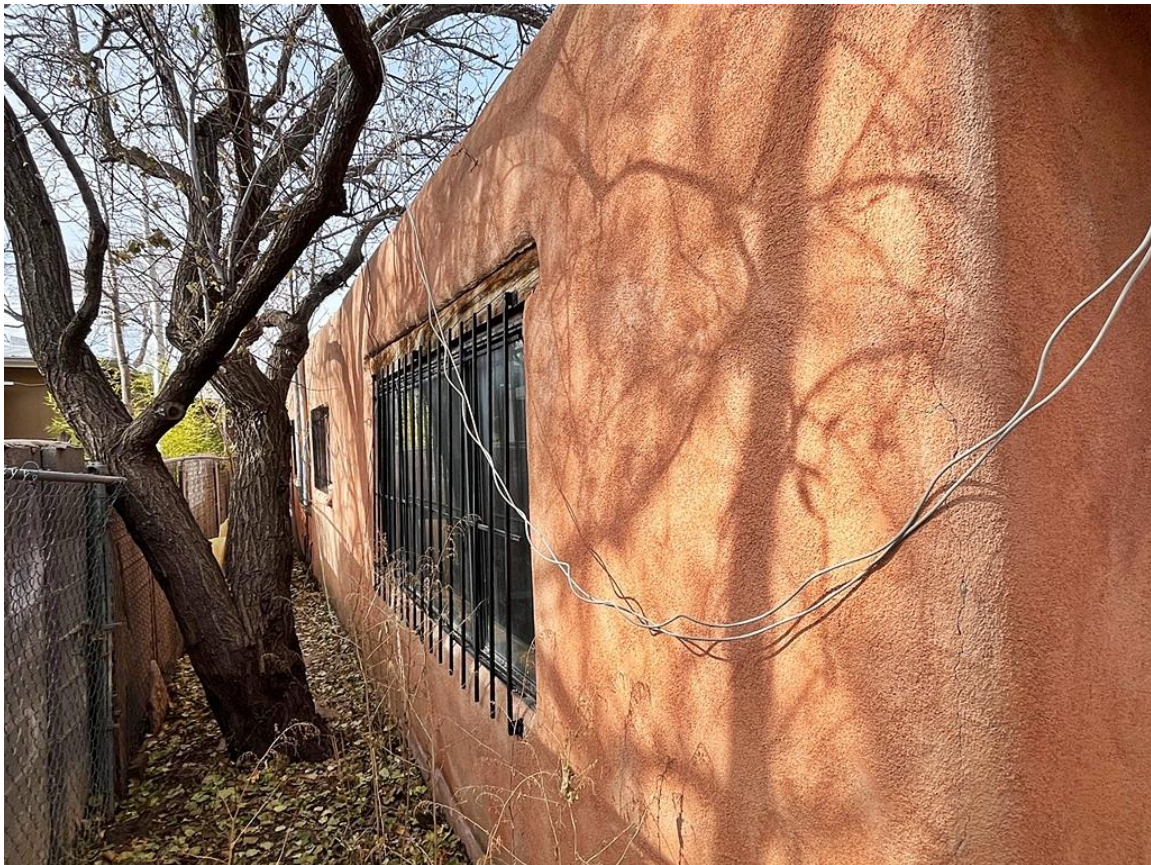
The south side of the building sits close to a block wall (Photo 11). Here stands one of two of the property’s apricot trees. It begins at the east end with a large window at the living room (Photo 12). An expansion joint signals the shift between the addition and the original building (Photo 13). The remaining windows of the façade are large aluminum sliding units with slanted concrete sills (Photos 14 & 15).

Photo 11: South elevation. Camera facing northwest.

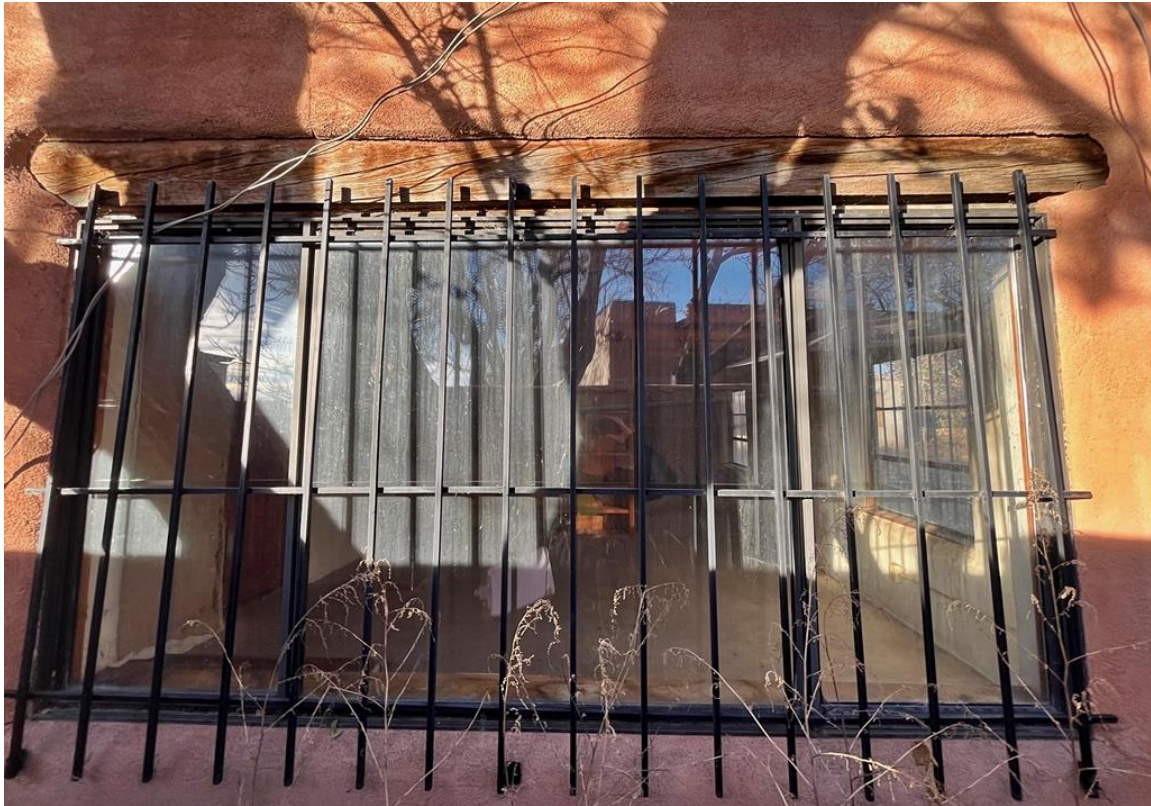
Photo 12: South elevation at 1980s addition. Window at living room. Camera facing north.

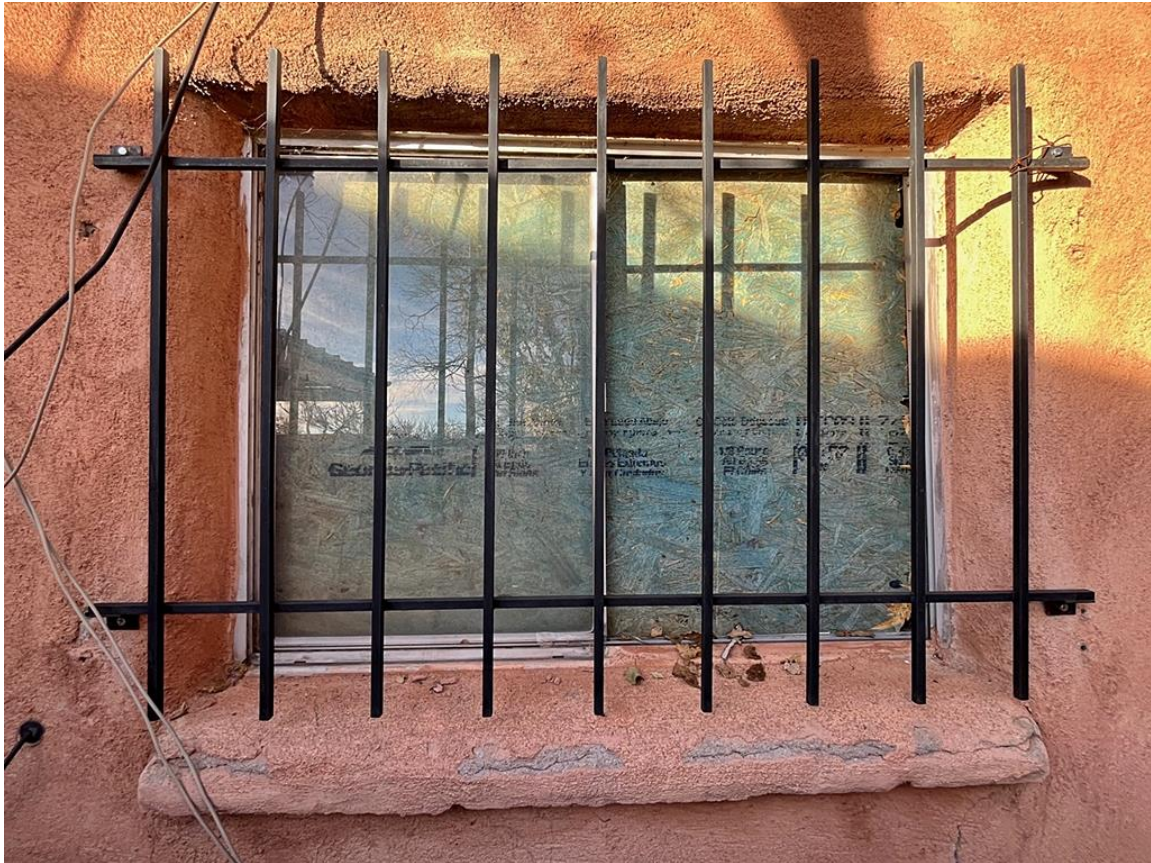
Photo 14: South elevation. Window of southeast room of the original core. Camera facing north.

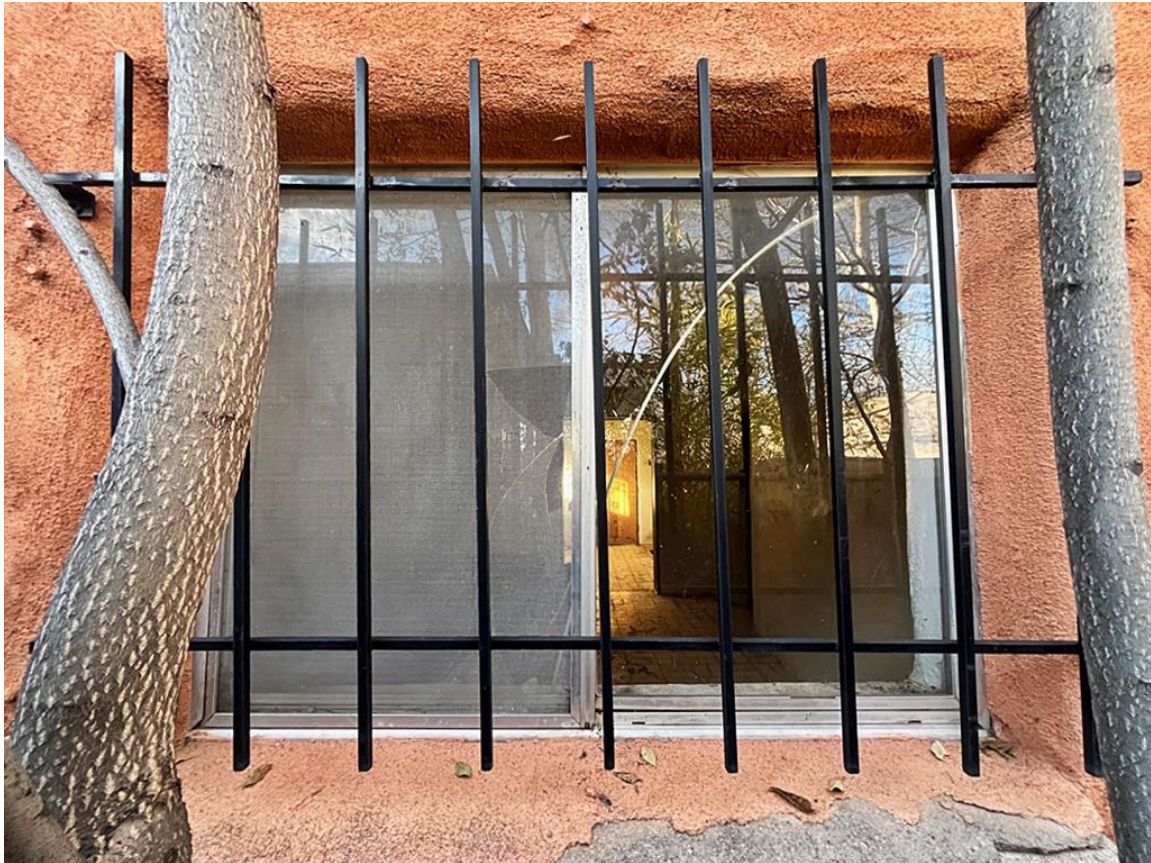
Photo 15: South elevation. Window of southwest room of the original core. Camera facing north.

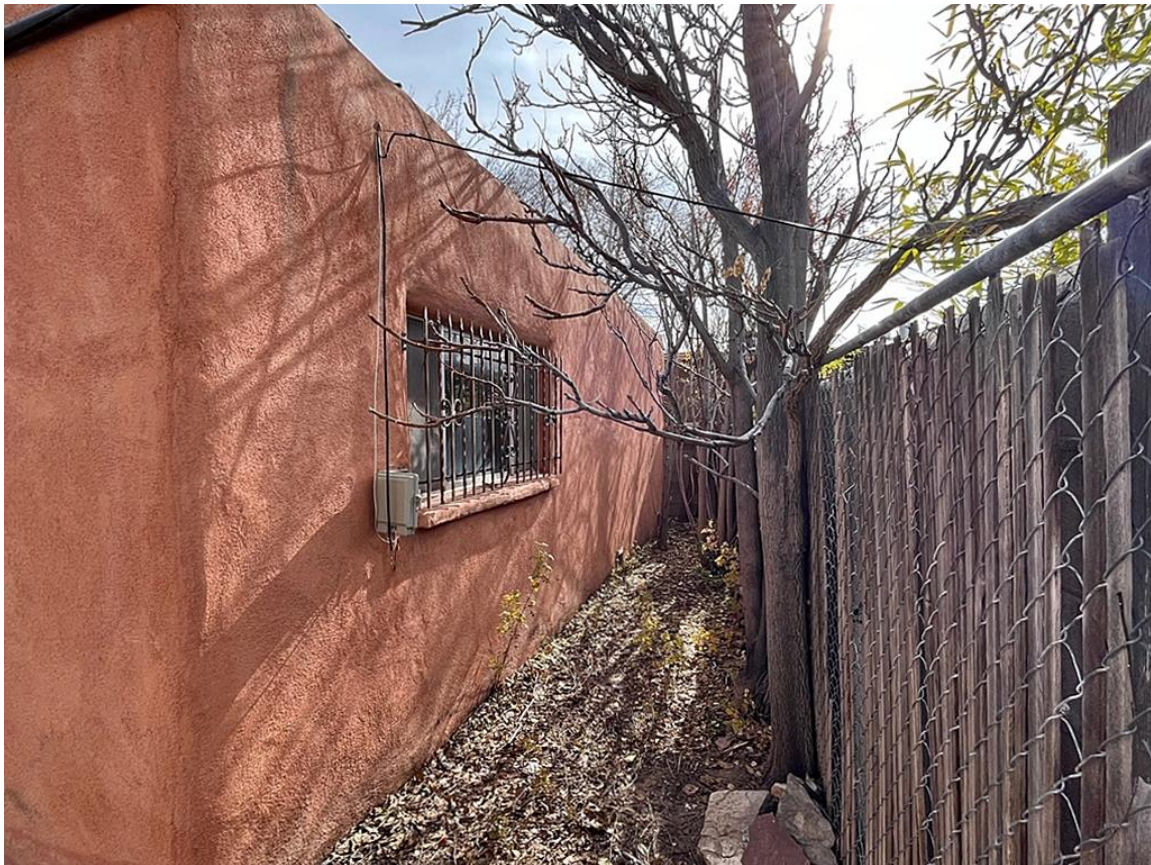
The short west elevation is the side of the building not attached to the addition (Photo 16). It has a single opening holding an aluminum combination window. The opening’s width and the concrete sill’s style seem more of a mid-century vintage.

Photo 16: West elevation. Camera facing southeast.

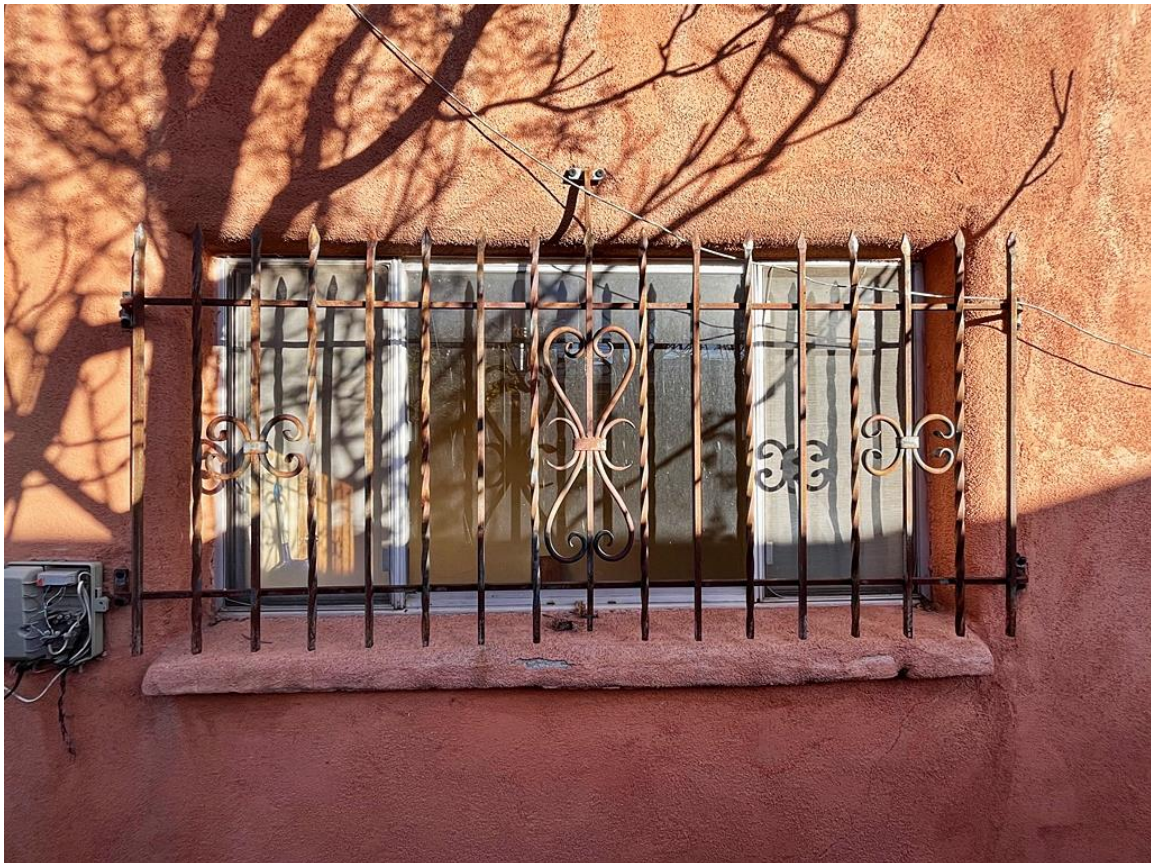
Photo 17: West elevation. Window of northwest room of the original core. Camera facing east.

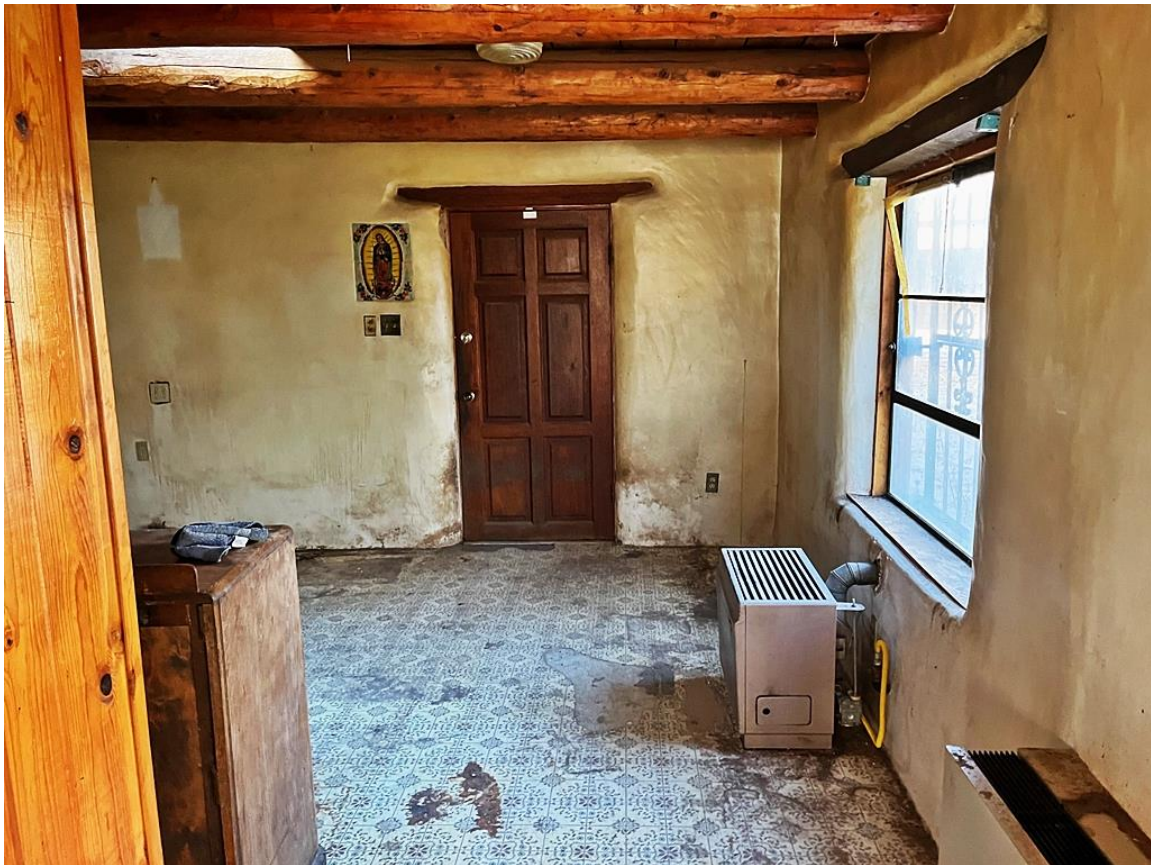
The addition has a plywood floor covered with vinyl tiling and a viga-spanned ceiling, interrupted by a skylight (Photo 22).

Photo 22: 1980s addition. Camera facing north.
