RPA & Associates

JOB	DATE
465 CAMINO MANZANO	11/30/2023

RPA & ASSOCIATES | WINDOW & DOOR CONDITION AND INTEGRITY CODES

RPA & ASSOCIATES | 465 CAMINO MANZANO, SANTA FE, NM 87501

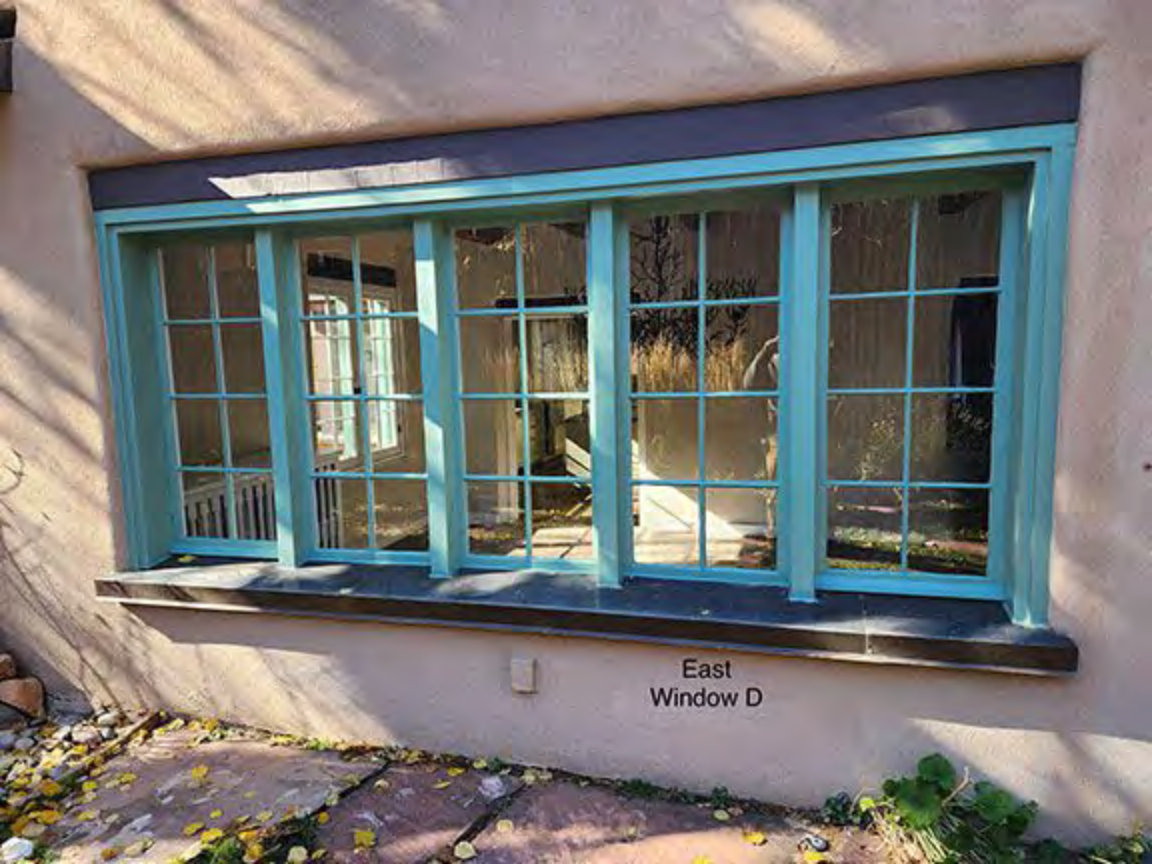
East
Window D

Windows D, K, O, S, T, W, & X.

Note: All the windows with copper sills should have the copper removed because this has been trapping moisture in the wall. In some cases, the whole window might need to be removed if sills are rotted underneath the copper. The window removal process may destroy the window entirely. At this point, the window will need to be replaced, historic or non-historic.
