# City of Santa Fe

Land Use Department | Historic Preservation Division

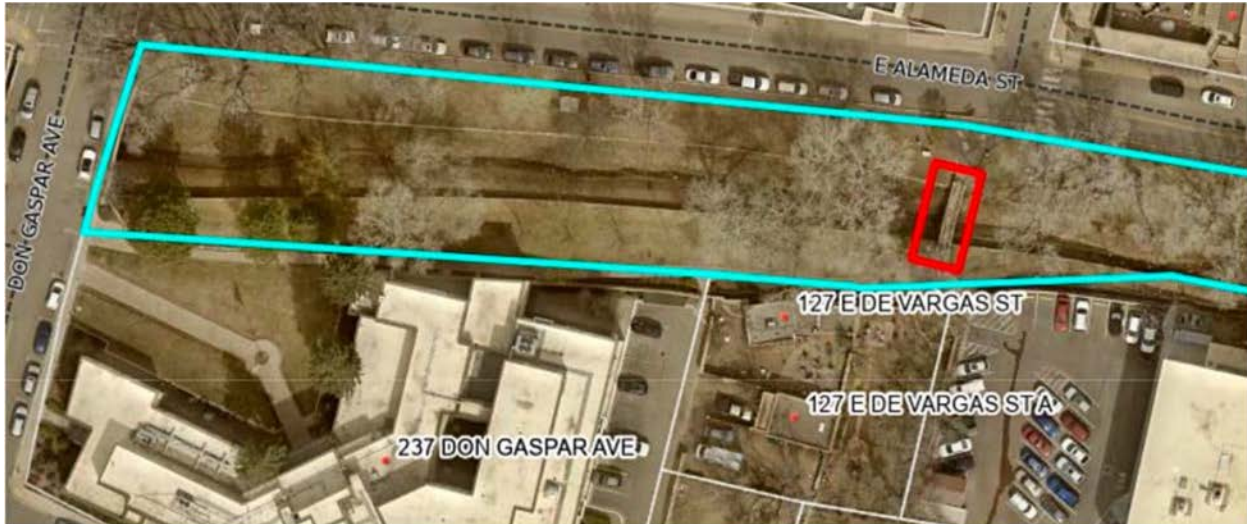
*Figure 1. Project location (in red).*

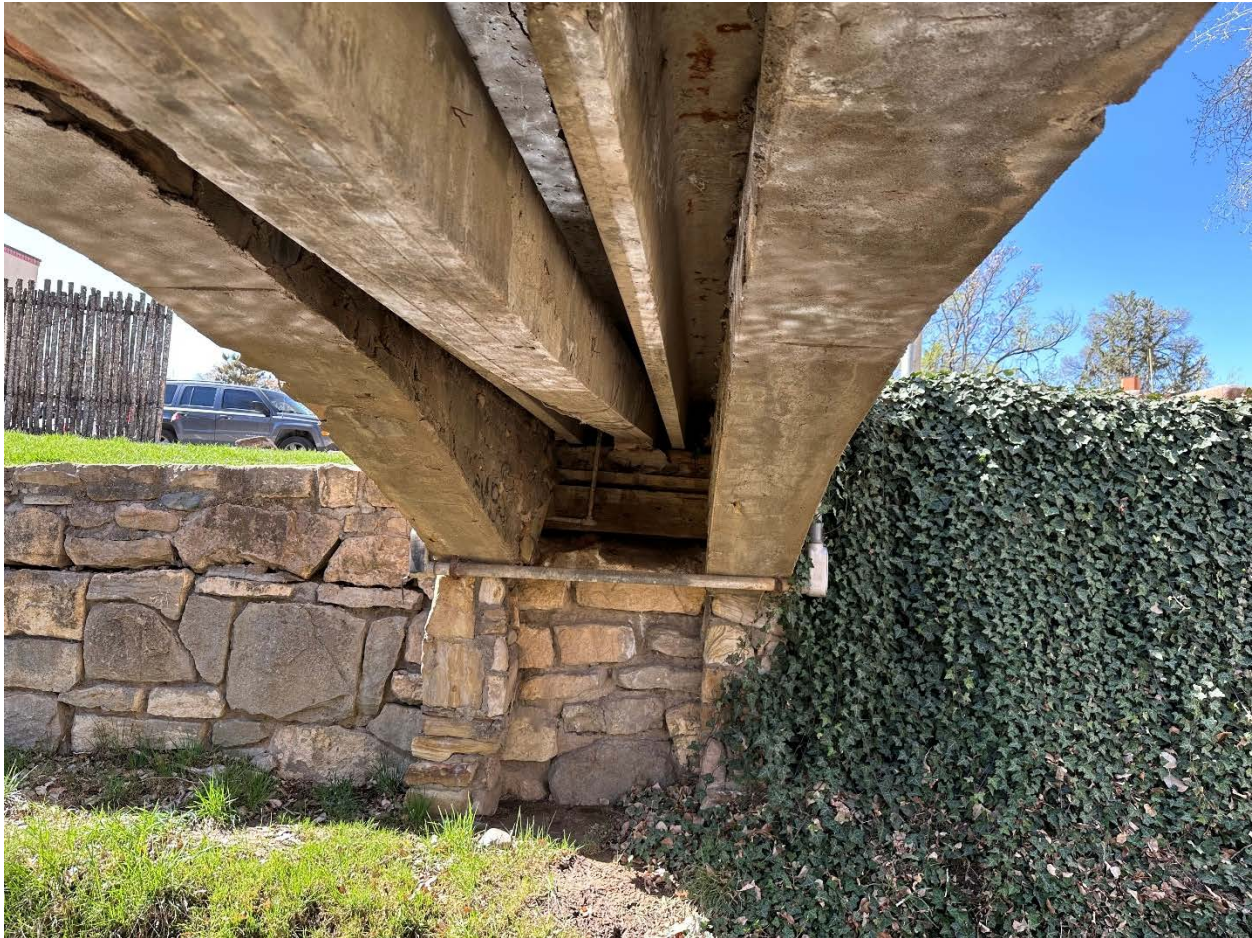
Figure 3 – Bridge superstructure configuration

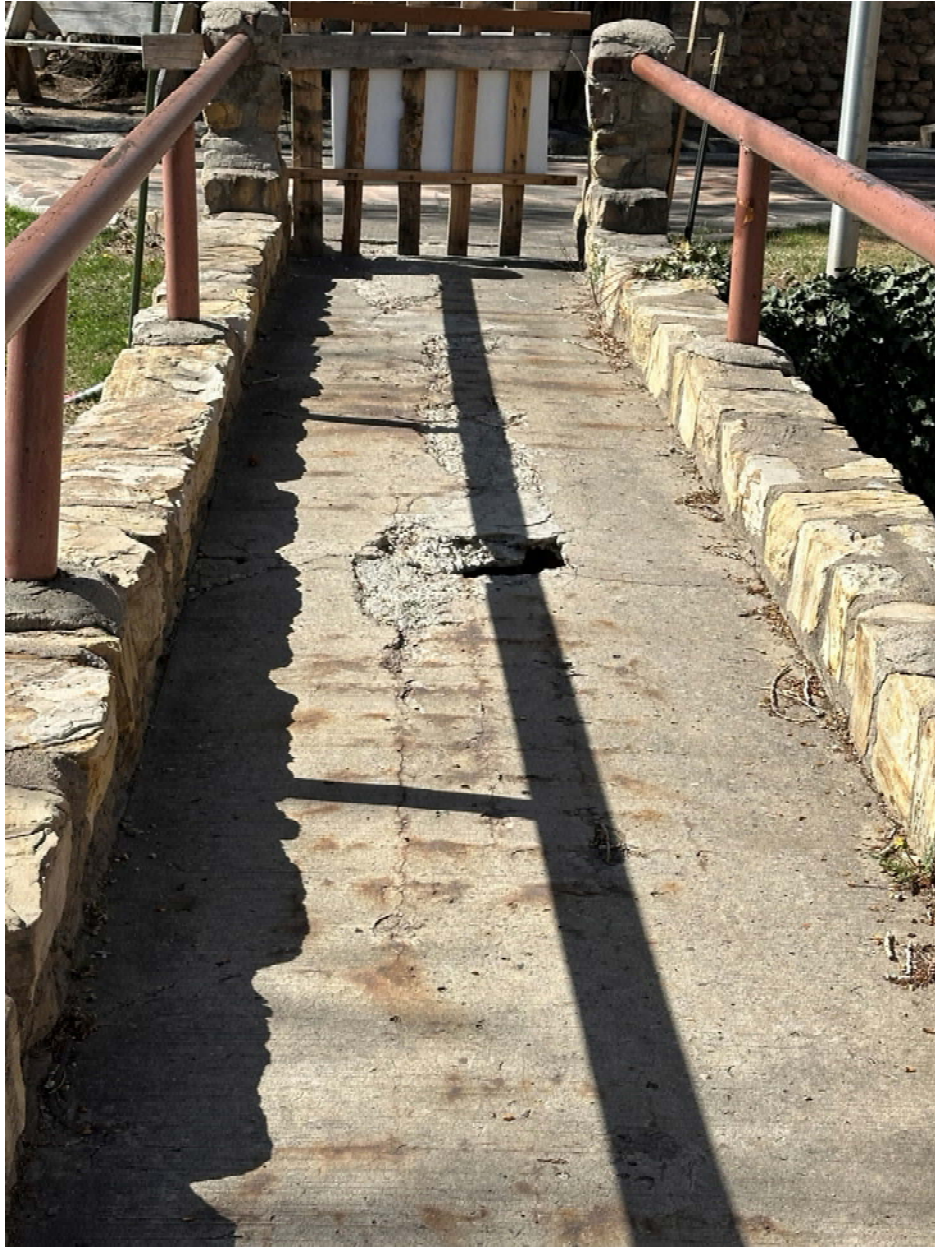
Figure 4 – Top of flange damage

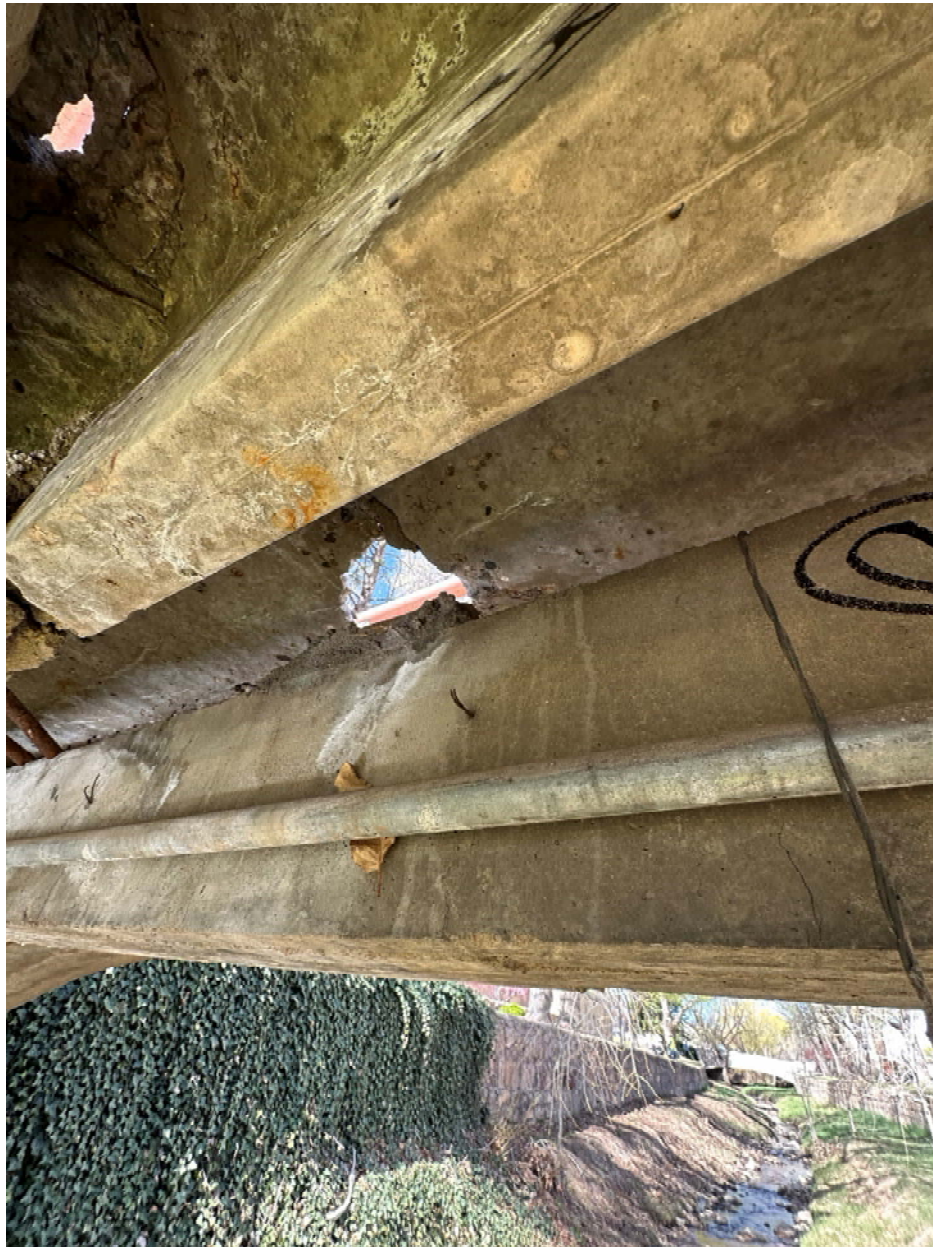
Figure 5 – Underside of flange damage

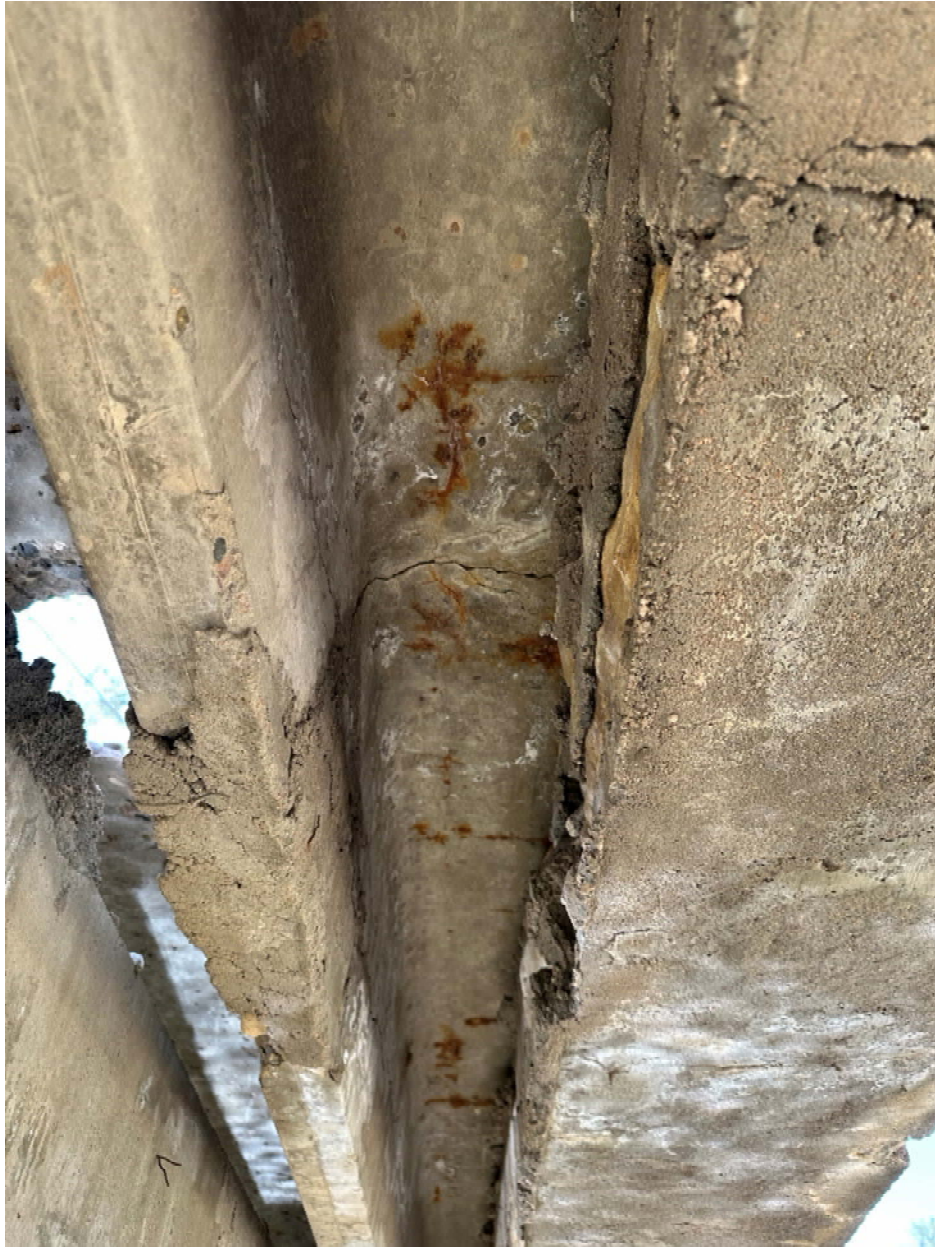
Figure 6 – Beam delamination and cracking along web and flange

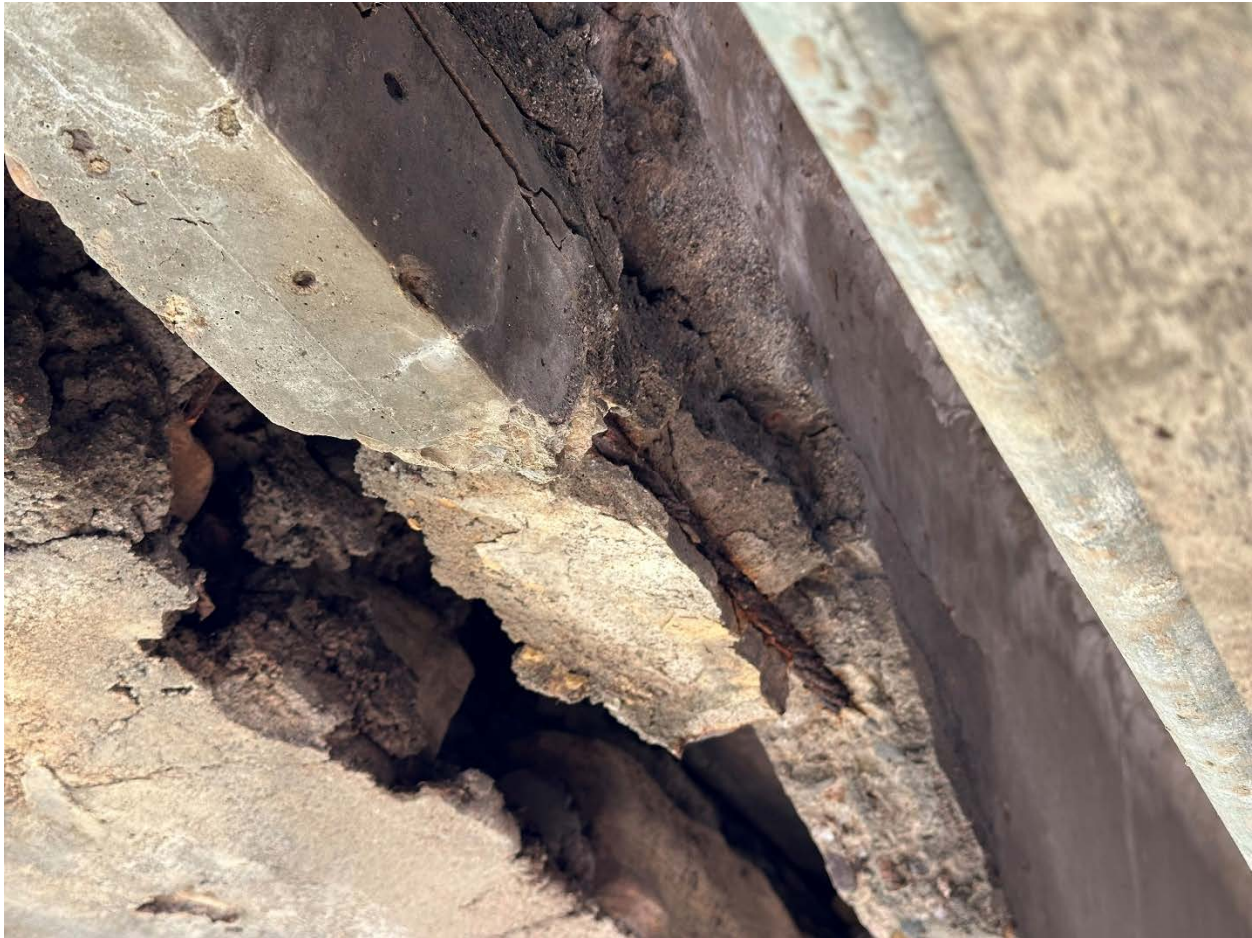
Figure 7 – Beam web spalling with exposed prestressing strand

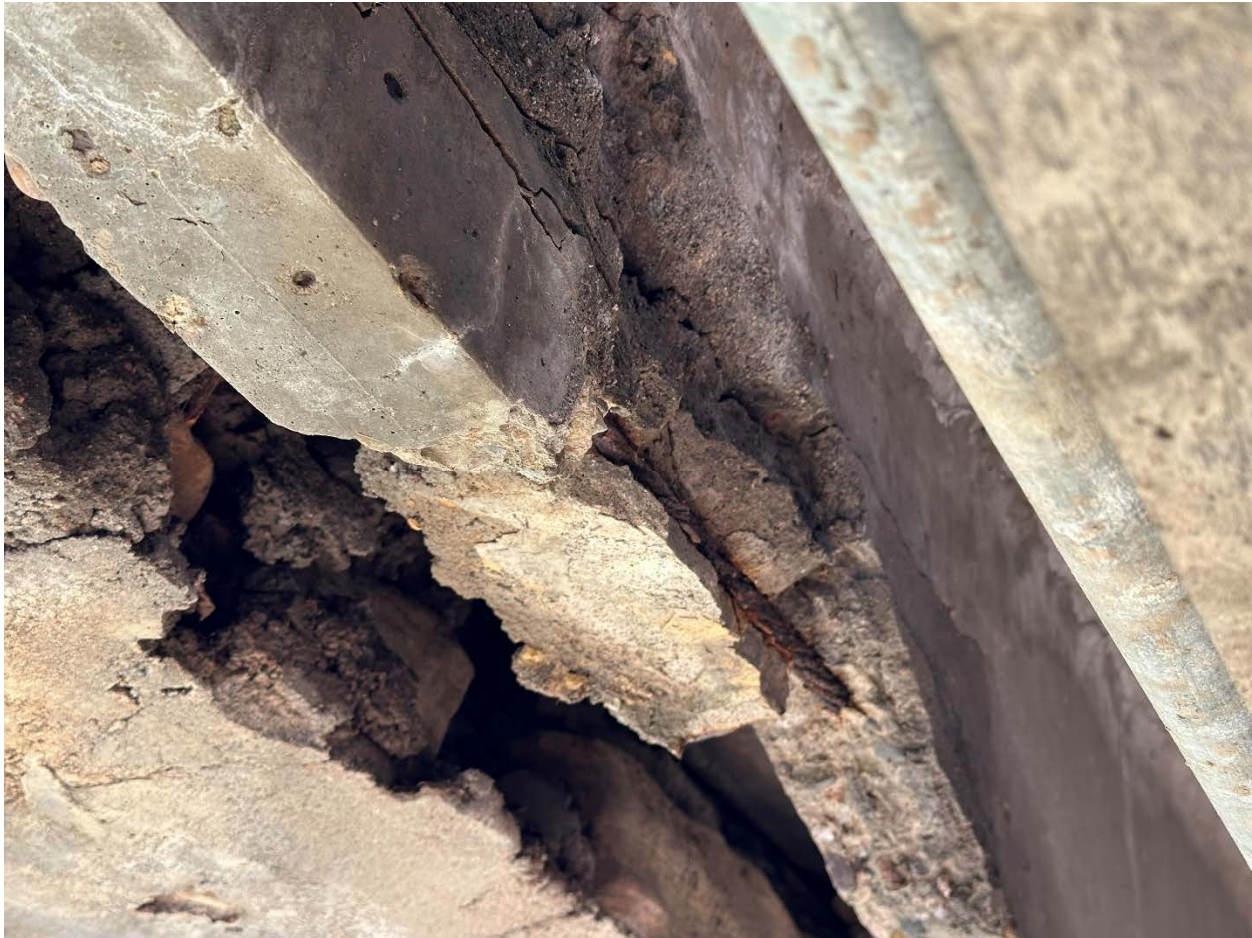
Figure 7 – Beam web spalling with exposed prestressing strand

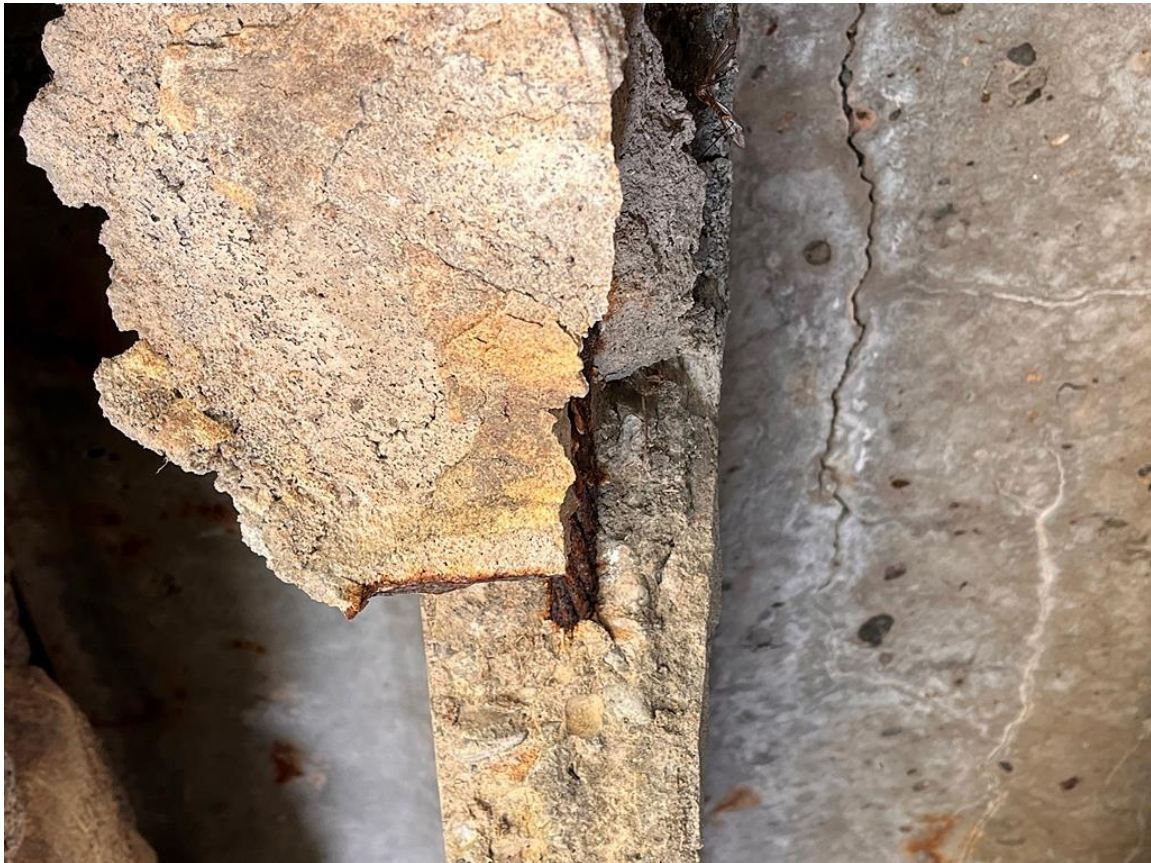
**Photo 12: Deterioration to structural members, including severe delamination and exposed rebar on the beam, along with longitudinal cracking and efflorescence across the slab.**
