Historic Cultural Properties Inventory (HCPI) Base Form (FORM 1)

1. Name of property: Plaza del Monte Residence 21	2. Location: 125 Camino Santiago <i>Downtown and Eastside Historic District</i>	3. Local Reference Number: Santa Fe ID #: N/A Plaza del Monte Inventory 4. County: Santa Fe

11. Brief Description of the Property: One of three apartment buildings at Plaza del Monte, 125 Camino Santiago is arranged as a long rectangle on the west side of the street. The front (east) façade reveals the apartment's strict symmetry and emphasis on economy. In plan, it is oriented along a roughly north-south axis. The rectangle is broken into angled planes at the northwest and southwest exposures. These bookend a portal interrupted at its center with a block-like volume punched with a square opening. The front elevation is characterized by a uniform pattern of door and window openings. The doors leading to the apartment are wood units with view light panels. Windows are standard multi-light steel casements. The angled north and south elevations contain three windows, each a non-original aluminum casement. The rear (west) elevation is divided into four patios sheltered by a shallow overhang.

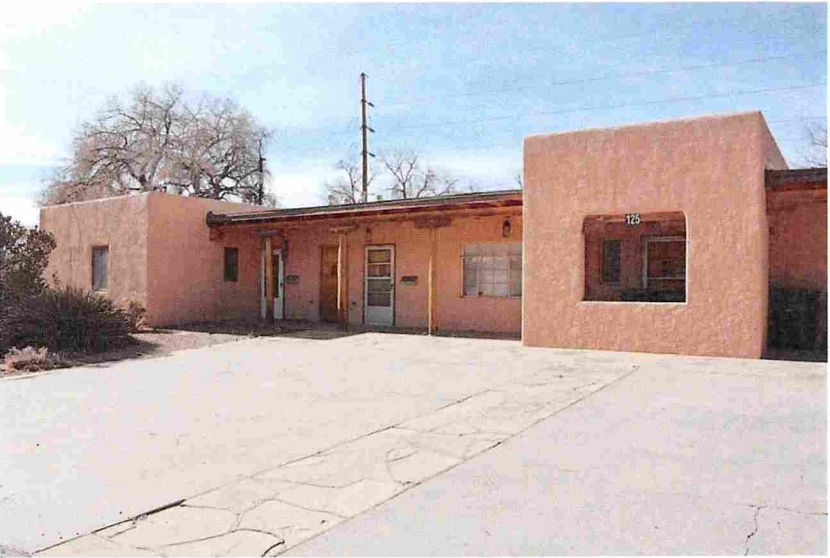
8. Name of Project: HDRB status review Plaza del Monte	9. Lat/Long: 35.693449, -105.937311		
10. Photo Information Negative: John Murphey View of: Front, east elevation, facing northwest.

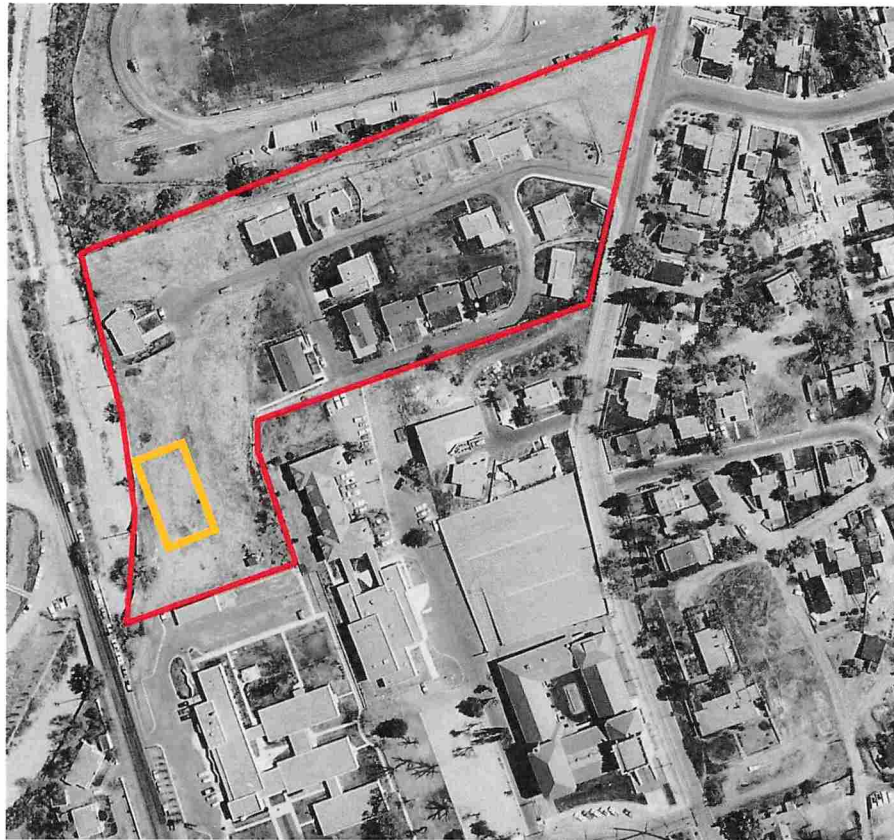
**Aerial 1: Portion of May 2, 1966 aerial photograph. Source: NMDOT – 05-02-66_0015.
 Apartment Building Not Present.**

12. Who uses the property? Residence			
13. Construction Date: c.1970 <input checked="" type="checkbox"/> Known <input checked="" type="checkbox"/> Source: aerial photographs and city directory entries - Does not appear on February 27, 1969 aerial photograph

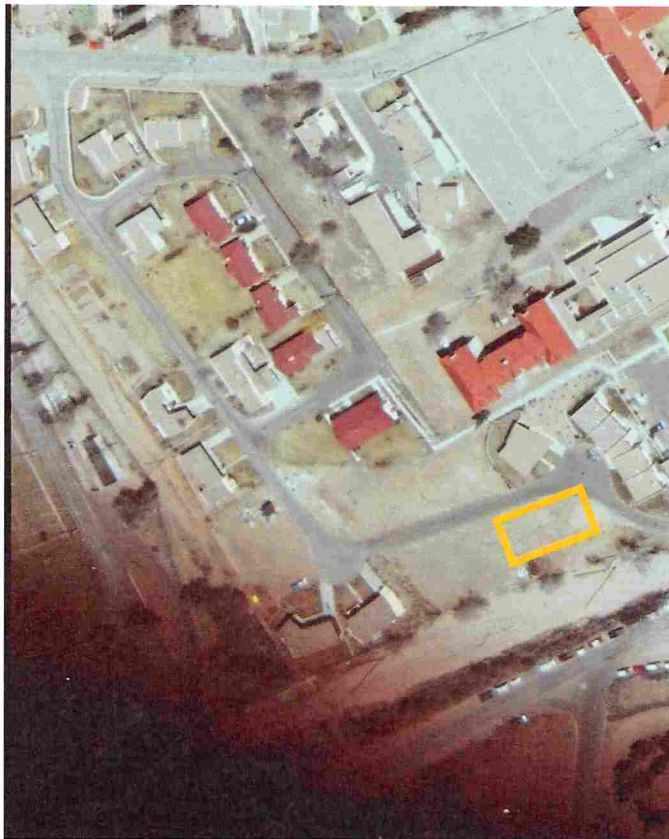
Aerial 2: Portion of February 27, 1969 aerial photograph. Source: NMDOT – 1969_2_27_4071.

Apartment Building Not Present.

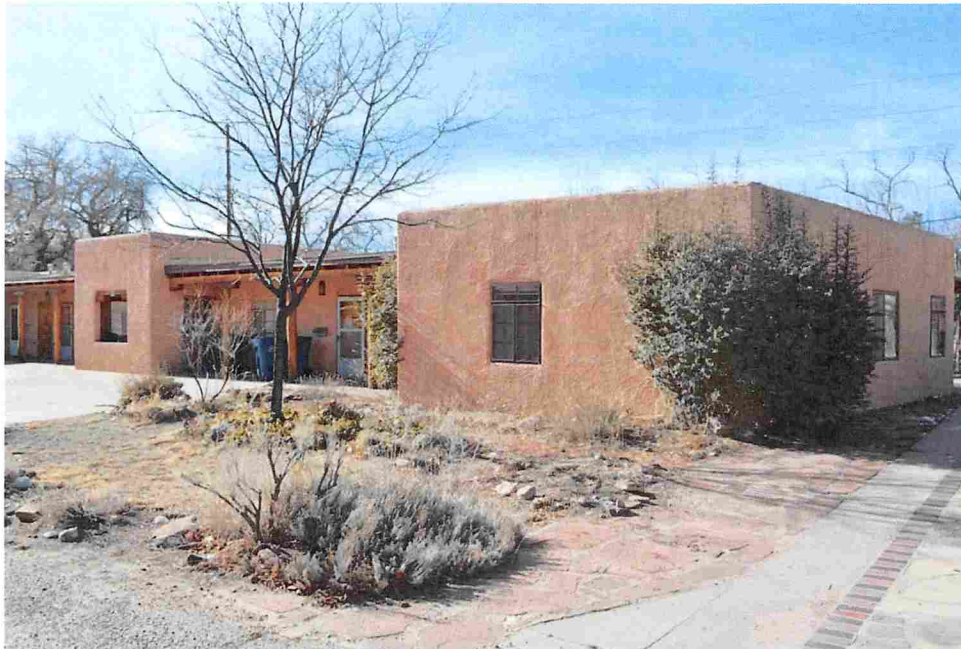
Photo 1: Street and north elevations, facing southeast.

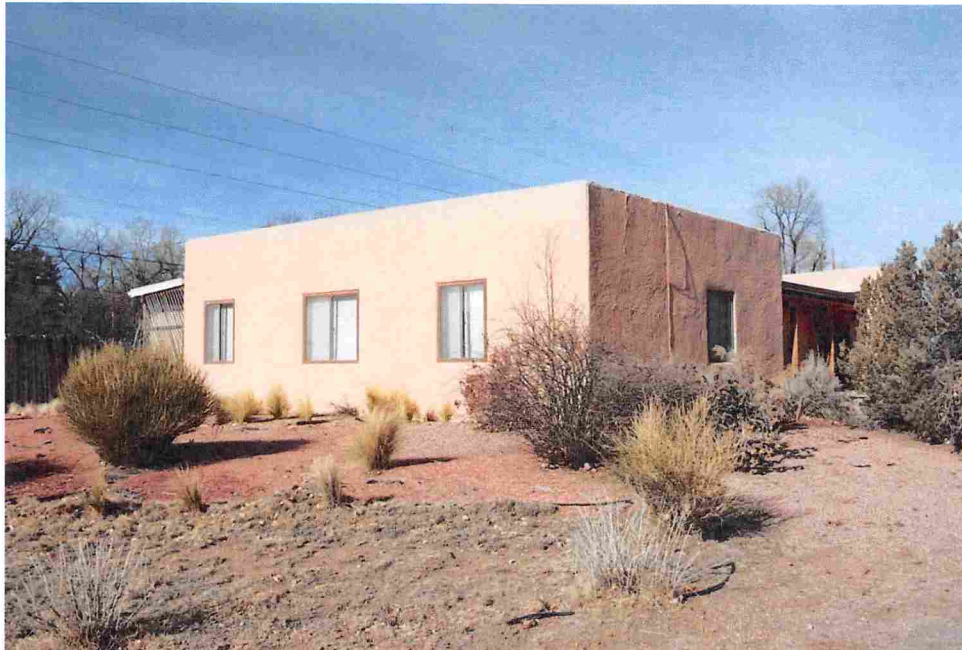
Photo 2: South elevation, facing north.

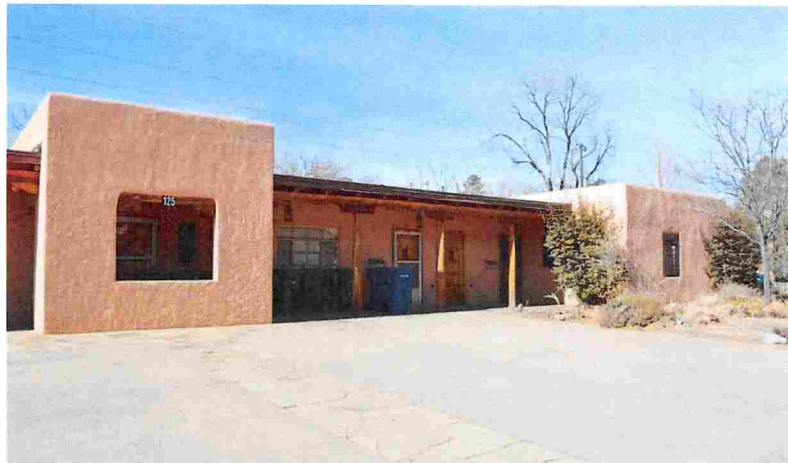
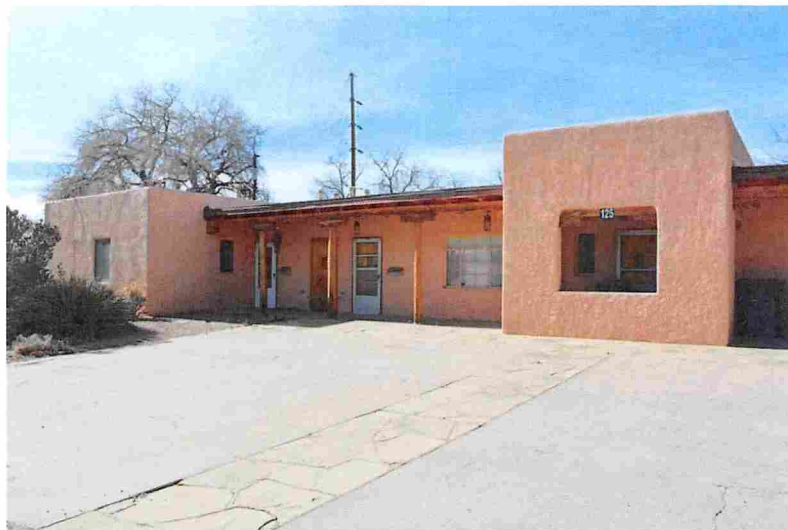
Photo 3: North Unit (top), facing northwest; South Unit (bottom), facing southwest.

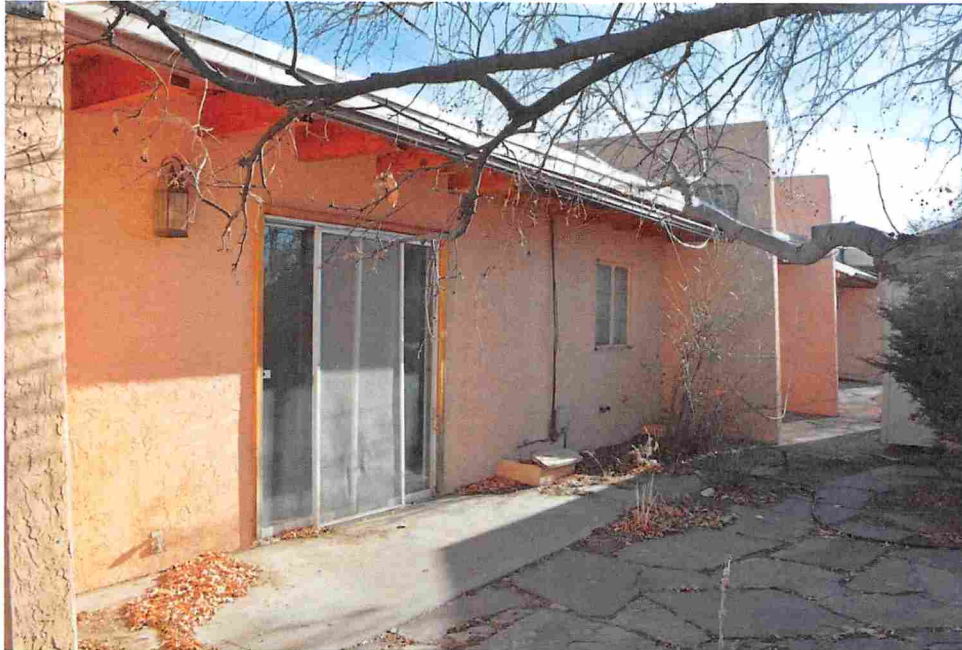
12. Chimneys Four, stucco-clad, west exposure	13. Porches <input type="checkbox"/> N/A Type: <input checked="" type="checkbox"/> Entry-portal <input type="checkbox"/> Partial-Width <input type="checkbox"/> Full-Width <input type="checkbox"/> Wrap

Photo 4: West elevation, facing southeast.

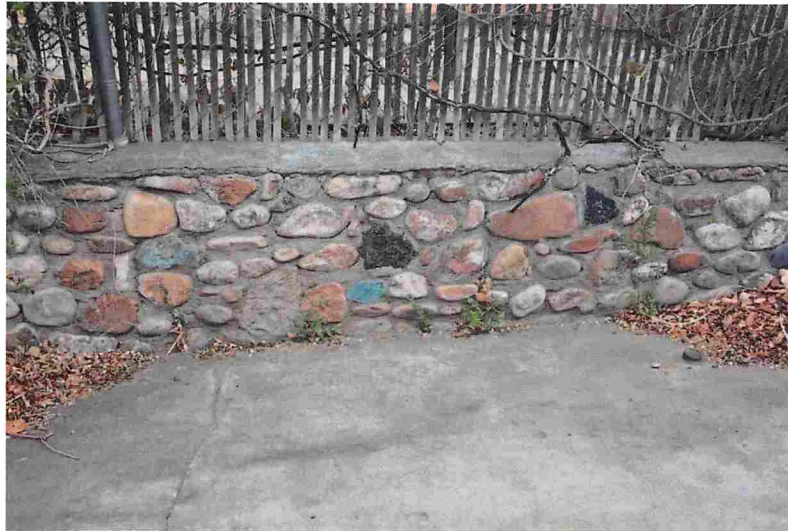
Given its low architectural value and presumed c.1969+ construction date, the retaining wall is not recommended for Contributing Structure status to the Downtown and Eastside Historic District.

**Photo 5: Retaining separating 121 and 125 Camino Santiago, facing northeast.
May 3, 2018.**
