WALL AND FENCE GUIDELINES SANTA FE HISTORIC DISTRICTS

HISTORIC CULTURAL PROPERTIES INVENTORY (HCPI) BASE FORM

HCPI # NMCRIIS # Project Name: 527 Agua Fria Street Survey Date: November 25, 2025	Agency Number: Other #Old ID# 051613581; Santa Fe ID Number H1510 <input checked="" type="checkbox"/> Update
NAME OF PROPERTY Historic Name: 243 Aqua Fria, 243/527 Agua Fria (Aqua Fria) Current Name: 527 Agua Fria Street	OWNER and contact information:
SURVEYOR and contact information: Tina Reames; CSR Architects; 220 Gold Avenue SW; Albuquerque, NM 87102	
PROPERTY TYPE Category: <input checked="" type="checkbox"/> Building <input type="checkbox"/> Structure <input type="checkbox"/> Object <input type="checkbox"/> District <input type="checkbox"/> Site Subcategory: <input type="checkbox"/> Acequia/Historic Irrigation Ditch <input type="checkbox"/> Road/Trail <input type="checkbox"/> Other Linear	
LAND STATUS <input type="checkbox"/> Federal <input type="checkbox"/> State <input type="checkbox"/> Local <input checked="" type="checkbox"/> Private <input type="checkbox"/> Other (land grant, tribal, etc.) Specify Other:

For HPD Office use only: HCPI No. _____ District No. _____		
1. Name of pro

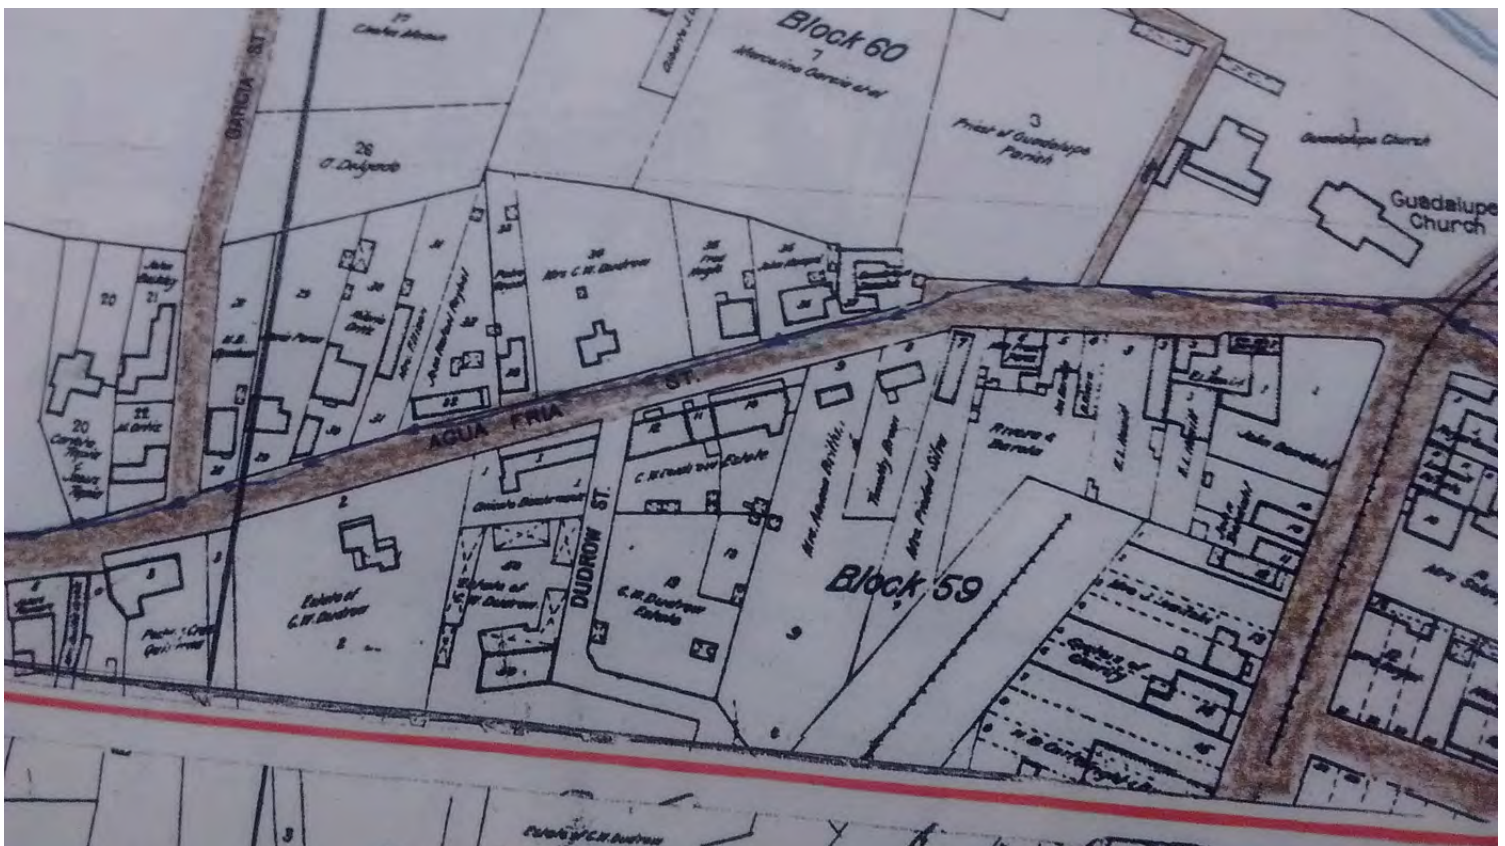
- The image below is an enlarged image of the 1912 King's Official Map of the City of Santa Fe, NM indicating property ownership - Mrs. C. W. Dudrow

On the 1912 King's Map, the building is marked as Block 60, Lot 34, and is attributed to Mrs. C. W. Dudrow.

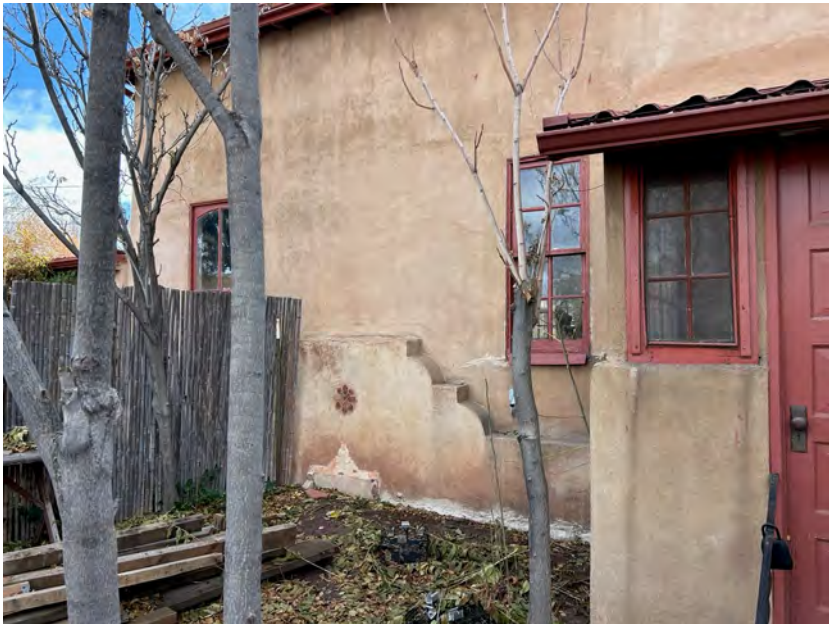
Describe: On the north side of the house there is a thickened wall with decorative tile where a fountain may have been.

North Elevation - northeast corner of house - thickened wall at exterior with decorative tile and broken spigot (remnants of a fountain)
