WALL AND FENCE GUIDELINES SANTA FE HISTORIC DISTRICTS

For HPD Office use only: HCPI No. _____ District No. _____ NRHP _____ SRCP _____ Criteria <u> </u> A <u> </u> B <u> </u> C <u> </u> D		
1. Name of property: Beverly A. Averitt House	2. Location: 1302 Cerro Gordo <i>Downtown and Eastside Historic District</i>	3. Local Reference Number: Santa Fe ID #: H 1377 4. County: Santa Fe Parcel # 10126300

For HPD Office use only:		Please complete HCPI FORM 1 before completing FORM 2		
HCPI No.	District No.	NRHP	SRCP	Criteria A B C D
1. Name of property: Beverly A. Averitt House	2. Location: 1302 Cerro Gordo Road Santa Fe: <i>Downtown and Eastside Historic District</i>	3. Local Reference Number: Santa Fe ID #: H 1377		
		4. County: Santa Fe		
		5. Date of Survey: June 9, 2021

Survey Photographs

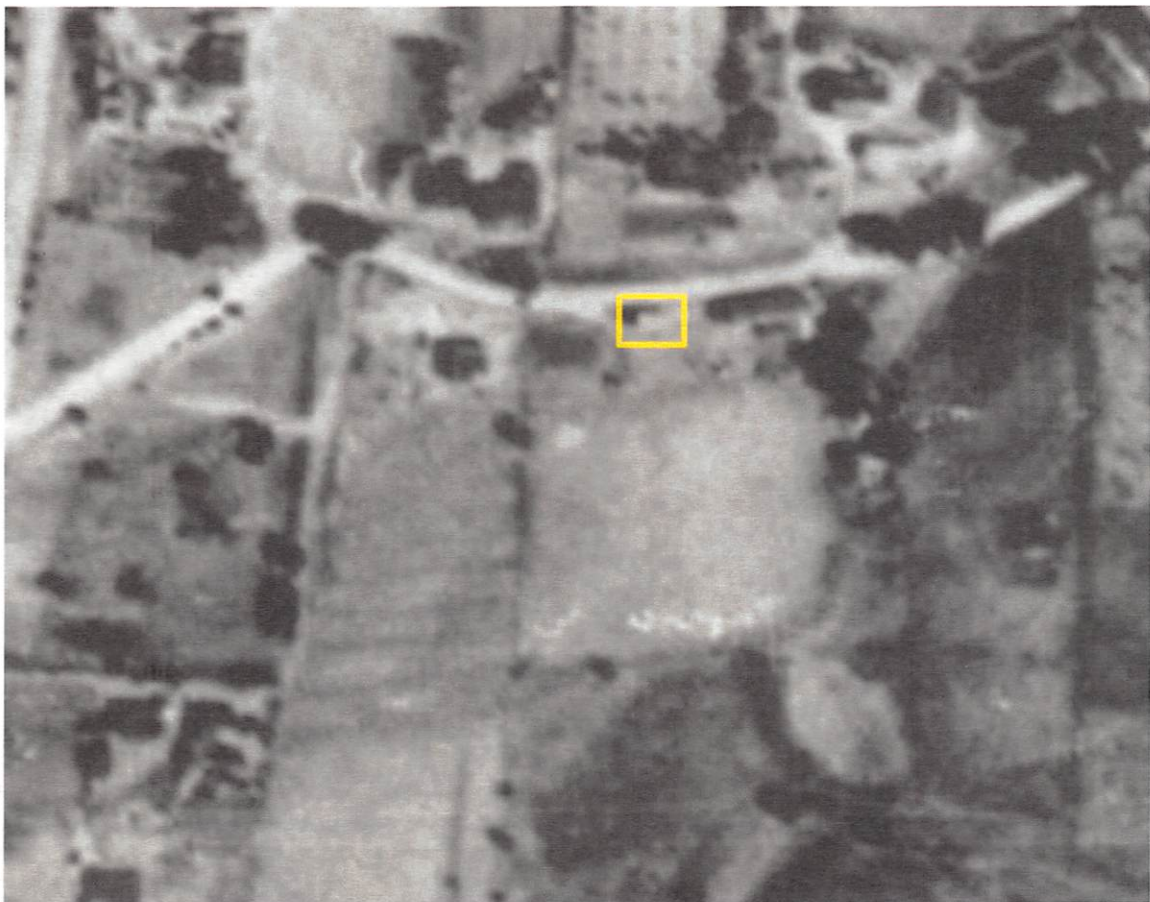
Figure 4: May 26, 1951 aerial photograph.

Rectangle shows structure close to the road which was likely demolished to build the present house. Courtesy EDAC - University of New Mexico.

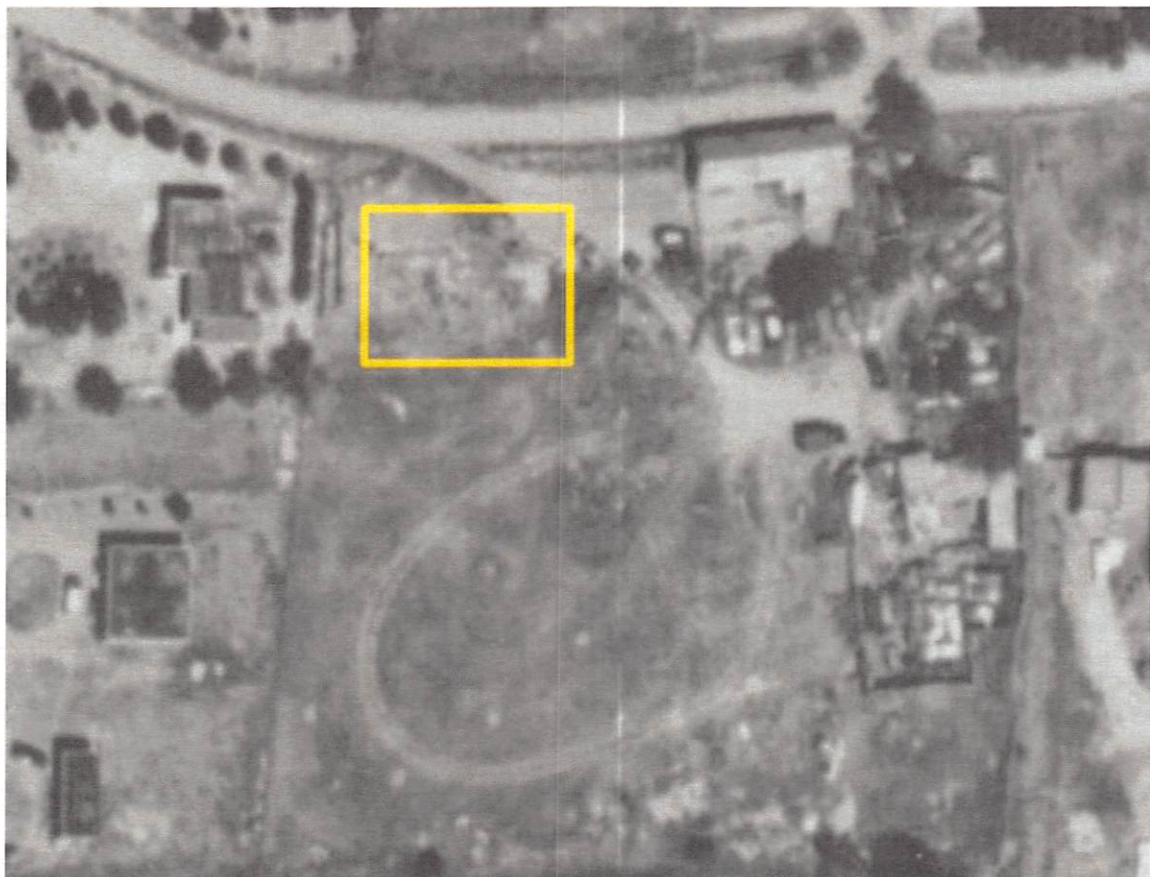
Figure 6: August 18, 1960, aerial photograph. Previous structure removed. Rectangle indicates ground activity; potentially foundation construction. Courtesy City of Santa Fe, GIS.

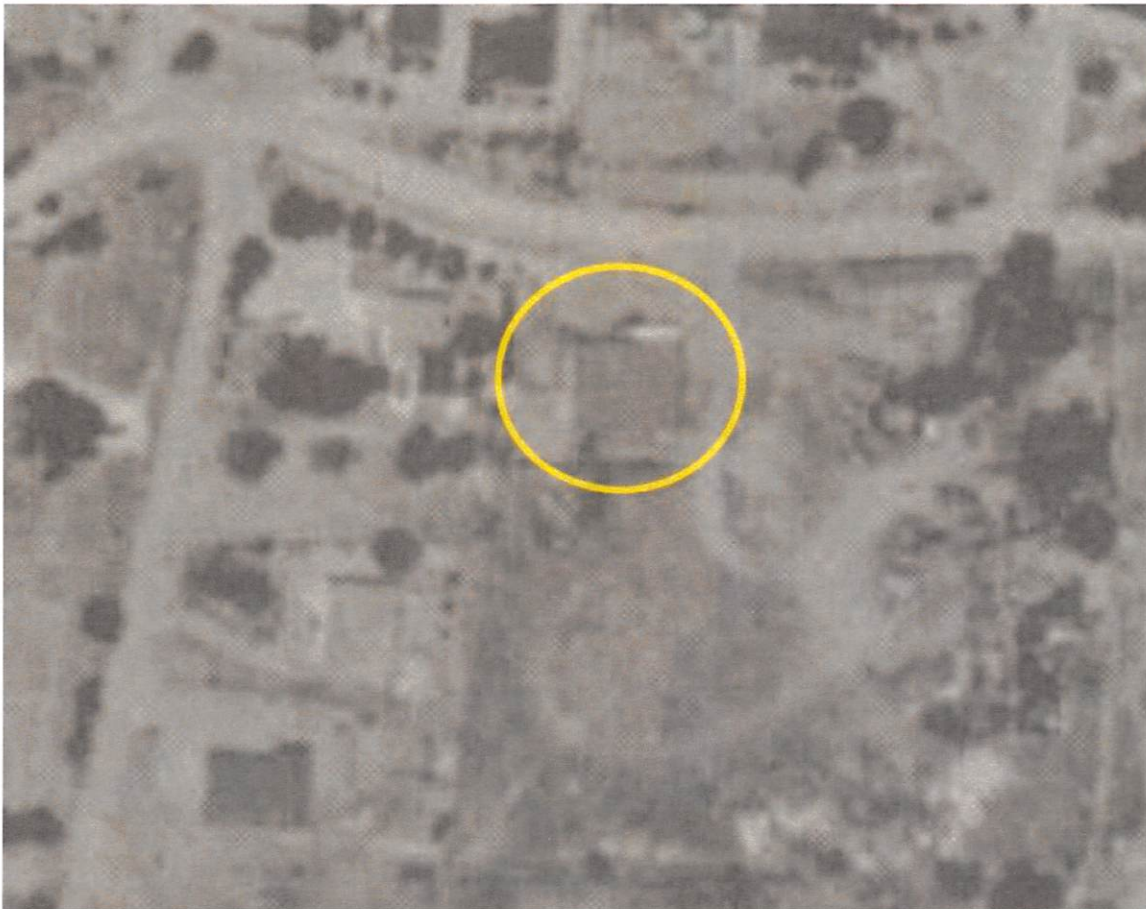
Figure 7: May 2, 1966 aerial photograph.
 House in place with original configuration. Courtesy City of Santa Fe, GIS.

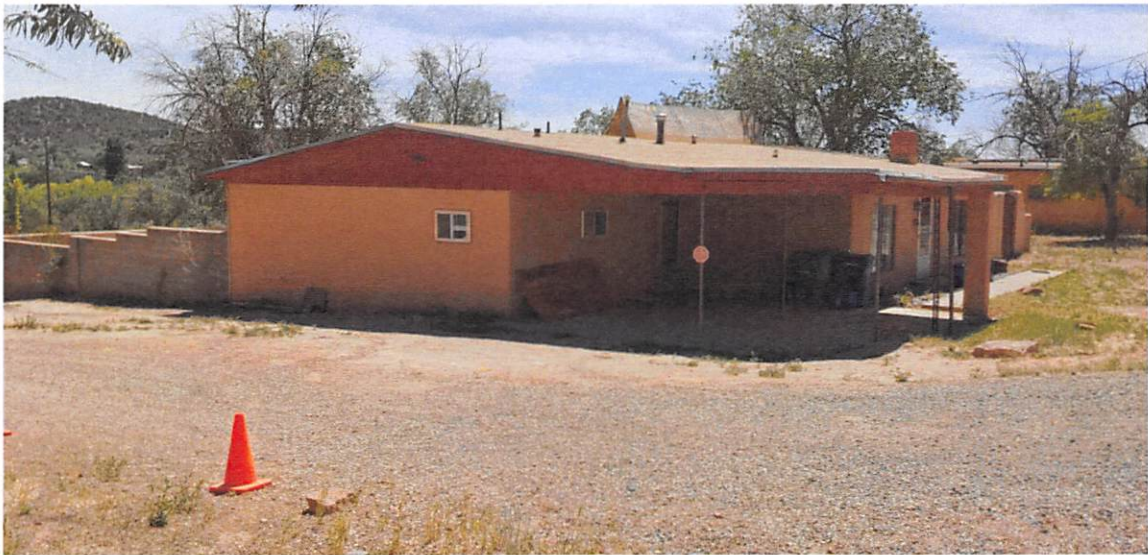
**Photo 2: North and east elevations.
Camera facing southeast.**

The awkwardness of the carport is amplified when viewing this side elevation (Photo 2). The flat, simple elevation has a single window near the northeast corner. The window's position differs from the 1961 drawing, which had it closer in line with the gable apex (Figure 9). The roof has a medium pitch, contemporary of its period. However, the play of the roof is marred by a run of painted vertical boards starting at the top plate. The boards, painted barn red, continue north across half of the carport.

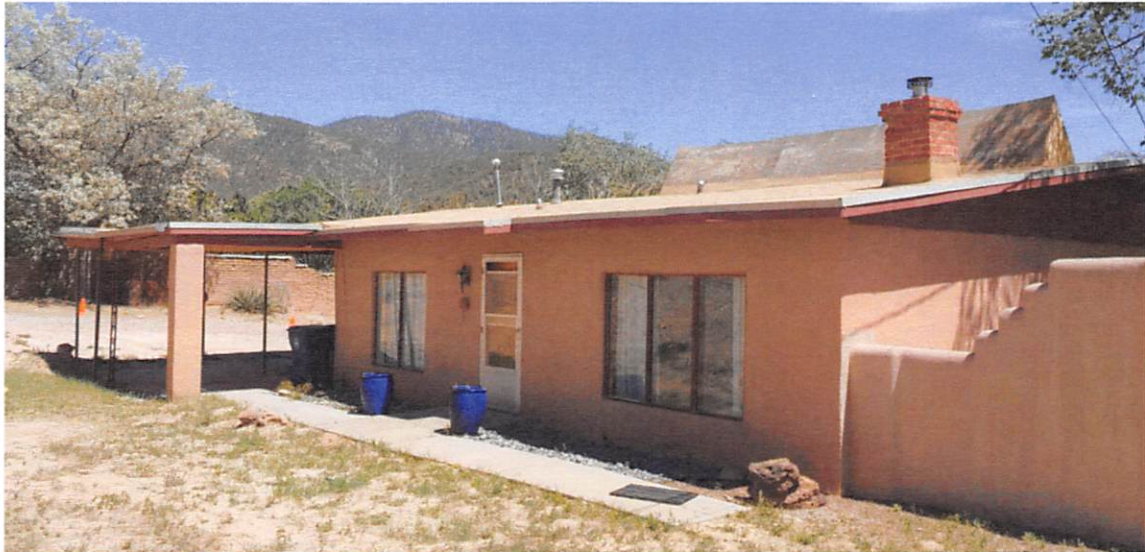
**Photo 3: North elevation.
Camera facing southeast.**

The roof is covered with weathered rolled asphalt. A line of sun-bleached plywood sheets rises from its ridge like a dorsal fin (Photo 3). The Historic

Styles Committee required these to hide solar collectors behind the house on the south slope. The two older solar water collectors are faced with sun-whitened fiberglass panels.

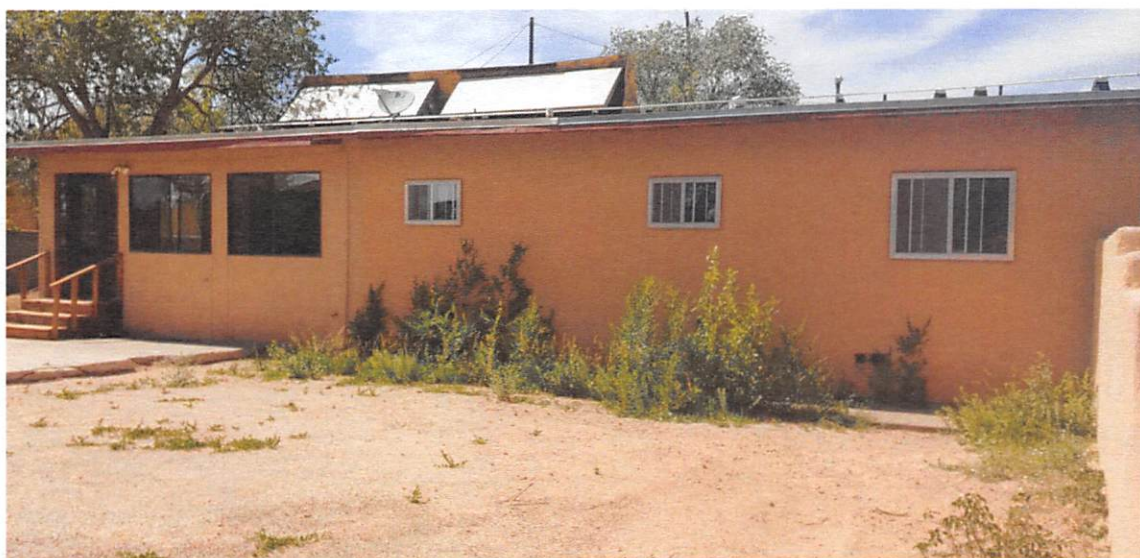
**Photo 5: South elevation.
Camera facing northwest.**

The south elevation encloses the private functions of the home. The east third of the elevation is an unarticulated wall punched with three sliding windows of differing size, providing light to bedrooms (Photo 5). As designed in 1961, the windows were large units of a uniform size (Figure 10). The façade's west end was originally open as a roofed patio. The gable carried over the space in the design, with an exposed wood beam and rafters delineating its south opening (Figure 10). As a cutout to the mass, it mirrored the carport. At some point in the late 1980s or early '90s, the space was enclosed with a frame addition faced with stucco. The roughly 274-square-foot area introduced much larger windows than the unaffected portion of the elevation (Photo 6).

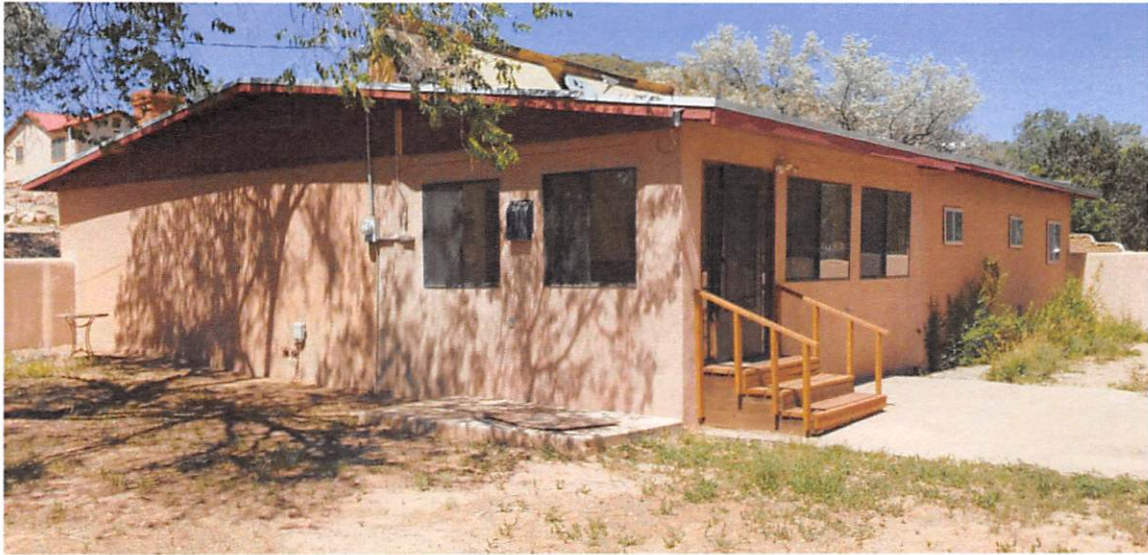
**Photo 7: West elevation; enclosed porch, right.
Camera facing northeast.**

The enclosed porch became a large part of the west elevation (Photo 7). Designed initially as a windowless wall, the modification introduced large sliding units at the south end. Similar to the east elevation, vertical gable boards run between the top plate and the roof.

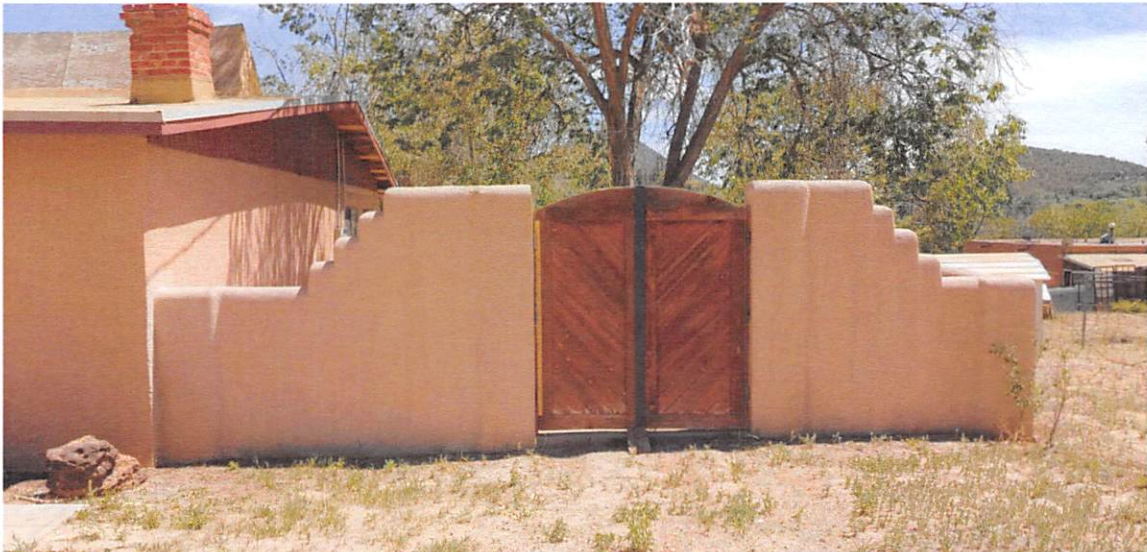
Photo 9: Non-historic gate.
Camera facing south.

For the above reasons, the House, perimeter wall, and north gate are recommended as Noncontributing Structures to the City of Santa Fe Downtown and Eastside Historic District.
