Historic Cultural Properties Inventory (HCPI) Base Form (FORM 1)

For HPD Office use only:		District No. _____		NRHP	SRCP	Criteria	A	B	C	D
1. Name of property: Catherine D. Janney/ Waldo and Ernestine Anton/ Henry and Virginia Wicks House		2. Location: 521 Calle Corvo Downtown and Eastside Historic District – Santa Fe		3. Local Reference Number: Santa Fe ID: H-632		4. County: Santa Fe Parcel # 13018752

8. Name of Project: HDRB Status Evaluation										
9. Lat/Long: 35.6819669,-105.9329764										
10. Photo Information: Giulia Caporuscio, photographer. Photo 1: View of south elevation. Facing northwest.

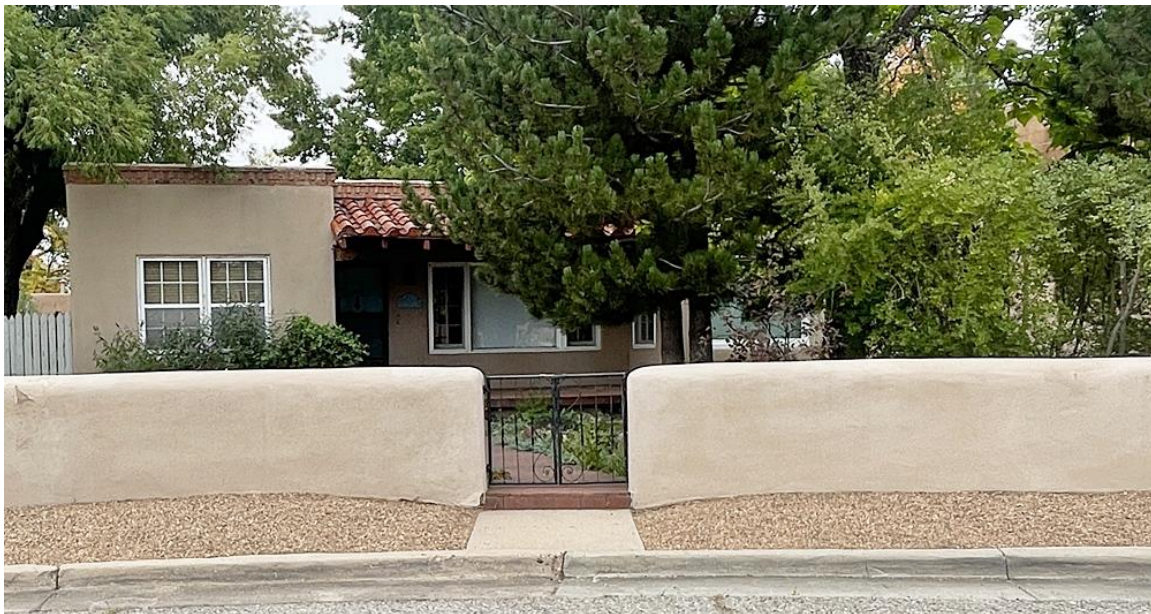
The primary house has a modified H-plan with a symmetrical façade (Photo 1). Its composition centers on an inset portal flanked by cubic projections (Photo 2). The arrangement recalls the influence of the historic Roque Lobato House, whose form was repeatedly adapted to organize small Territorial-style dwellings. The Territorial theme continues in the brick coping laid in a stretcher–rowlock–stretcher pattern extending along all sides of the house.

A roughly three-foot-high, two-foot-wide adobe wall extends along the front property line (Photo 2). Near the center, a steel entry gate opens onto a brick walkway leading to the main entrance. Comparison with a 1978 aerial photograph and the 1984 HBI suggests that the wall is relatively recent, replacing what had historically been a hedge (Figs. 4 & 5). The rear patio walls are also of modern construction.

Photo 2: House and setting. Camera facing northeast.

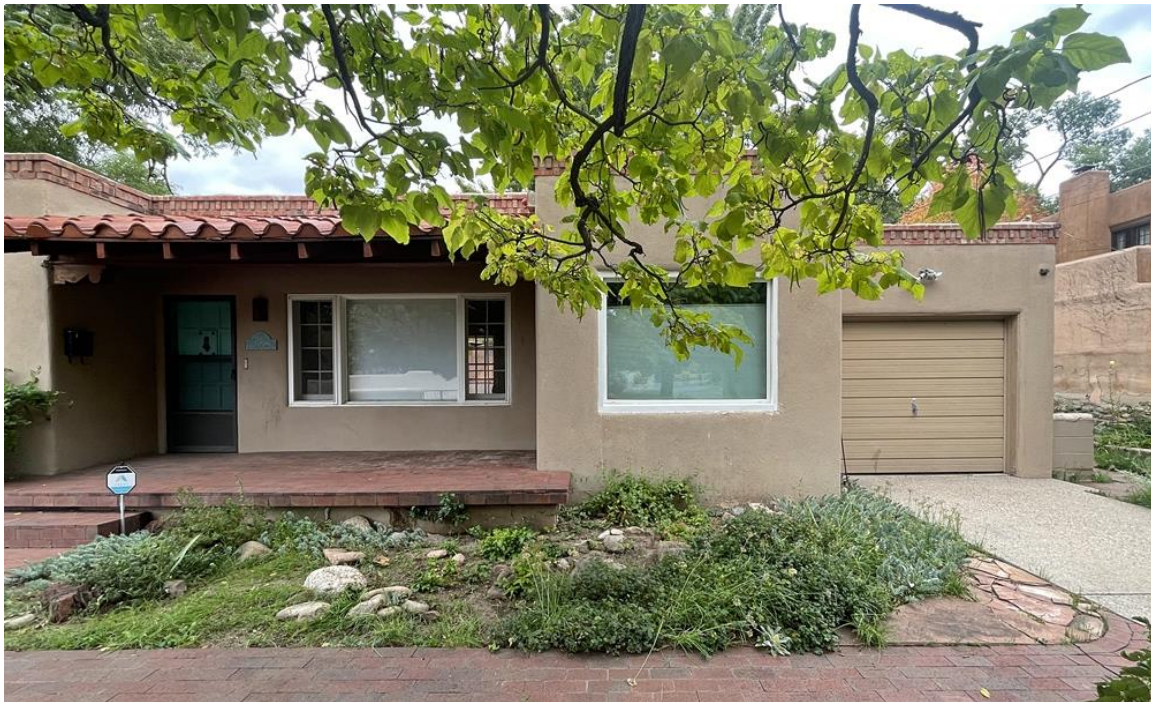
A broad combination window—composed of eight-light casements flanking a fixed center panel—illuminates the living room. The casements are simple wood sash, hung on barrel hinges and operated by small surface latches. The main entry is a fifteen-panel wood door painted turquoise.

Photo 5: South (front) façade, center and east sections. Camera facing northeast.

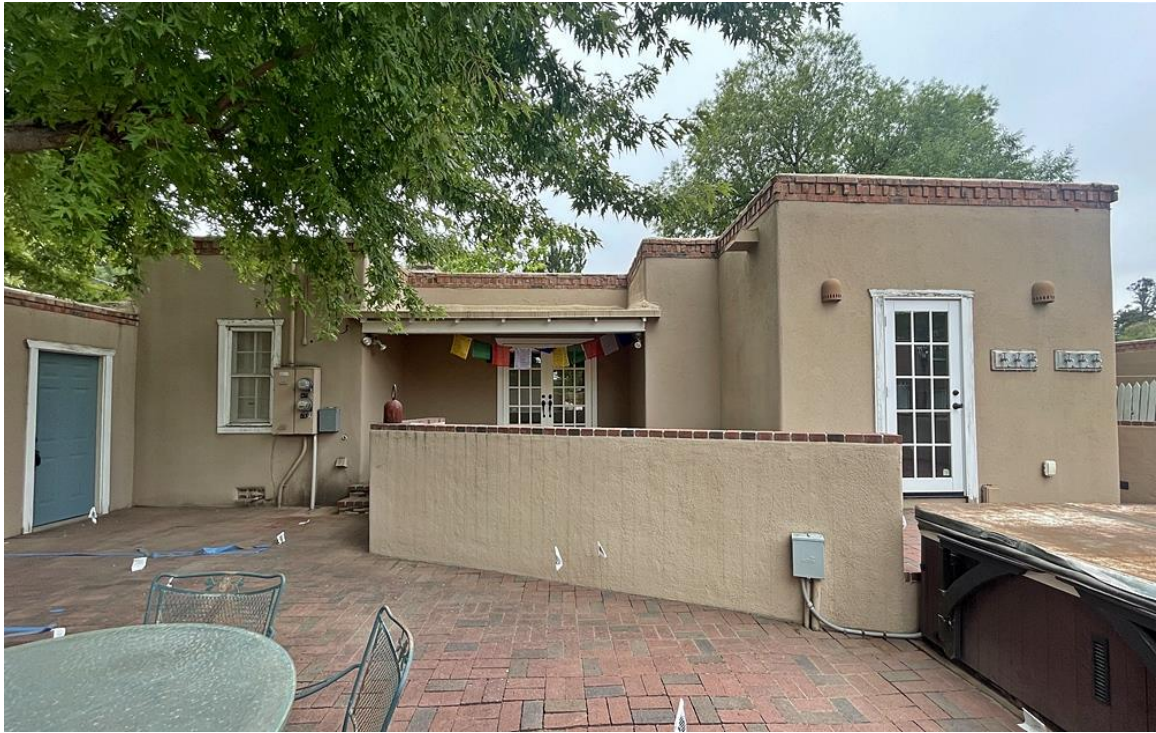
Photo 8: North (rear) elevation, center and west sections. Camera facing southwest.

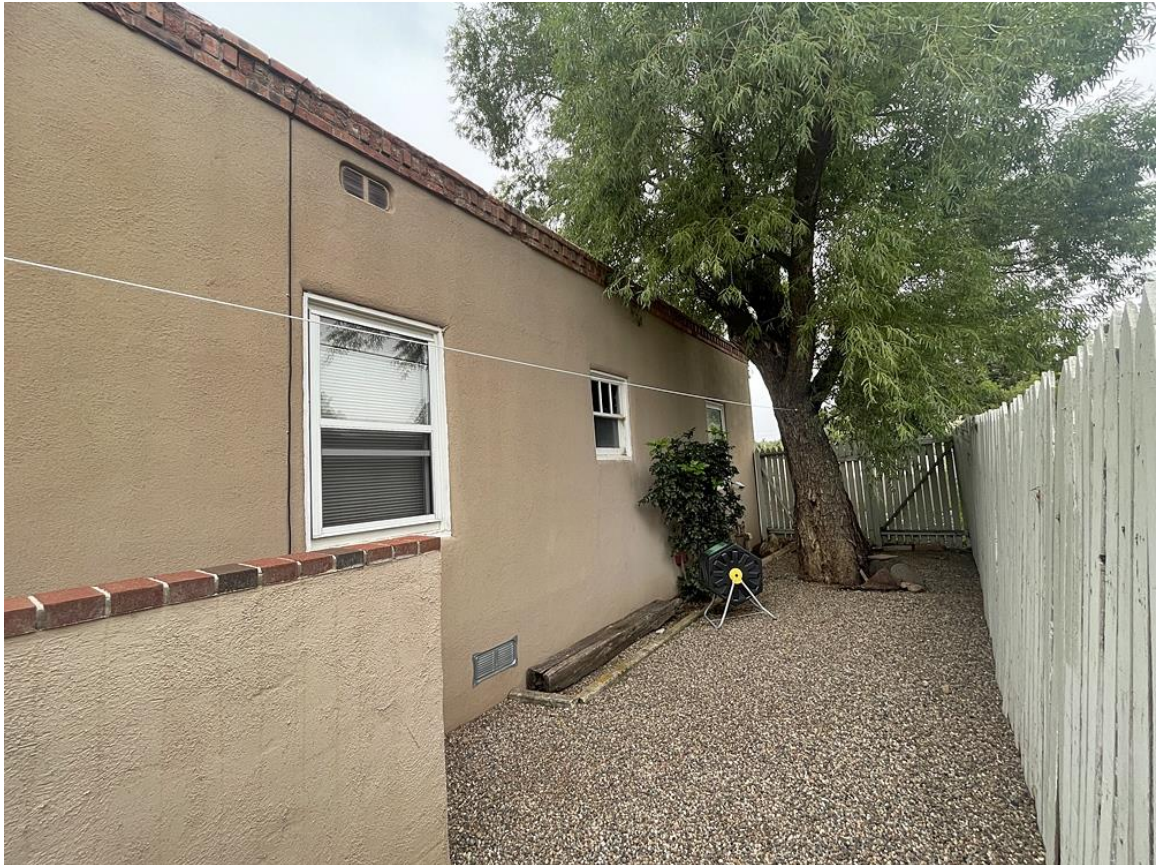
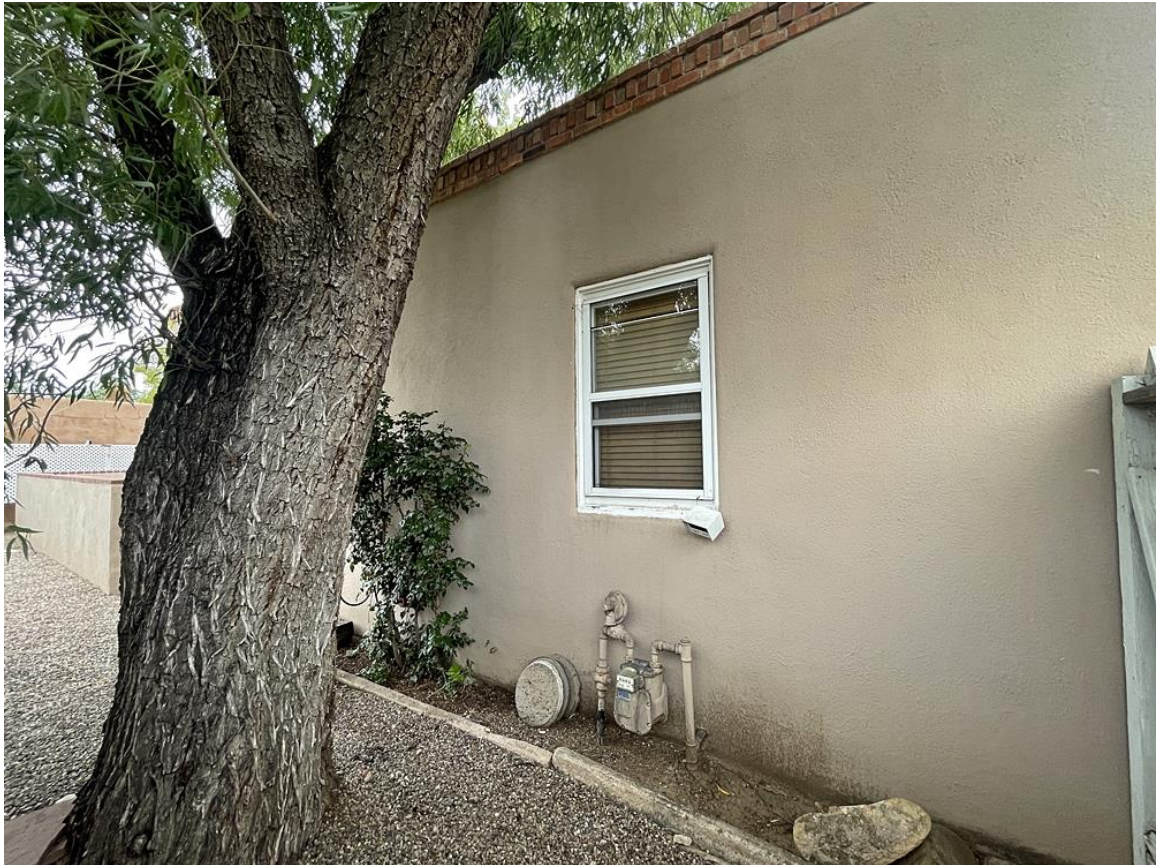
This elevation parallels a graveled side yard and contains several wood-sash windows serving the primary bedroom, bathroom, and sitting room (Photos 9 and 10).

Photo 9: West elevation. Camera facing southeast.

Photo 10: West elevation. Camera facing northeast.
