# RPA & Associates, LLC.

JOB	DATE
801 OLD SANTA FE TRAIL, SANTA FE, NM 87501	12/8/2025

**RPA & ASSOCIATES, LLC | WINDOW & DOOR CONDITION AND INTEGRITY CODES**

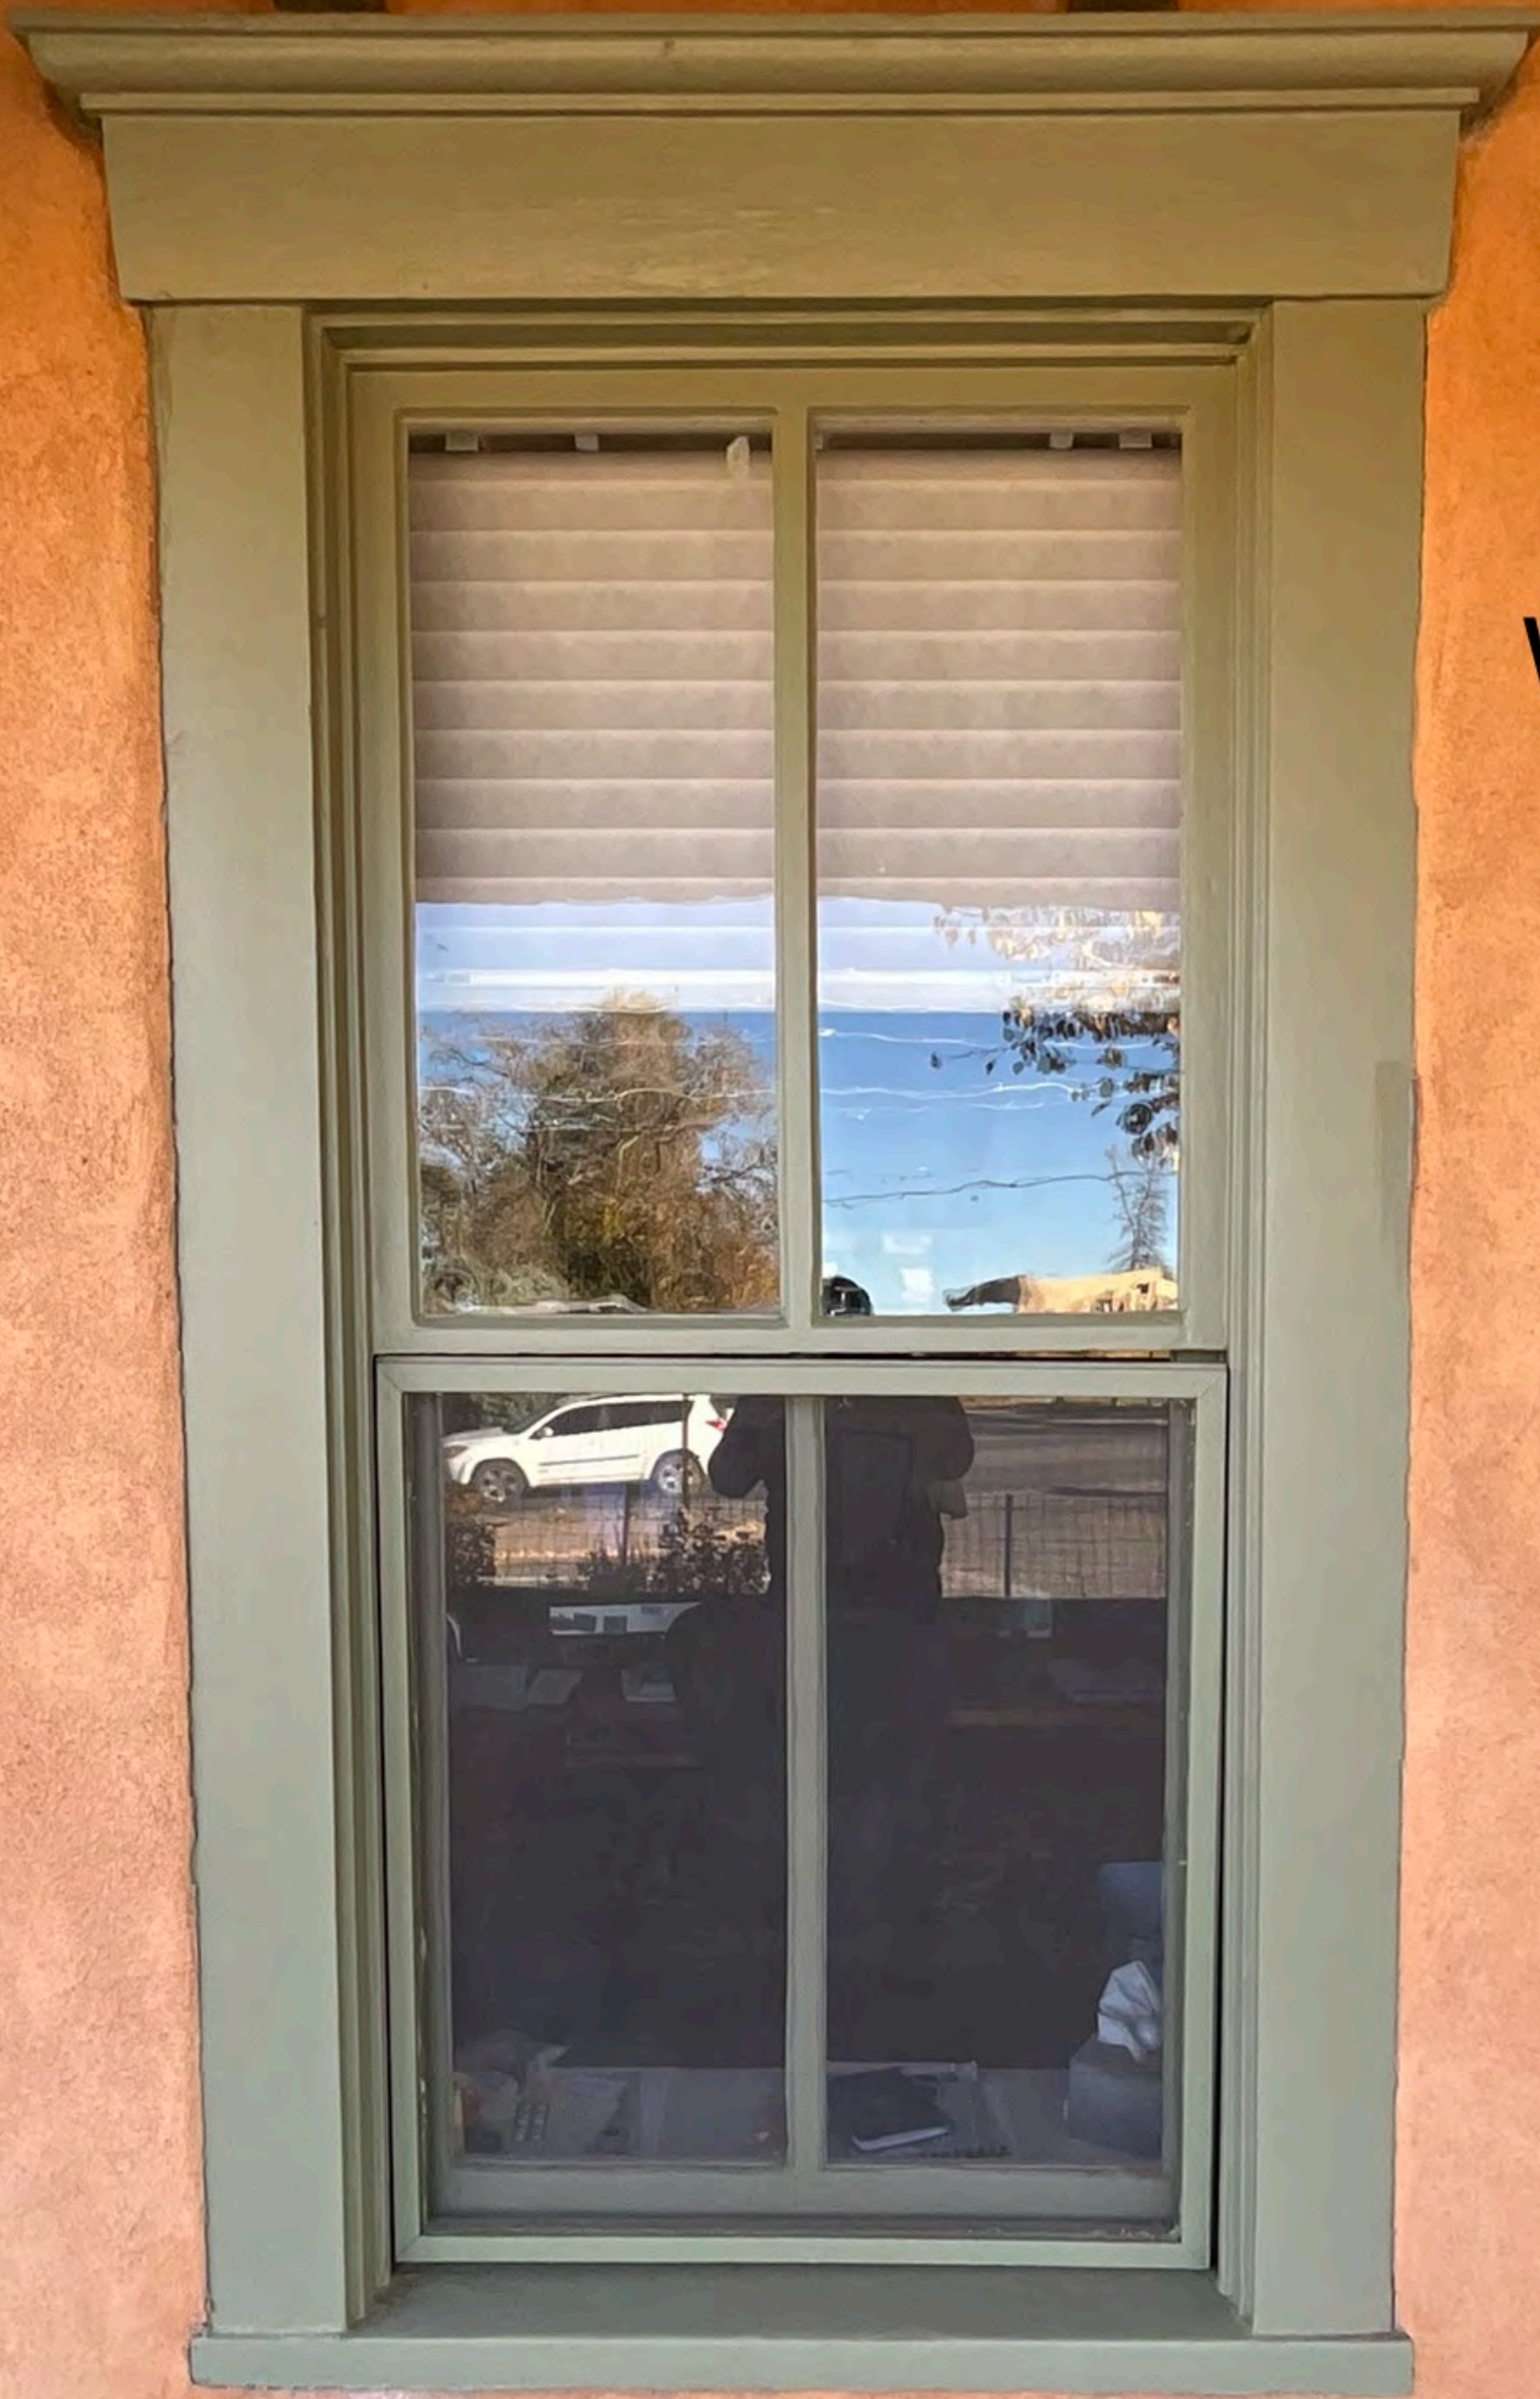
West Elevation  
Window  
A

LABEL	WINDOW & DOOR DESCRIPTION	CONDITION & INTEGRITY CODE	HISTORIC/NON-HISTORIC - AGE
A	38" x 83" DOUBLE HUNG 2W1H/2W1H 1 ½" BAR & ROPE PULLEY ALL WOOD 6" FLAT CASINGS – SIDES 8" HEAD CASINGS W/ 2 ¼" CROWN MOULD & DRIP CAP	S	HISTORIC – RESTORABLE SCREWS ARE NON-HISTORIC AIR GUN NAILS FROM 1992
DR #1	36" x 80" LH INSWING DOOR 3W5H "SIMPSON" FIR DOOR (1992) 1 1/8" DIVIDED LIGHT ALL WOOD OG DOOR STOP FROM 1984	S	NON-HISTORIC – "SIMPSON" MANUFACTURED (1992)
B	38" x 83" DOUBLE HUNG 2W1H/2W1H 1 ½" BAR & ROPE PULLEY ALL WOOD 6" FLAT CASINGS – SIDES 8" HEAD CASINGS W/ 2 ¼" CROWN MOULD & DRIP CAP	S	HISTORIC – RESTORABLE SCREWS ARE NON-HISTORIC AIR GUN NAILS FROM 1992
C	30" x 70" DOUBLE HUNG 1/1 ALL WOOD NO ROPES – 3 ½" EXTERIOR FLAT CASINGS ON EXTERIOR ROTTED BOTTOM RAIL OF BOTTOM OF SASH EXTERIOR STOPS BROKEN, EXTERIOR CASINGS 30% - 40% ROTTED	F	HISTORIC – ONLY THE FRAME NON-HISTORIC – SASHES HAVE BEEN REPLACED SOME TIME BETWEEN 1988 & 1994 MACHINED JOINTS & AIR GUN NAILS

Window A, B, and Q are historic and restorable.

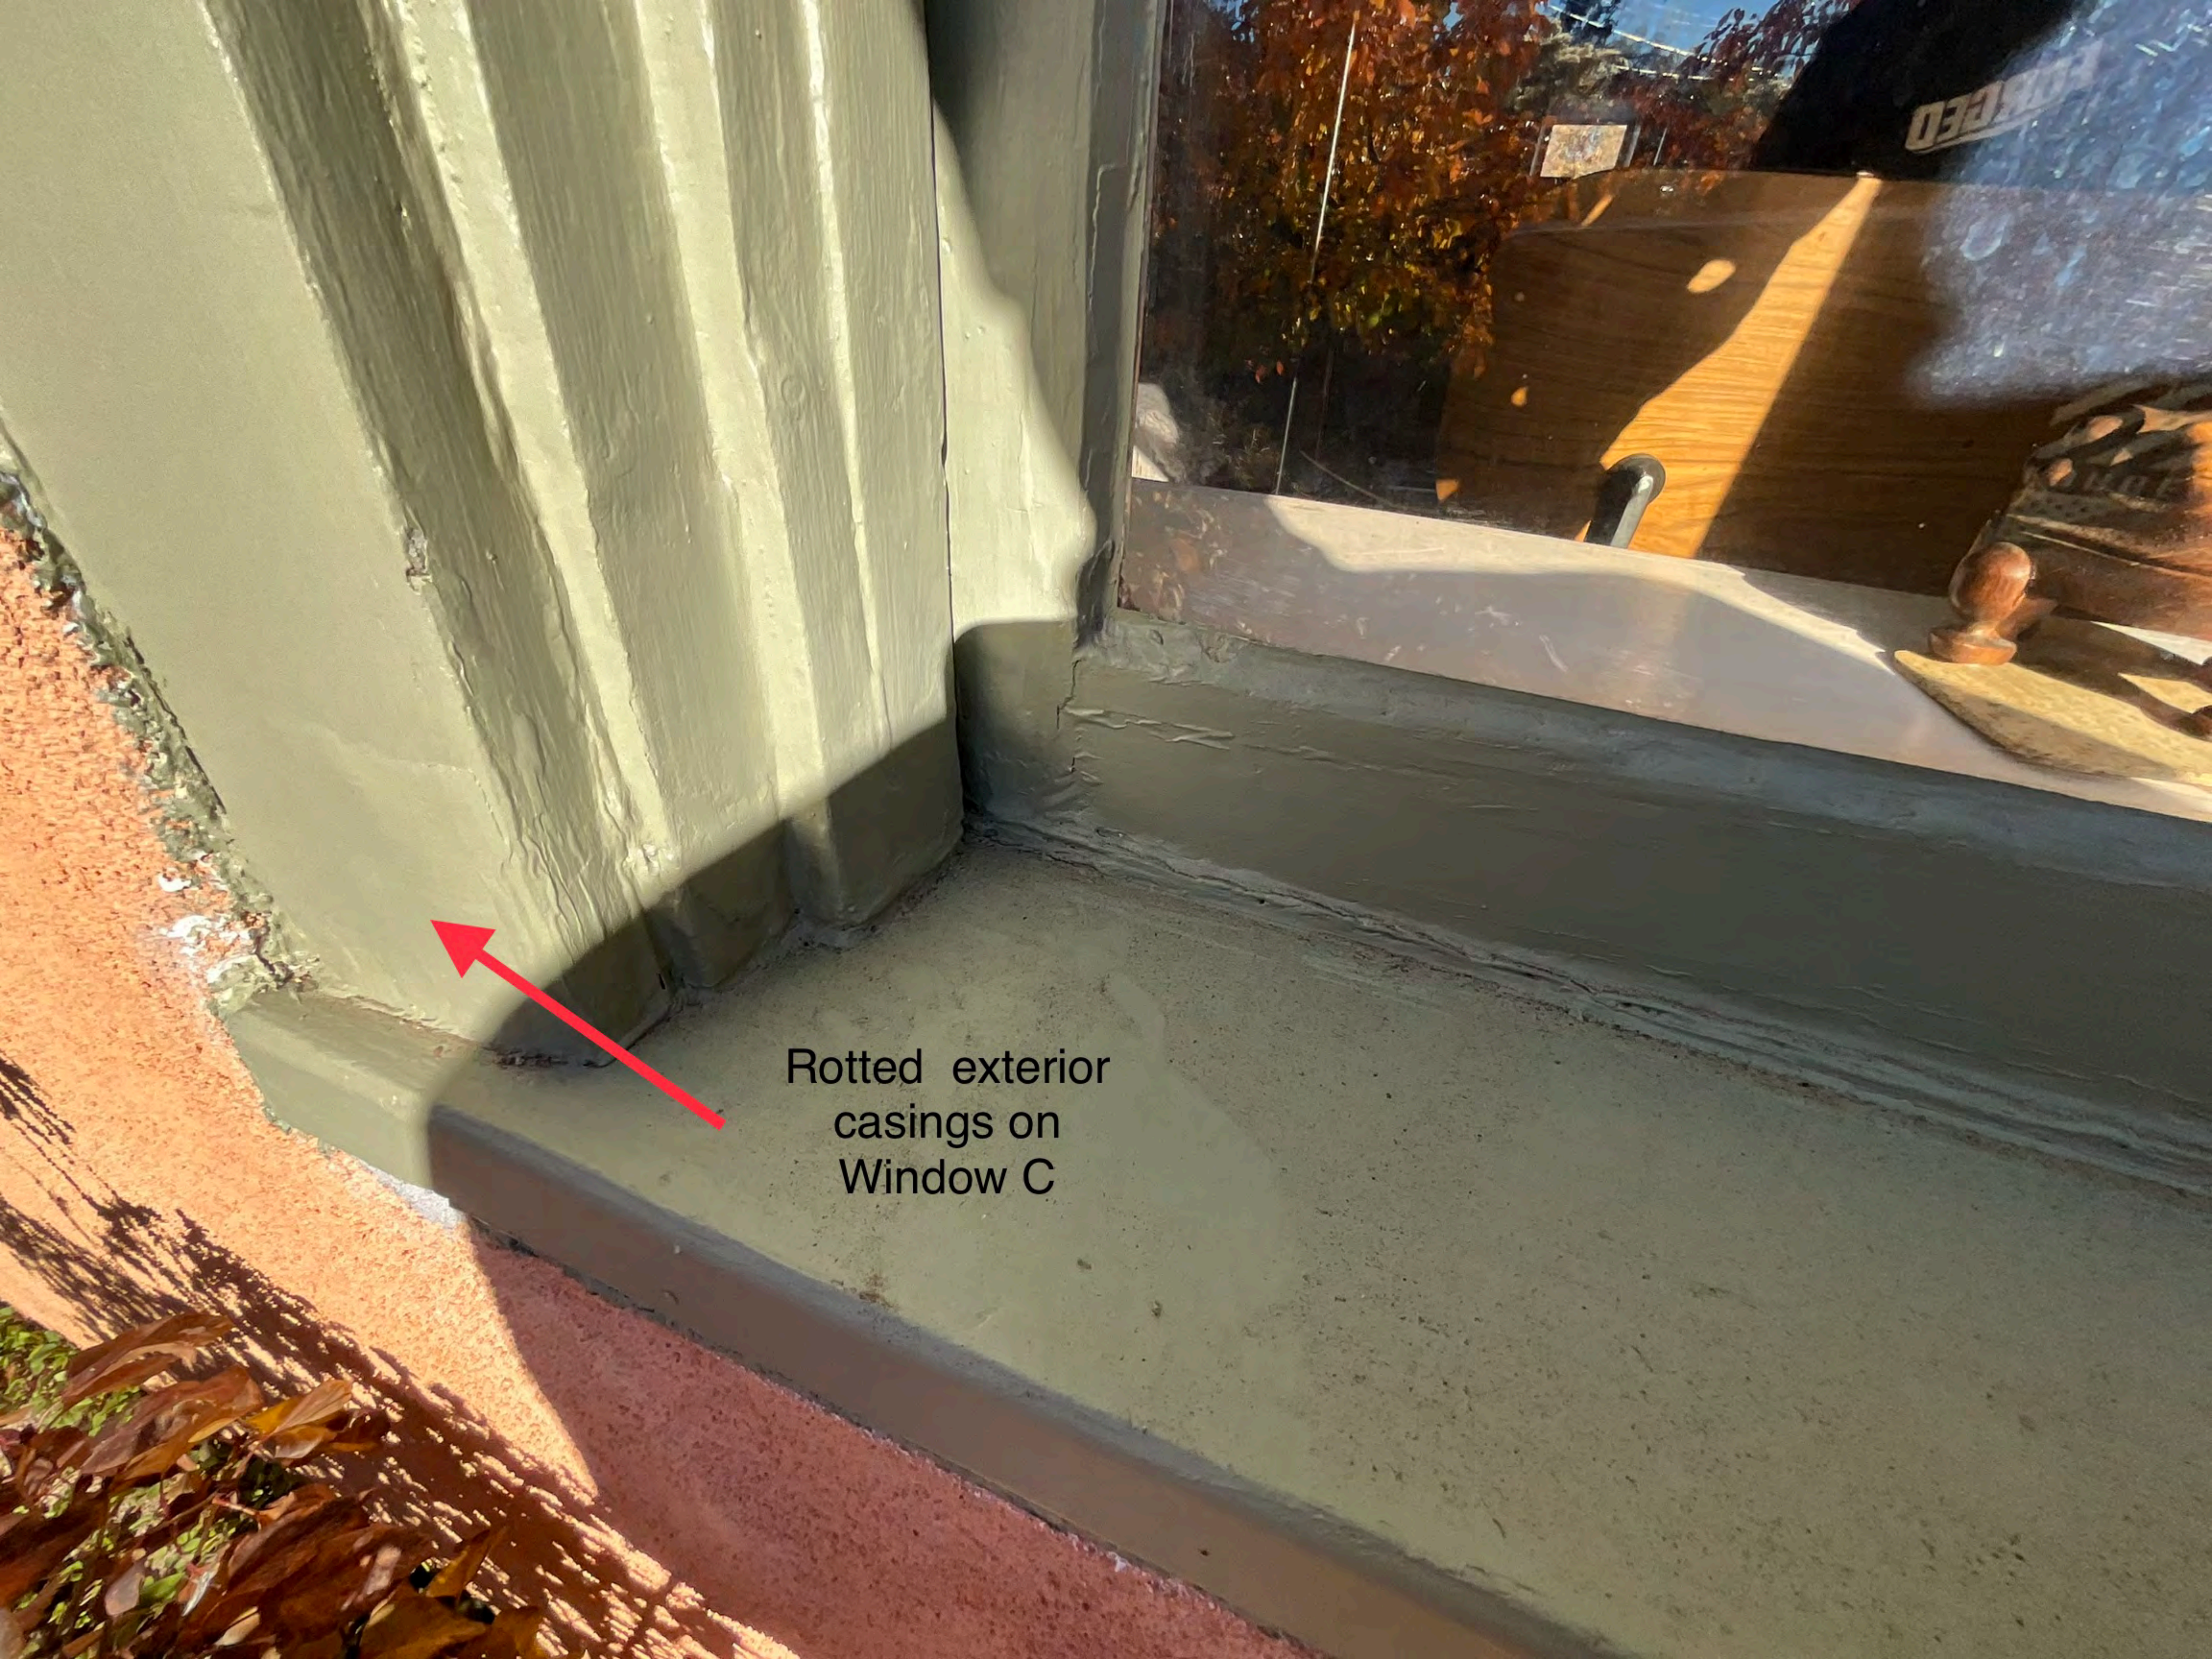
Rotted exterior casings on Window C

Window C, E, F, G, O, and P sashes are non-historic however the frames are historic.

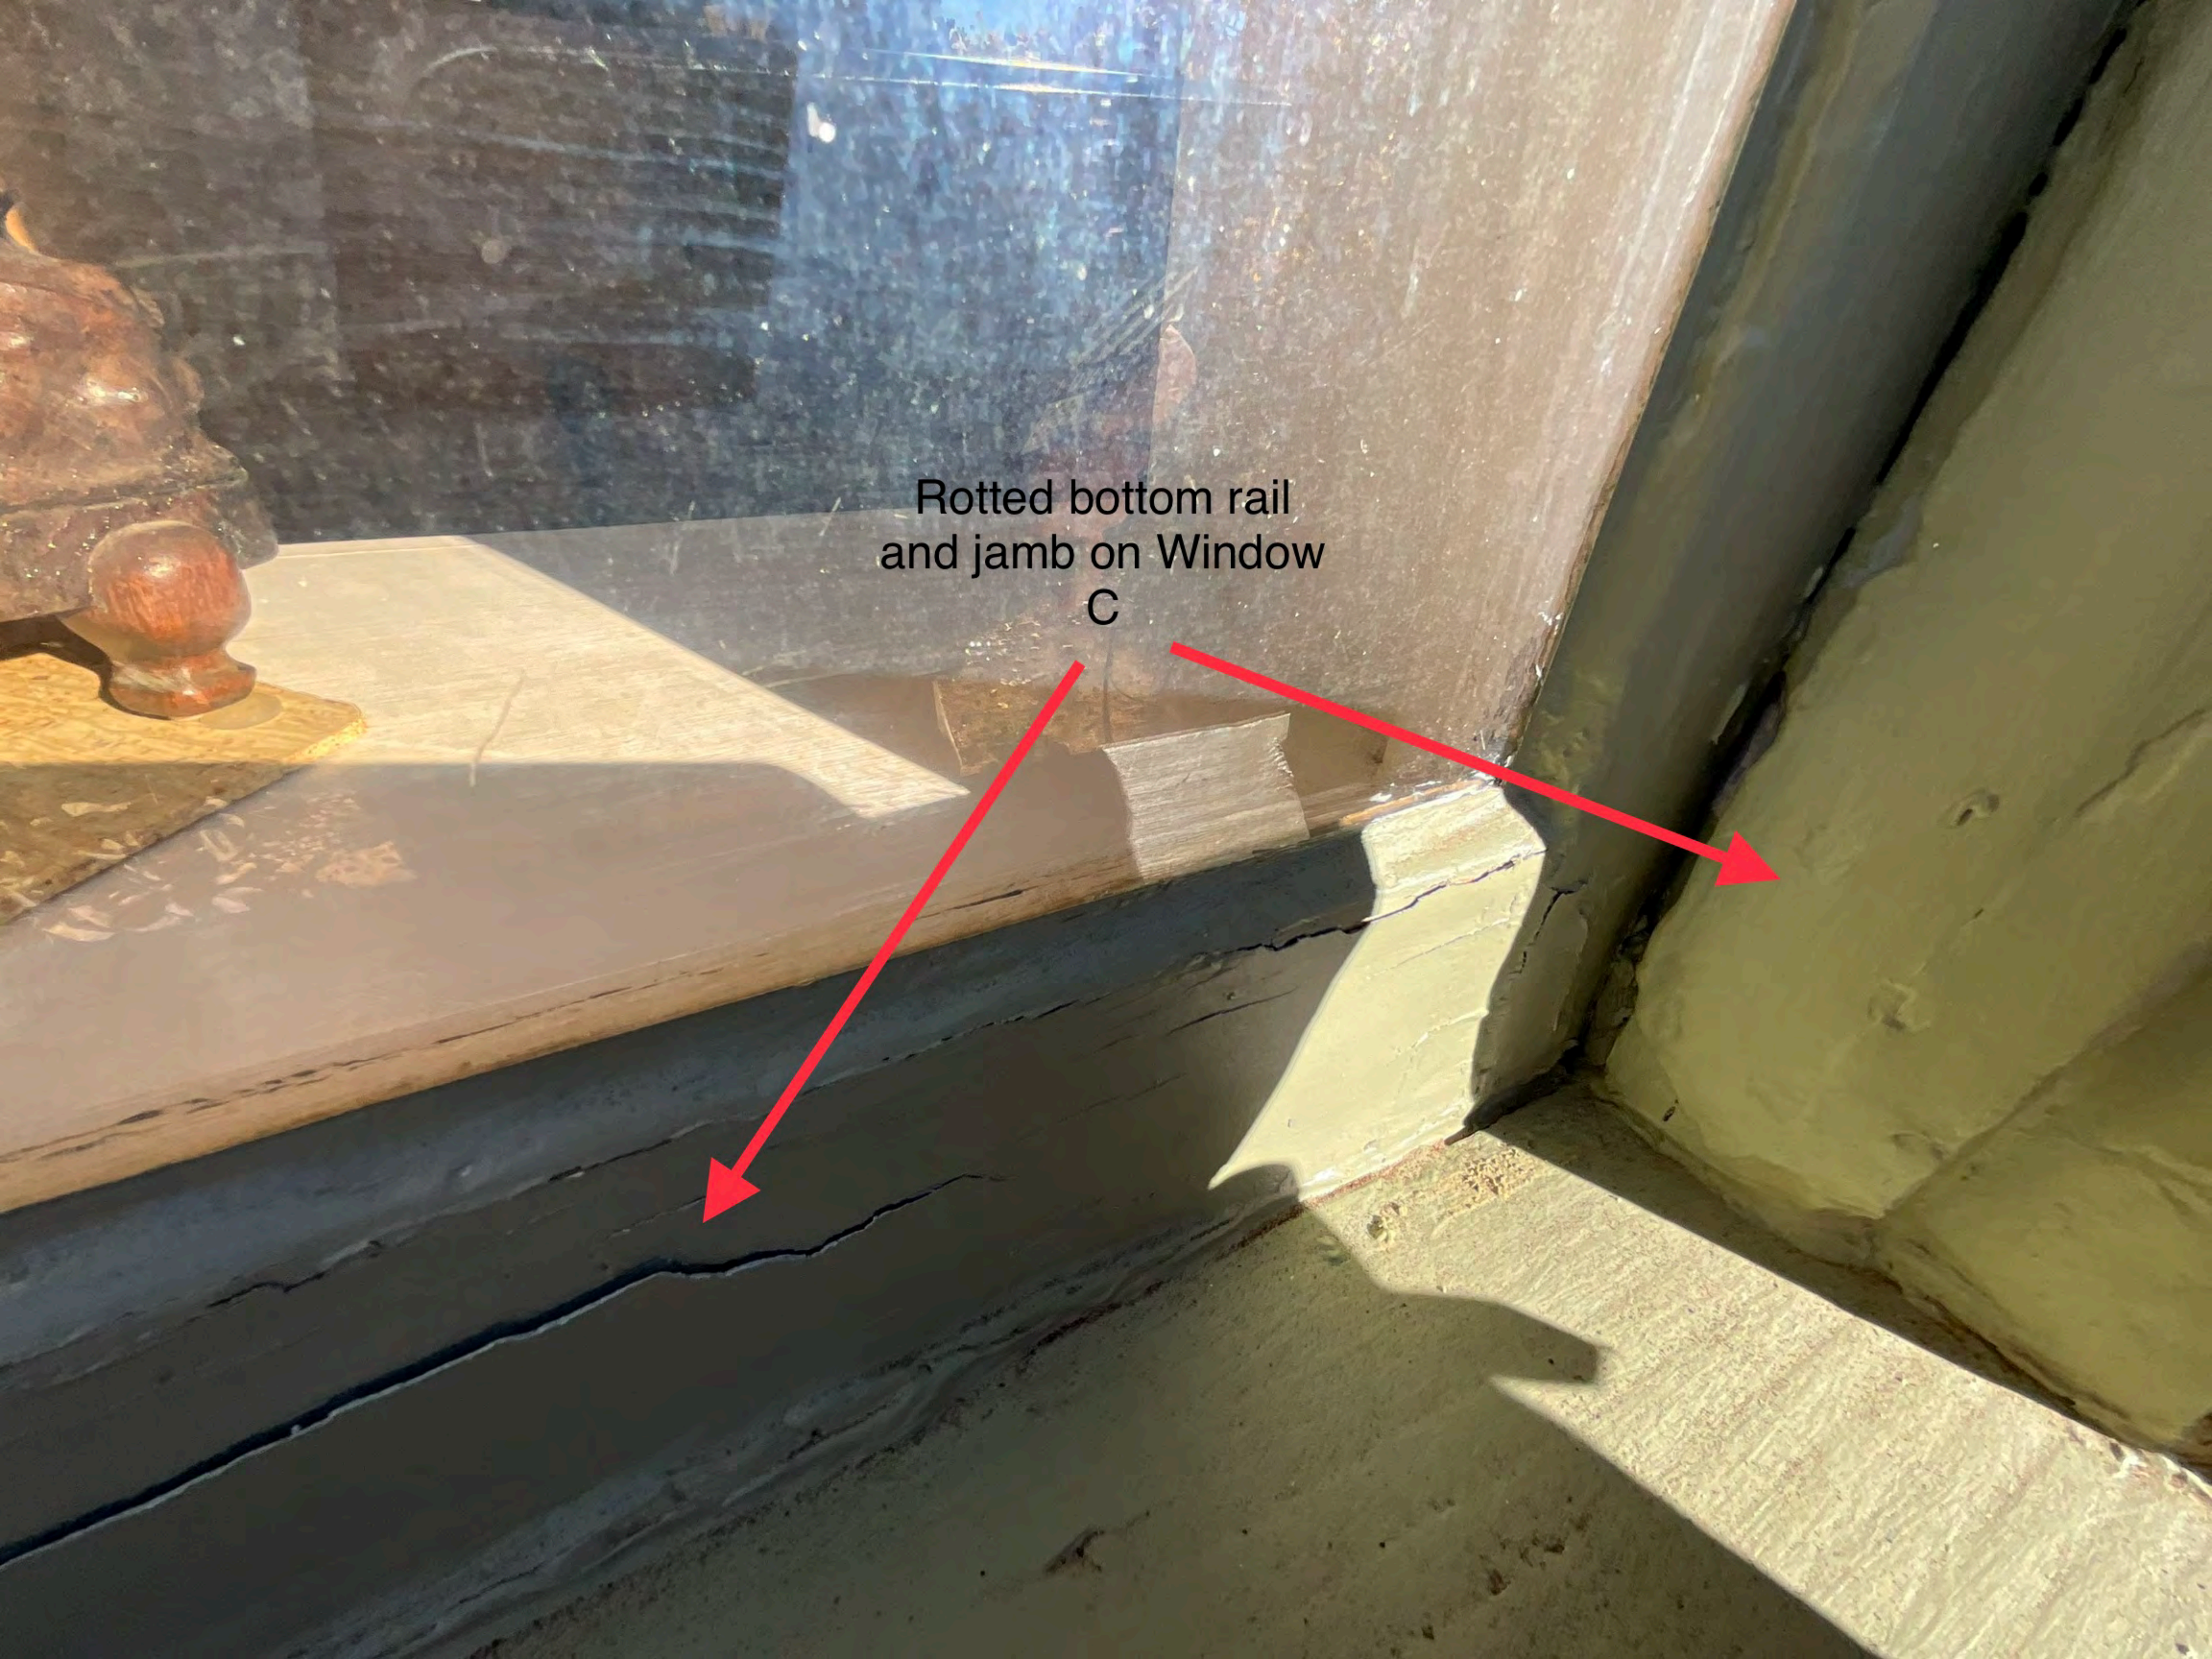
Rotted bottom rail  
and jamb on Window  
C

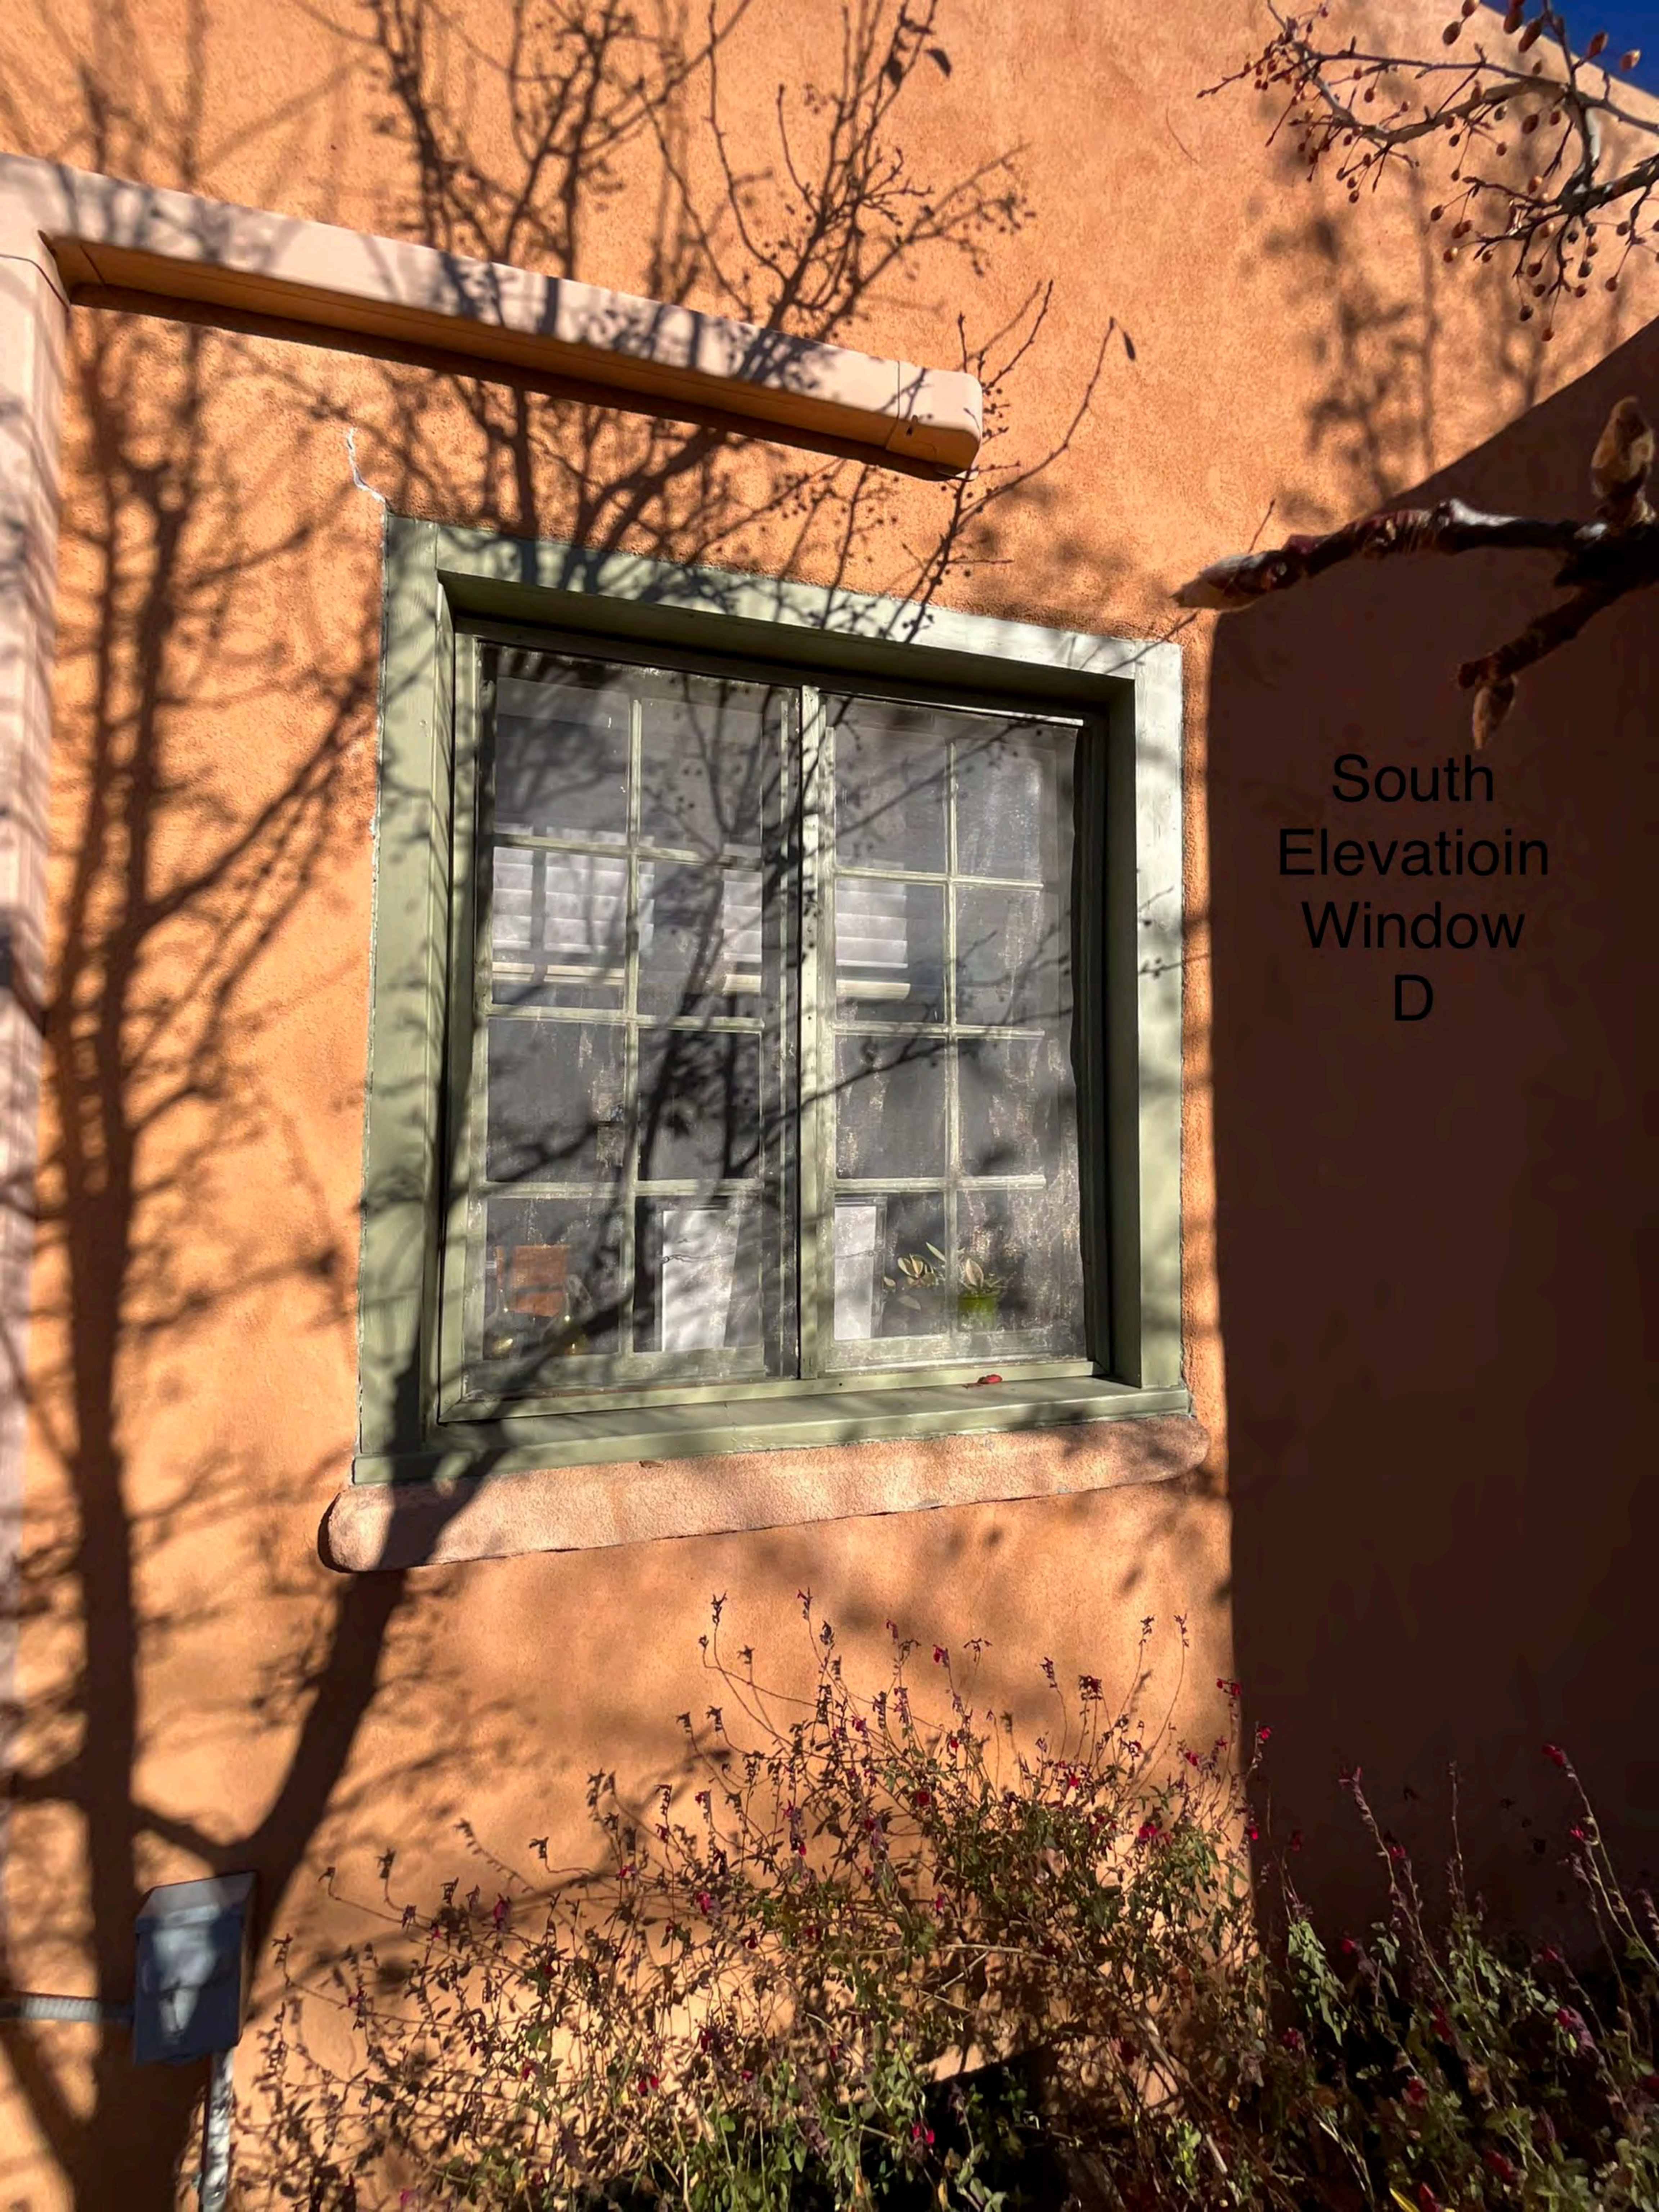
South  
Elevation  
Window  
D

LABEL	WINDOW & DOOR DESCRIPTION	CONDITION & INTEGRITY CODE	HISTORIC/NON-HISTORIC – AGE
D	50" x 54" – 2 TWIN LR INSWING CASEMENT (2-25") ¾" DIVIDED LIGHT BAR 3 ½" EXTERIOR FLAT CASINGS BOTTOM RAILS ROTTED	F	NON-HISTORIC – 1988 TO 1994 BARN SASHES ¾" DIVIDED LIGHT – THESE SASHES WERE MODIFIED TO PUT IN A FRAME THAT WAS ORIGINALLY A DOUBLE HUNG FRAME
E	30" x 70" DOUBLE HUNG 1/1 ALL WOOD NO ROPES – 3 ½" EXTERIOR FLAT CASINGS ON EXTERIOR ROTTED BOTTOM RAIL OF BOTTOM OF SASH EXTERIOR STOPS BROKEN, EXTERIOR CASINGS 30% - 40% ROTTED	U	HISTORIC – ONLY THE FRAME NON-HISTORIC – TOP & BOTTOM SASHES HAVE BEEN REPLACED (1988) NEW AIR GUN BRADS & WOOD STOP, NOT PUTTY GLAZED FRAME WOULD NEED TO BE TORN OUT TO RE-SET SQUARE & THIS WOULD DESTROY THE FRAME
F	62" x 62" – 2 TWIN INSWING R CASEMENT 1W3H 1/1 WITH 5 ½" SPREAD MULL (2-28") 3 ½" EXTERIOR FLAT CASINGS	F	HISTORIC – ONLY THE FRAME NON-HISTORIC – BOTH SASHES HAVE BEEN REPLACED WITH 1/1 NO DIVIDED LIGHTS (1988 TO 1994)

Windows D, I, J, K, L, M, and N are non-historic.

My recommendation for the units that are non-historic are that they should be replaced in "like and kind" to the units being restored.

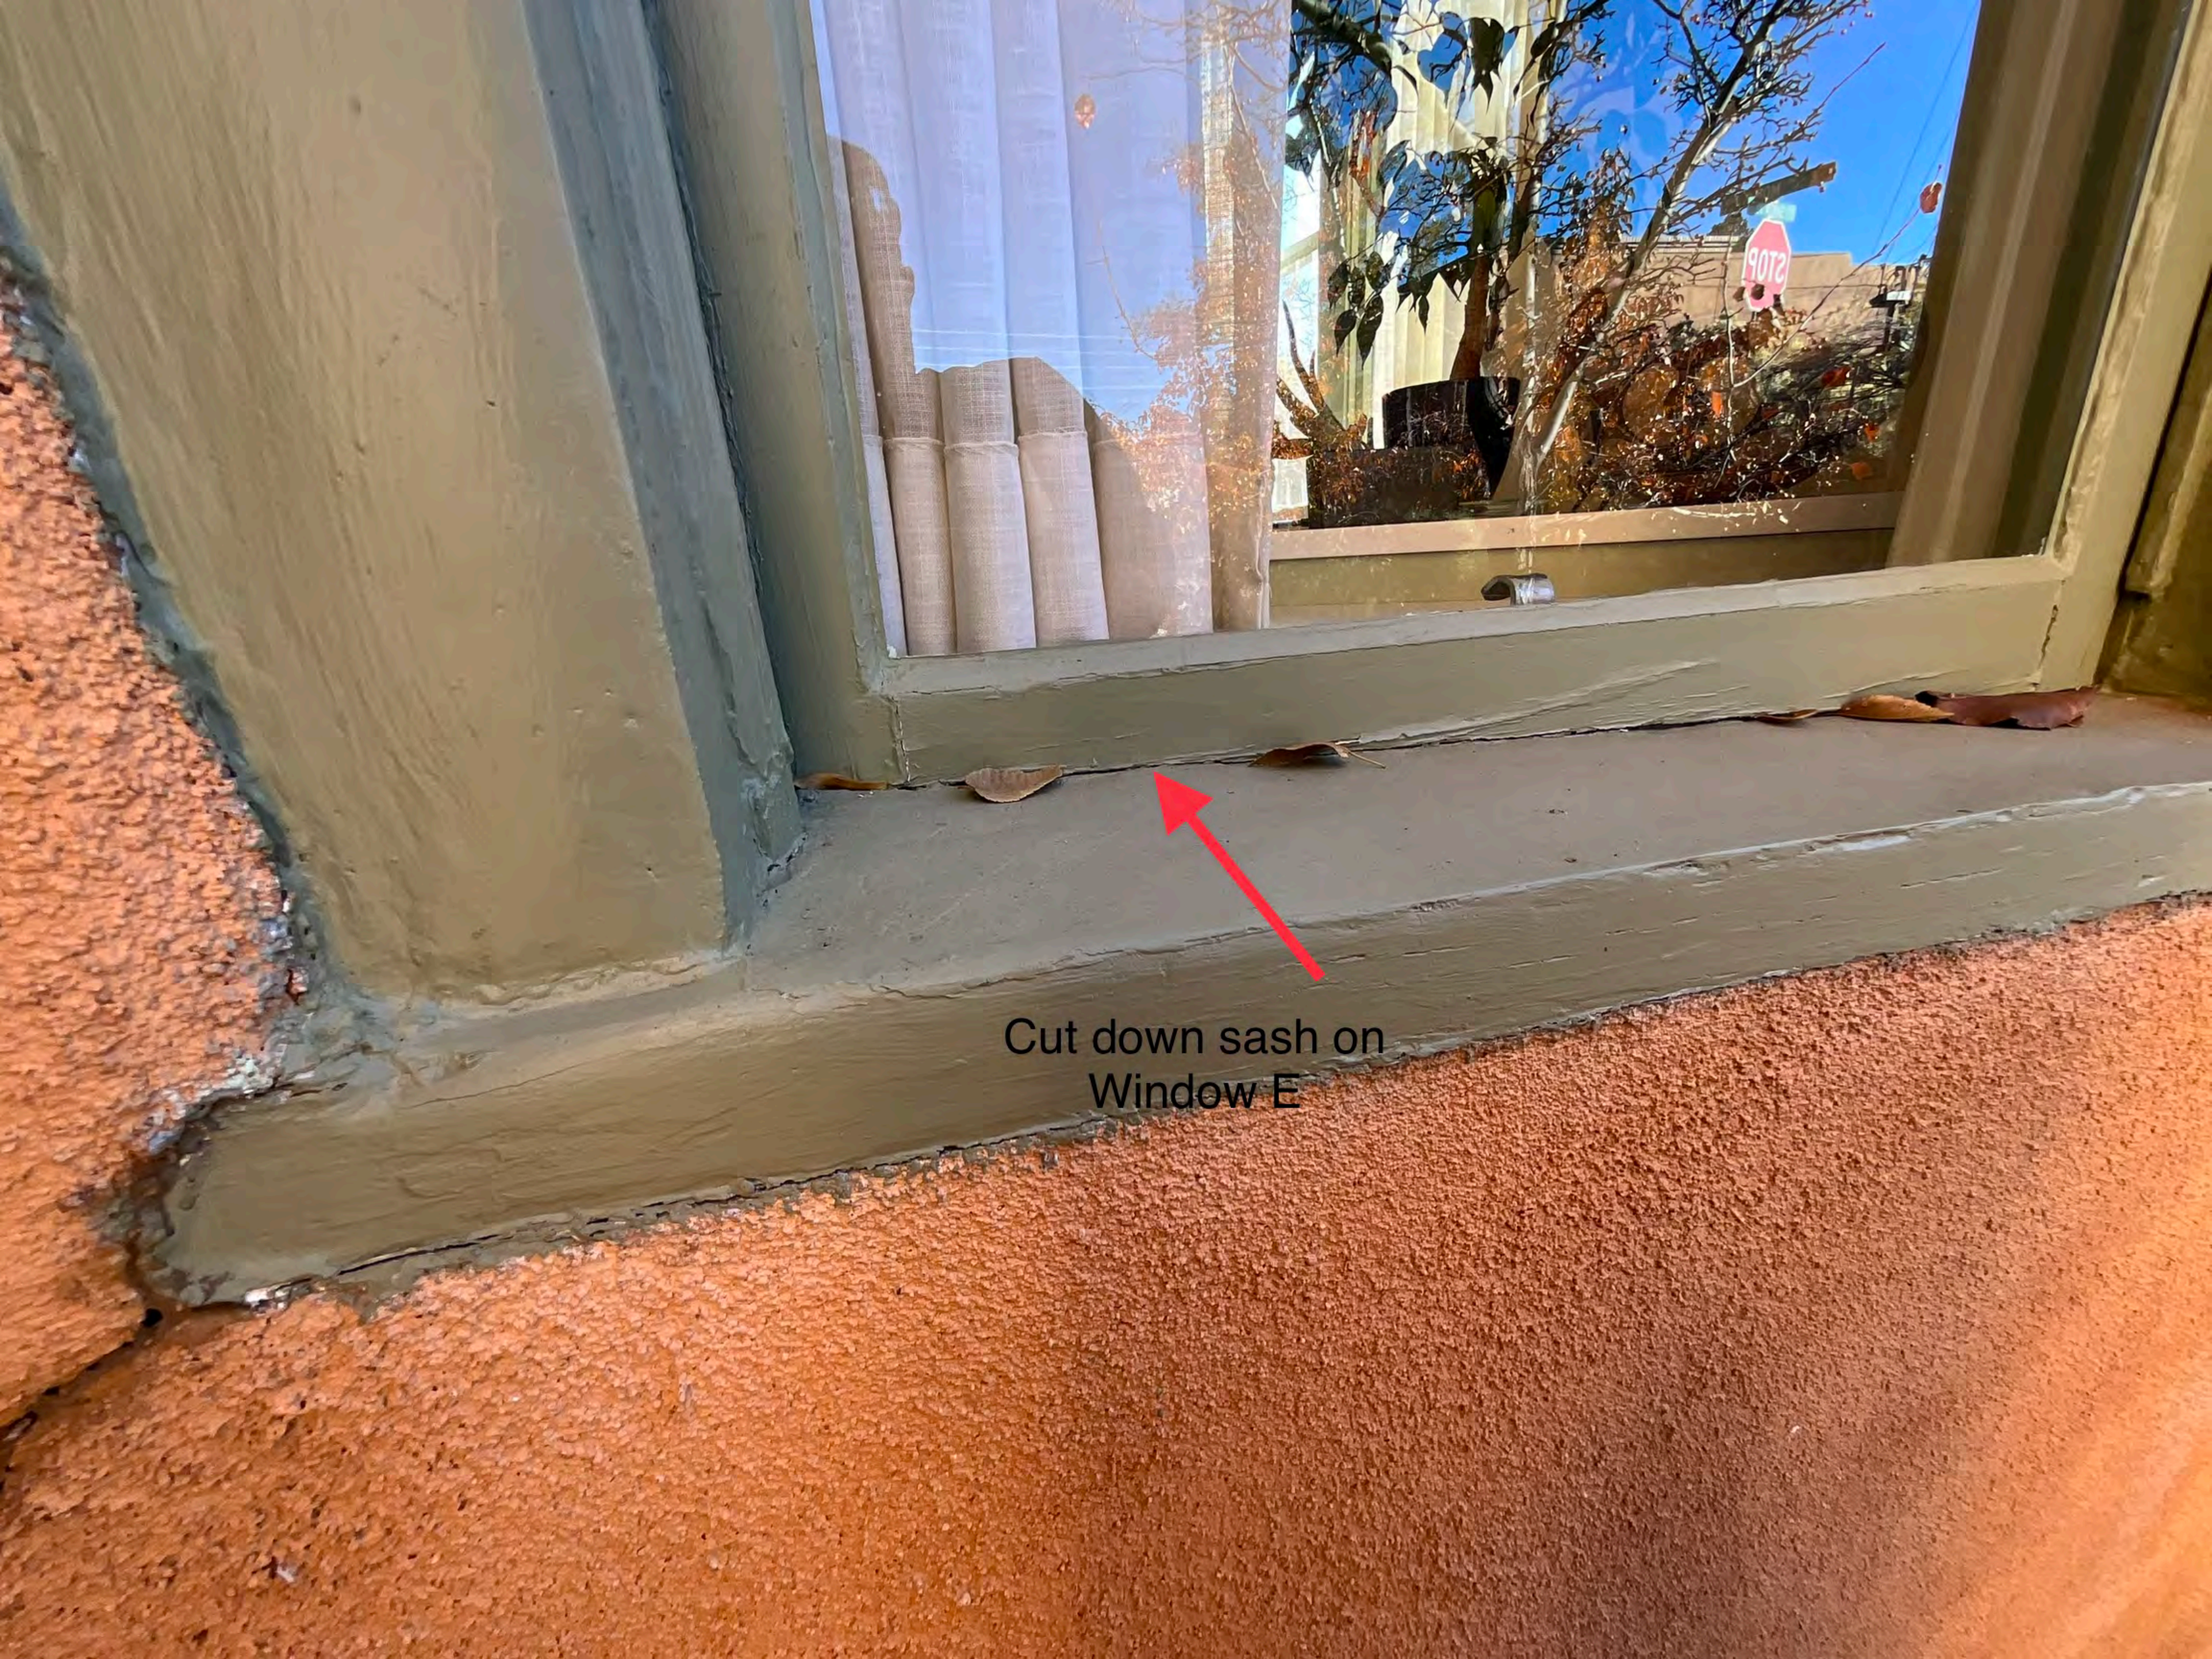
Cut down sash on  
Window E

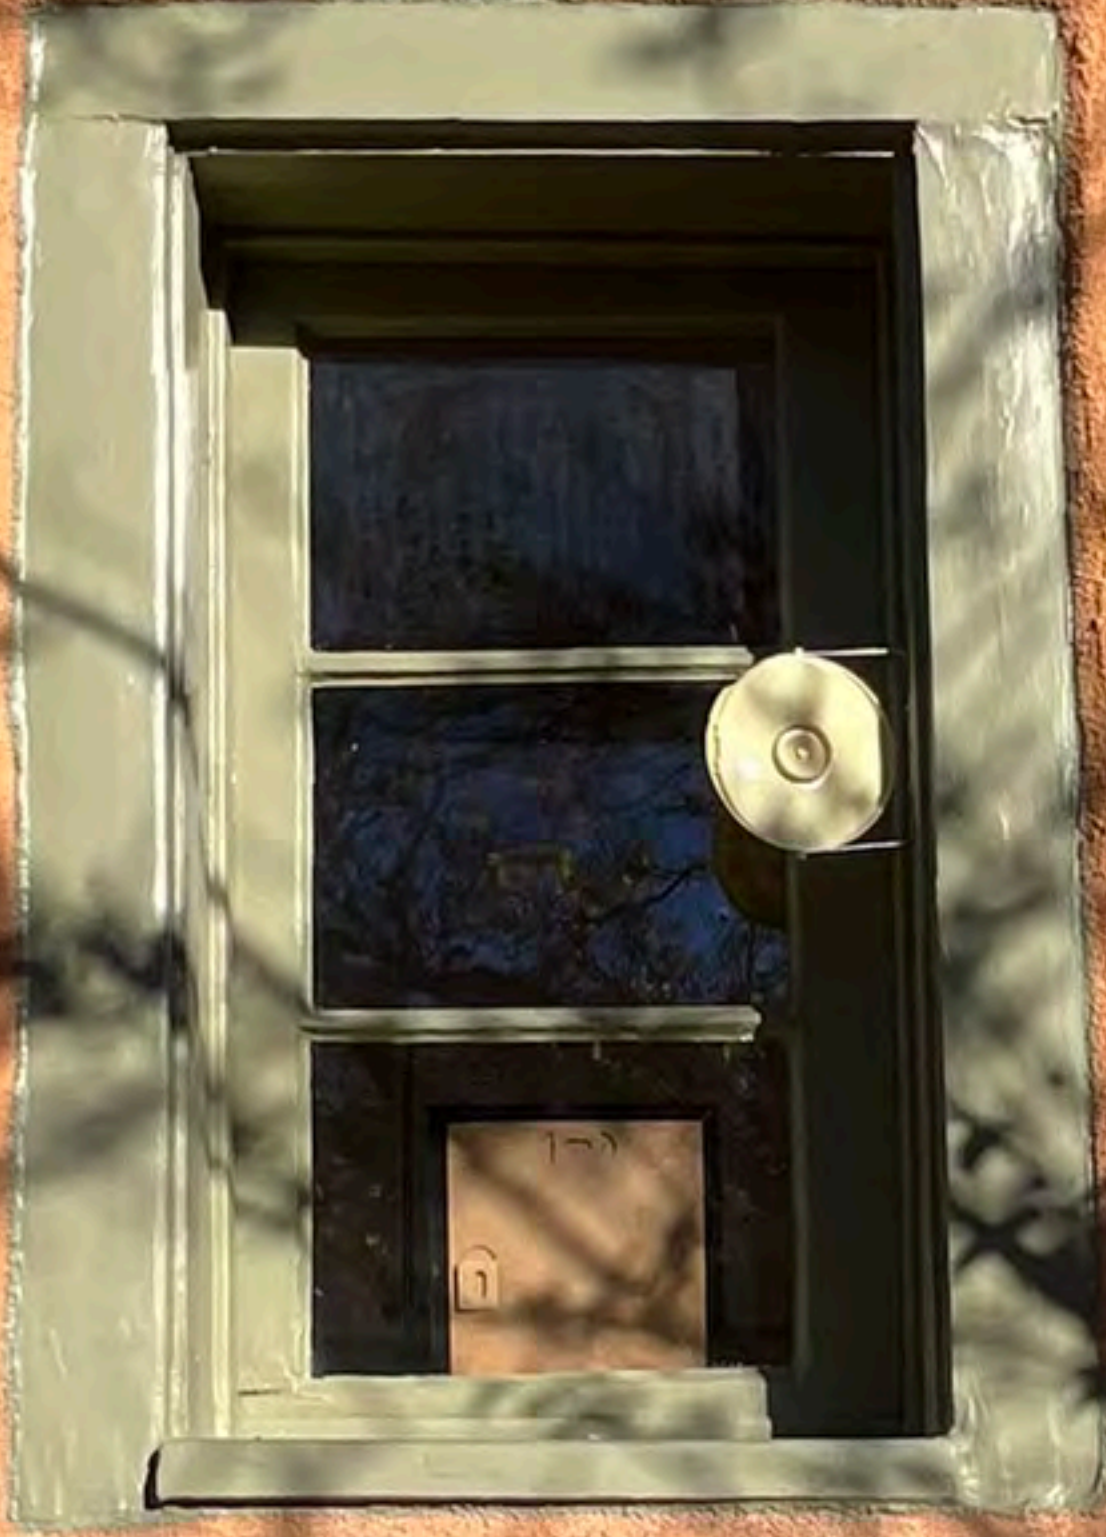
South Elevation  
Window  
G

G	19 ½" x 34" INSWING R CASEMENT 1W3H 7/8" BAR – 3 ½" EXTERIOR FLAT CASINGS	F	NON-HISTORIC – BARN SASH 7/8" DIVIDED LIGHT BAR WITH BOTTOM SASH RAIL CUT TO FIT EXISTING FRAME (HISTORIC)
BASEMENT H	28" x 19" HOPPER TILT IN 1-LT ROTTED SASH	U	HISTORIC – SASH IS ROTTED BEYOND REPAIR
