# RPA & Associates, LLC.

JOB	DATE
801 OLD SANTA FE TRAIL, SANTA FE, NM 87501	12/8/2025

**RPA & ASSOCIATES, LLC | WINDOW & DOOR CONDITION AND INTEGRITY CODES**

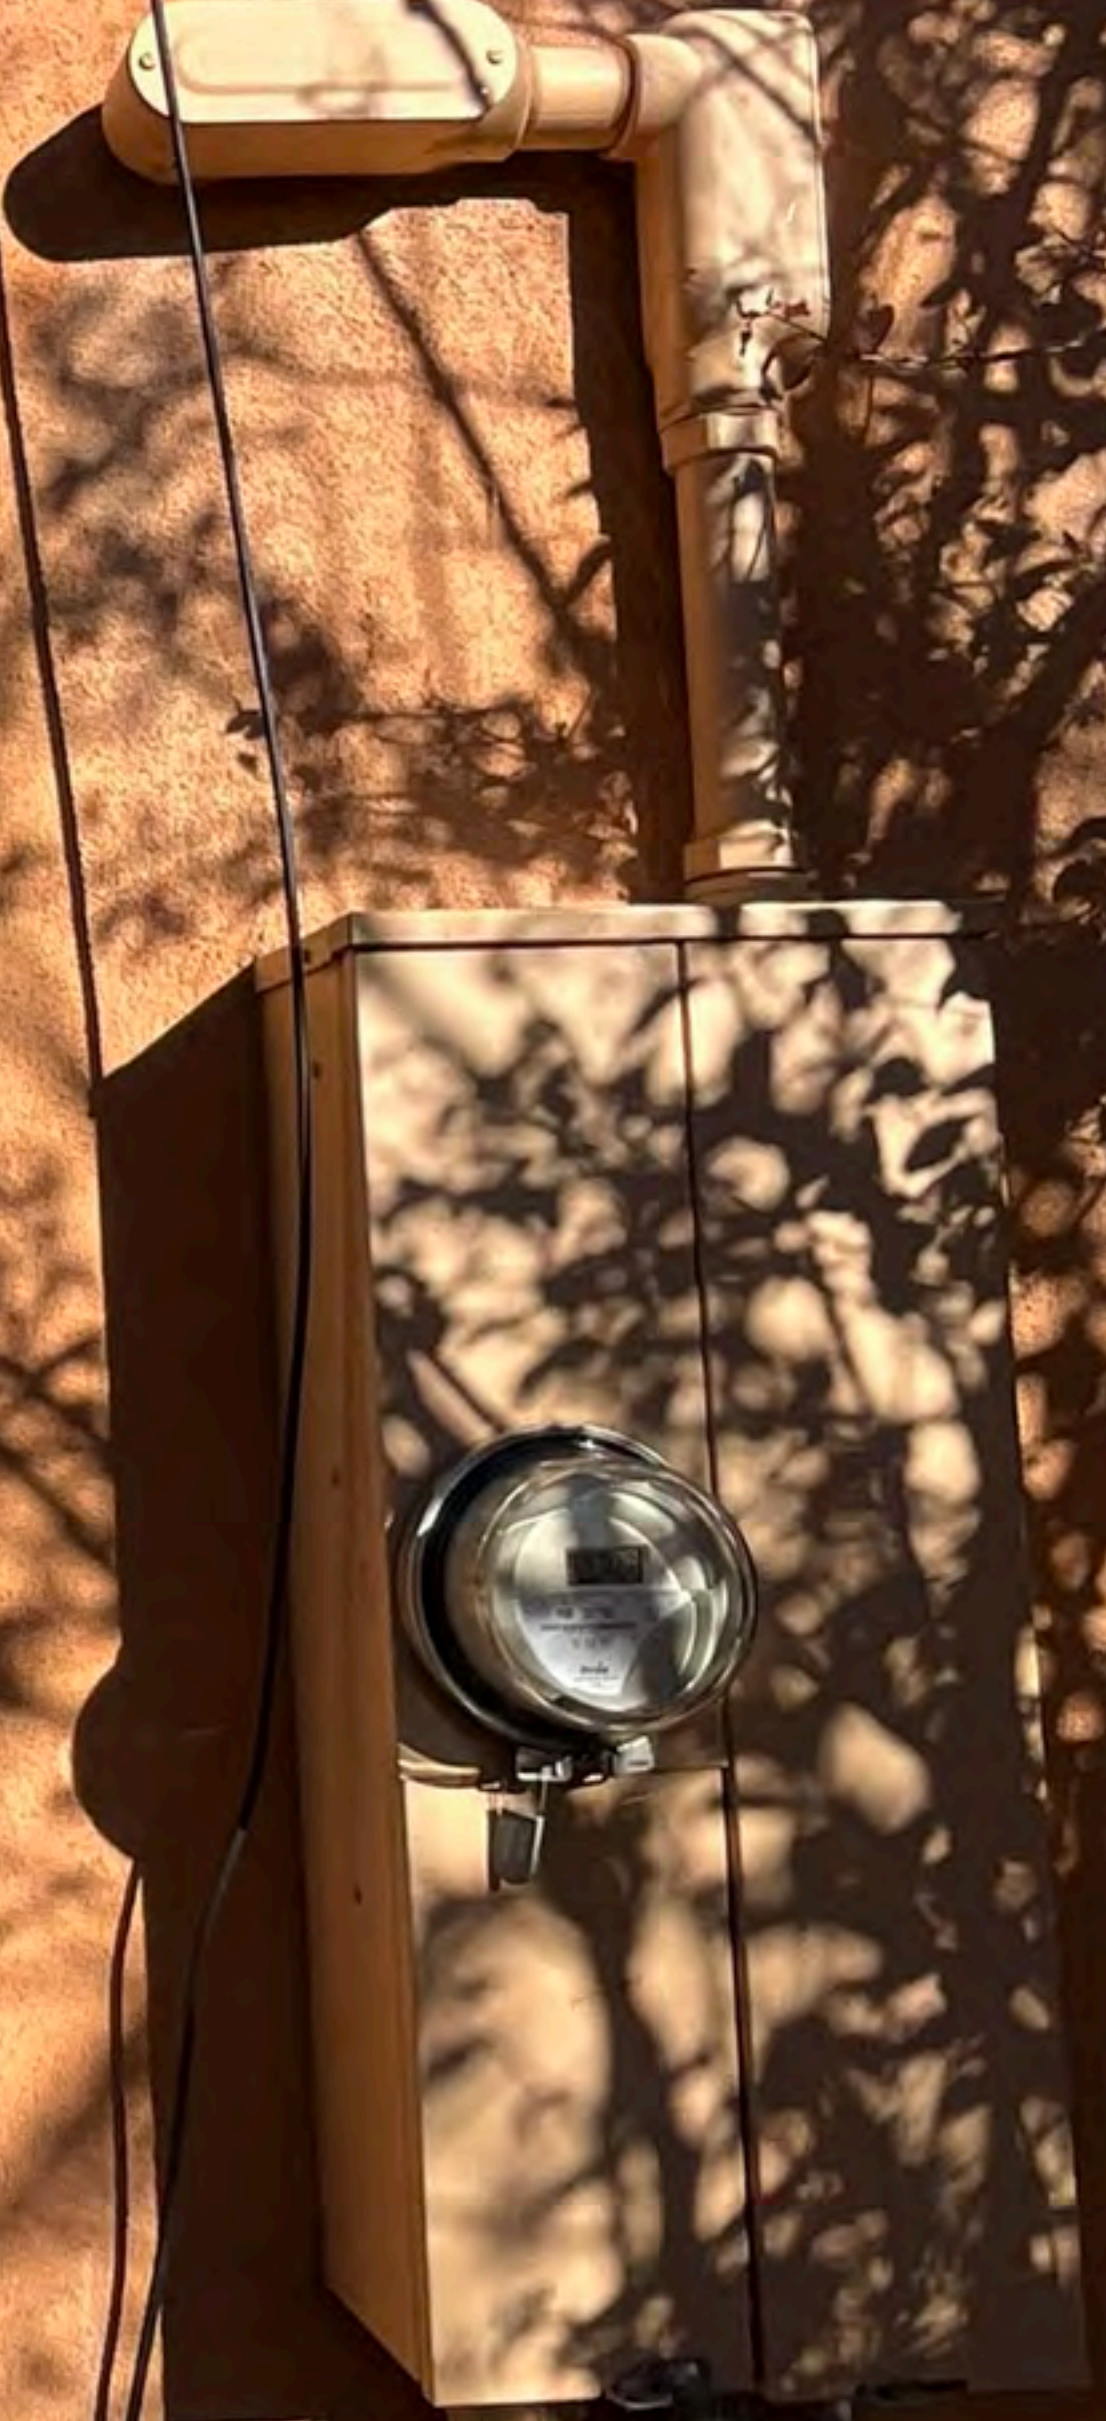
South Elevation  
Basement  
H Window

Window H is historic however unrestorable, there is too much rot.

G	19 ½" x 34" INSWING R CASEMENT 1W3H 7/8" BAR – 3 ½" EXTERIOR FLAT CASINGS	F	NON-HISTORIC – BARN SASH 7/8" DIVIDED LIGHT BAR WITH BOTTOM SASH RAIL CUT TO FIT EXISTING FRAME (HISTORIC)
BASEMENT H	28" x 19" HOPPER TILT IN 1-LT ROTTED SASH	U	HISTORIC – SASH IS ROTTED BEYOND REPAIR

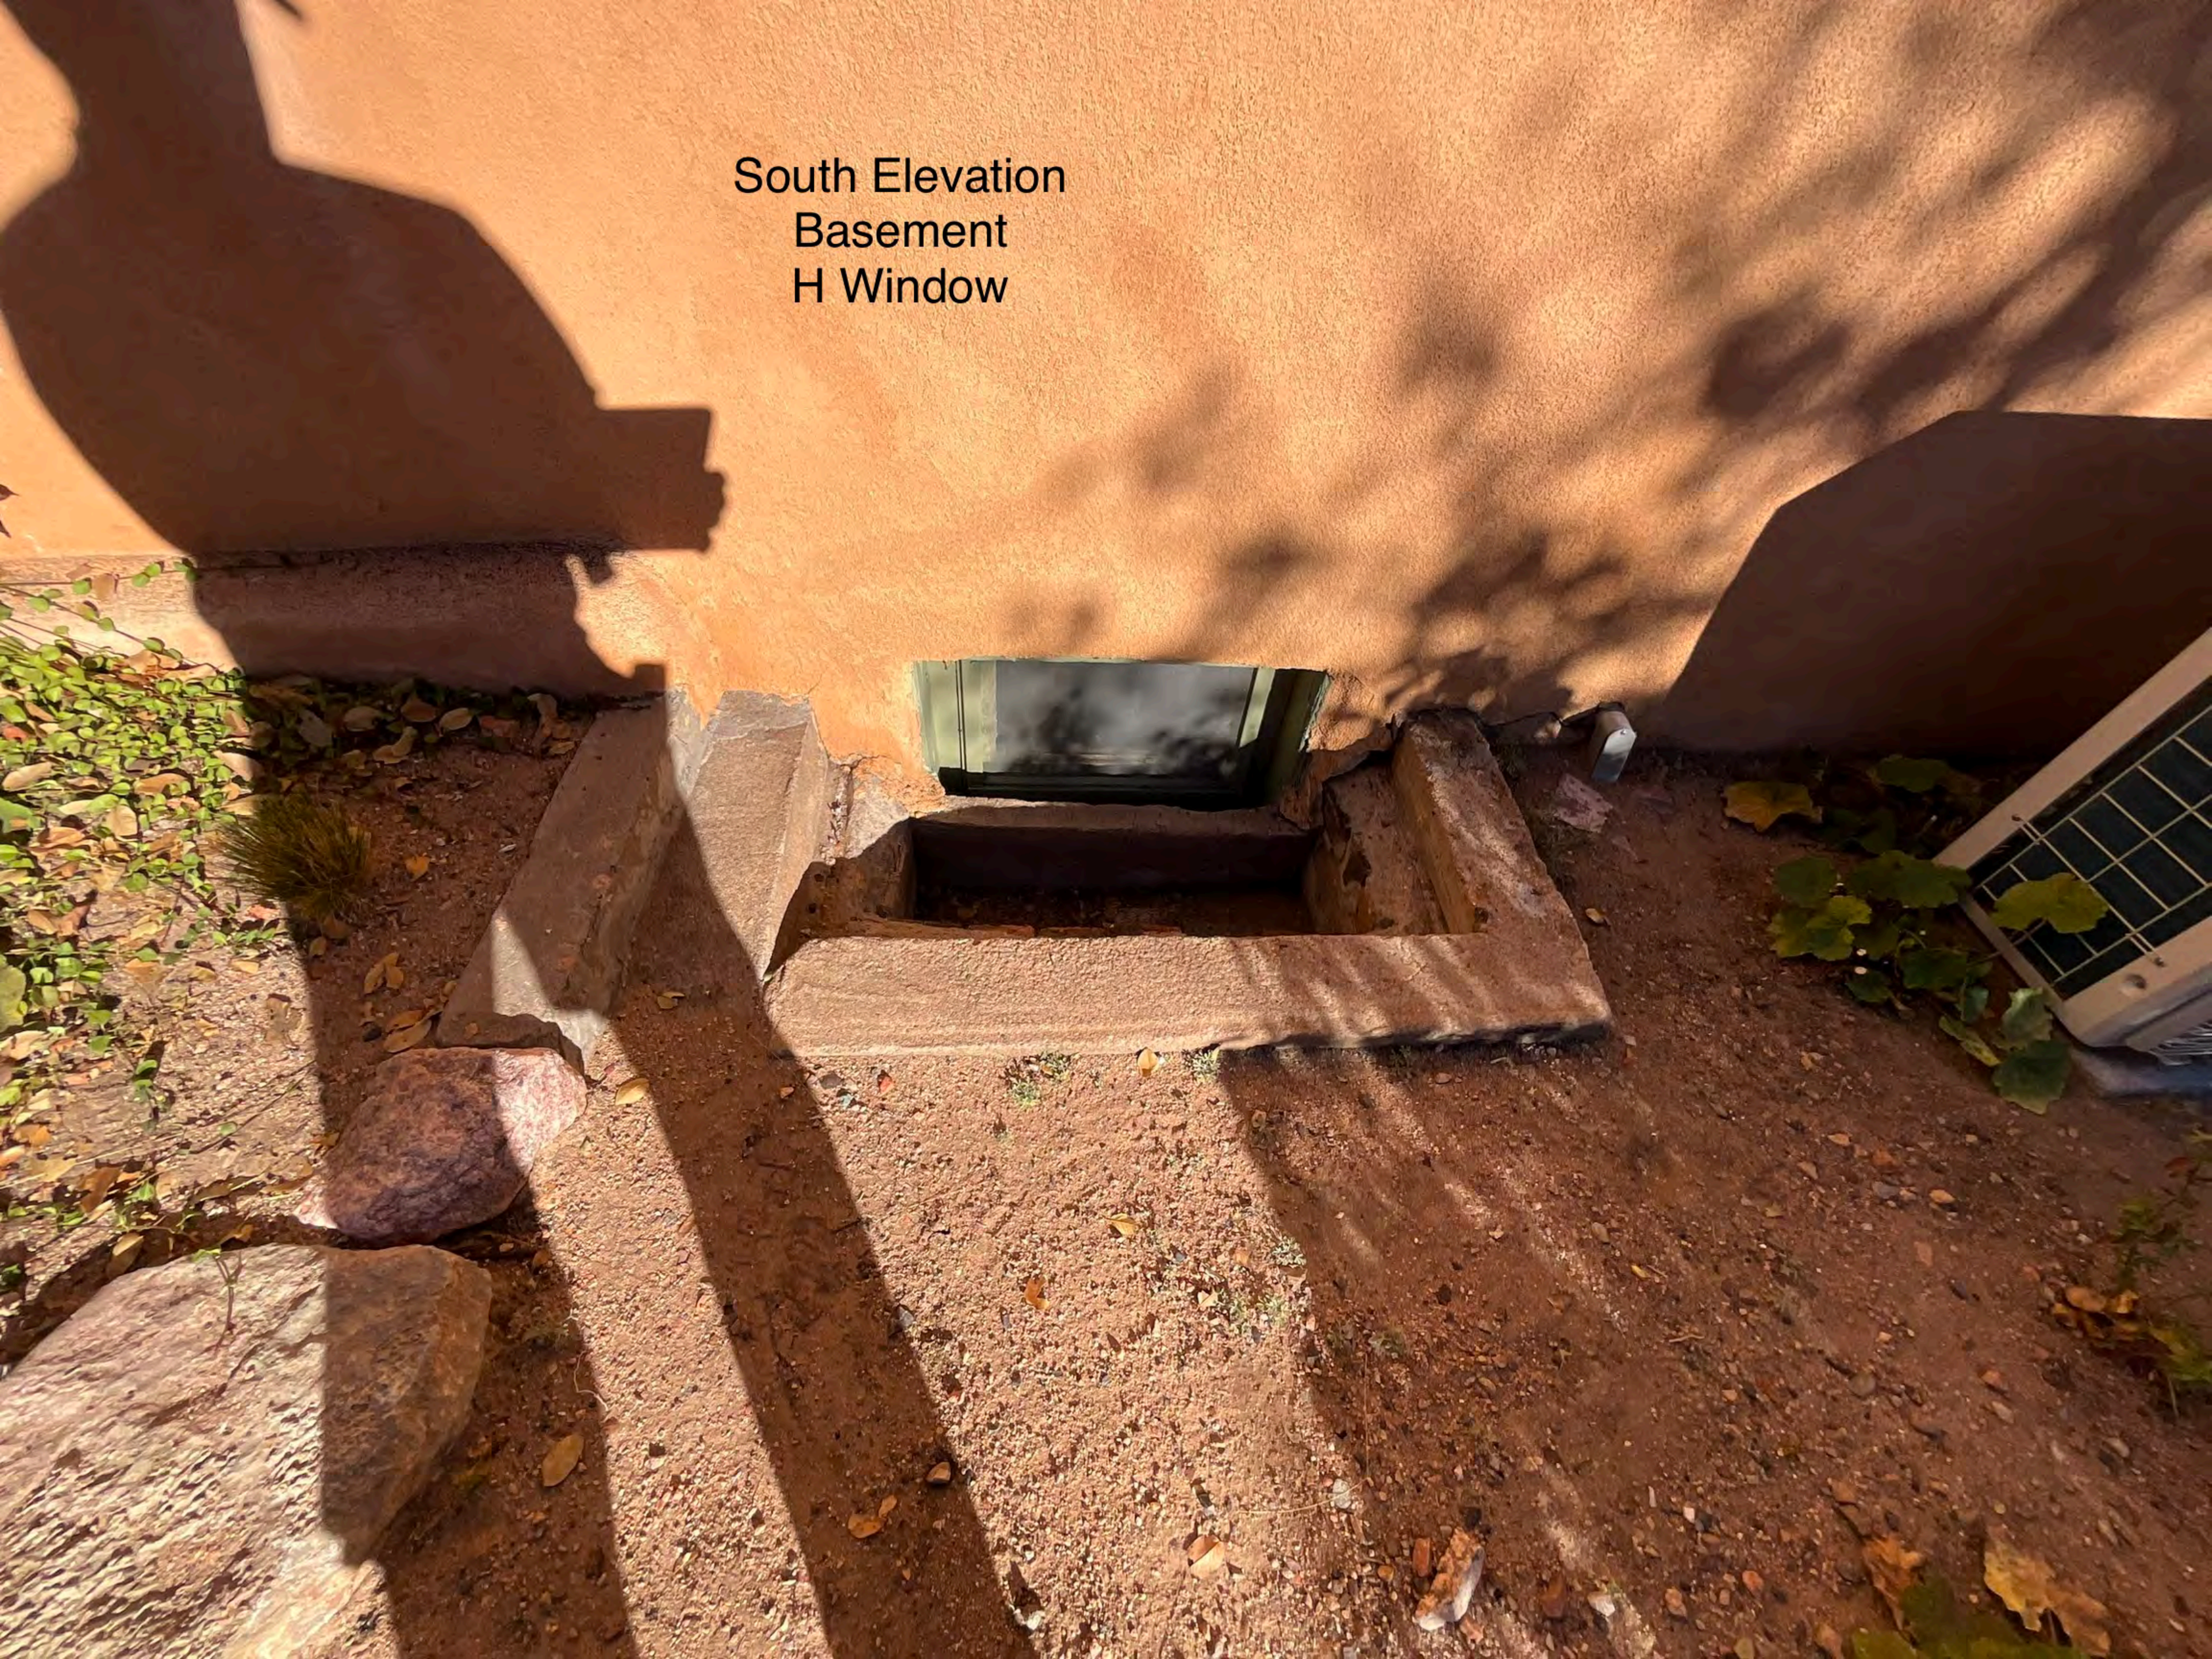
East Elevation  
Door #2

LABEL	WINDOW & DOOR DESCRIPTION	CONDITION & INTEGRITY CODE	HISTORIC/NON-HISTORIC – AGE
DR #2	32" x 82" LH DOOR ½" GLASS AND ½ 2-PANEL METAL DOOR 3W3H METAL GRILLES IN AIR SPACE	S	NON-HISTORIC – 2022
I	23" x 35" INSWING STATIONARY CASEMENT 1W4H ALL WOOD 7/8" BAR – 3 ½" EXTERIOR FLAT CASINGS HEAD & SIDES	F	NON-HISTORIC – DIVIDED LIGHT PATTERN NOT THE SAME HISTORIC – ONLY THE FRAME
J	60" x 40" R VV HOPPER TWIN INSWING WINDOW 2W1H – 1 3/8" DIVIDED LIGHT BAR 3 ½" EXTERIOR FLAT CASINGS HEAD & SIDES USING DOUBLE HUNG BOTTOM & LOWER SASHES	S	NON-HISTORIC – SASHES USING DOUBLE HUNG 2W1H BOTTOM LOWER SASHES PUT INTO A HOPPER FRAME FRAMES HAVE A DIFFERENT SILL, AIR GUN NAILS USED IN THESE WINDOWS (1988 TO 1994 GLASS DATE) SCREENS ARE NON-HISTORIC – MECHANICAL STAPLES
K	150" x 40" – 5 VVVVV 5W INSWING HOPPER ALL WOOD (5-29" SASHES) USING DOUBLE HUNG 2W1H BOTTOM LOWER SASHES – 1 3/8" DIVIDED LIGHT BAR WITH 3 ½" EXTERIOR FLAT CASINGS HEAD & SIDES	S	NON-HISTORIC – SASHES USING DOUBLE HUNG 2W1H BOTTOM LOWER SASHES PUT INTO A HOPPER FRAME FRAMES HAVE A DIFFERENT SILL, AIR GUN NAILS USED IN THESE WINDOWS (1988 TO 1994 GLASS DATE) SCREENS ARE NON-HISTORIC – MECHANICAL STAPLES

Doors #1, #2, and #3 are non-historic.

My recommendation for the units that are non-historic are that they should be replaced in "like and kind" to the units being restored.

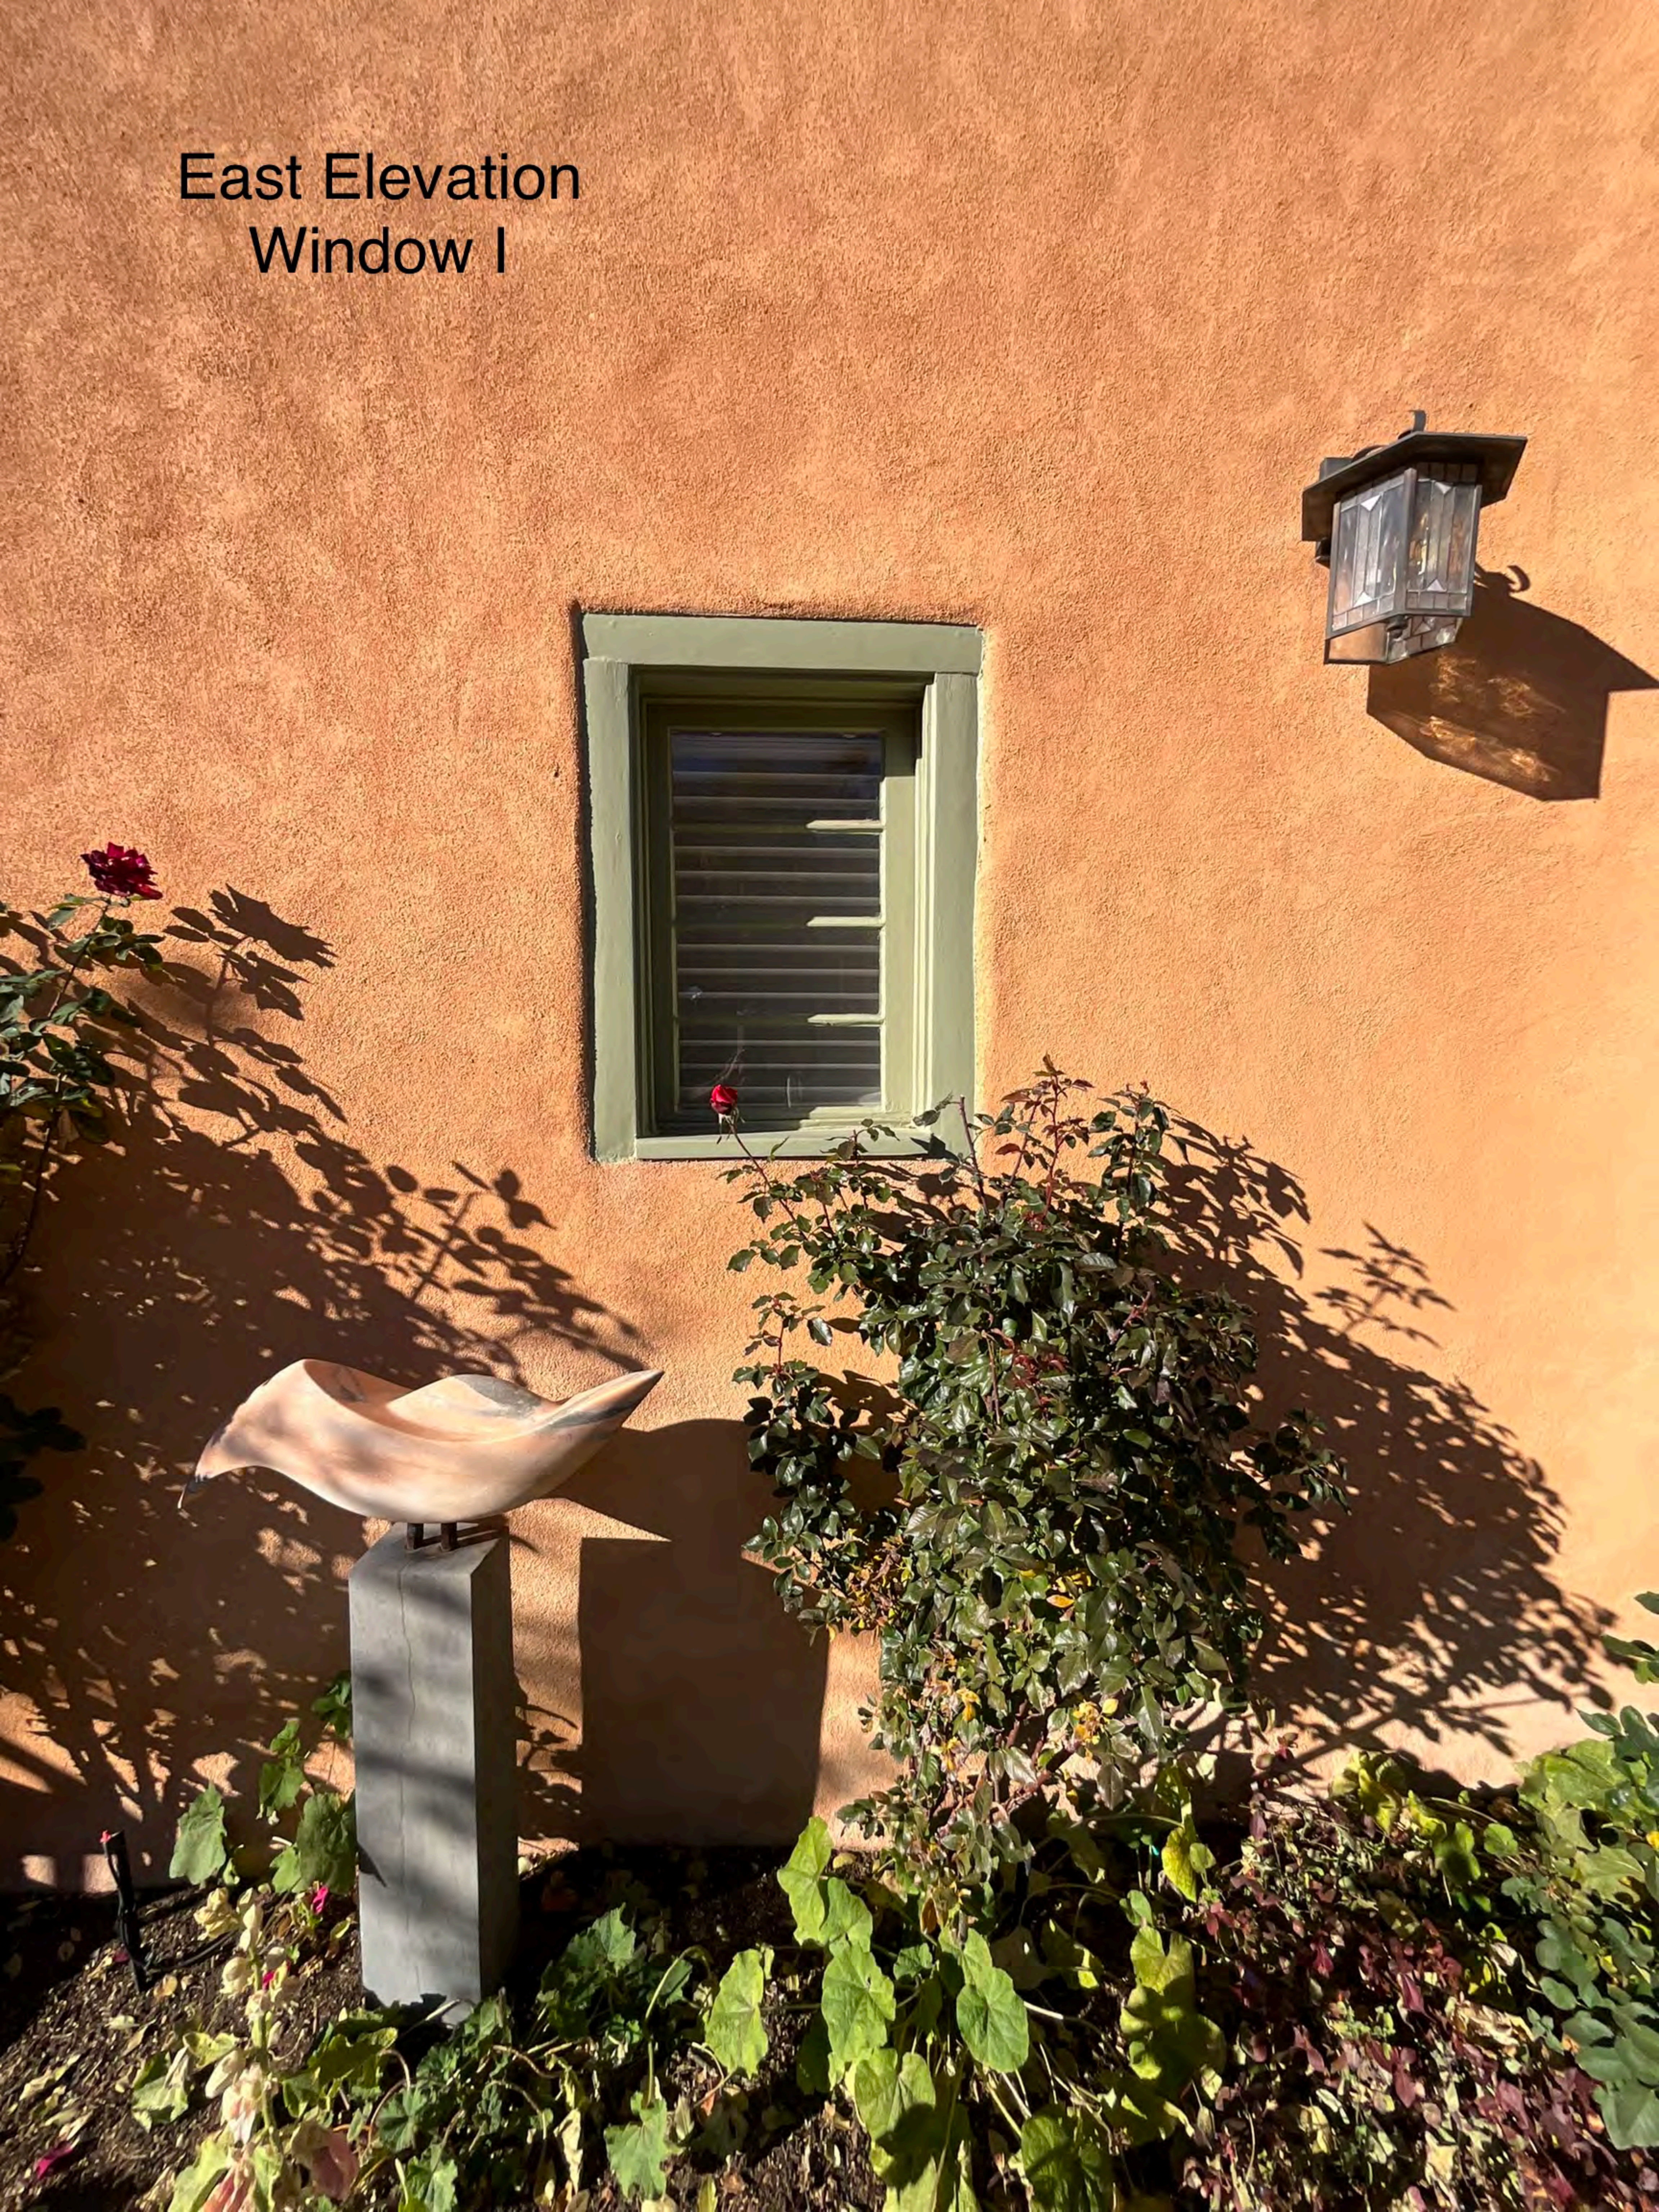
East Elevation  
Door #3

JOB		DATE
801 OLD SANTA FE TRAIL, SANTA FE, NM 87501		12/8/2025
LOCATION	DESCRIPTION	
<b><u>WEST</u></b>		
E	30" x 70" DOUBLE HUNG 1/1 ALL WOOD	
	NO ROPES – 3 ½" EXTERIOR FLAT CASINGS ON HEAD & SIDES	
	BOTTOM SASH – BOTTOM RAIL CUT AT AN ANGLE TO FIT FRAME	
<b><u>SOUTH</u></b>		
F	61" x 62" – 2 TWIN DOUBLE HUNG 1/1 ALL WOOD WITH 5 ½" SPREAD MULL	
	WITH 3 ½" EXTERIOR FLAT CASINGS ON HEAD & SIDES	
G	19 ½" x 34" INSWING CASEMENT 1W3H – 7/8" DIVIDED LIGHT BAR	
	HINGED RIGHT – ALL WITH 3 ½" EXTERIOR FLAT CASINGS HEAD & SIDES	
<b><u>SOUTH - BASEMENT</u></b>		
H	28" x 19" HOPPER TILT IN 1-LT ALL WOOD	
<b><u>EAST</u></b>		
DR #2	32" x 82" LH INSWING ALL METAL/WOOD JAMB	
	HALF GLASS – 2-PANEL BOTTOM 3W3H GRILLES BETWEEN GLASS	
I	23" x 35" STATIONARY INSWING CASEMENT 1W4H ALL WOOD	
	7/8" DIVIDED LIGHT BAR WITH 3 ½" EXTERIOR FLAT CASINGS HEAD & SIDES	
DR #3	36" x 82" LH INSWING DOOR 3W3H PRAIRIE ALL WOOD	
	"SIMPSON" DOOR WITH PREHUNG JAMB & BRONZE THRESHOLD

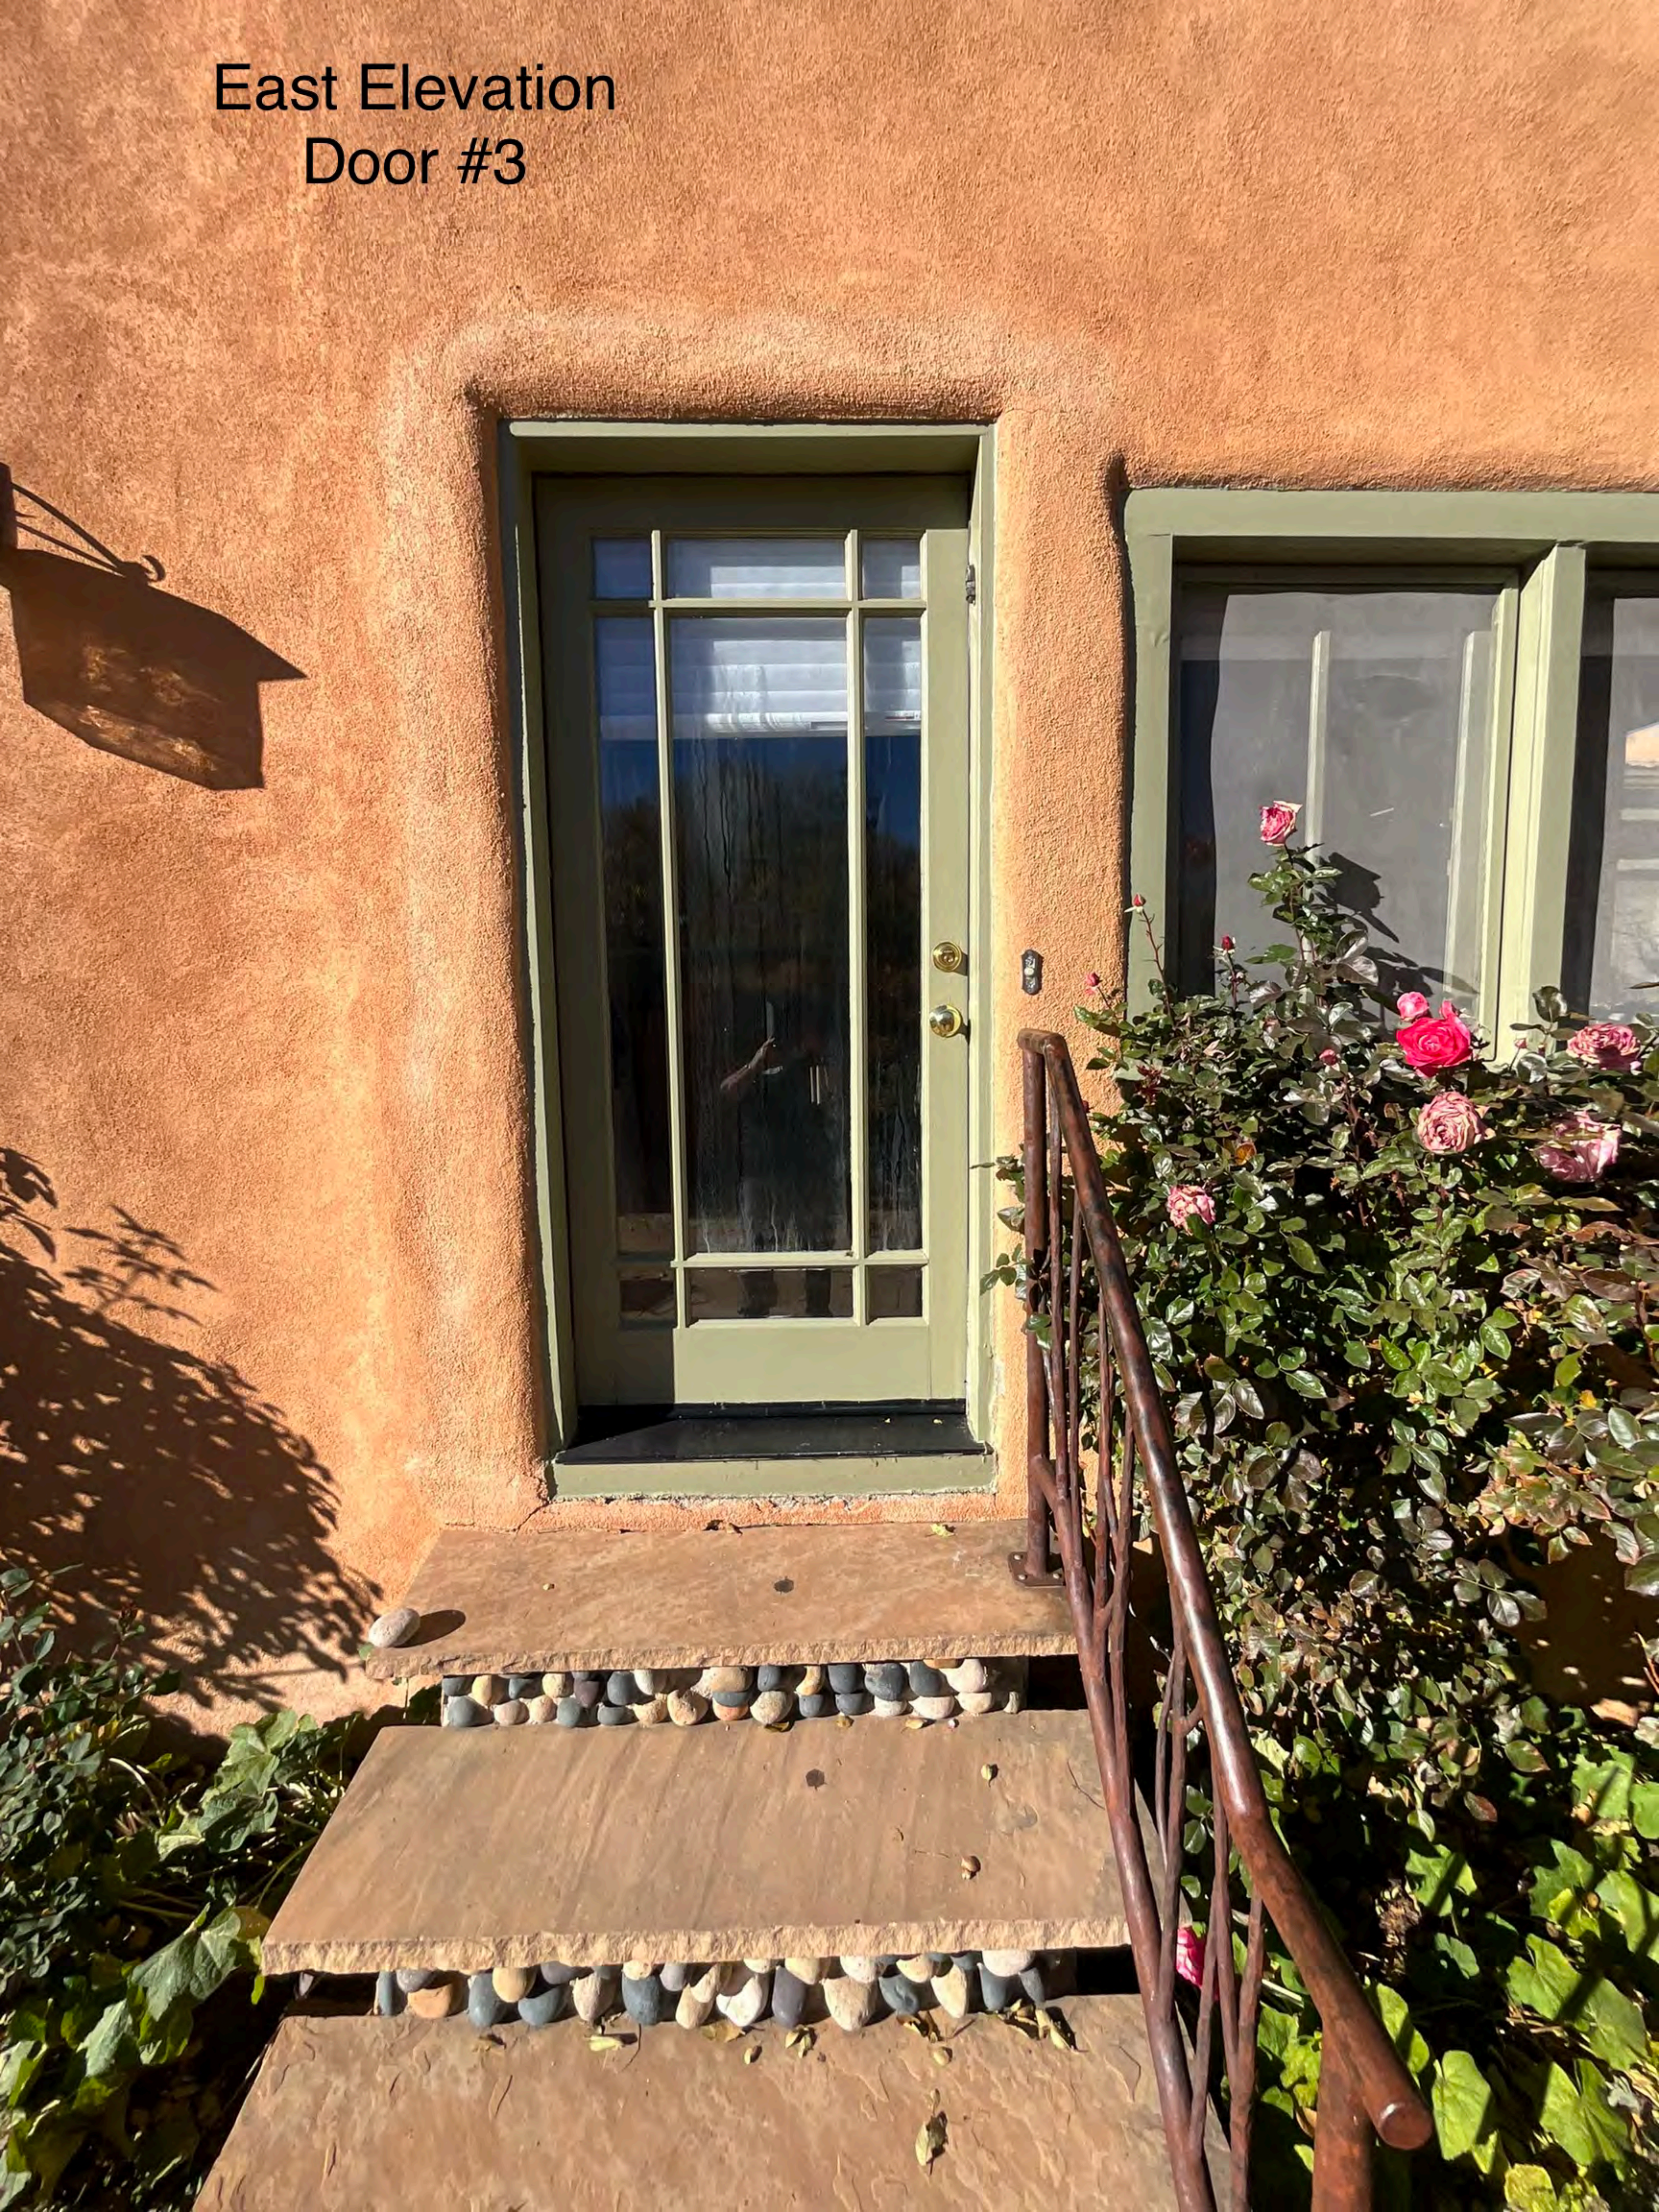
East Elevation  
Window  
J

J	60" x 40" – 2 VV TWIN INSWING HOPPER ALL WOOD	
	(2-29" SASHES) USING DOUBLE HUNG (2W1H) BOTTOM LOWER SASHES	
	1 3/8" DIVIDED LIGHT BAR WITH 3 ½" EXTERIOR FLAT CASINGS HEAD & SIDES	
<b><u>NORTH</u></b>		
K	150" x 40" – 5 VVVVV 5W INSWING HOPPER ALL WOOD (5-29" SASHES) USING DOUBLE HUNG (2W1H) BOTTOM LOWER SASHES	
	1 3/8" DIVIDED LIGHT BAR WITH 3 ½" EXTERIOR FLAT CASINGS HEAD & SIDES

Windows D, I, J, K, L, M, and N are non-historic.

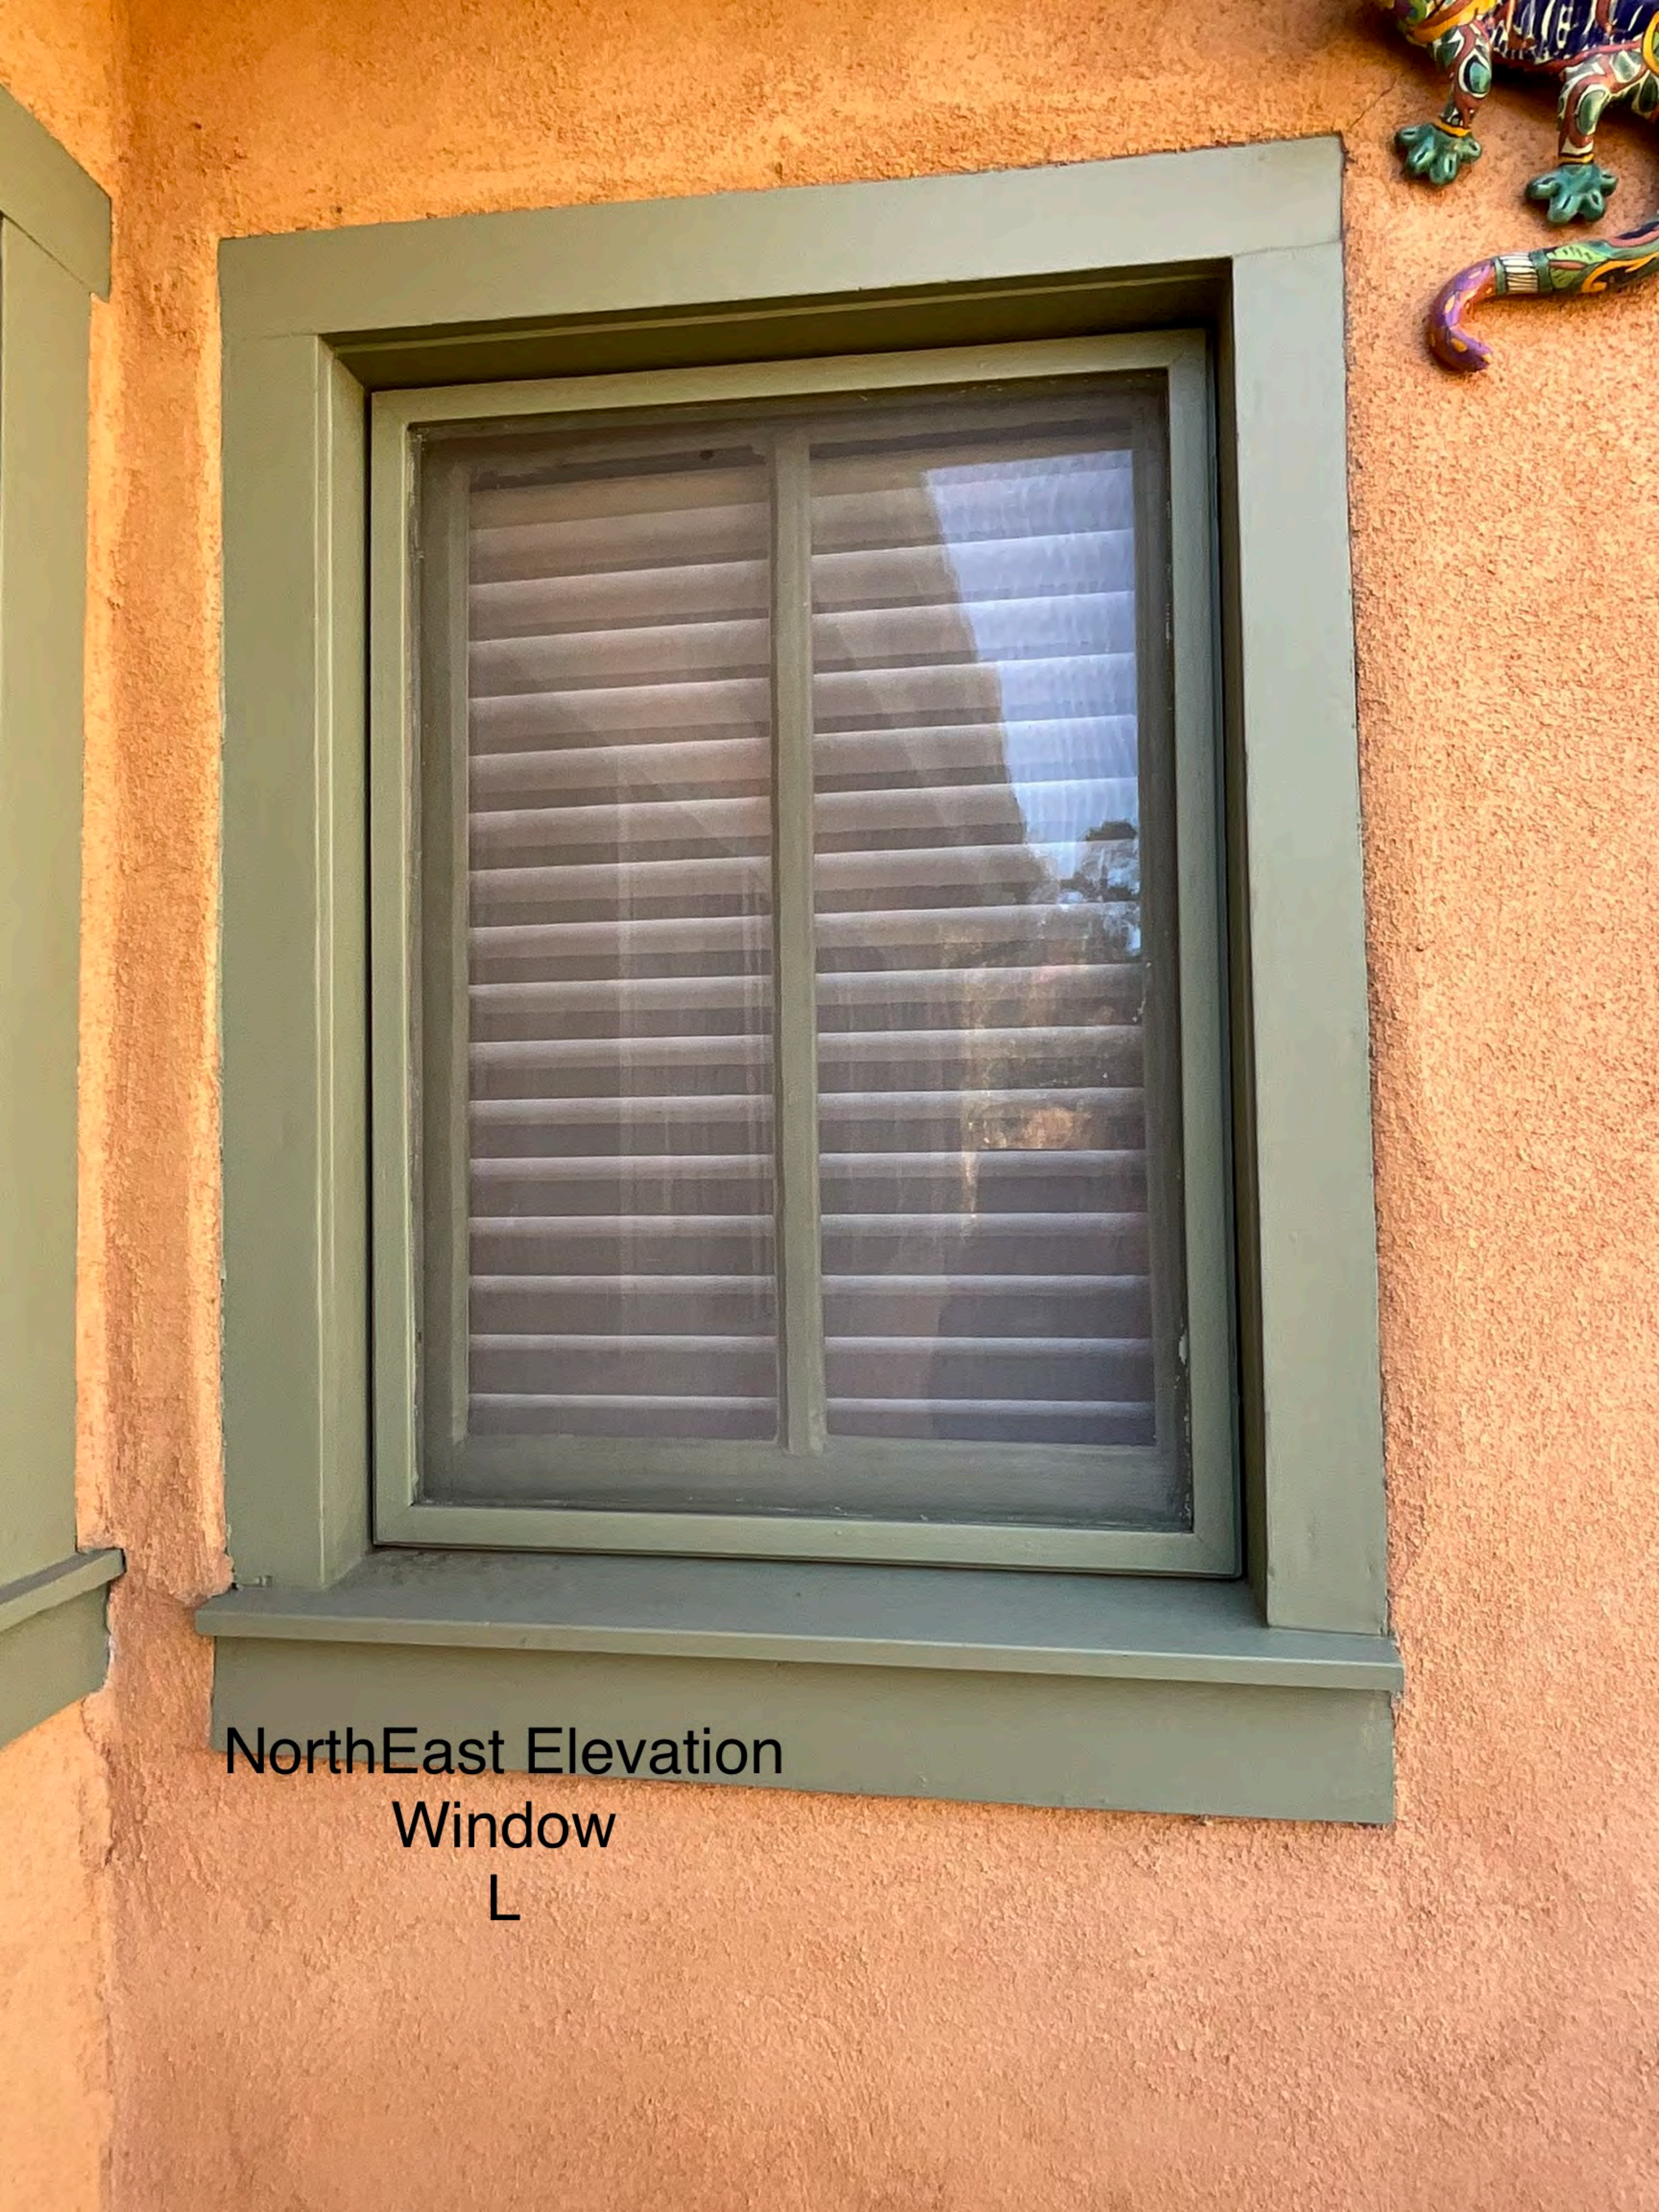
NorthEast Elevation  
Window  
L

LABEL	WINDOW & DOOR DESCRIPTION	CONDITION & INTEGRITY CODE	HISTORIC/NON-HISTORIC – AGE
L	29" x 40" – 1 V INSWING HOPPER ALL WOOD USING DOUBLE HUNG 2W1H BOTTOM LOWER SASHES – 1 3/8" DIVIDED LIGHT BAR WITH 3 1/2" EXTERIOR FLAT CASINGS HEAD & SIDES	S	NON-HISTORIC – SASHES USING DOUBLE HUNG 2W1H BOTTOM LOWER SASHES PUT INTO A HOPPER FRAME FRAMES HAVE A DIFFERENT SILL, AIR GUN NAILS USED IN THESE WINDOWS (1988 TO 1994 GLASS DATE) SCREENS ARE NON-HISTORIC – MECHANICAL STAPLES
M	90" x 40" – 3 VVV TWIN INSWING HOPPER ALL WOOD (3-29" SASHES) USING DOUBLE HUNG 2W1H BOTTOM LOWER SASHES – 1 3/8" DIVIDED LIGHT BAR WITH 3 1/2" EXTERIOR FLAT CASINGS HEAD & SIDES	S	NON-HISTORIC – SASHES USING DOUBLE HUNG 2W1H BOTTOM LOWER SASHES PUT INTO A HOPPER FRAME FRAMES HAVE A DIFFERENT SILL, AIR GUN NAILS USED IN THESE WINDOWS (1988 TO 1994 GLASS DATE) SCREENS ARE NON-HISTORIC – MECHANICAL STAPLES
N	60" x 40" – 2 VV TWIN INSWING HOPPER ALL WOOD (2-29" SASHES) USING DOUBLE HUNG 2W1H BOTTOM LOWER SASHES – 1 3/8" DIVIDED LIGHT BAR WITH 3 1/2" EXTERIOR FLAT CASINGS HEAD & SIDES	S	NON-HISTORIC – SASHES USING DOUBLE HUNG 2W1H BOTTOM LOWER SASHES PUT INTO A HOPPER FRAME FRAMES HAVE A DIFFERENT SILL, AIR GUN NAILS USED IN THESE WINDOWS (1988 TO 1994 GLASS DATE) SCREENS ARE NON-HISTORIC – MECHANICAL STAPLES

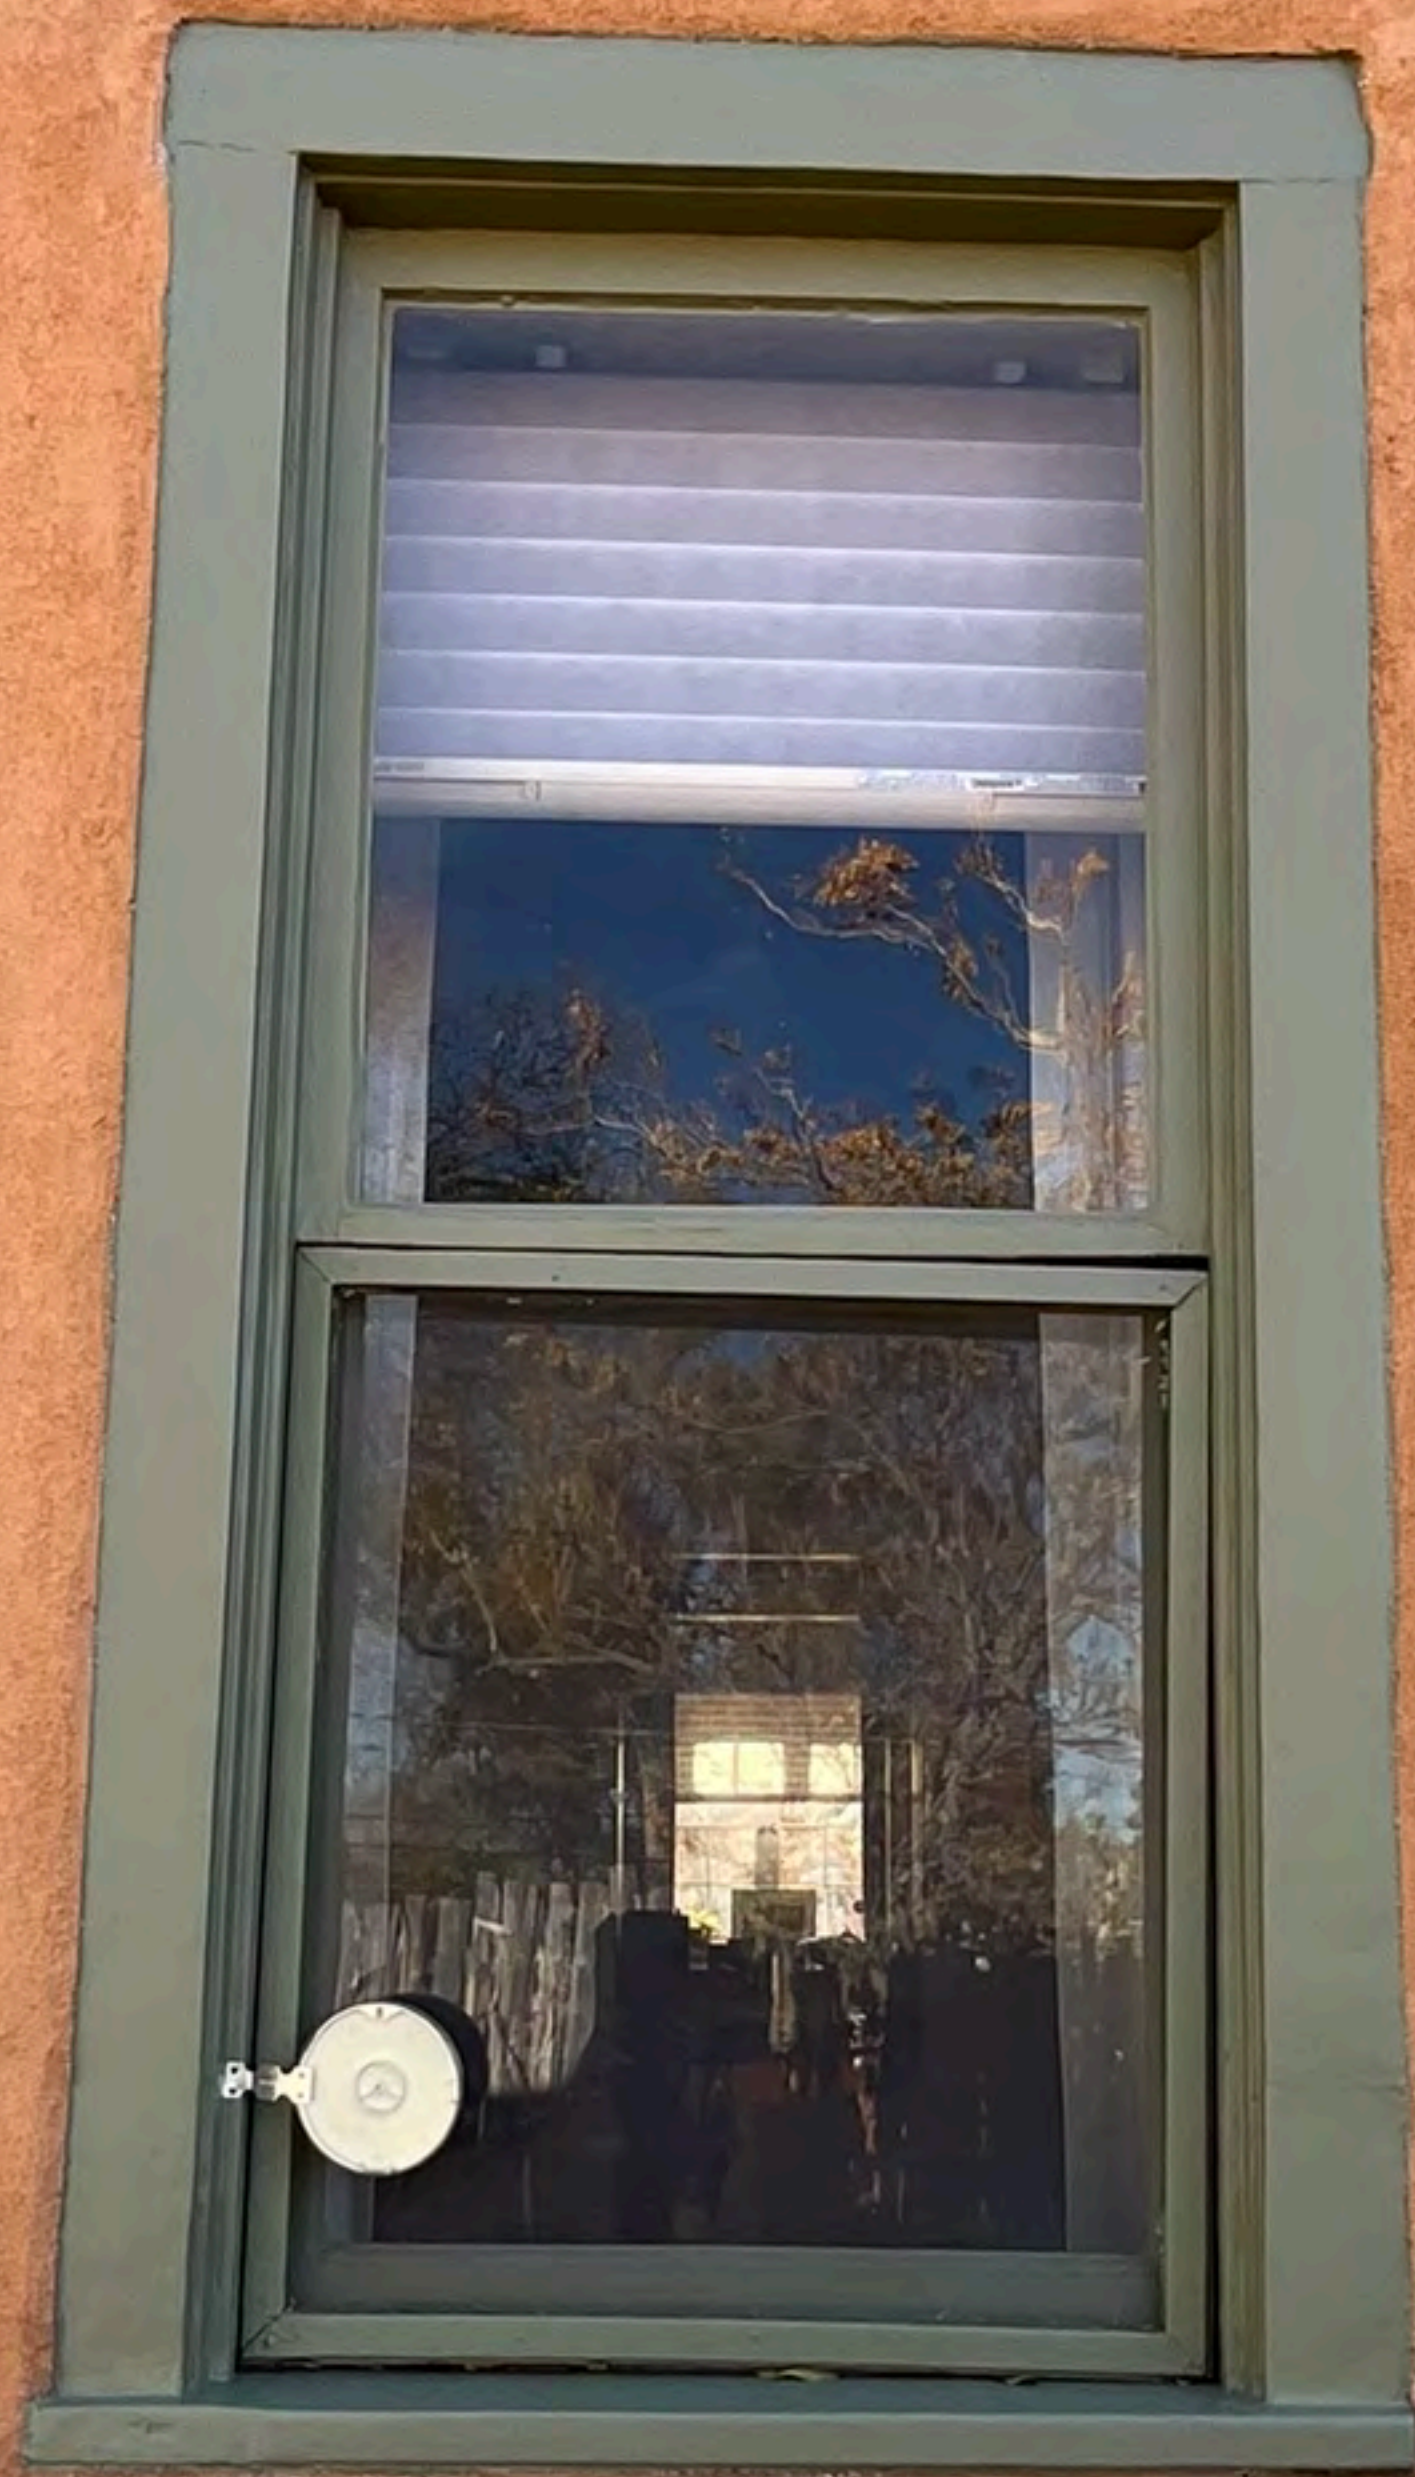
North Elevation  
Window  
O

LABEL	WINDOW & DOOR DESCRIPTION	CONDITION & INTEGRITY CODE	HISTORIC/NON-HISTORIC – AGE
O	30" x 70" DOUBLE HUNG 1/1 ALL WOOD WITH 3 1/2" EXTERIOR FLAT CASINGS HEAD & SIDES	F	HISTORIC – ONLY THE FRAME NON-HISTORIC – SASHES HAVE BEEN REPLACED SOME TIME BETWEEN 1988 & 1994 MACHINED JOINTS & AIR GUN NAILS
P	30" x 70" DOUBLE HUNG 1/1 ALL WOOD NO ROPES – 3 1/2" EXTERIOR FLAT CASINGS HEAD & SIDES	F	HISTORIC – ONLY THE FRAME NON-HISTORIC – SASHES HAVE BEEN REPLACED SOME TIME BETWEEN 1988 & 1994 MACHINED JOINTS & AIR GUN NAILS
BASEMENT Q	29" x 18" HOPPER TILT IN ALL WOOD 1-LT	F	HISTORIC – RESTORABLE

Window C, E, F, G, O, and P sashes are non-historic however the frames are historic.
