Historic Cultural Properties Inventory (HCPI) Base Form (FORM 1)

For HPD Office use only:		
HCPI No. _____	District No. _____	NRHP _____ SRCP _____ Criteria <u> </u> A <u> </u> B <u> </u> C <u> </u> D
1. Name of property: Robert & Patt Berardinelli/ Adolfo & Lola Ortiz/ Lois C. Herrmann Residence	2. Location: 528 and 530 Calle Corvo Downtown and Eastside Historic District Santa Fe	3. Local Reference Number: Santa Fe ID: H-640 4. County: Santa Fe Parcel # 11911552

8. Name of Project: HDRB Status Evaluation		
9. Lat/Long: 35.680783,-105.9331077		
10. Photo Information: Giulia Caporuscio, photographer. Photo 1: View of east elevation. Camera facing west.

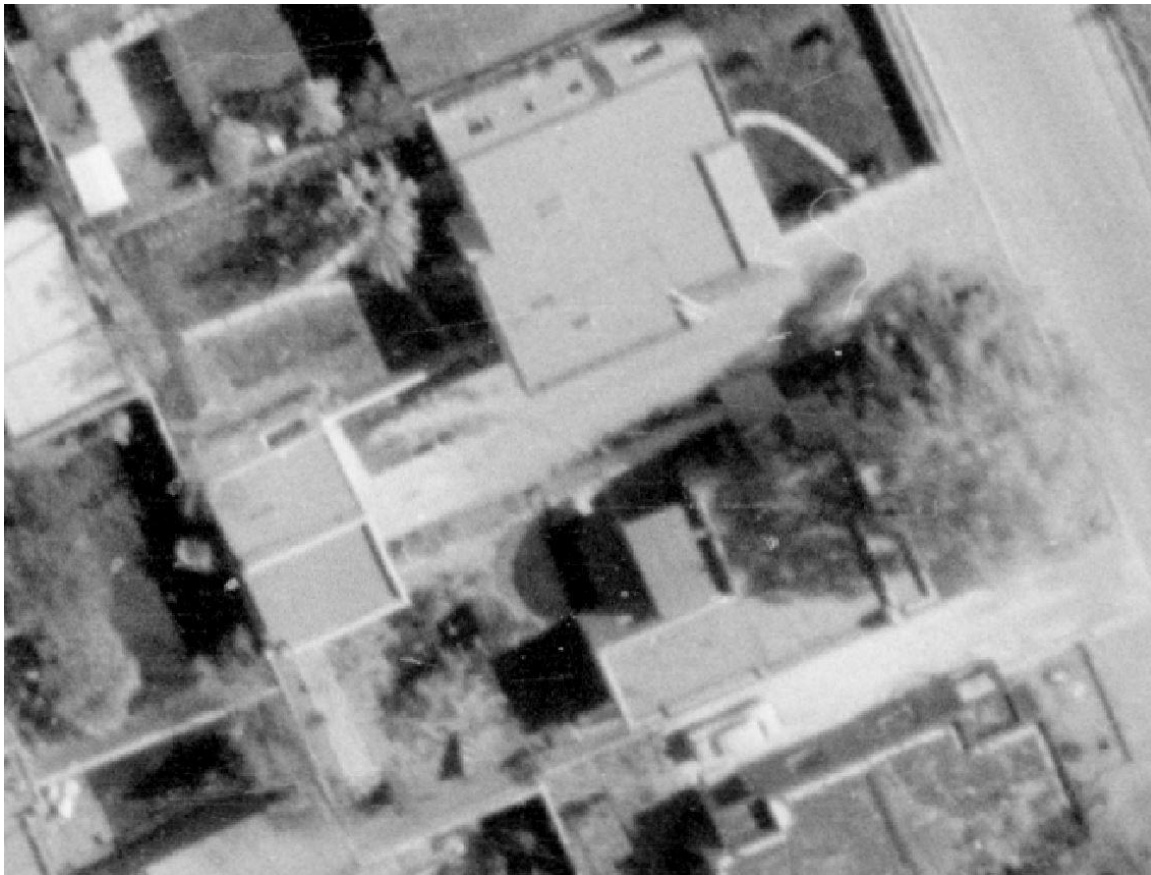
Figure 4: May 1, 1973, aerial photograph.
Note garage has no attachment, and large window across its north elevation.

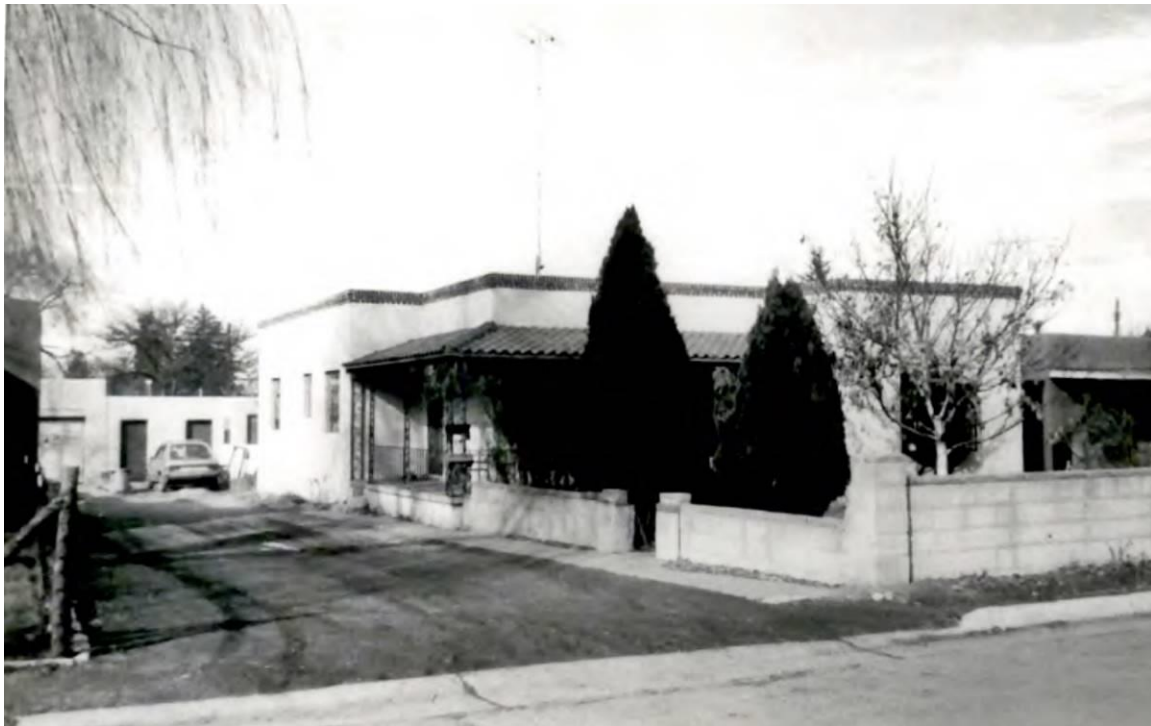
Located at the end of the driveway is a former garage with an attached workshop (Photo 16). Constructed of CMU, the garage appears on a 1951 aerial photograph and is likely original to the site (Fig. 2). Its south wall is built at the zero-lot-line, adjoining the neighboring garage at 532 Calle Corvo. The original vehicular door was removed prior to 1985 and replaced with flush panel units (Fig. 7).

Figure 7: December 2, 1985, HBI survey photograph. Michael Belshaw. Note absence of the two greenhouse window boxes along the south elevation.

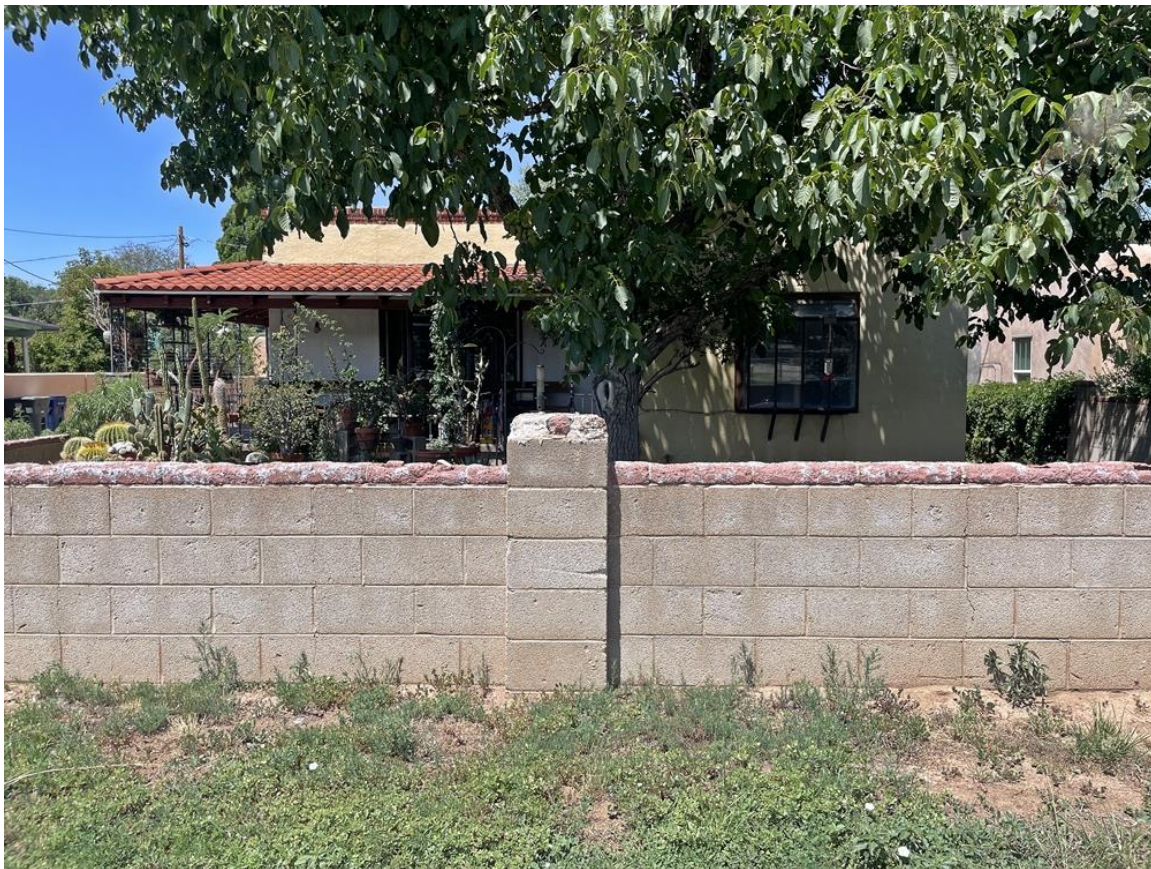
Occupying Lot 16, the subject property sits along Calle Corvo, directly across from what is now the parking lot of Acequia Madre Elementary School. The school was constructed after the residence was completed in 1950. The combined residence and apartment are positioned near the front of the lot, with a setback consistent with neighboring properties (Photo 2).

The landscaping is minimal. The front yard consists primarily of natural terrain and is anchored by a mature walnut tree—a rarity in Santa Fe. In the southwest corner, more than 50 potted cacti and succulents are clustered together in a collection originally assembled by the current owner’s father (Photo 3). A plain gray concrete masonry wall defines the front yard (Photo 2).

Photo 2: Front yard wall and setting. Camera facing west.

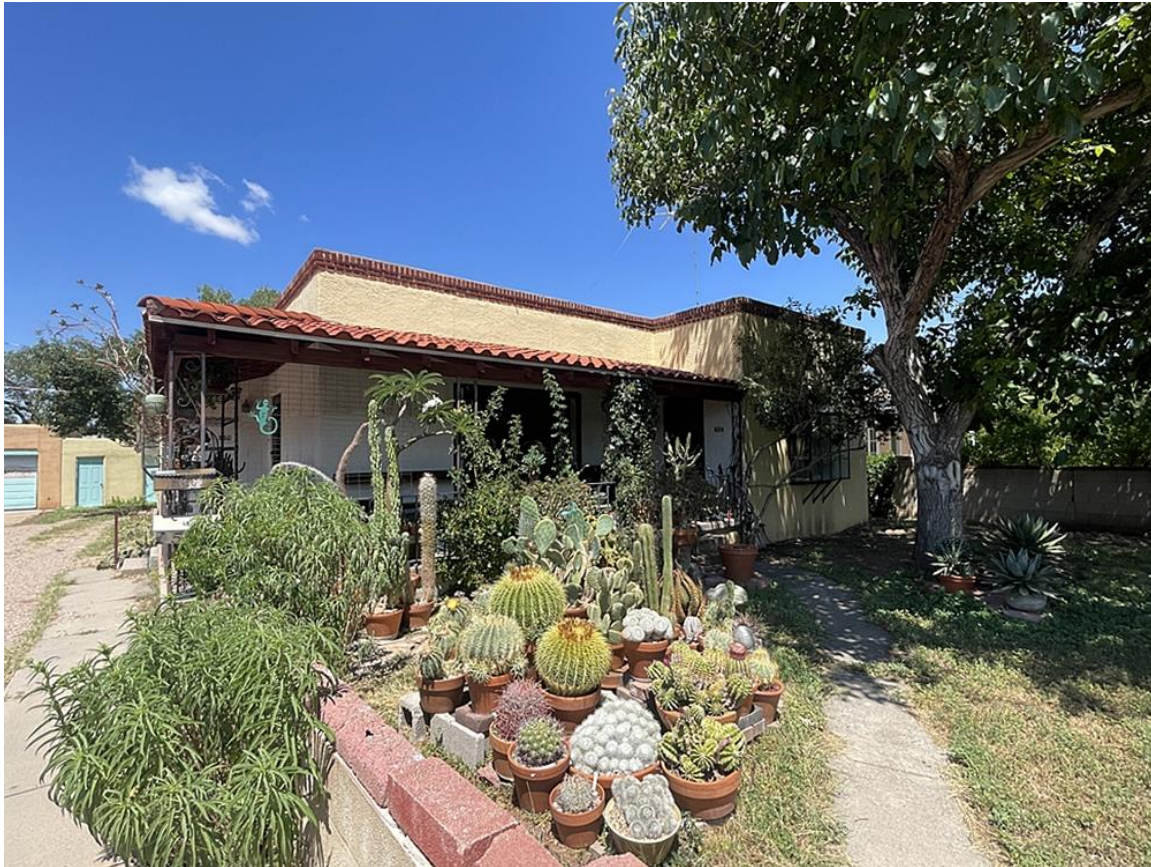
Photo 3: Cacti and succulent collection. Camera facing northwest.

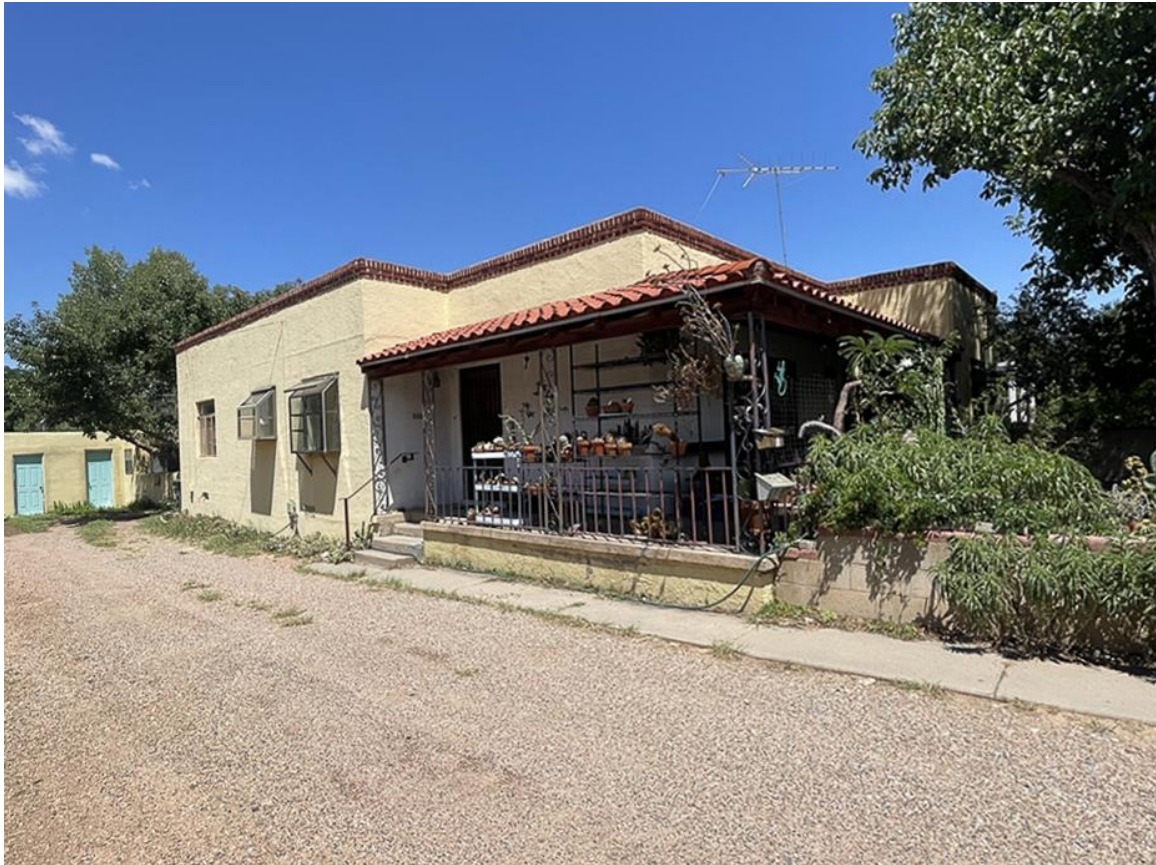
The east façade is defined by its hipped, clay-tile-roofed wrap-around porch (Photo 4). This L-shaped structure runs the full width of the façade and provides sheltered access to both the residence and the apartment.

Photo 4: Setting and south and east elevations. Camera facing north.

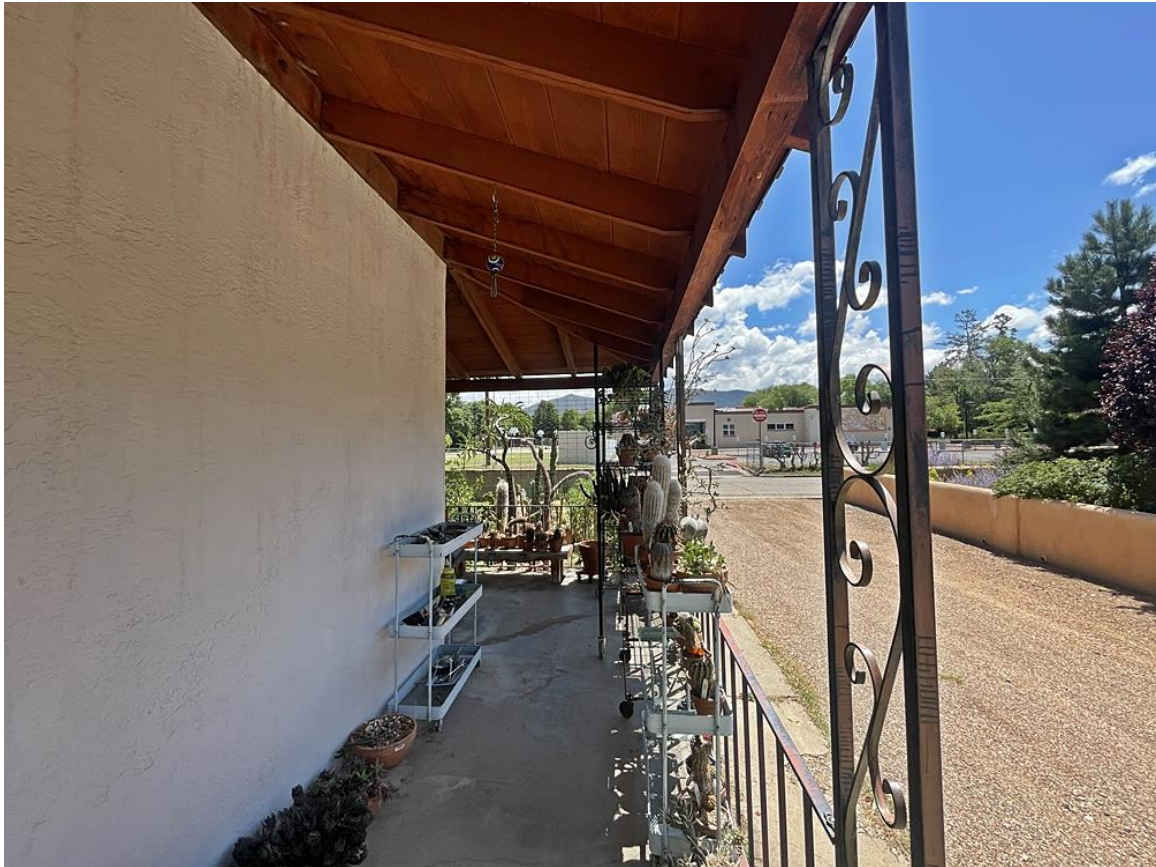
The porch is supported by a slender metal post with integrated scrollwork and railing—typical of mass-produced ornamental ironwork used in the mid-20th century (Photo 5). This type of prefabricated support, advertised in the SANBUSCO catalog during the period, was commonly used in modest postwar homes for both structural and decorative purposes. Identical supports were once present on the house immediately to the south but were replaced with wood posts in the 2010s.

Photo 5: Porch on south elevation. Camera facing east.

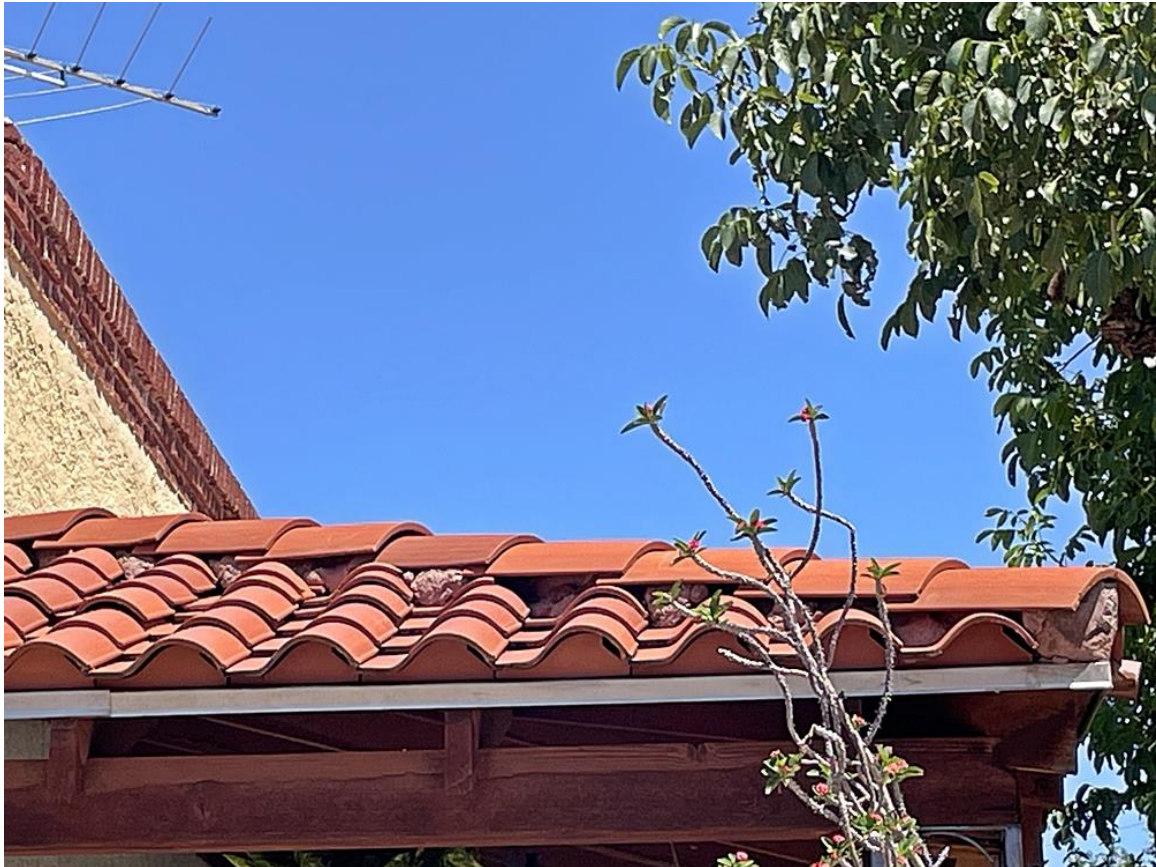
The porch roof is finished with S-shaped, or “Modern Spanish,” clay tiles that provide visual texture (Photo 6). It is unclear whether these tiles are original, as their style contrasts with the Territorial Revival-style brick cornice that tops the parapet.

Photo 6: Porch roofing material. Camera facing up.

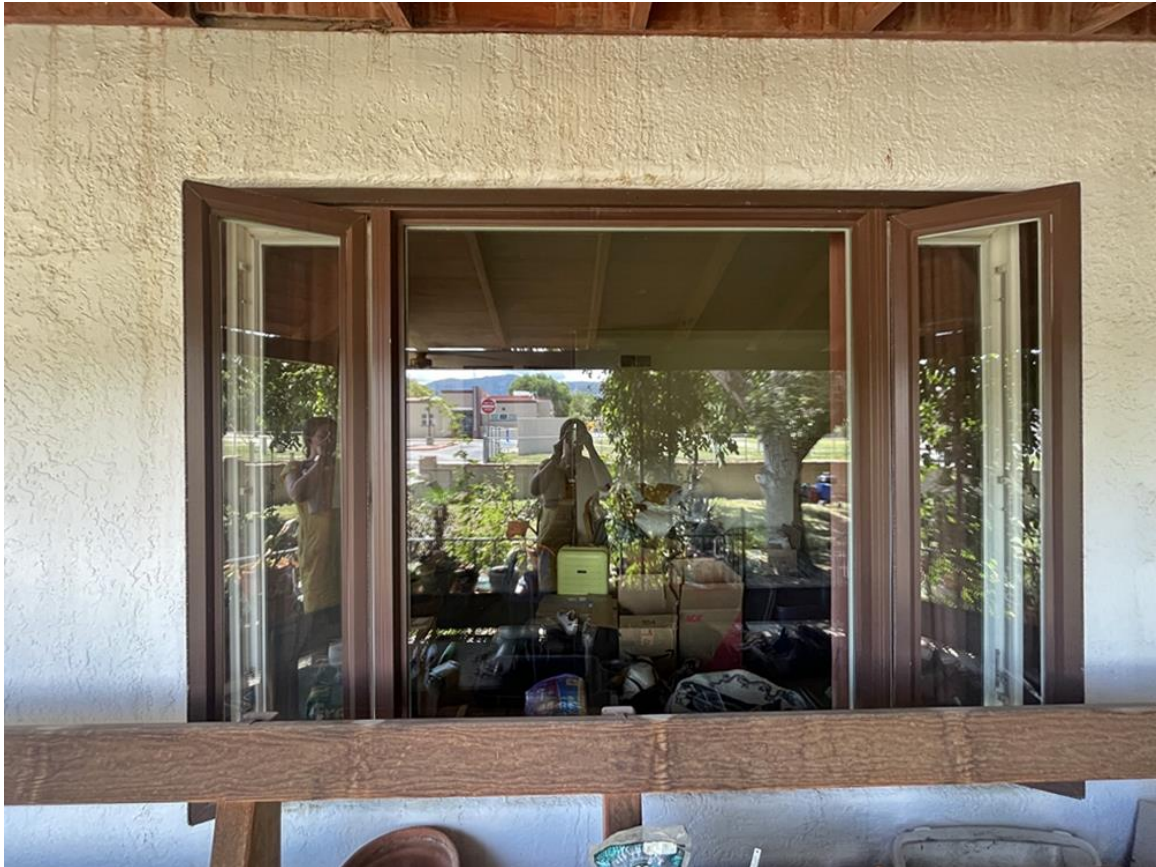
The porch walls are painted white. At the center, a newer window—replacing an original steel combination unit—has been installed (Photo 7). At the north end of the porch stands a 32-panel wood door providing access to the apartment (Photo 8).

Photo 7: Porch. East elevation window. Camera facing west.

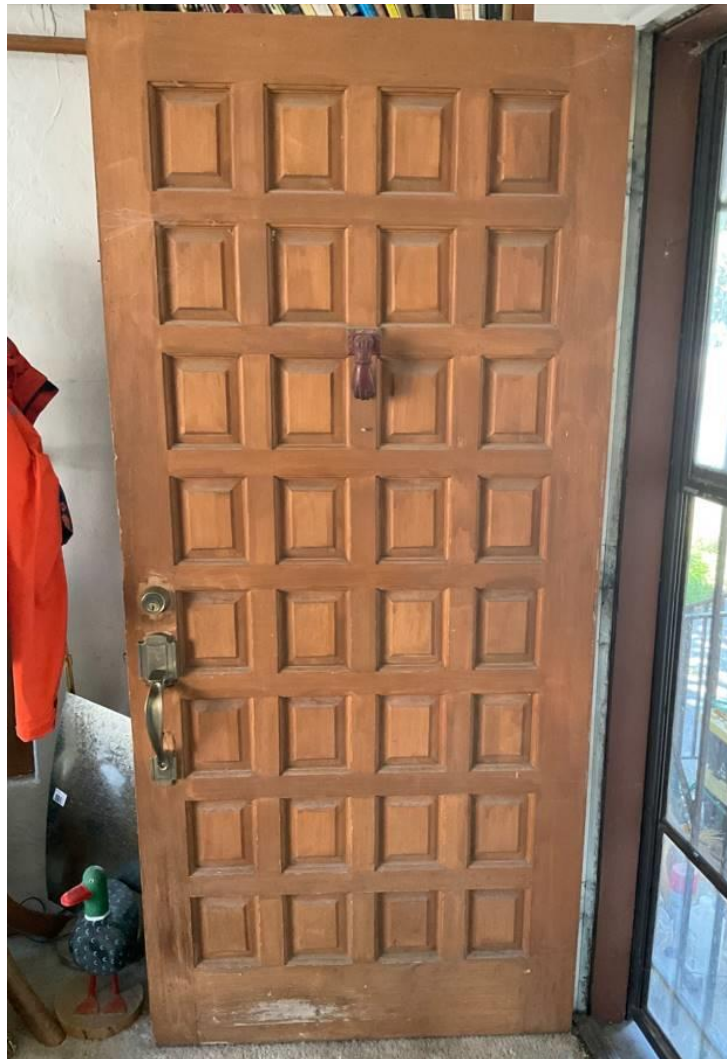
Photo 8: Porch. East elevation entry door to apartment. David Kozlowski, August 5, 2025.

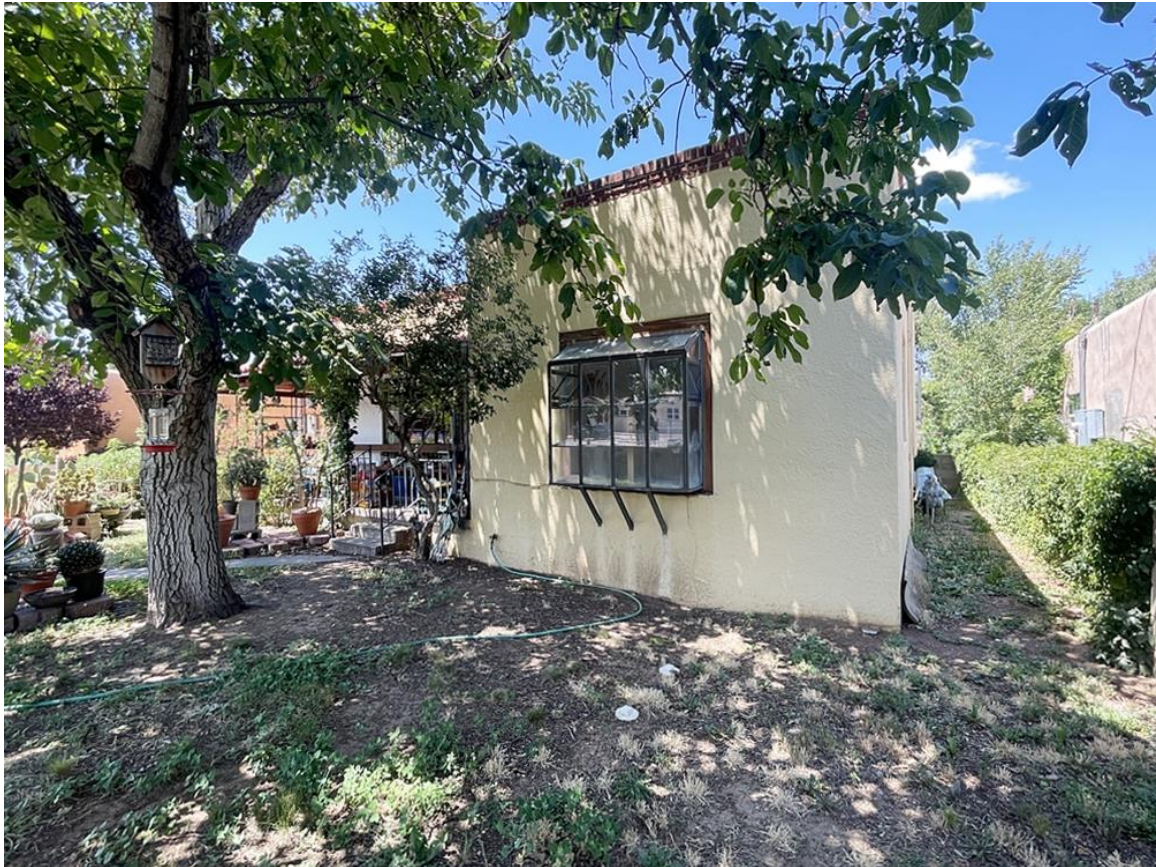
North of the porch, the building projects eastward approximately seven feet to form a volume that contains the apartment. This portion is fenestrated with a projecting greenhouse window, which replaced an original steel combination unit (Photo 9).

Photo 9: East elevation. Camera facing southwest.

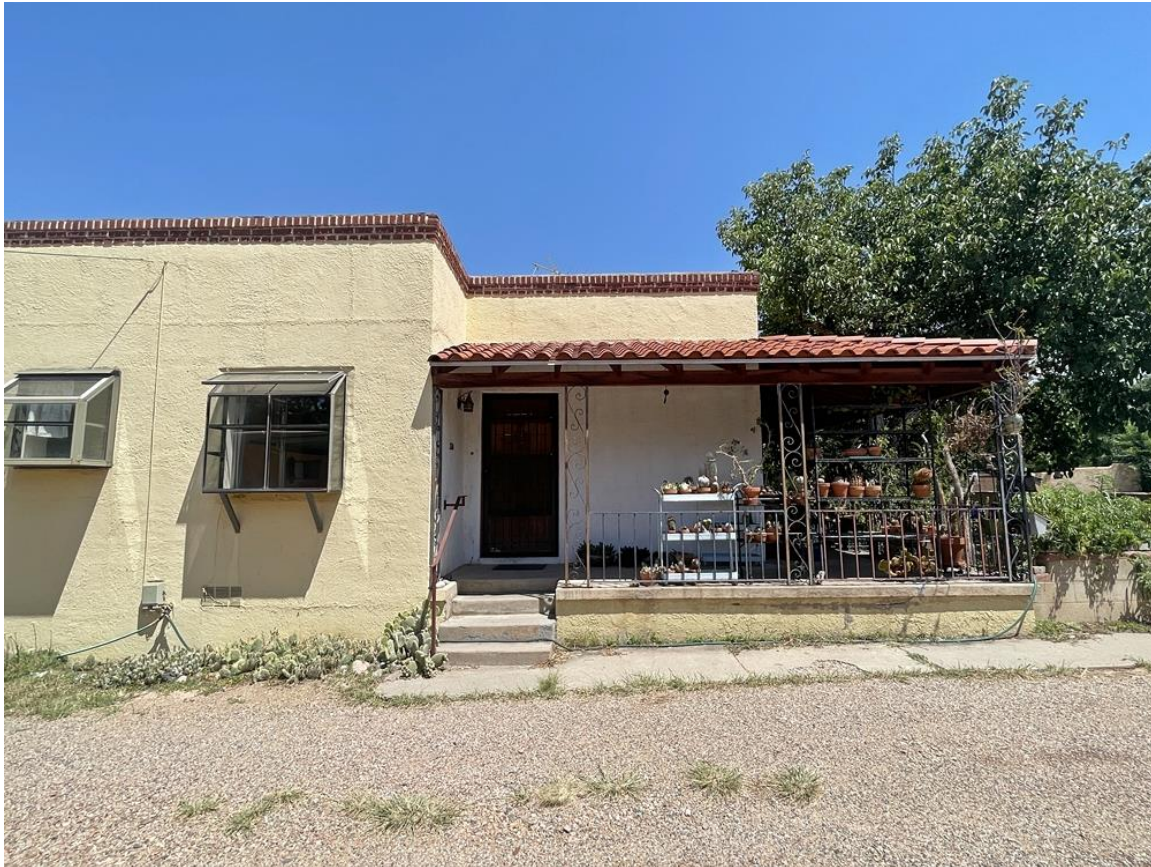
The south elevation faces the shared driveway and reveals the functional, or service, side of the residence. The porch continues along this elevation for approximately 13 feet, running along an offset wall. This portion of the wall is blank except for a 32-panel wood door, which opens into the home’s living room (Photo 10).

Photo 10: South elevation, east end. Camera facing north.

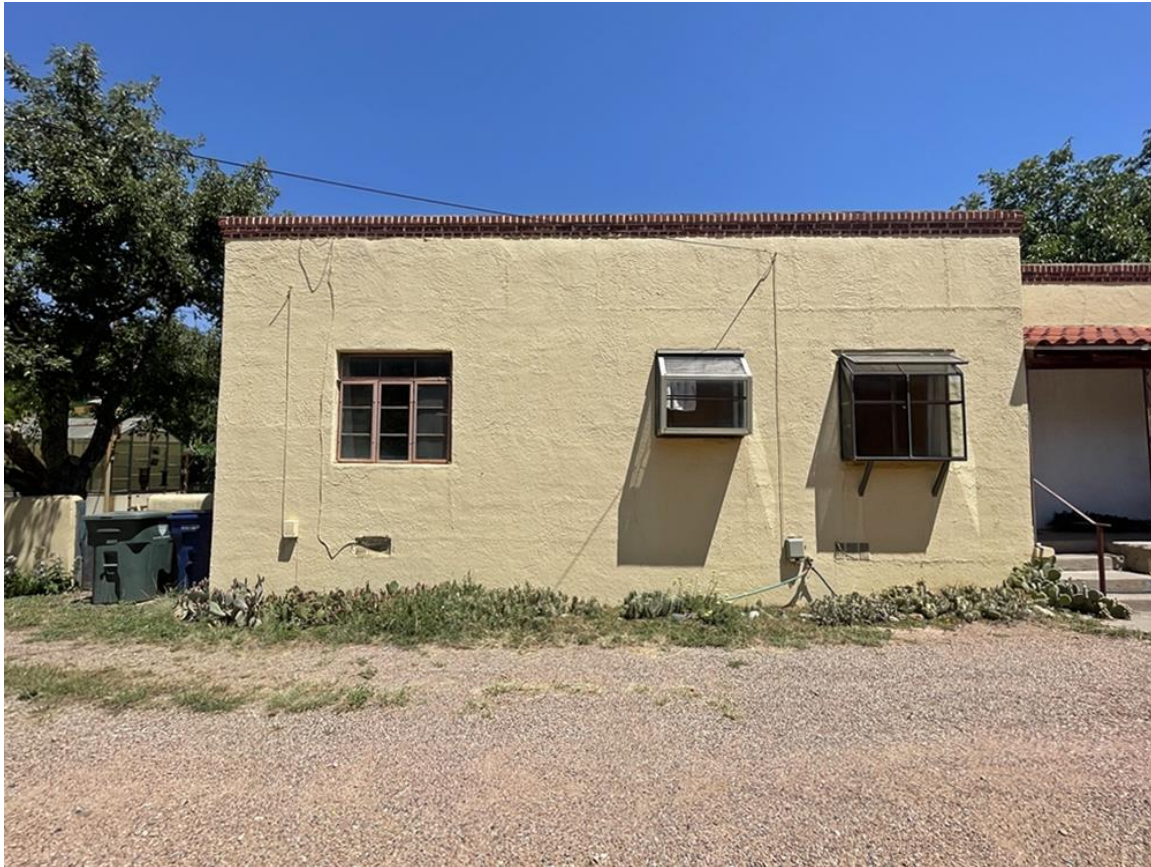
The rest of the façade includes three window openings (Photo 11). Two have been replaced with projecting greenhouse units. The third retains a standard 3C–3F–3C | 3T steel combination window. The lights are putty-glazed, and the casements open with exterior-mounted scissor hinges.

Photo 11: South elevation, west end. Camera facing north.

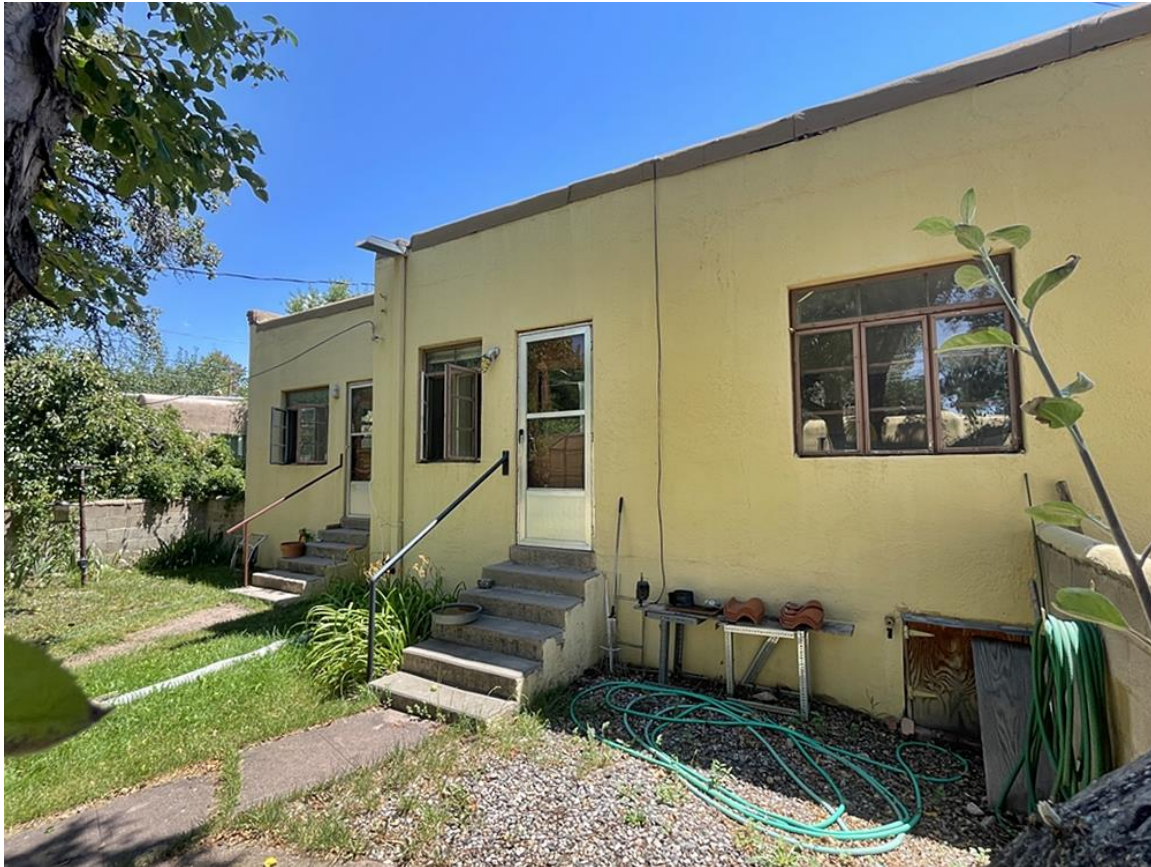
The west elevation opens onto the backyard and more clearly reveals the building’s duplex configuration (Photo 12). Each unit is accessed by a set of six concrete steps leading to identical half-light wood doors, both protected by aluminum screen doors (Photo 13). Surface-mounted utility conduit and dual electric meters further confirm the presence of two separate residential units. The arrangement evokes the rear elevation of a modest Pasadena garden court apartment.

Photo 12: West elevation. Camera facing northeast.

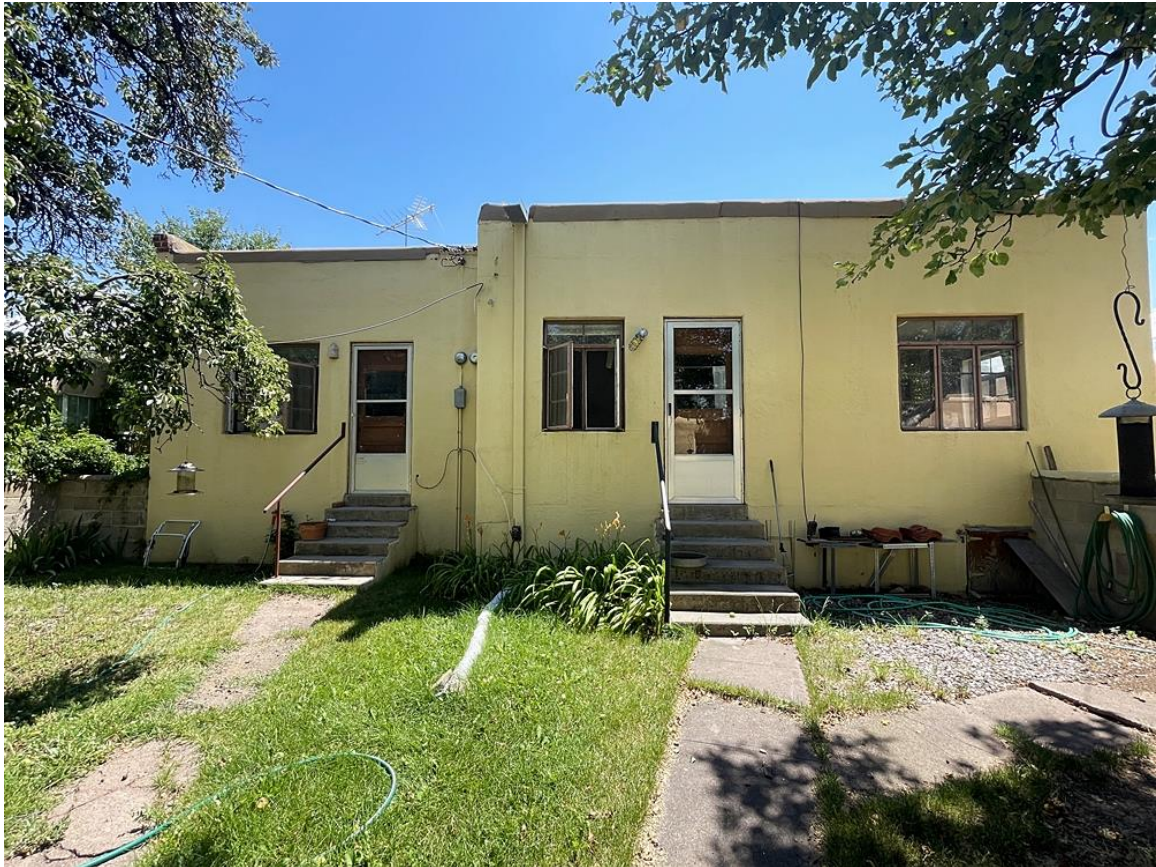
Photo 13: West elevation. Camera facing east.

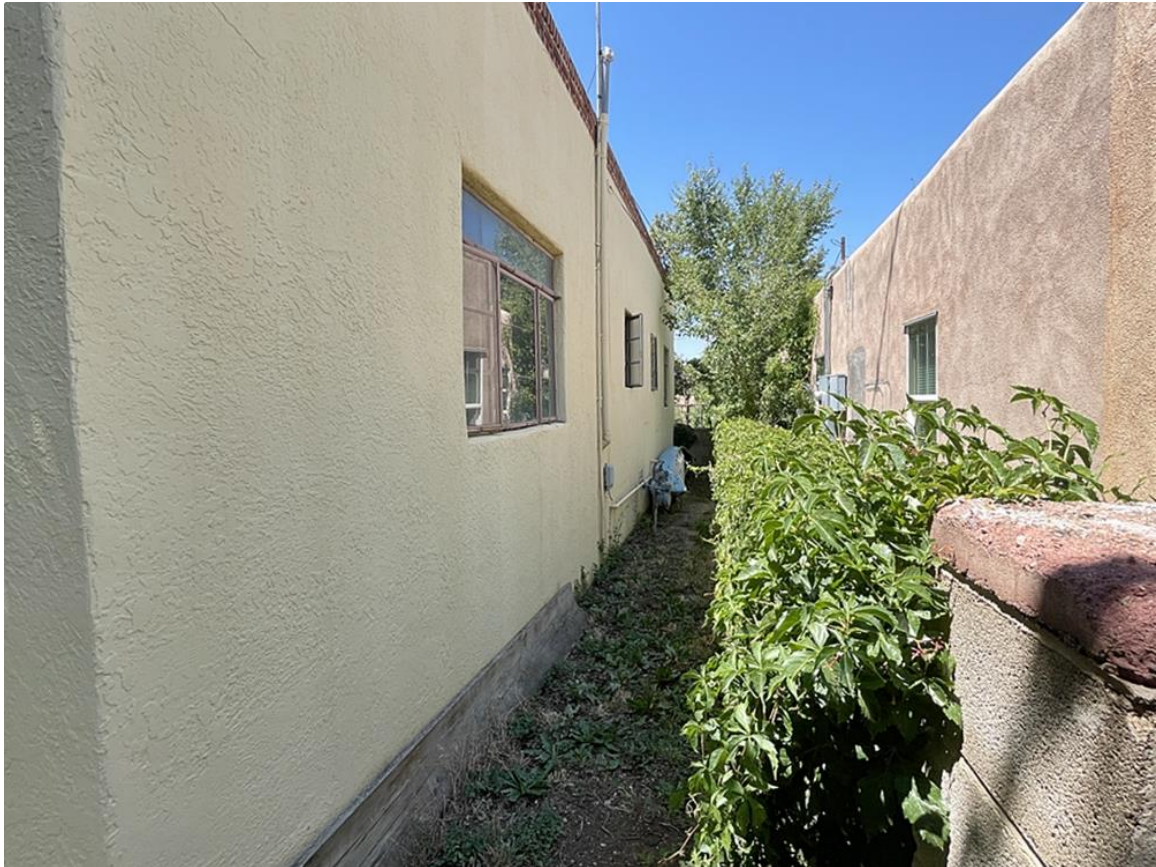
The north elevation sits close to the neighboring property and is difficult to photograph (Photo 14). It corresponds to the apartment side of the building and includes several window openings for the bedroom, bath, kitchen, and living room. All appear to be original steel combination units. These include a 3C–3F–3C | 3T window at the bedroom, as well as a larger 3C–6F–3C | 4T window at the living room (Photo 15). Other than the continuation of the brick cornice at the parapet, the elevation is flat and unarticulated.

Photo 14: North elevation. Camera facing west.

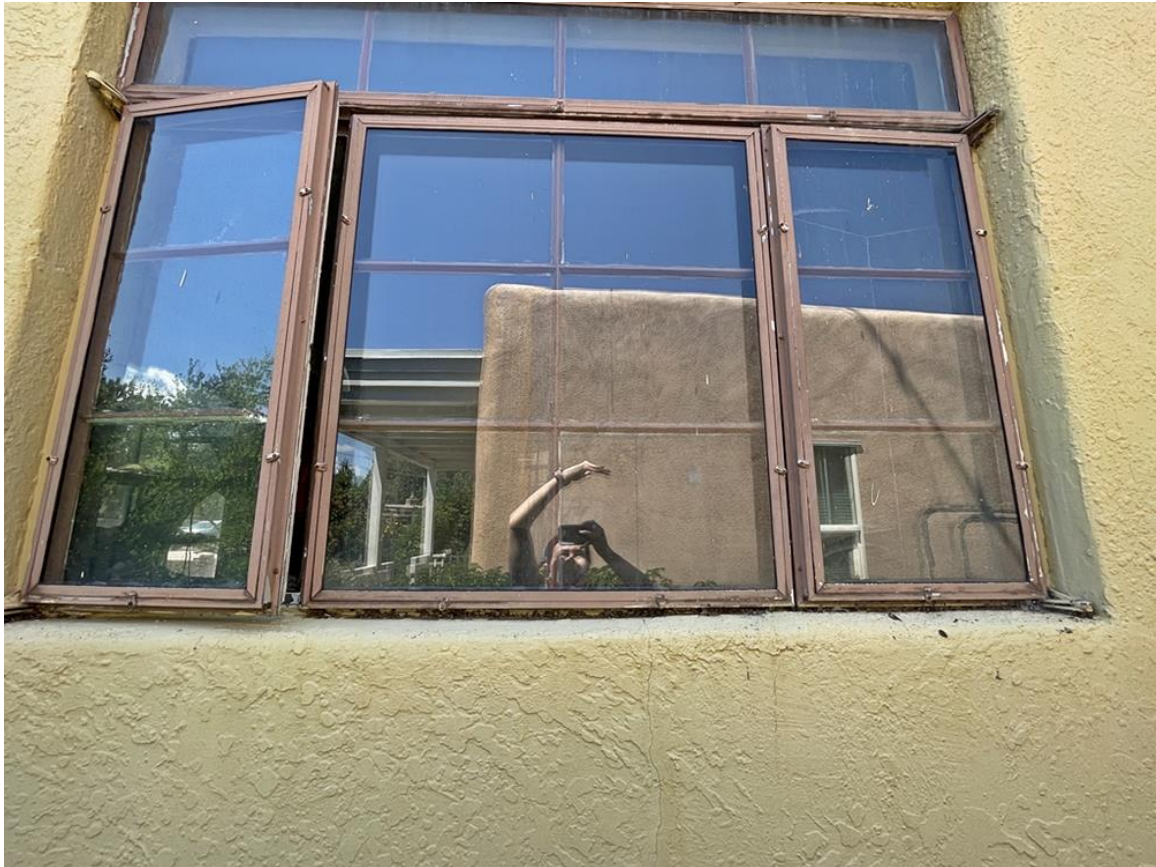
Photo 15: North elevation. Window at apartment living room. Camera facing south.

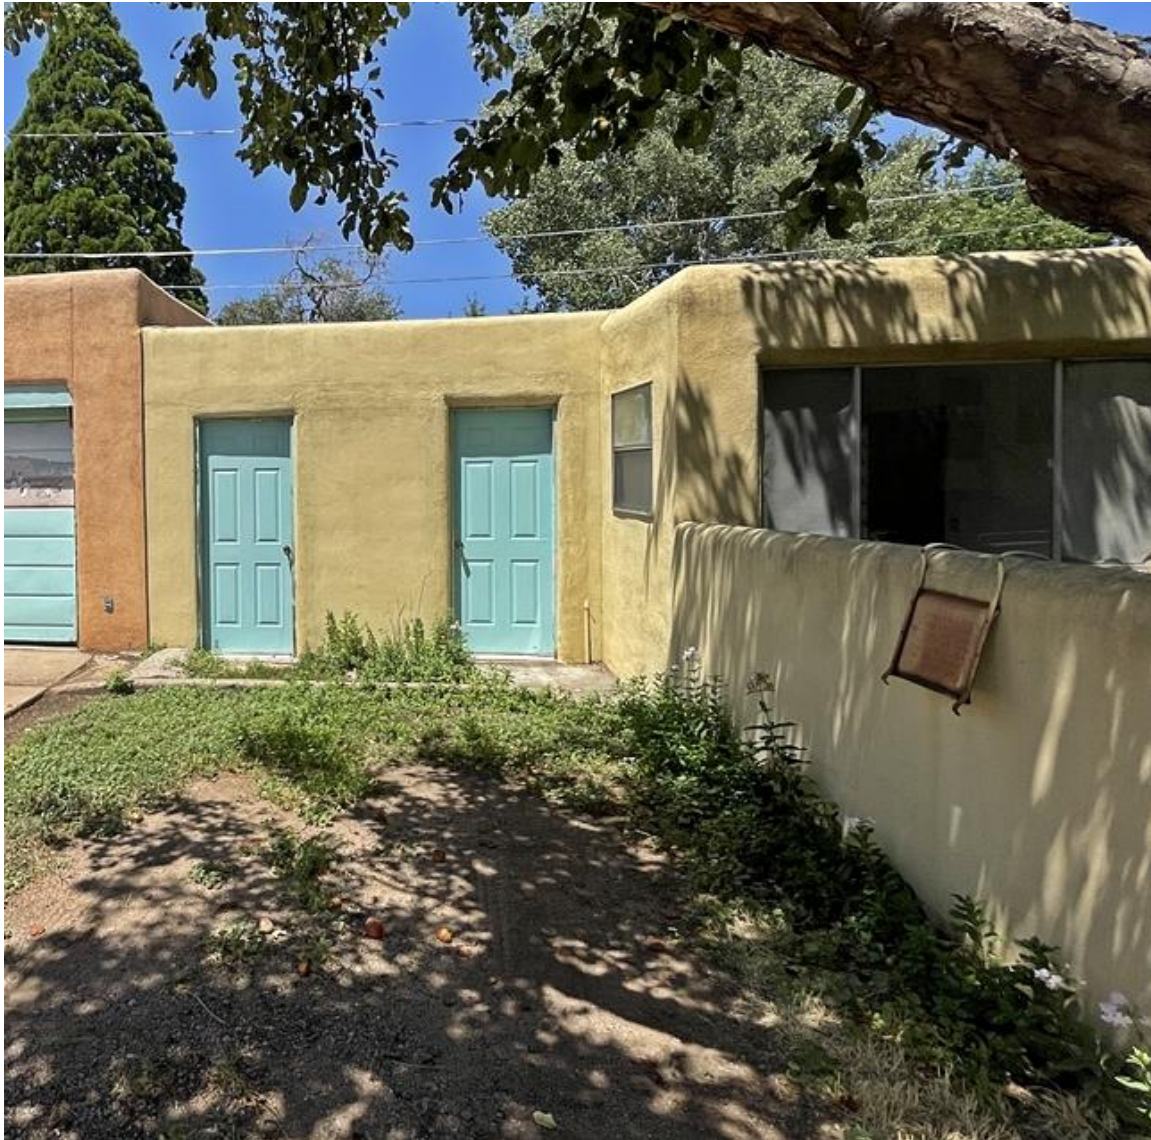
Photo 16: Former garage. Camera facing west.

The former garage, by contrast, has undergone significant alterations and no longer clearly communicates its original function. Accordingly, both the garage and the attached workshop are recommended for Non-contributing status.

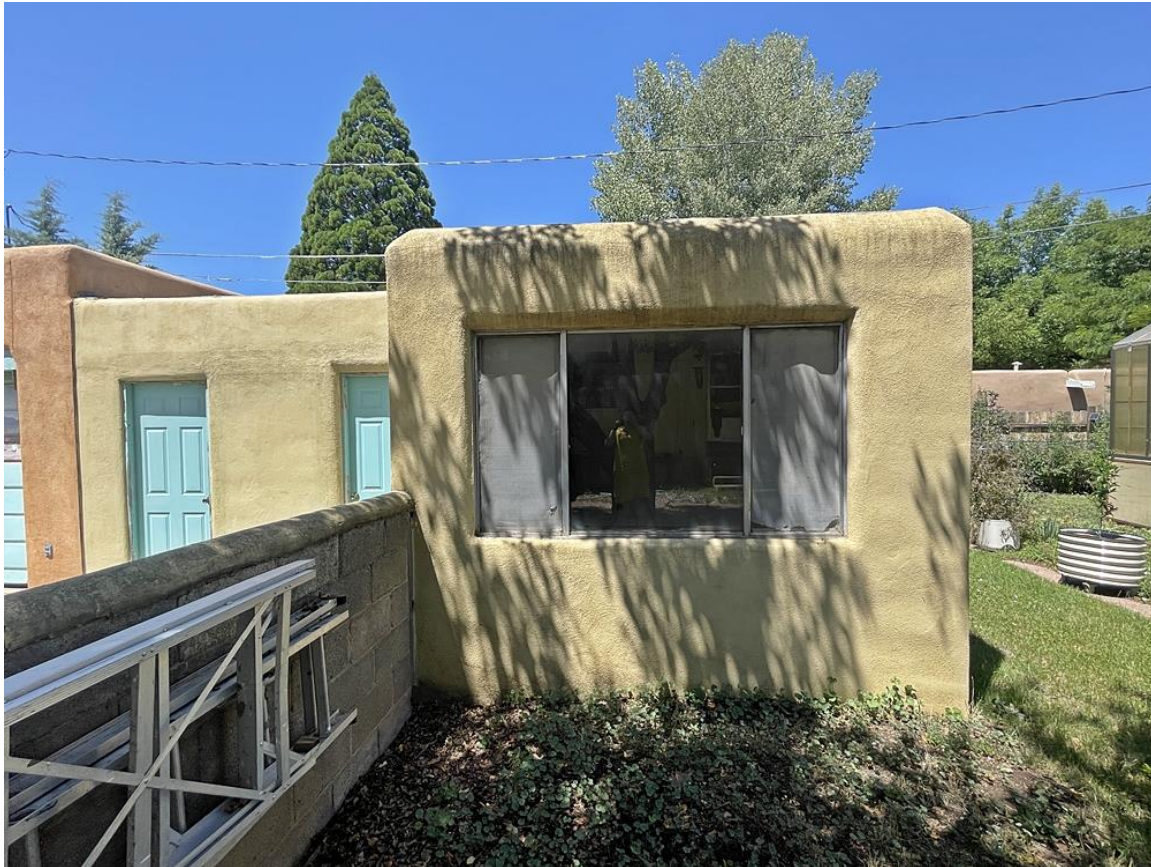
Photo 17: Workshop. East elevation. Camera facing west.

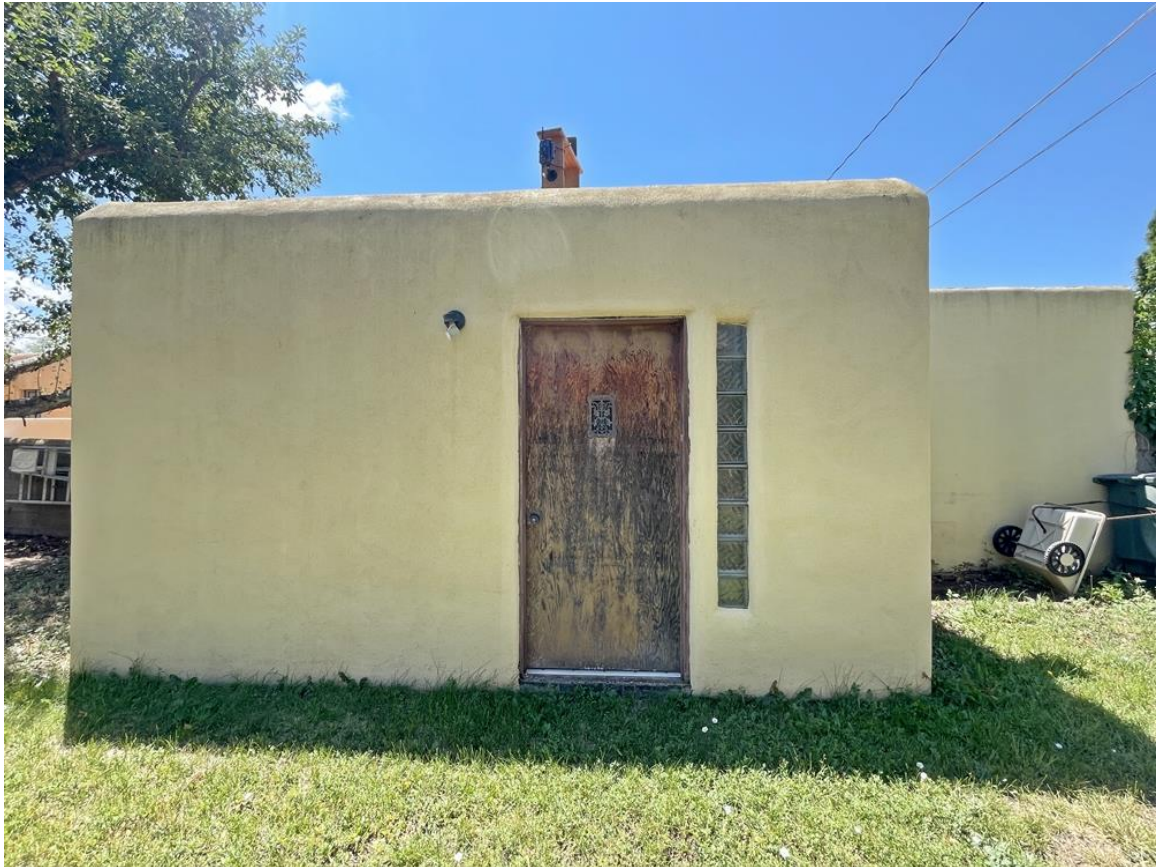
Attached to the north side of the garage is a small workshop constructed of wood framing with a stucco finish (Photo 17). Added before 1975 (Fig. 6), this addition exhibits modest Pueblo Revival detailing. It features aluminum windows on the south and east elevations (Photo 17 and is entered from the north through a flush plywood door, located adjacent to a narrow sidelight composed of small glass blocks (Photo 18).

Photo 18: Workshop. North elevation. Camera facing south.
