building threatened? yes	surveyed date 28-9-84 by mg	county Santa Fe	ID no. 0516 1120
field map SFHD	number 3-1120	UTM reference easting zone 12 13	northing
location description 1121 Peralta		city/town Santa Fe	
building name		legal description twp N S range E W sec	
film roll no. 6	negative nos. 10	loc. of neg. HCB	plan shape

building threatened? yes	surveyed date 28-9-84 by M B	county Santa Fe	ID no. 0516 1119
field map SFHD	number 3-1119	UTM reference zone 12 13	easting northing

location description 1123 Peralta	city/town Santa Fe
land grant/reservation

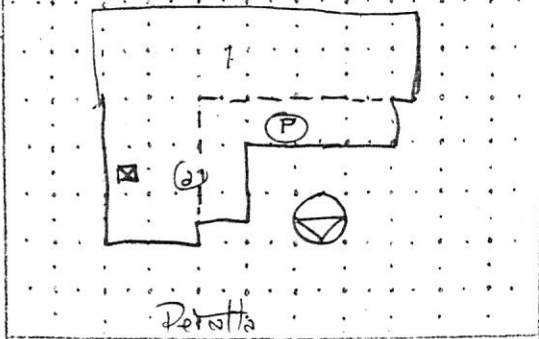
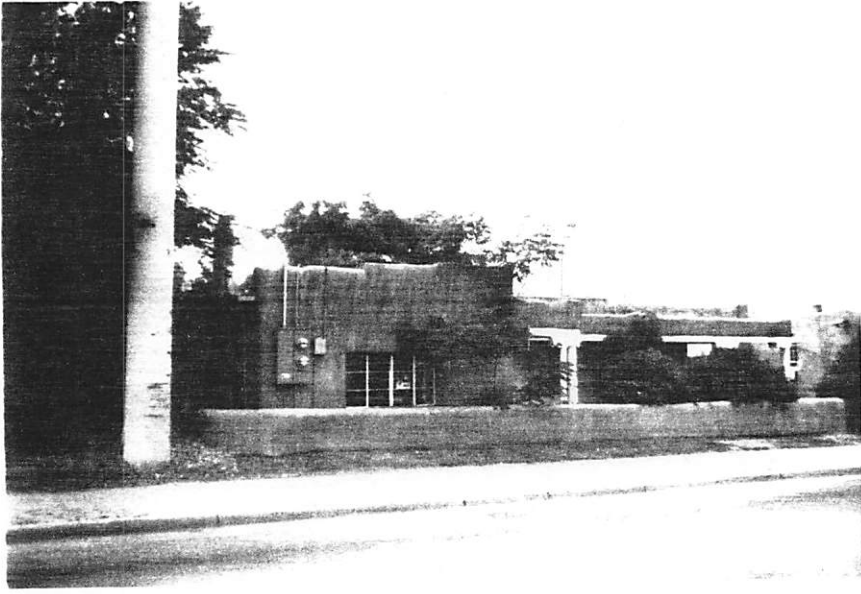
style Pueblo Rev	foundation material Brick?	date of construction 1920-30 estimate actual source
wall material/surface Adobe/Stucco	use present Comm residential other historic residential other	condition excellent x good fair deteriorating
architectural features Roof - flat, undulating parapet w horns, metal eaves, 1 chimney, 2 flues, brick coping at @ stuccoed over Windows - 10/1, 4 lite w/casement (E Wing), trim white Doors - post w/ panel Portal - post, zapatas + beam (white), low wall (stucco), posts (6) show at rear of portal half embedded in wall.	degree of remodeling x minor moderate major	relationship to surroundings x similar not similar
comments	describe:	district potential yes no
	surroundings Res/Com	significance eligible x of none
	why? CONTRIB.	if eligible, interest
	associated buildings? yes what type?	if inventoried, list ID nos.
		see back? yes

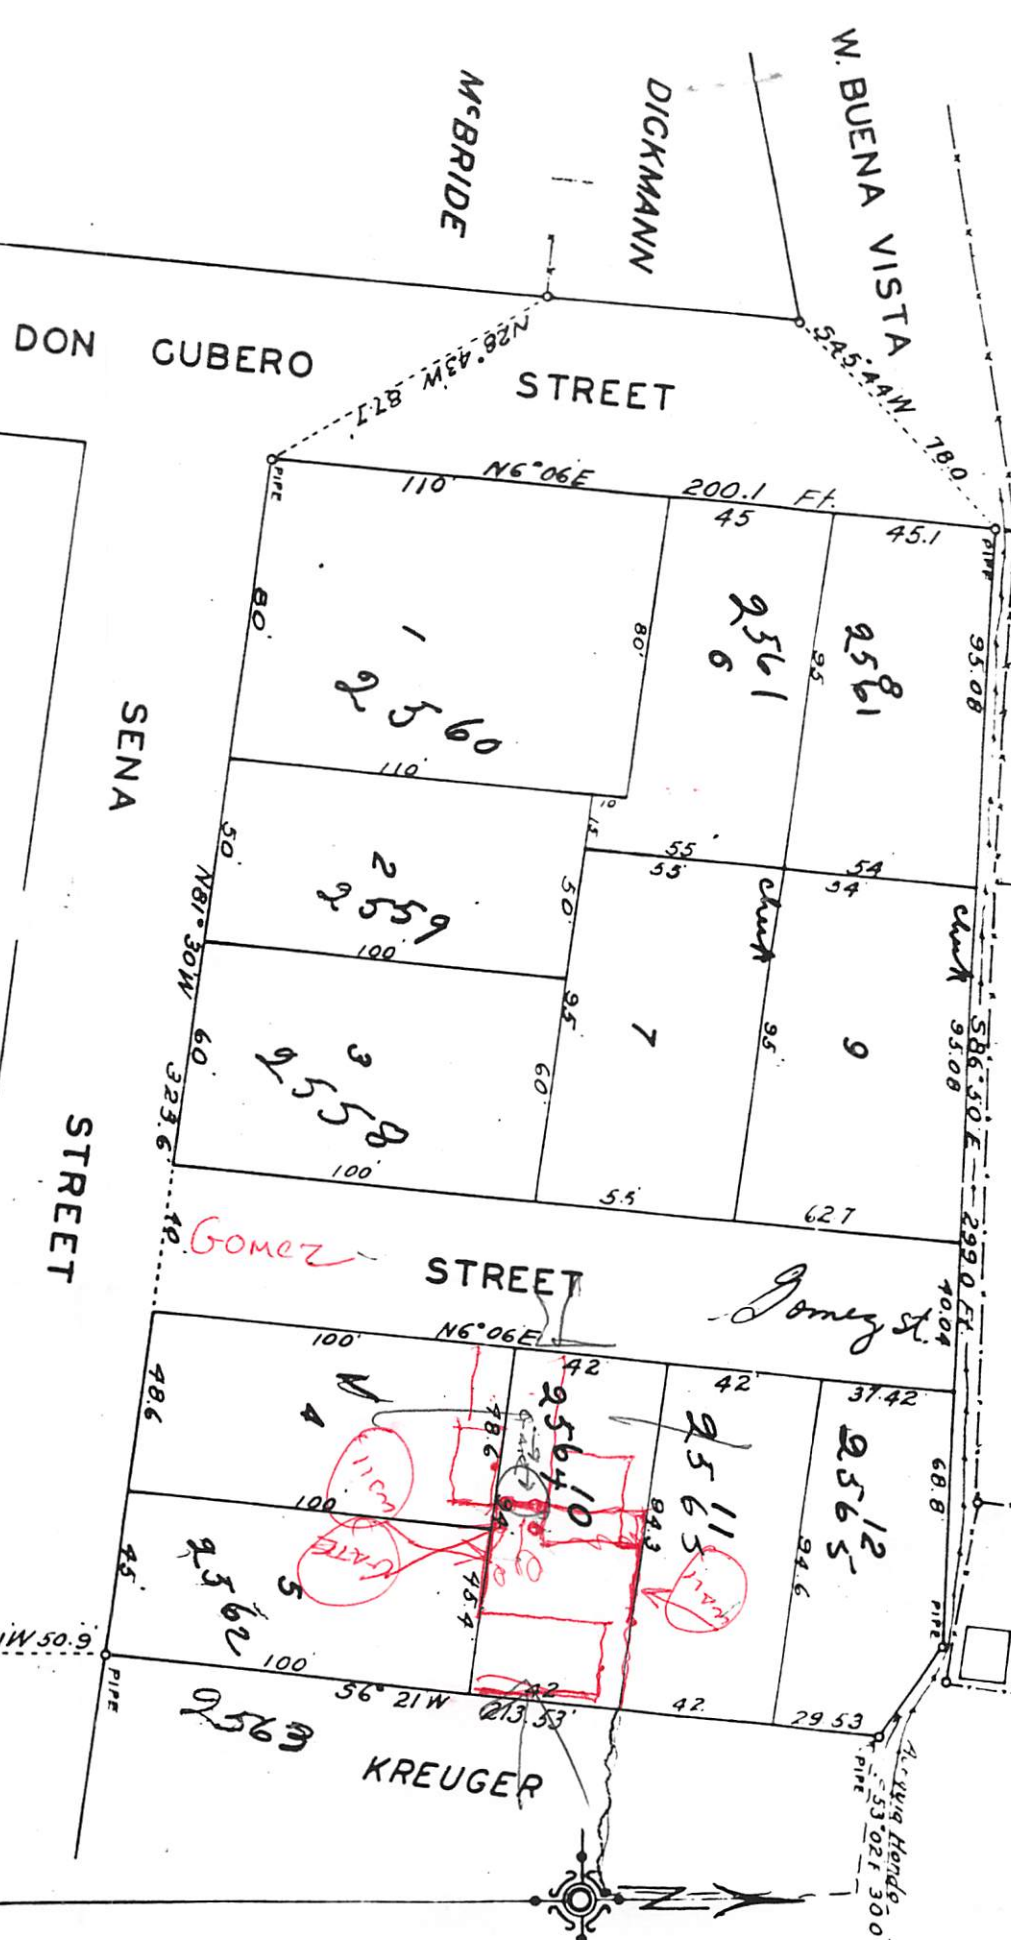
MAP
SHOWING SUBDIVISION OF LAND BELONGING TO

PROPERTY OF THE
CITY OF SANTA FE

FRANK ANDREWS

PRECINCT No. 4.
GEO. M. NEEL, ENGR.
SANTA FE, N.M.
SEP. 2, 1929

SCALE 1"=40'

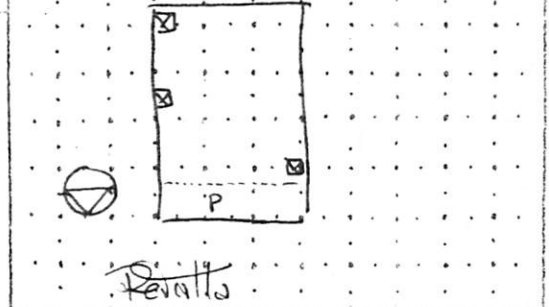
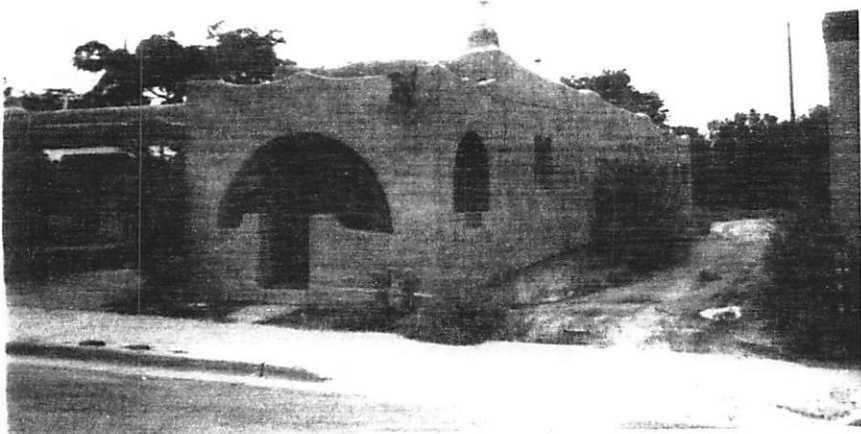
style SW Vern. *	foundation material NV
	wall material/surface Adobe

architectural features Roof - flat, parapet undulating w horns, wood canals wtl canals Windows - 3 lite steel casmt, 3 chimneys 6 wtl plus brick sills, white trim Door - wd multi panel, modern w/r.

Mail box under portal has brick sill & appears closed off Porch - arches front & side, 1/2 wall w side

comments on each side w scalloped cutouts.

*The undulating parapet, the canals, and the shape of the chimney relate to Pueblo Revival. The arches and the lack of vigas are not congruent. This is an example of 2 possible subspecies.
