RE: 1123 Paseo de Peralta Santa Fe, NM 87501 Status Review

Historic Cultural Properties Inventory (HCPI) Base Form (FORM 1)

1. Name of property: Alarid-Cisneros Property	2. Location: 1121 and 1123 Paseo de Peralta Downtown and Eastside Historic District — Santa Fe	3. Local Reference Number: Santa Fe ID: H-3032 & H-3033 4. County: Santa Fe Parcel # 12899330

8. Name of Project: HDRB Status Evaluation		
9. Lat/Long: 35.6812077,-105.9392107		
10. Photo Information: Giulia Caporuscio, photographer. Photo 1: View of north side of 1121 Paseo de Peralta. Camera facing southeast.

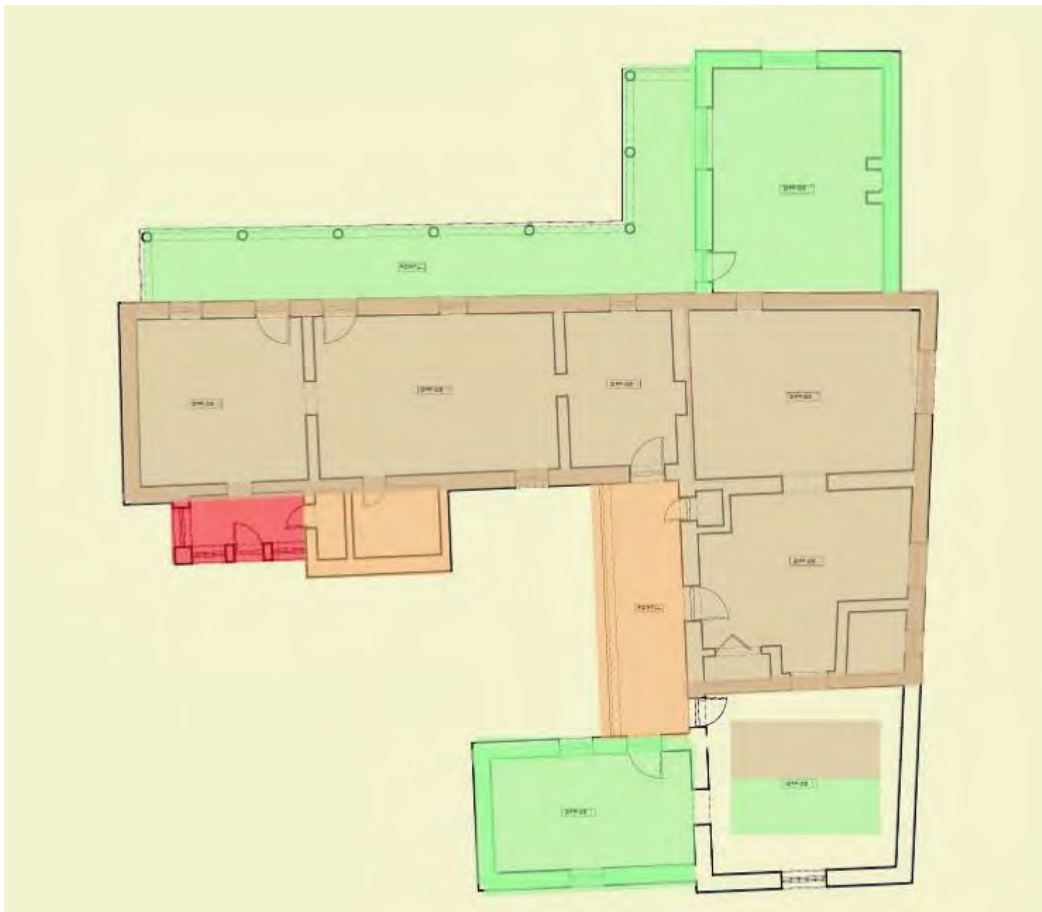
Figure 1: Approximation of building footprint growth for 1121 Paseo del Peralta.

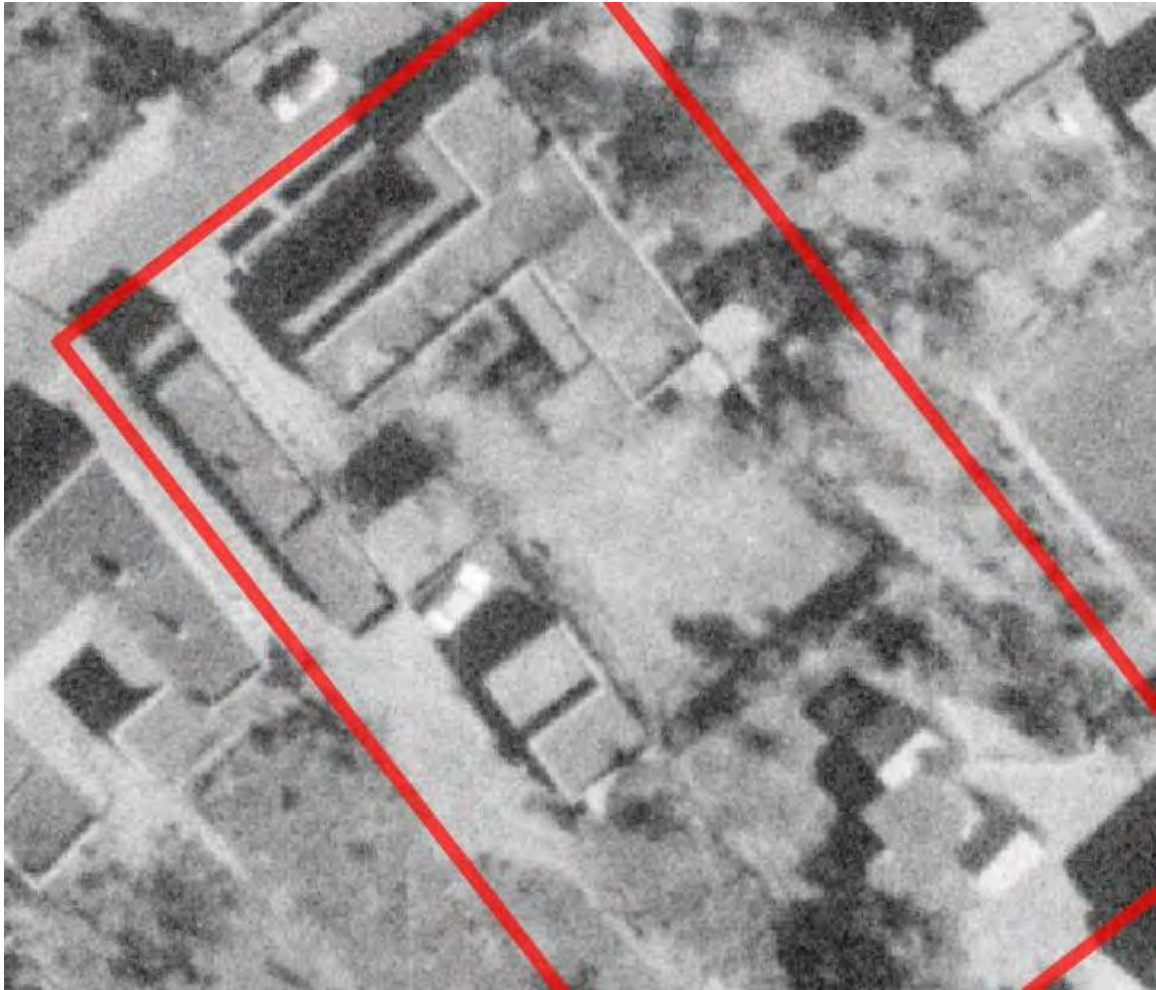
Figure 6: November 10, 1958, aerial photograph.
Note presence of south portal at 1121 and continued presence of frame garage at 1123.

Beyond this section, and largely concealed by a tall fence, is a garden courtyard planted in front of a west-facing portal. Based on Sanborn maps and aerial imagery, this structure was introduced between 1948 and 1958 (Figs. 5 & 6). This area was not accessible at the time of survey; however, views over the fence indicate a mix of earlier and replacement fenestration, including three modern 15-light wood doors (Photos 14 & 15).

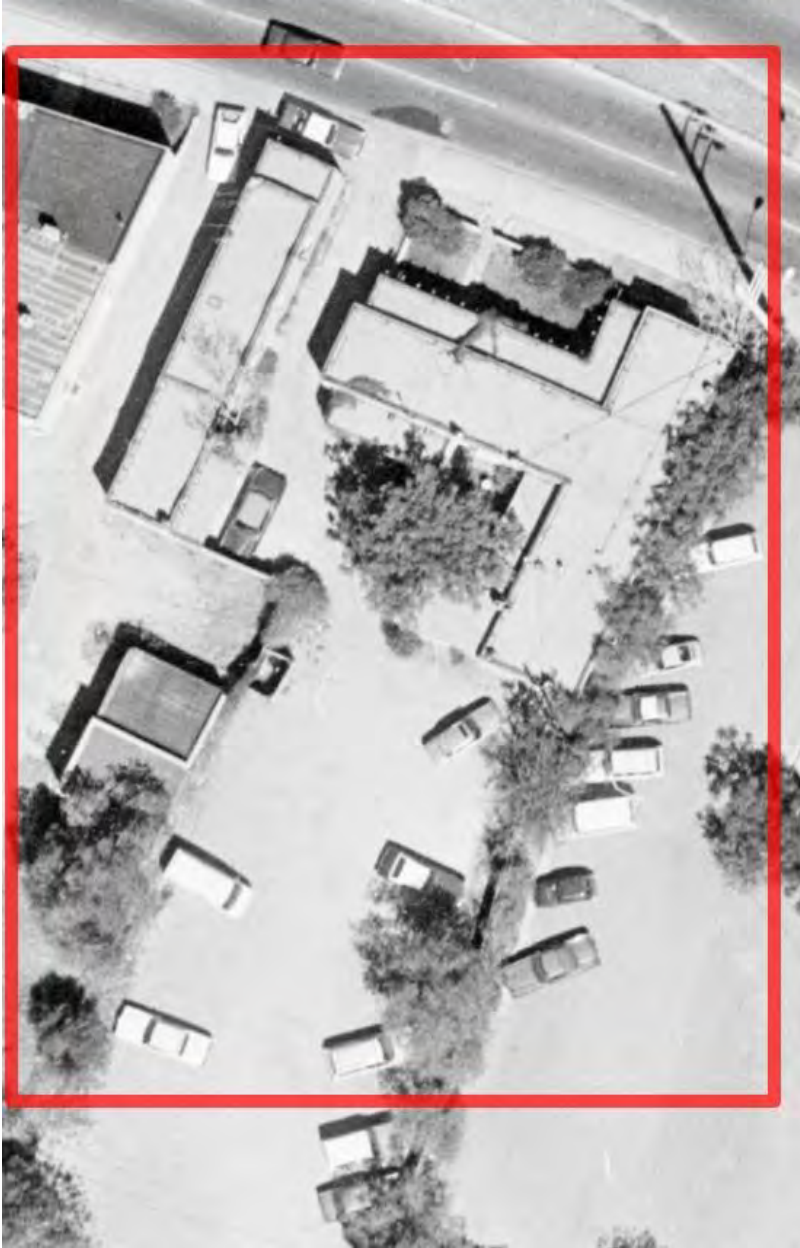
Figure 7: September 11, 1978, aerial photograph.
Note likely enclosure of rear entrance at 1121 and removal of frame garage at 1123.
Note addition has not been constructed on east side of 1123. Note also cleanup of site and use of back area for parking, signaling conversion to commercial use.

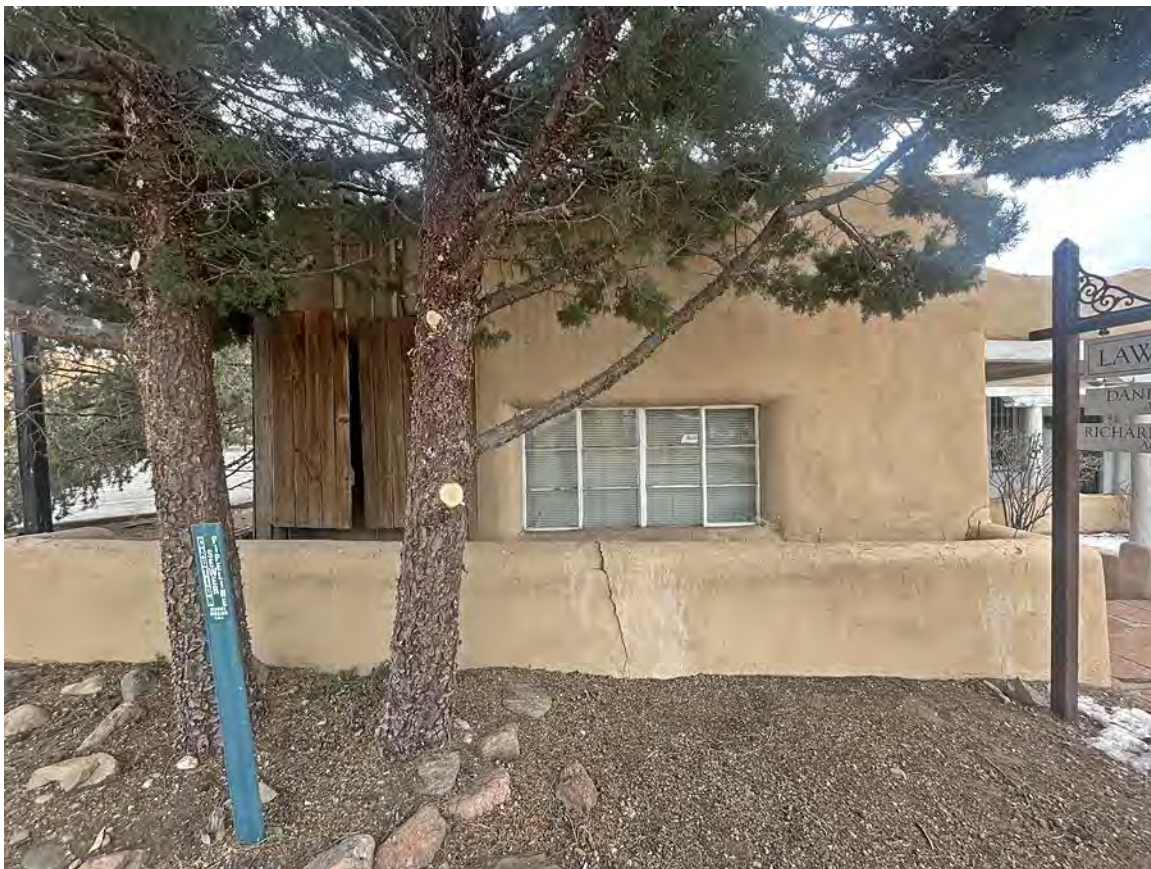
The building faces north onto Paseo de Peralta and features an L-shaped portal or porch reflecting a modification made after 1912 (Photos 1 & 2). At the east end of the façade is a cubic projection that, based on Sanborn Fire Insurance Company maps, was added after 1930 (Photo 3) (Figs. 1 & 4). Like most of the building, this projection is constructed of adobe. A 12-light steel combination window penetrates its façade; the unit incorporates crank-out end casements and is set deep within the wall with bullnose stucco reveals.

Photo 3: North elevation, east end. Camera facing south.

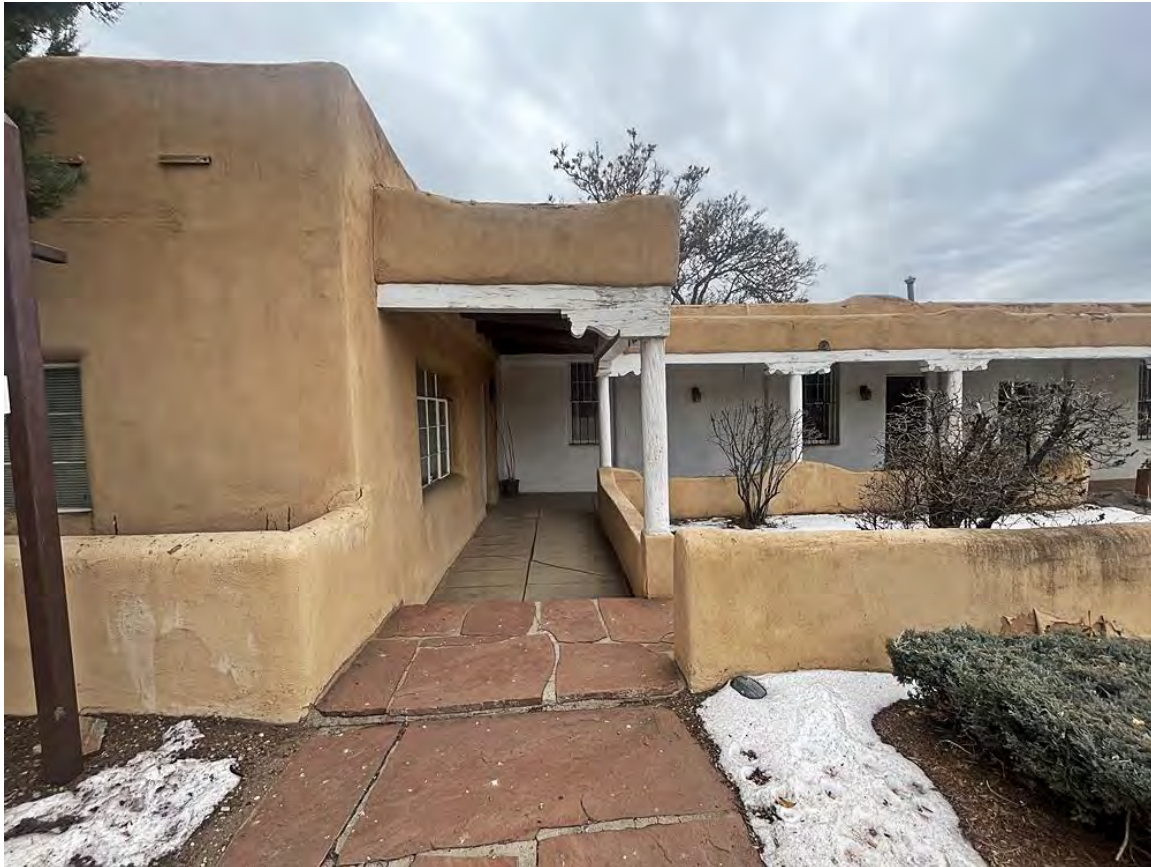
The shading structure is supported by heavy, painted wood posts. The plates are dimensioned lumber, while the corbels are sawn and scroll-cut (Photo 4). The portal ceiling incorporates older vigas and rough-sawn board decking (Photo 5). These have been shorn off on the exterior of the structure.

Photo 4: North elevation, portal. Camera facing south.

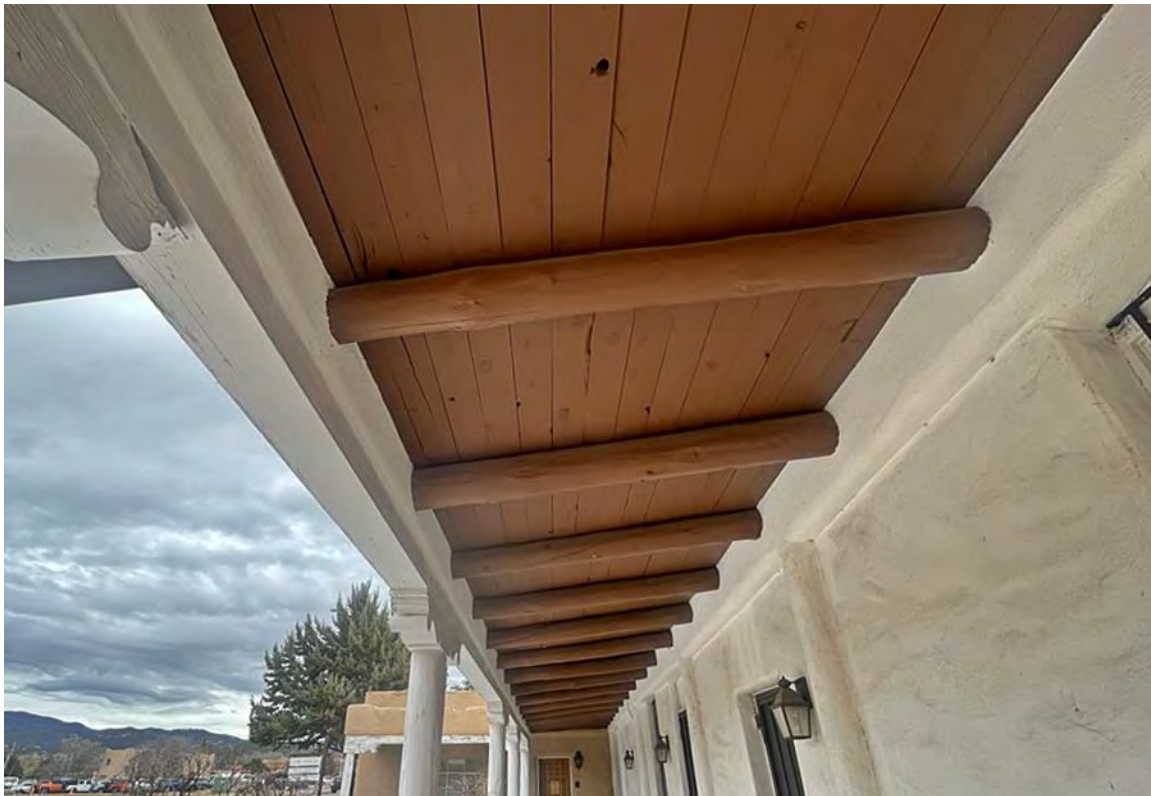
Photo 5: North elevation, portal decking. Camera facing up.

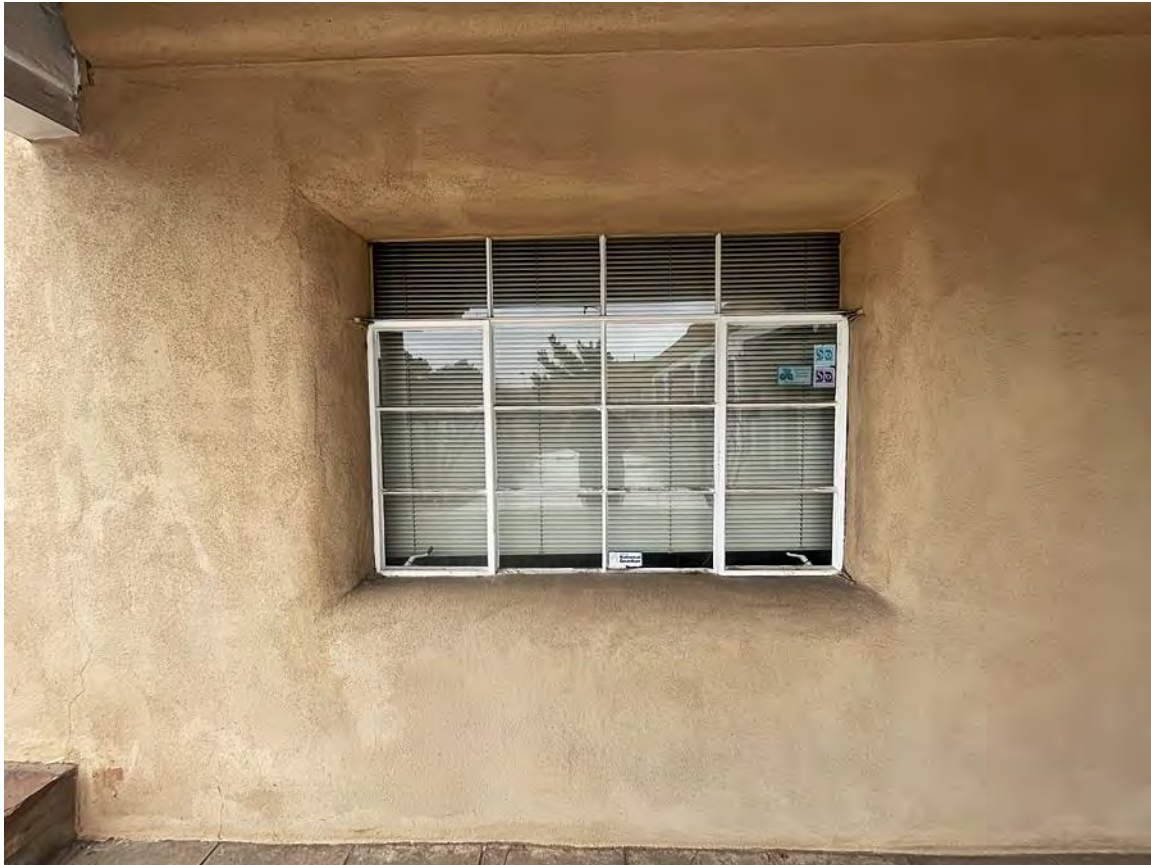
Photo 6: North elevation, portal west wall. Camera facing east.

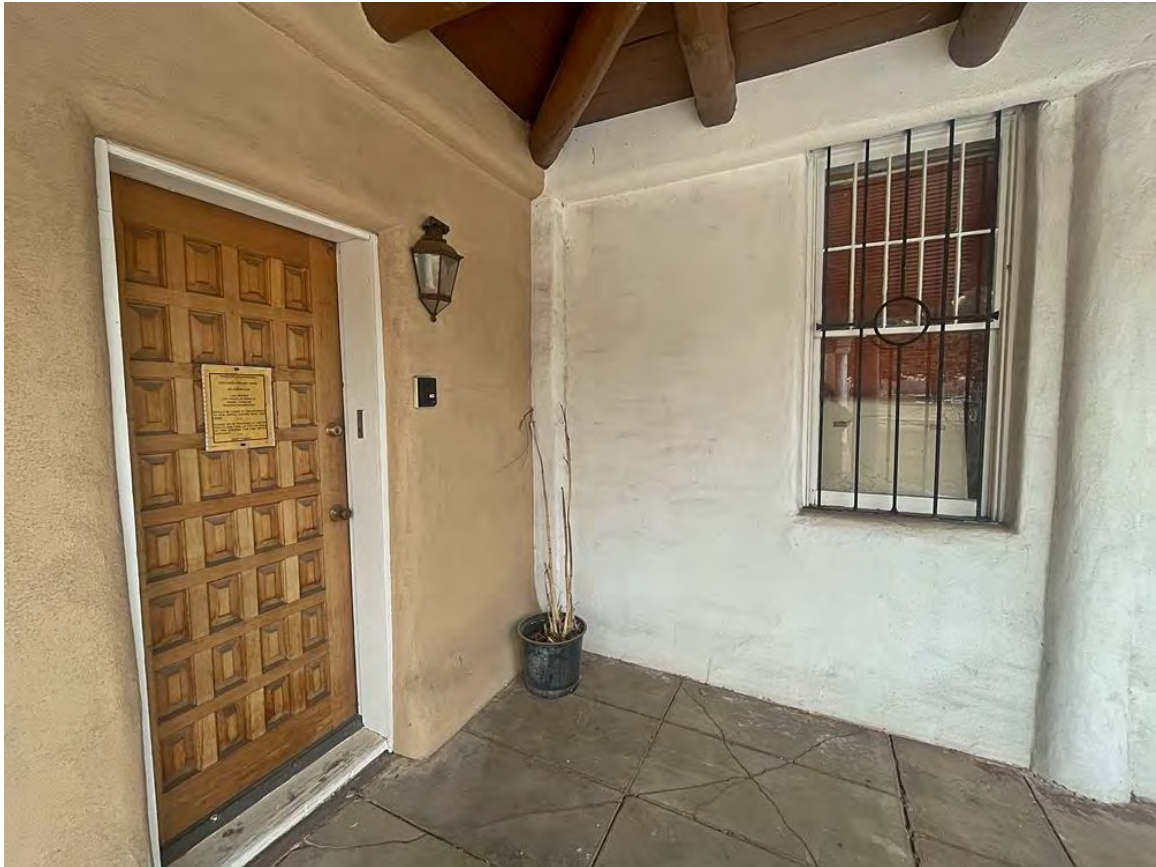
Several upright supports along this façade have been stuccoed. These supports, together with the plate above, indicate structural reinforcement associated with the added portal. In one location, the plate partially obscures a window opening (Photo 7). The portal terminates at the west end with the final ten-over-ten hung-sash window (Photo 10).

Photo 7: North elevation, portal southeast corner. Camera facing southeast.

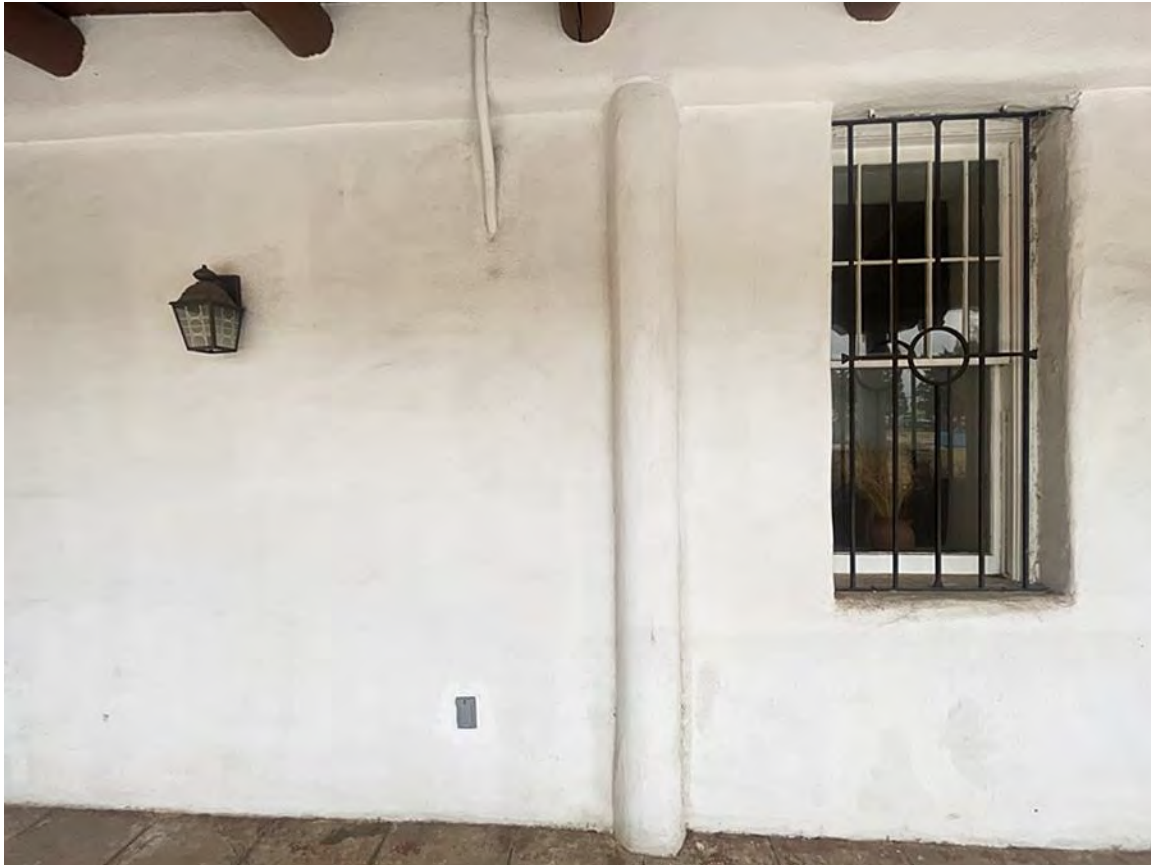
The north façade is uniformly painted white from ground to ceiling (Photos 8–10). It includes two non-historic doors and three earlier ten-over-one wood double-hung windows (Photo 8). The windows are set slightly back from the wall plane and are protected by metal security bars.

Photo 8: North elevation, portal north wall. Camera facing south.

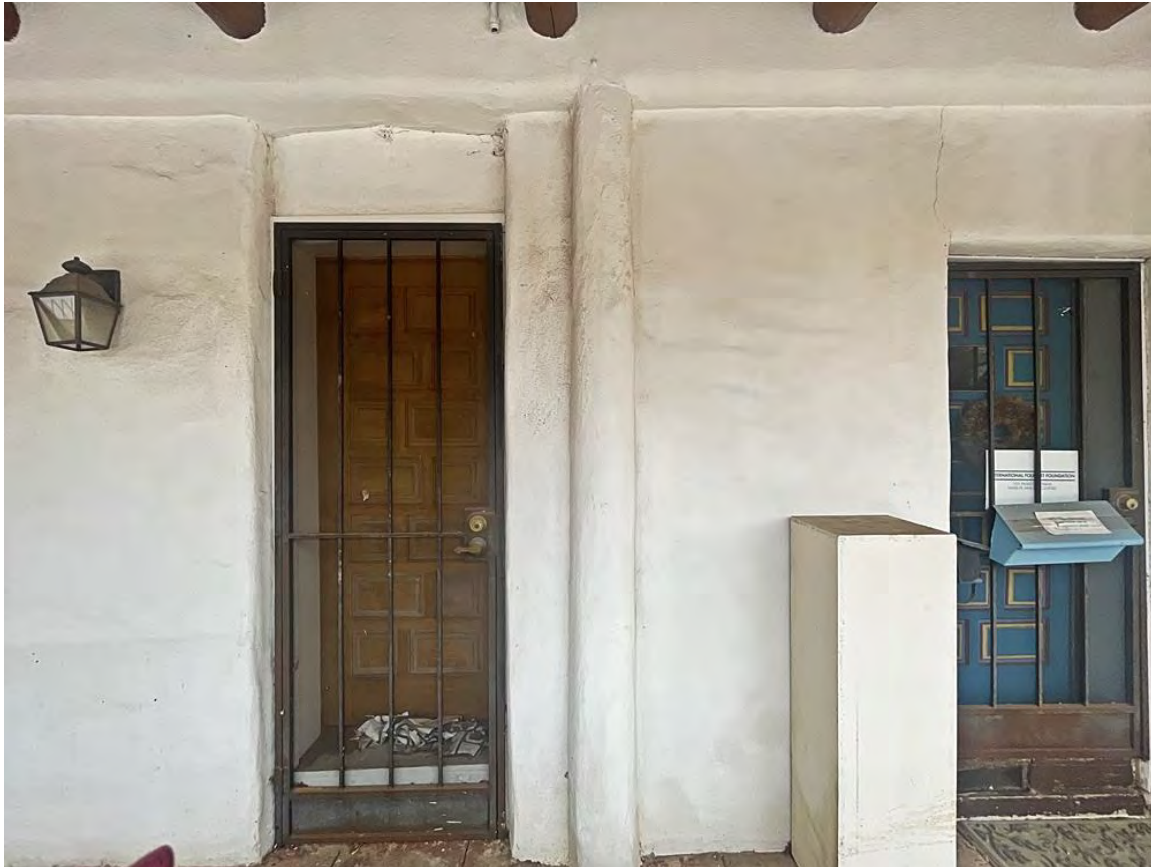
Photo 9: North elevation, portal north wall. Camera facing south.

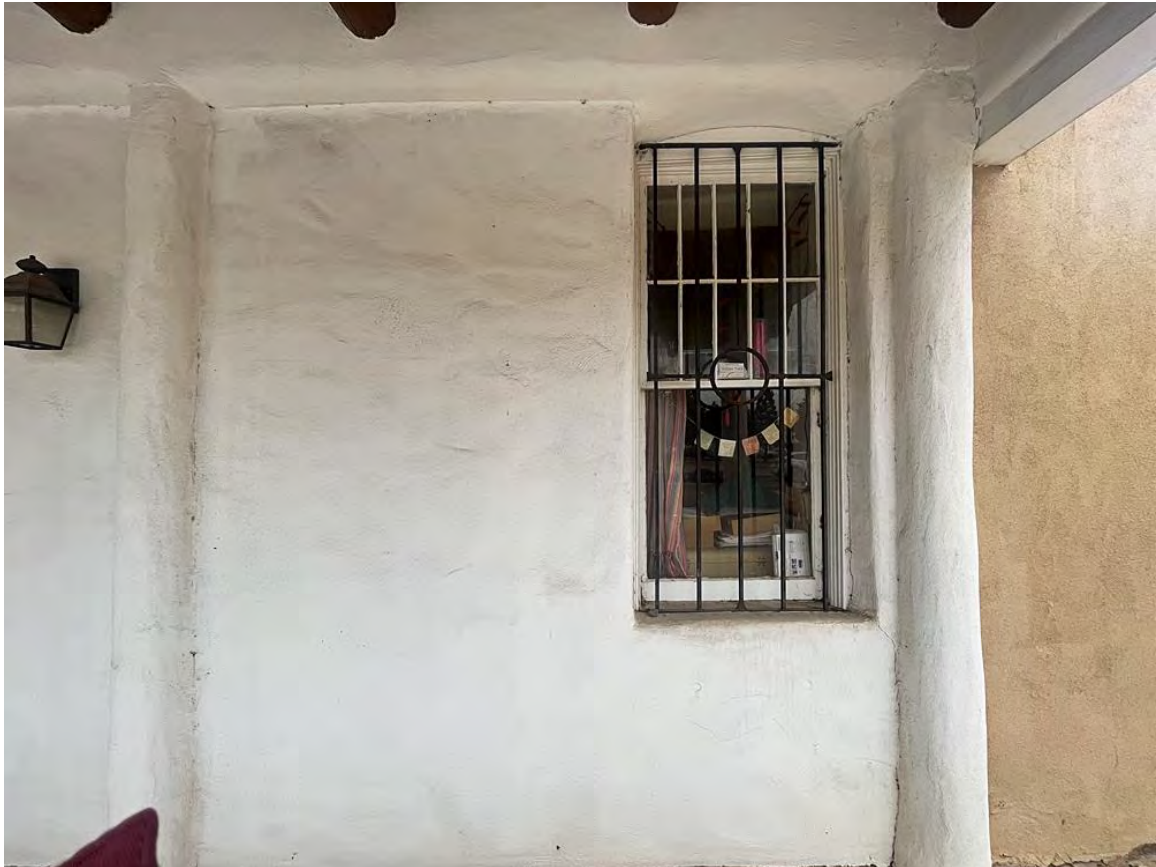
Photo 10: North elevation, portal north wall. Camera facing south.

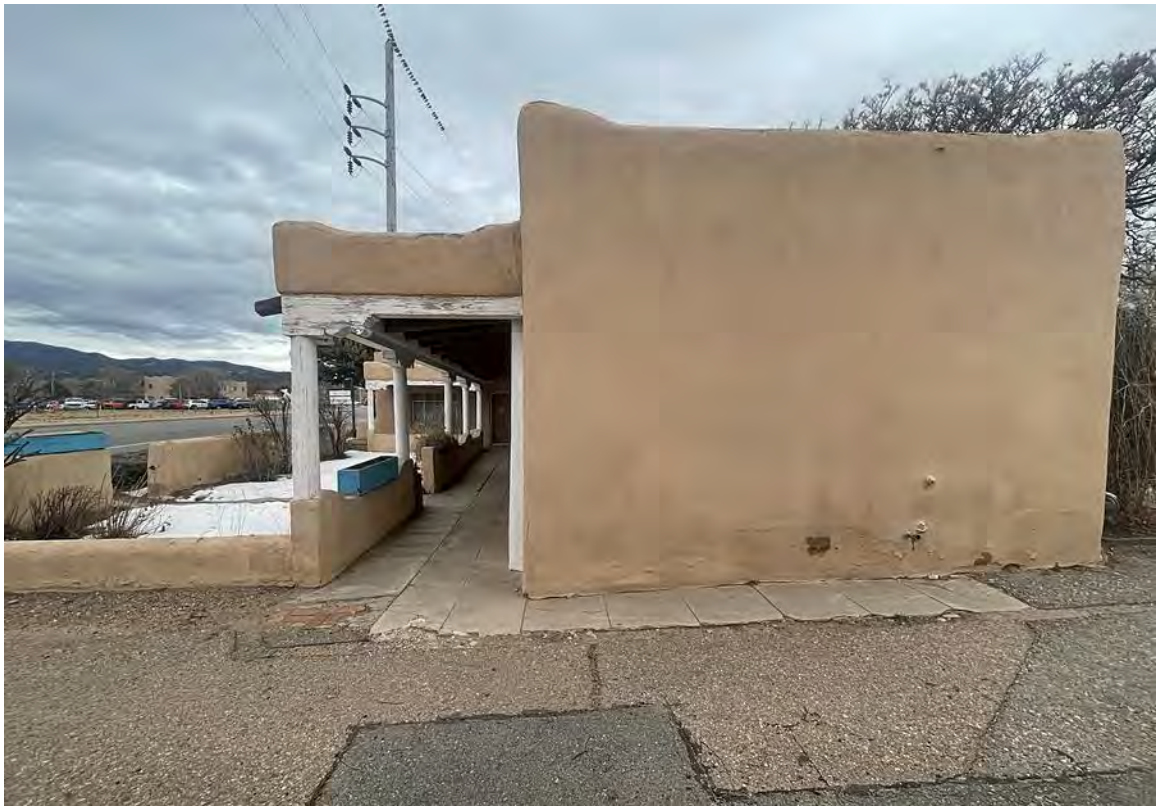
The west wall of the original building at this position has no fenestration (Photo 11).

Photo 11: West elevation. Camera facing east.

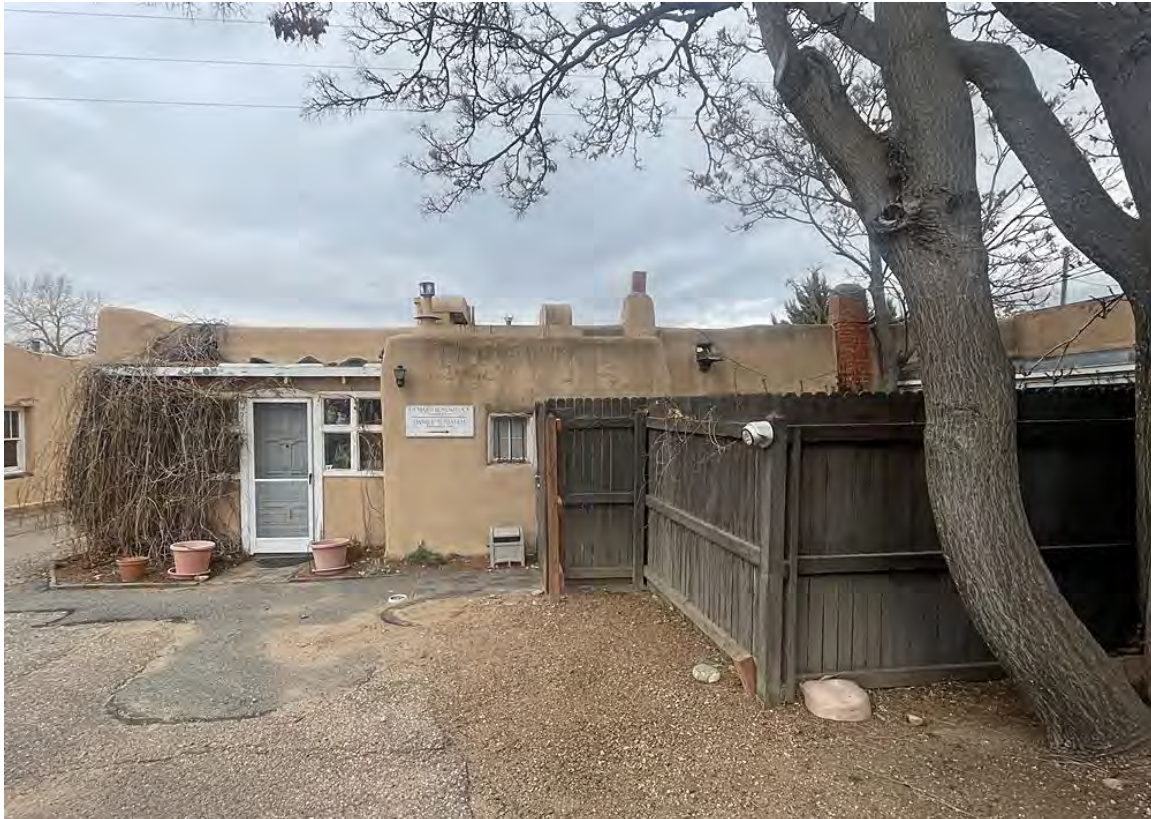
The south elevation, beginning at the west corner, includes a bumped-out section that postdates 1958 (Photo 12). This lower-roofed volume, possibly representing the enclosure of an earlier porch, incorporates a low pony wall topped by a series of mulled wood windows (Photo 13). An older raised-panel Dutch wood door opens into what may have functioned as a mudroom or service entry.

Moving east, the elevation transitions to a historic addition erected before 1958. The addition is characterized by a rounded, Pueblo-like parapet and a line of sawn-off vigas (Photo 12).

Photo 12: South elevation, west end. Camera facing north.

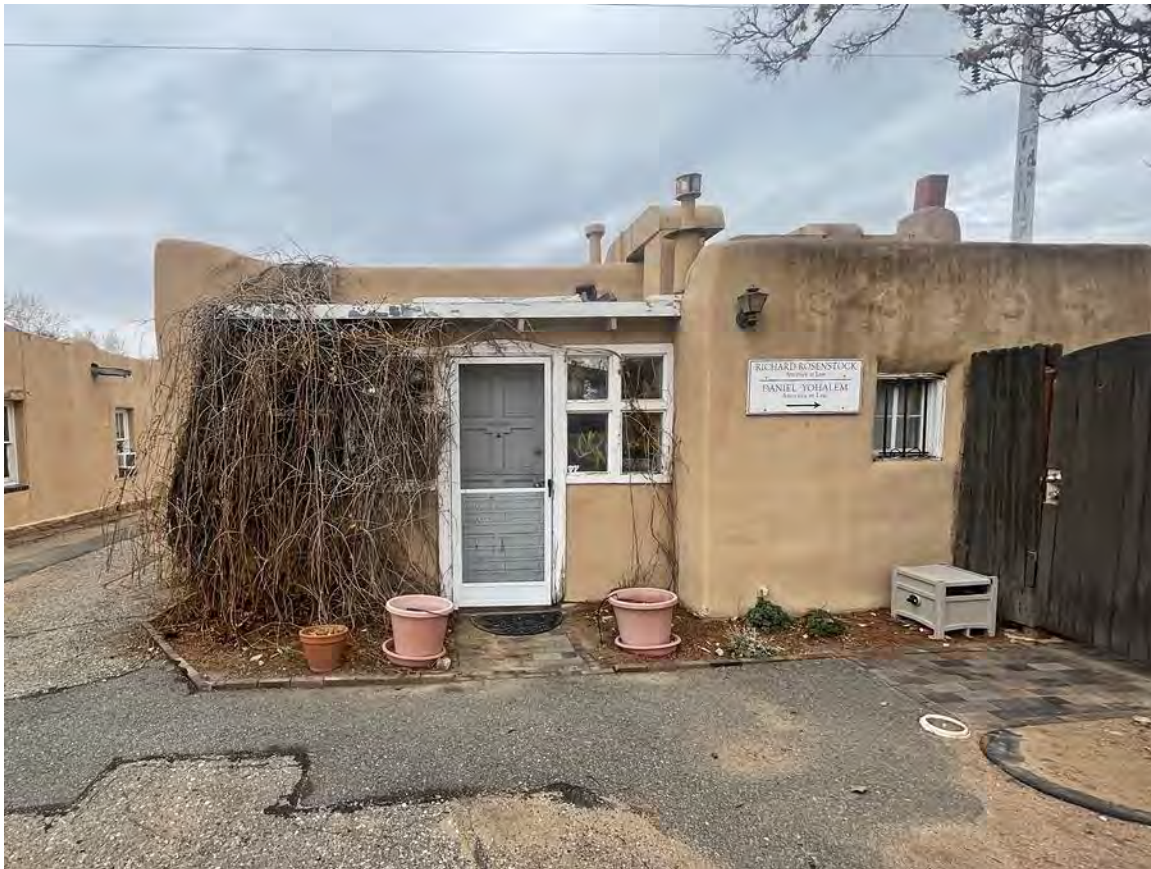
Photo 13: South elevation, west end. Closeup of enclosed porch. Camera facing north.

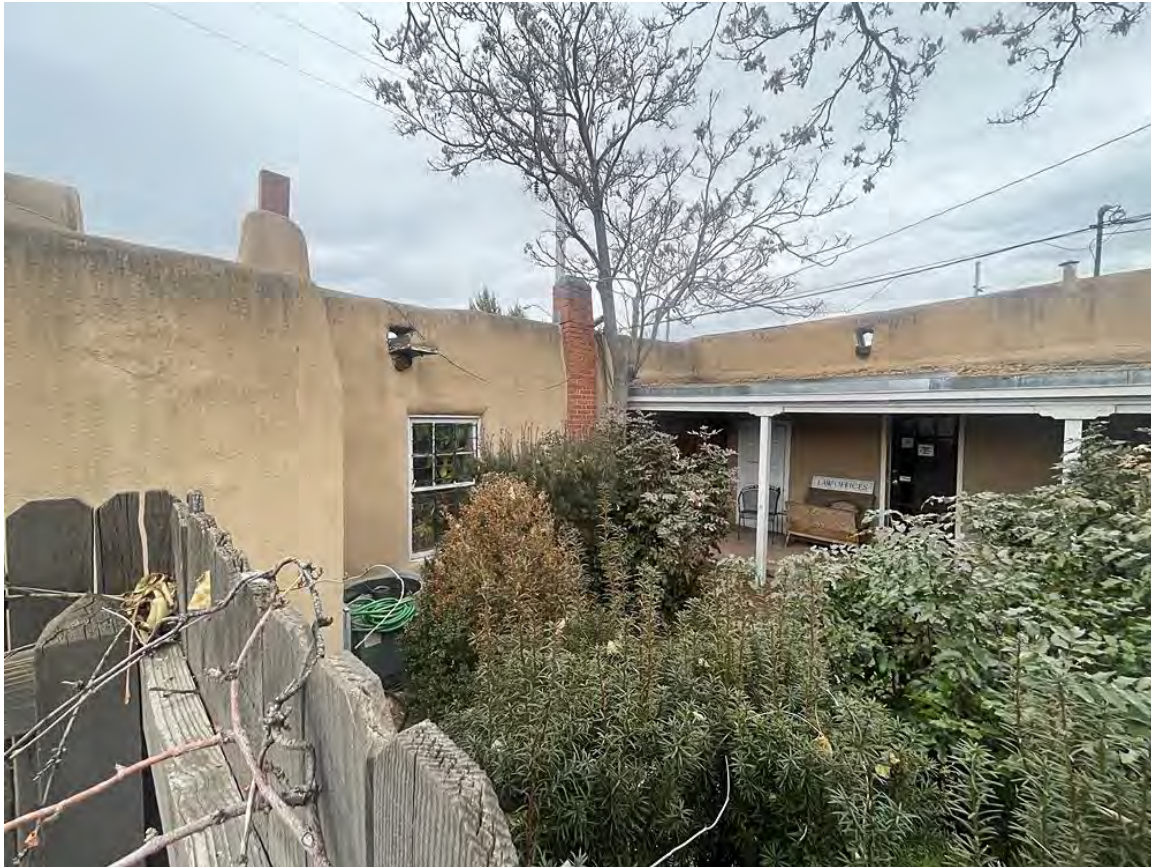
Photo 14: South elevation, east and post-1948 portal. Camera facing northeast.

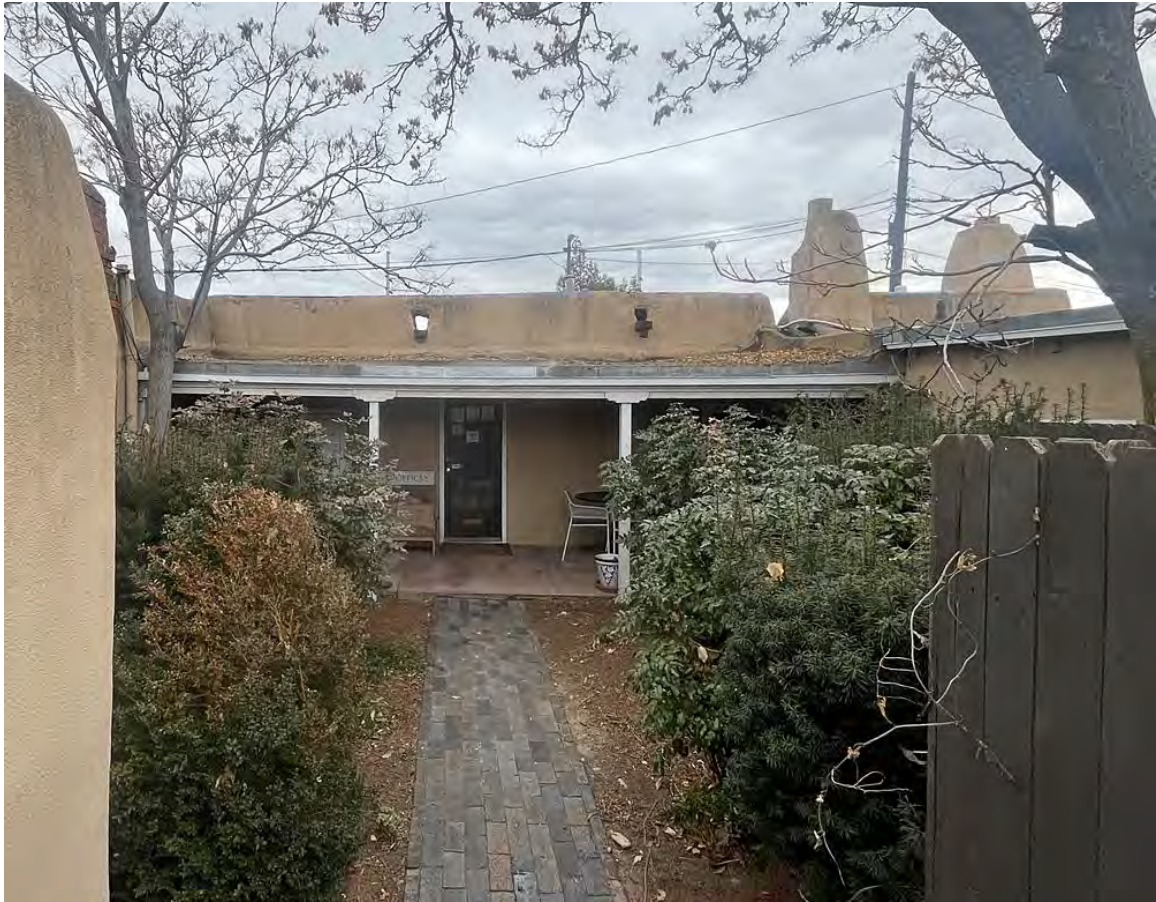
Photo 15: West elevation, post-1948 portal. Camera facing east.

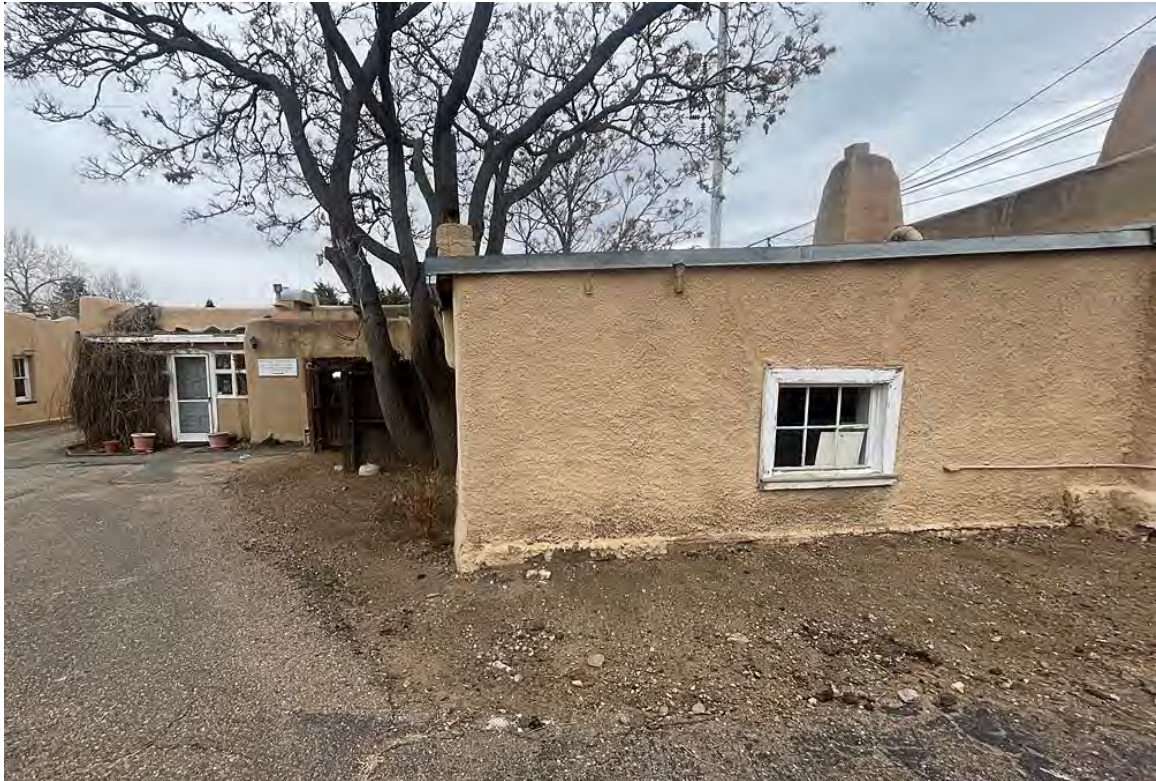
The west wall contains a 16-light steel combination window of the same general vintage as the unit on the north façade (Photo 16). A 32-panel door is located at the southeast corner (Photo 17). This door, along with the remaining doors along the north façade, is a replacement unit. Several openings have a segmental-arched head, suggesting an earlier configuration.

Photo 16: South elevation, pre-1930 addition. Camera facing north.

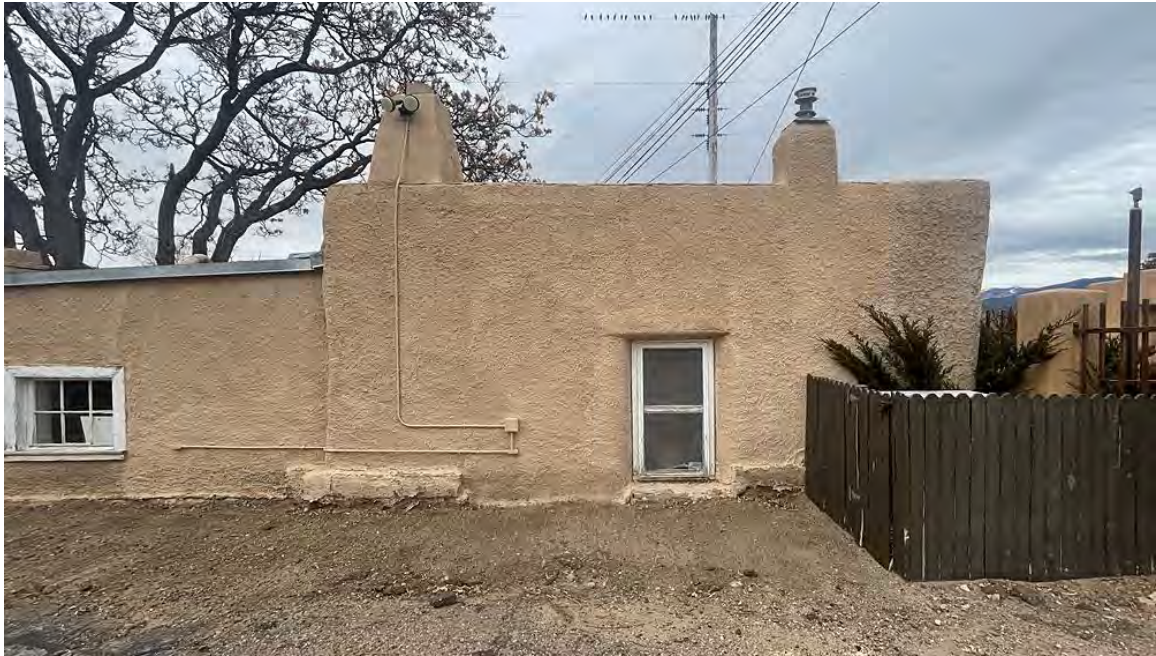
Photo 17: South elevation, original building or pre-1930 addition. Camera facing north.

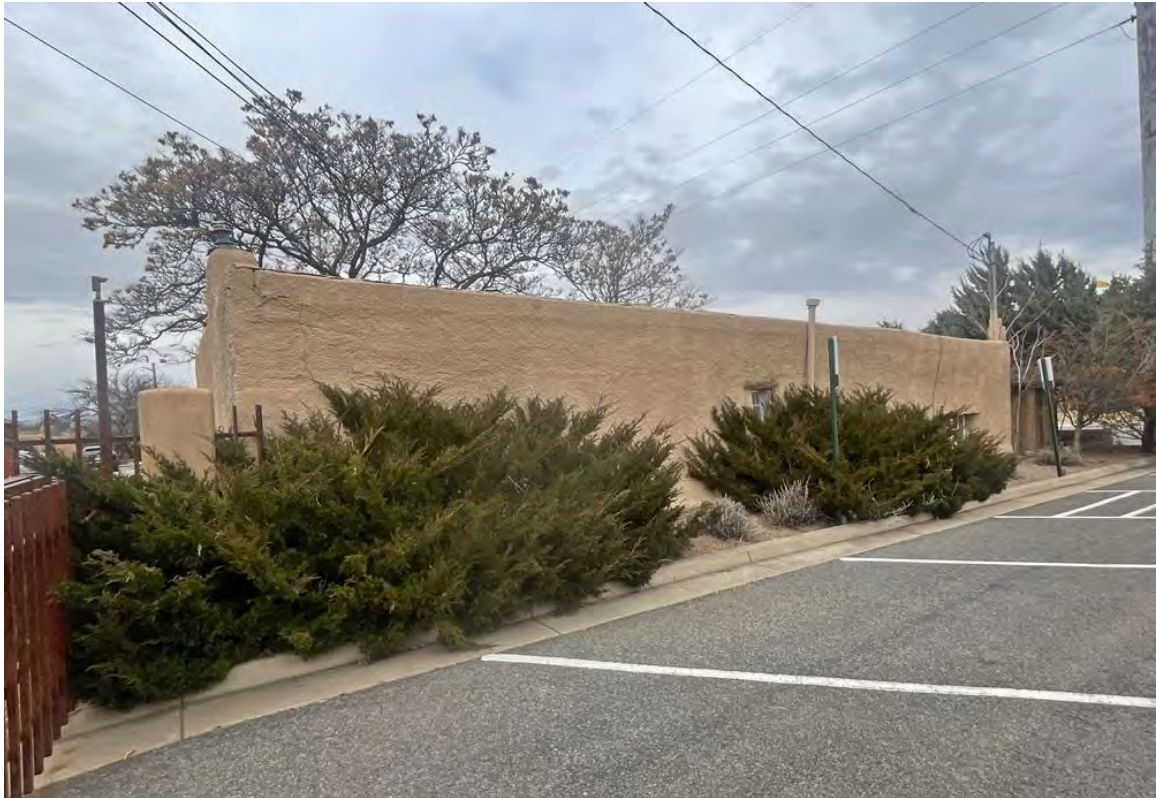
The long east elevation forms a backdrop to the neighboring property’s asphalt parking lot (Photo 18). Much of the wall is bordered by a narrow planting bed with overgrown juniper obscuring several window openings (Photo 19).

Photo 18: East elevation. Camera facing northwest.

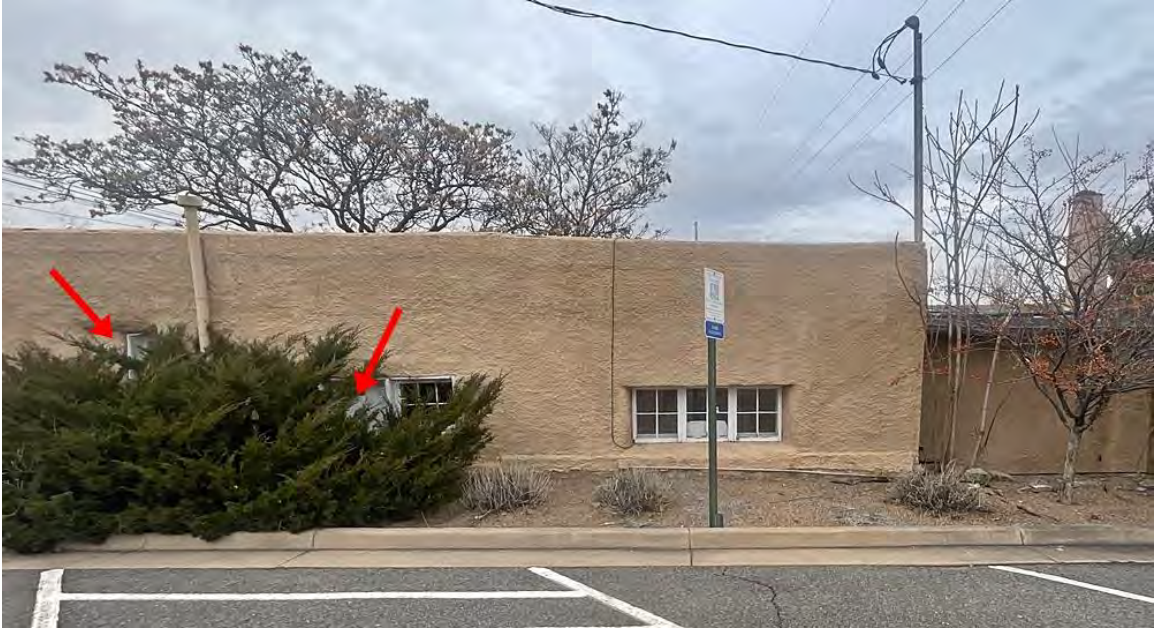
Photo 19: East elevation. Location of obscured windows. Camera facing west.

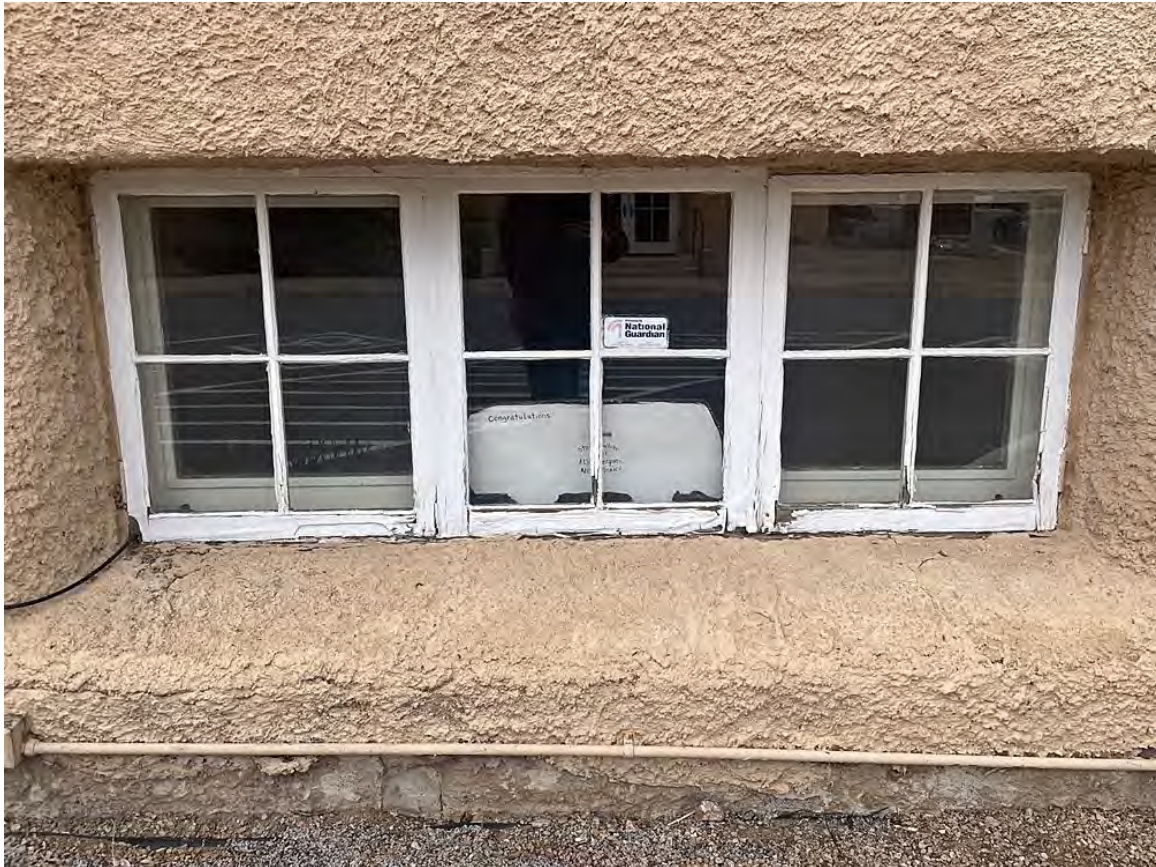
Fenestration is limited and consists of a mix of older wood sash windows, most set close to grade (Photo 20). One opening retains only partial sash elements (Photo 21), while another appears to have been partially filled in with stucco (Photo 22). The elevation terminates at the north with the post-1912 projection discussed above. Its east wall contains no fenestration but includes an exterior stuccoed chimney (Photo 23).

Photo 20: East elevation. Window detail. Camera facing west.

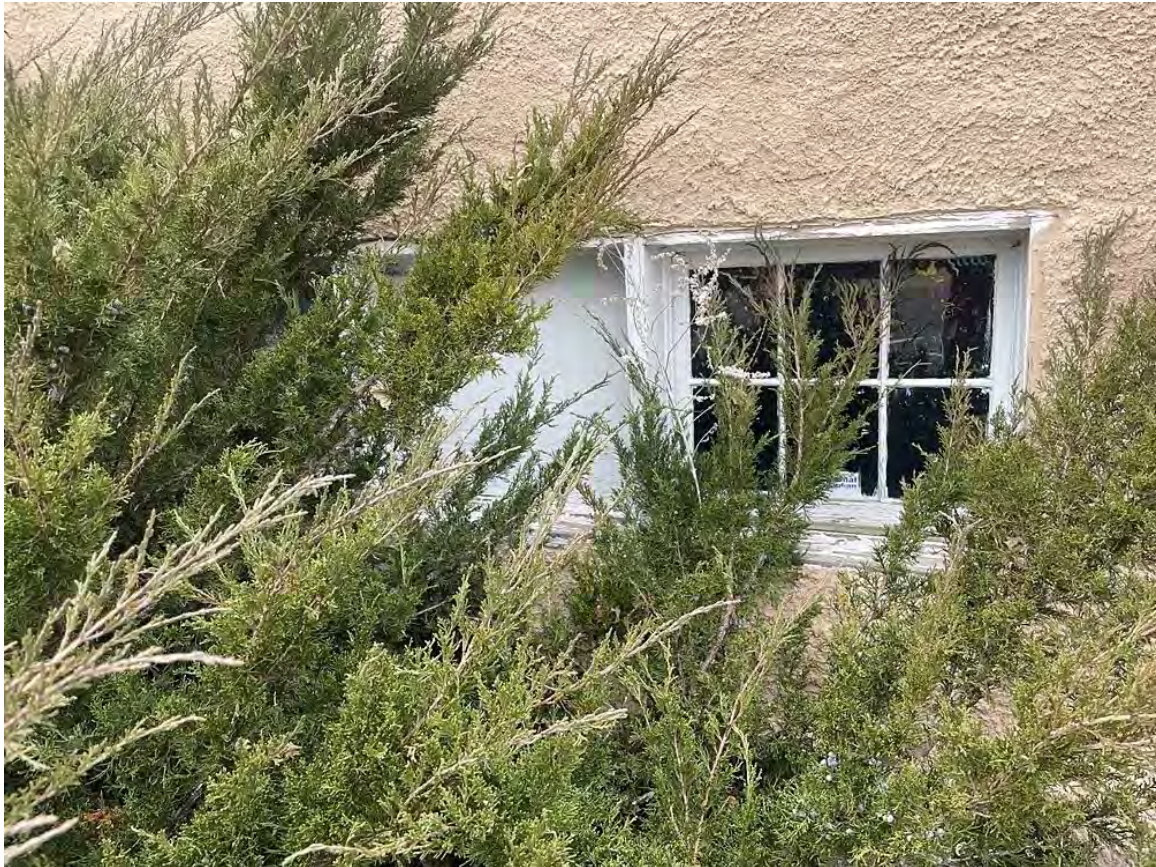
Photo 21: East elevation. Window detail. Camera facing west.
