RE: 1123 Paseo de Peralta Santa Fe, NM 87501 Status Review

Historic Cultural Properties Inventory (HCPI) Base Form (FORM 1)

1. Name of property: Alarid-Cisneros Property	2. Location: 1121 and 1123 Paseo de Peralta Downtown and Eastside Historic District — Santa Fe	3. Local Reference Number: Santa Fe ID: H-3032 & H-3033 4. County: Santa Fe Parcel # 12899330

8. Name of Project: HDRB Status Evaluation		
9. Lat/Long: 35.6812077,-105.9392107		
10. Photo Information: Giulia Caporuscio, photographer. Photo 1: View of north side of 1121 Paseo de Peralta. Camera facing southeast.

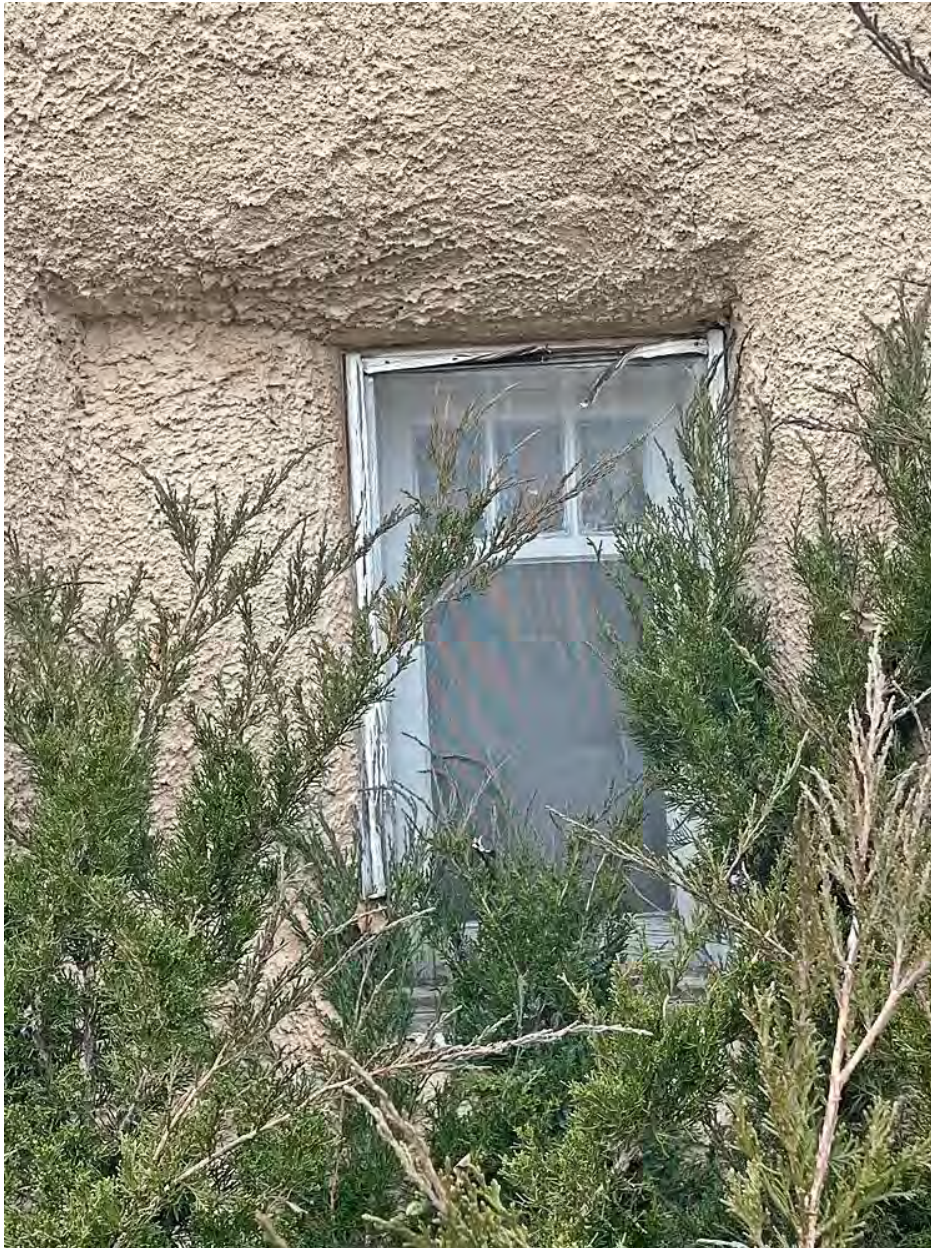
Fenestration is limited and consists of a mix of older wood sash windows, most set close to grade (Photo 20). One opening retains only partial sash elements (Photo 21), while another appears to have been partially filled in with stucco (Photo 22). The elevation terminates at the north with the post-1912 projection discussed above. Its east wall contains no fenestration but includes an exterior stuccoed chimney (Photo 23).

Photo 22: East elevation. Window detail. Camera facing west.

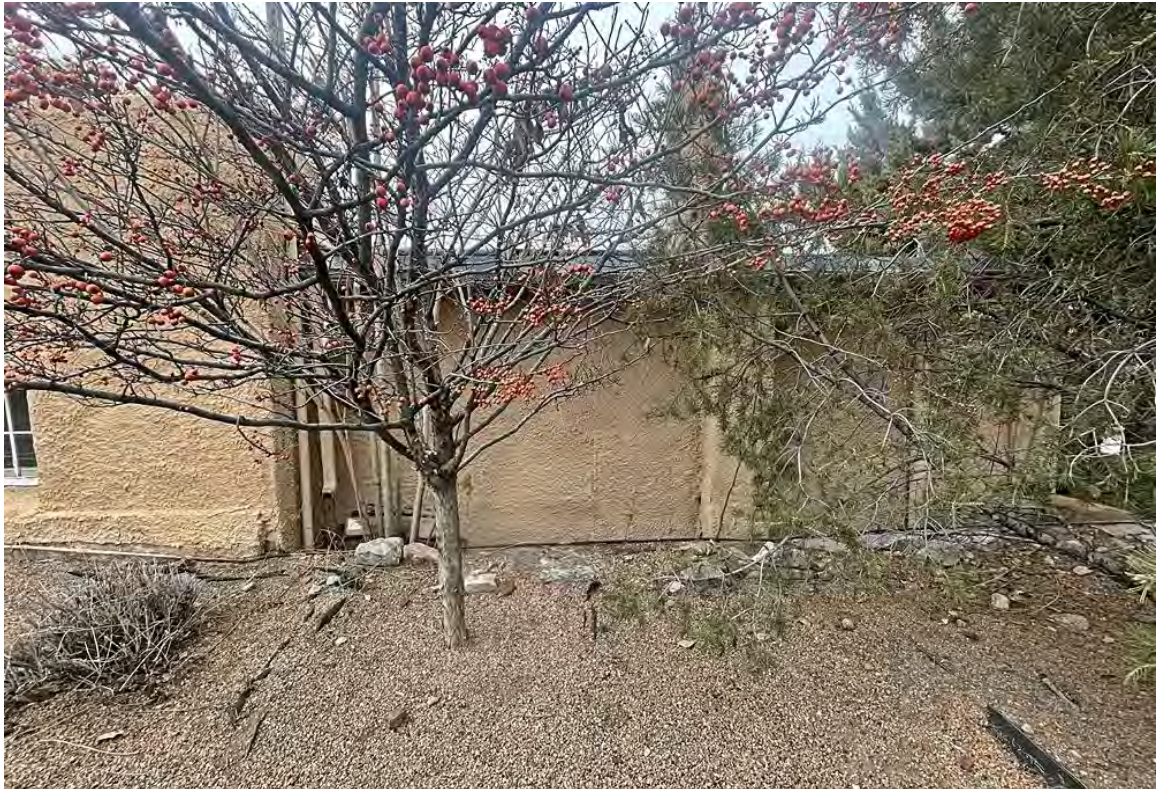
Photo 23: East elevation, pre-1930 addition. Camera facing west.

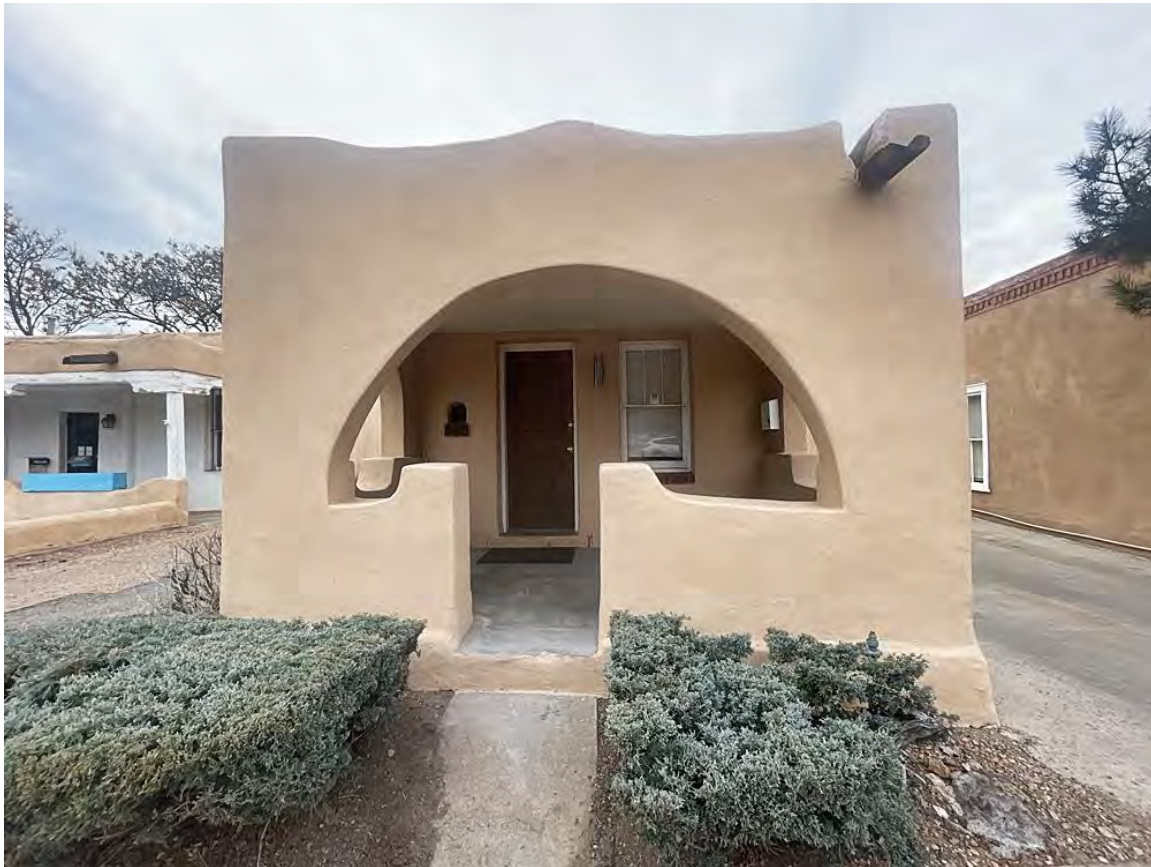
This building faces Paseo de Peralta with a shallow front porch distinguished by a series of uniquely shaped openings that reflect a vernacular expression of Mission Revival design. The central entry is articulated by an asymmetrical, mushroom-shaped opening with softened, rounded contours (Photo 24). Flanking the porch façade are more disciplined keyhole-shaped openings—a form also rooted in Mission Revival and related architectural modes influenced by Spanish and Moorish precedents (Photos 28 & 34).

Photo 24: North elevation. Camera facing south.

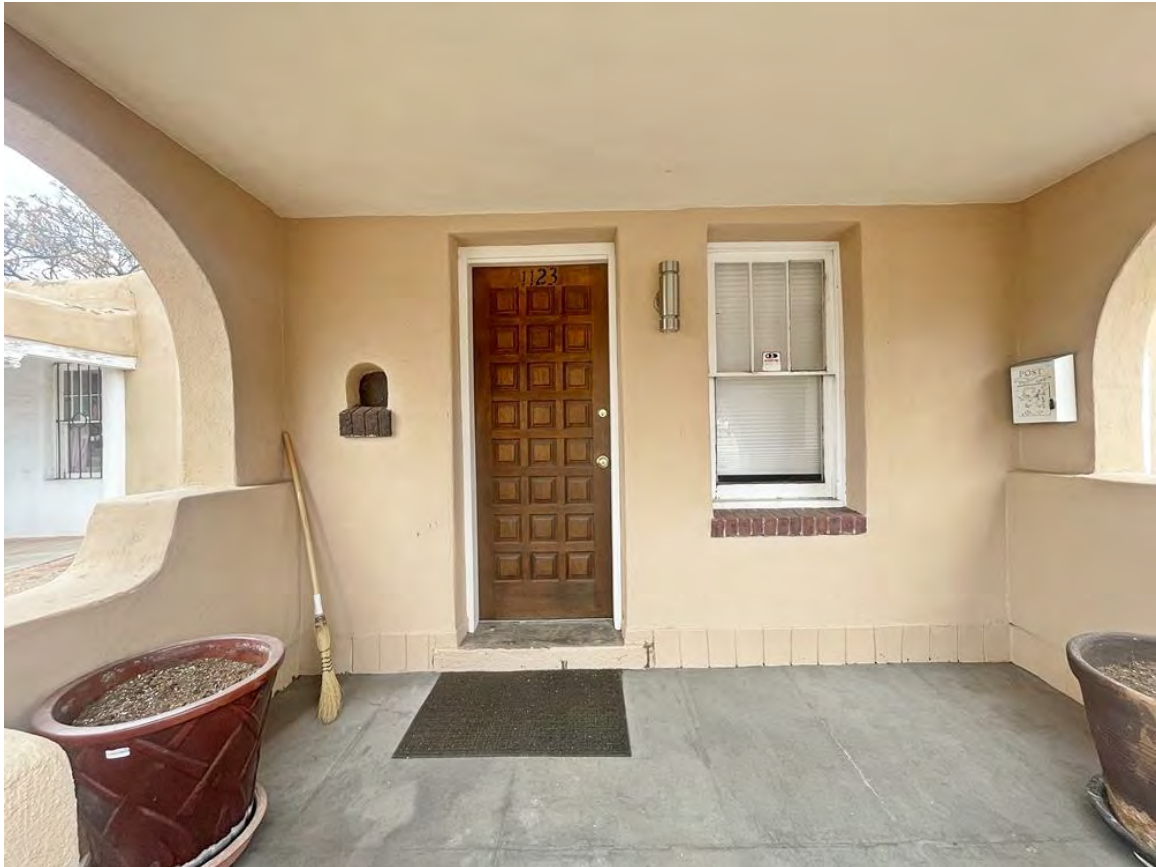
The porch interior features a plastered ceiling and a concrete floor. Historically, the floor incorporated decorative swastika motifs cast into the concrete, reflecting pre-World War II ornamental usage of the symbol.¹ These features were later intentionally removed or covered, likely in response to the symbol’s postwar associations. Interior access is provided through a non-historic 24-panel wood door (Photo 25). Near it is a *nicho* that once worked as a mailbox.

Photo 25: North elevation. Porch. Camera facing south.

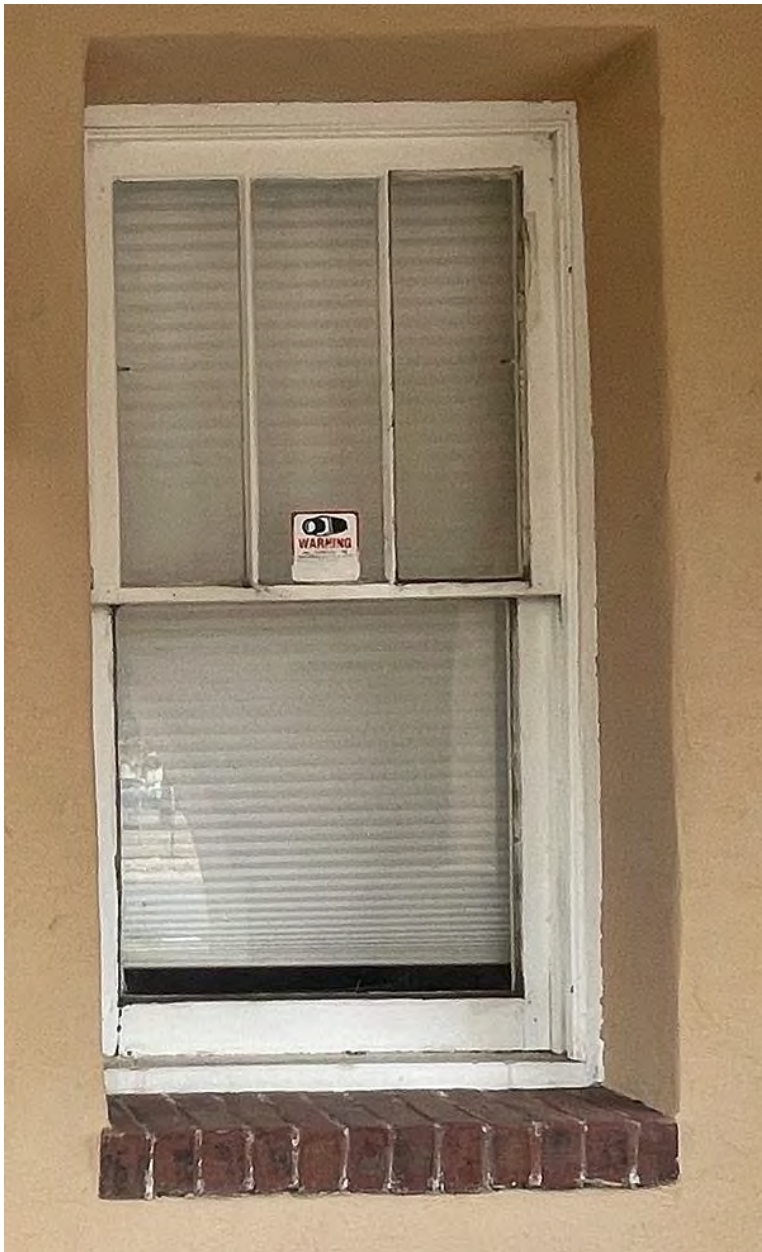
West of the entry is an opening containing a three-over-one wood hung-sash window (Photo 26). This window appears consistent in age with other original or early fenestration units associated with the 1931 construction. The opening is set several inches back from the wall plane, with straight, squared reveals lacking evidence of adobe shaping. A course of sloped bricks forms a sill beneath the window.

Photo 26: North elevation. Window detail. Camera facing south.

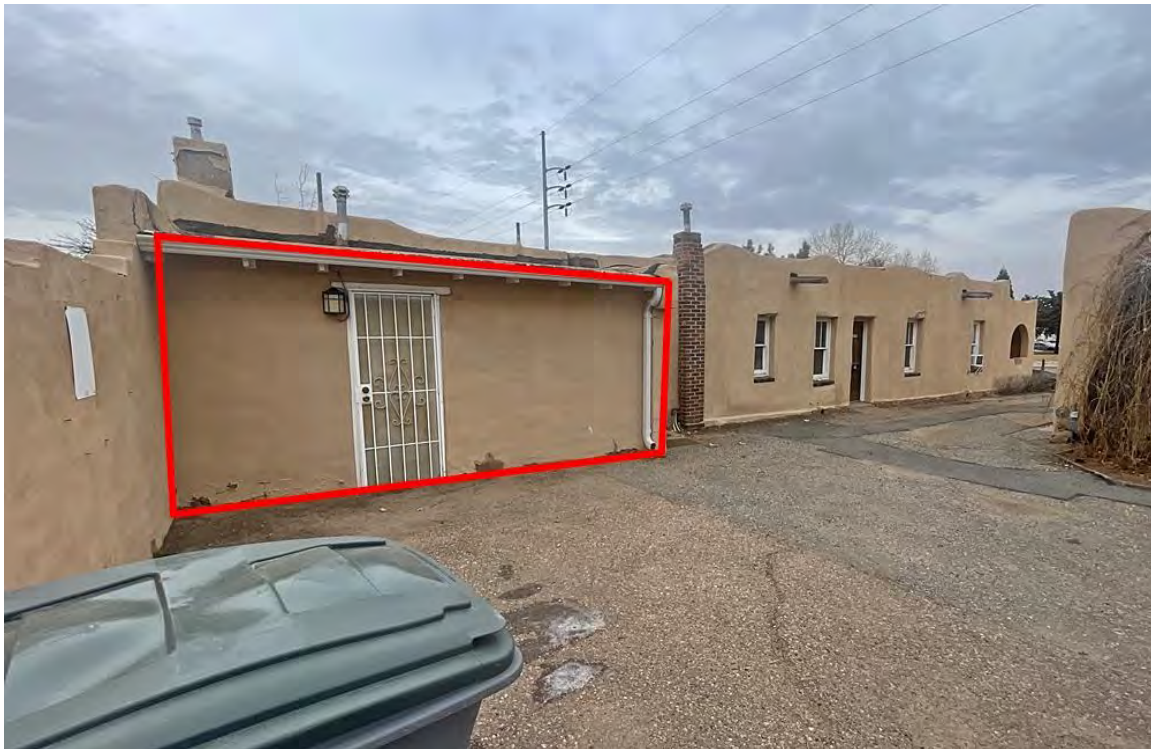
The long east elevation overlooks a narrow driveway separating the two former residences (Photo 27). Beginning at the north end are two window openings containing three-over-one wood sash units like the window on the porch; these rest on darker brick sills (Photo 28). An older galvanized metal trough *canale* penetrates the parapet above, one of several such drainage features found along the building.

Photo 27: East elevation. Camera facing northwest.

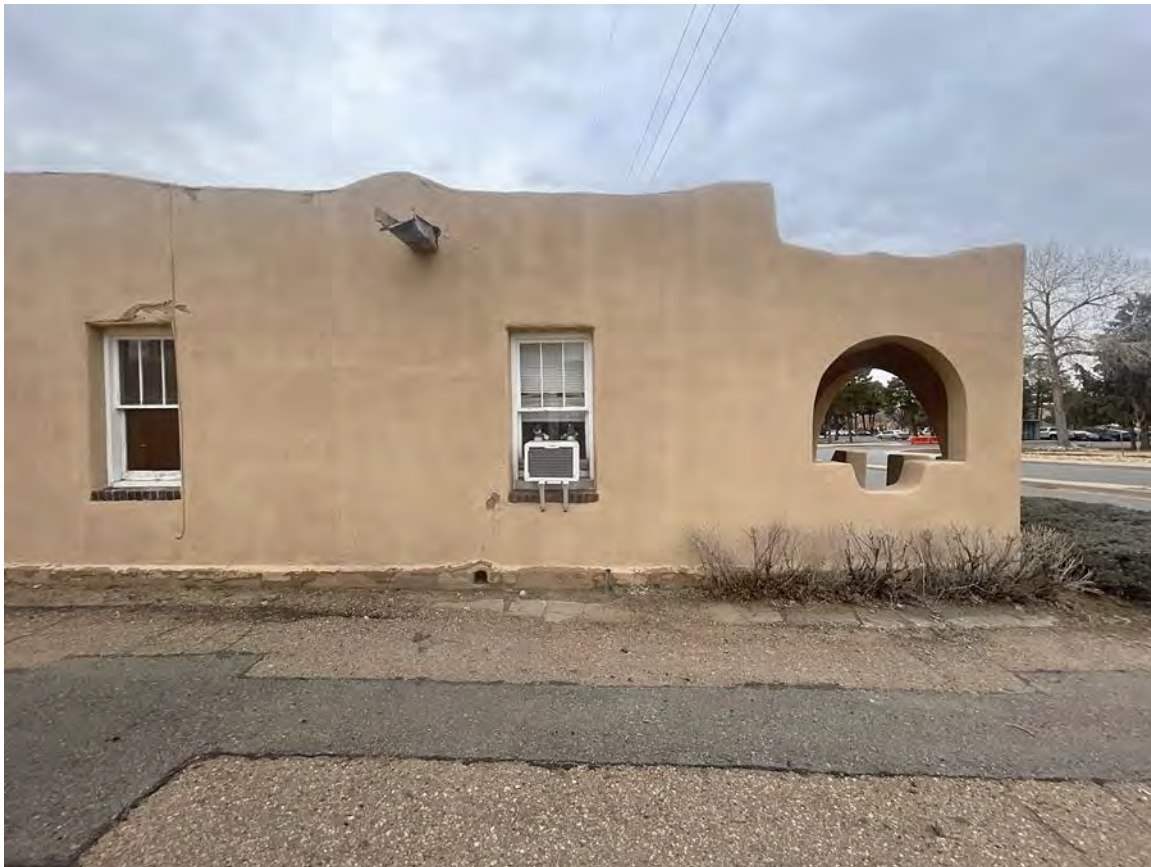
Photo 28: East elevation. North section. Camera facing west.

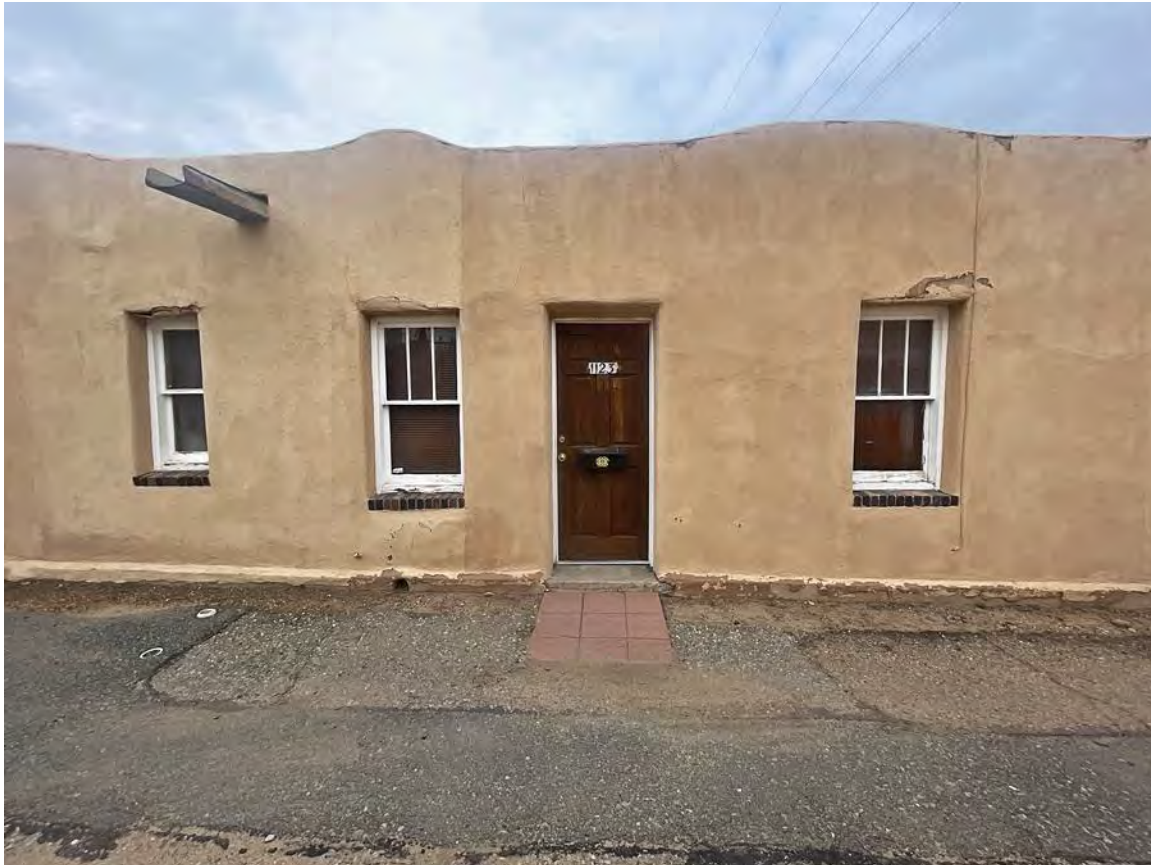
Near the center of the elevation is an entry fitted with a modern raised five-panel wood door (Photo 29). Immediately to the south is another three-over-one wood sash window, followed by a one-over-one wood window associated with a restroom. Beyond this point stands a small, multi-hued brick chimney stack and an adjacent entry obscured by a steel security door with applied scrollwork (Photo 30). This doorway appears to mark a transition between the 1931 house and an earlier structure incorporated into the building.

Photo 29: East elevation. Middle section. Camera facing west.

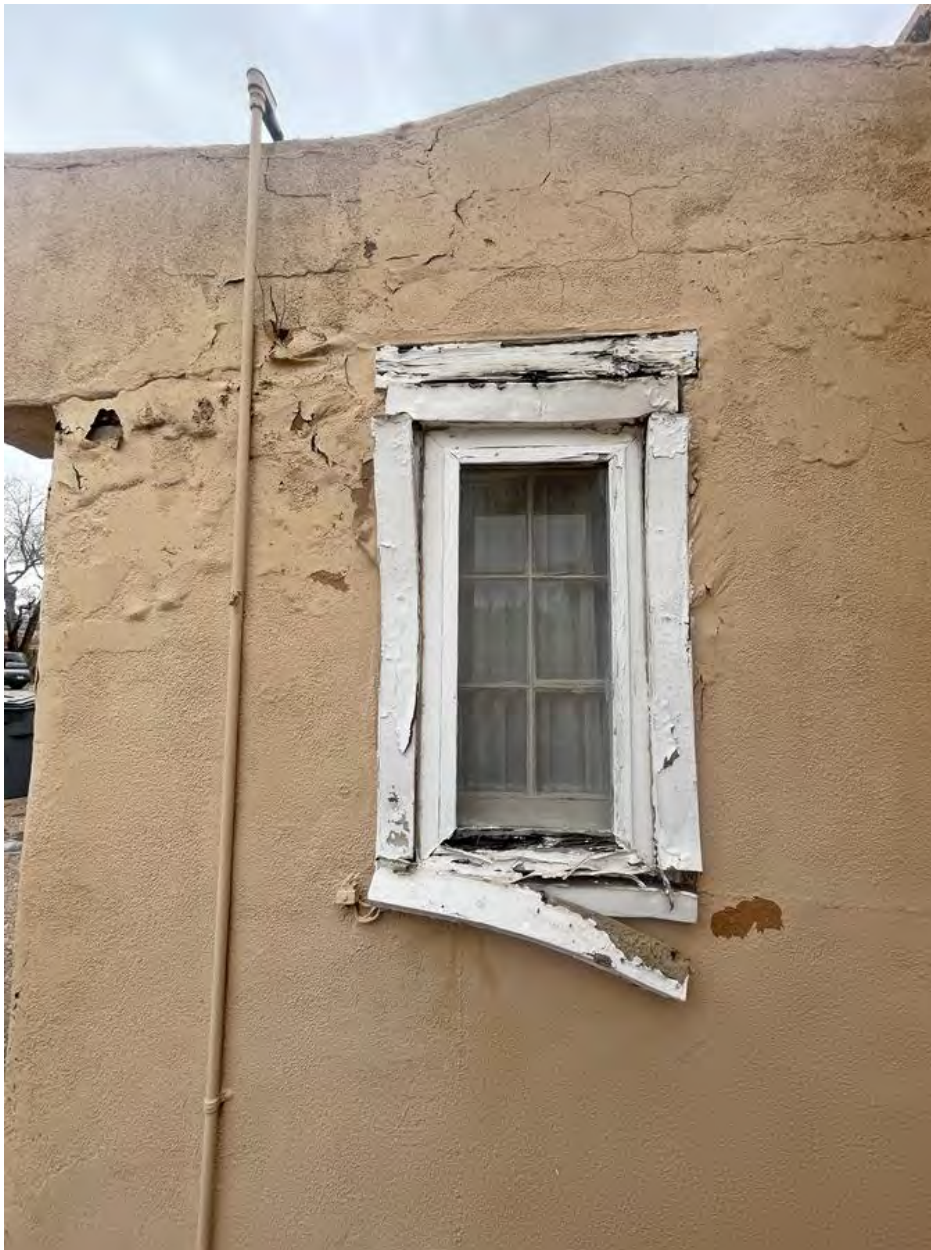
The addition’s short north elevation contains a small opening fitted with a six-light wood sash. The window is framed with simple wood casings and its sill appears partially disengaged (Photo 30). Subtle telegraphing lines at the top of the wall indicate that the addition is constructed of block.

Photo 30: East elevation. Addition and window detail. Camera facing south.

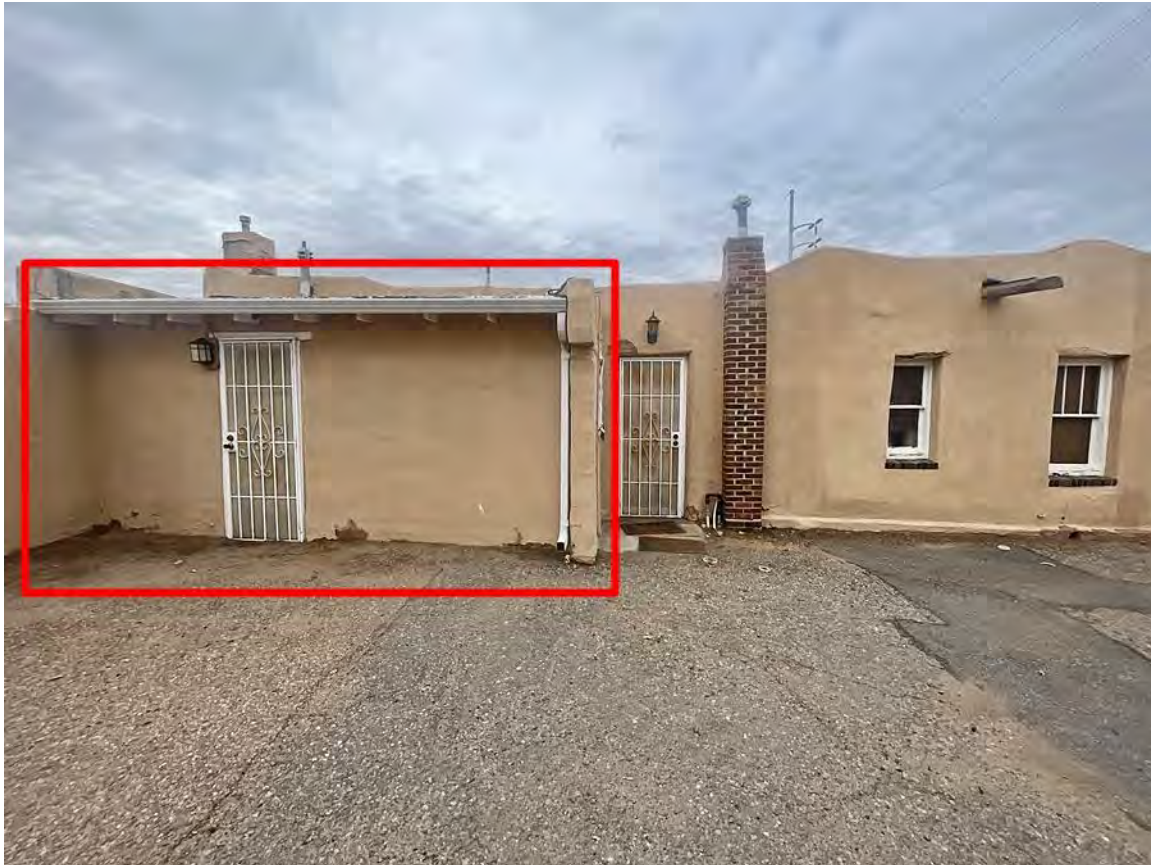
An entry on the east side is concealed by a second steel security door (Photo 31).

Photo 31: East elevation. Post-1978 addition. Camera facing west.

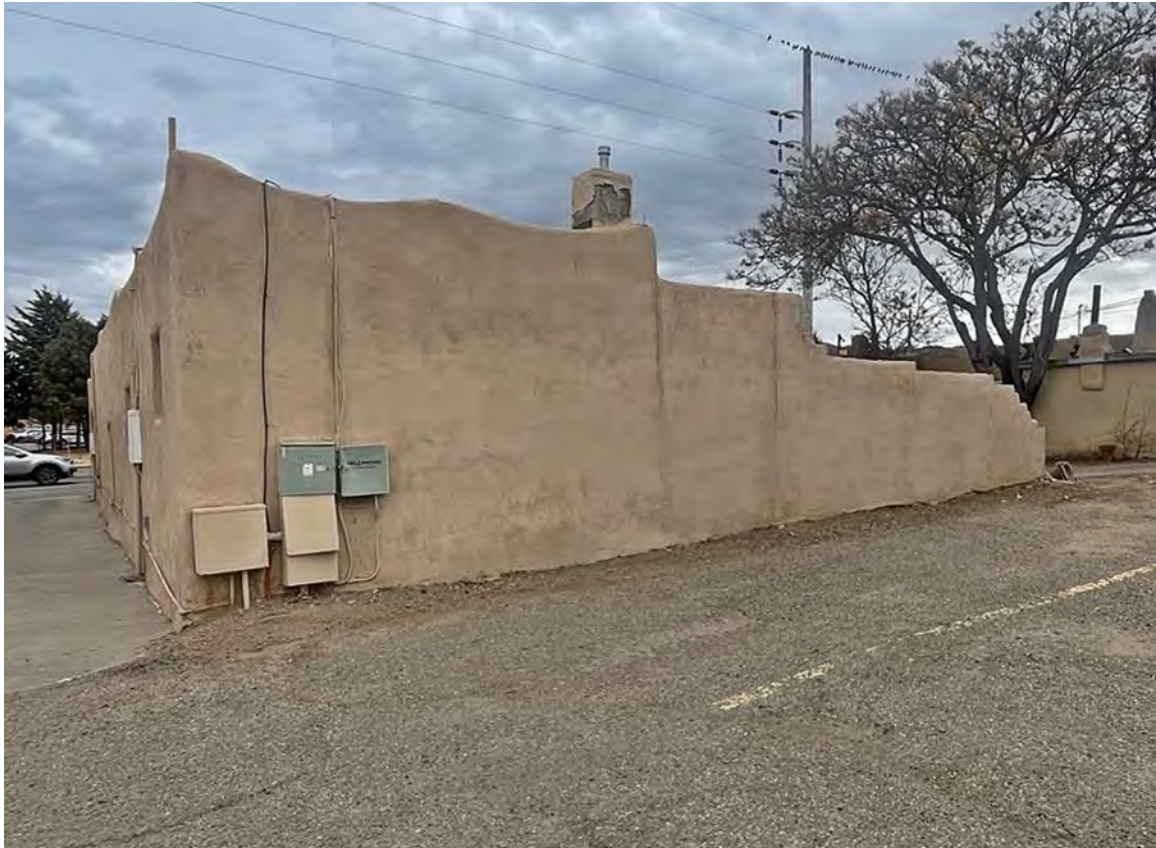
The short south elevation presents a transitional Mission-Pueblo silhouette, but of a much later date, and contains no fenestration (Photo 32). A wall attaches along the east side of this elevation and steps down along an eastward axis.

Photo 32: South elevation. Camera facing northeast.

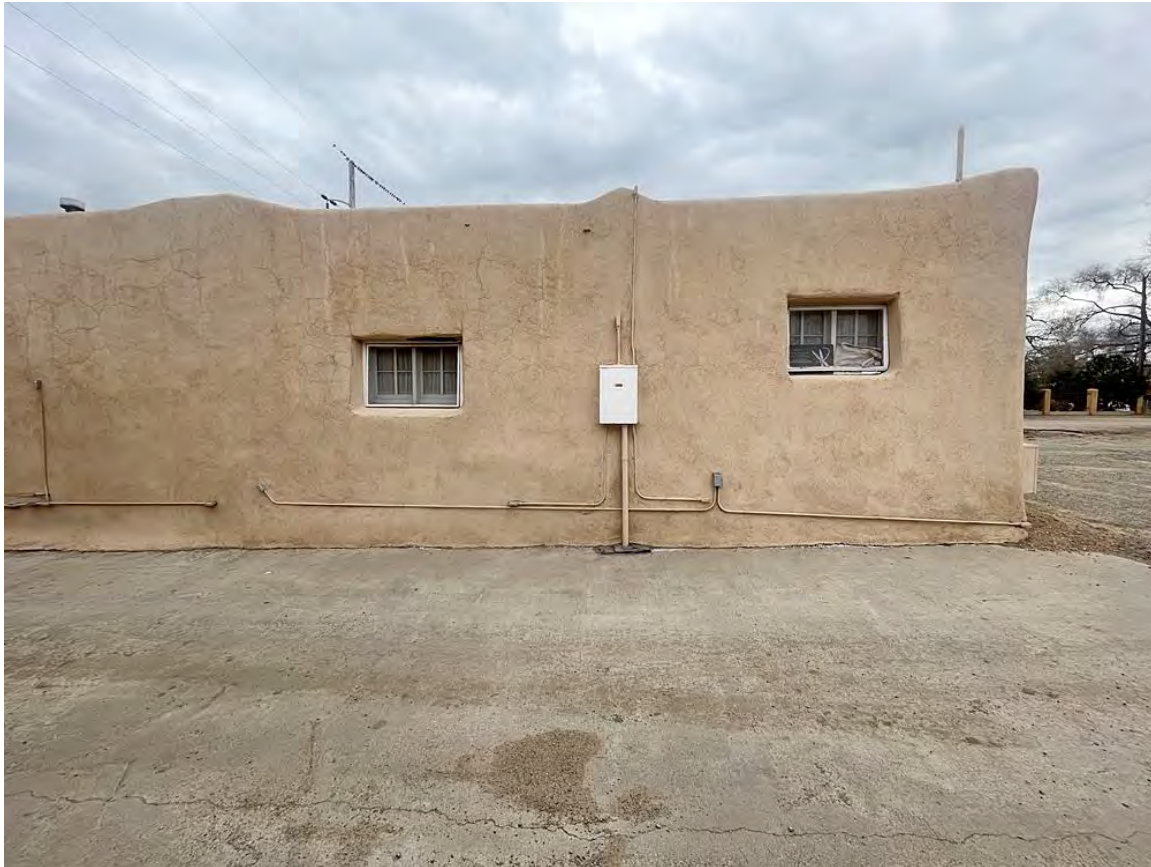
At the south end there are two small openings containing paired four-light wood casement windows (Photo 33). Their reduced size and elevated placement above grade suggest specialized or service-related interior uses. Moving north, the elevation transitions to an extended stretch of unfenestrated wall. Near the north end, adjacent to the porch, is a single opening fitted with paired three-light steel casement windows (Photo 34). Based on the straight reveals and the positioning of the opening, the casement units appear to be replacements for an earlier wood window.

Photo 33: West elevation. South end. Camera facing east.

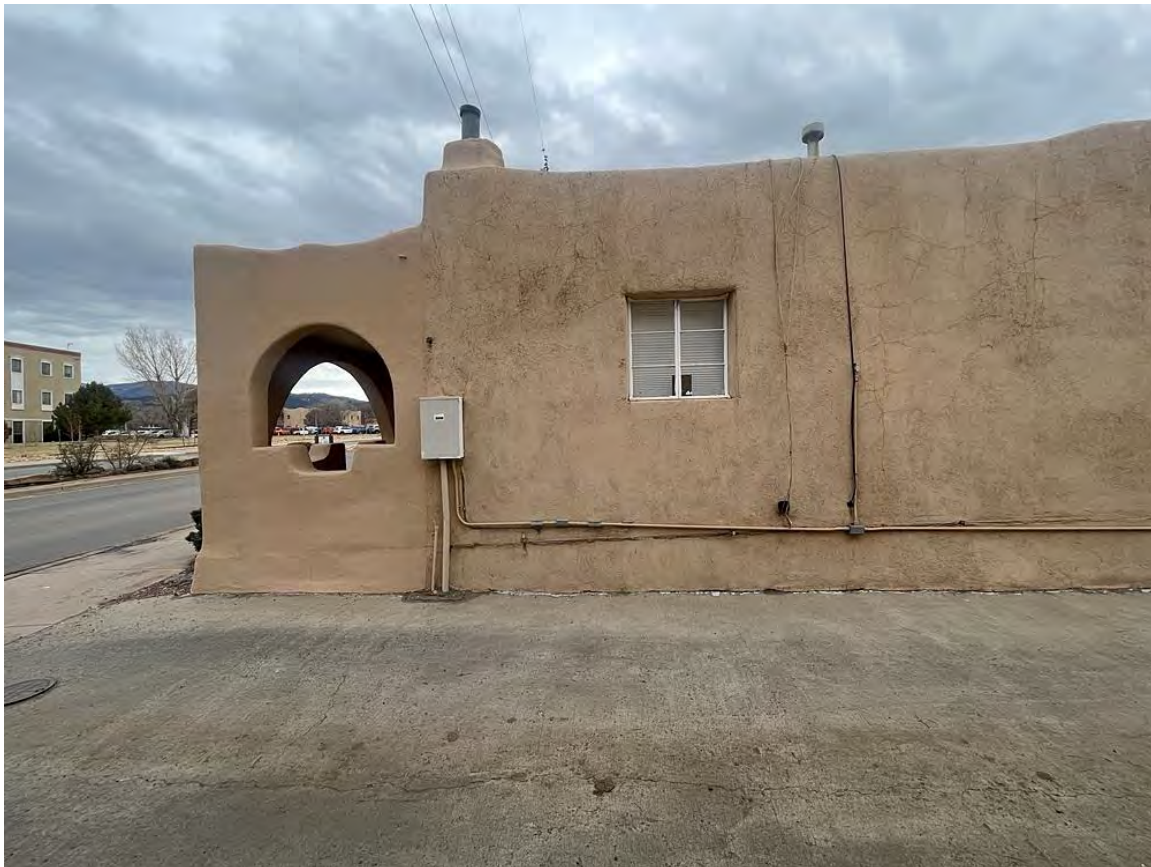
Photo 34: Camera facing east. North end. Camera facing east.
