# RPA & Associates, LLC.

JOB	DATE
120 Camino Santiago, Santa Fe, NM 87501	03/10/2026

RPA & ASSOCIATES, LLC | WINDOW & DOOR CONDITION AND INTEGRITY CODES

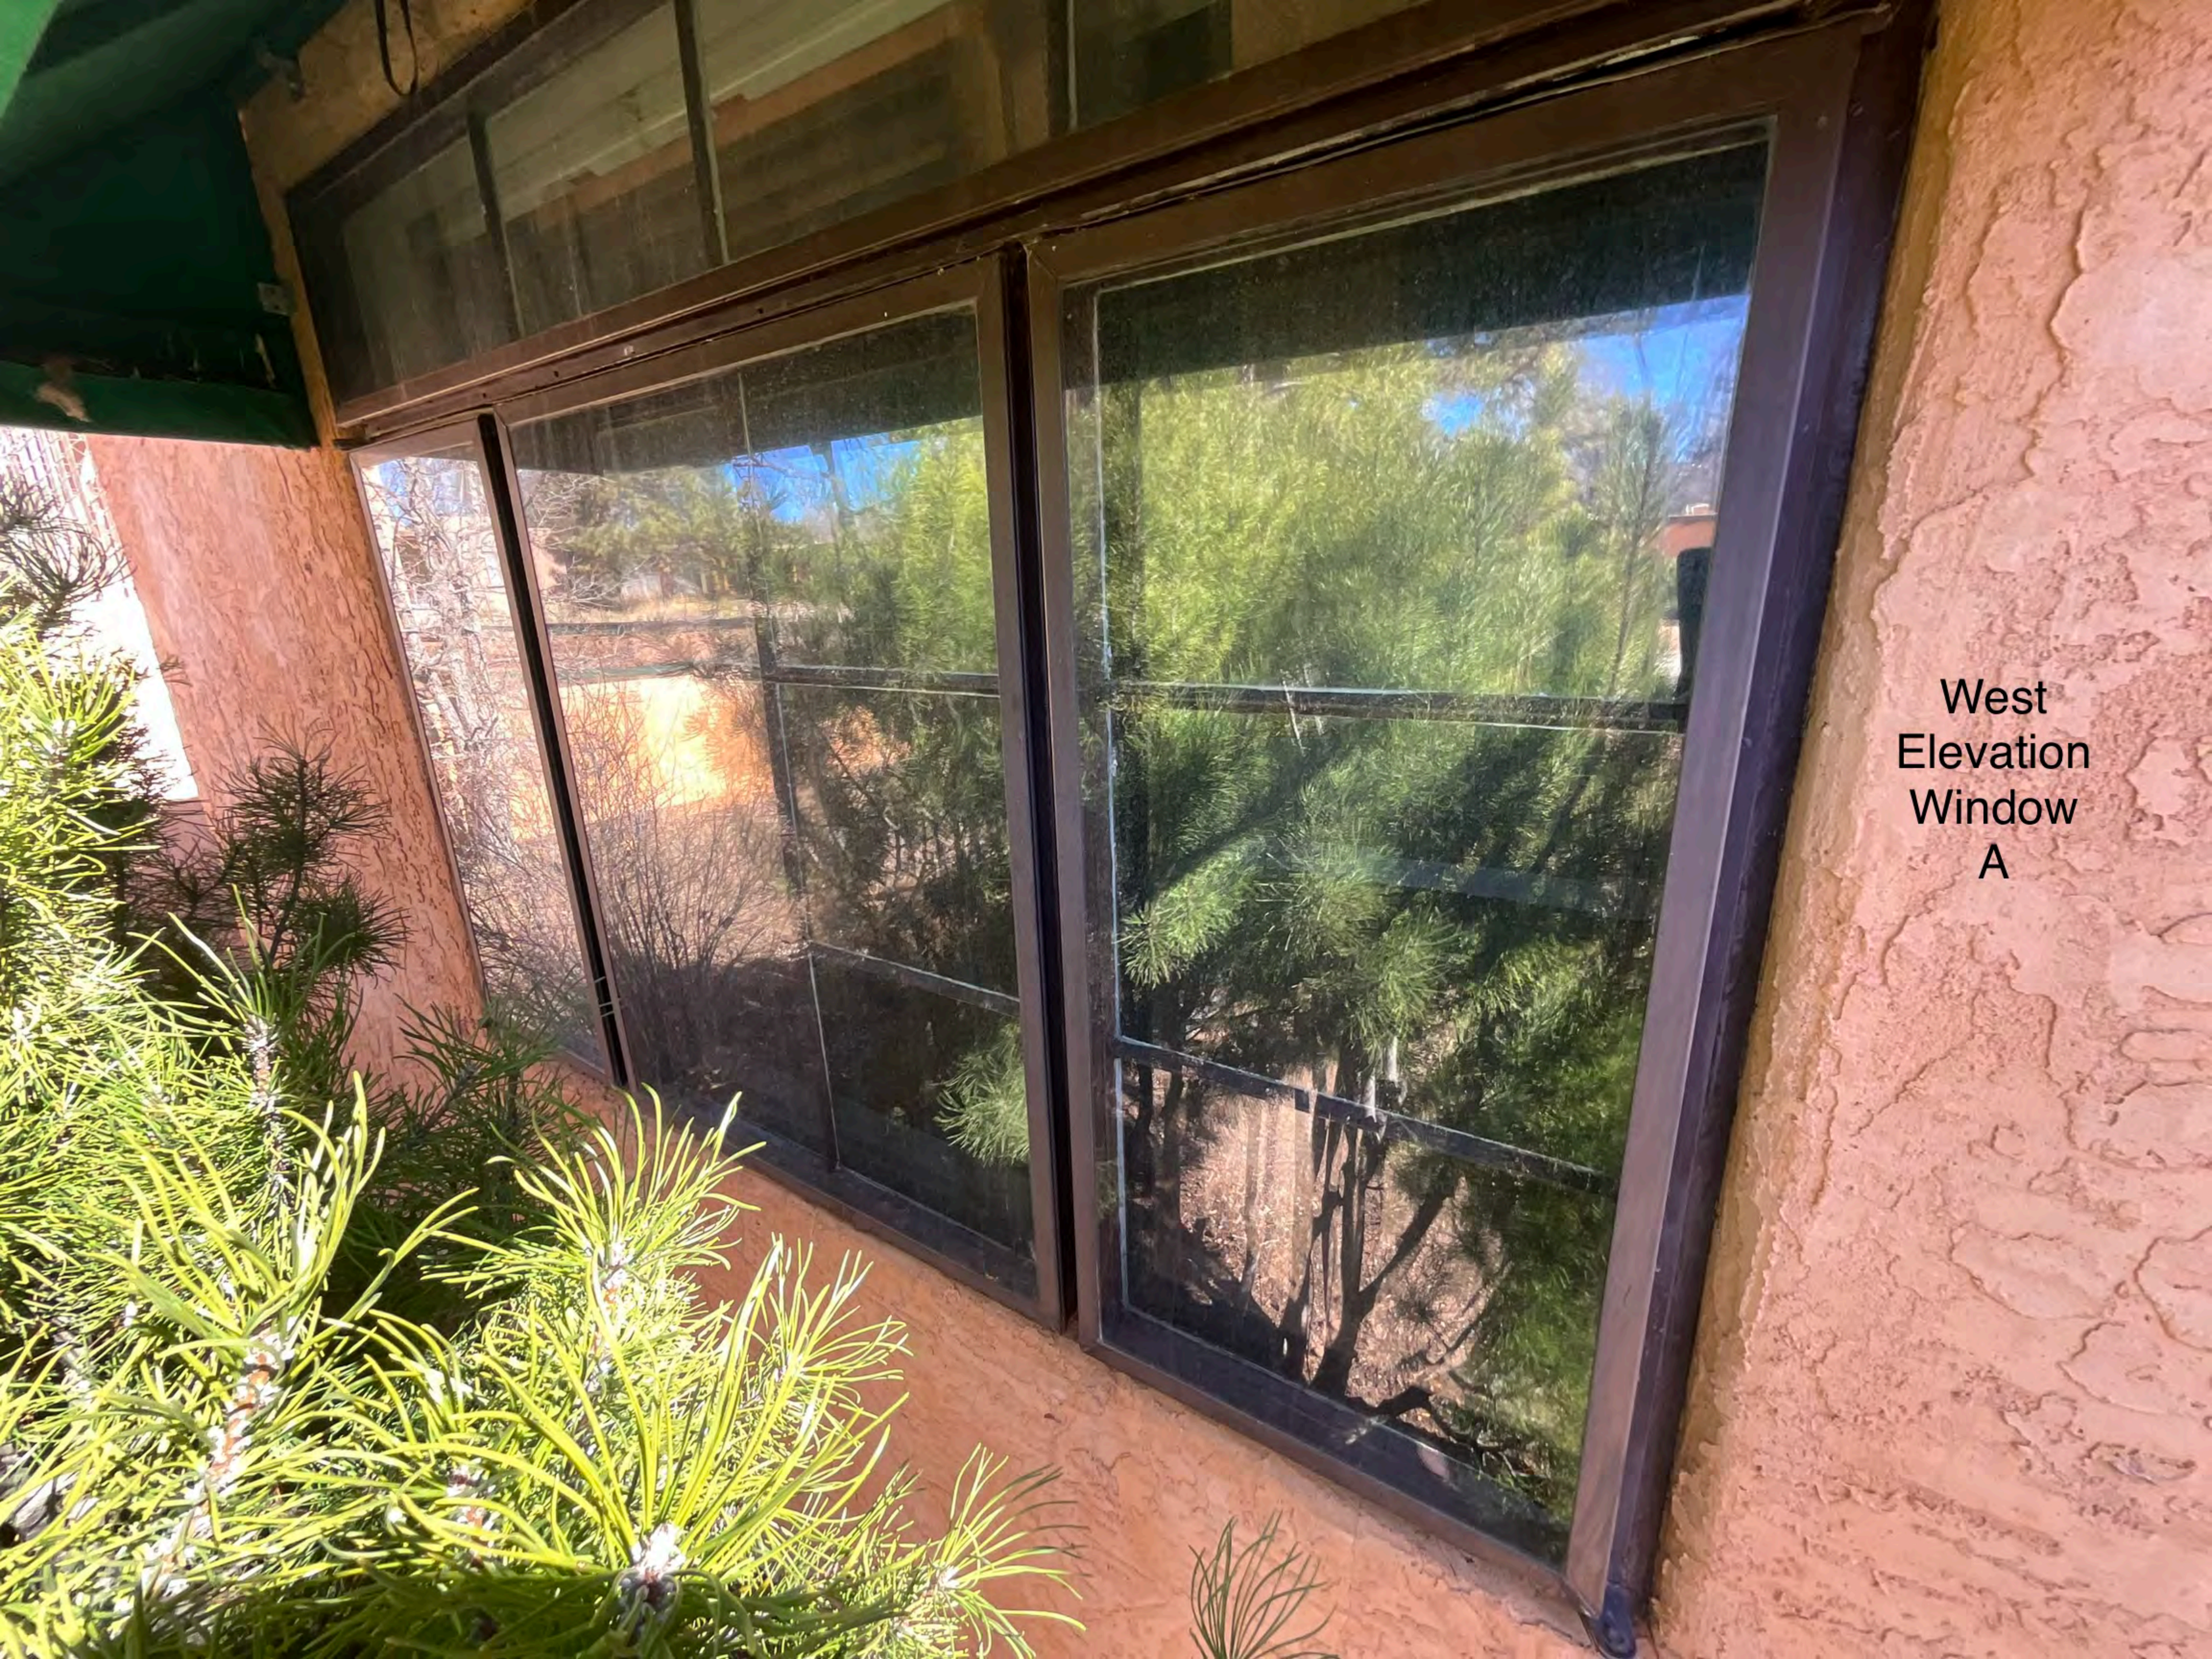
West  
Elevation  
Window  
A

Windows A, C, E, and F are historic however there is interior wall damage from the condensation of the steel casement. The storms of these units are not historic.

LABEL	WINDOW & DOOR DESCRIPTION	CONDITION & INTEGRITY CODE	HISTORIC/NON-HISTORIC - AGE
<b><u>WEST</u></b>			
A	68" x 51" LSR TRIPLE STEEL CASEMENT W/STORM 38" TALL W/12" TRANSOM 18"/32"/18" x 38" W/68' x 12" TRANSOM 1W3H/2W3H/1W3H W/4W1H TRANSOM	F	<b>HISTORIC</b> - CONDENSATION FROM THE STEEL CASEMENT CAUSING DAMAGE TO THE INSIDE PLASTER <b>NON-HISTORIC</b> - STORMS (1989)
DR #1	36" x 80" LH INSWING DOOR 3W5H PANELS 1-CTR GLASS ALL WOOD	S	<b>NON-HISTORIC</b> - SIMPSON FIR DOOR (1996)
DR #2	36" x 80" RH OUTSWING DOOR MASONITE 6-PANEL	S	<b>NON-HISTORIC</b> - MASONITE (2008)
DR #3	36" x 80" RH INSWING DOOR 3W5H PANELS 1-CTR GLASS ALL WOOD	S	<b>NON-HISTORIC</b> - SIMPSON FIR DOOR (1996)
<b><u>NORTH</u></b>			
DR #4	50" x 80" TWIN (2-24") LH OUTSWING 1 3/4" SC FLUSH BIRCH ALL WOOD	S	<b>NON-HISTORIC</b> - SKINNED BIRCH DOOR (2008)
DR #5	50" x 80" TWIN (2-24") LH OUTSWING 1 3/4" SC FLUSH BIRCH ALL WOOD	S	<b>NON-HISTORIC</b> - SKINNED BIRCH DOOR (2008)

The window units that are going to be replaced should be in “like and kind” similar to historic windows. These units should be in a composite or clad/wood pop-in with simulated divided light (no grilles) or metal bars, manufactured such as Kolbe, Weathershield, or Marvin.

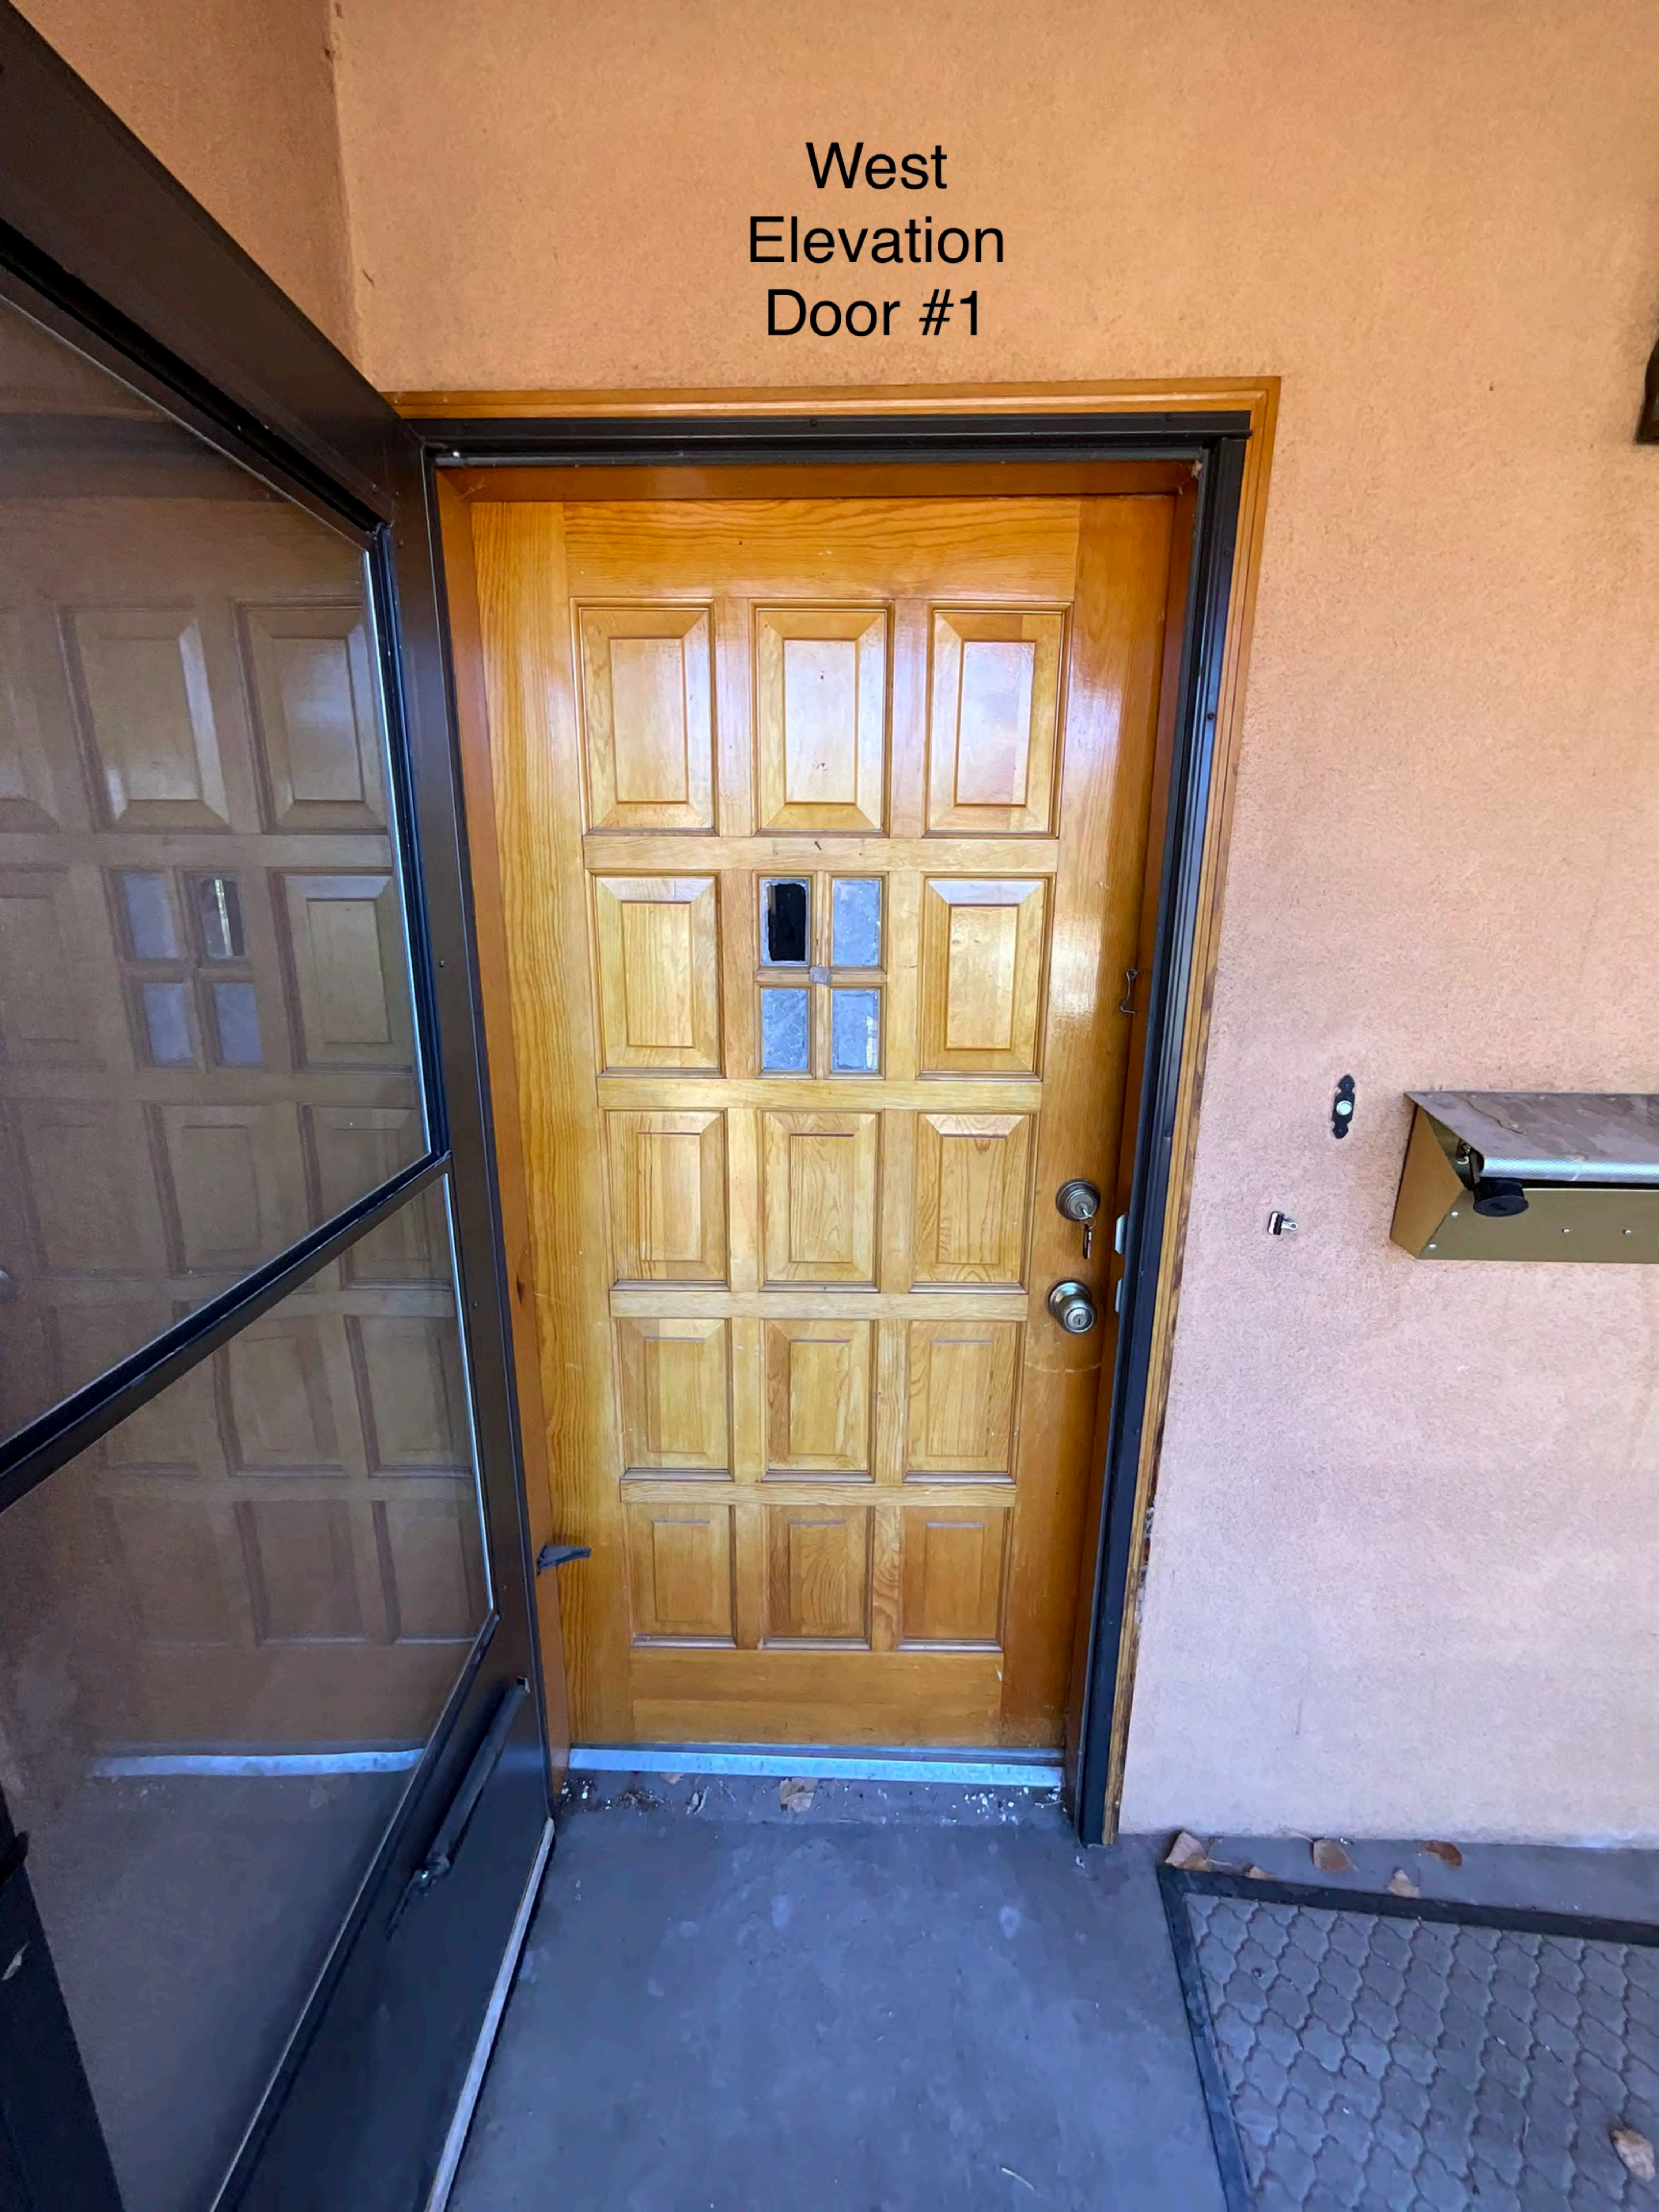
West  
Elevation  
Door #1

Doors 1, 2, 3, 4, 5, 6, 7, 8, and 9 are non-historic.

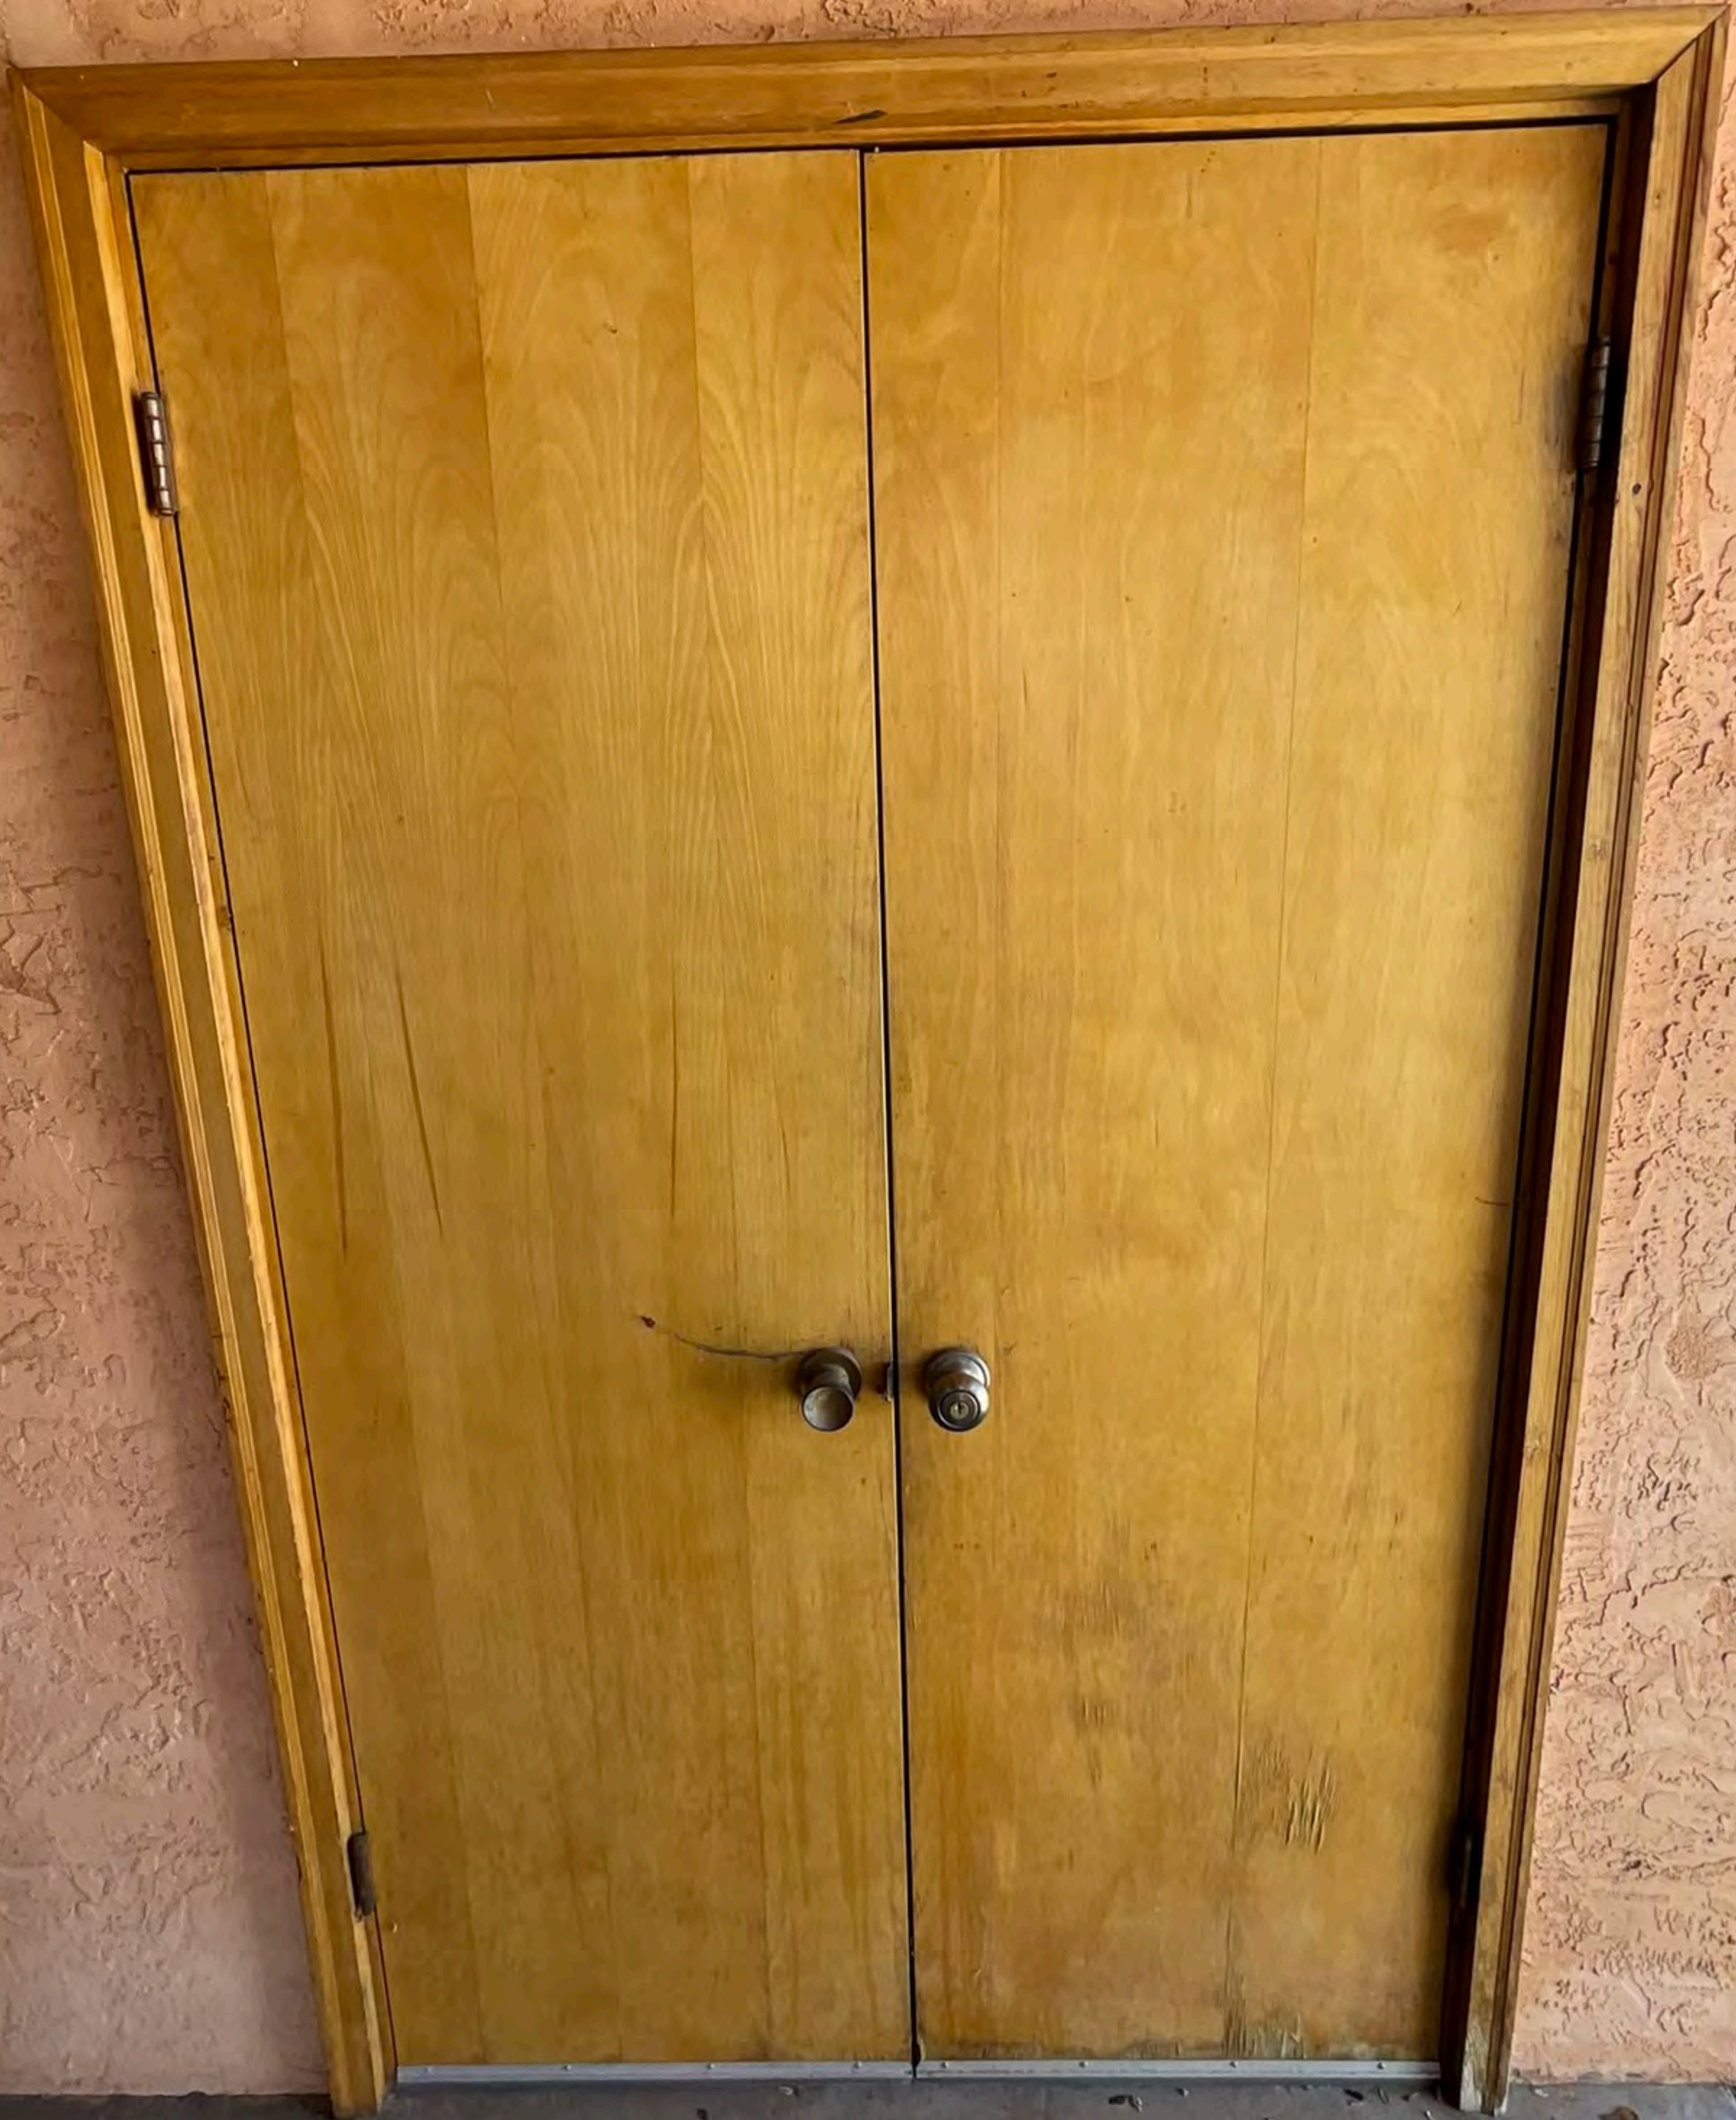
North  
Elevation  
Door #6

DR #6	50" x 80" TWIN (2-24") LH OUTSWING 1 3/4" SC FLUSH BIRCH ALL WOOD	S	<b>NON-HISTORIC</b> - SKINNED BIRCH DOOR (2008)
<b><u>SOUTH</u></b>			
B	36" x 35 1/2" AWNING VENT BRONZE CLAD/INTERIOR WINDOW 3W2H SDL W/INSULATED LOW-E GLASS	S	<b>NON-HISTORIC</b> - MARVIN (2012)

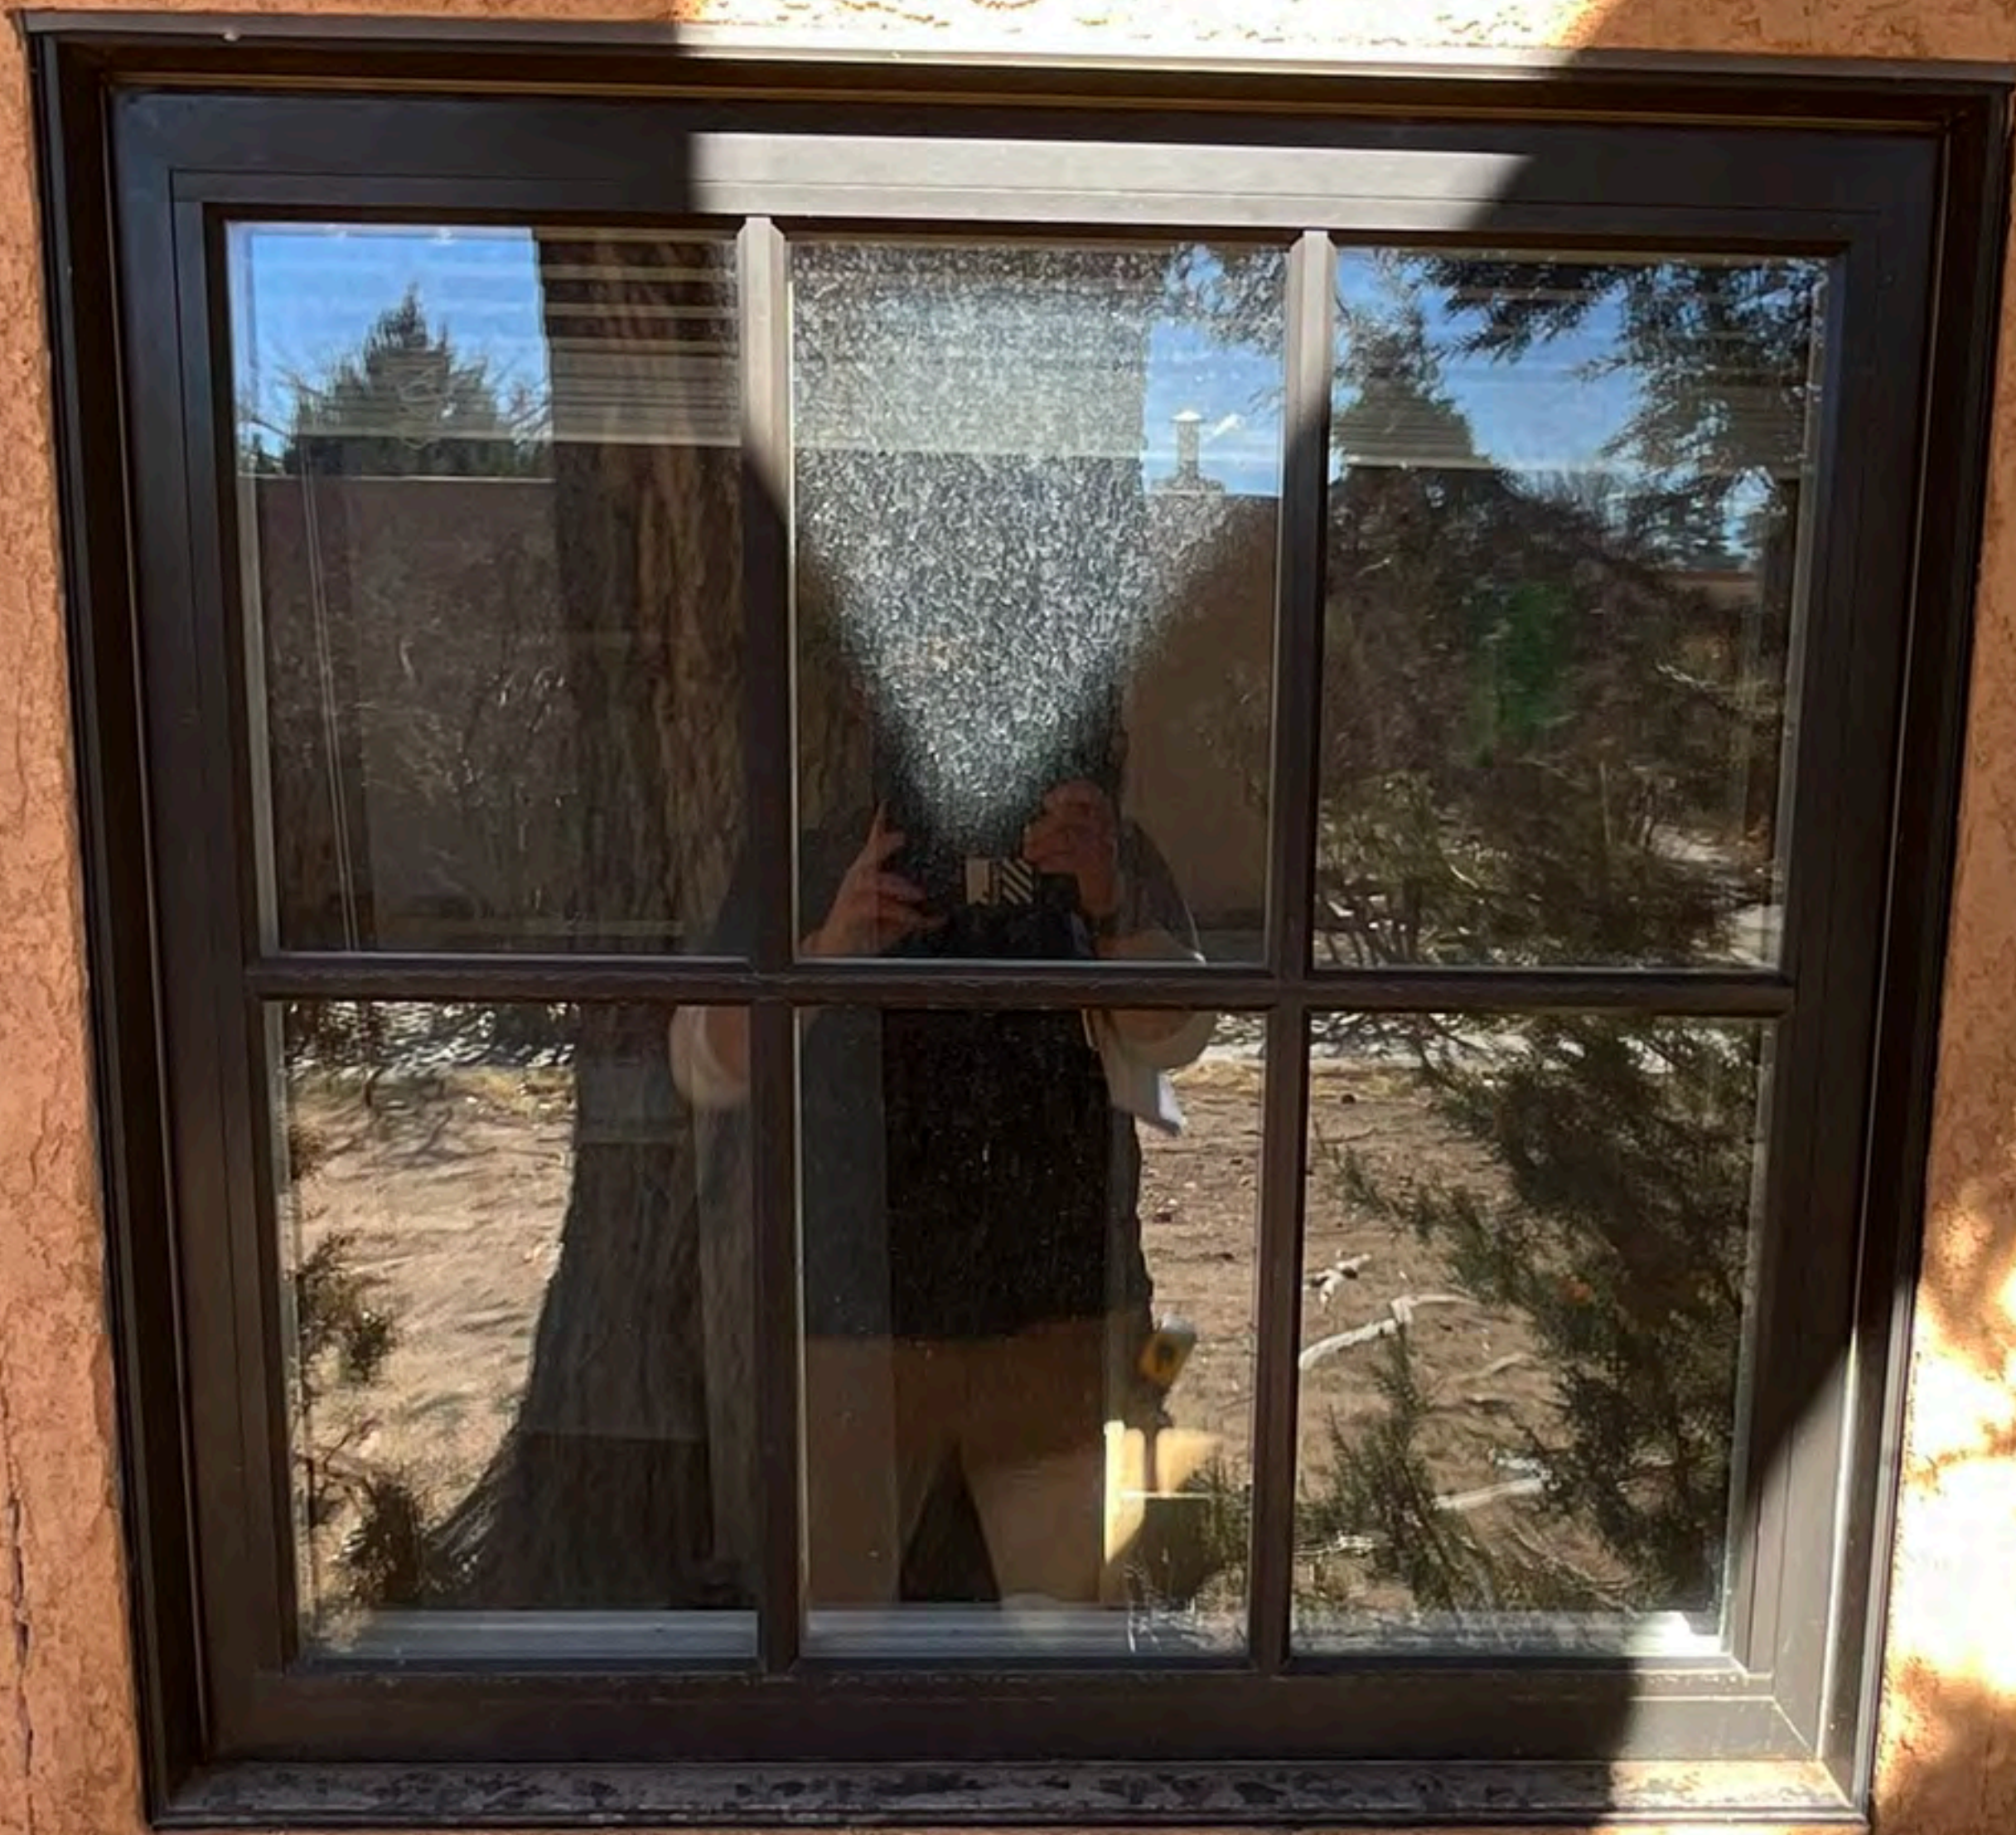
South  
Elevation  
Window  
B

Window B and D are non-historic.

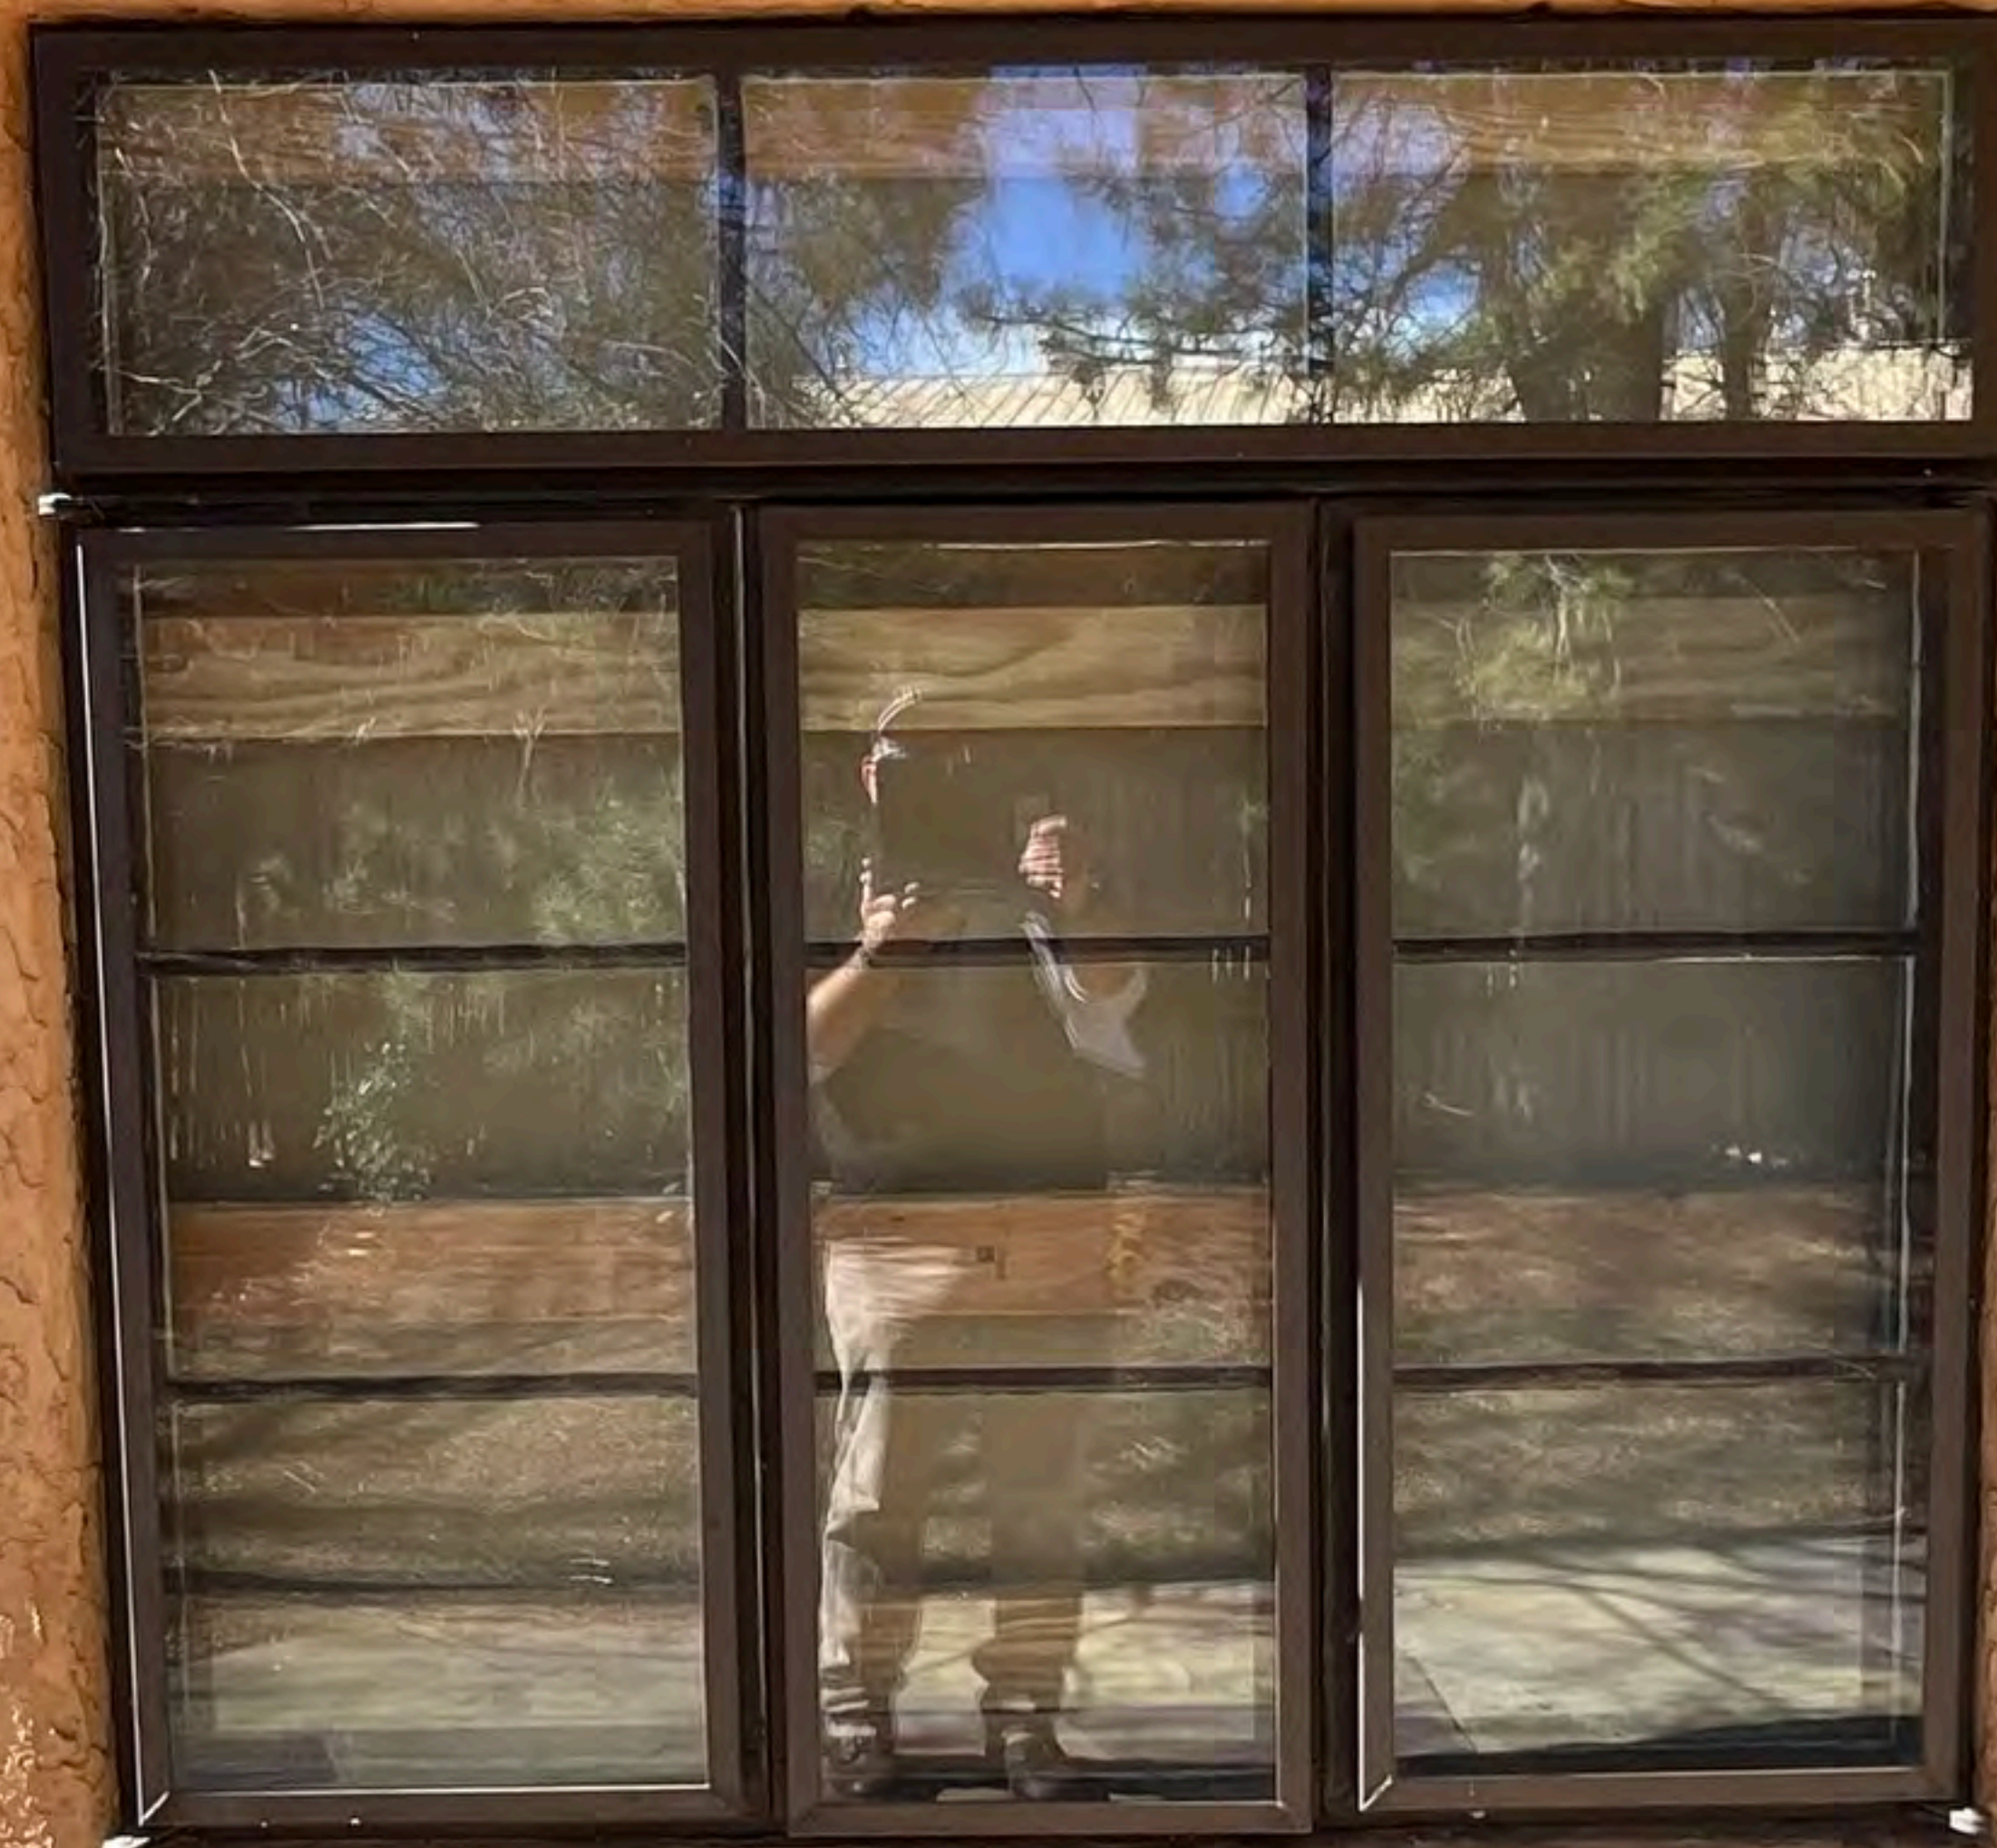
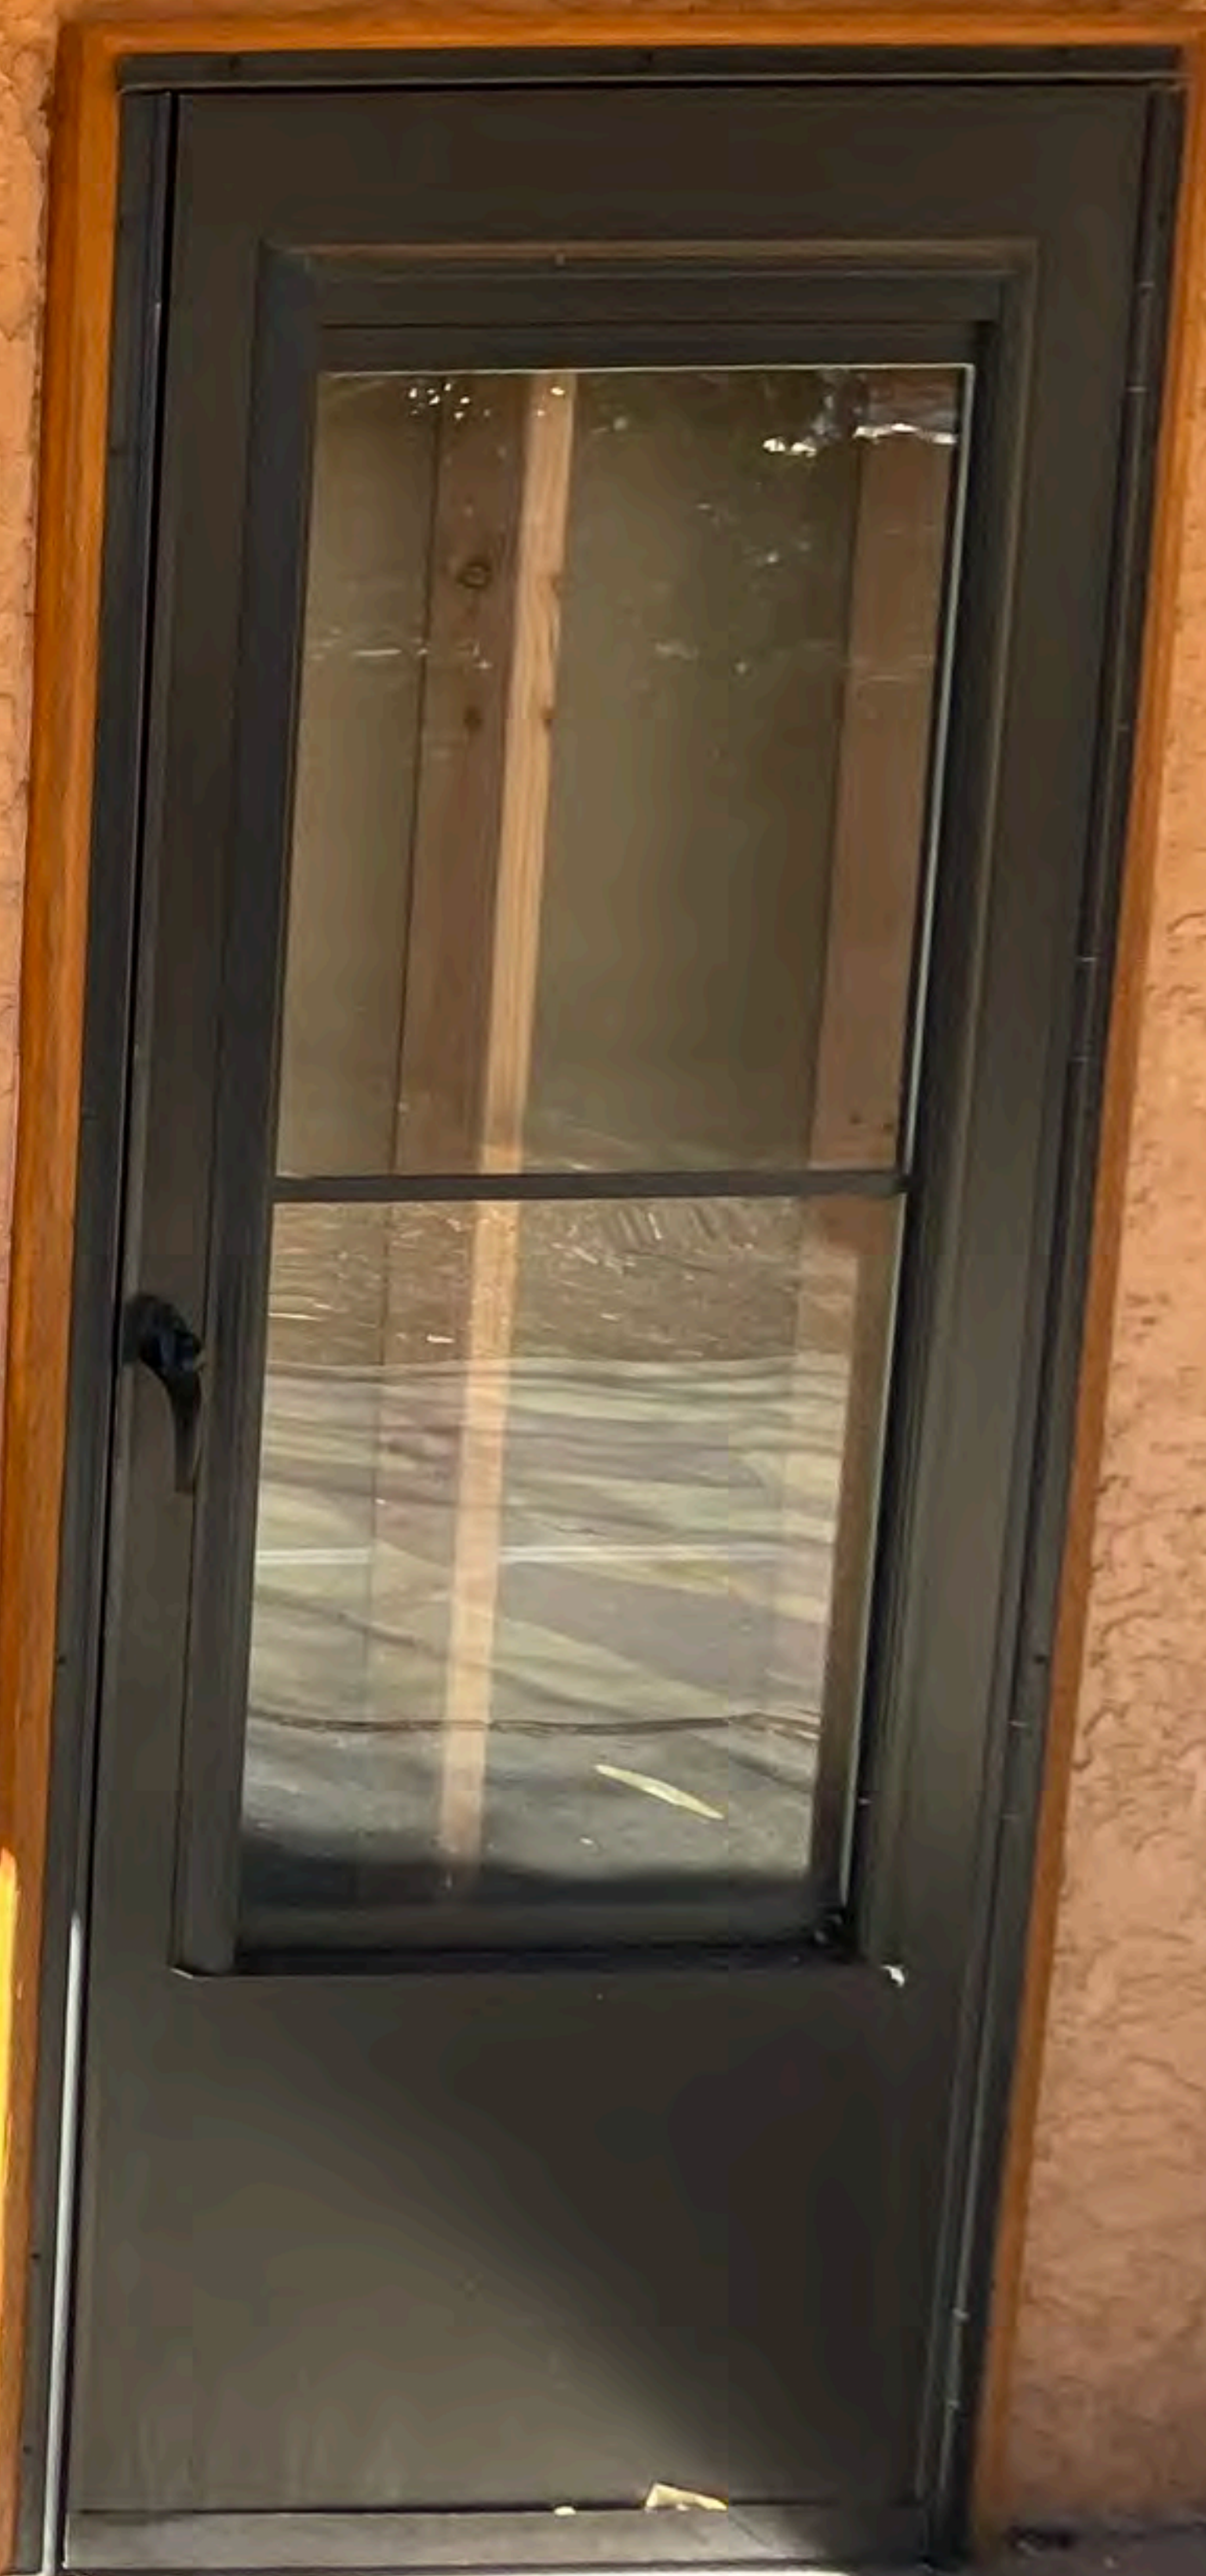
East Elevation  
Window  
C

LABEL	WINDOW & DOOR DESCRIPTION	CONDITION & INTEGRITY CODE	HISTORIC/NON-HISTORIC - AGE
<b><u>EAST</u></b>			
C	52" x 52" LSR TRIPLE STEEL CASEMENT (3-18") W/TRANSOM 38" HEIGHT/12" HEIGHT 1W3H/1W3H - 3W1H	S	<b>HISTORIC</b> - CONDENSATION FROM THE STEEL CASEMENT CAUSING DAMAGE TO THE INSIDE PLASTER <b>NON-HISTORIC</b> - STORMS (1989)
DR #7	30' x 80" RIGHT HINGED STORM DOOR - COMBINATION BRONZE	S	<b>NON-HISTORIC</b> - (2012)
DR #8	72" x 80" SLIDING GLASS DOOR ALUMINUM CLAD/WOOD 3W5H SDL W/INSULATED LOW-E GLASS	S	<b>NON-HISTORIC</b> - MARVIN (2012)
D	72" x 40" FIXED WINDOW ALUMINUM CLAD/WOOD 7W3H SDL W/INSULATED LOW-E GLASS	S	<b>NON-HISTORIC</b> - MARVIN (2012)
<b><u>SOUTH</u></b>			
DR #9	30" x 80" RH INSWING DOOR W/3W3H/CROSSBACK BOTTOM ALL WOOD	F	<b>NON-HISTORIC</b> - SIMPSON FIR DOOR (1996)
<b><u>EAST</u></b>			
E	52' x 52" LSR TRIPLE STEEL CASEMENT (3-18") W/TRANSOM 38" HEIGHT/12" HEIGHT 1W3H/1W3H - 3W1H	F	<b>HISTORIC</b> - CONDENSATION FROM THE STEEL CASEMENT CAUSING DAMAGE TO THE INSIDE PLASTER <b>NON-HISTORIC</b> - STORMS (1989)
