# RPA & Associates, LLC.

JOB	DATE
120 Camino Santiago, Santa Fe, NM 87501	03/10/2026

RPA & ASSOCIATES, LLC | WINDOW & DOOR CONDITION AND INTEGRITY CODES

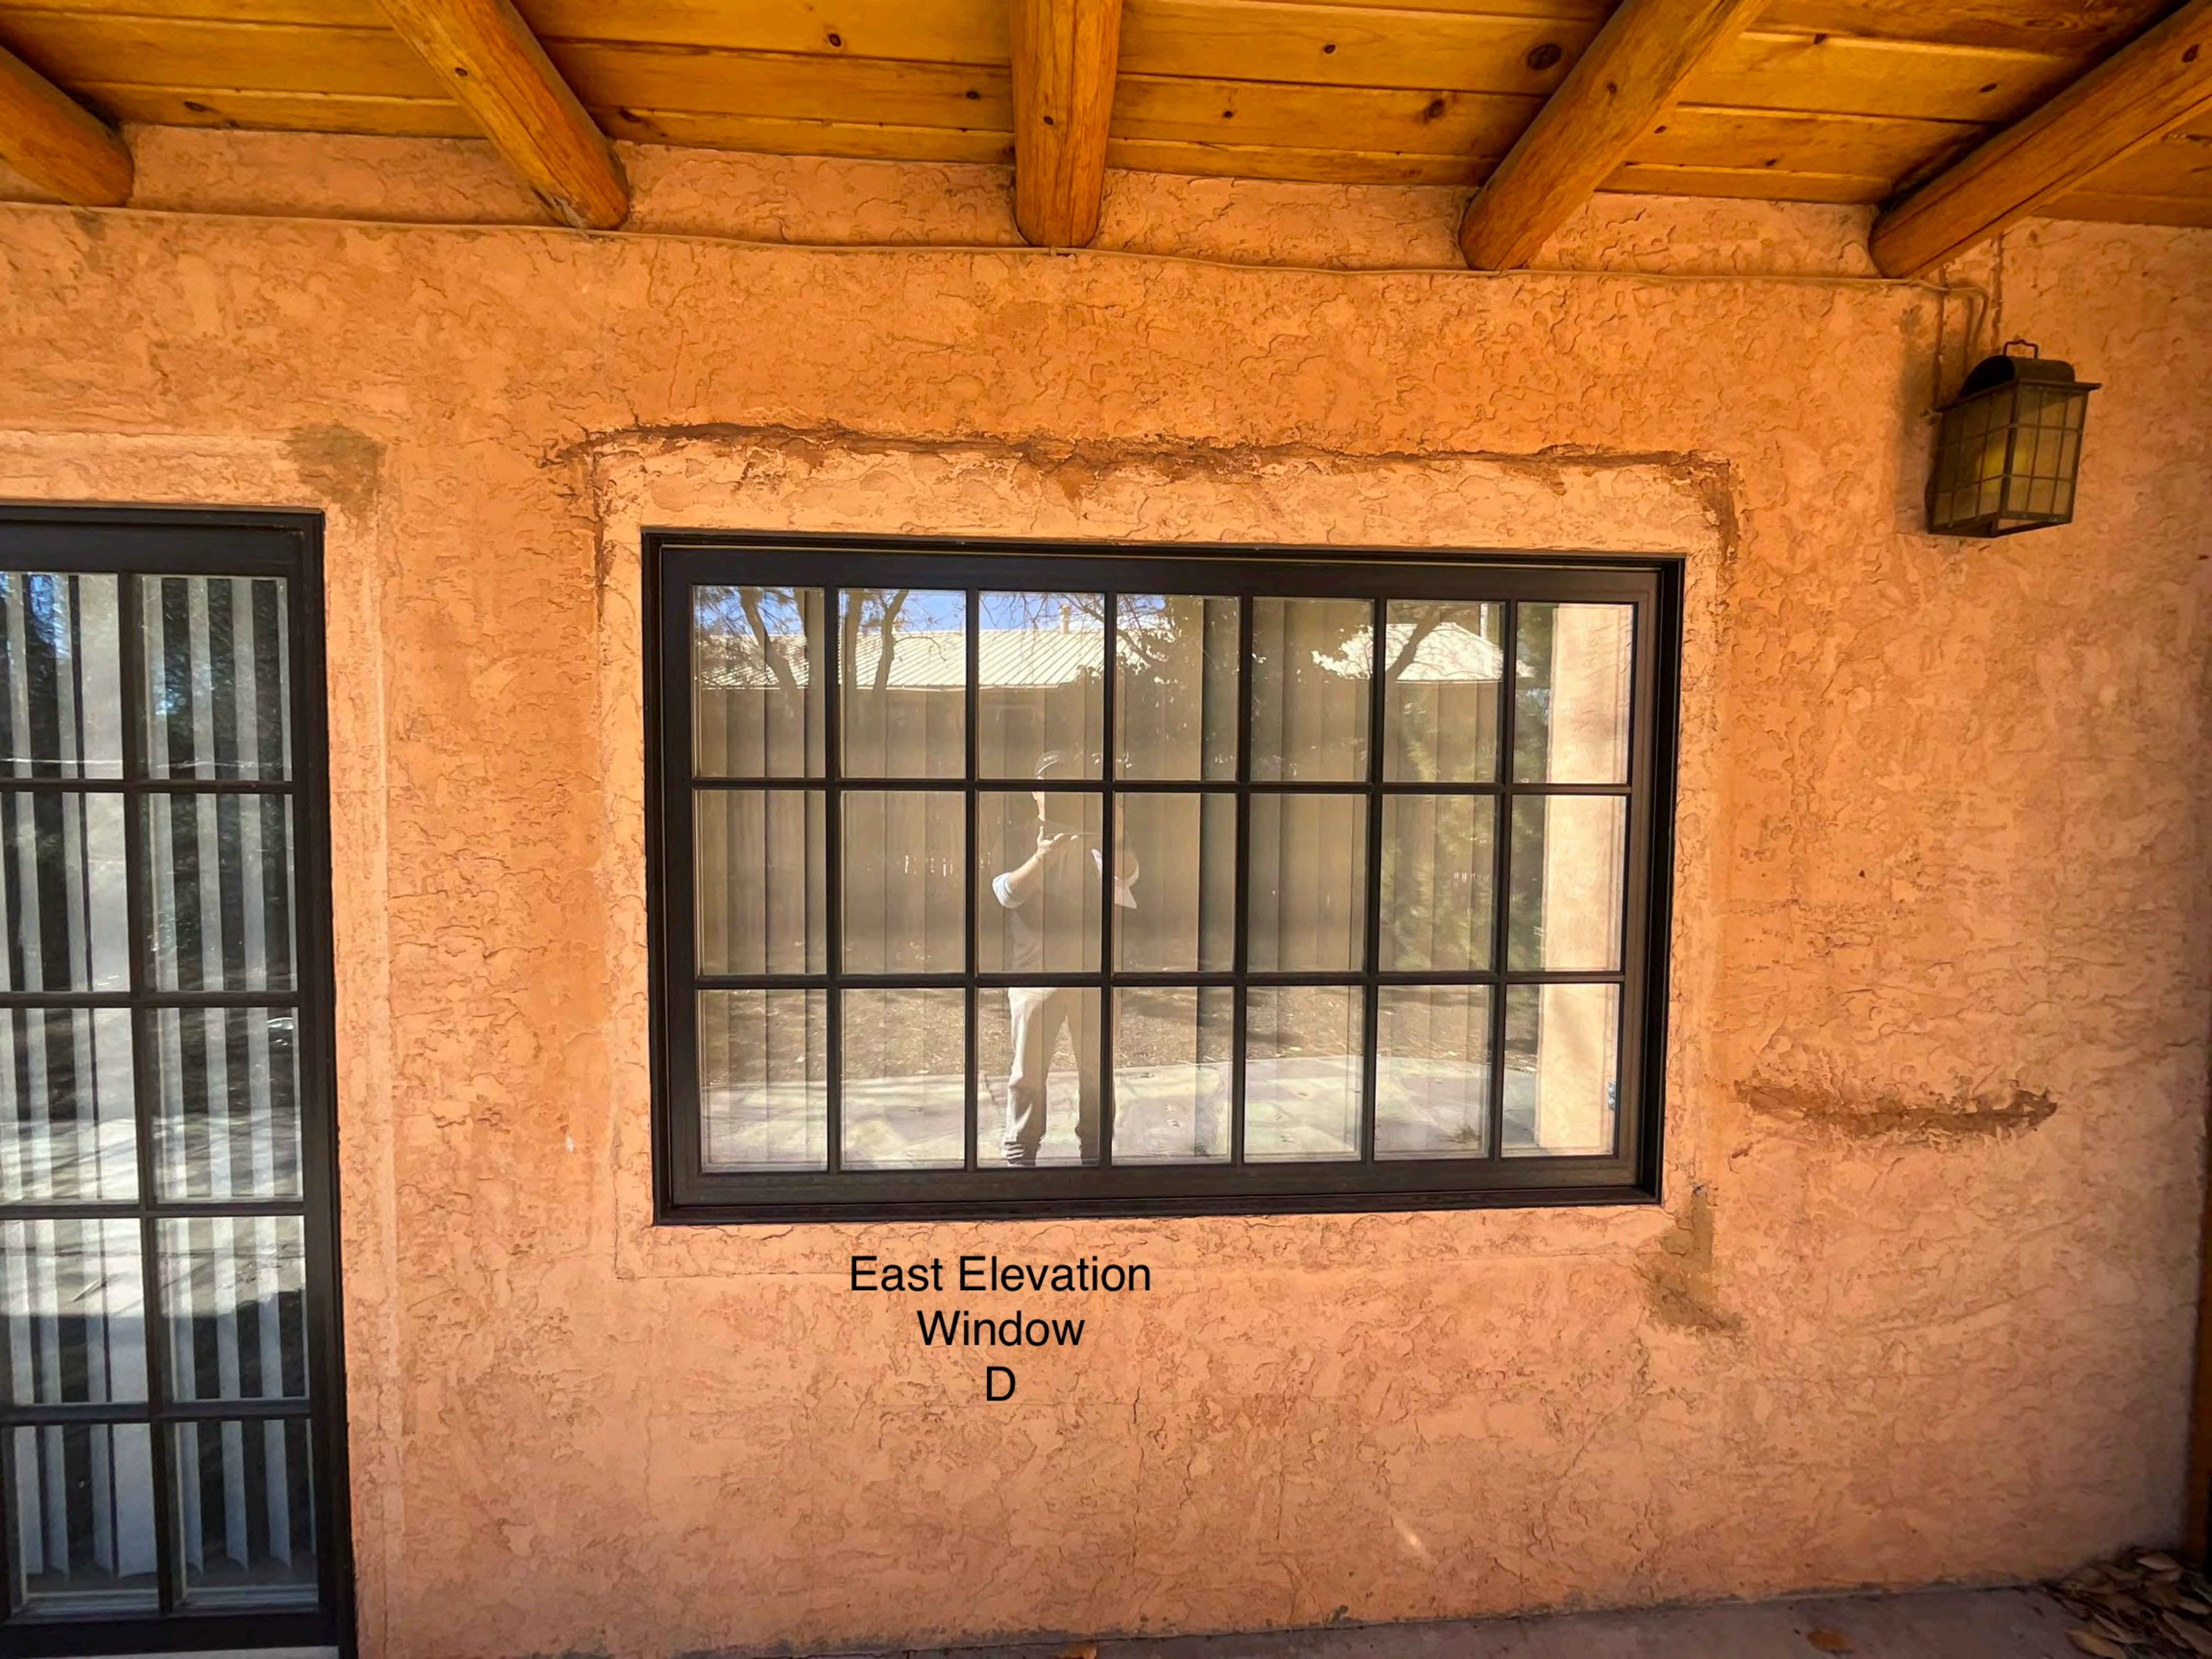
East Elevation  
Window  
D

D	72" x 48" FIXED WINDOW ALUMINUM CLAD/WOOD 7W3H BSDL W/INSULATED LOW-E GLASS
<b><u>SOUTH</u></b>	
DR #9	30" x 80" RH INSWING DOOR W/3W3H/CROSSBACK BOTTOM ALL WOOD

Window B and D are non-historic.

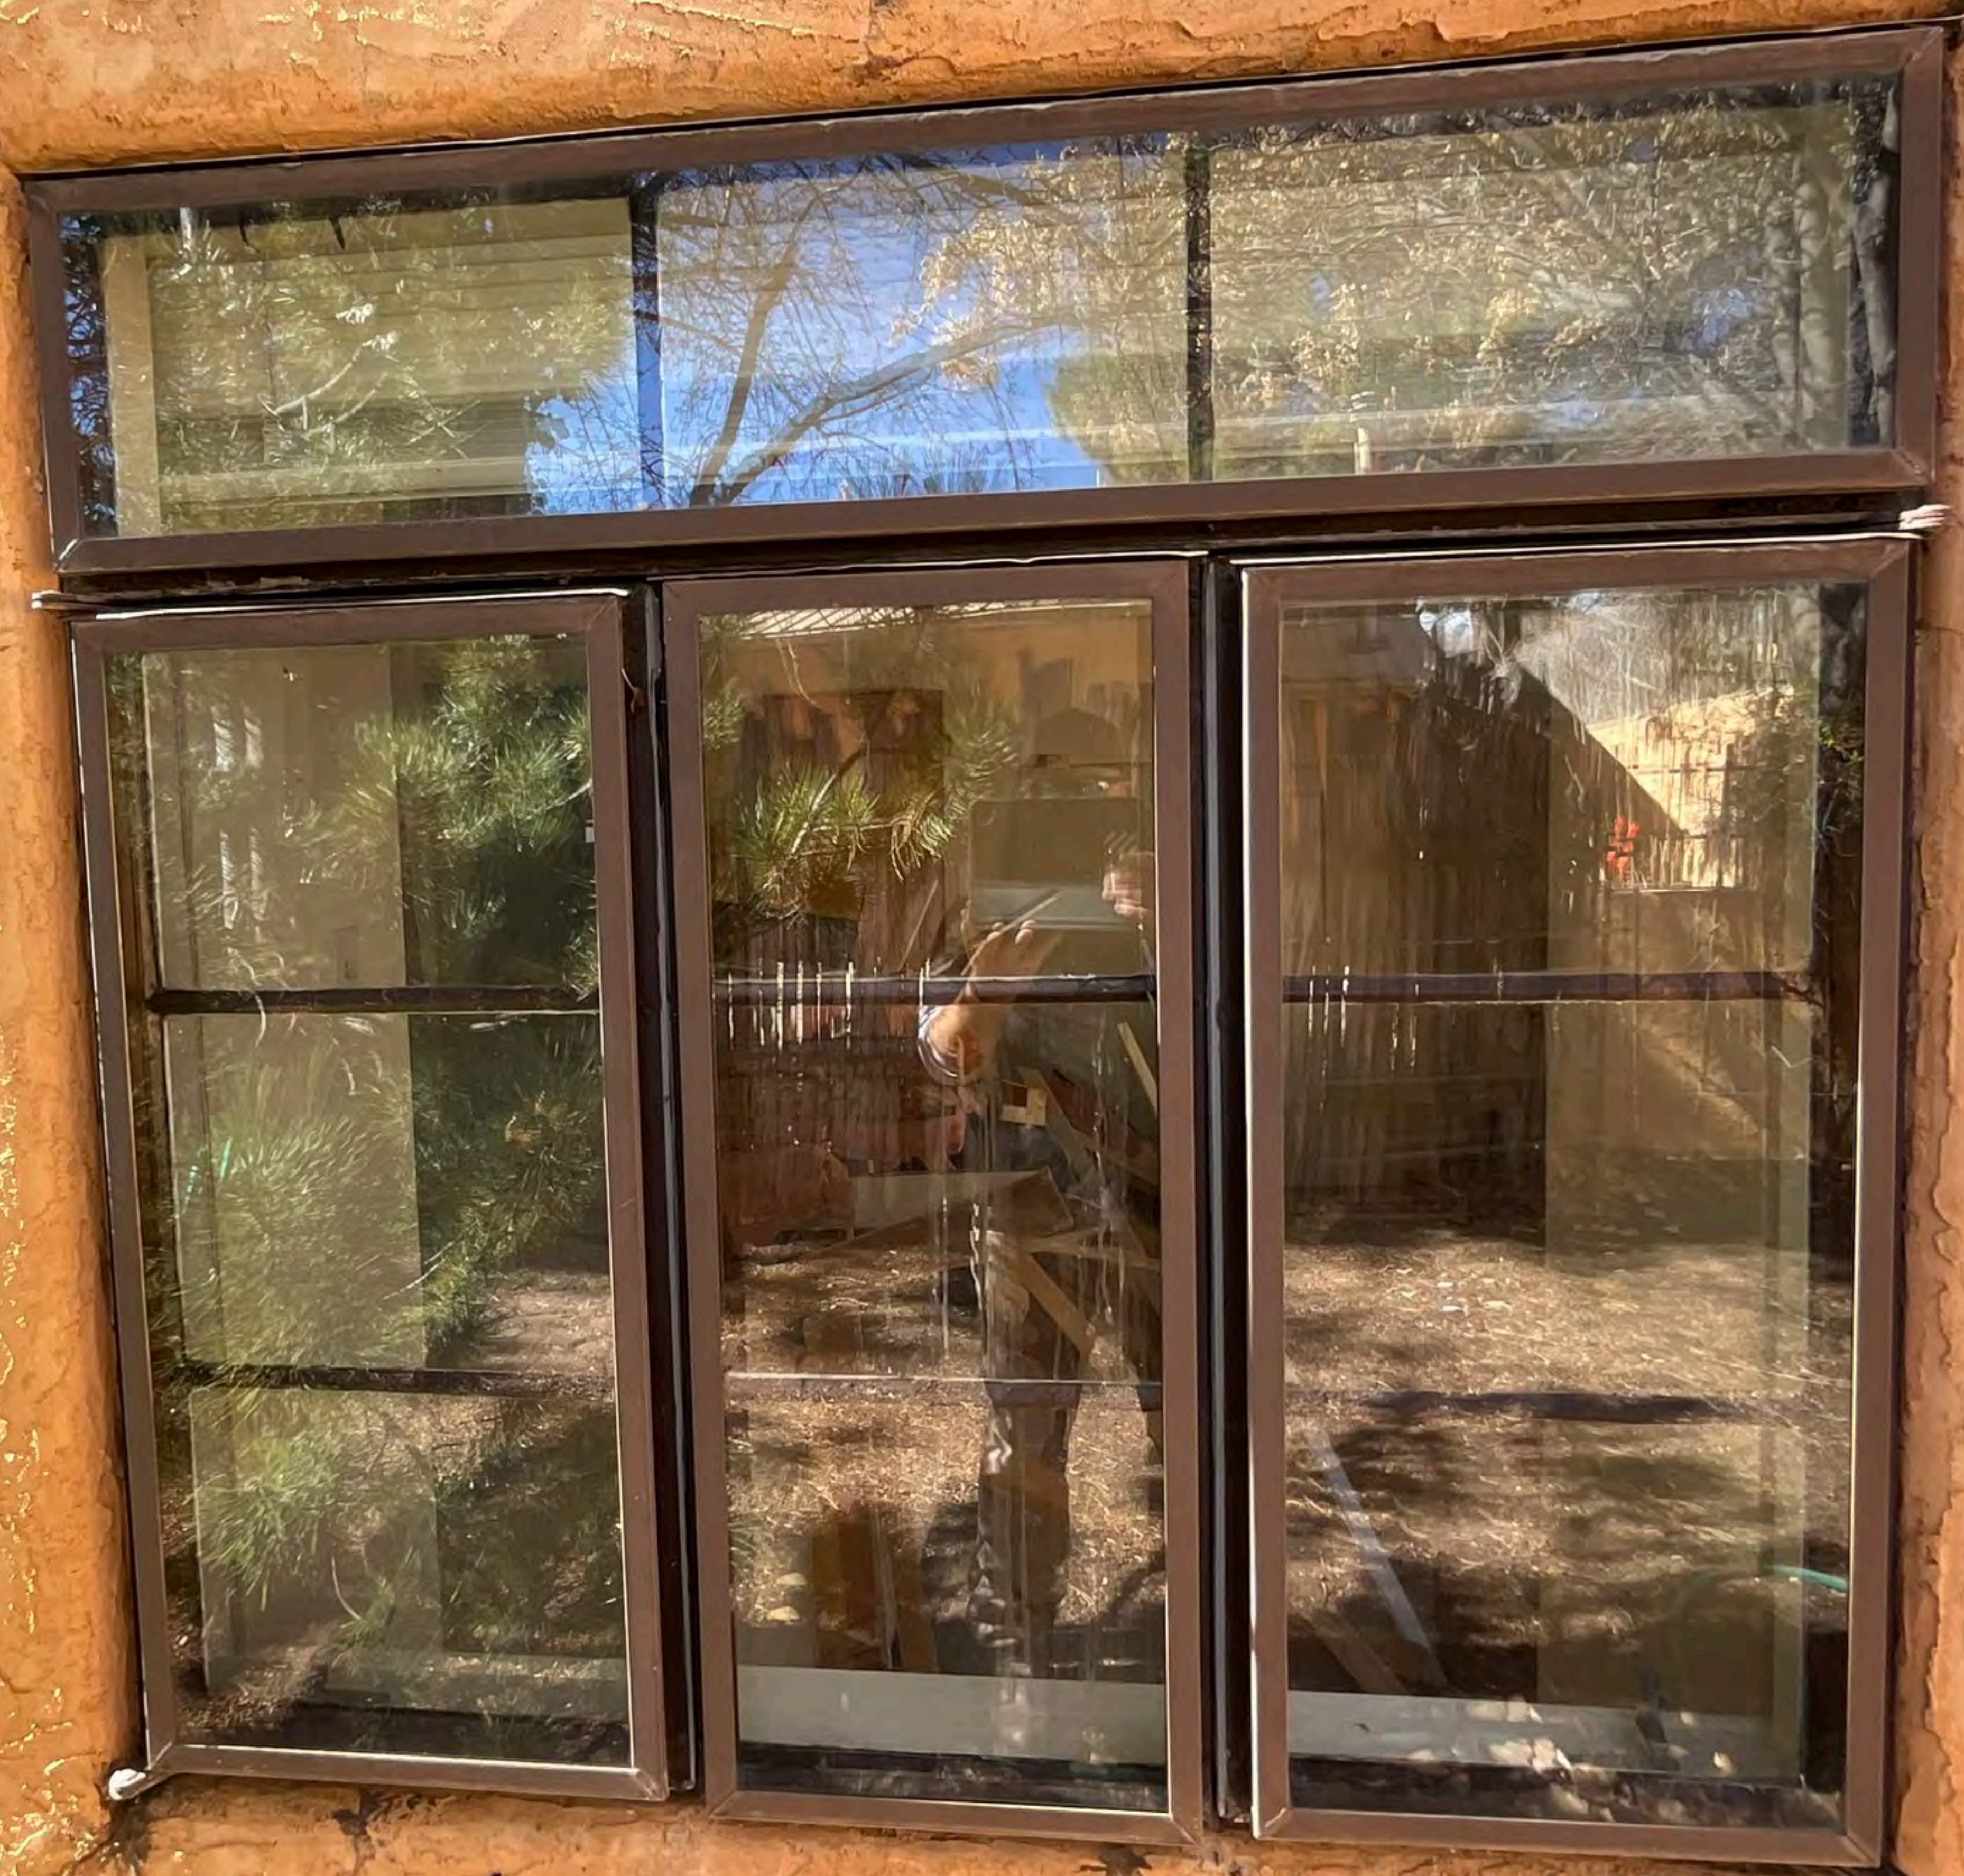
East  
Elevation  
Window  
E

Windows A, C, E, and F are historic however there is interior wall damage from the condensation of the steel casement. The storms of these units are not historic.

The window units that are going to be replaced should be in “like and kind” similar to historic windows. These units should be in a composite or clad/wood pop-in with simulated divided light (no grilles) or metal bars, manufactured such as Kolbe, Weathershield, or Marvin.

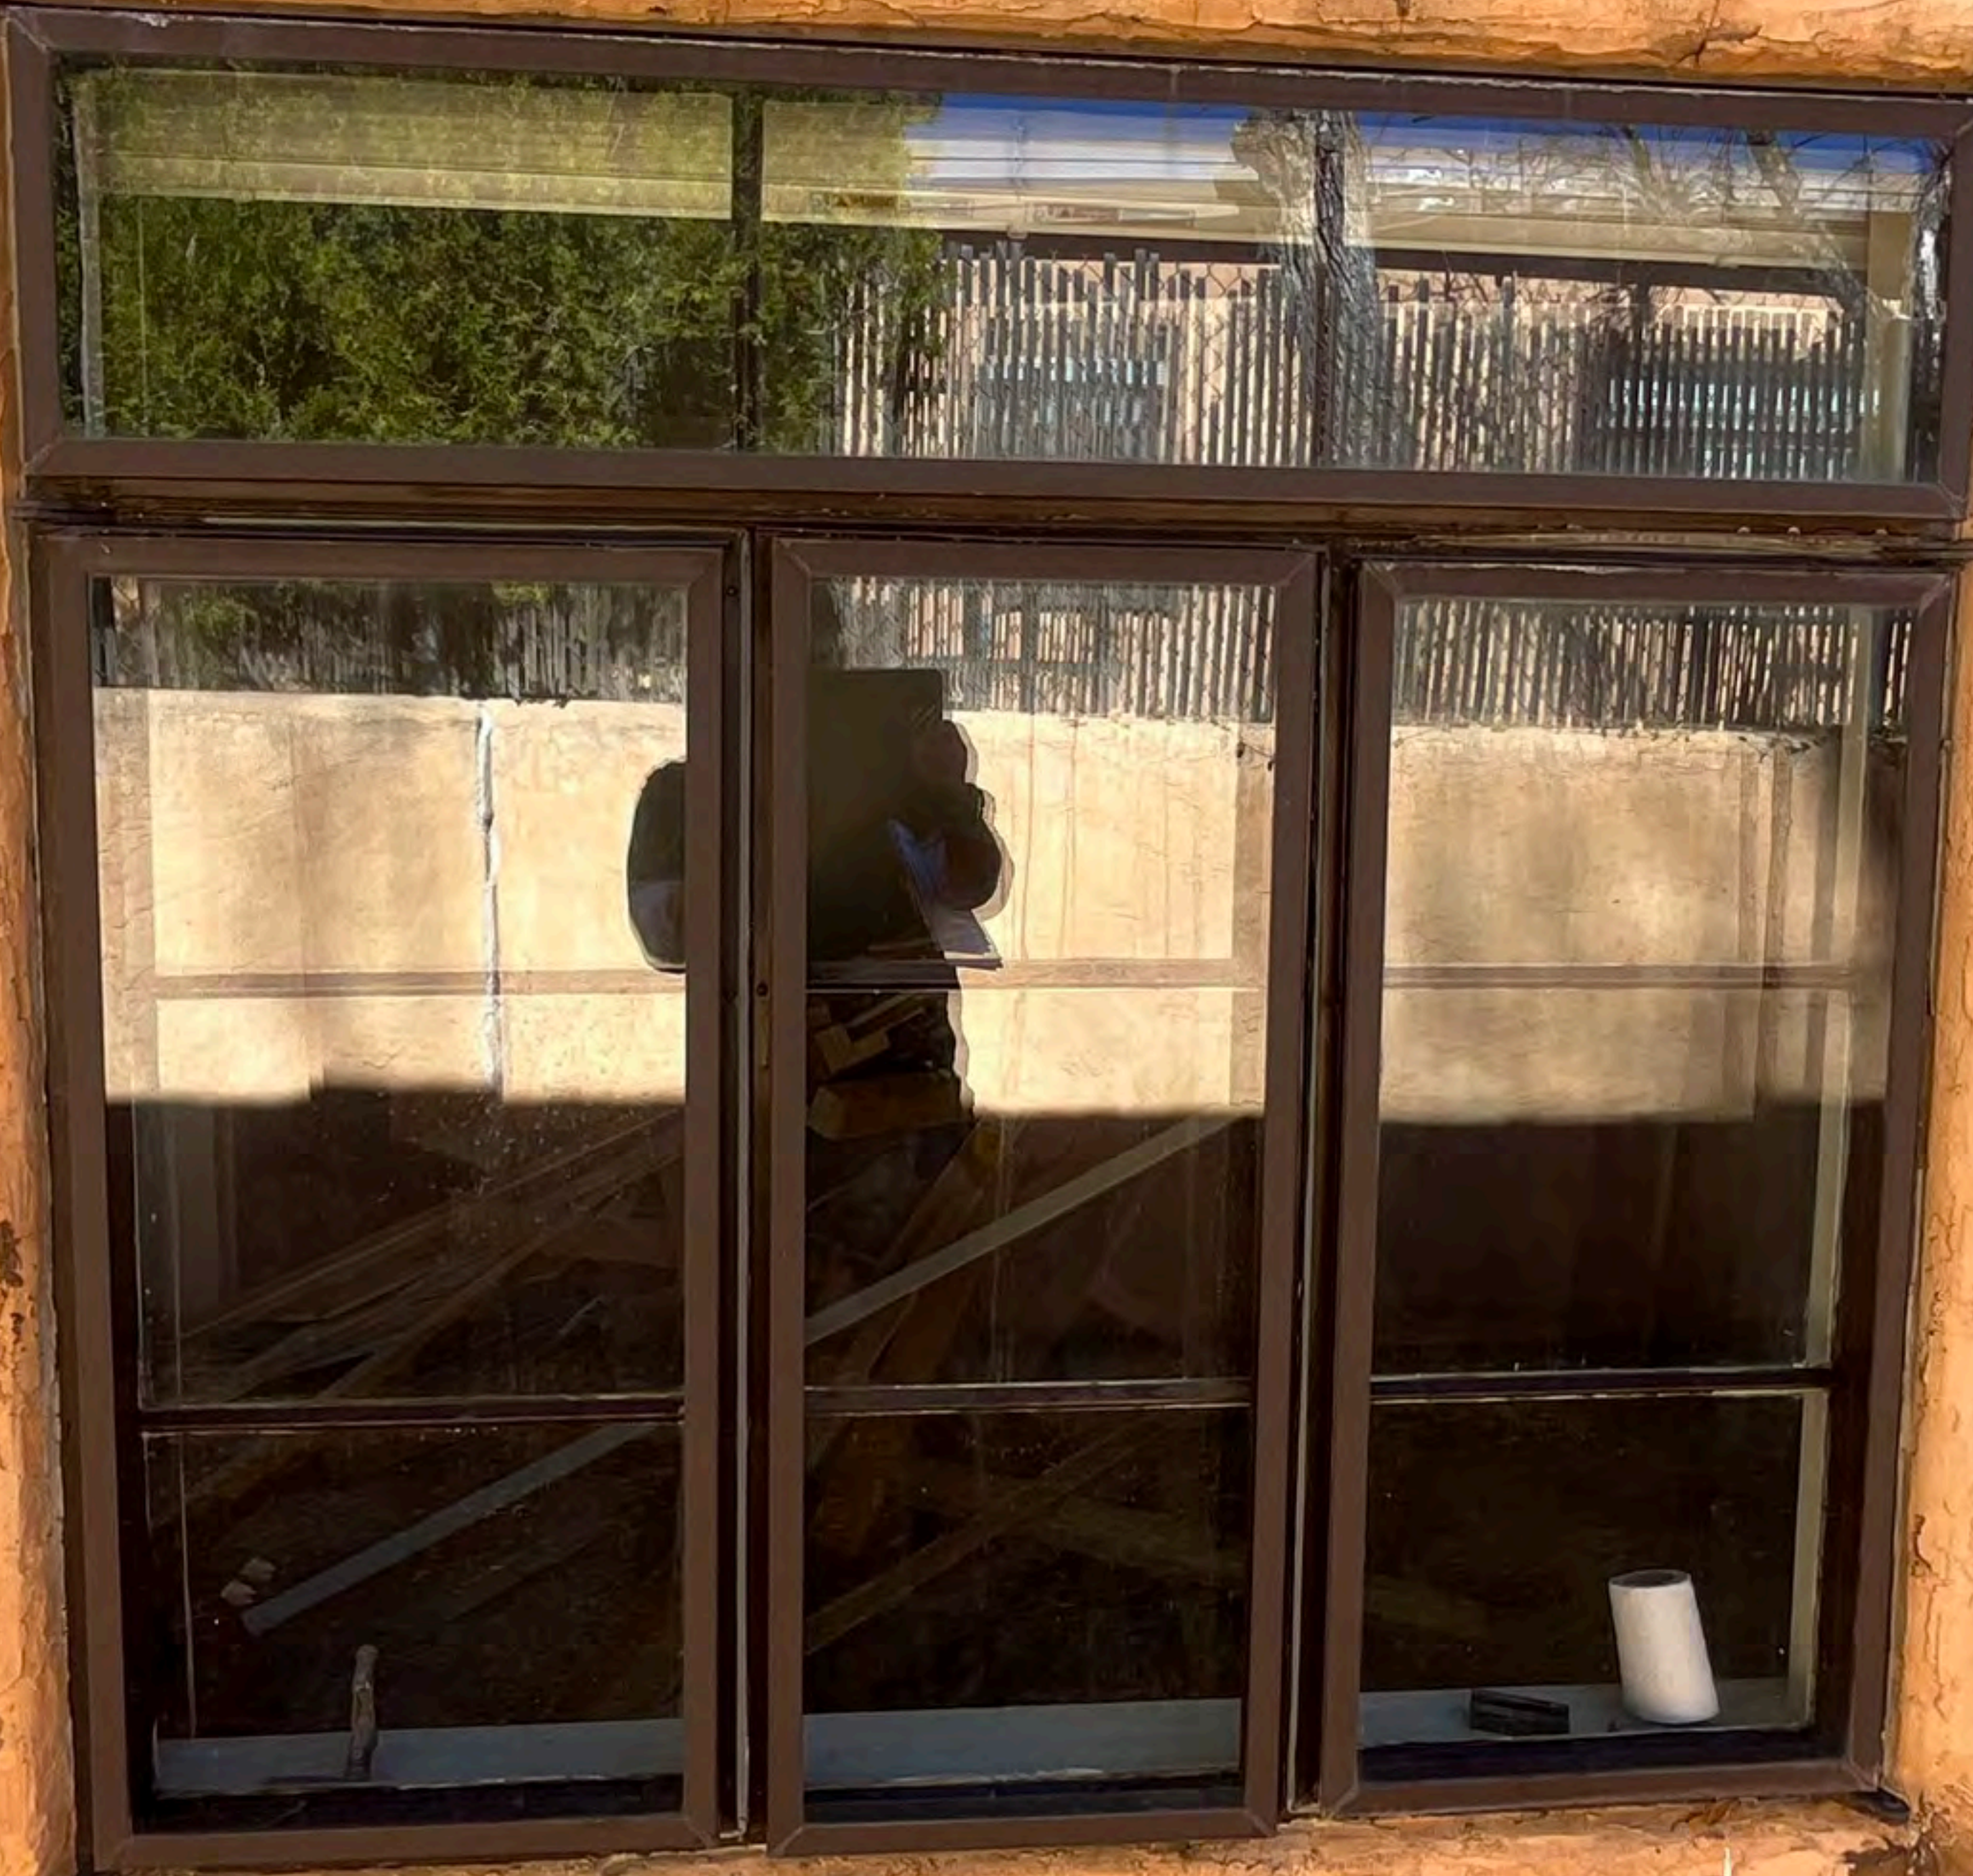
North  
Elevation  
Window  
F

<b><u>NORTH</u></b>			
F	52' x 52" LSR TRIPLE STEEL CASEMENT (3-18") W/TRANSOM 38" HEIGHT/12" HEIGHT 1W3H/1W3H - 3W1H	F	<b>HISTORIC</b> - CONDENSATION FROM THE STEEL CASEMENT CAUSING DAMAGE TO THE INSIDE PLASTER <b>NON-HISTORIC</b> - STORMS (1989)
