PROJECT DESC: 2023-007358-HDRB. 1062 Camino San Acacio. Downtown & Eastside Historic District. Non-contributing. Praxis Design Build, agent for Gabriel and Mariam Browne, owners, requests a historic status review with primary facade(s) designation, if applicable, for two non-residential structures.

PROJECT 2026-012133-HDRB. 1062 Camino San Acacio. Downtown & Eastside Historic District,
DESC: non-contributing, Gabriel Brown, agent/owner, proposes to demolish a 755 sq. ft. accessory structure.

Historic Cultural Properties Inventory (HCPI) Base Form (FORM 1)

1. Name of property: Rodriguez-Maes Outbuildings	2. Location: 1062 Camino San Acacio <i>Downtown and Eastside Historic District</i>	3. Local Reference Number: Santa Fe ID #: 4. County: Santa Fe Parcel # 99309930

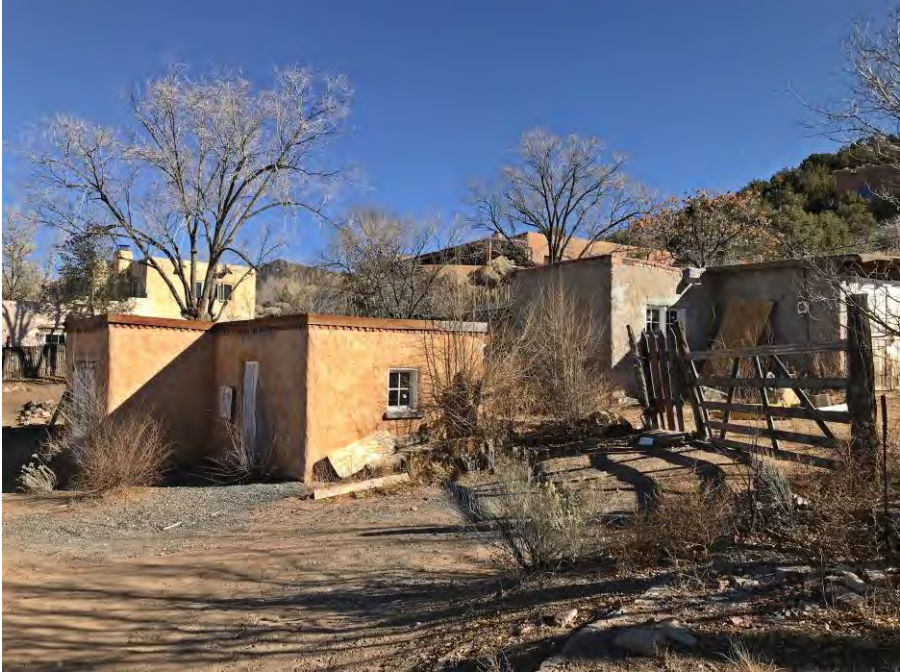
8. Name of Project: HDRB status review		
9. Lat/Long: 35.6767743, -105.9198448		
10. Photo Information: John Murphey, photographer. View of north and west elevations, facing southeast. November 27, 2021.

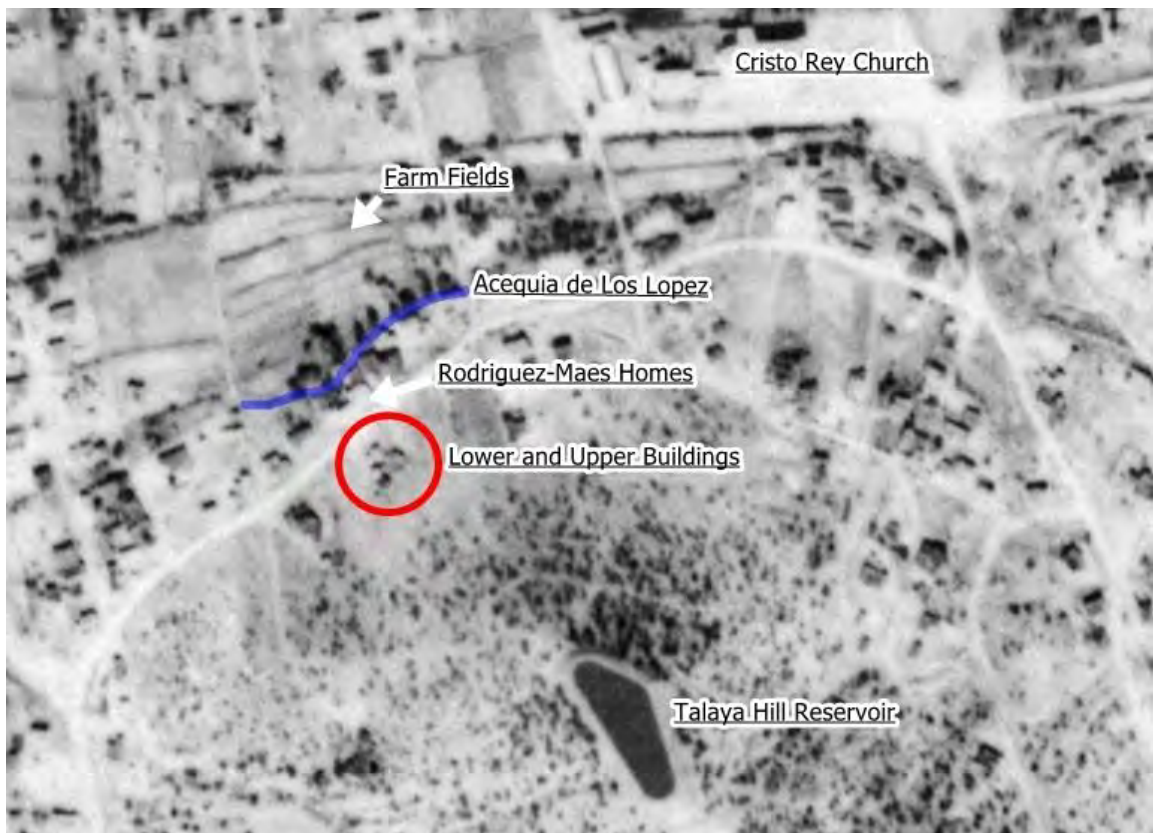
Figure 1: Area context.
Subject buildings circled
October 25, 1948, aerial photograph.
Courtesy EDAC, University of New Mexico.

As a narrow shelf above Canyon Road, Camino San Acacio — originally San Acacio Road — developed slowly in the early 20th century and was considered the south edge of settlement (Figure 1).

Families built their homes on the tiny ridge, forming a row of houses known as a *cordillera* in regional archaic Spanish (Figure 1). The south side of the road, composed of a slope of Talaya Hill, served as uplands. Here, goats and sheep wandered the hillside.² The top of the hill was crowned by Talaya Hill Reservoir, a basin built in the 1890s to collect rainwater for fire suppression and to supplement the city's drinking water.

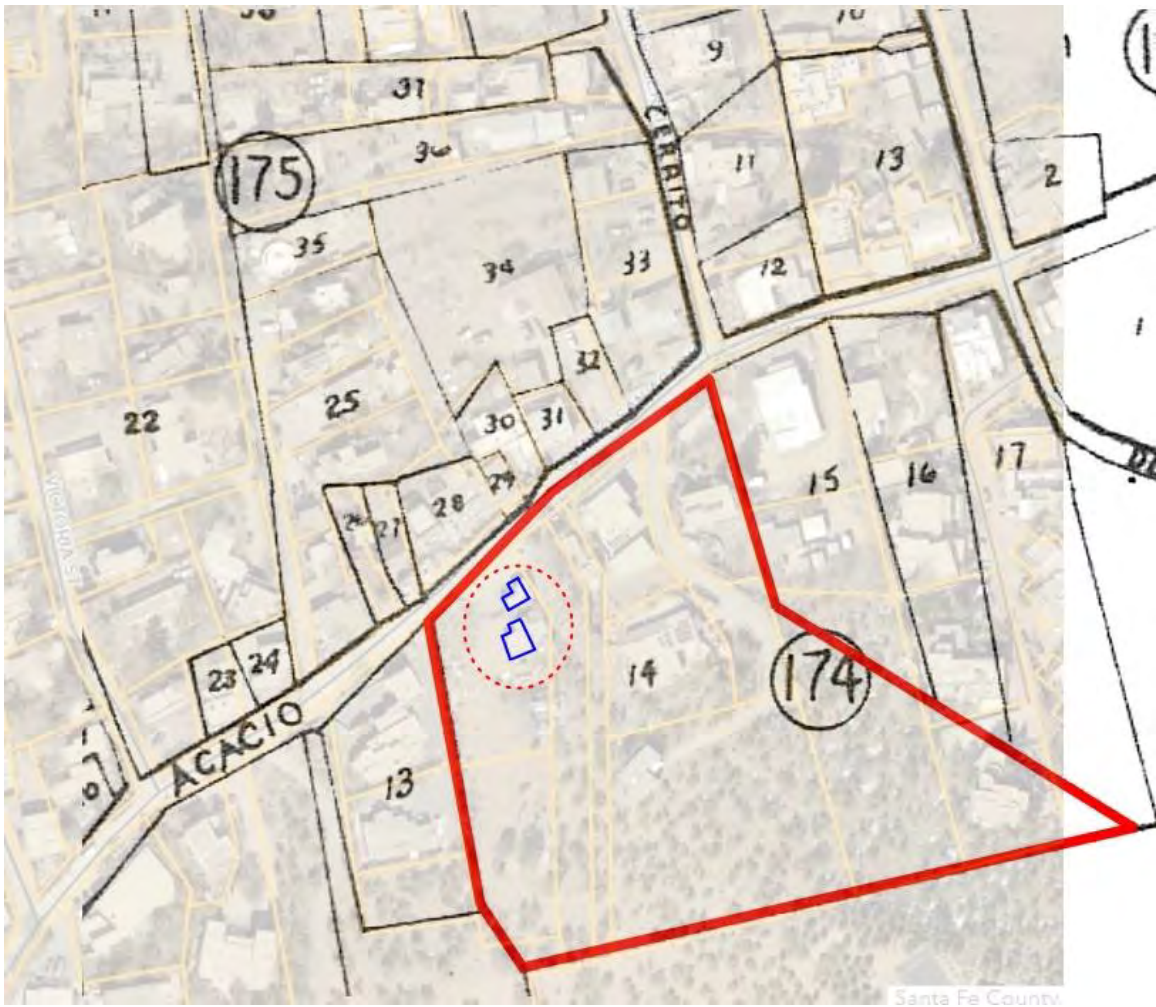
Figure 3: 1957 parcel map superimposed over contemporary aerial. Subject buildings circled.
 "Scanlon-Erwin & Associates, "Block and Parcel Map of Santa Fe,"1957.

The land on the south side of the road holding the building remained intact as a large parcel (Figure 3) at this time. Over subsequent years it would be whittled down and subdivided.

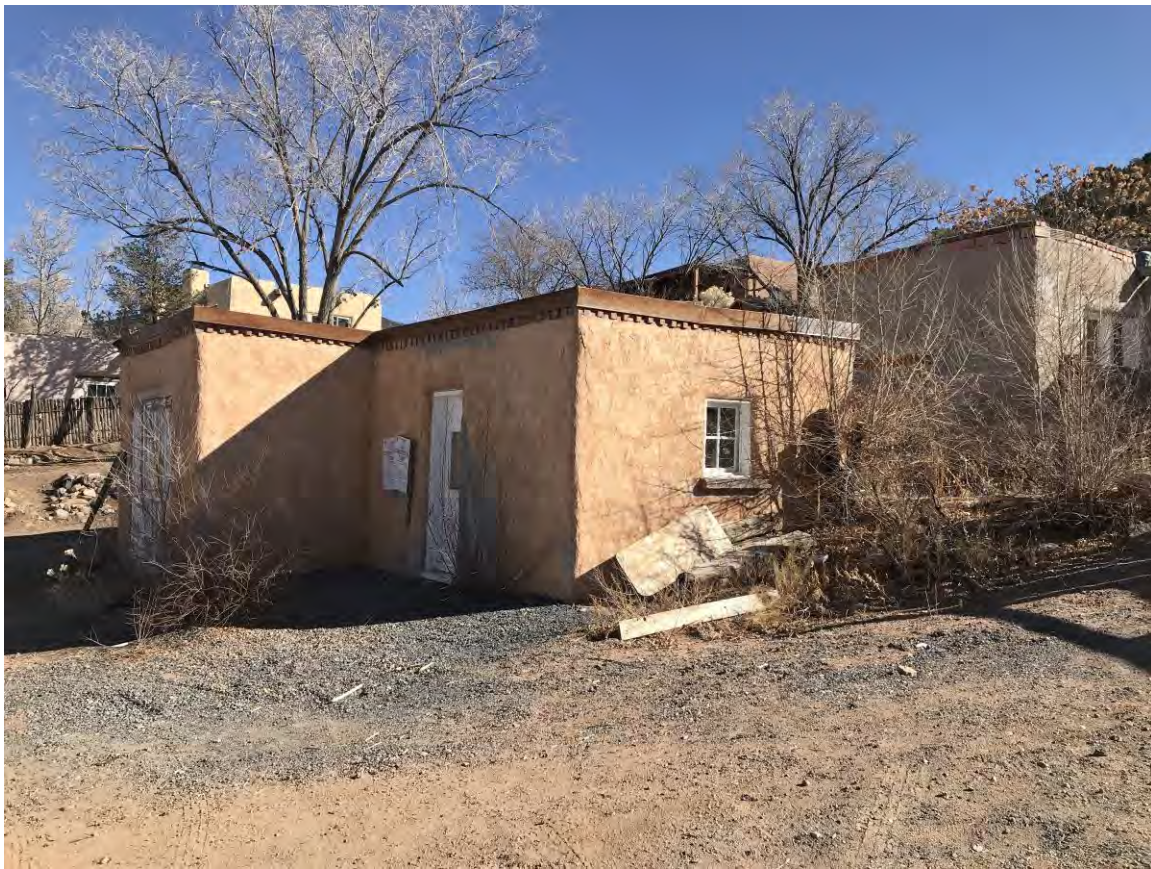
**Photo 1: View of property from Camino San Acacio.
Camera facing southeast.**

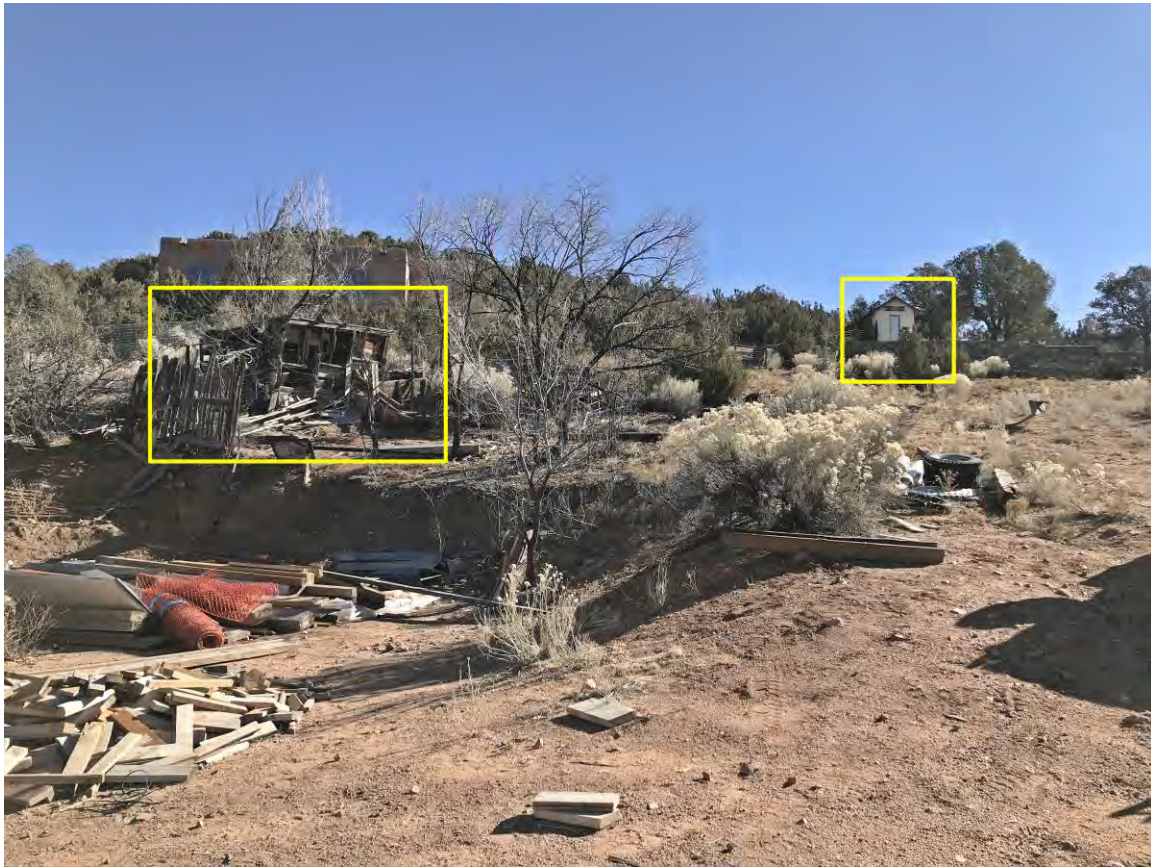
**Photo 2: Deteriorating structure and capilla on separate property.
Camera facing southeast.**

Surrounding the property is land formerly owned by the same two families, now mostly separated and sold off. A piece to the south holds a family *capilla* crowning a ridge (Photo 2). Immediately to the east is the foundation of a knocked-down building and an old apricot tree.

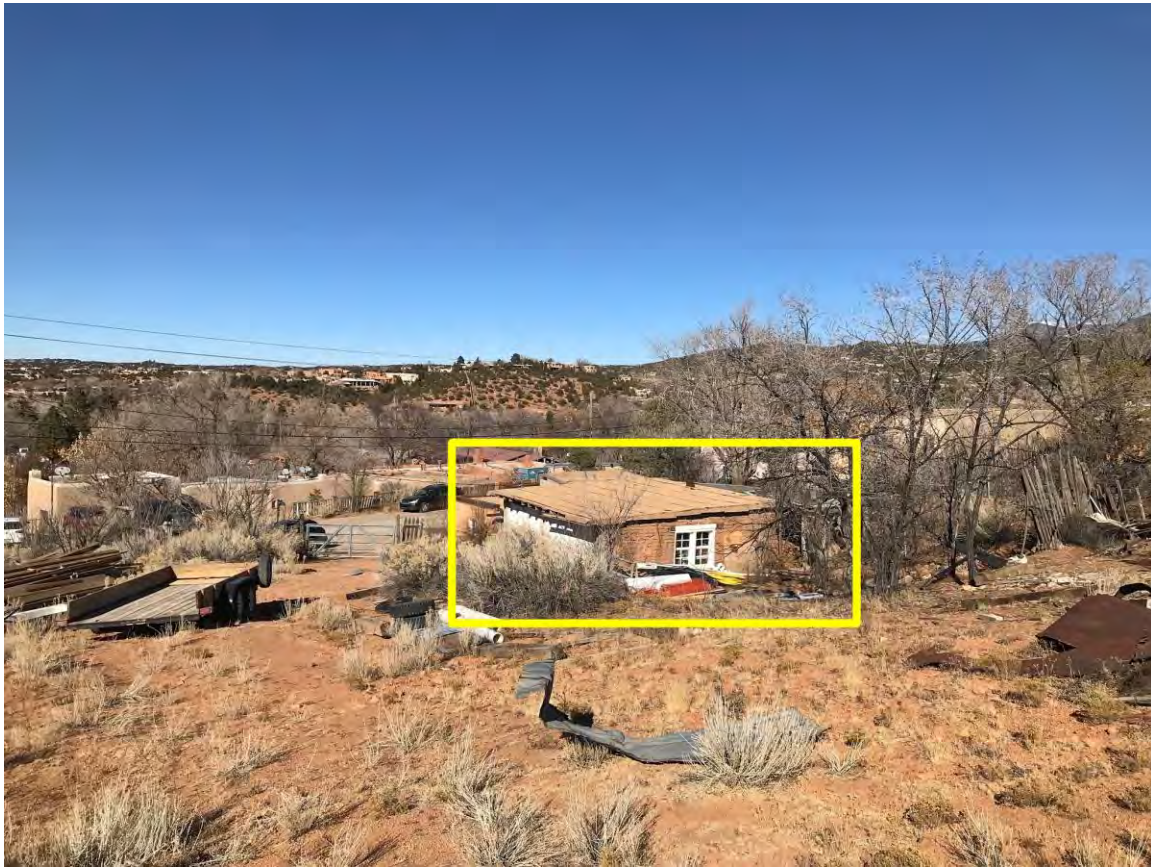
**Photo 3: View of Upper Building from south edge of property.
Camera facing northeast.**

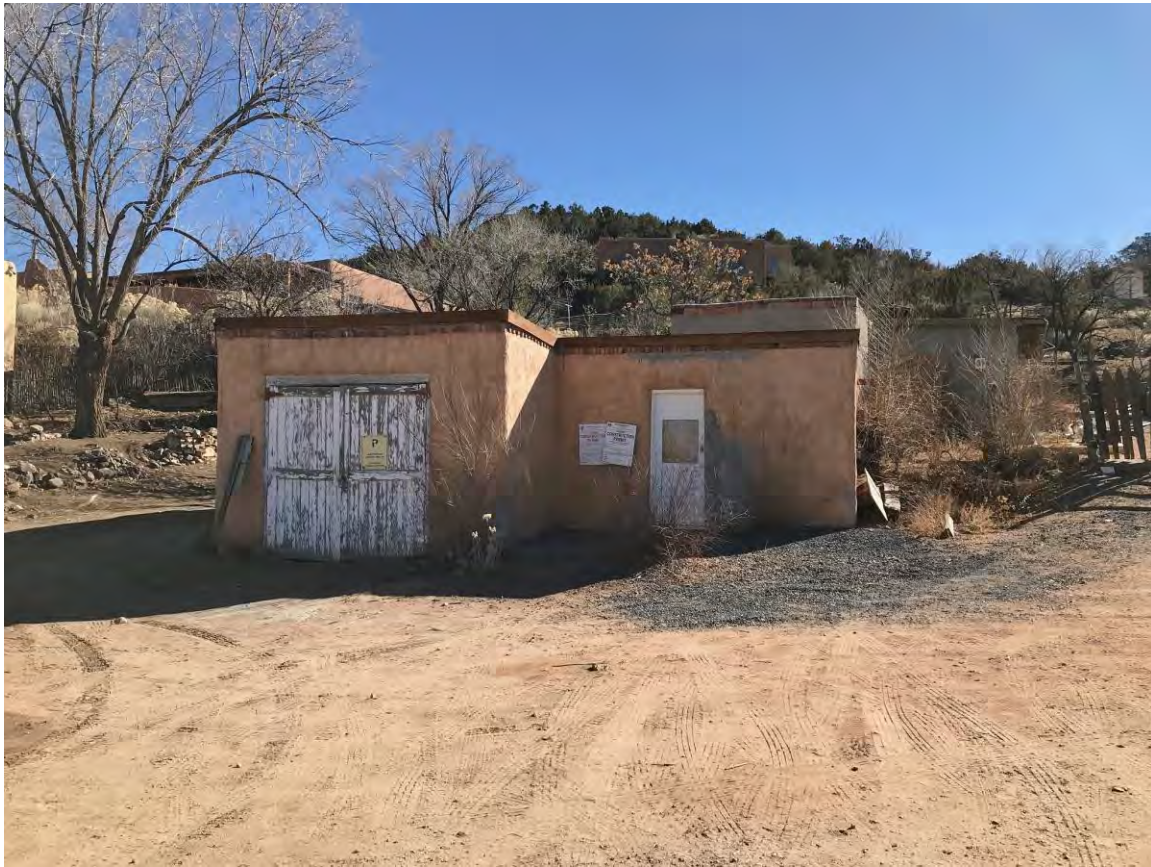
**Photo 4: Lower Building, north elevation.
Camera facing south.**

The garage has an 8' opening holding swinging wood panel doors (Photo 4). The doors, made of 5"-wide boards, are painted white. The paint shows an older green coat. The panels swing out on 12" metal "T" hinges of unknown vintage. Rounding the round corner to the west is the only pedestrian entry to the building, holding a stock ¼ glass unit with four raised panels.

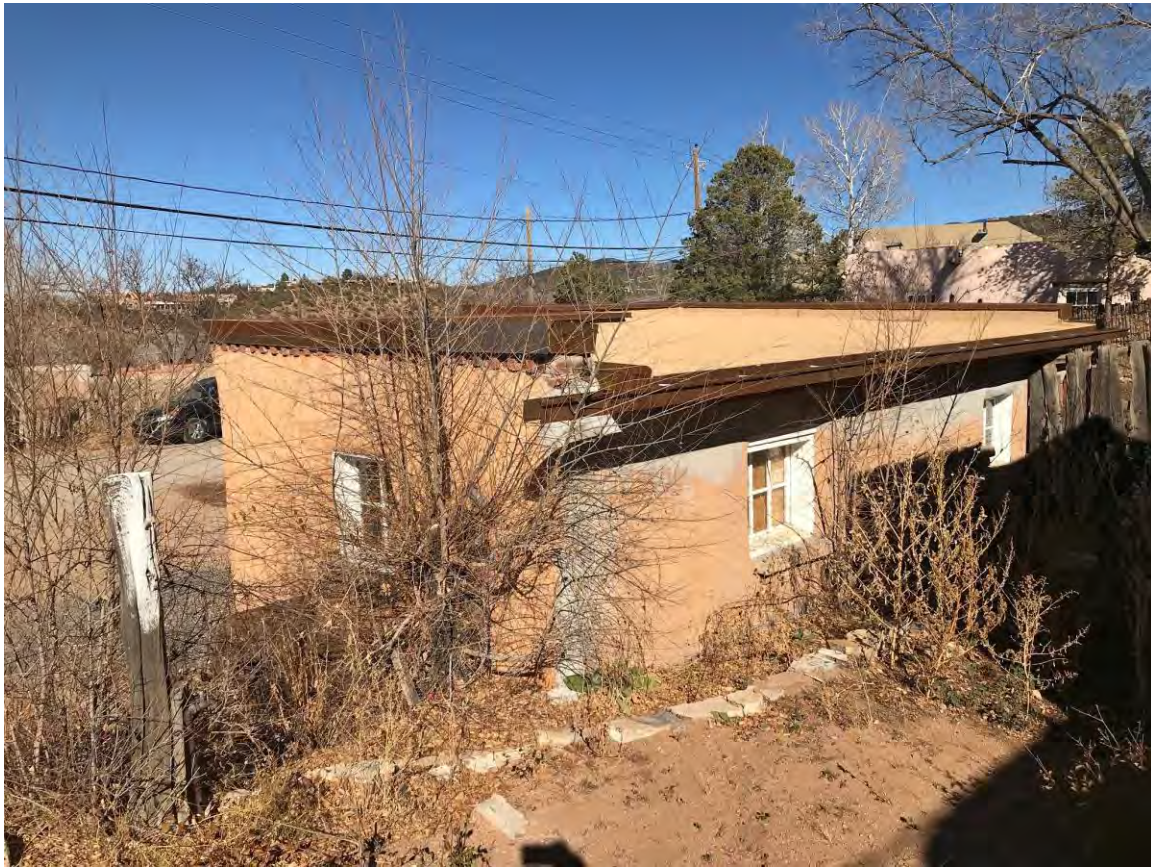
**Photo 5: Lower Building, west and south elevations.
Camera facing northeast.**

A single opening penetrates the west elevation (Photo 5). It contains a four-light, non-historic in-swing casement. A heavy concrete sill runs at the bottom of the window.

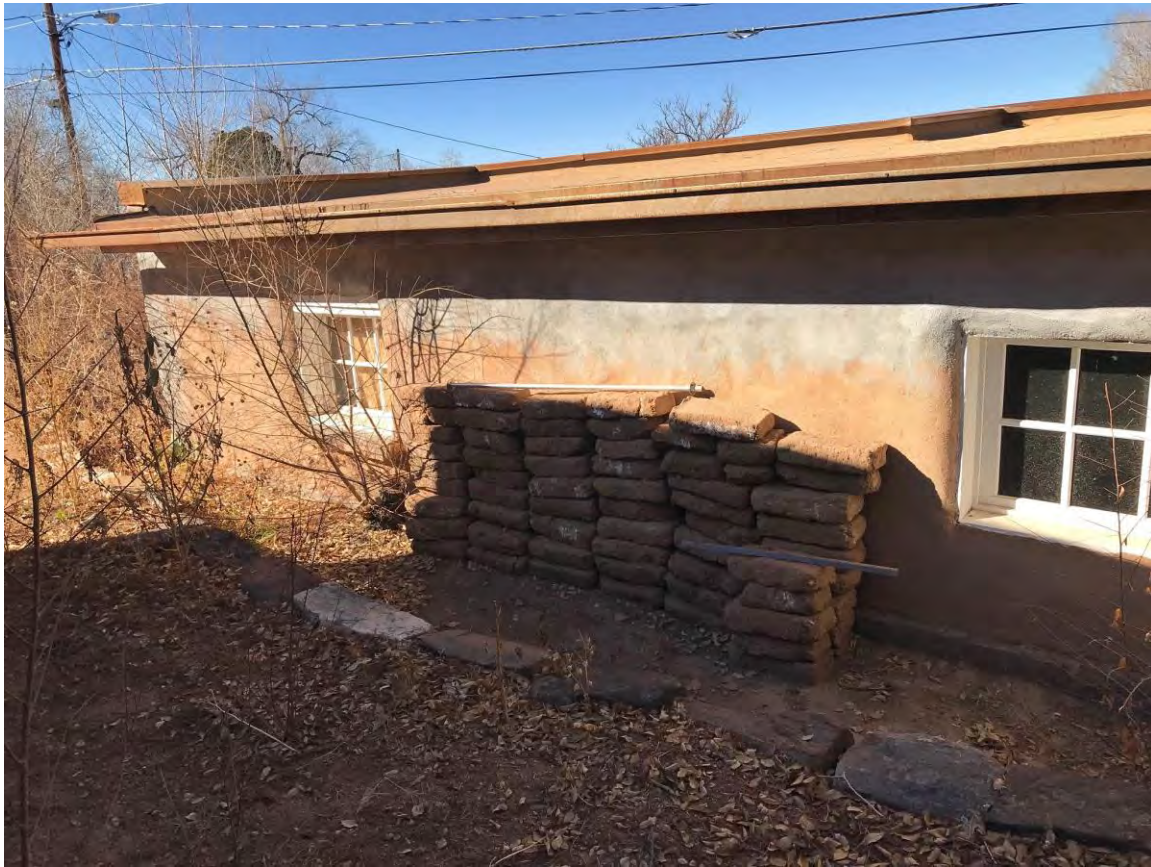
**Photo 6: Lower Building, south elevation.
Camera facing northwest.**

The long south elevation is partially dug into the slope (Photo 6). It is divided evenly with two openings holding recent six-light casements. A non-historic overhang spans the façade (Photo 6). Sticking out 13½", it supports a metal gutter.

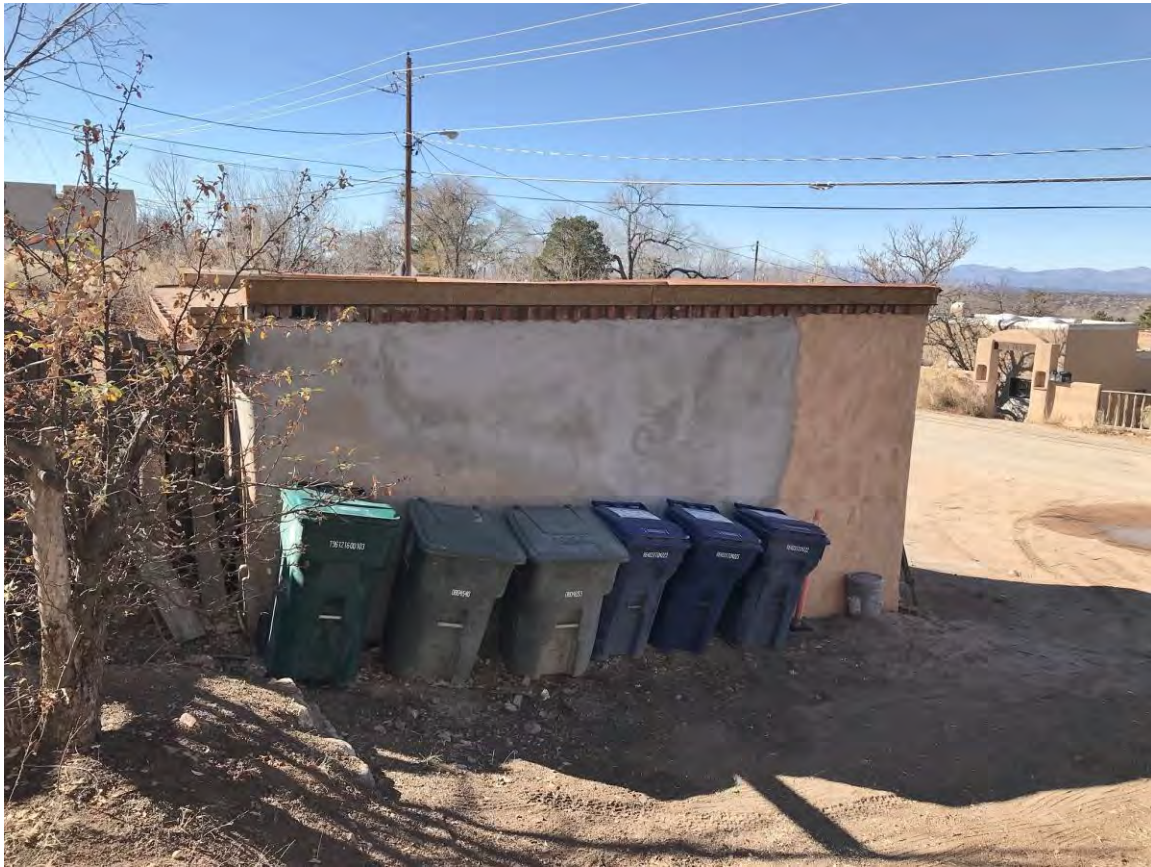
**Photo 7: Lower Building, north elevation.
Camera facing northwest.**

The mountain-side of the building is a blank wall revealing stucco patching (Photo 7).

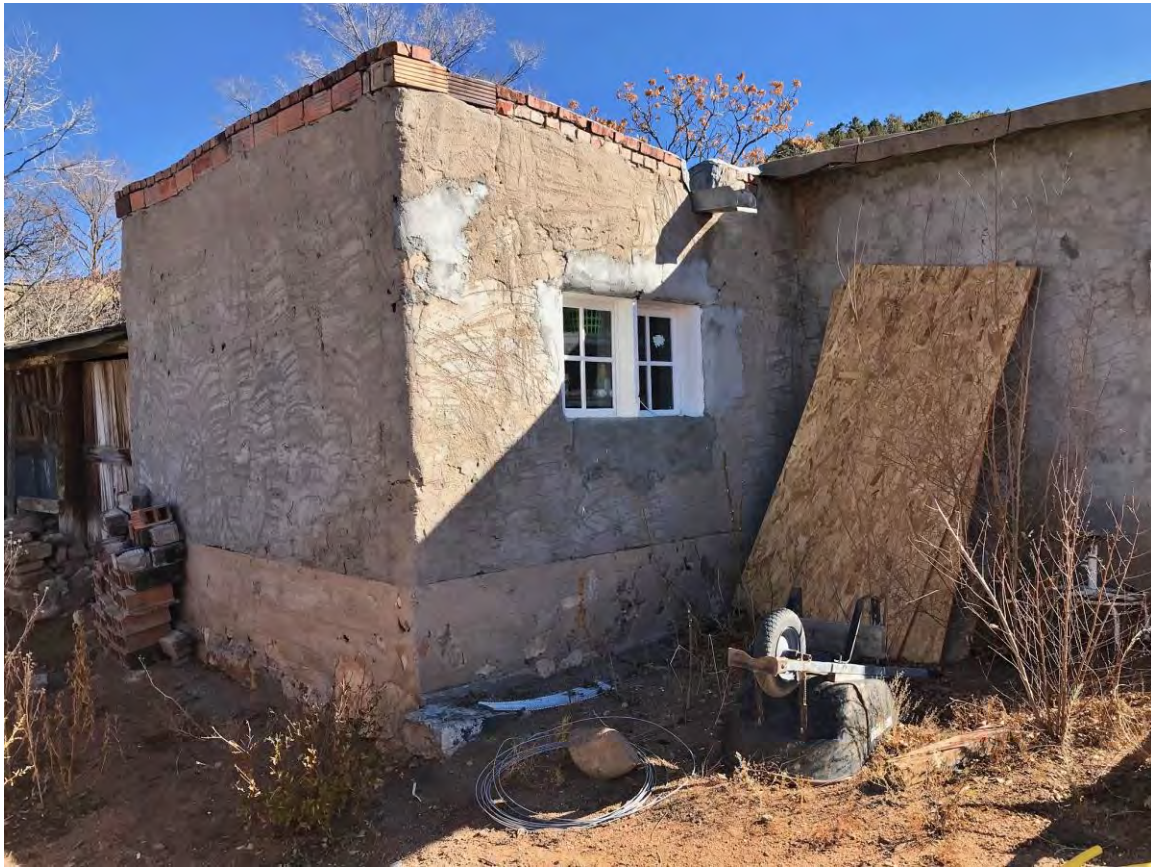
**Photo 8: Upper Building, partial north elevation.
Camera facing southeast.**

The north elevation rises above grade on a mixed concrete and rubble foundation. The walls, reaching 3’ above the ground, show their formwork (Photo 8). Above are adobe walls covered with a gray scratch coat. A crude coping made of clay tile blocks and bricks surmount the walls.

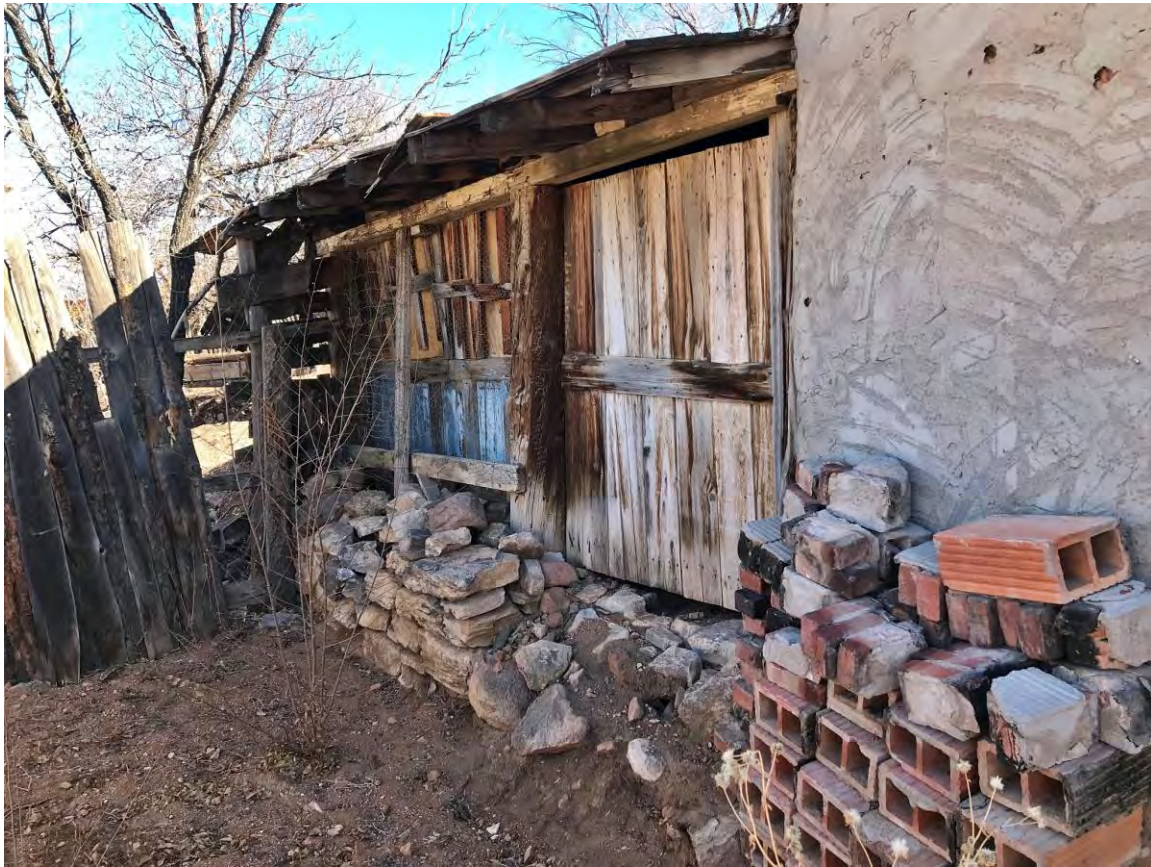
**Photo 9: Upper Building, north elevation, shed portion.
Camera facing southeast.**

Attached to the east side is the beginning of the shed. It sits on a rubble stone wall and reveals various wood surfaces (Photo 9). It has a single gate, sheltered by an overhang of 2’x4’s.

The lower north section has a roof sloping in the same direction and erected over a rubble stone wall (Photo 9).

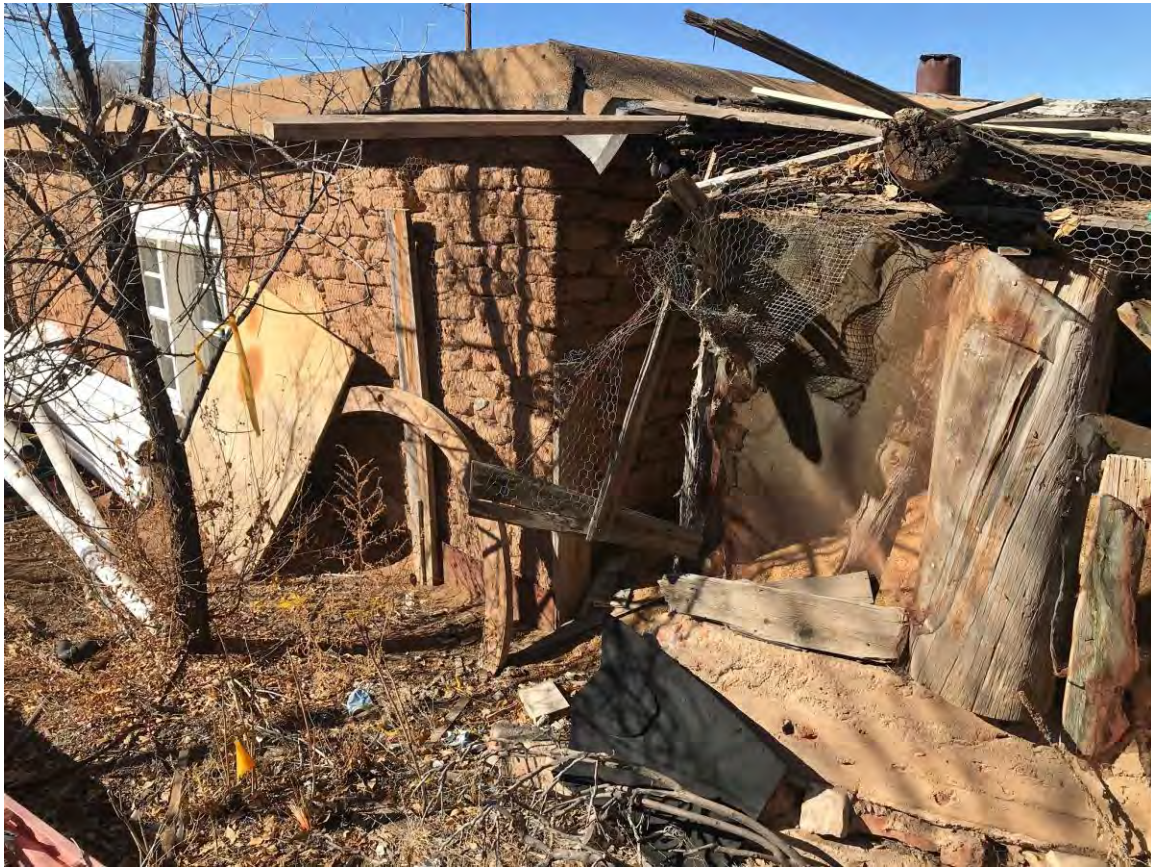
**Photo 13: Shed, south portion at right.
Camera facing northwest.**

The south end has an opening framed by large rough beams. Its structure sits on a mixed concrete and rubble foundation. Its roof is partially collapsed (Photo 13).

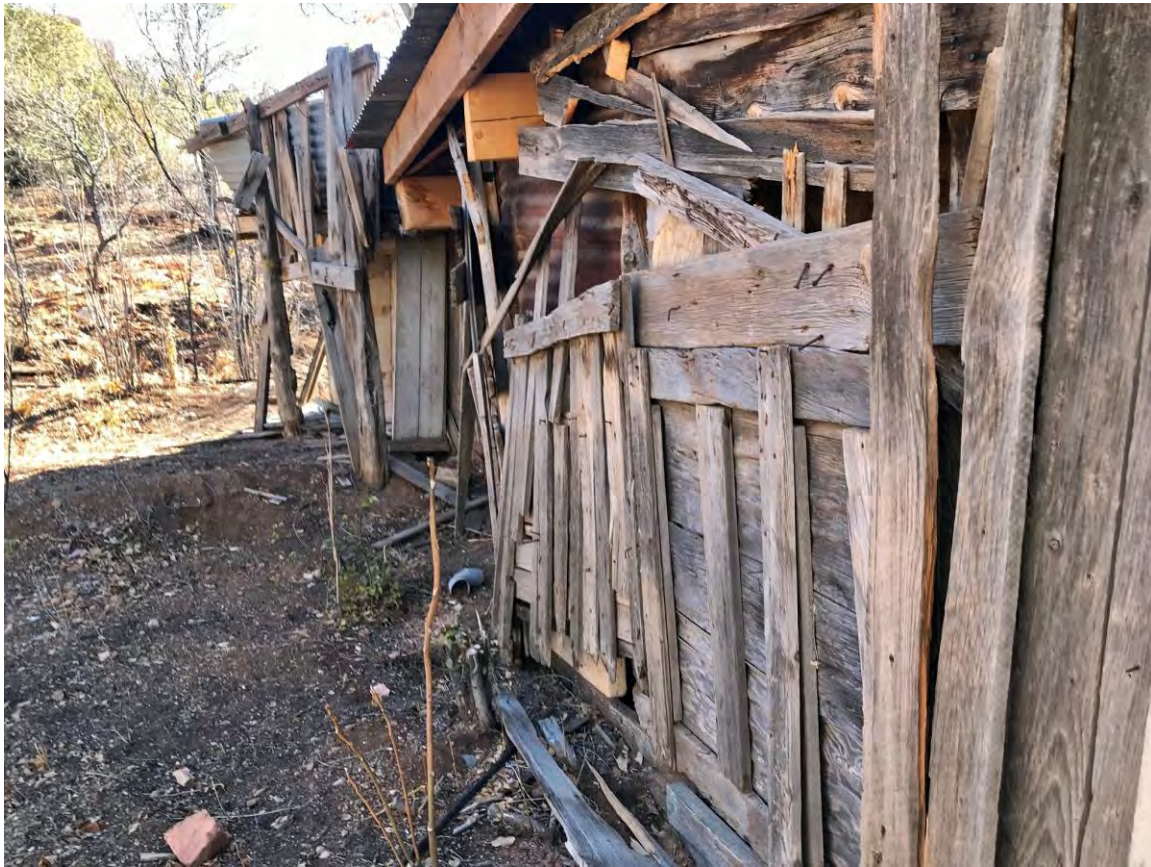
Photo 14: Shed, middle portion.
Camera facing south.

The middle section has an east-sloping shed roof with openings that resemble animal pens. It has been recently reinforced by new 3 ½” x 9 ½” beams (Photo 14).
