# AGENDA

HISTORIC DISTRICTS  
REVIEW BOARD  
JANUARY 12, 2021  
5:30 PM  
ATTEND VIRTUALLY

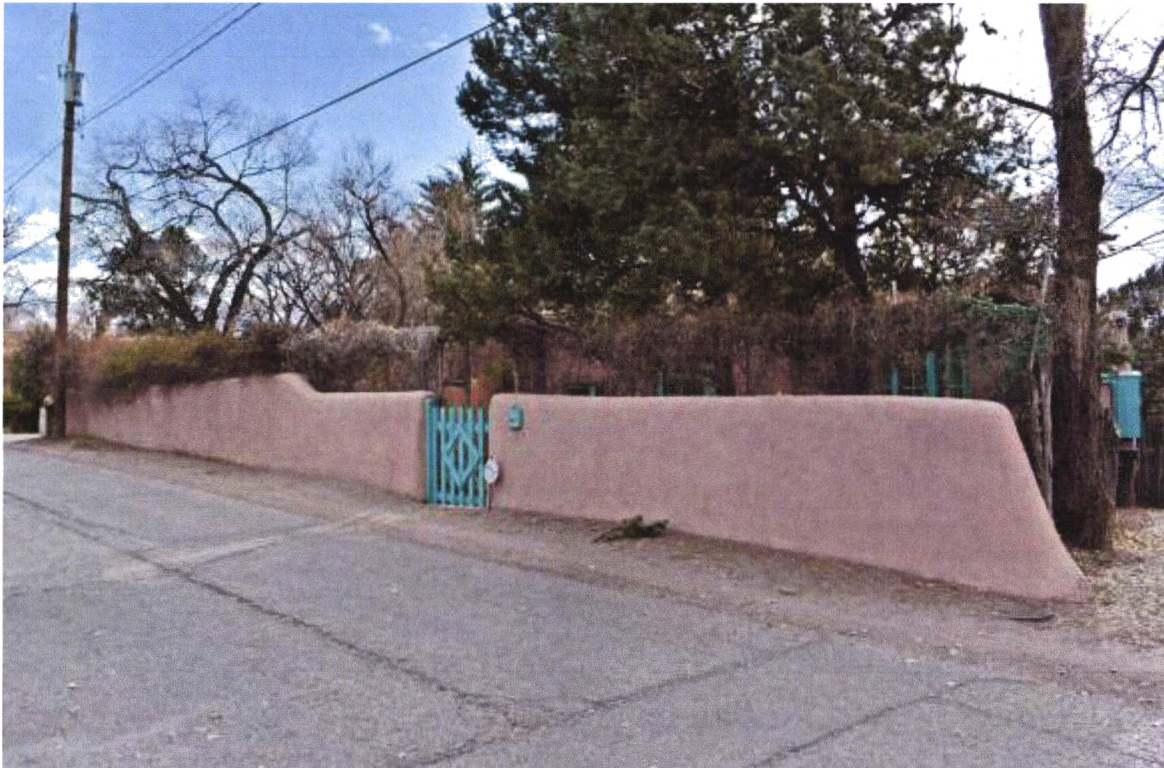
**Photo 1: Street Wall.**  
**Camera facing southwest.**

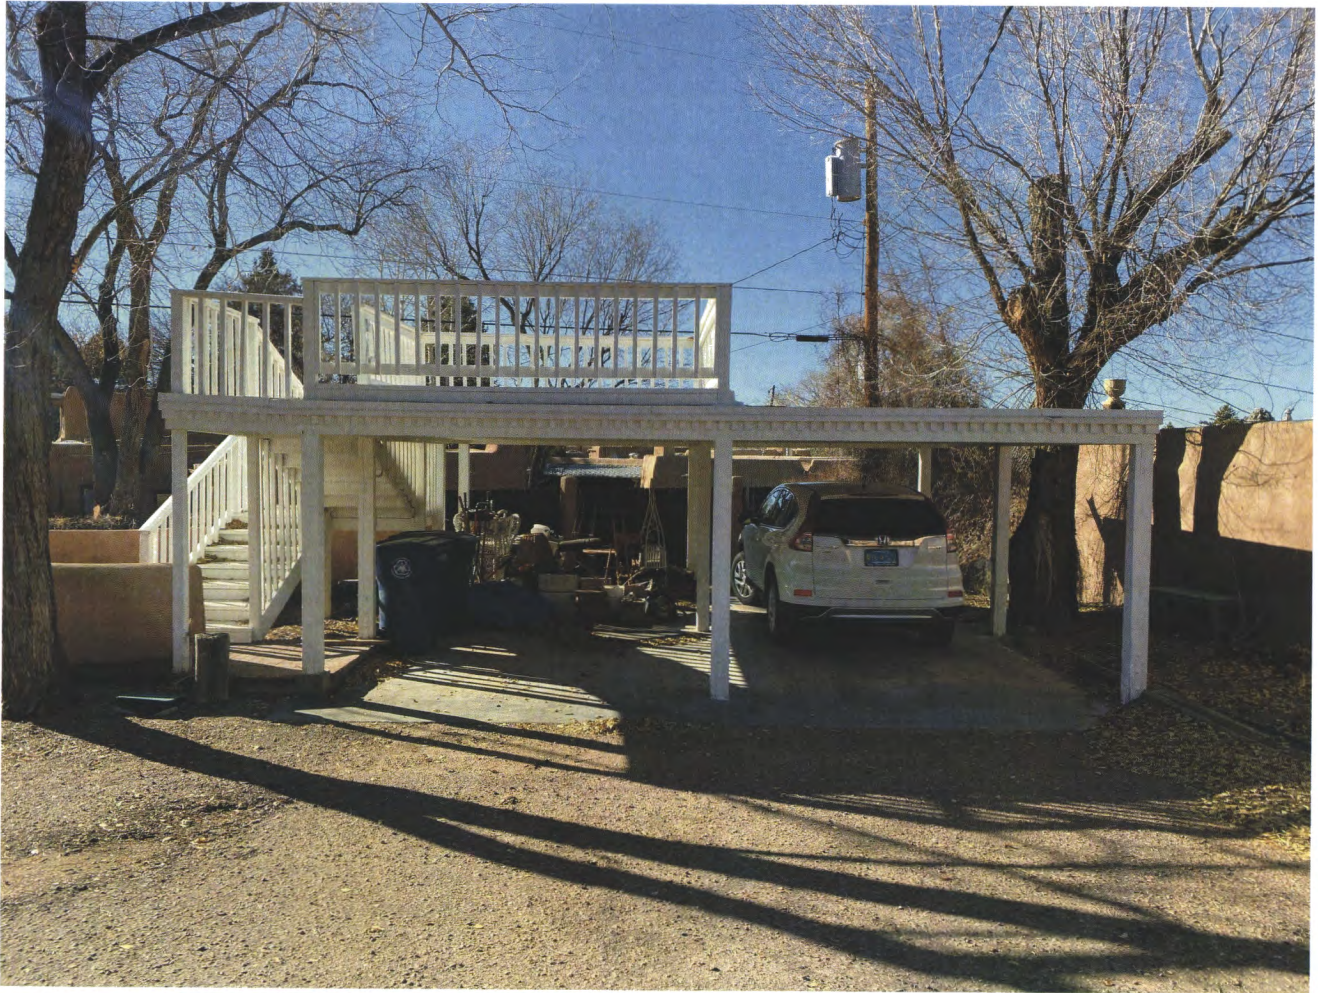
**EXISTING CARPORT – (non-historical) To be removed - site of new casita**

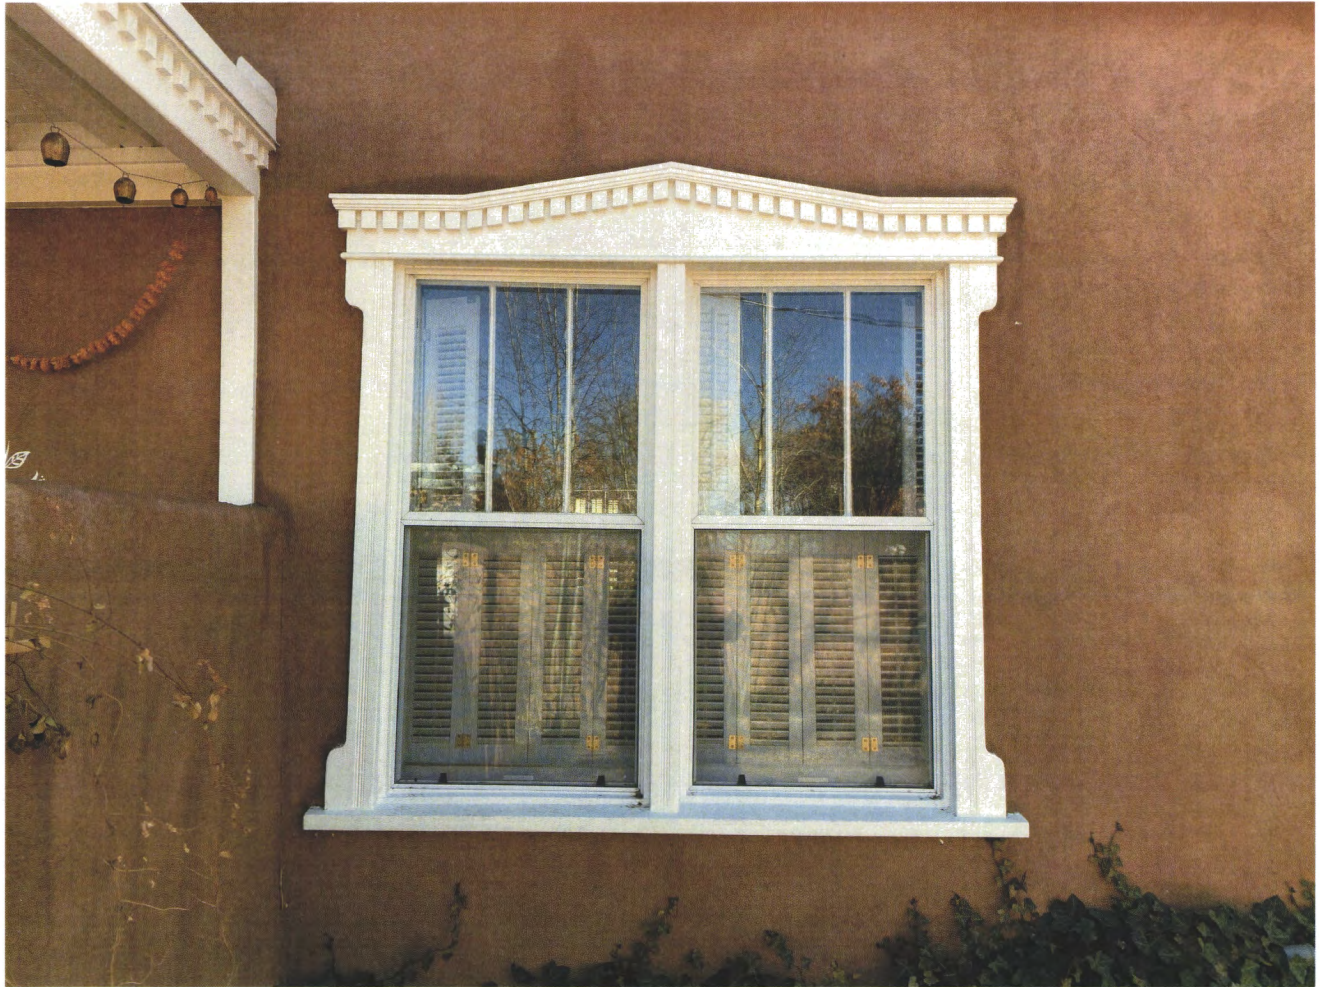
**EXISTING WINDOW @ EXISTING RESIDENCE** – New window along street front to match existing Territorial style; painted wood.

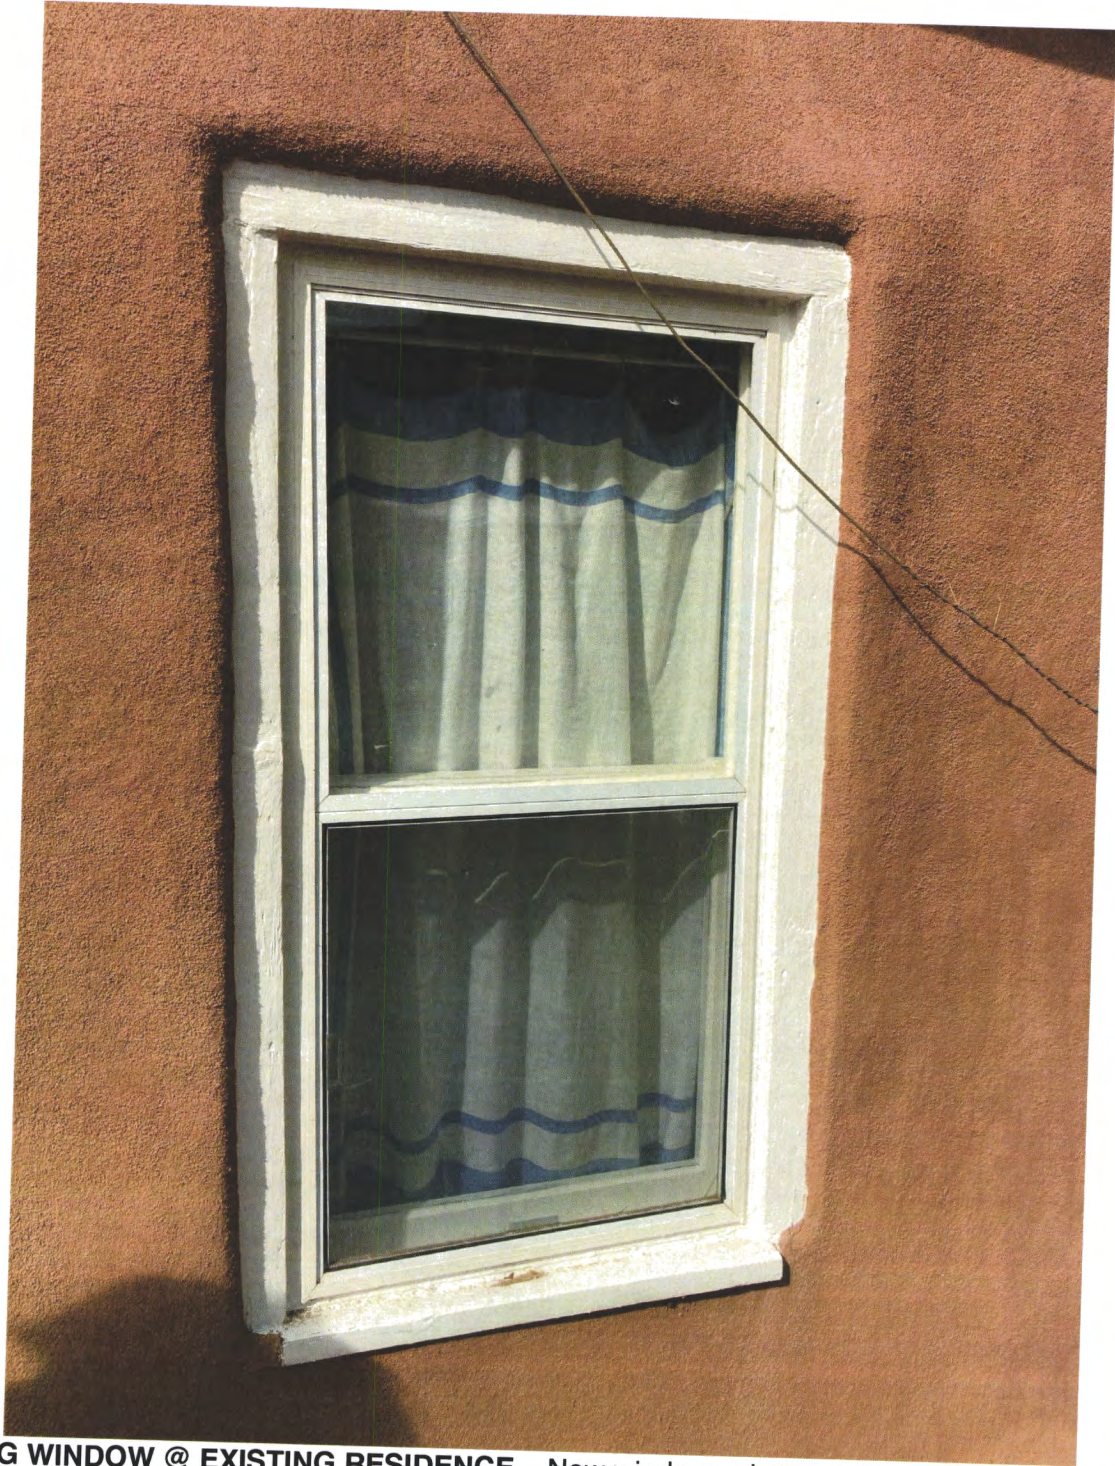
**EXISTING WINDOW @ EXISTING RESIDENCE** – New windows along southern and eastern Casita elevations to match; painted wood.
