AGENDA

HISTORIC DISTRICTS
REVIEW BOARD
JUNE 14, 2022
5:30 PM
COUNCIL CHAMBERS
CITY HALL
200 LINCOLN AVENUE

1. 2022-005163-HDRB. 824 Agua Fria St. Westside-Guadalupe Historic District. Marc Naktin, agent for Wendy and Christopher Weatherford, owners, proposes to remove a yard wall, replace windows, re-stucco, construct a 147 sq. ft. portal and make other changes to a contributing structure. An exception to 14-5.2(D)(5) is requested to replace historic windows on a primary facade. (Carly Piccarello, cpiccarello@santafenm.gov)
2. 2022-005167-HDRB. 428 Camino del Monte Sol. Downtown and Eastside Historic District. Lightfoot, Inc., agent for James Tustin, owner, requests a status downgrade for a contributing single family residence. (Carly Piccarello)

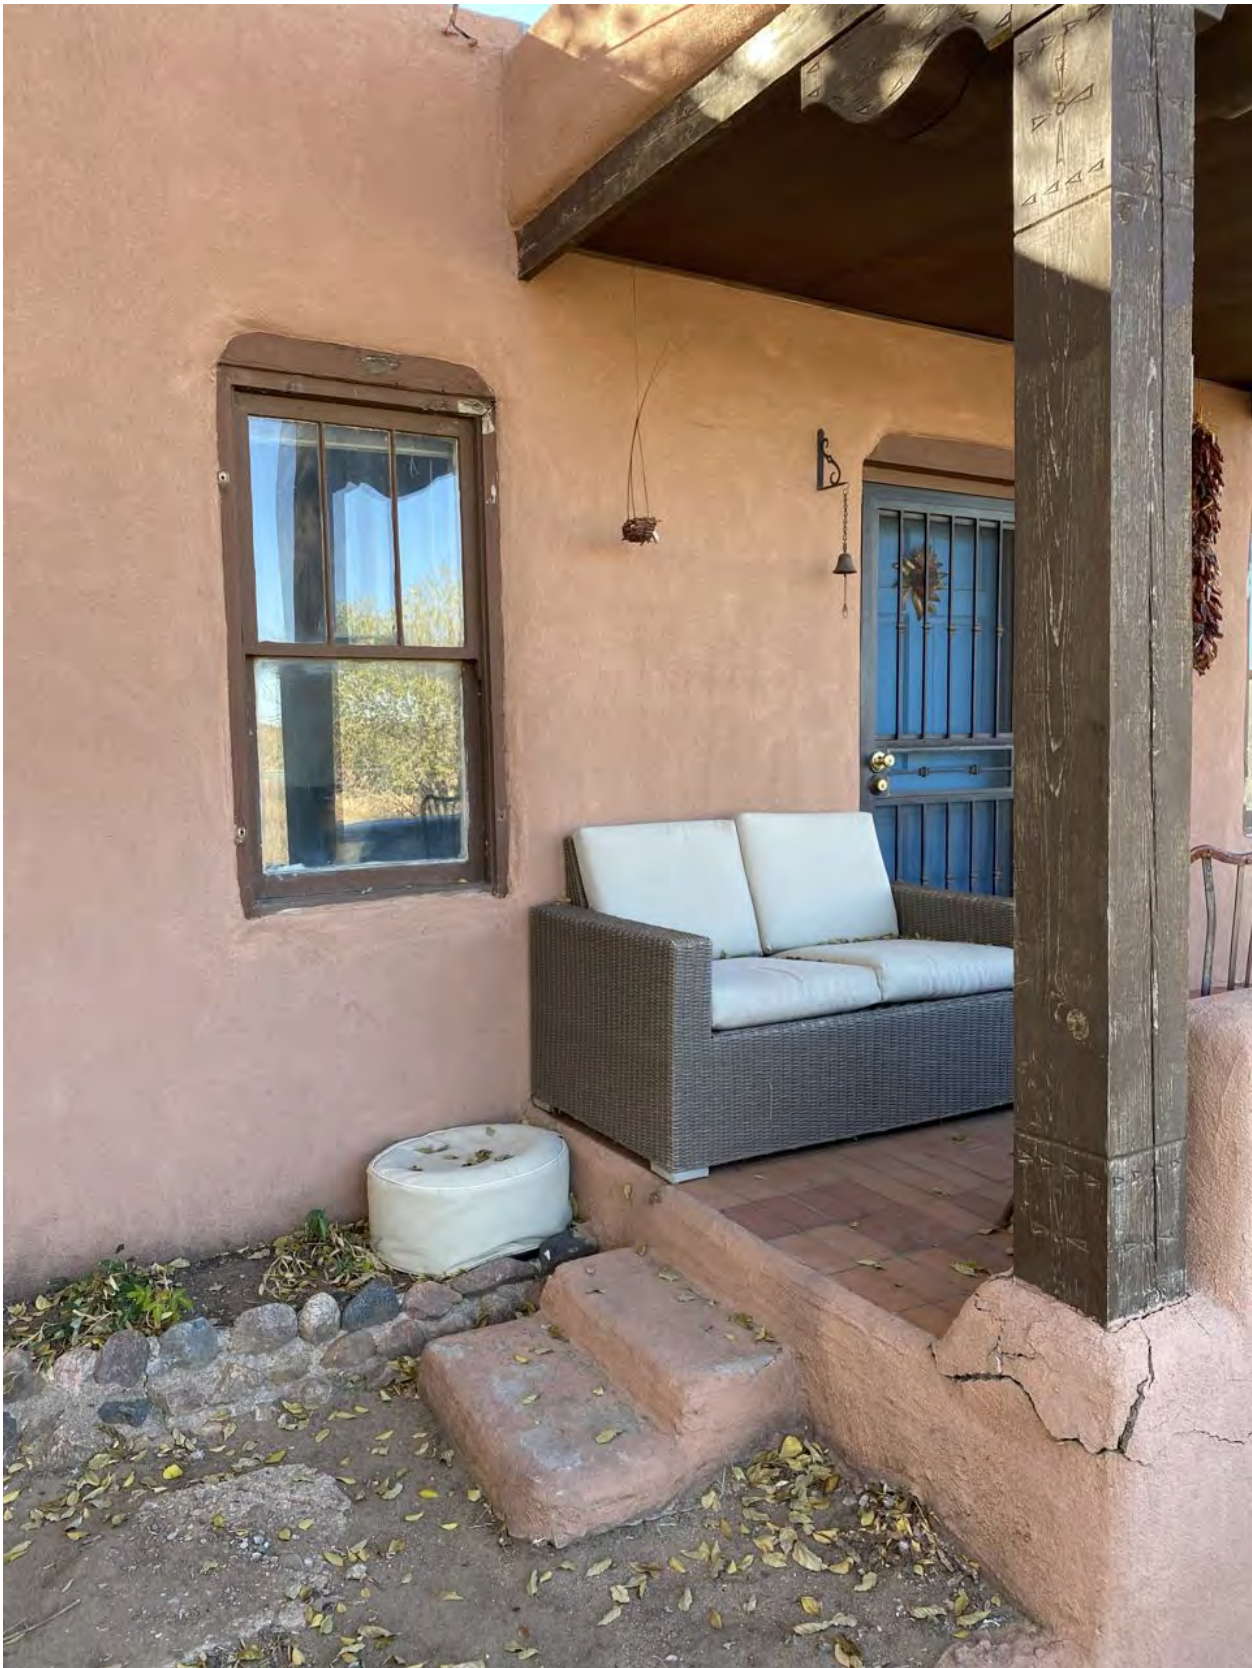
PROPOSED NEW CONCRETE STEPS WIDTH OF PORTAL

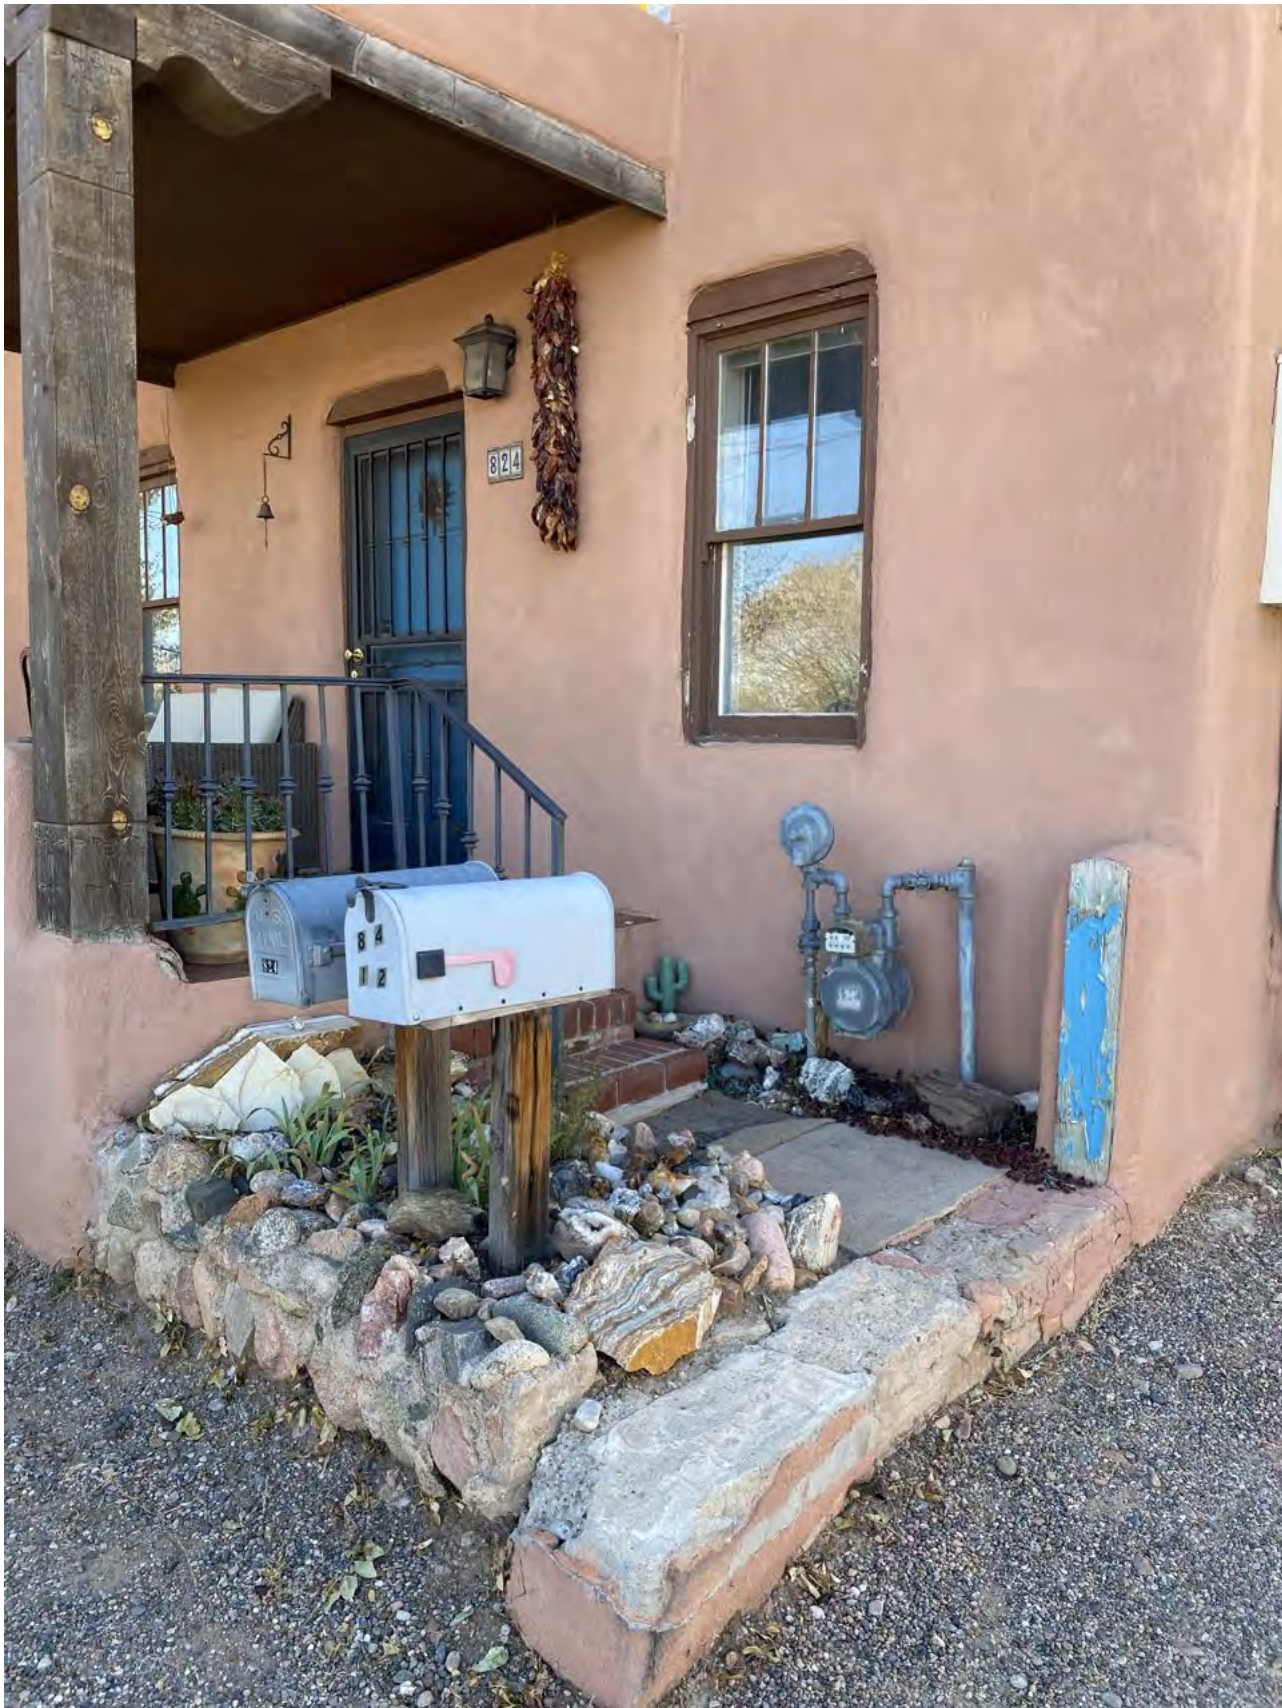
PROPOSED NEW CONCRETE STEPS WIDTH OF PORTAL -
REMOVE HODGE-PODGE ROCK PLANTER / MAILBOXES

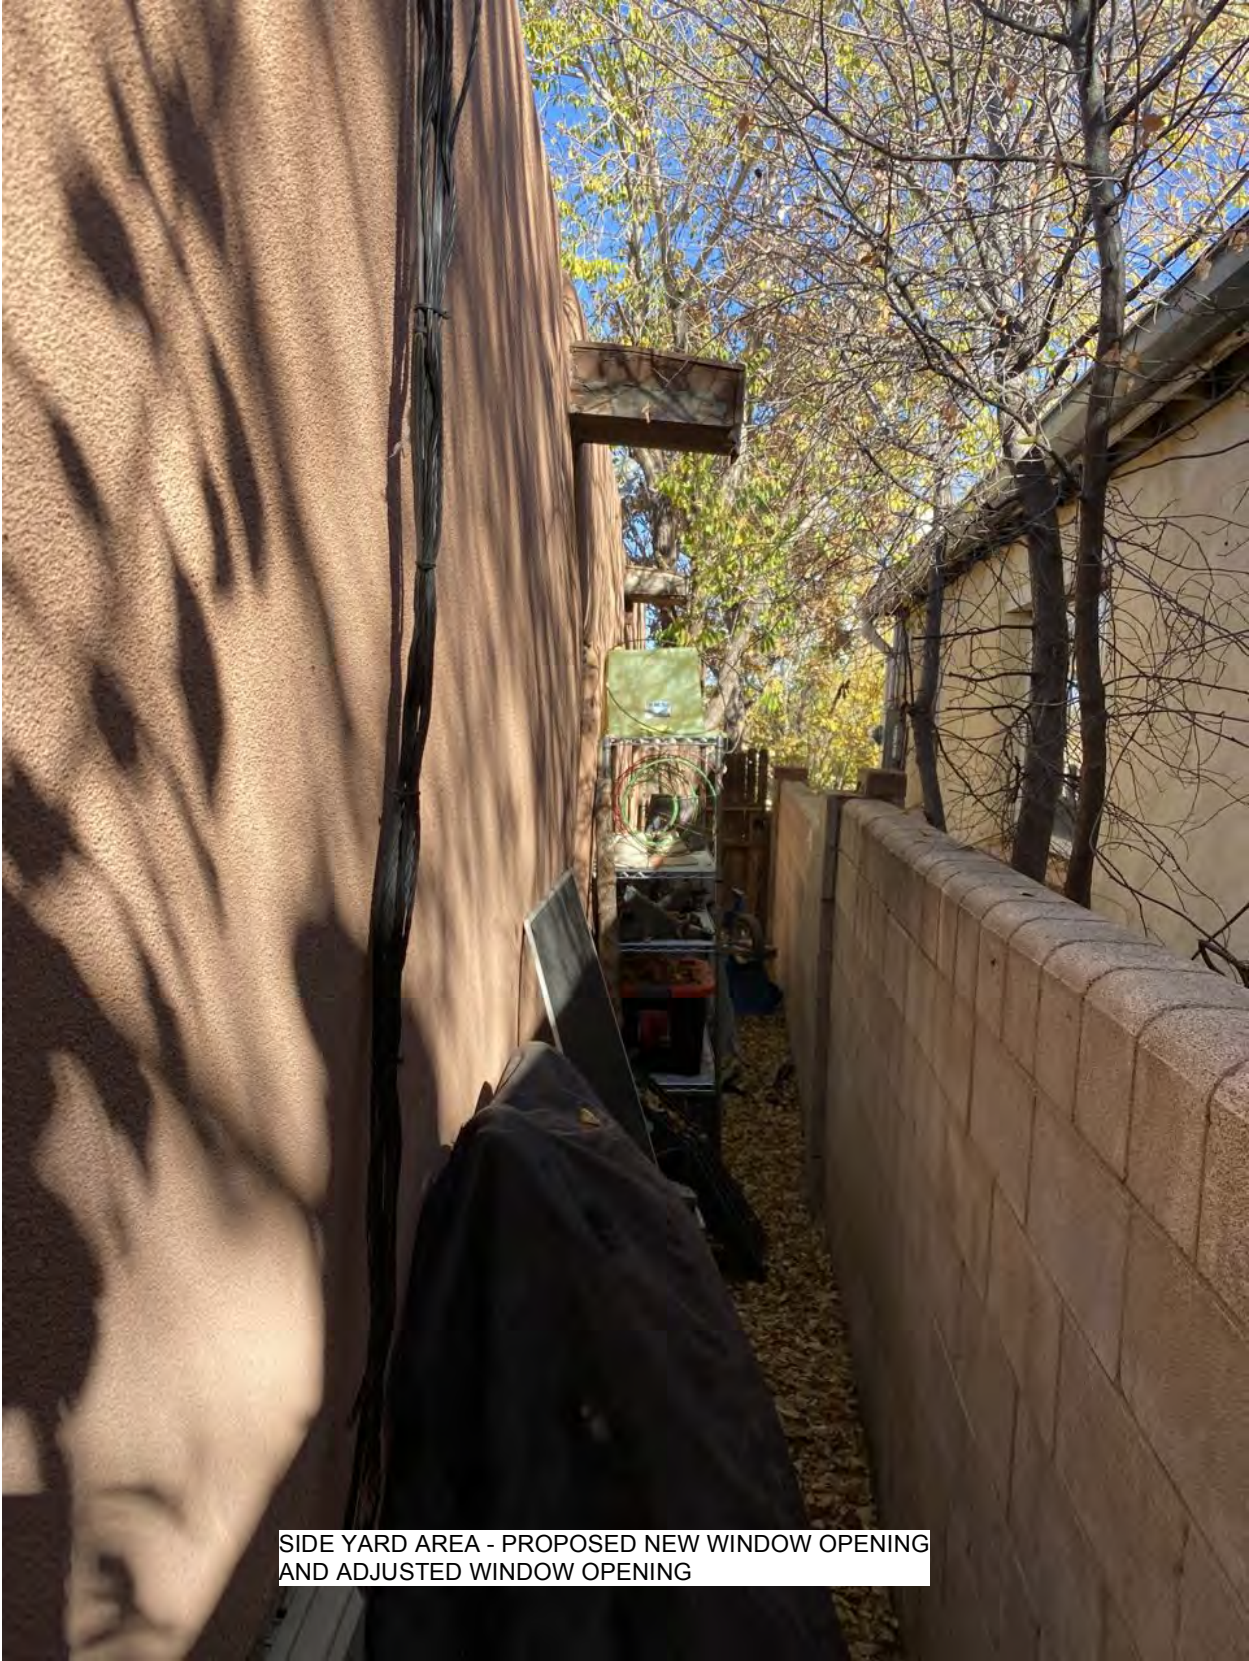
SIDE YARD AREA - PROPOSED NEW WINDOW OPENING
AND ADJUSTED WINDOW OPENING

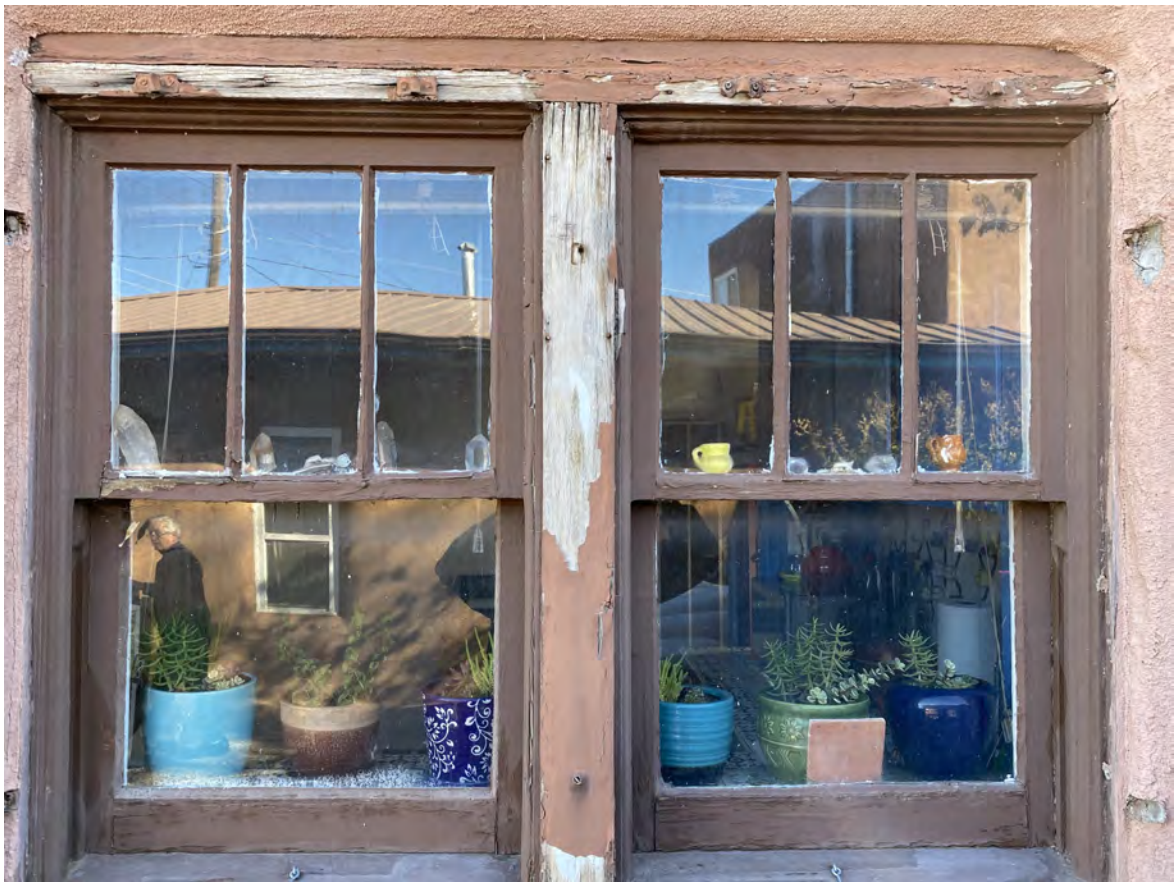
ROTTED WINDOWS PROPOSED TO BE REPLACED THROUGHOUT
SEE PROFESSIONAL ASSESSOR'S REPORT

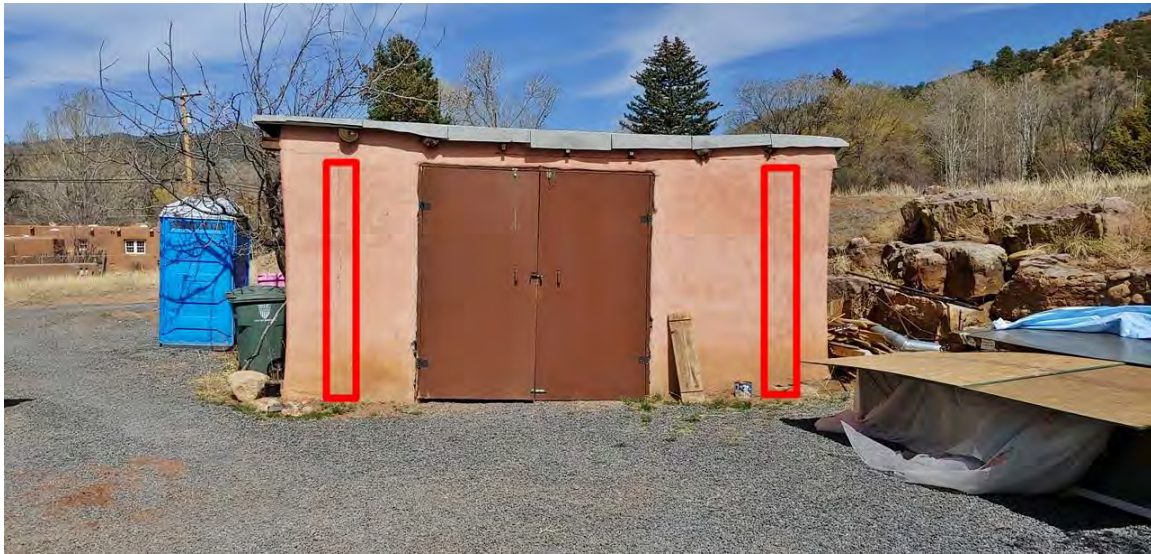
Photo 7: West elevation.
Vertical cracking highlighted.
Camera facing east.

- 2) The wood beams will not be visible from the Garcia Street but may be visible from the eastern side of Johnson Lane. The wood beams are to be hued and stained to a brown gray to match the entry gate. Oiled rust is the steel color of the gate and all proposed steel work is to match. Refer to photo 7 for color of finishes.

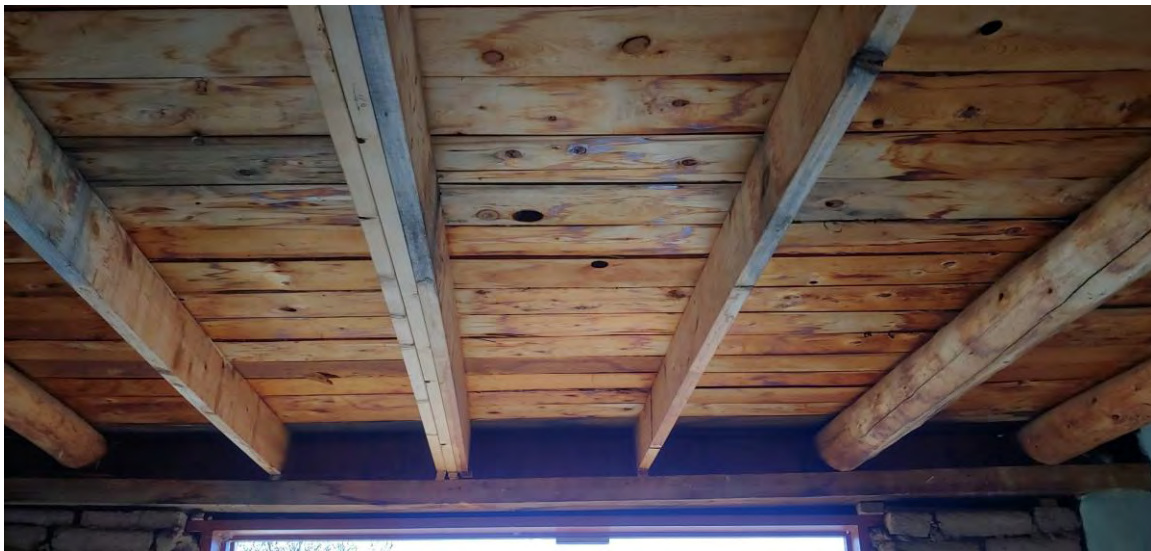
Photo 8: Roof structure and decking.
Camera facing up toward west elevation opening.

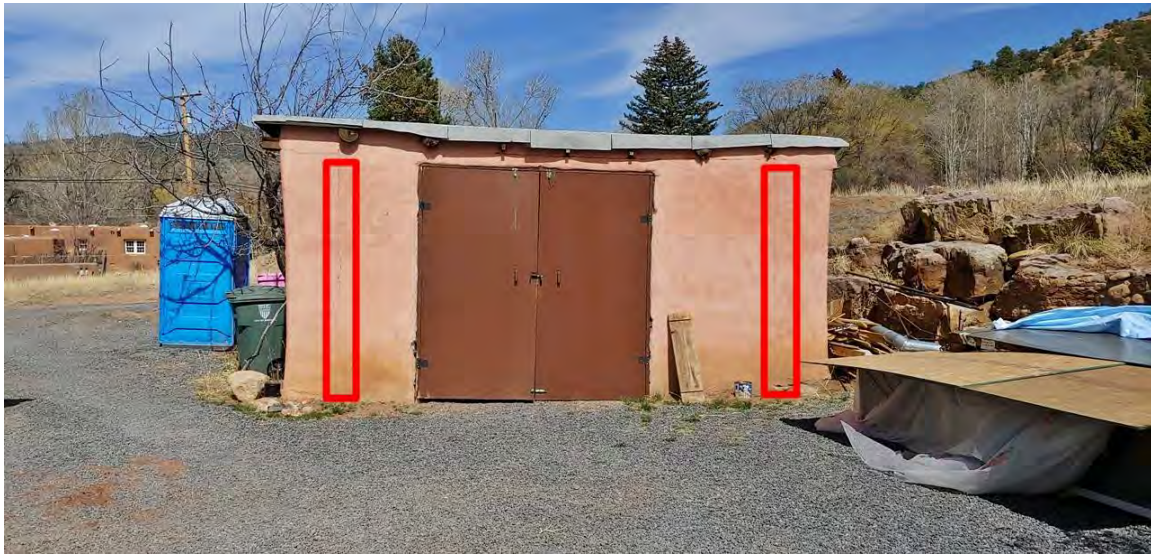
Photo 7: West elevation.
Vertical cracking highlighted.
Camera facing east.

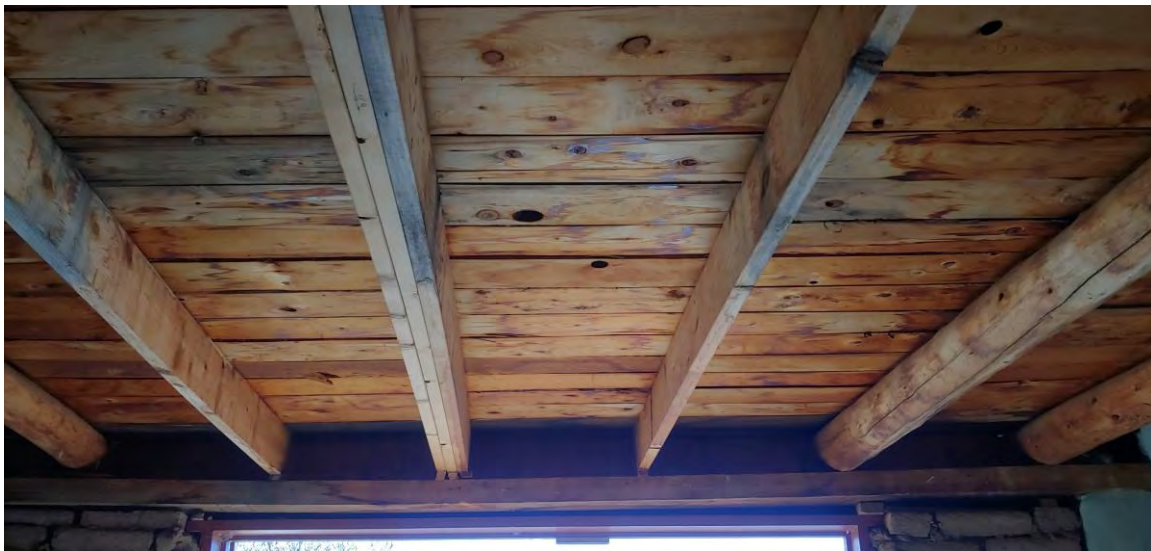
Photo 8: Roof structure and decking.
Camera facing up toward west elevation opening.
