AGENDA

HISTORIC DISTRICTS REVIEW
BOARD
JULY 25, 2023
5:30 PM
CITY COUNCIL CHAMBERS
CITY HALL
200 LINCOLN AVENUE

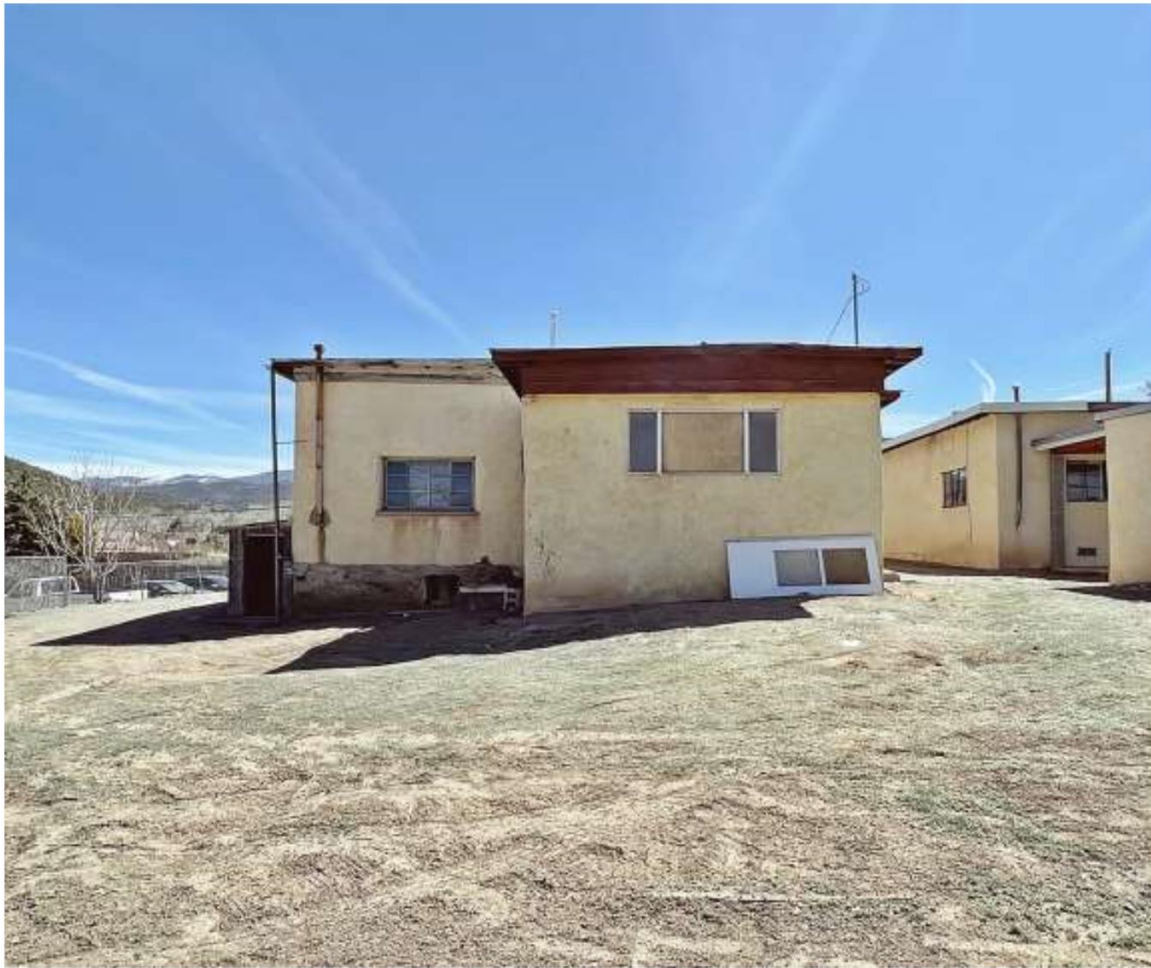
Photo 6: West elevation. Camera facing east.

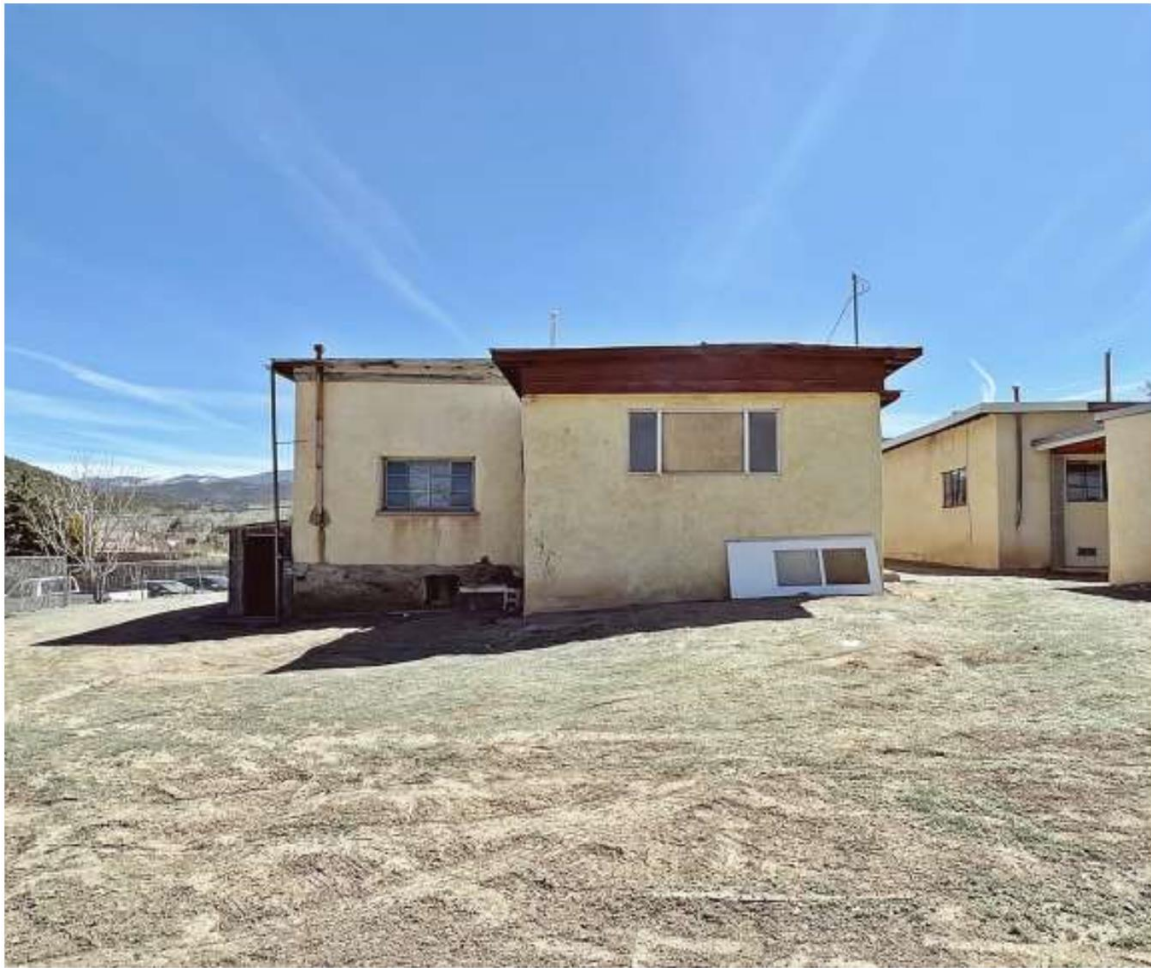
Photo 6: West elevation. Camera facing east.

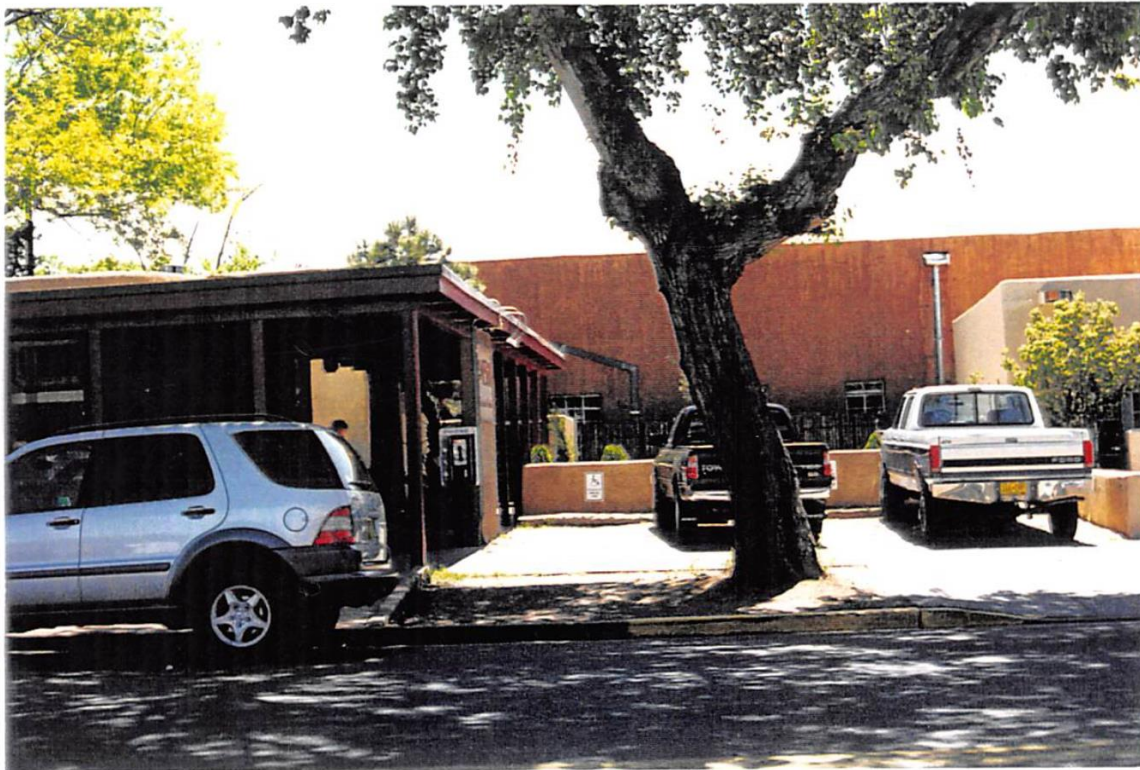
H.99.102
213 Washington

This is an overall view of the area where the fence would be installed. The fence would be right behind the low wall.
