AGENDA

HISTORIC DISTRICTS REVIEW
BOARD
DECEMBER 12, 2023
5:30 PM
CITY COUNCIL CHAMBERS
CITY HALL
200 LINCOLN AVENUE

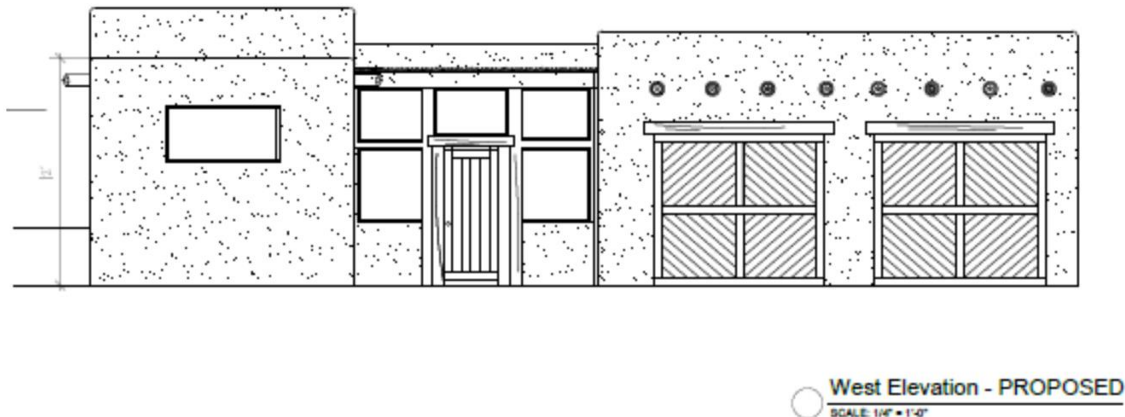
Now the applicant requests to alter the previous approval by constructing a 140 sq. ft. addition to a height of 12'0" where the maximum allowable height is 14'7" on the west façade of the historic addition on the north side of the shop with carport structure.

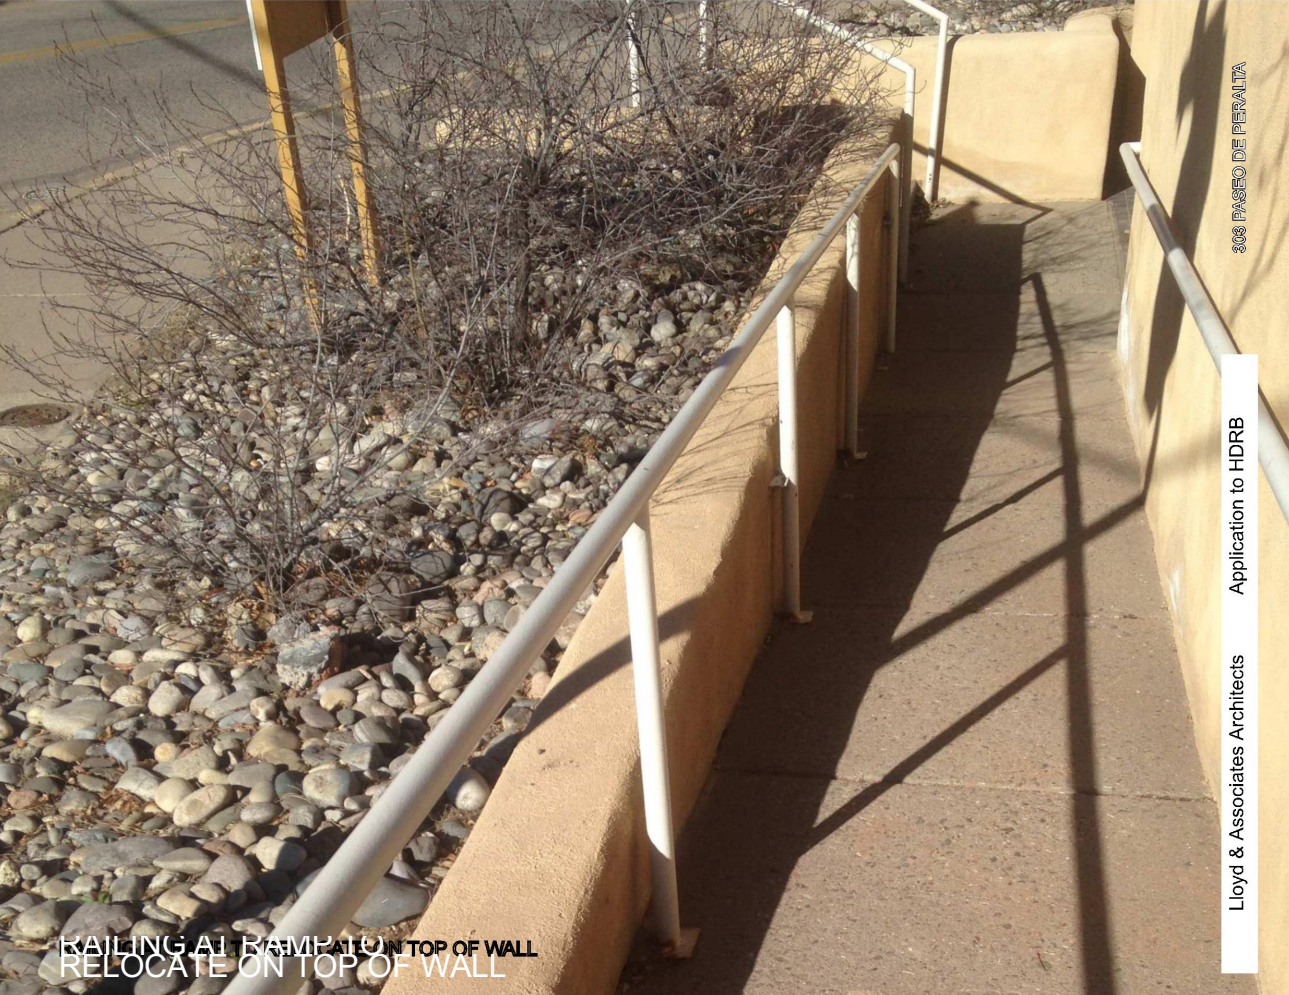
RAILING AT RAMP ALL ON TOP OF WALL
RELOCATE ON TOP OF WALL

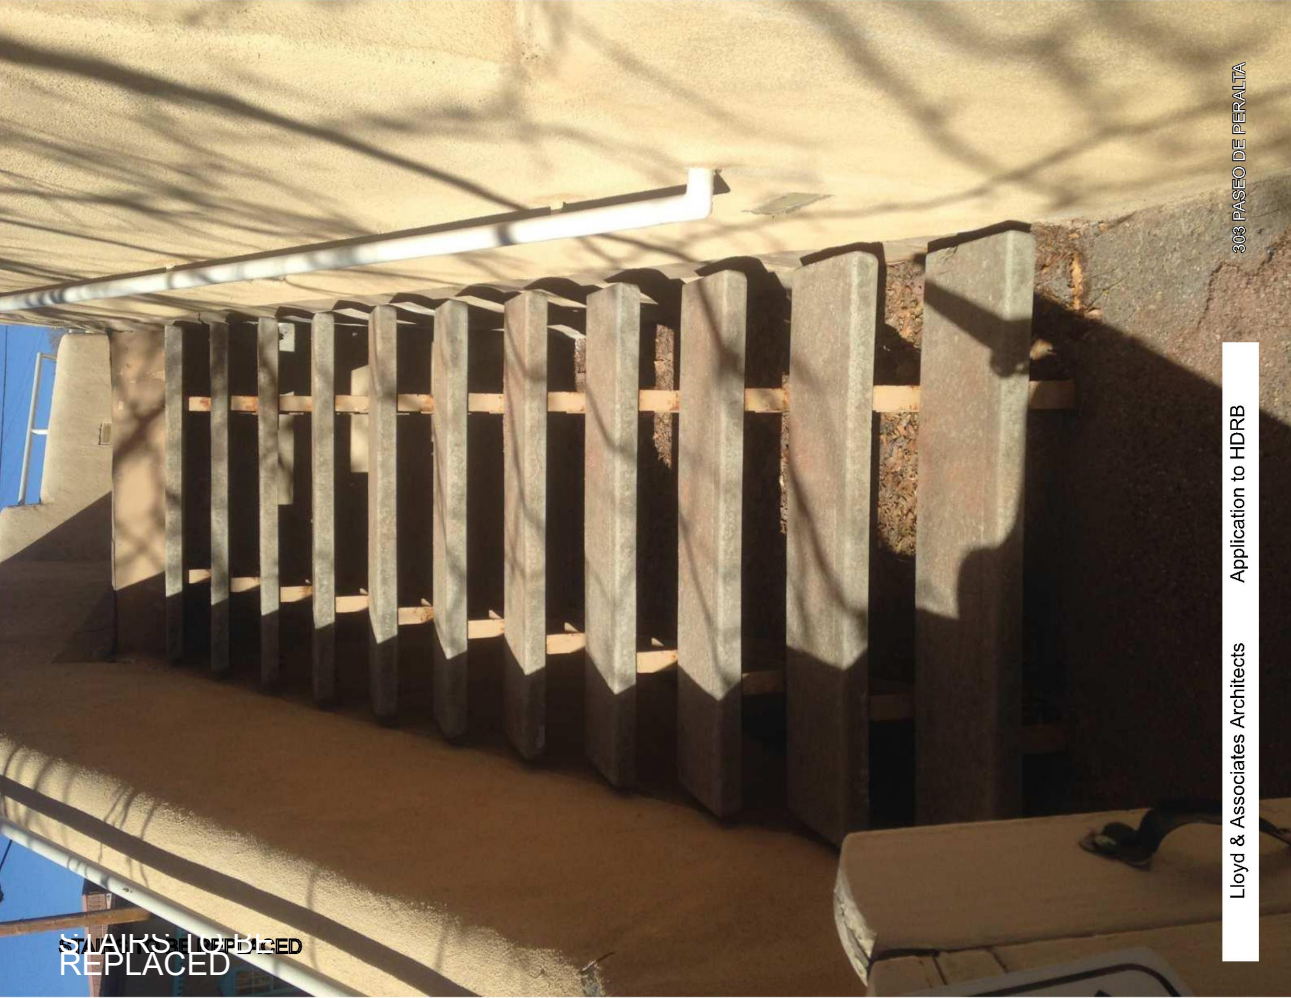
STAIRS LIFTED
REPLACED

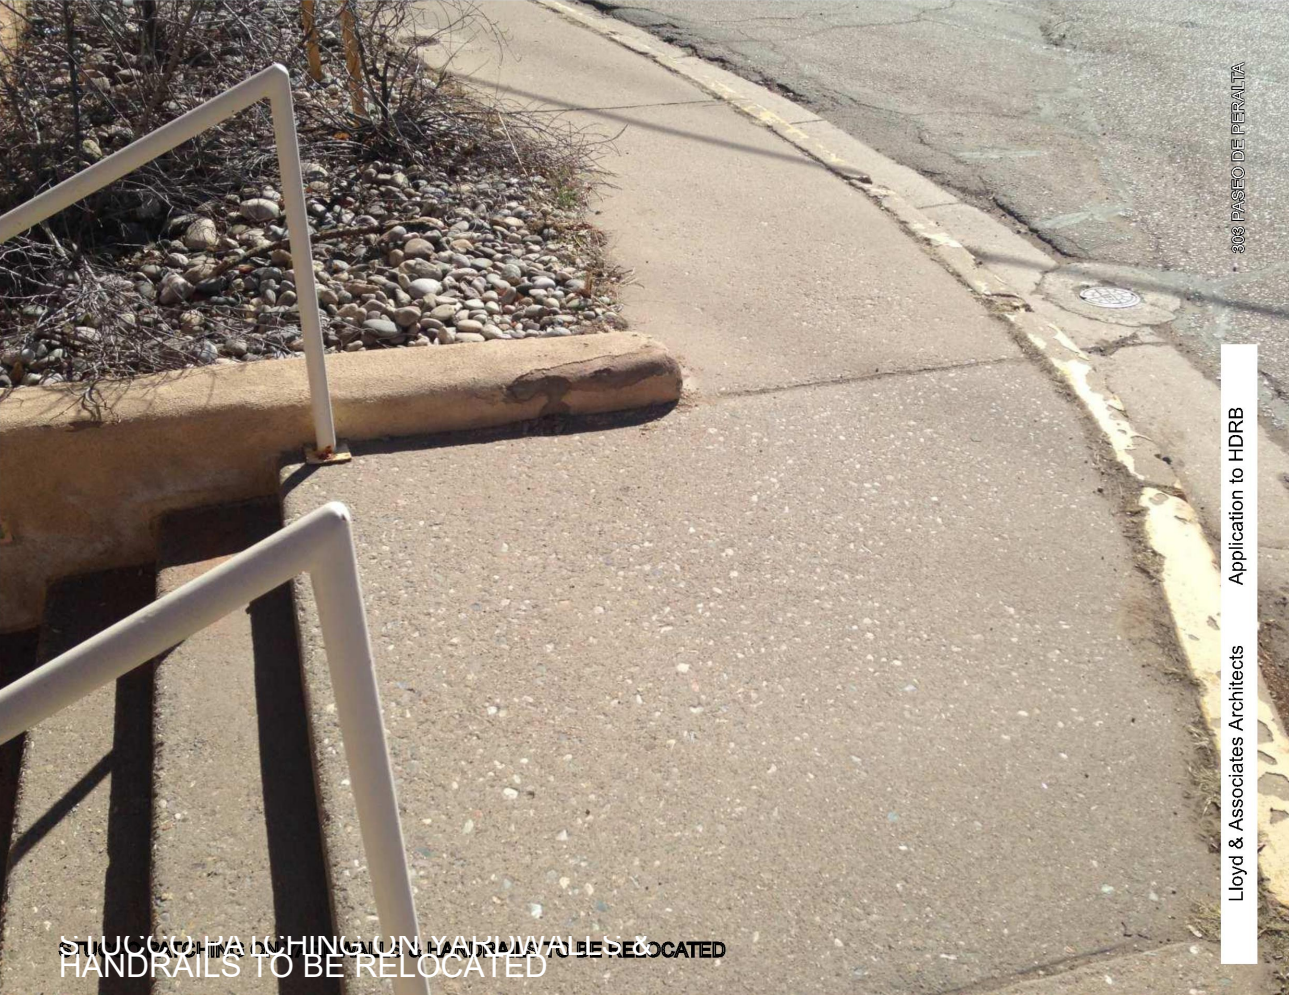
STUCCO MATCHING ON YARD WALLS &
HANDRAILS TO BE RELOCATED

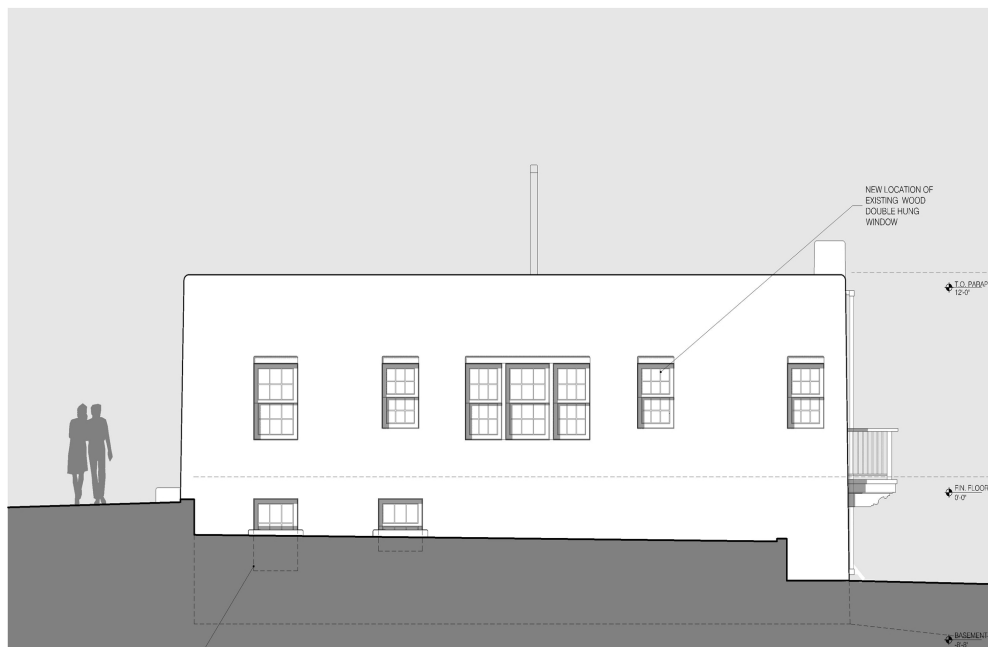
4 PROPOSED SIDE ELEVATION - NORTH

- HOUSE TO BE RE-STUCCOED WITH CEMENTIOUS 'BUCKSKIN' by EL REY
- WHITE PAINTED STUCCO BELOW FRONT PORTAL TO BE REPLICATED
- WOOD WINDOWS and HEADERS TO BE REPAIRED AS NEEDED and REFINISHED WITH EXTERIOR SEMI-SOLID STAIN 'HAWTHORN' by SHERWIN WILLIAMS
- PROPOSED SIDEWALK GATE TO BE SINGLE WOOD PANEL MATCH HEIGHT OF WALL MATCH WINDOW STAIN COLOR

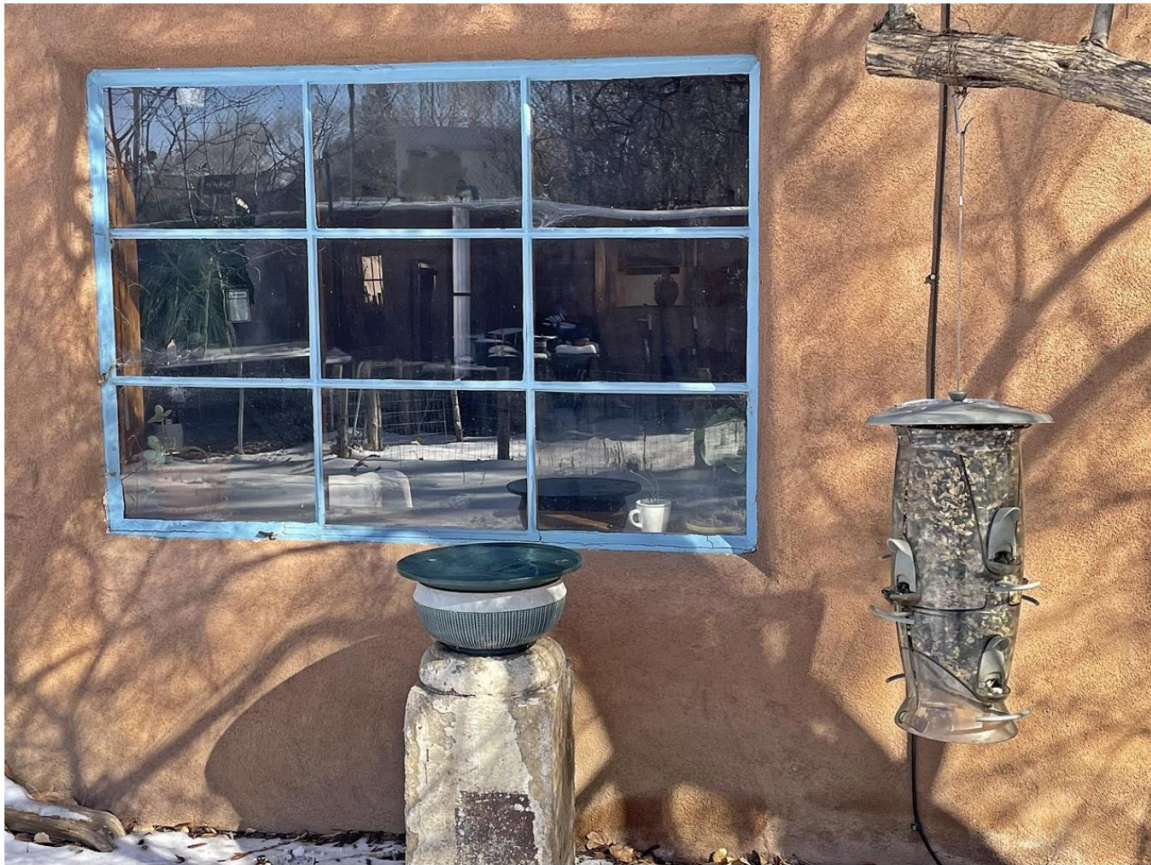
Photo 6: West elevation. Example of nine-light window. Camera facing northeast.

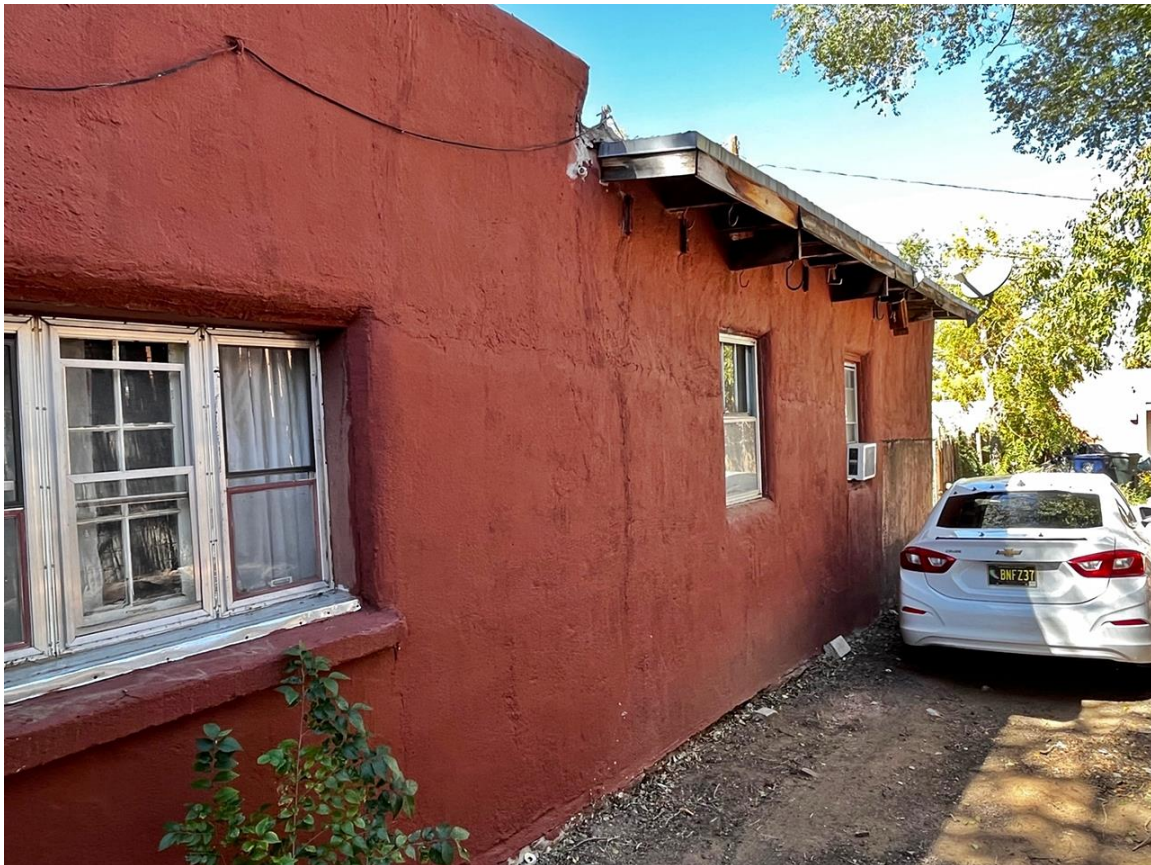
**Photo 11: Partial east elevation. Camera facing northwest.
 Note change in parapet height and window pattern and placement.**
