SANTA FE RIVER COMMISSION
JUNE 13, 2024
6:00 PM
CITY OF SANTA FE TRANSIT
CENTER RM #117
2931 RUFINA ST.

First Quarter 2024 Monitoring Report Two-Mile Pond Complex Riparian Survey City of Santa Fe, New Mexico

**FIRST QUARTER 2024 MONITORING REPORT
TWO-MILE POND COMPLEX RIPARIAN SURVEY,
CITY OF SANTA FE, NEW MEXICO**

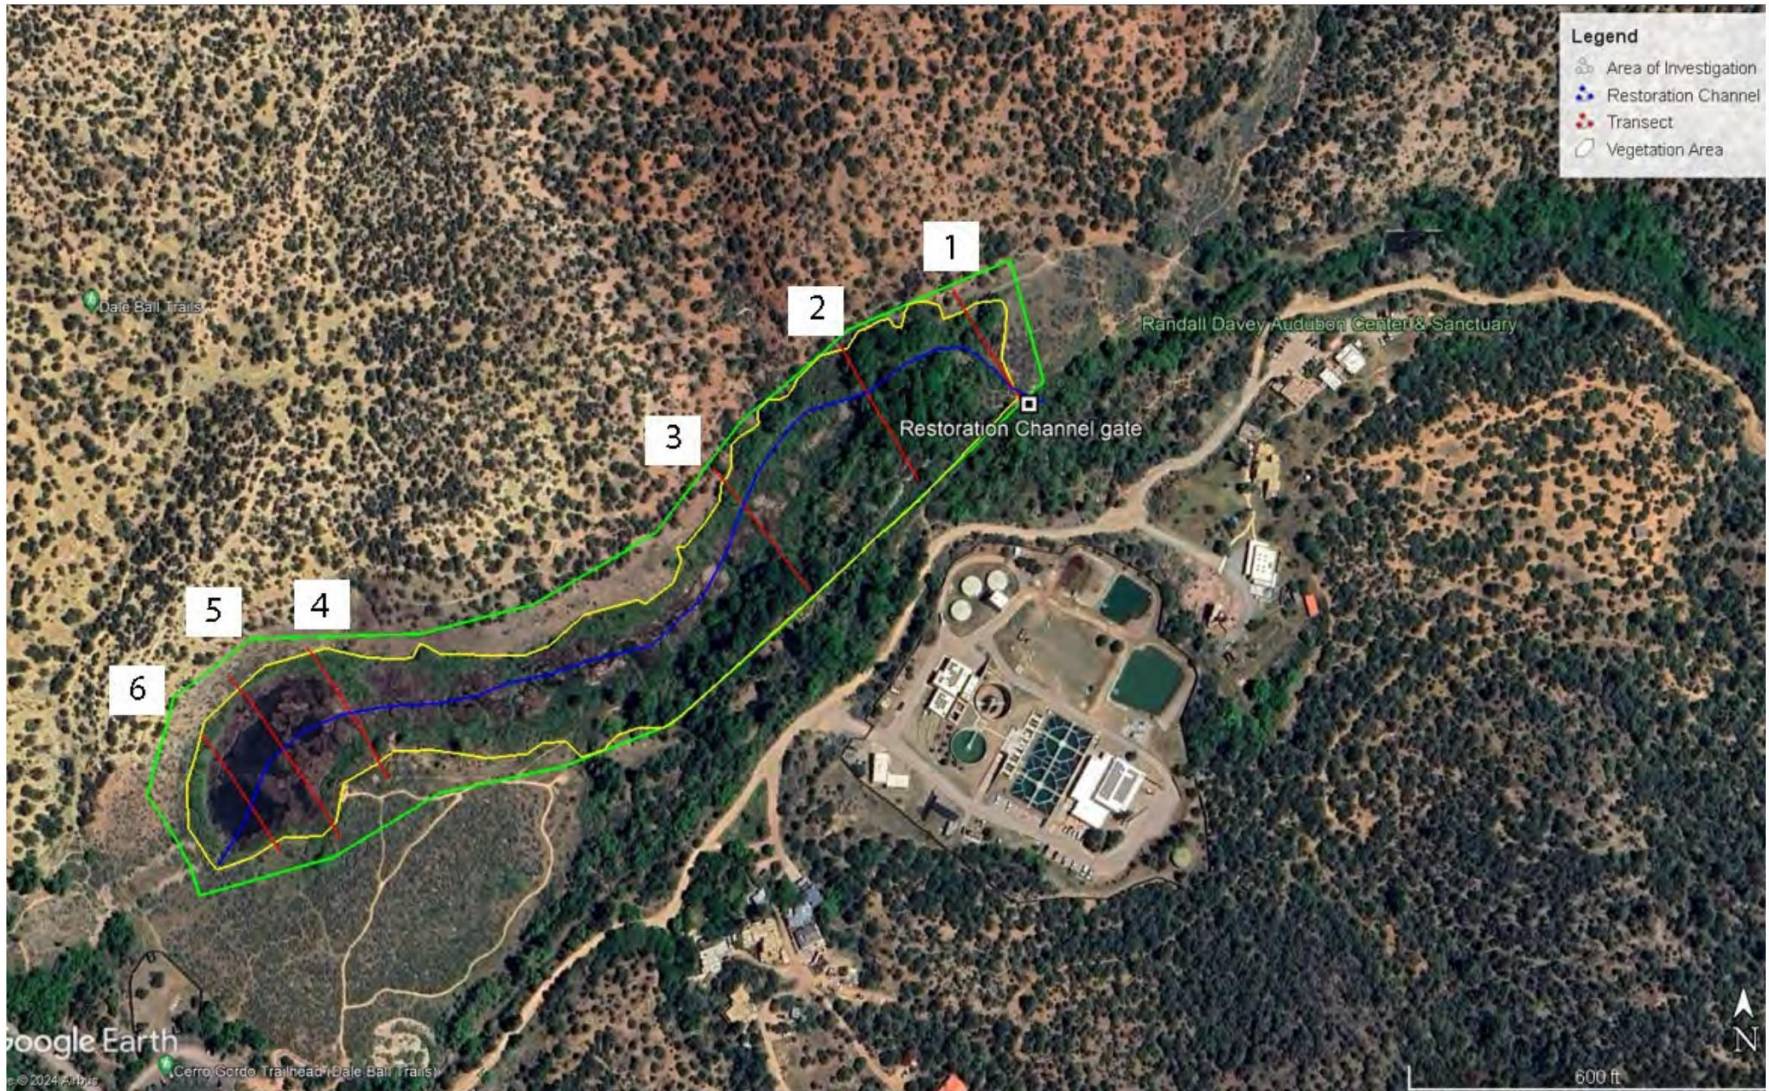
Figure 3. Landscape-scale map showing the Two-Mile Pond Complex and area of investigation on June 7, 2023 aerial photograph.

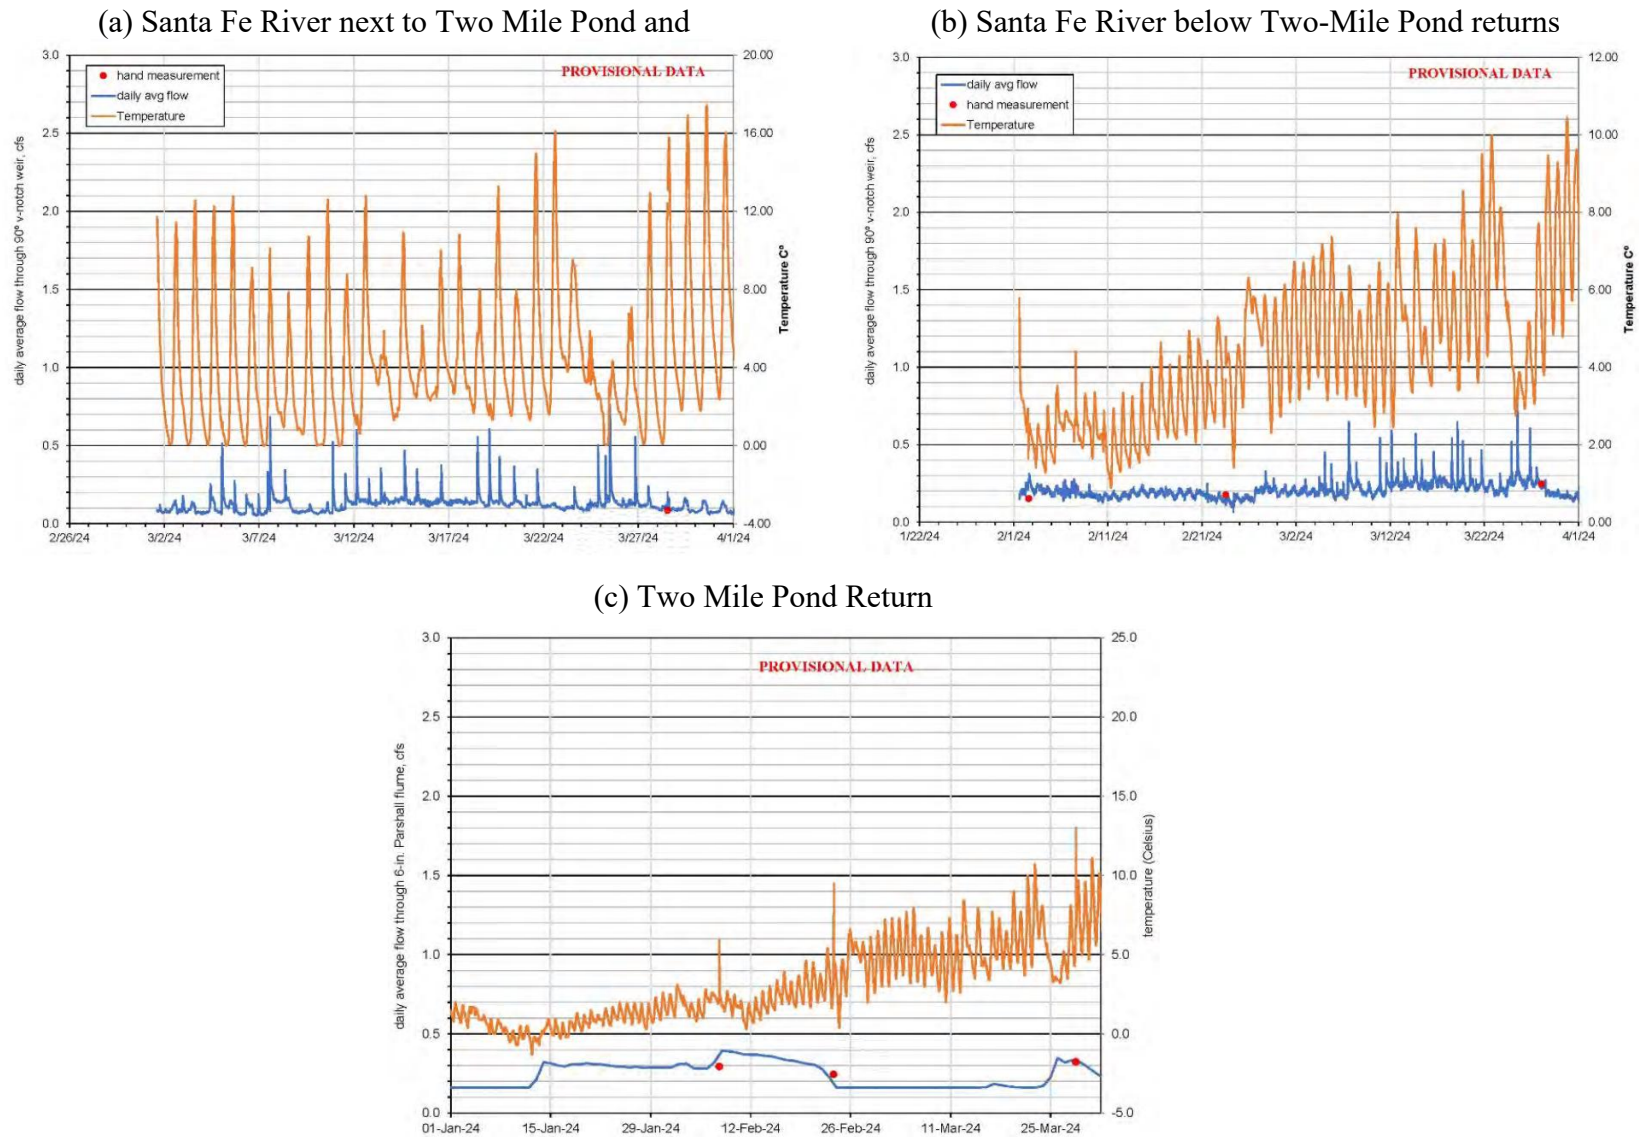
Figure 6. Hydrographs for First Quarter 2024 of (a) Santa Fe River next to Two Mile Pond, (b) Santa Fe River below Two Mile Pond returns, and (c) Two-Mile Pond returns (below Two-Mile).

Hydrographs were prepared for the time period January 1 to March 31, 2024 (Fig. 6). Santa Fe River flows next to Two Mile Pond had a base flow of 0.1 from Nichols Dam ranged from 0.1 to 0.5 cfs during the First Quarter of 2024. Streamflow measured at the Two-Mile return flume ranged from 0.16 to 0.40 cfs, and average 0.24 cfs during the First Quarter of 2024. Santa Fe River flows below the confluence with Two-Mile Pond returns ranged from 0.1 to 0.7 cfs. Water temperature is plotted with measured flows which ranged between 0 and 16 degrees Celsius.

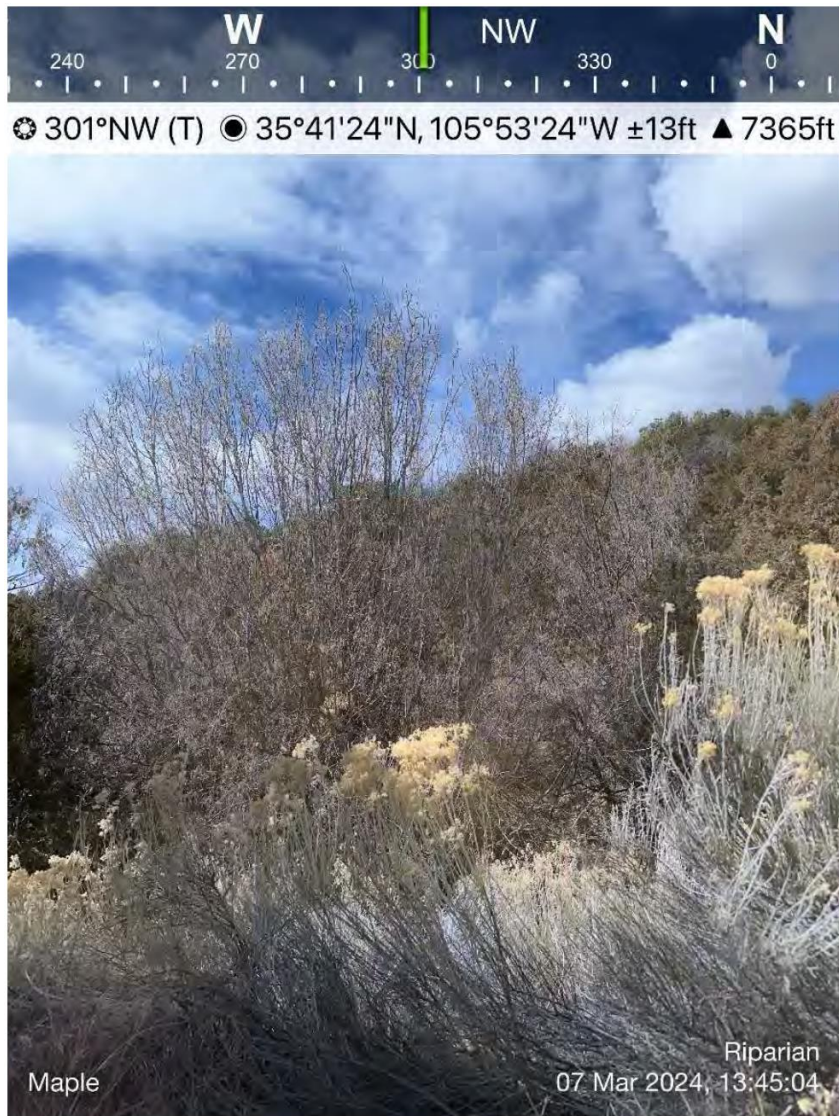
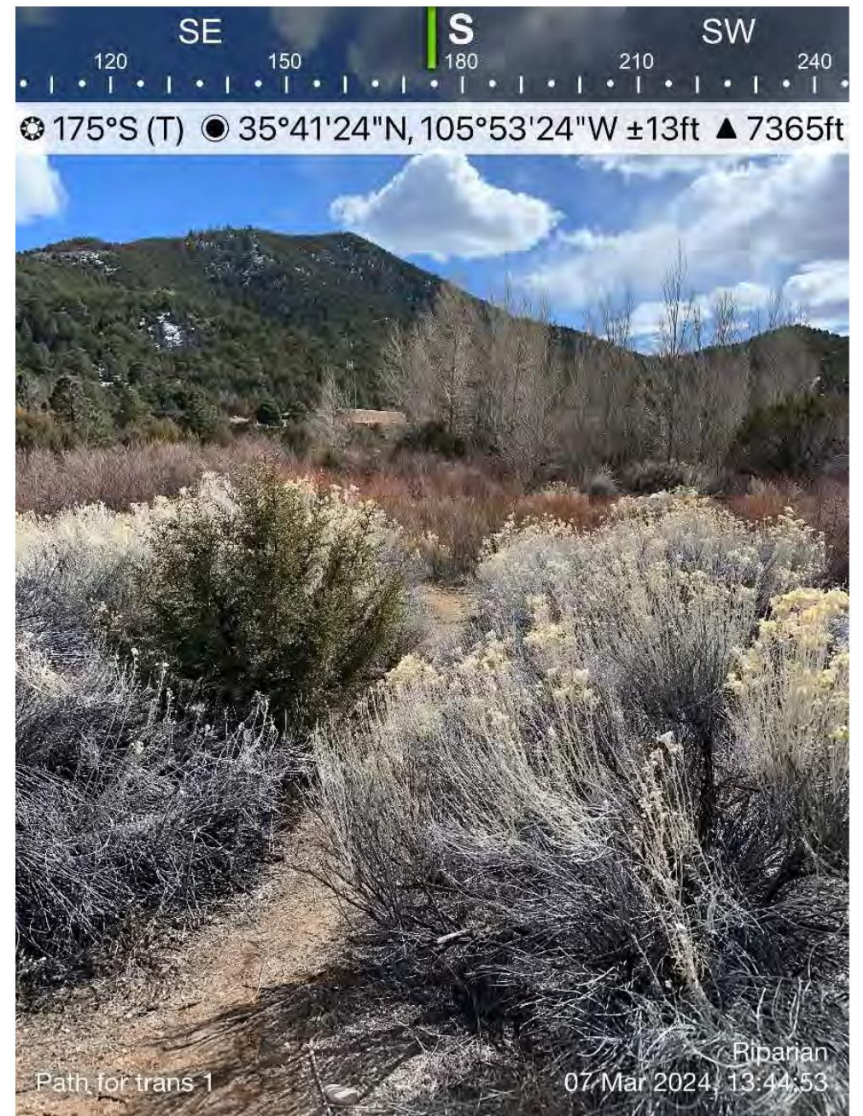
Figure E1. Photos from Transect 1 taken on 3/7/24. This area was the driest area in the entire investigation and begins at the start of the transition into a high desert-like landscape.

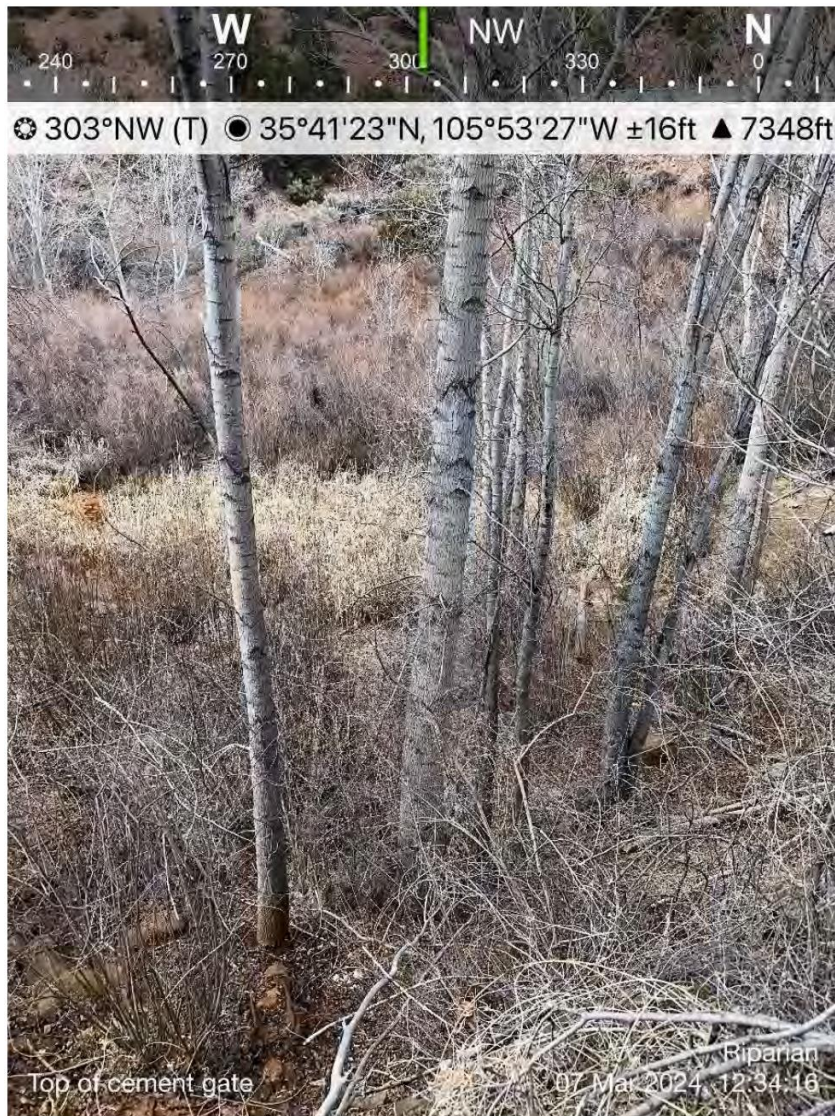
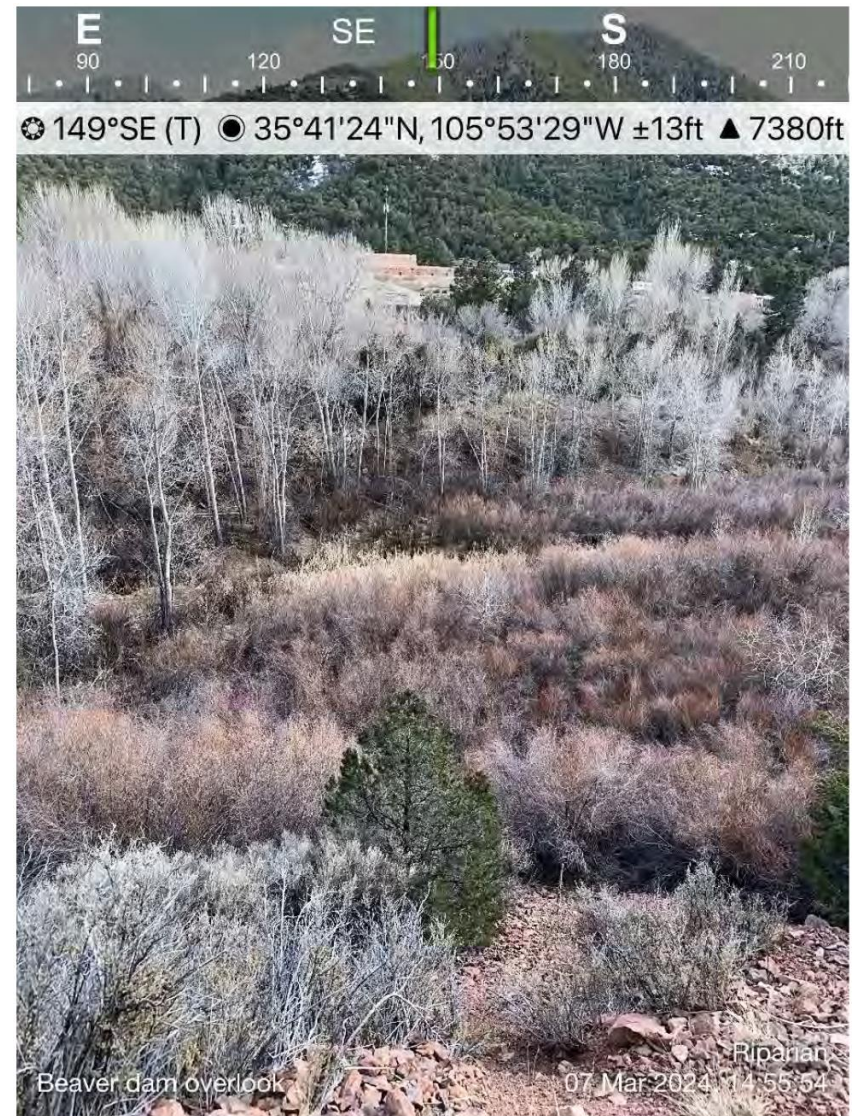
Figure E2. Photos taken of Transect 2 on 3/7/24. This area is located above the dam. The second photo also overlooks some of Transect 3 on the south and Transect 2 on the east.

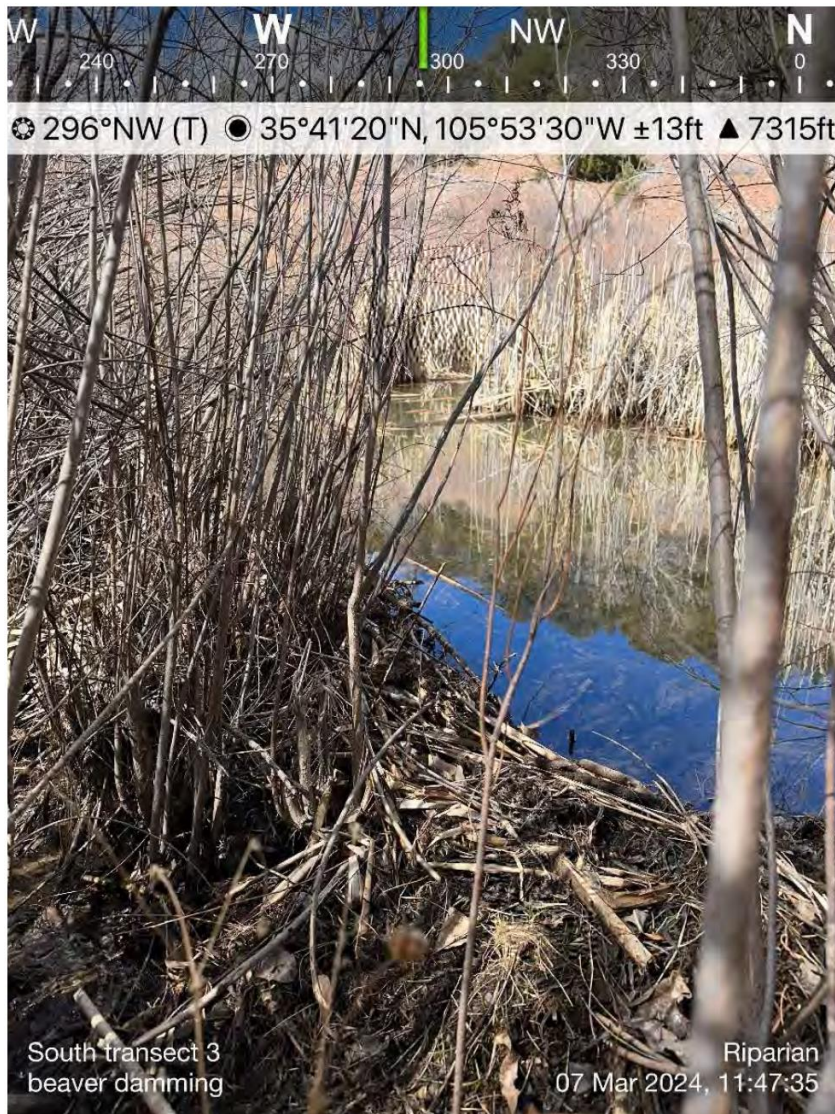
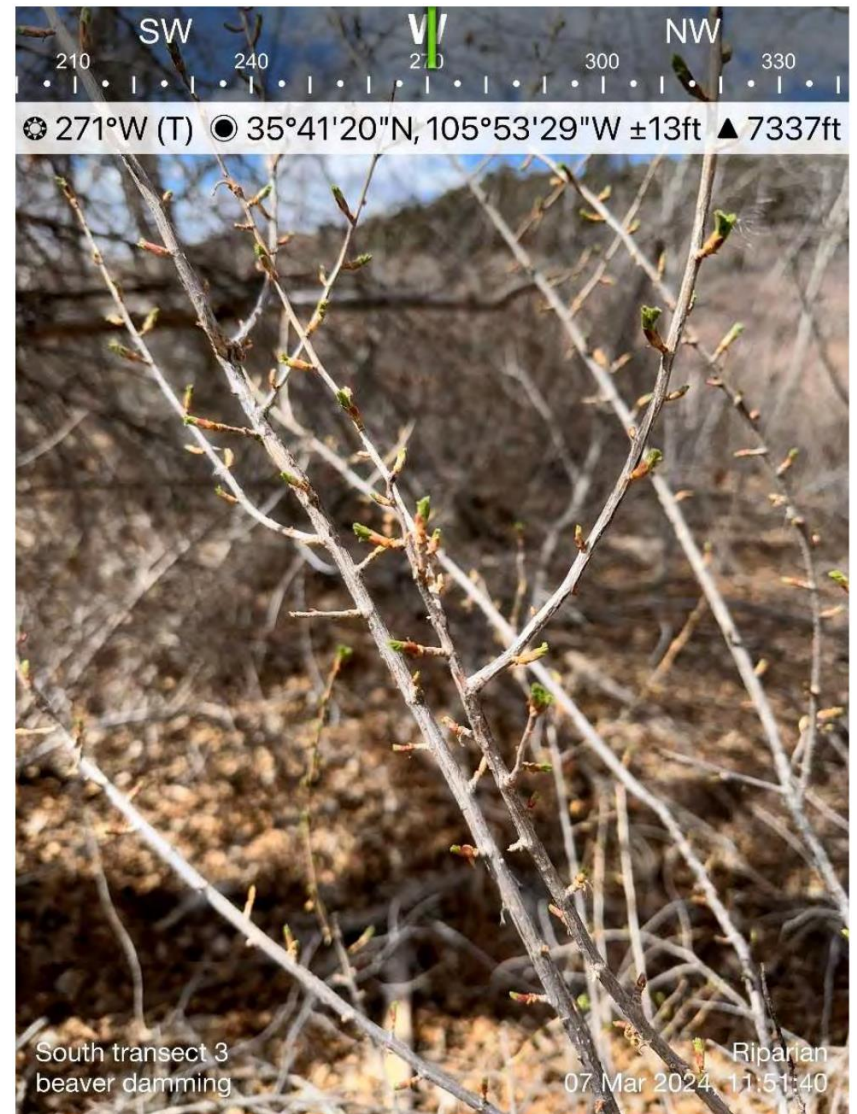
Figure E3. Photos taken along Transect 3 on 3/7/24. The photo on the left shows the storm flood formed dam and the photo on the right represents new growth on a younger tree.

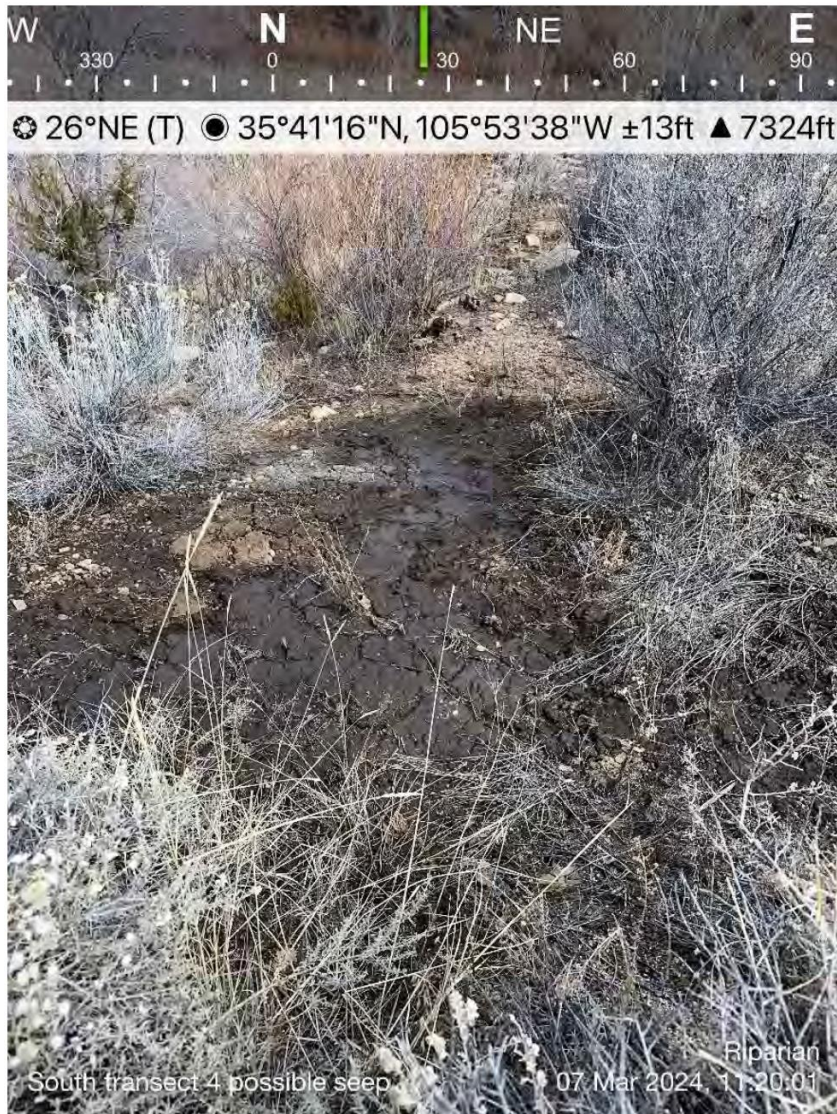
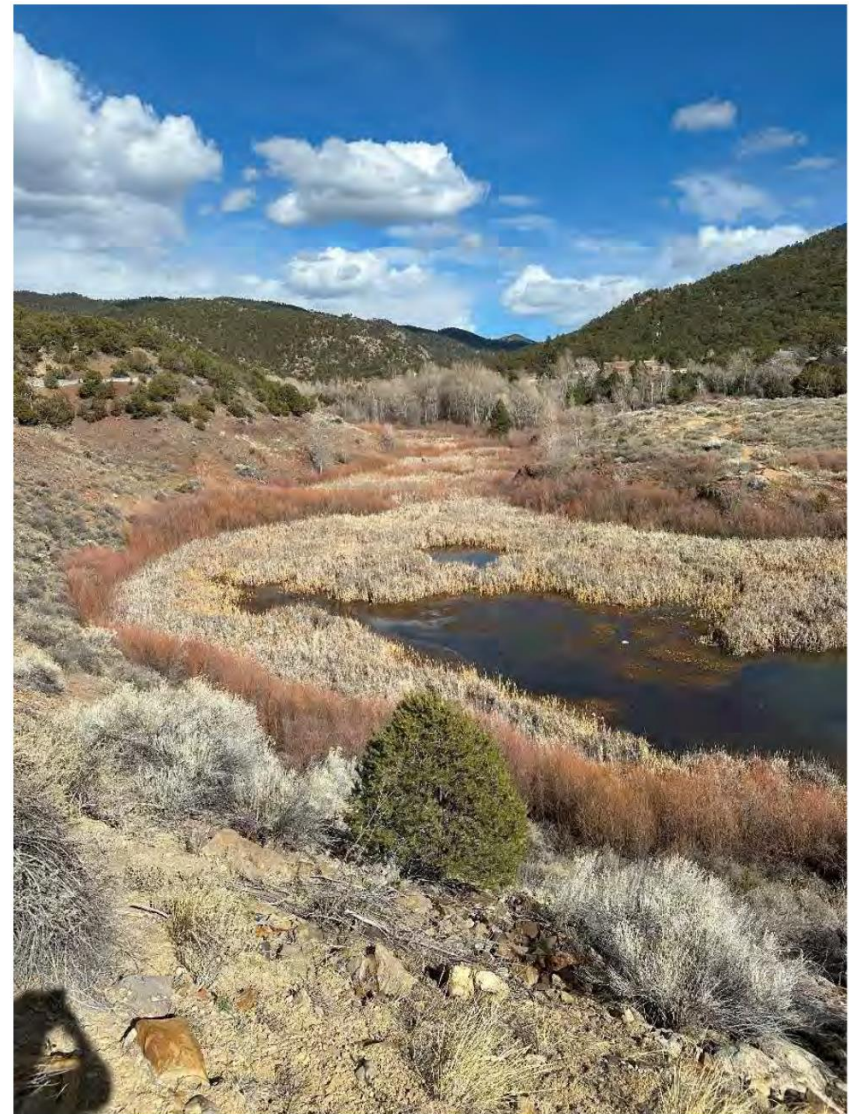
Figure E4. Photos taken of Transect 4 on 3/7/24. The photo on the left shows a possible seep that comes out on the hill approximately 15 ft above the pond. The photo on the right shows the entirety of Transect 4 across.

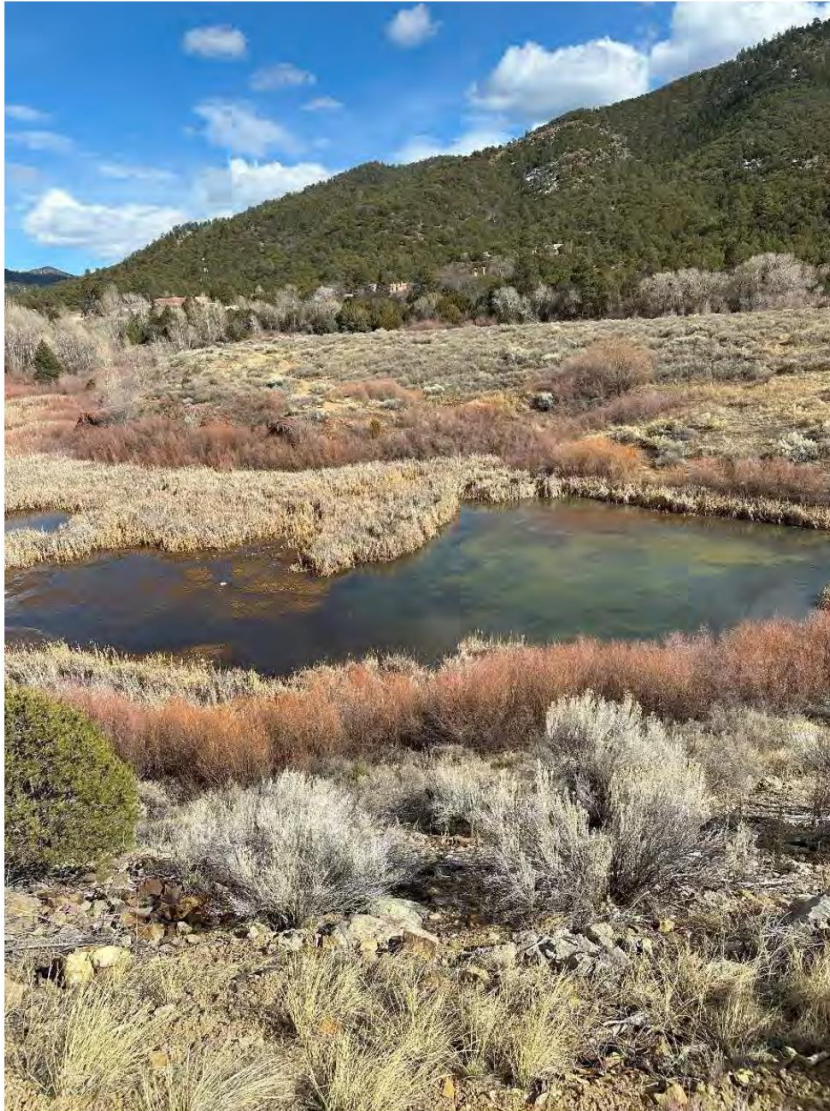
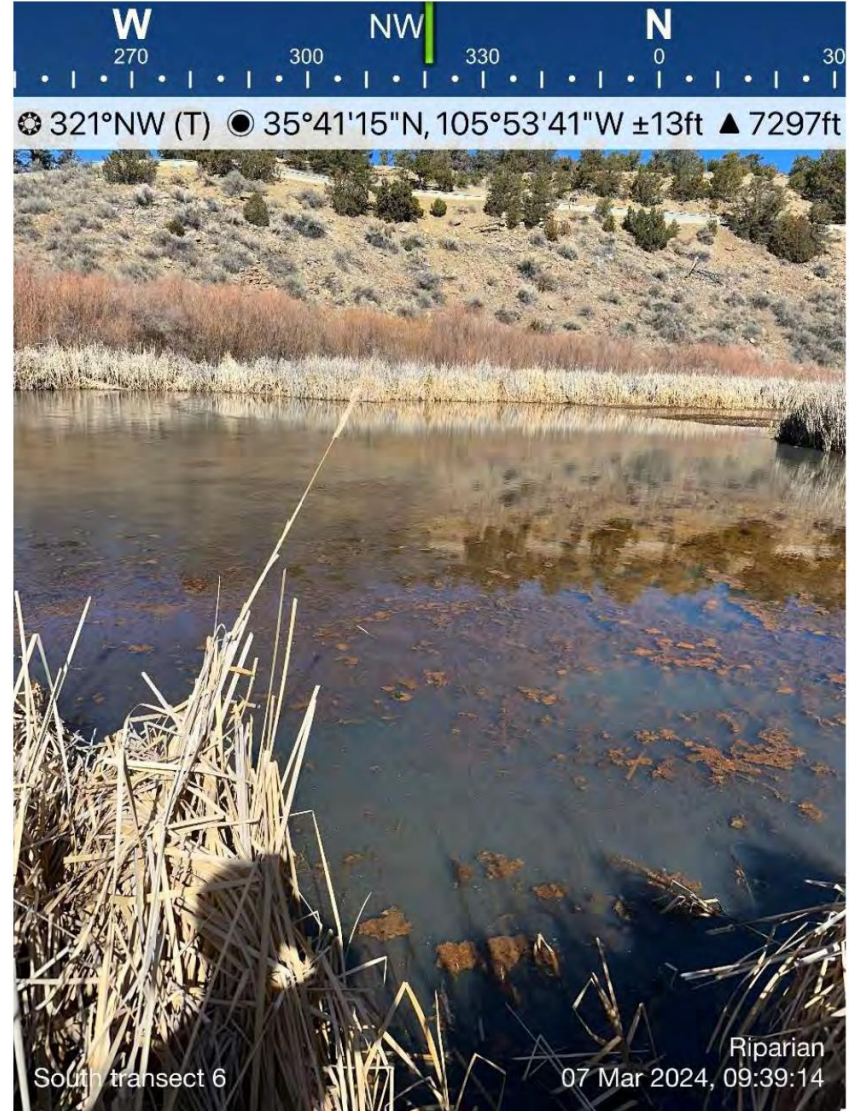
Figure E6. Photos taken along Transect 6 on 3/7/24. The left photo is an overview of the entire transect and the right photo is of the pond and growth within it.
