Pafuth Residence Window Assessment

1295 Cerro Gordo

Pafuth Residence Window Assessment Summary

April 20, 2026

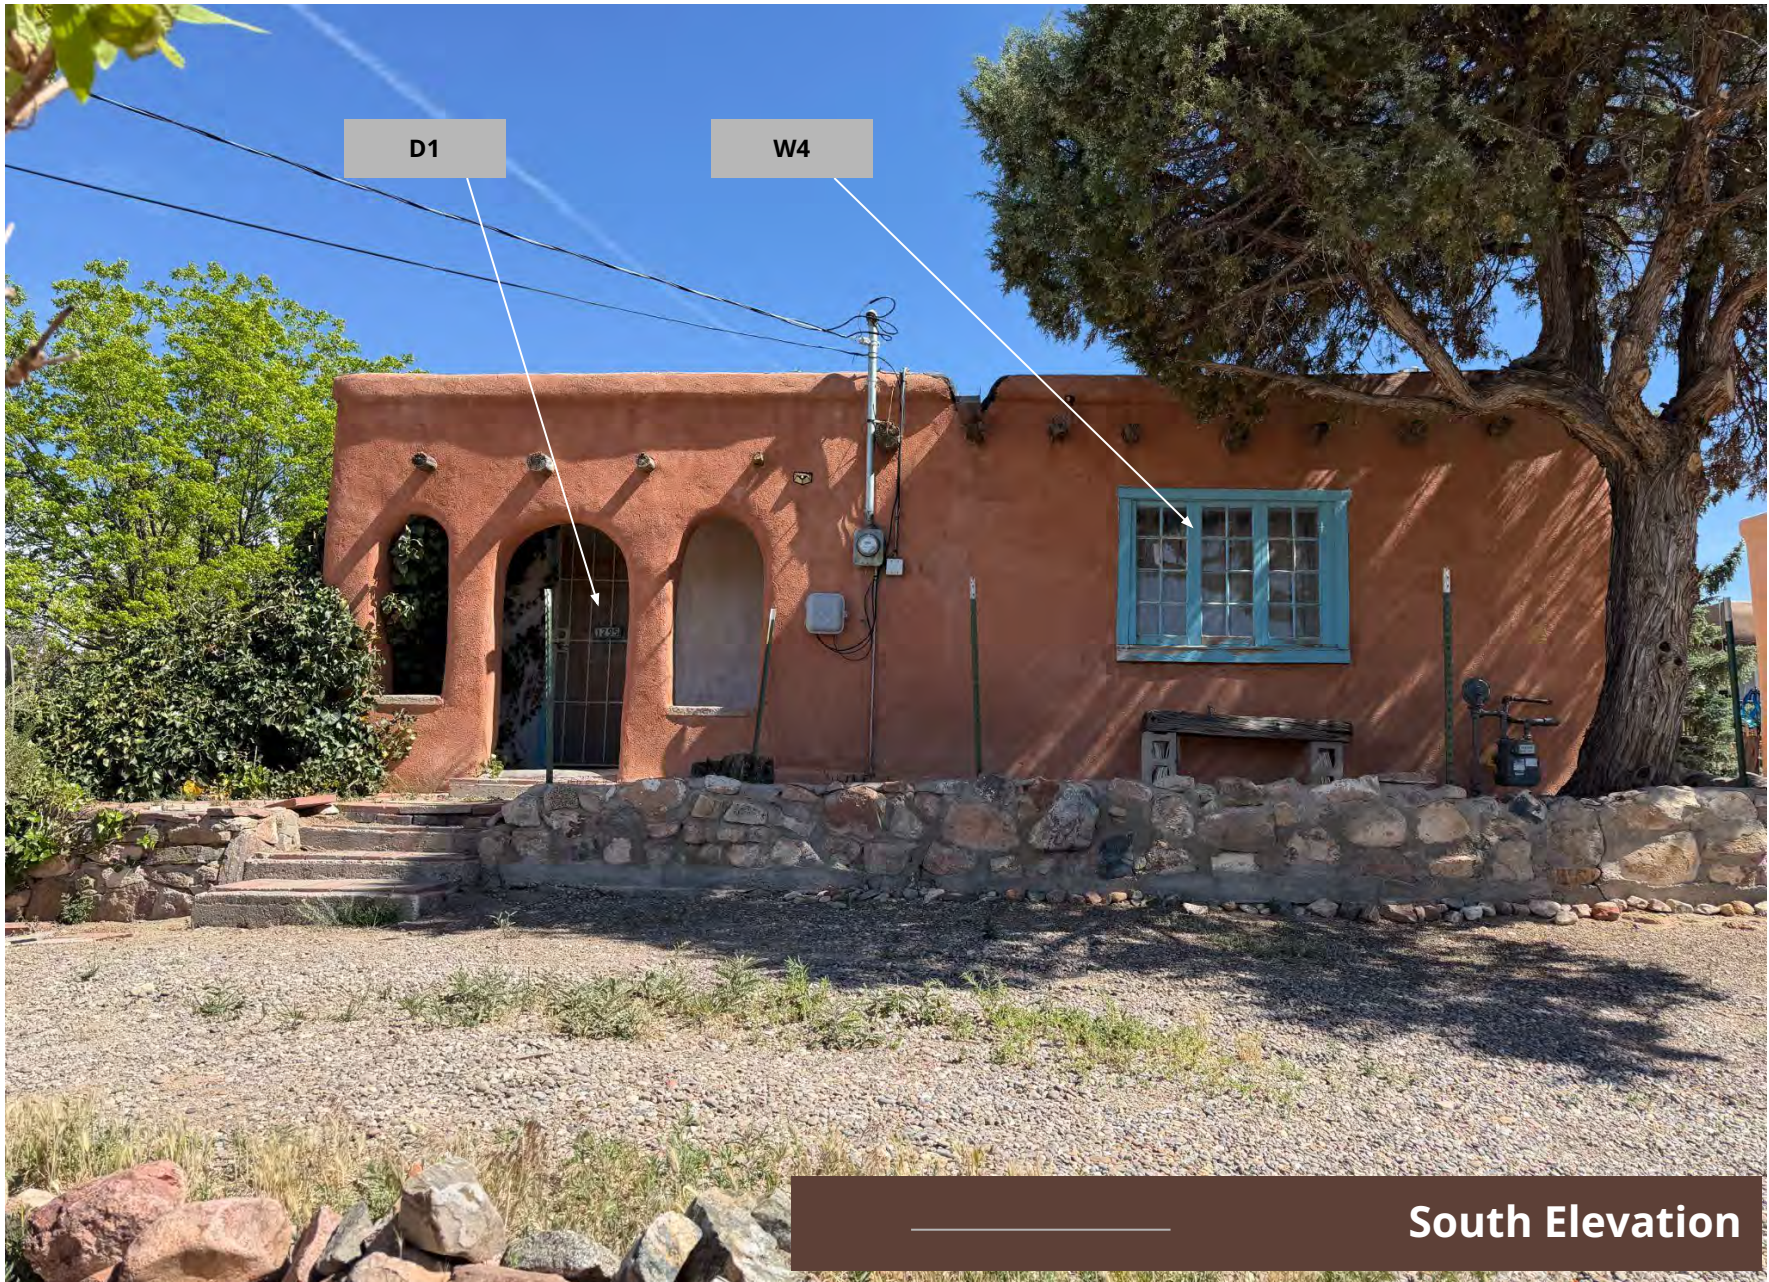
South Elevation

The Entry door is modern and has been replaced in the 1990's. The bottom rail has been cut to a point that compromises the integrity of the door. The hardware is modern, inexpensive, unremarkable and worn out.

The Living room window is a series of sashes connected and fixed in place probably by nails and the opening is severely out of square and probably has been for some time. The window is cased in an adobe opening.

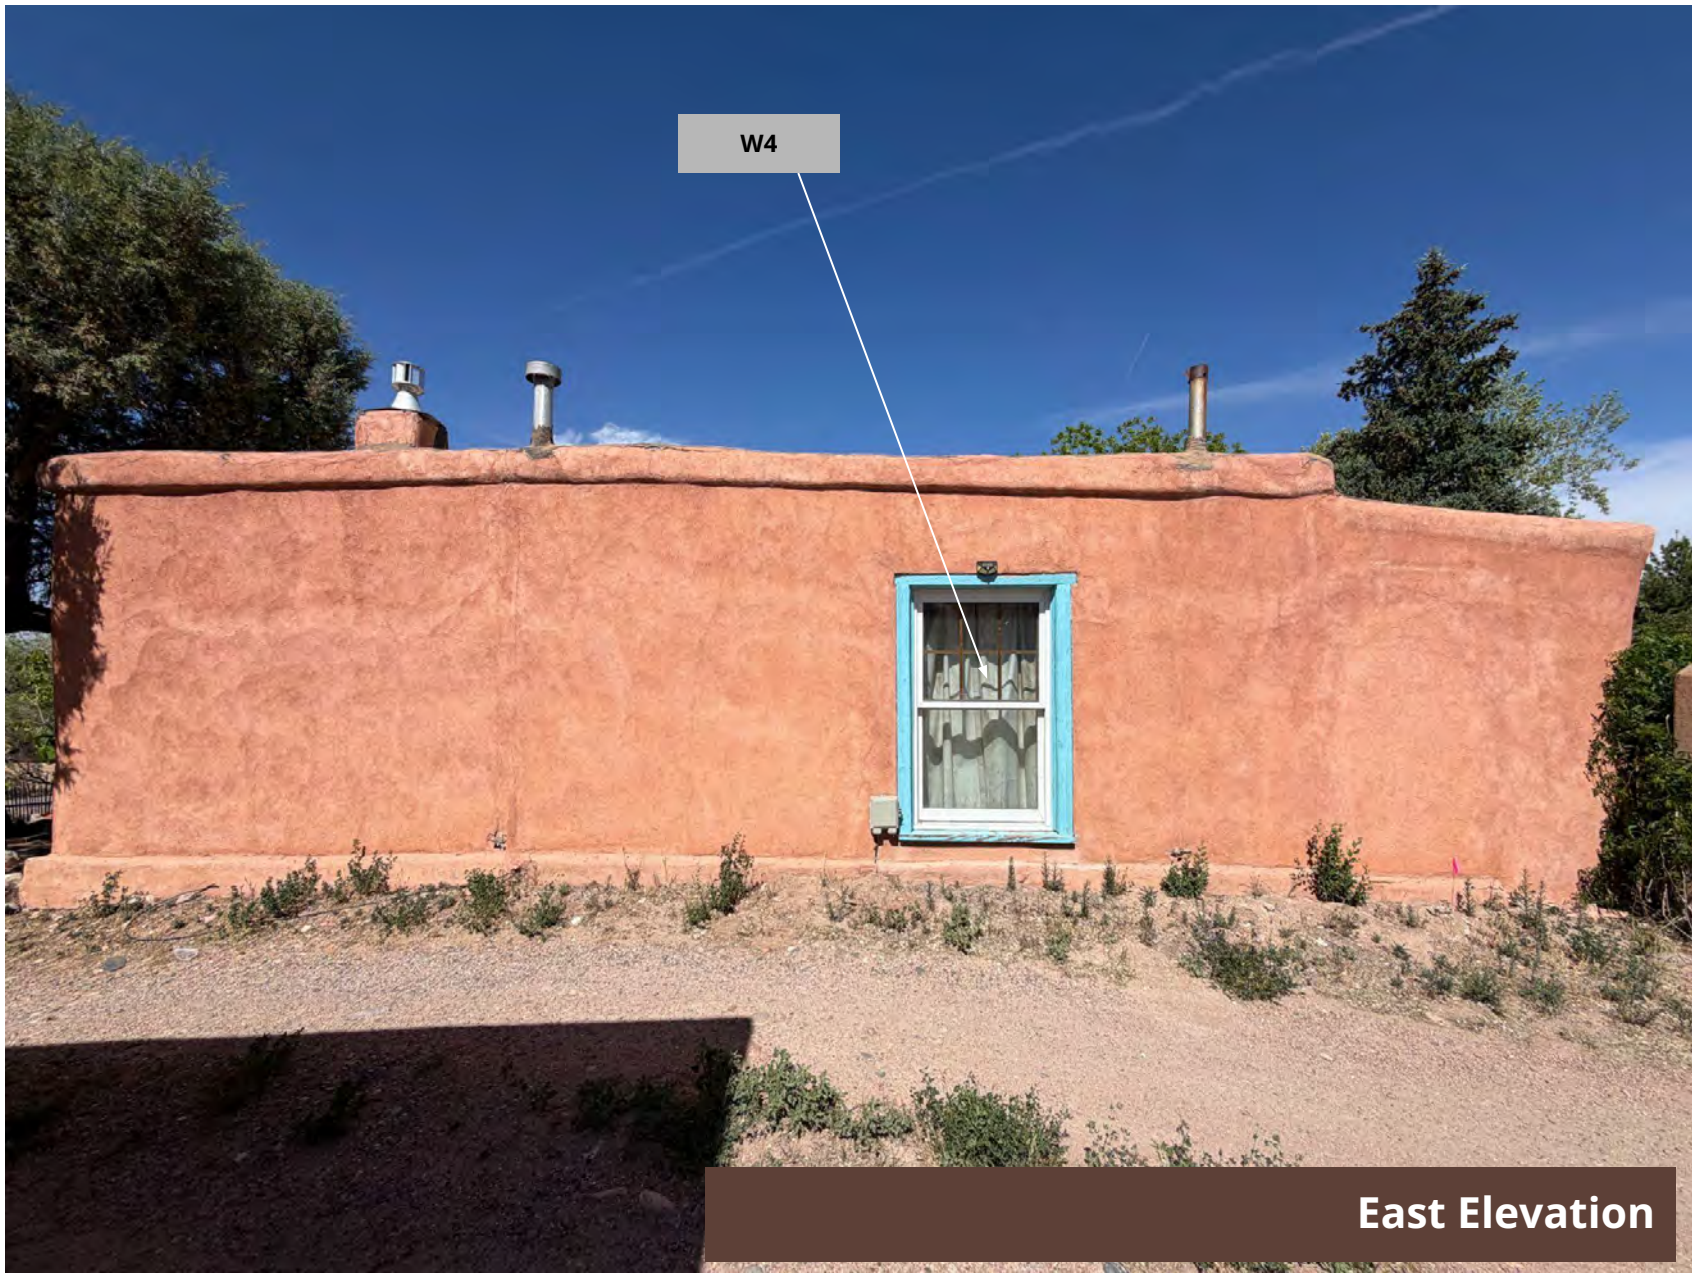
East Elevation

WINDOW #W4 - Living Room		
INFO	Description	(3) 8 lt. Sashes Fixed
	Size	54" X 40" (3) 18" X 40"
	Type	Fixed
	Overall Condition	Poor
FRAME	Material	Wood
	Moulding Profile	Square
	Jamb Condition	Poor
	Stool Condition	Poor
	Shape	Straight
	Exterior Trim & Stops	Poor
	Paint	Poor
SASH / PANEL	Material	Wood
	Moulding Profile	Ogee
	Bottom Rail Condition	Poor
	Rails and Stiles	Poor
	Mullions	Fair
	Shape	Straight
	Glazing Putty & Paint	Poor
FUNCTION	Operators/Hinges	None
	Handel/Hardware	None
	Locks	None
	Weatherstripping	None
<p>Notes: Arrangement of 3 sashes fastened together and fixed. Exterior wood condition is severely degraded</p> <p>Recommendations:</p> <ul style="list-style-type: none"> • Replace
