Historic Cultural Properties Inventory (HCPI) Base Form (FORM 1)

1. Name of property: Lugarda Sparr House/ Halla Residence	2. Location: 878 East Palace Avenue Downtown and Eastside Historic District – Santa Fe	3. Local Reference Number: Santa Fe ID: H-2935 4. County: Santa Fe Parcel # 12625792

8. Name of Project: HDRB Status Evaluation		
9. Lat/Long: 35.6811028,-105.926169		
10. Photo Information: Giulia Caporuscio, photographer. Photo 1: View of property from East Palace Avenue.

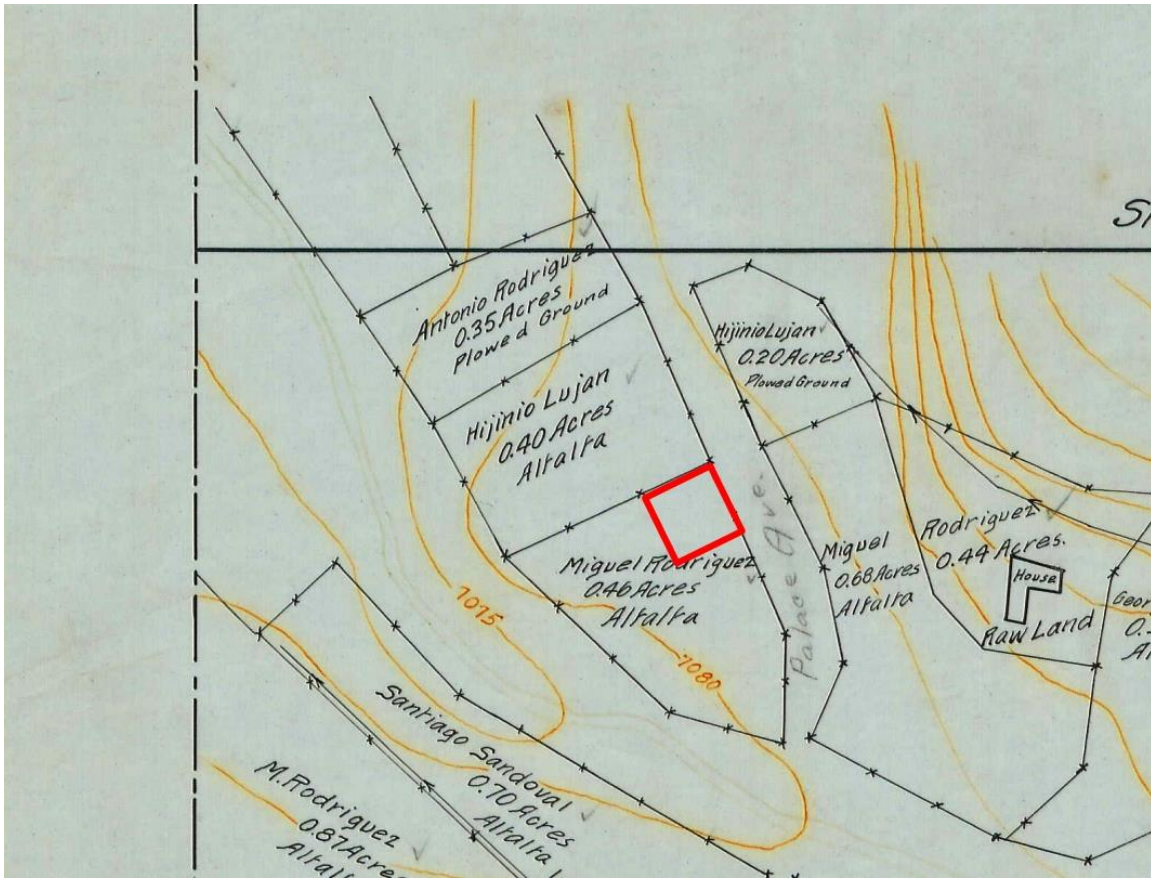
The subject house was built over a such field shown on the 1914 hydrological map planted with alfalfa (Fig. 1). Sixteen years later, the property had been subdivided, with the subject lot holding a small house. It is unclear who built the house, but it may have been Francisco Montoya, who is thought to be the landowner. The house may have been an investment as it initially worked as a rental.

Figure 1: Proximate location of current parcel over 1914 map.
 Source: State Engineer's Office, "Santa Fe Hydrological Survey," [series of maps] (Santa Fe: State Engineer's Office, 1914 (published 1919)).

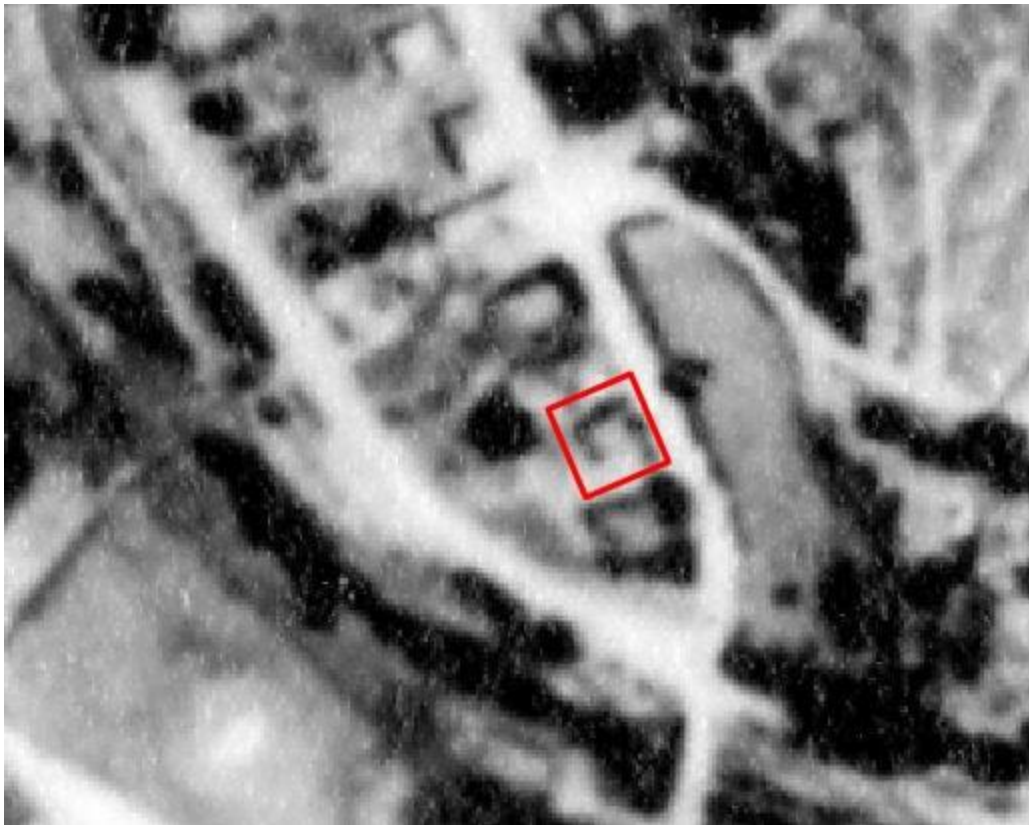
Figure 2: Presence of house on 1935 aerial photograph.
Source: United States Soil Conservation Service, Sheet # 1009.

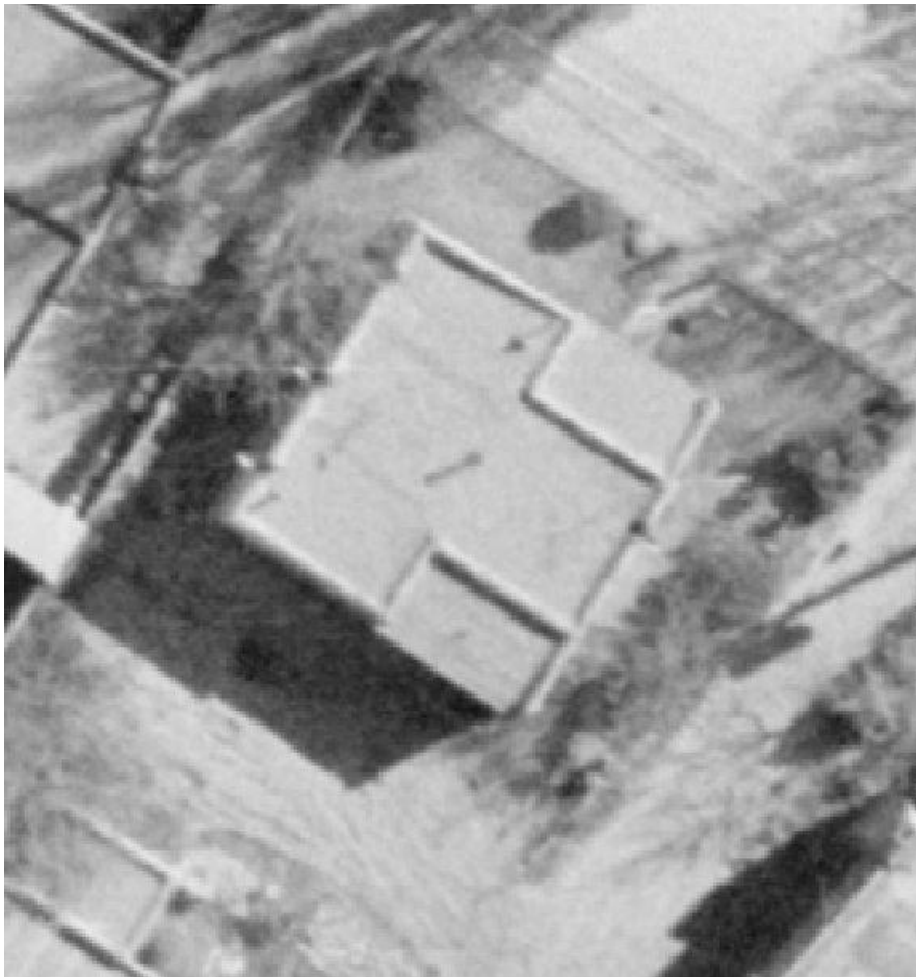
Based on a 2019 survey plat, the east and south yard walls are part of the property. The east wall (Photo 1), measuring 62” to 92” tall, may have started as a much shorter wall which gained in height in the 1970s. This lower wall appears on a 1966 aerial photograph (Fig. 5) and seems to have stayed at that height through at least 1973 (Fig. 6). By 1978, it had gained height to match a new wall built along the alley (Photo 12 & Fig. 7). The alley wall measures between 62” and 102” above finished grade. Neither is considered historic.

Figure 5: 1973 aerial photograph. Source: May 11, 1973, Sheet 64.
