# Historic Cultural Properties Inventory (HCPI) Base Form (FORM 1)

For HPD Office use only:		
HCPI No.	District No.	Criteria <u>  </u> A <u>  </u> B <u>  </u> C <u>  </u> D
<b>1. Name of property:</b>  Atanacio and Feliciano Vigil Property Arturo Vigil House	<b>2. Location:</b>  925 Acequia Madre Street Downtown and Eastside Historic District – Santa Fe	<b>3. Local Reference Number:</b> Santa Fe ID: Old # 051611486  <b>4. County:</b> Santa Fe Parcel # 12919936
<b>5. Property Type:</b> <input checked="" type="checkbox"/> Buildings: house <input checked="" type="checkbox"/> Structures: walls <input type="checkbox"/> Site <input type="checkbox"/> Object		
<b>6. Date of Survey:</b> November 25, 2024		
<b>7. Previous Survey Date(s):</b> <input checked="" type="checkbox"/> Yes: November 14, 1984, Michael Belshaw; June 27, 2003, Giovana Buckley <input type="checkbox"/> No:		
<b>8. Name of Project:</b> HDRB Status Evaluation		
<b>9. Lat/Long:</b> 35.6791526,-105.92438

# Historic Cultural Properties Inventory (HCPI) Detail Form (FORM 2)

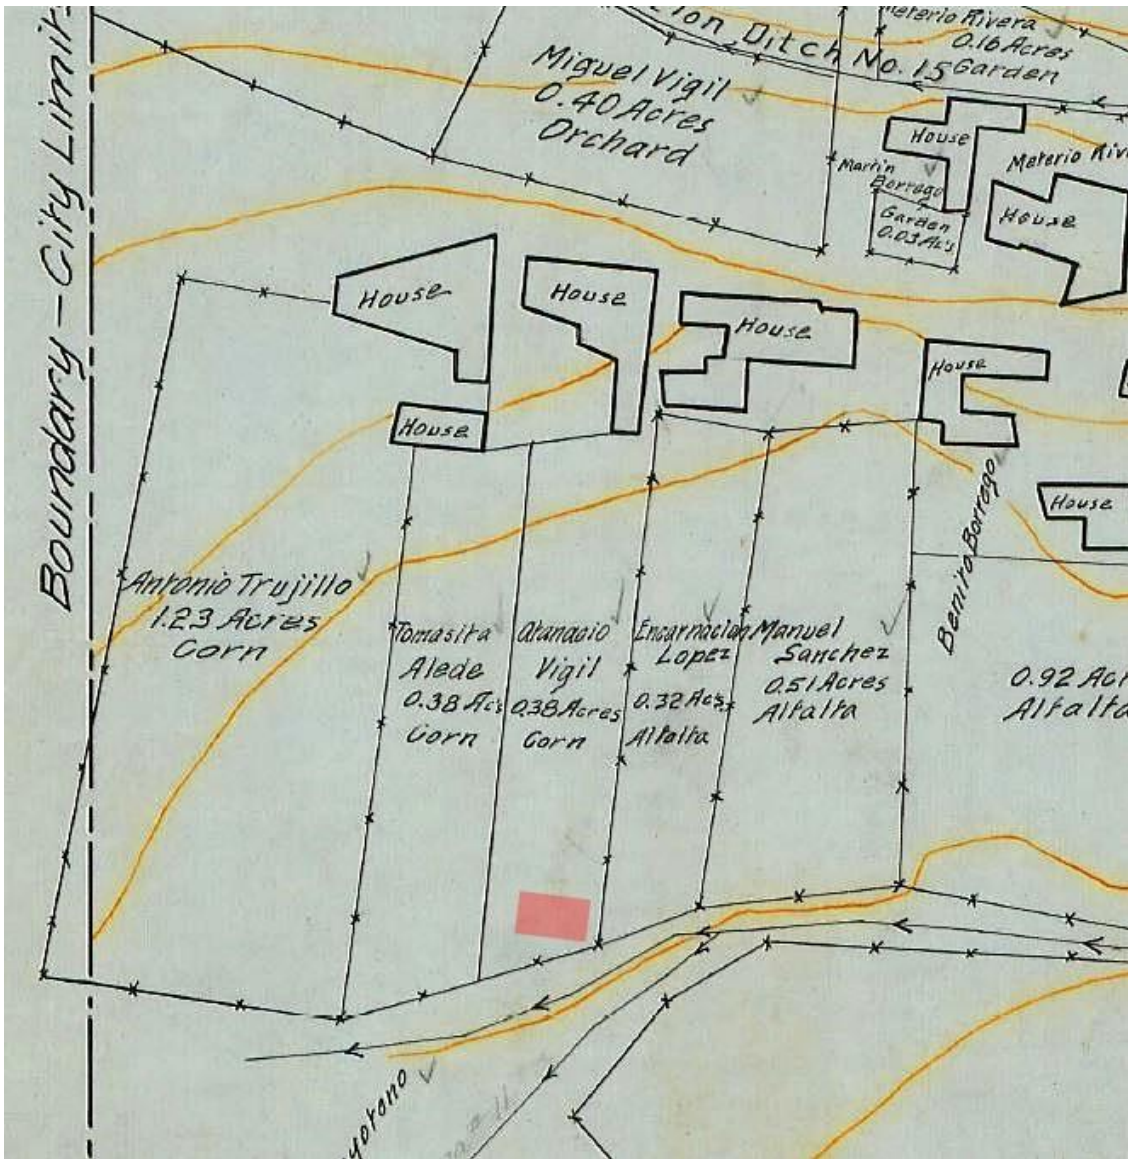
Mapping conducted by the state hydrological survey in 1914 shows that Don Atanacio owned a large home on Canyon Road (Fig. 1). His home corresponds with the building at 830 Canyon Road. Like his neighbors, Don Atanacio maintained a small farm field below the house. His and neighboring fields were irrigated by the *Acequia Madre*, of which Vigil was a *parciante*<sup>2</sup> At the time of the mapping, the field was planted with corn, a traditional crop used for home consumption and trading.

**Figure 1: 1914 hydrological survey map of Atanacio Vigil property. Approximate location of future house indicated in red.**

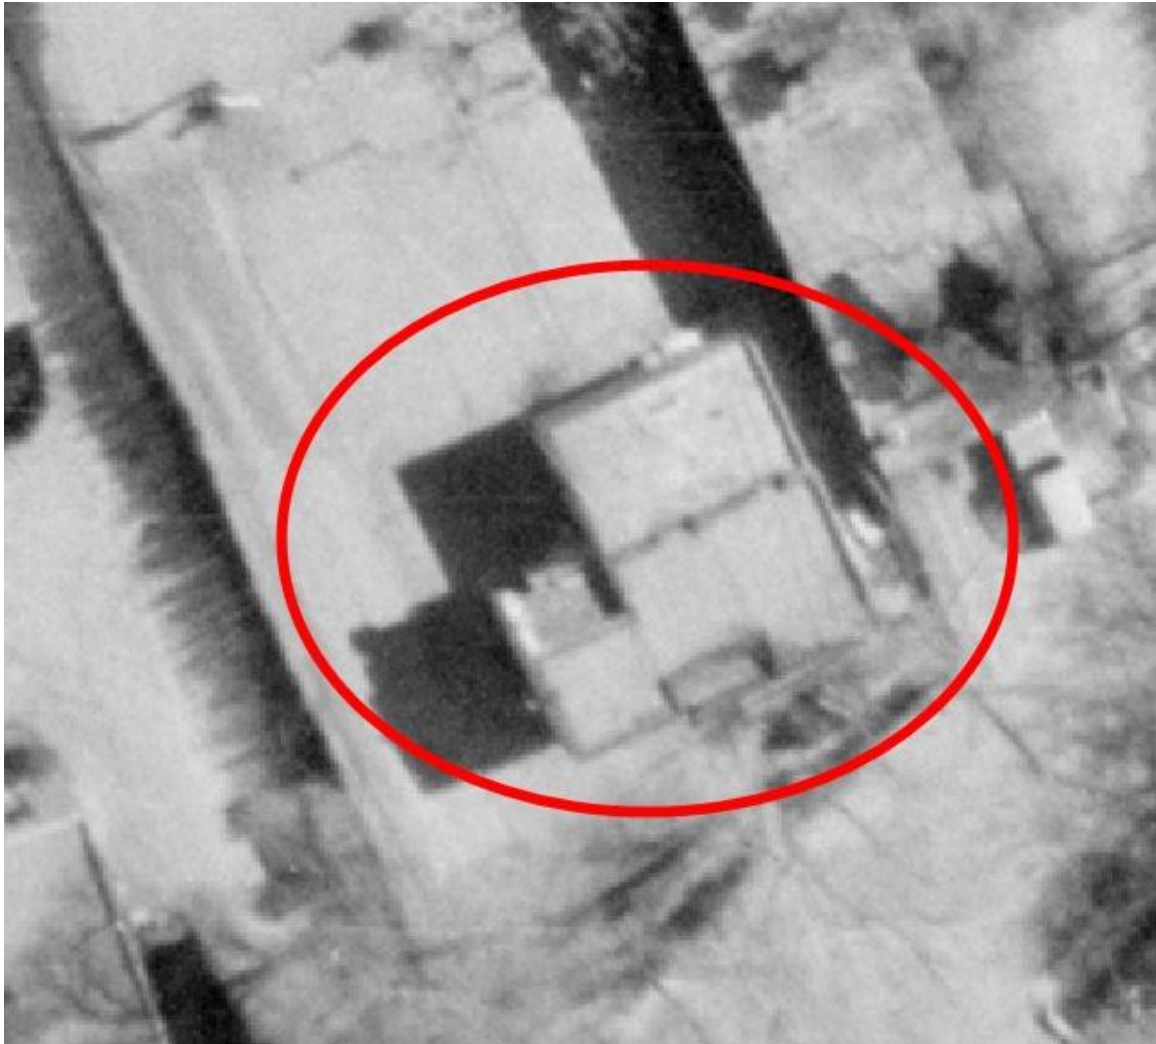
**Figure 4: May 11, 1973, aerial photograph.**

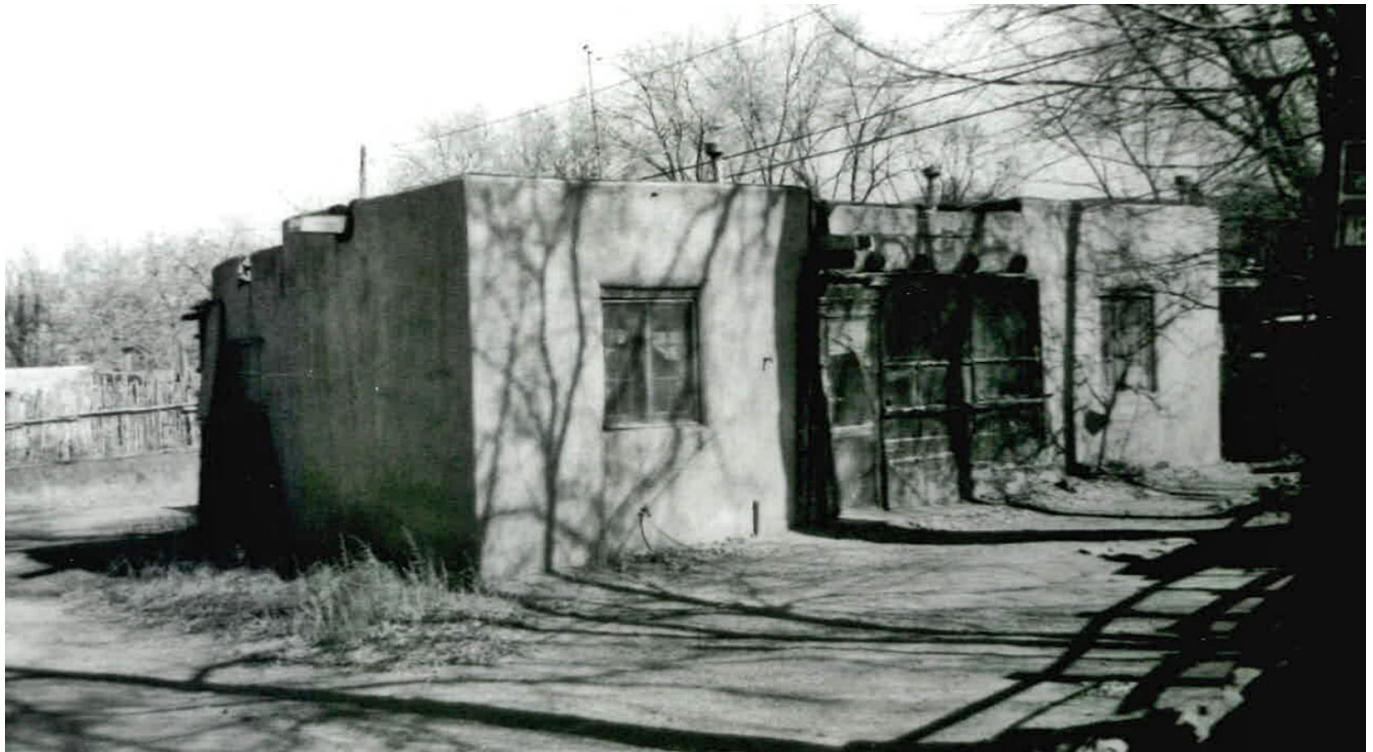
**Figure 6: November 14, 1984, HBI survey photograph. Michael Belshaw, photographer. Courtesy of NMCRIS.**
