Birgfeld Window Assessment

512 Abeyta St

Window Assessment Summary Birgfeld Residence

July 31 2024

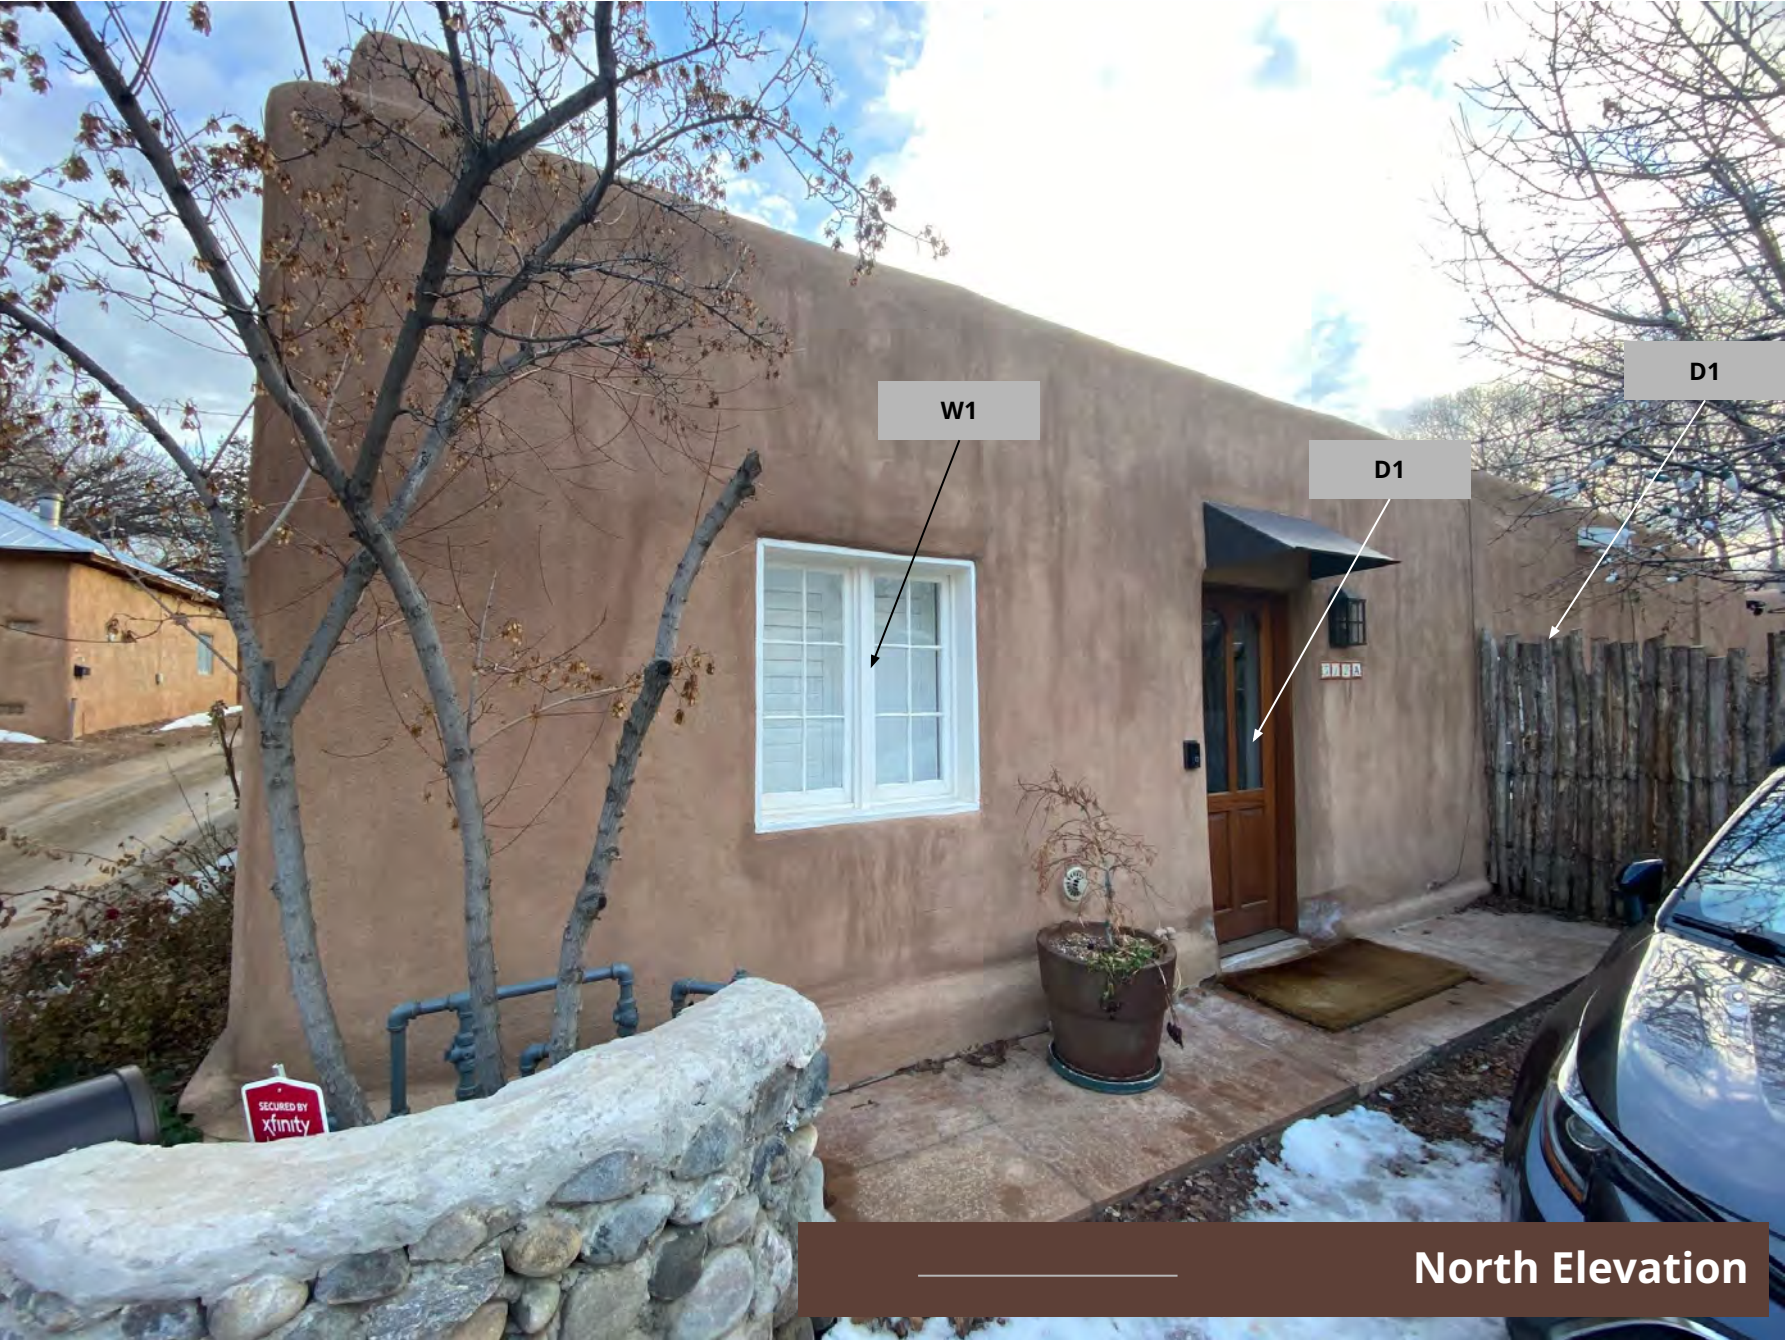
North Elevation

W1

D1

WINDOW W1 - Office		
INFO	Description	8 Lite Double Casement
	Size	38"X42"
	Type	Casement
	Overall Condition	Good
SASH	Material	Wood
	Moulding Profile	Ogee
	Bottom Rail	Good Condition
	Rails and Stiles	Good Condition
	Mullions	Good Condition
	Shape	Good Condition
	Paint	Good Condition
FRAME	Material	Wood
	Moulding Profile	Square
	Jamb Condition	Good
	Threshold Condition	Fair
	Shape	Straight
	Exterior Trim and Stops	Good
	Paint Condition	Good
FUNCTION	Operators/Hinges	Poor
	Handel/Hardware	Fair
	Locks	Fair
	Weatherstripping	N/A
Notes: Needs Sill Repair

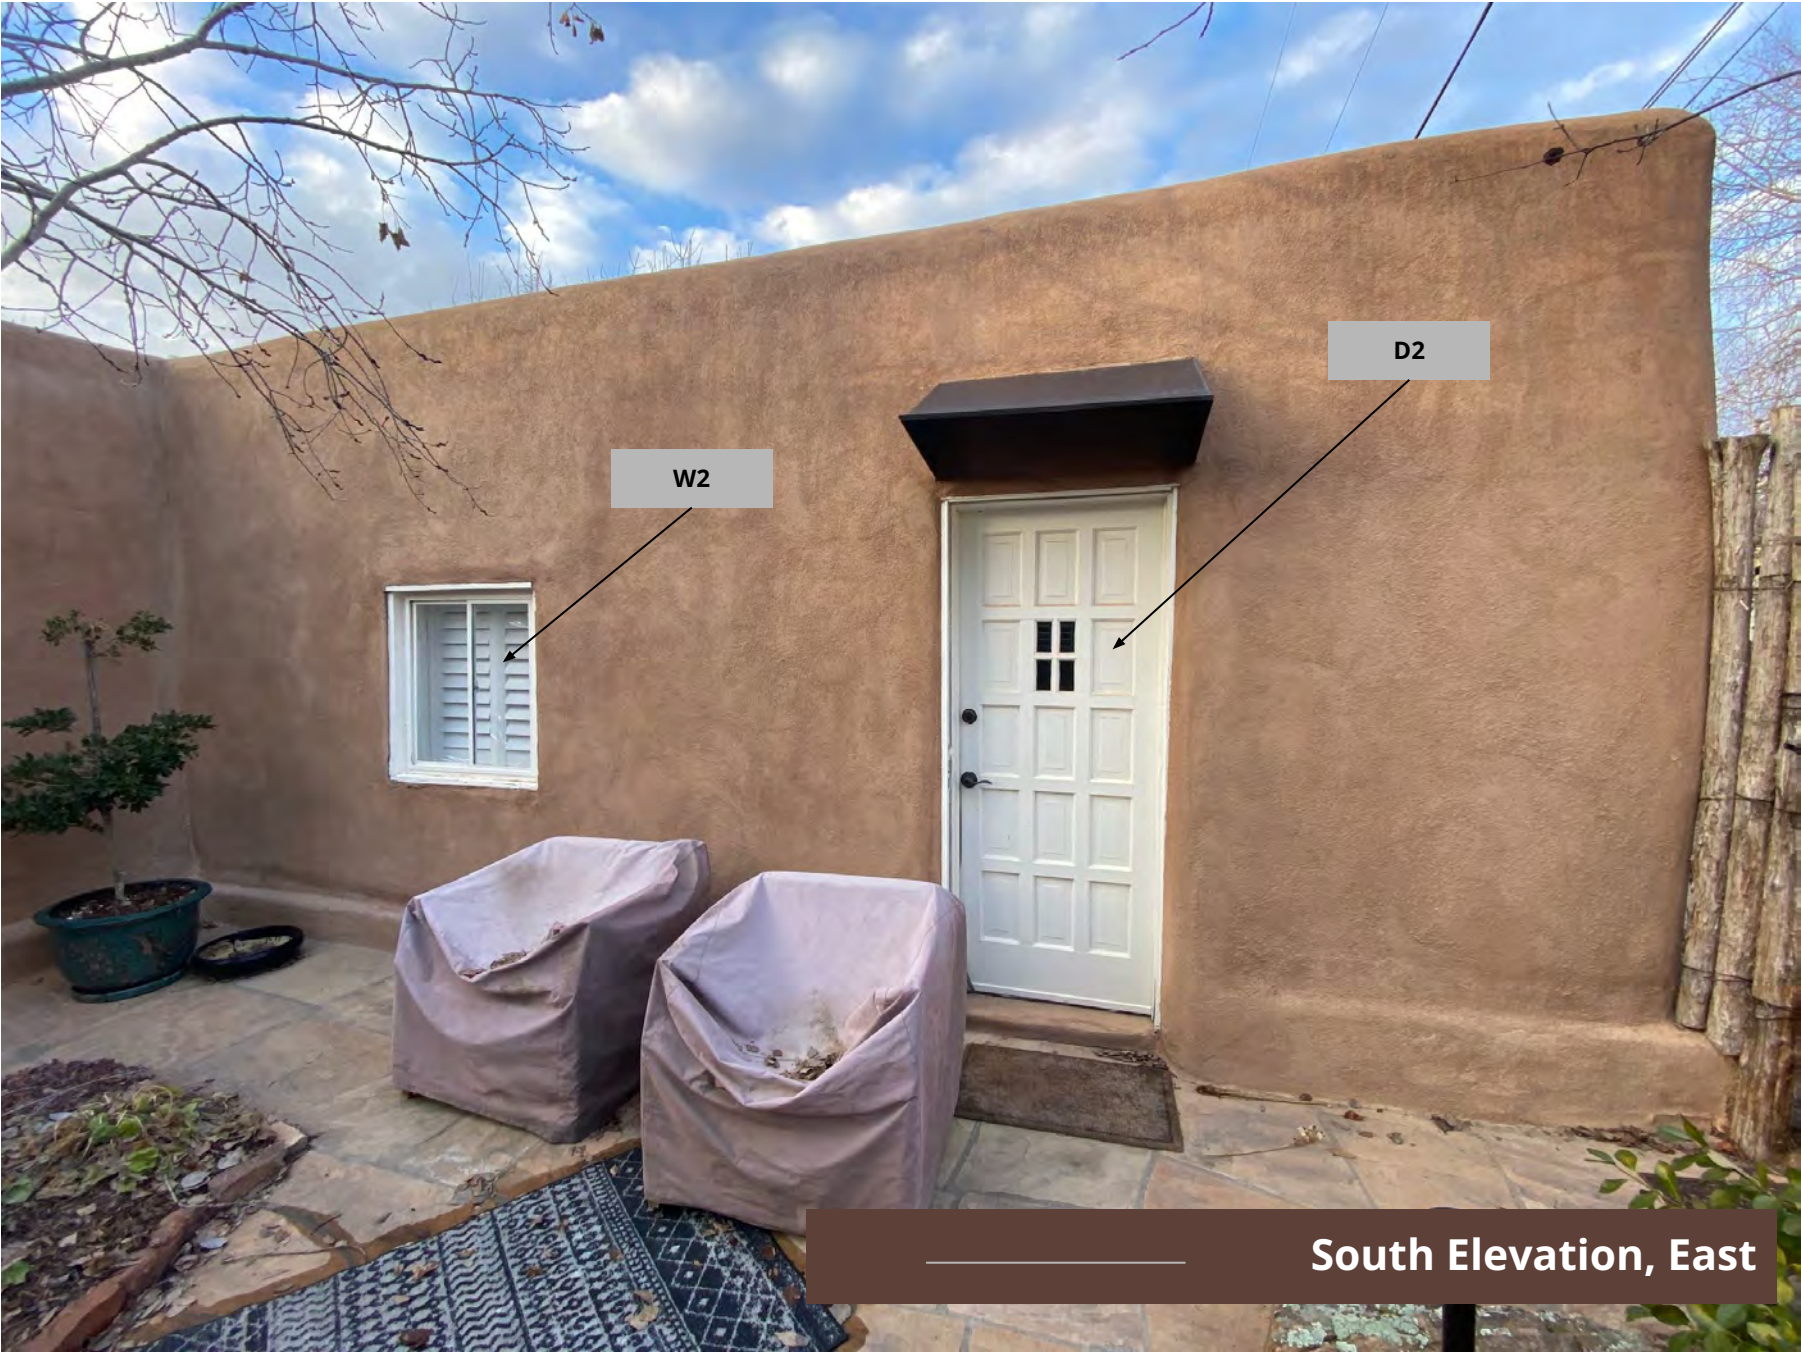
South Elevation, East

W2

D2

WINDOW W2 - Entry		
INFO	Description	2 lite Sliding Storm Sash
	Size	32"X36"
	Type	Sliding Storm Sash
	Overall Condition	Poor
SASH	Material	Aluminum
	Moulding Profile	Square
	Bottom Rail	Fair Condition
	Rails and Stiles	Fair Condition
	Mullions	Fair Condition
	Shape	Fair Condition
	Paint	Fair Condition
FRAME	Material	Wood
	Moulding Profile	Square
	Jamb Condition	Fair
	Threshold Condition	Poor
	Shape	Warped
	Exterior Trim and Stops	Poor
	Paint Condition	Poor
FUNCTION	Operators/Hinges	Poor
	Handel/Hardware	Poor
	Locks	Poor
	Weatherstripping	N/A
Notes: Storm Sash No Sash Present Recommend Replacement

Door D2 Office		
INFO	Description	Single with Deco lite
	Size	32"X80"
	Type	Single Frame and Panel
	Overall Condition	Good
Panel	Material	Wood
	Moulding Profile	Raised Panel
	Bottom Rail	Good Condition
	Rails and Stiles	Good Condition
	Mullions	Good Condition
	Shape	Warped
	Paint	Good Condition
FRAME	Material	Wood
	Moulding Profile	Square
	Jamb Condition	Good
	Threshold Condition	Fair
	Shape	Straight
	Exterior Trim and Stops	Poor
	Paint Condition	Fair
FUNCTION	Operators/Hinges	Poor
	Handel/Hardware	Poor
	Locks	Poor
	Weatherstriping	N/A
Notes: Needs Refit and rehang

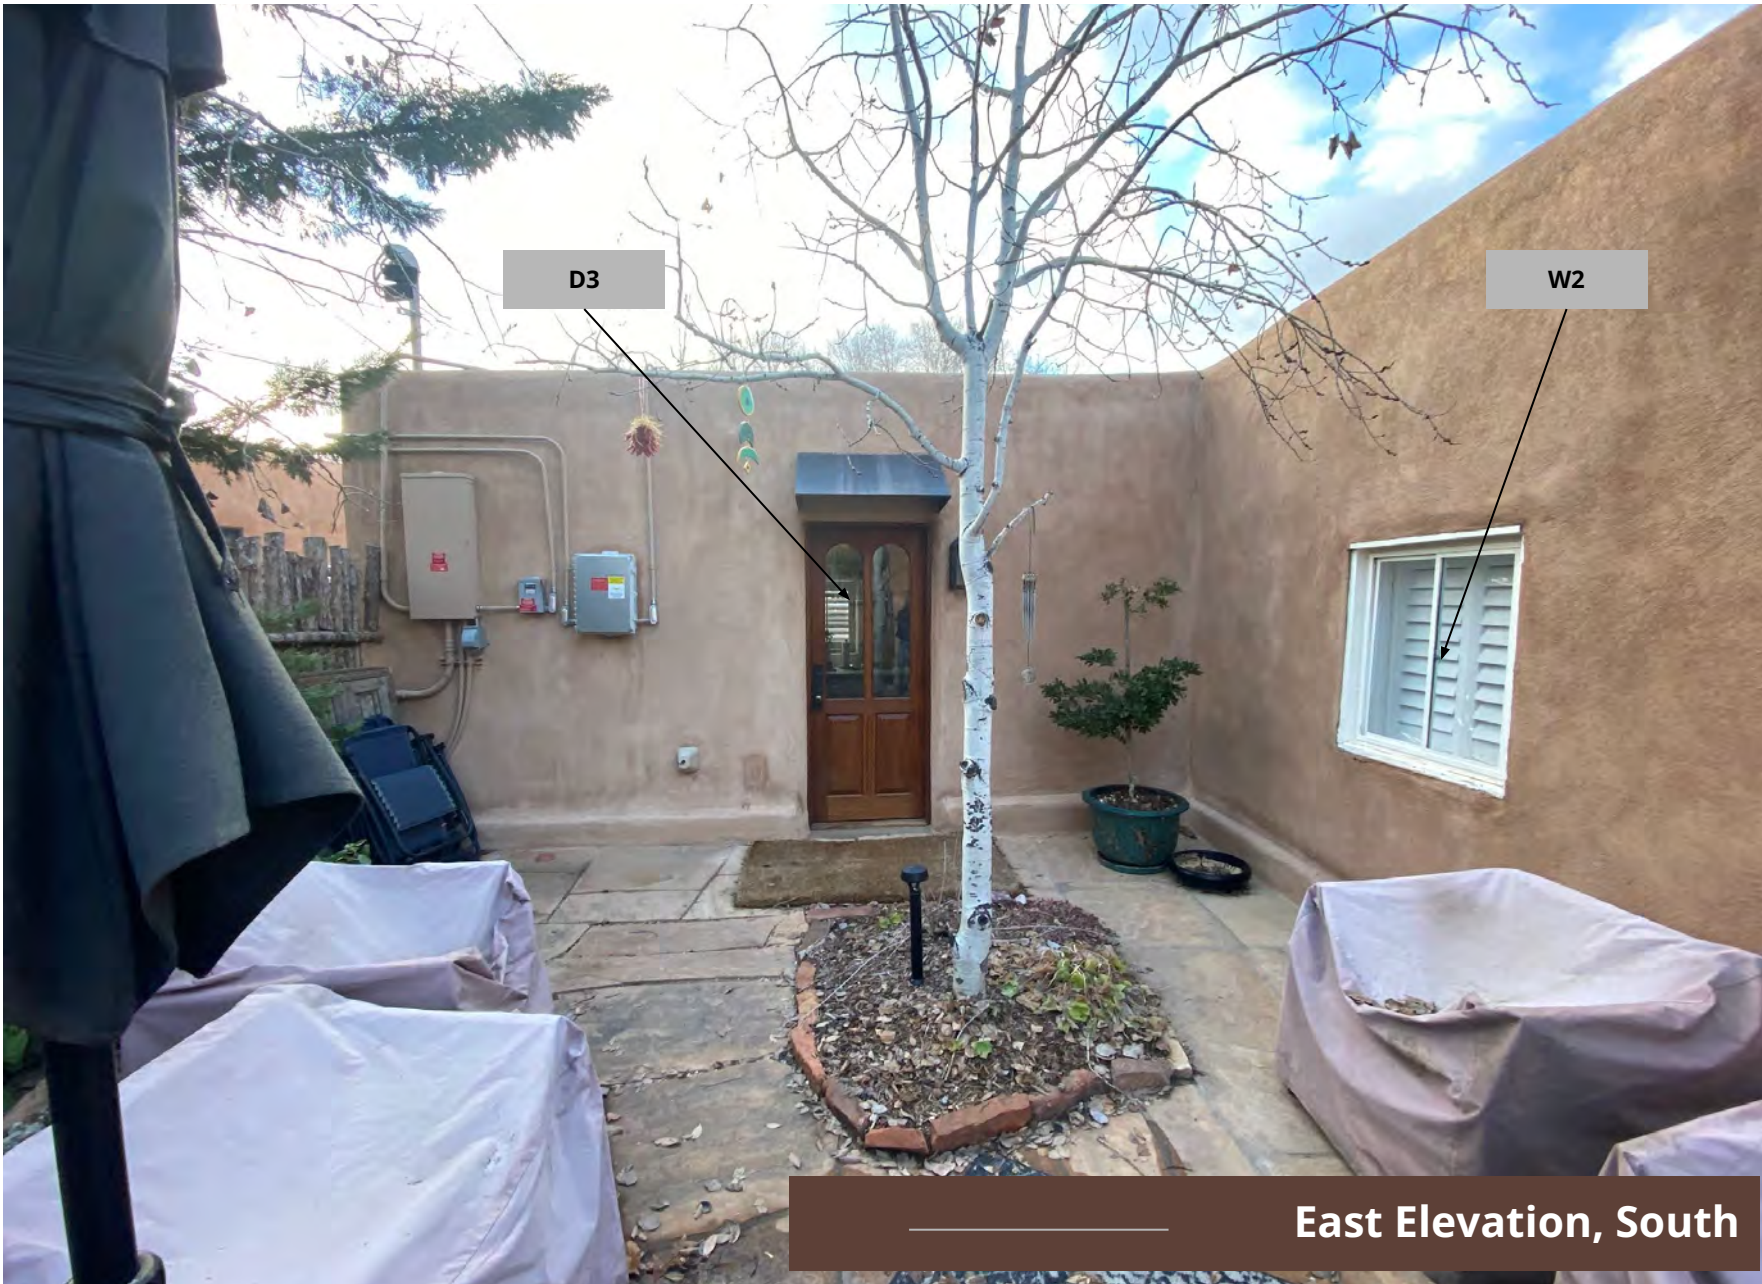
East Elevation, South

D3

W2

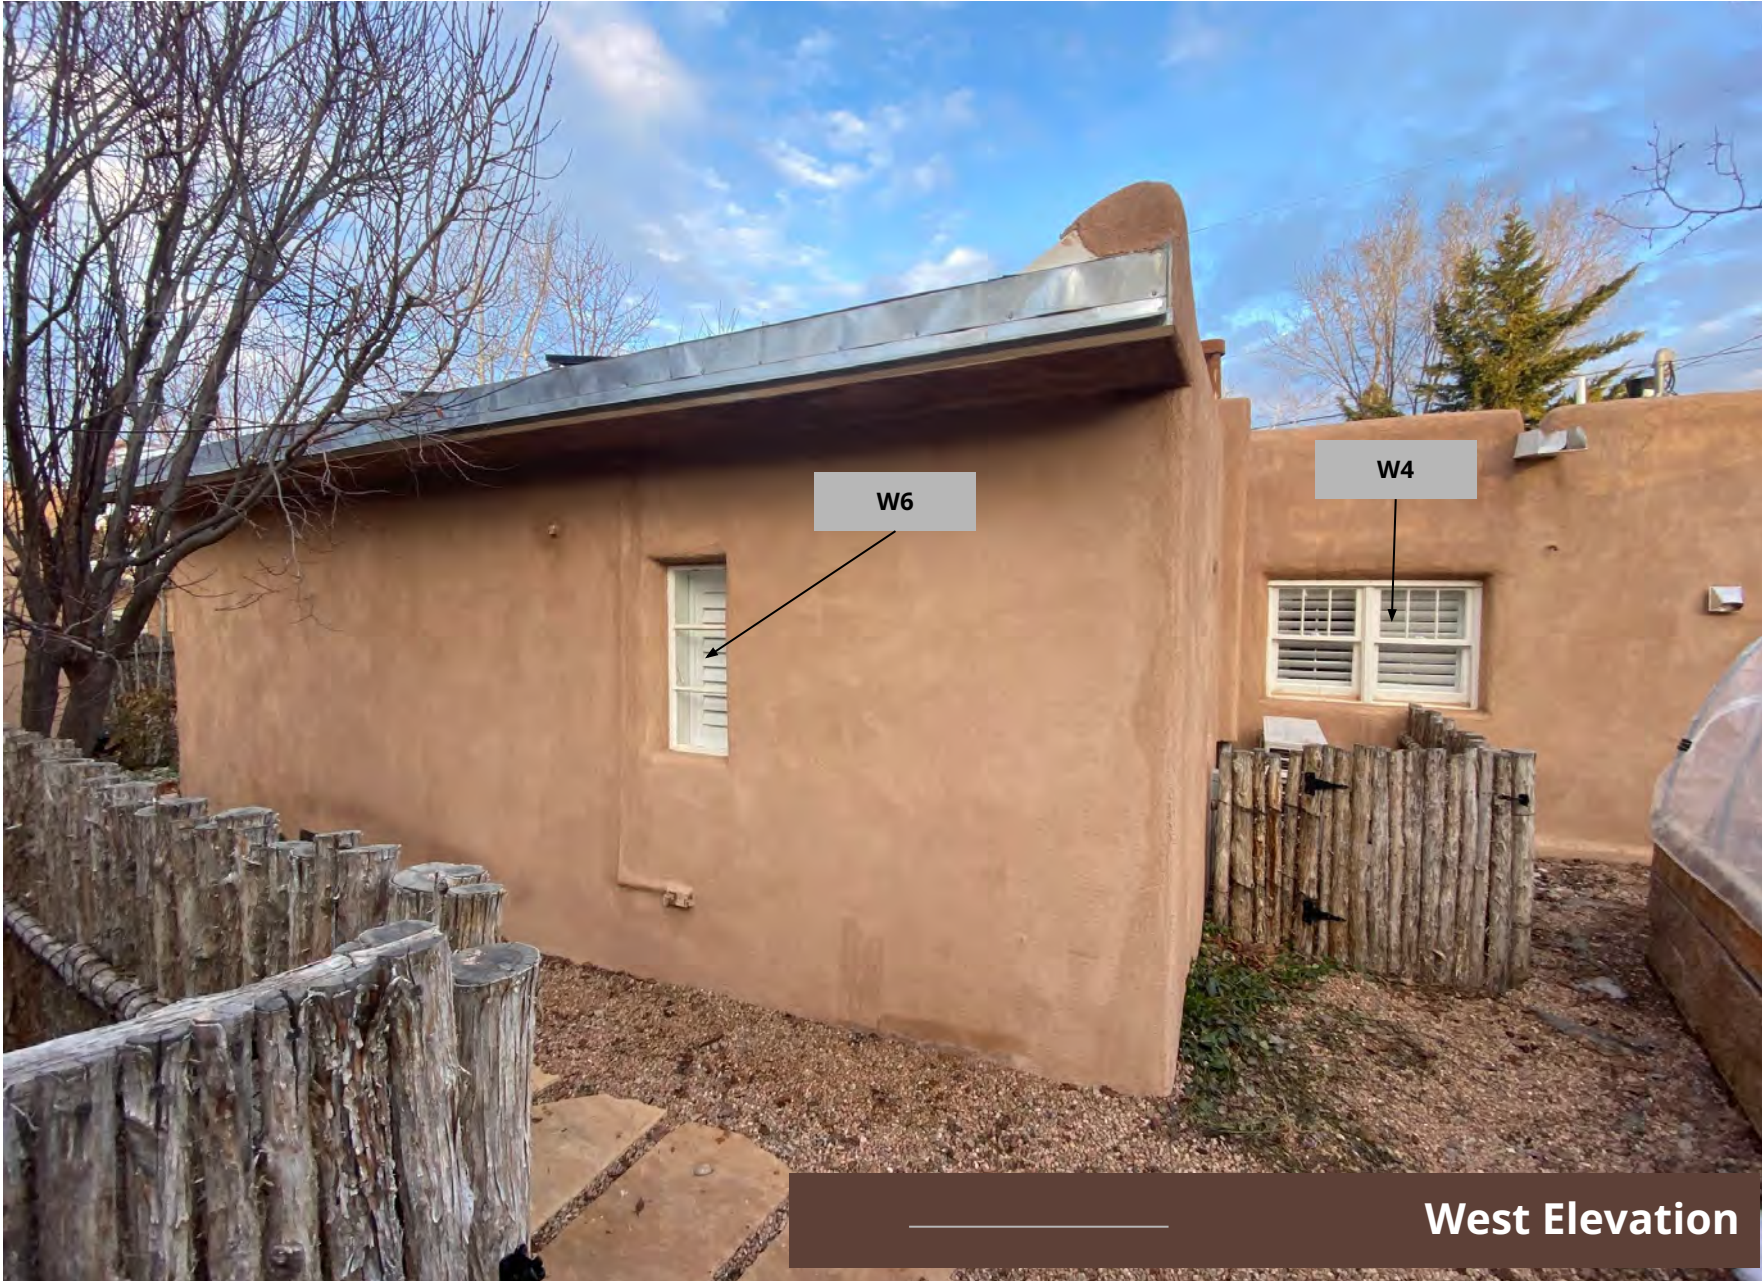
West Elevation

W6

W4

WINDOW W4 - Kitchen		
INFO	Description	(2) 3 over 1 Lite
	Size	50"X36"
	Type	Single Hungs
	Overall Condition	Fair
SASH	Material	Wood
	Moulding Profile	Ogee
	Bottom Rail	Poor Condition
	Rails and Stiles	Poor Condition
	Mullions	Fair Condition
	Shape	Warped
	Paint	Good Condition
FRAME	Material	Wood
	Moulding Profile	Square
	Jamb Condition	Good
	Threshold Condition	Fair
	Shape	Straight
	Exterior Trim and Stops	Poor
	Paint Condition	Poor
FUNCTION	Operators/Hinges	None
	Handel/Hardware	None
	Locks	Poor
	Weatherstripping	N/A
Notes: No Balances Painted Shut

WINDOW W6 - Bedroom		
INFO	Description	3 Lite
	Size	18"X36"
	Type	Casement
	Overall Condition	Poor
SASH	Material	Steel
	Moulding Profile	Flat
	Bottom Rail	Fair Condition
	Rails and Stiles	Fair Condition
	Mullions	Fair Condition
	Shape	Straight
	Paint	Fair Condition
FRAME	Material	Steel
	Moulding Profile	Flat
	Jamb Condition	Fair Condition
	Threshold Condition	Fair Condition
	Shape	Straight
	Exterior Trim and Stops	None
	Paint Condition	Fair Condition
FUNCTION	Operators/Hinges	Poor
	Handel/Hardware	Poor
	Locks	Poor
	Weatherstripping	N/A
Notes: Non Functional
