Historic Cultural Properties Inventory (HCPI) Base Form (FORM 1)

1. Name of property: Atanacio and Feliciano Vigil Property Arturo Vigil House	2. Location: 925 Acequia Madre Street Downtown and Eastside Historic District – Santa Fe	3. Local Reference Number: Santa Fe ID: Old # 051611486 4. County: Santa Fe Parcel # 12919936

8. Name of Project: HDRB Status Evaluation		
9. Lat/Long: 35.6791526,-105.92438		
10. Photo Information: John W. Murphey, photographer. Photo 1: Front elevation, view from Acequia Madre, camera facing north.

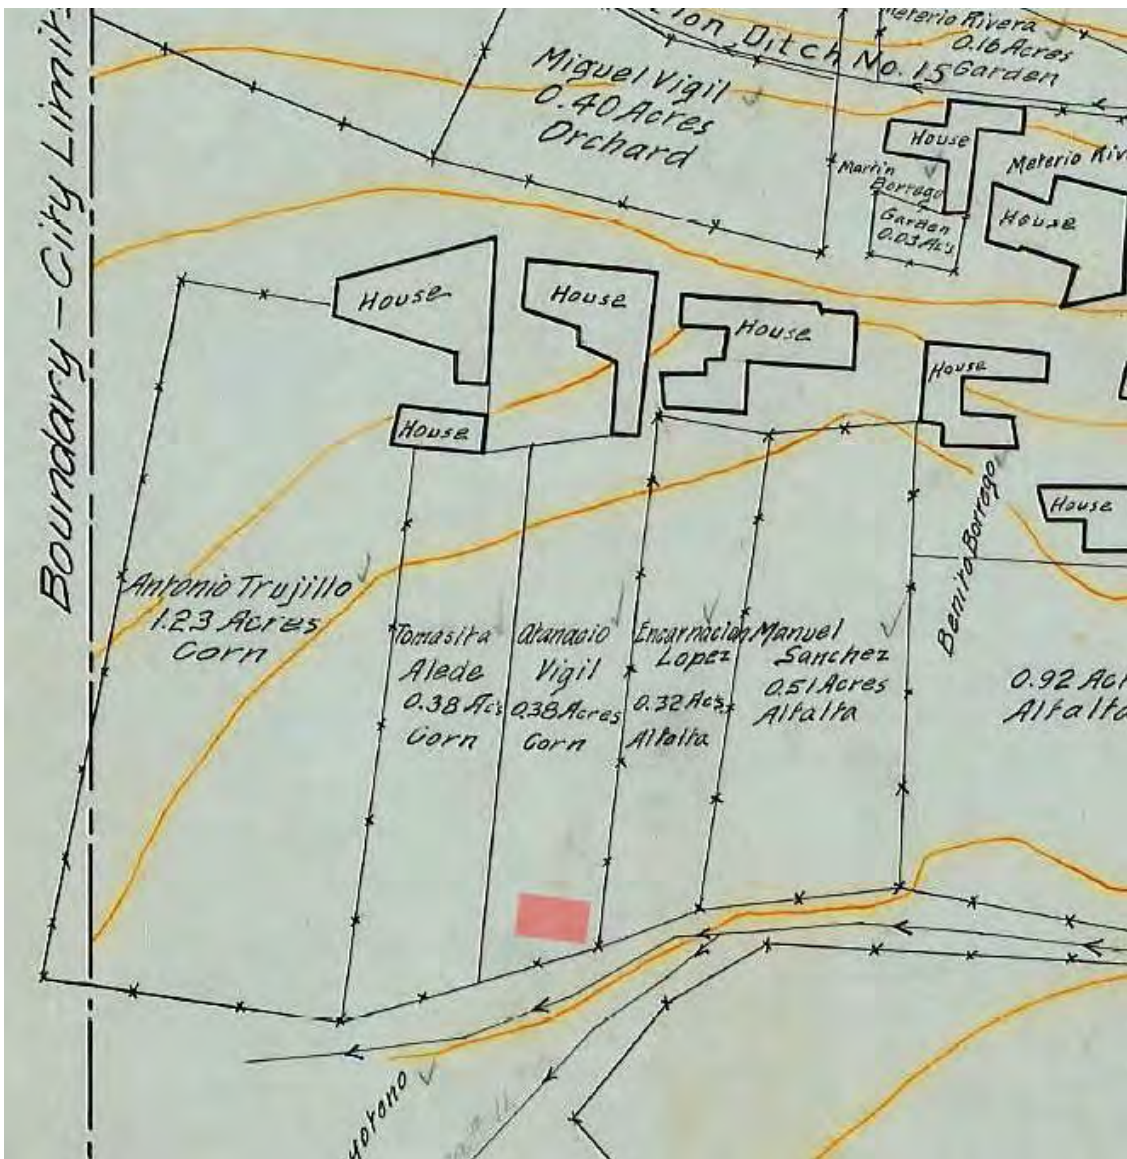
Figure 1: 1914 hydrological survey map of Atanacio Vigil property. Approximate location of future house indicated in red.

Mapping conducted by the state hydrological survey in 1914 shows that Don Atanacio owned a large home on Canyon Road (Fig. 1). His home corresponds with the building at 830 Canyon Road. Like his neighbors, Don Atanacio maintained a small farm field below the house. His and neighboring fields were irrigated by the *Acequia Madre*, of which Vigil was a *parciante*² At the time of the mapping, the field was planted with corn, a traditional crop used for home consumption and trading.

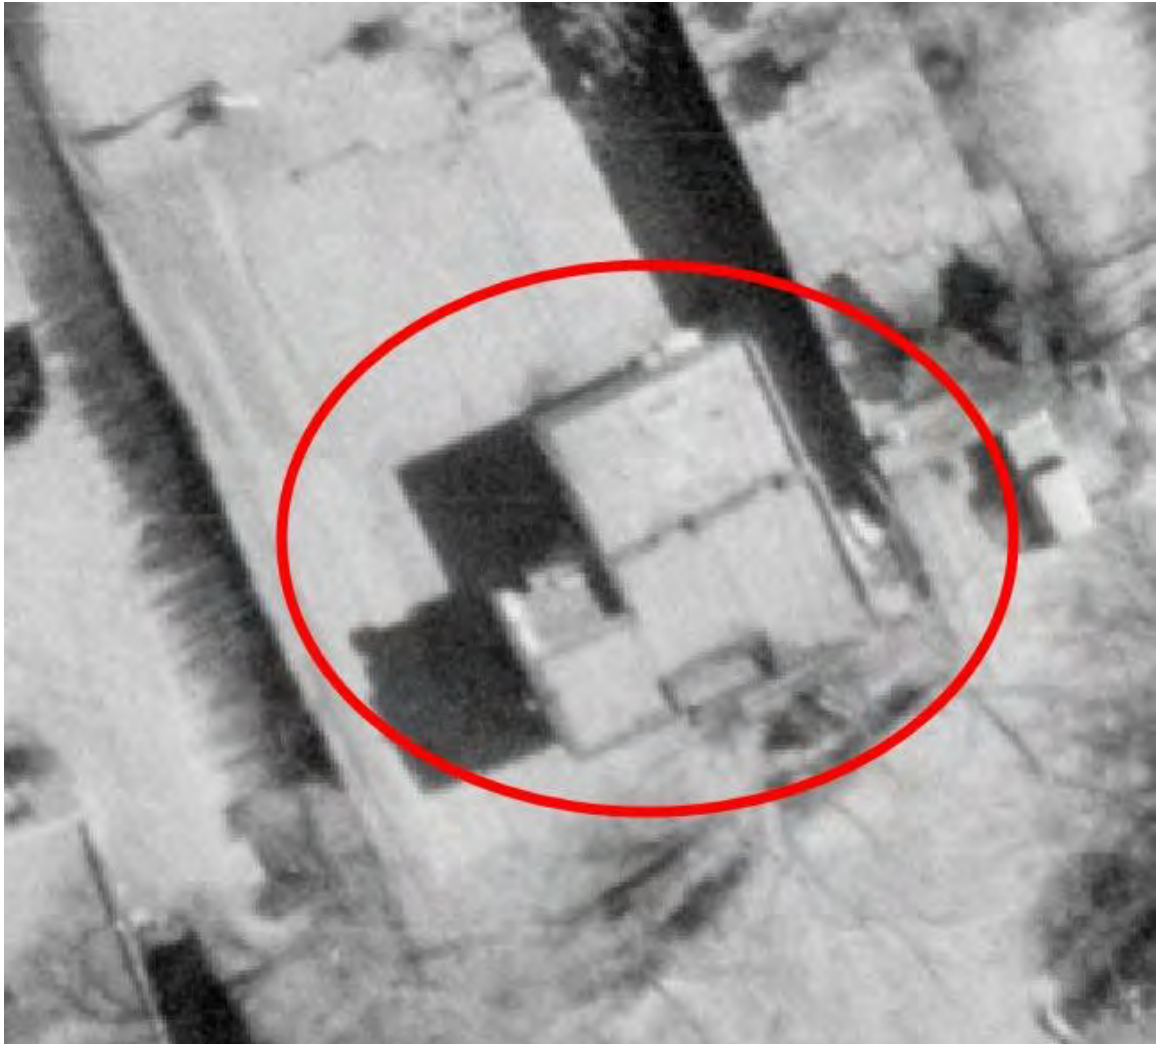
Figure 4: May 11, 1973, aerial photograph.

Overhead photographs from this period illustrate the layout of the property. Images taken in 1973 and 1978 show a small, lower-roofed structure at the northwest corner, which may have functioned as an open porch (Figs. 5 & 6). This area has since been enclosed and converted into a heated living space.

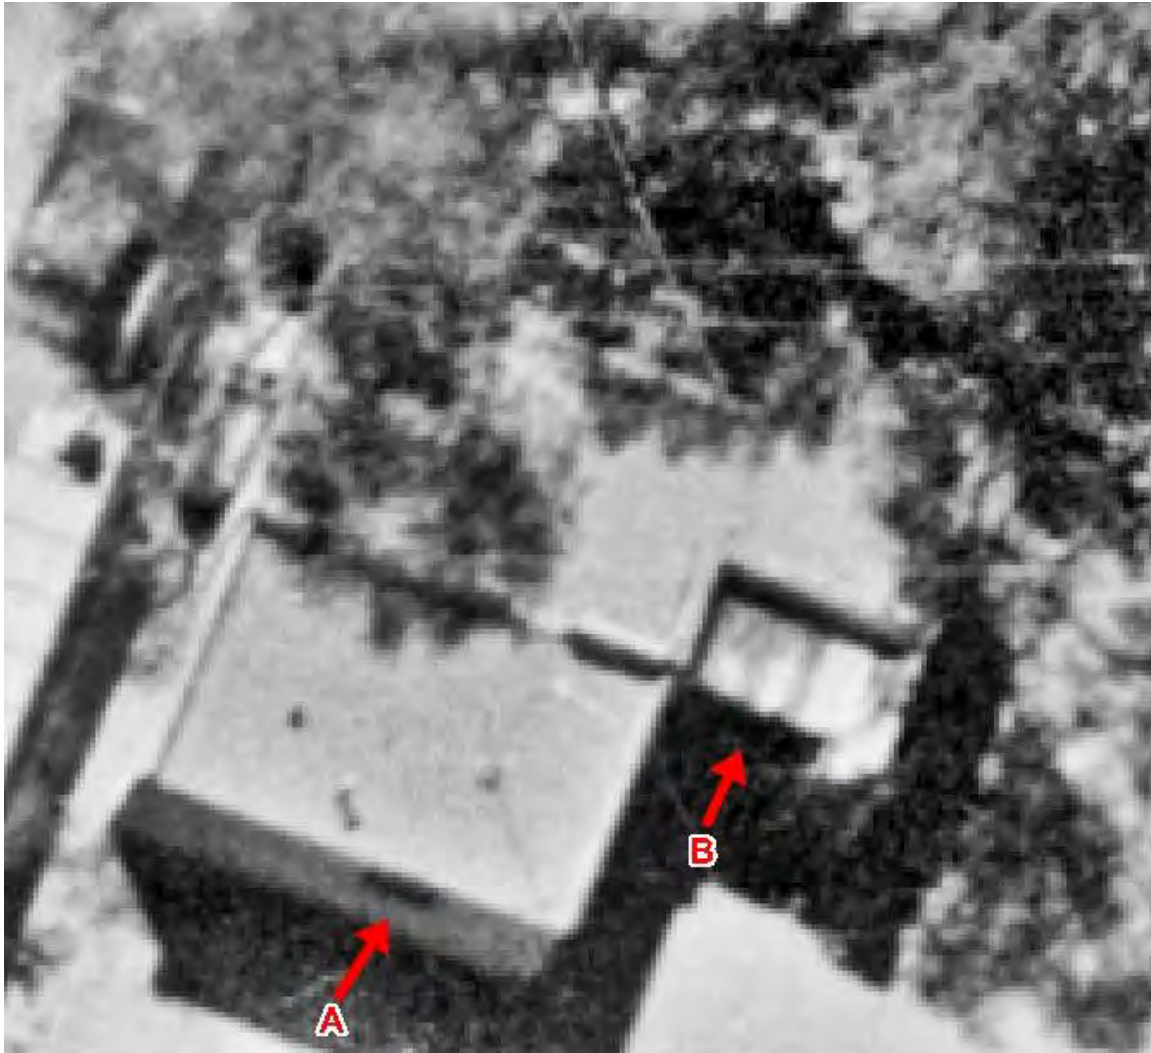
Figure 5: September 11, 1978, aerial photograph, direction reversed. Note opening closer to west edge of building (A) and what appears to be an open porch (B).

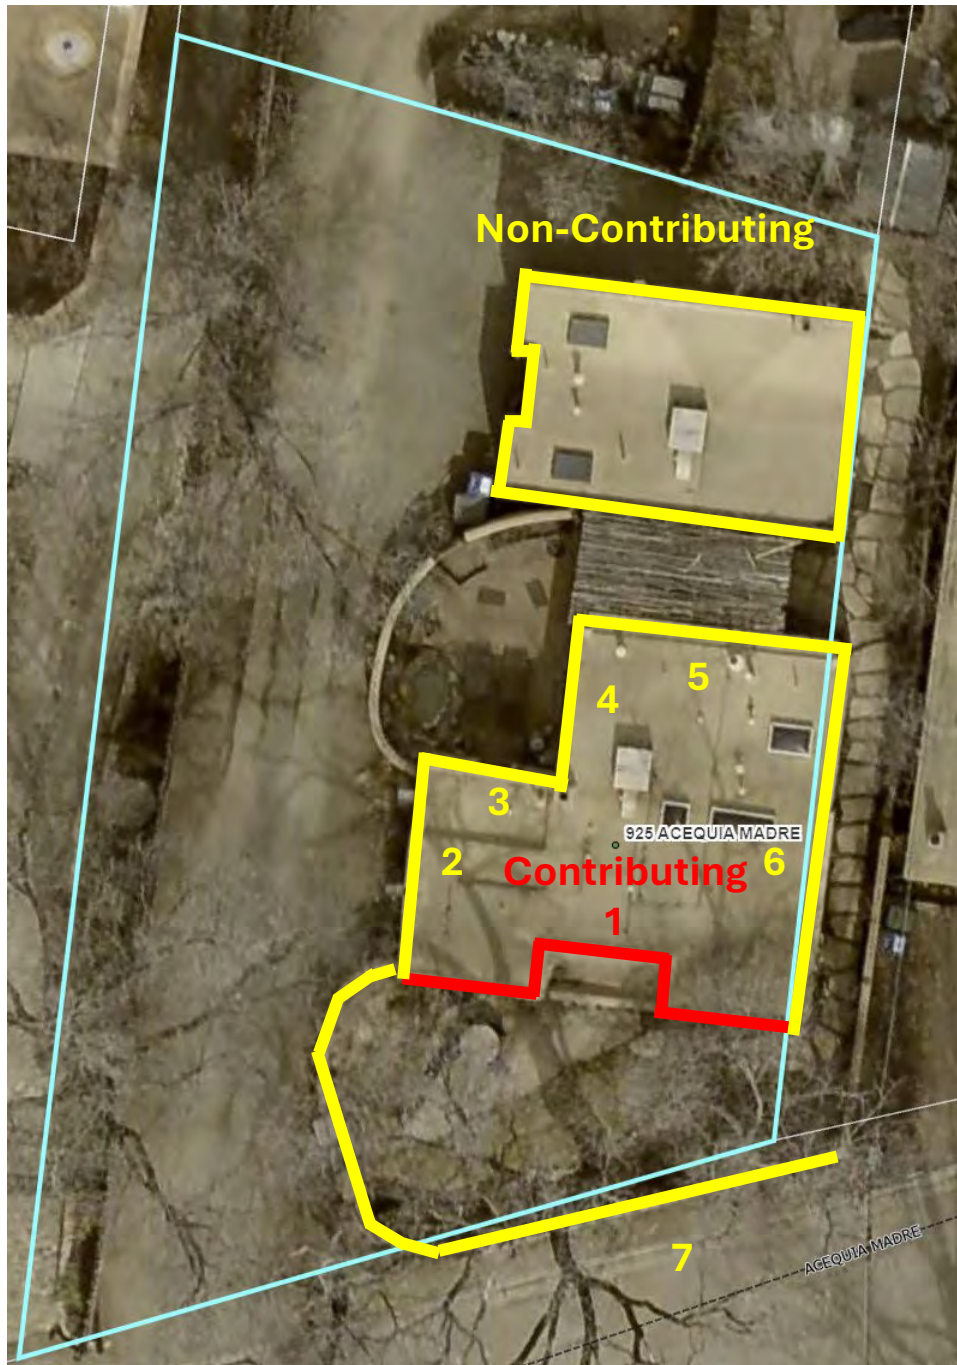
925 Acequia Madre: Façade Diagram

This is to certify that the Historic Districts Review Board (HDRB) acted on your request at their hearing on Feb 11, 2025. The decision of the Board was to except staff's recommendation, the status of the structure be maintained as contributing with the south façade, excluding non-historic materials, be designated as primary.
