PROJECT 2024-009369-HDRB, 345 Garcia St., Downtown & Eastside Historic District, Contributing,
DESC: Gayla Bechtol, agent for Robert Holleyman and Bill Keller, owners, requests downgrade of historic status from Contributing to Non-Contributing for a residential structure and an accessory structure and a status review for a street frontage yard wall.

CASE NUMBER: 2024-009369--HDRB

PROJECT TYPE: Historic Status Review

DATE: November 26, 2024
TO: Historic Districts Review Board Members
FROM: Lani McCulley, Senior Planner, Historic Preservation Division

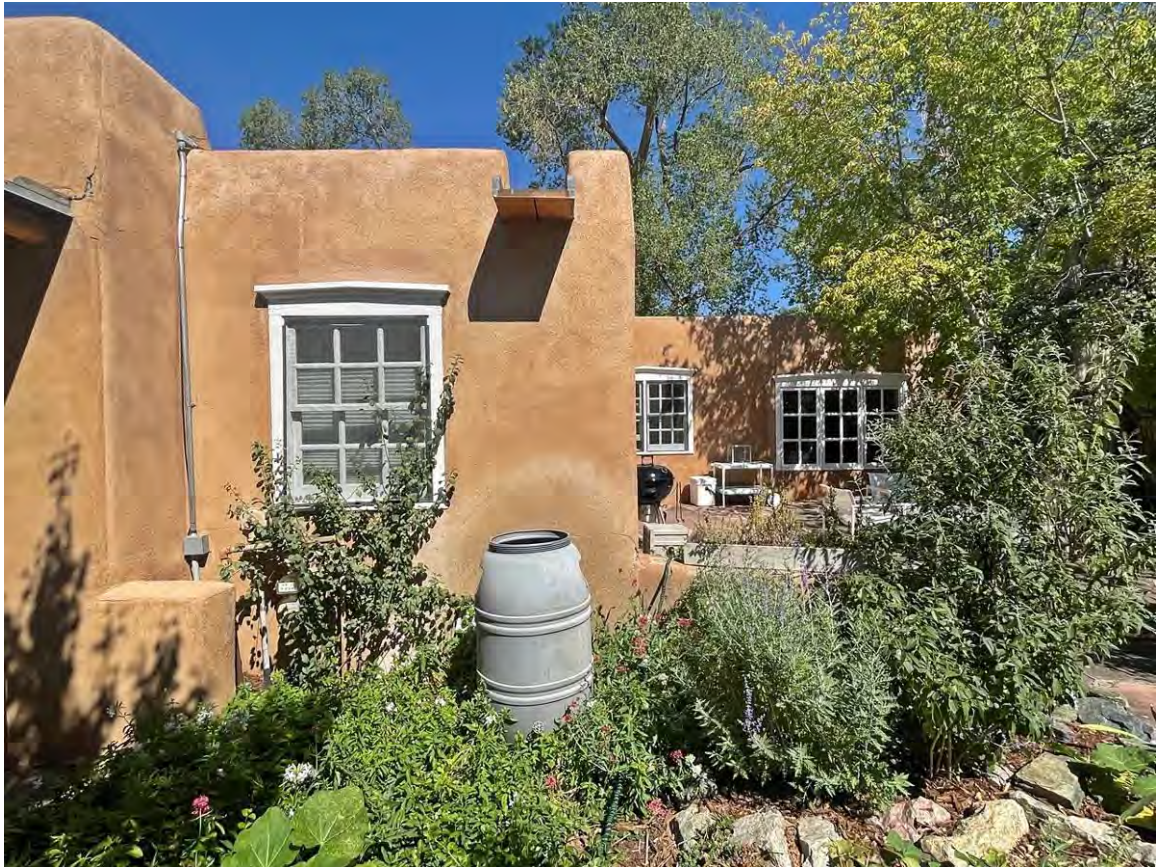
At the east end of the portal, the building steps back a few feet to what appears to be an enclosed porch (Photos 1 & 4). The space has a different type of parapet than the older portion of the house. In the 1980s, the roofs of this room, the primary bedroom, the library, and the two baths were raised to a uniform height and given new parapets with vents.¹

Photo 4: South elevation, east end and presumed enclosed porch. Camera facing north.

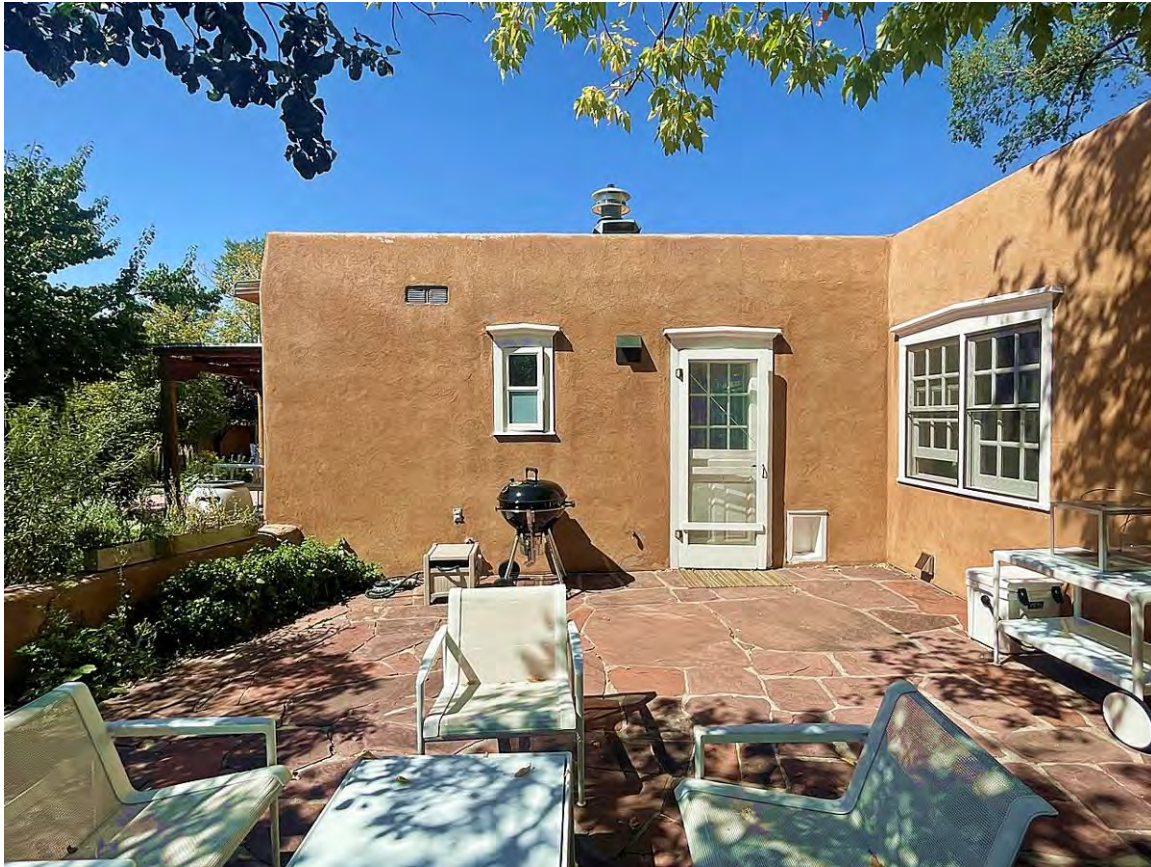
Photo 6: East elevation and presumed enclosed porch. Camera facing west.

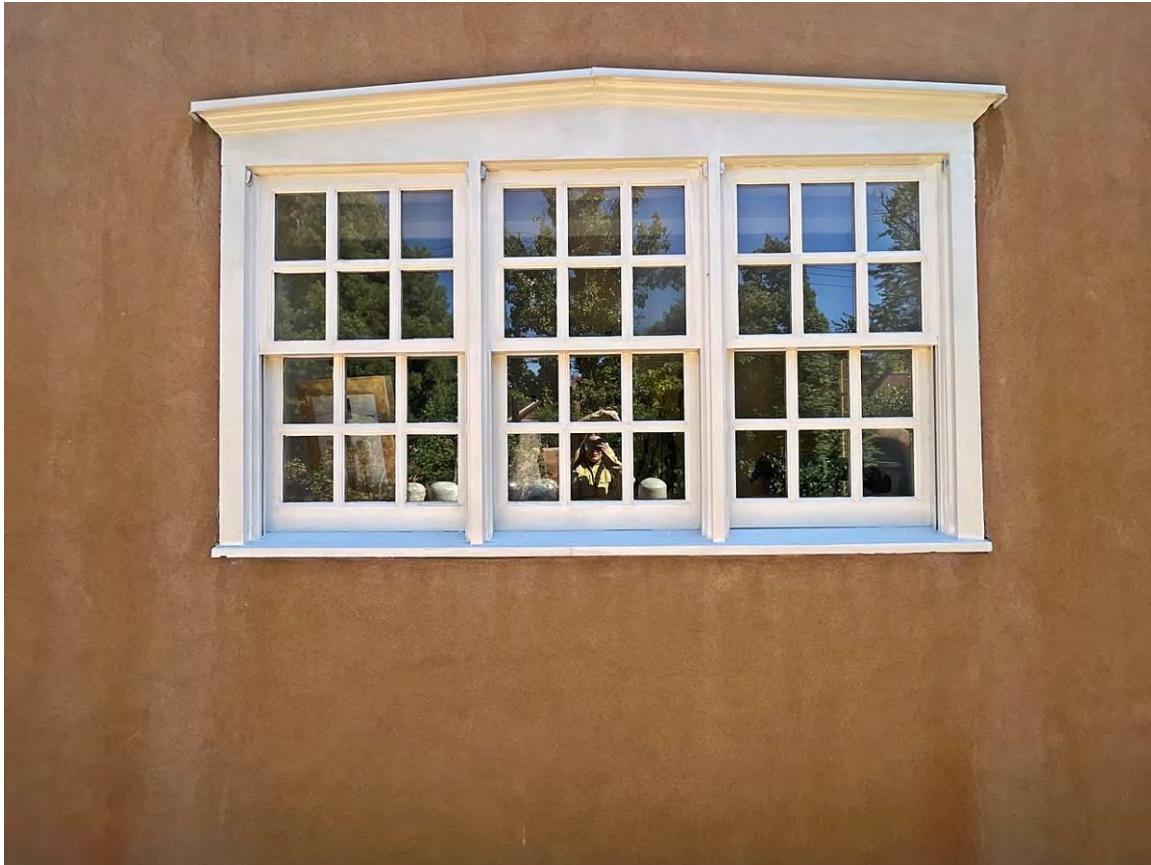
trim (Fig. 11). In the photo, the end pediment stopped where it met the vertical casing. Presently, it extends beyond this juncture by a few inches and has a different type of molding. In the 1980s, the windows terminated at the bottom with a piece of horizontal casing. Today, they rest on a sill with no casing. According to the current owner, the patch of ivy on the north side of the façade covers what may be an infilled door opening.²

Photo 8: West elevation, detail of right (south) window. Camera facing east.

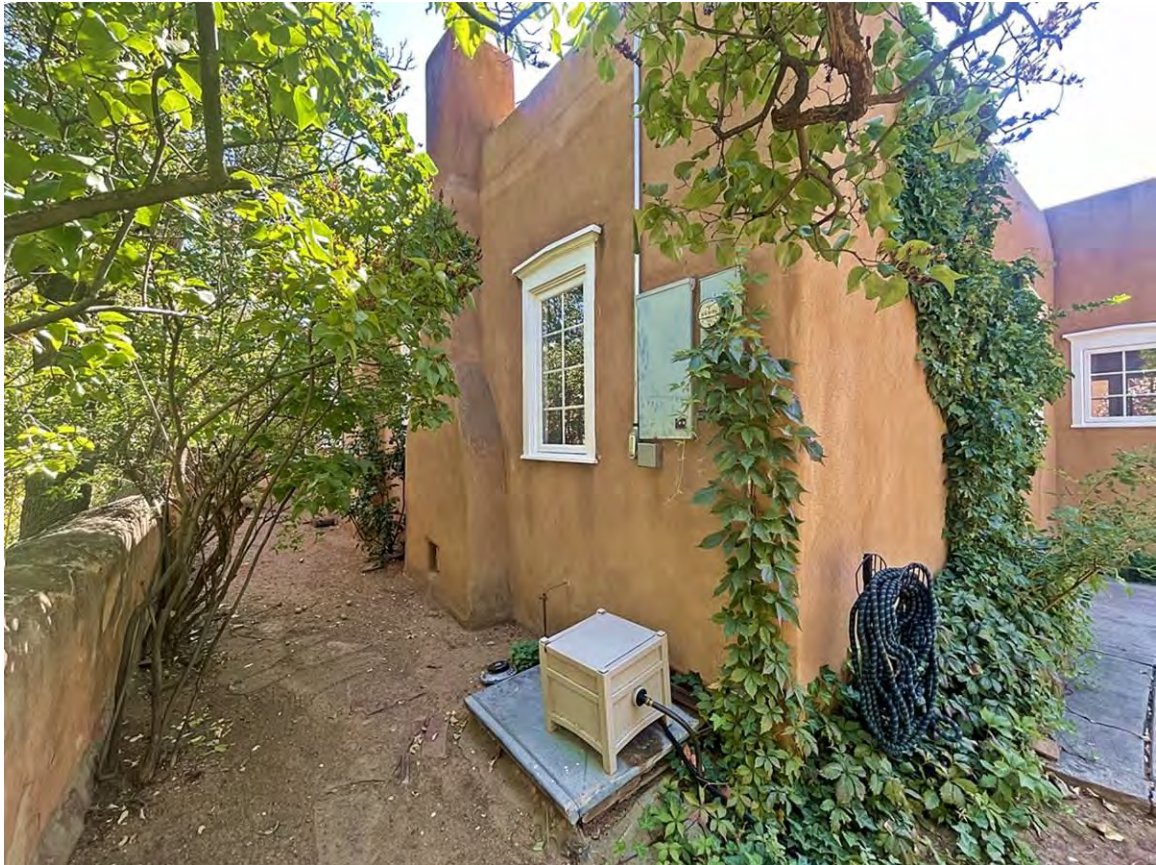
The north elevation sits close to the property line, separating it from the old Mary Victory house. A low stuccoed wall and *latilla* pole fence define the property line. This side of the building was also altered in the 1980s. Starting at the west is a molded, stucco chimney flanked by modern casement windows trimmed with triangular heads (Photo 9). Moving eastward, one encounters an asynchronous bay window (Photos 10 & 11) which was added in the 1980s. It mimics the style of a similar window on the south elevation of the Mary Victory house facing the subject house.

Photo 9: North elevation oblique. Camera facing southeast.

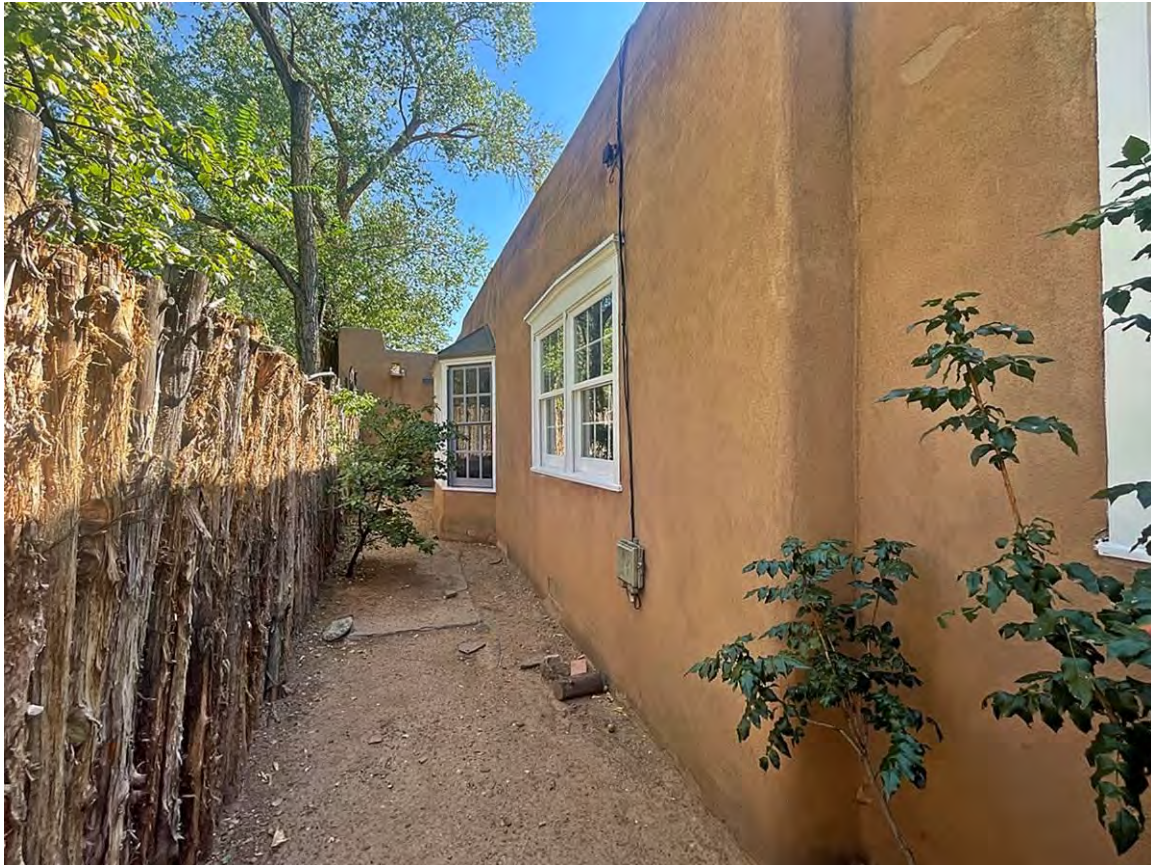
Photo 10: North elevation, bay window in distance. Camera facing southeast.

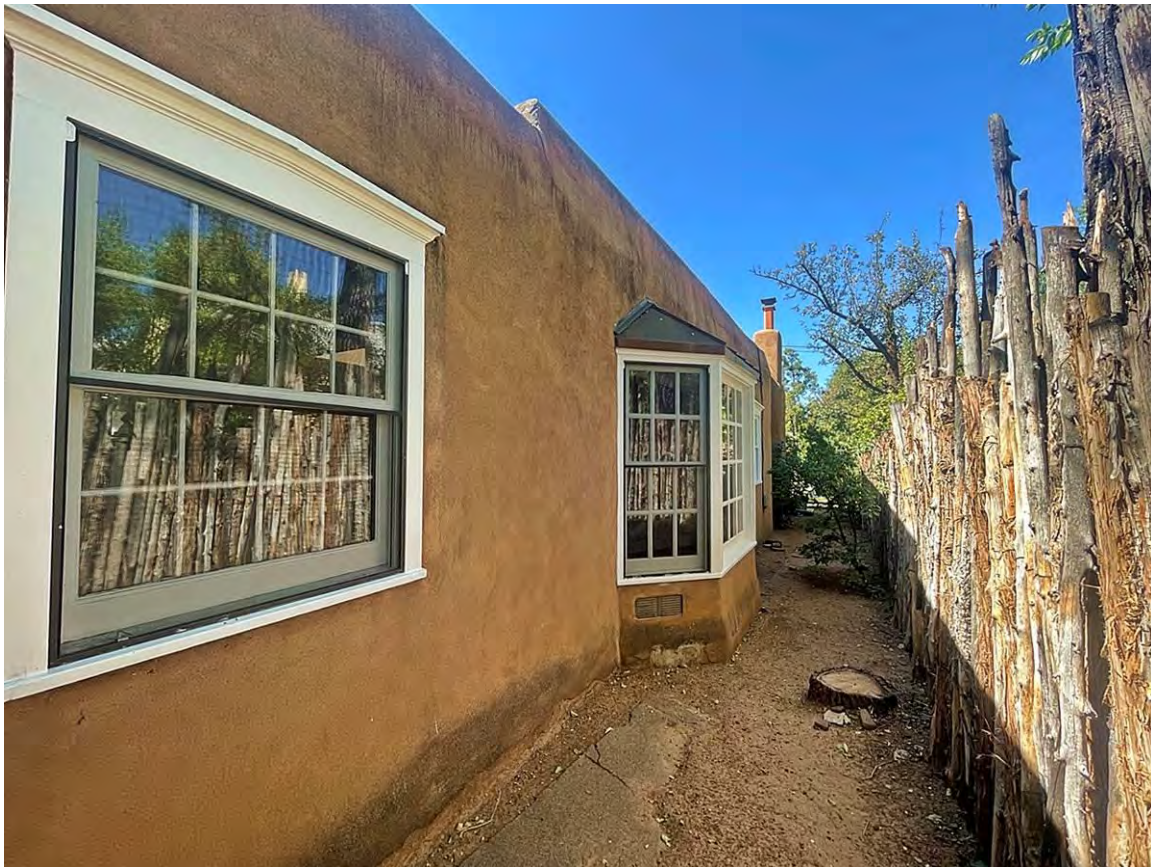
Photo 11: North elevation, east end. Camera facing southwest.
