**PROJECT** 2024-009369-HDRB, 345 Garcia St., Downtown & Eastside Historic District, Contributing,  
**DESC:** Gayla Bechtol, agent for Robert Holleyman and Bill Keller, owners, requests downgrade of historic status from Contributing to Non-Contributing for a residential structure and an accessory structure and a status review for a street frontage yard wall.

**CASE NUMBER:** 2024-009369--HDRB

**PROJECT TYPE:** Historic Status Review

**DATE:** November 26, 2024  
**TO:** Historic Districts Review Board Members  
**FROM:** Lani McCulley, Senior Planner, Historic Preservation Division

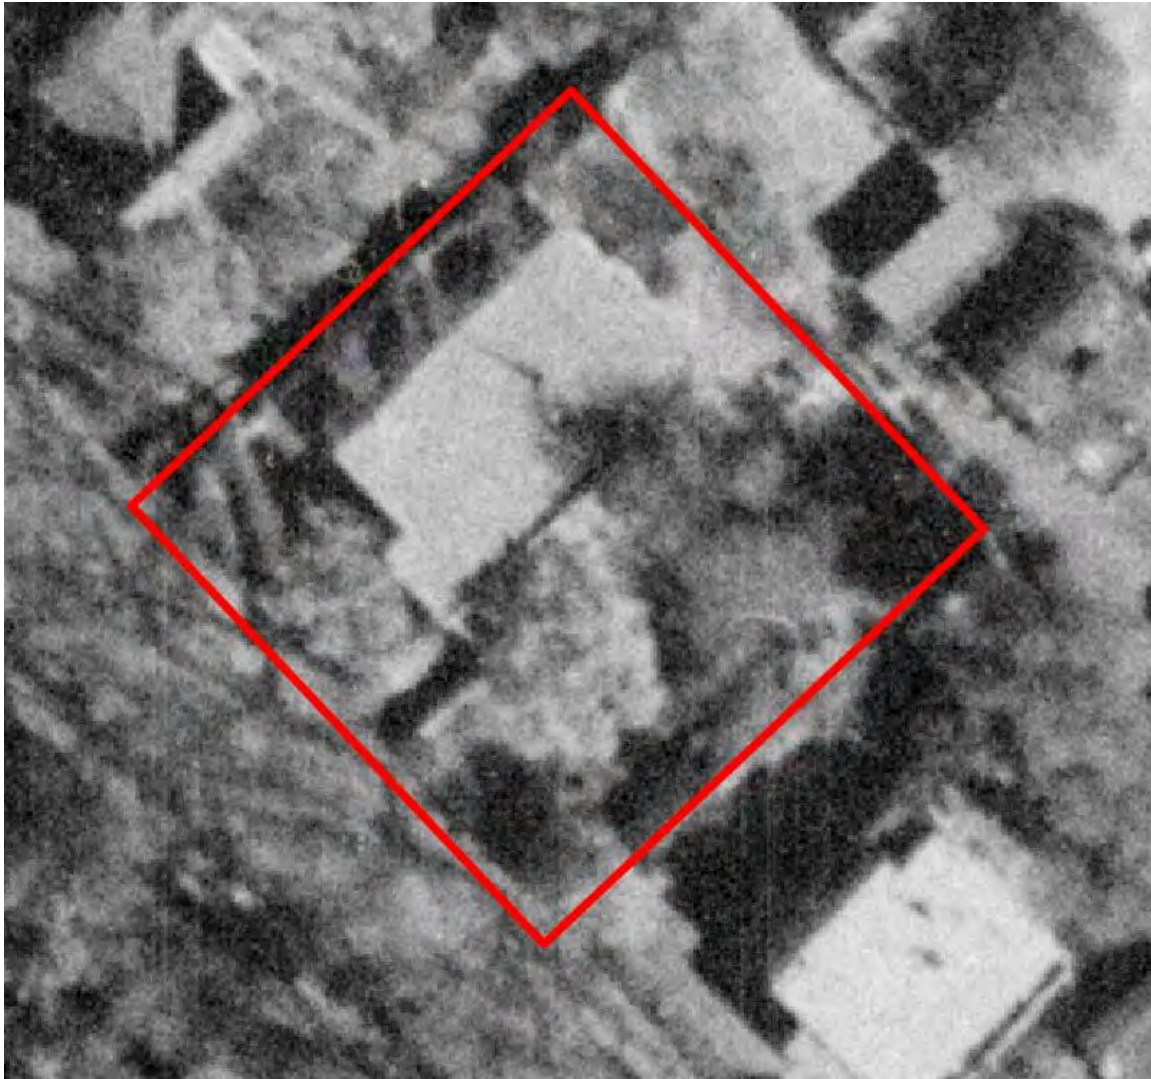
The house sits at a higher grade than the street and is oriented south with a long shade-making *portal*. The date of the portal is unknown but appears on 1958 aerial photograph (Fig. 5). The south elevation has the most architectural expression of the building and, as it holds the main entry, would be considered its front. The portal, which stretches 50', looks over a flagstone patio (Photo 3).

Stepping 18' back from this section is the last piece of the house — the primary bedroom suite (Photo 5). Based on aerial photographs, this room was constructed by 1958 but may have served a different purpose (Fig. 5). The enclosed porch is now a bathroom, which along with the bedroom frames a private patio (Photos 5 & 6). According to a 1987 photo, the patio elevations have significantly changed in fenestration — both doors and windows (Fig. 10). Like the rest of the house, the elevations are presently pierced with newer units topped with pedimented heads.

**Figure 5: November 10, 1958, aerial photograph.**

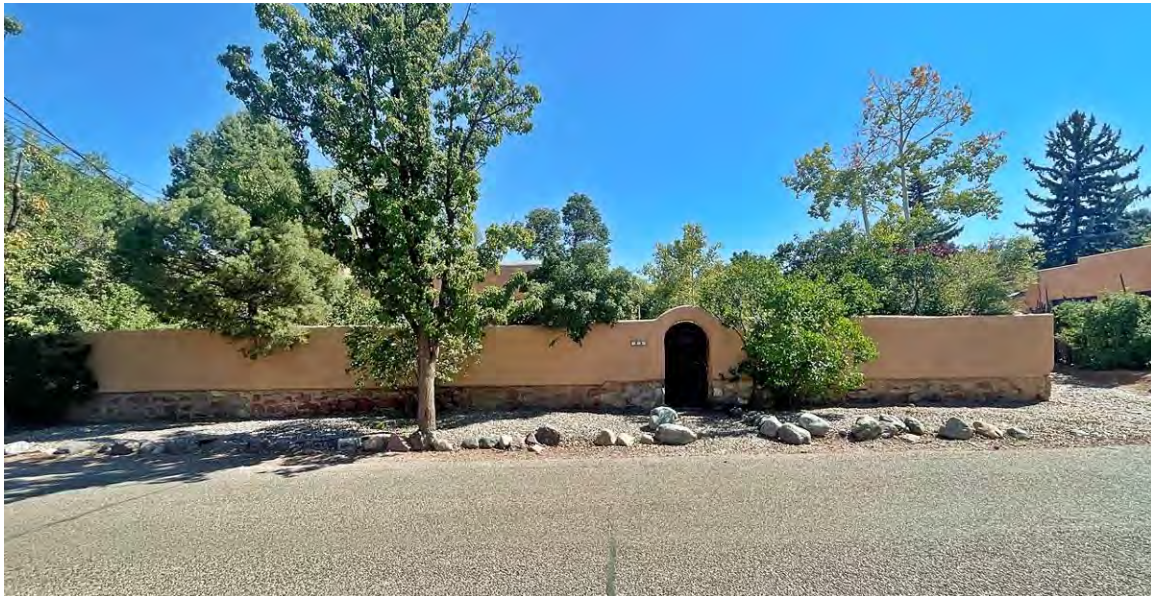
The second piece of wall connects to the front wall at the northwest corner. It extends eastward for approximately 80’ (Photo 18). It measures 39” above grade with a 15” thickness. Areas where the stucco has deteriorated show several layers of traditional plasterwork. It appears to be of the same vintage as the front wall.

Photo 2: Front wall taken from street. Camera facing east.

Portions of the front wall and the entire span of the north wall appear to be vintage. It is recommended to designate the sections that retain integrity as a Contributing structure.

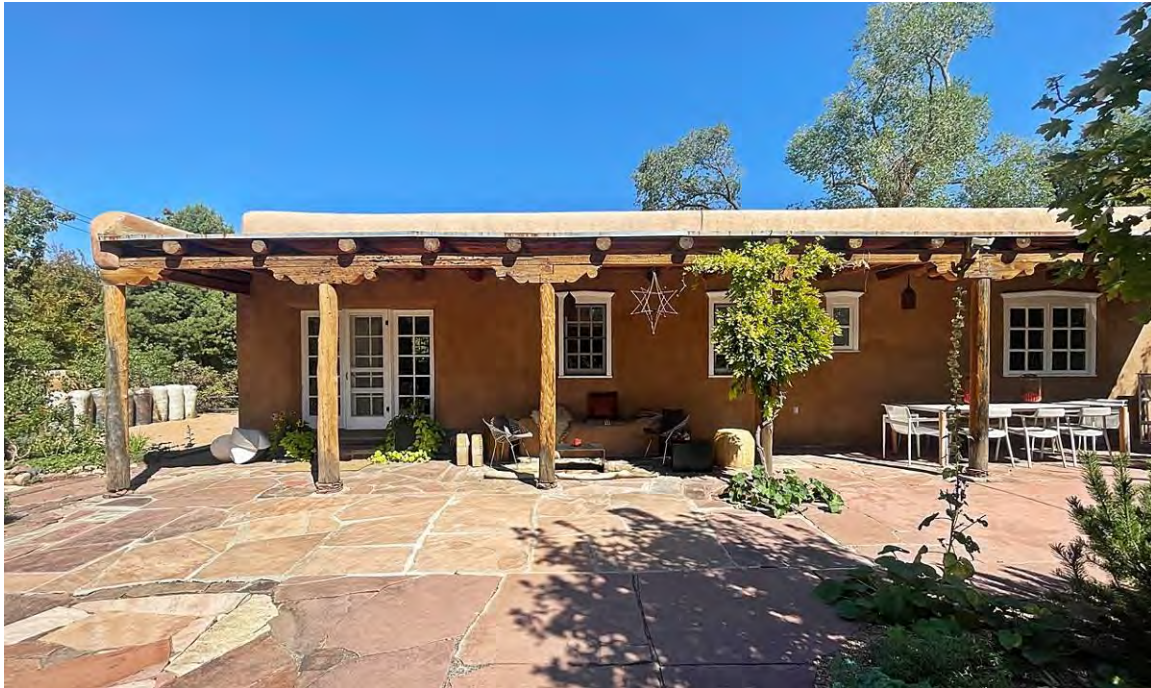
In its shadow is a line of fenestration that has been altered over the years. This is established by comparing current conditions with how the porch appeared in 1987 before being renovated (Fig. 9). Some window openings were removed, while others were newly installed. One enters the house at the west end of the portal through a narrow ten-light wood door flanked by divided side lights. Marching east are various multi-light windows, all with pedimented heads.

**Photo 3: South elevation, west end. Camera facing north.**

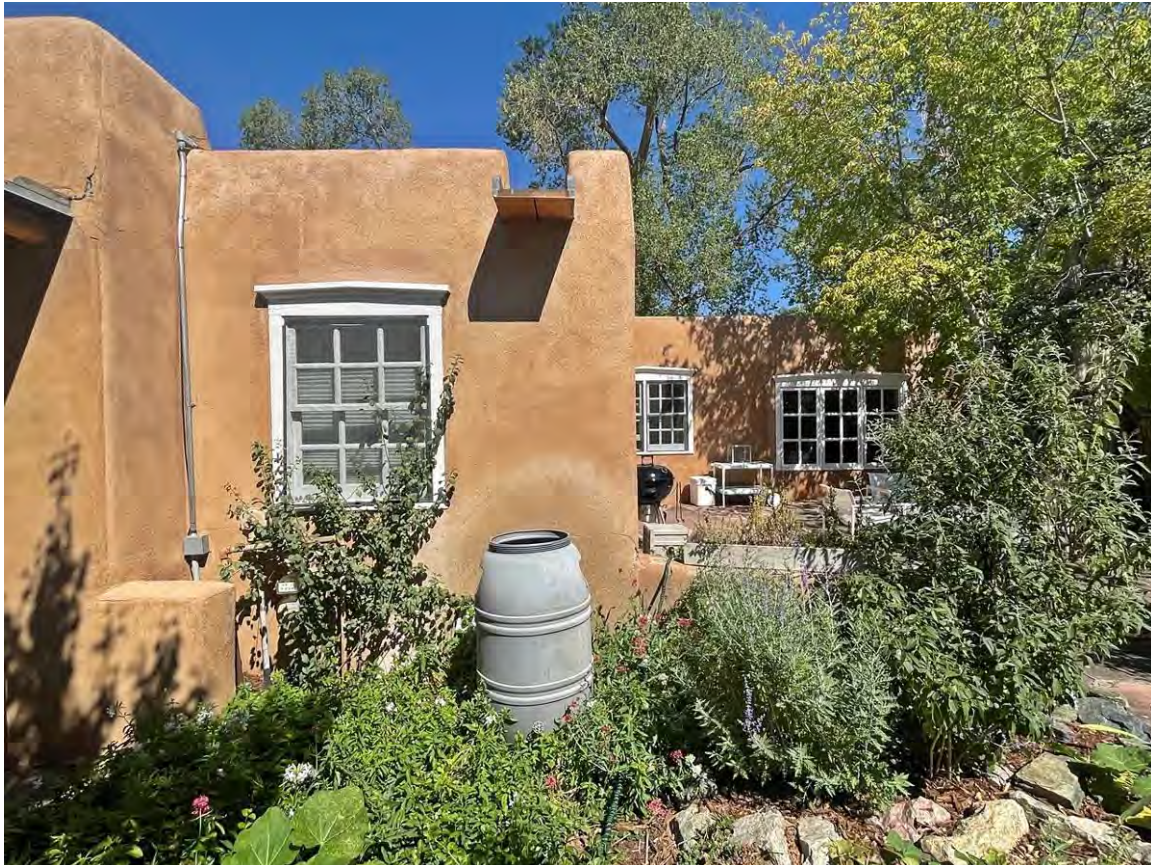
At the east end of the portal, the building steps back a few feet to what appears to be an enclosed porch (Photos 1 & 4). The space has a different type of parapet than the older portion of the house. In the 1980s, the roofs of this room, the primary bedroom, the library, and the two baths were raised to a uniform height and given new parapets with vents.<sup>1</sup>

**Photo 4: South elevation, east end and presumed enclosed porch. Camera facing north.**

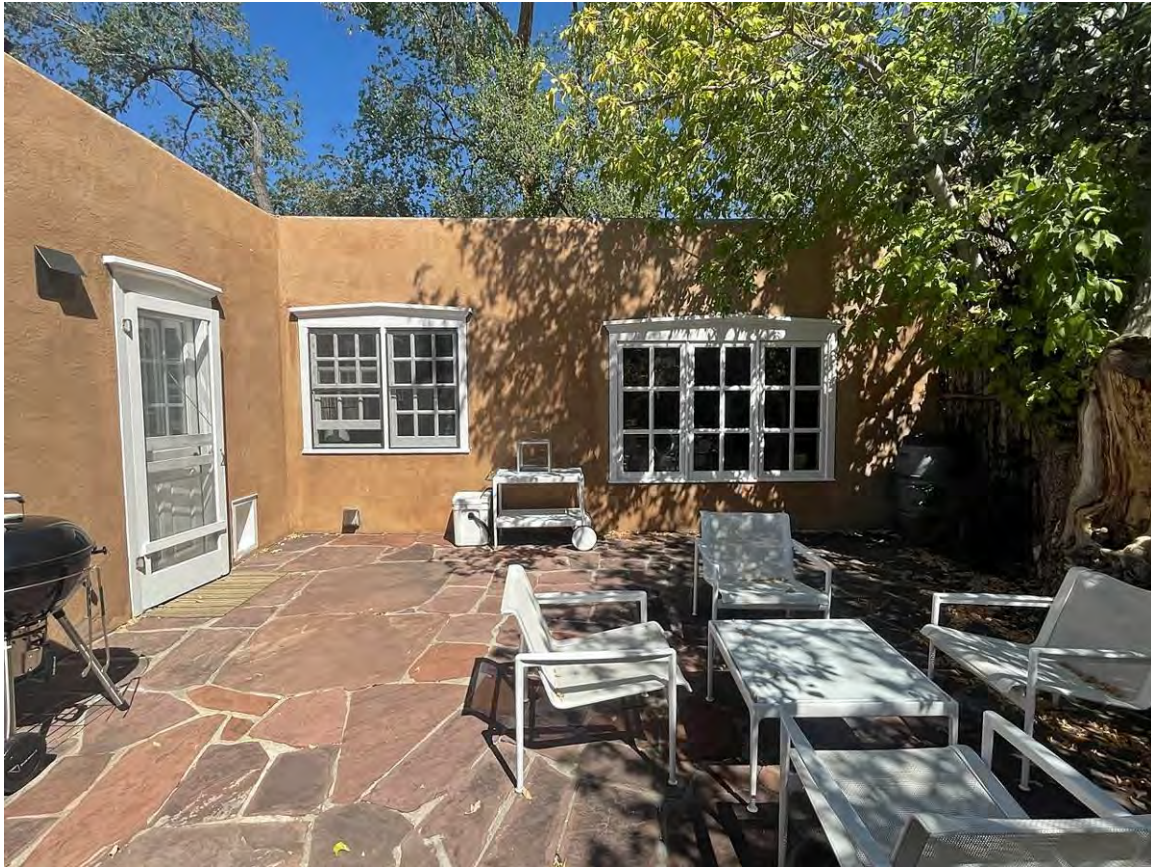
**Photo 5: South elevation, primary bedroom suite. Camera facing north.**

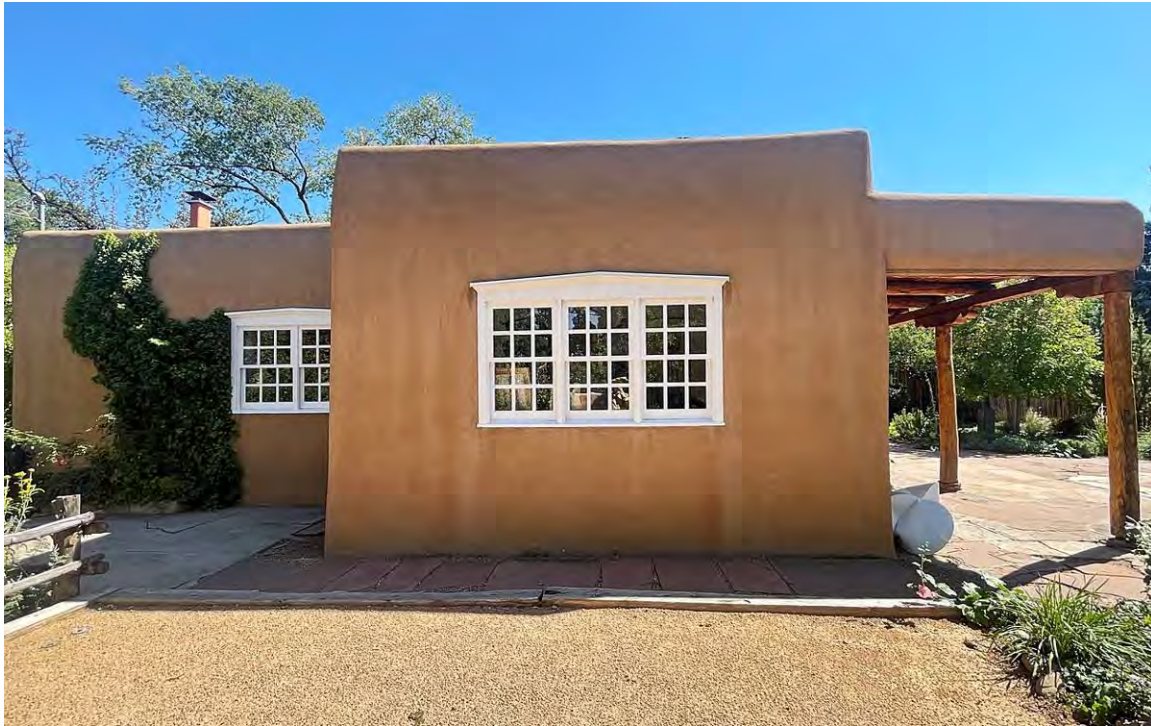
The west elevation faces the street with a façade divided by a 6' offset (Photo 7). Both pieces have Territorial-style window heads topping groupings of hung sash (Photo 8). A 1987 photo of the right (south) window shows that it had a different casing and head

**Photo 7: West elevation. Camera facing east.**

The original design of the west elevation is not known, but it seems to have undergone fewer changes compared to the south and rear parts of the house. If the Board decides to maintain its Contributing status, the recommendation is to designate the west elevation and the northwest corner (the area around the chimney) as the primary façades.

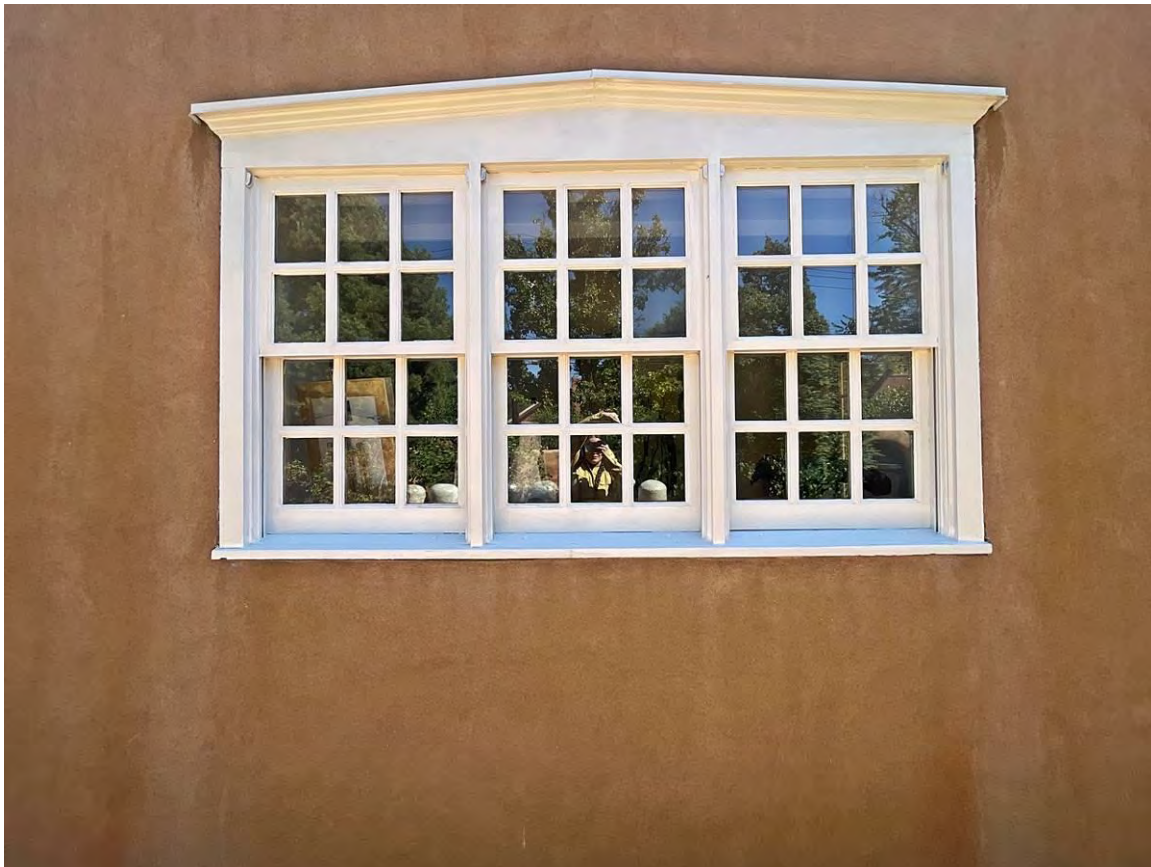
trim (Fig. 11). In the photo, the end pediment stopped where it met the vertical casing. Presently, it extends beyond this juncture by a few inches and has a different type of molding. In the 1980s, the windows terminated at the bottom with a piece of horizontal casing. Today, they rest on a sill with no casing. According to the current owner, the patch of ivy on the north side of the façade covers what may be an infilled door opening.<sup>2</sup>

**Photo 8: West elevation, detail of right (south) window. Camera facing east.**

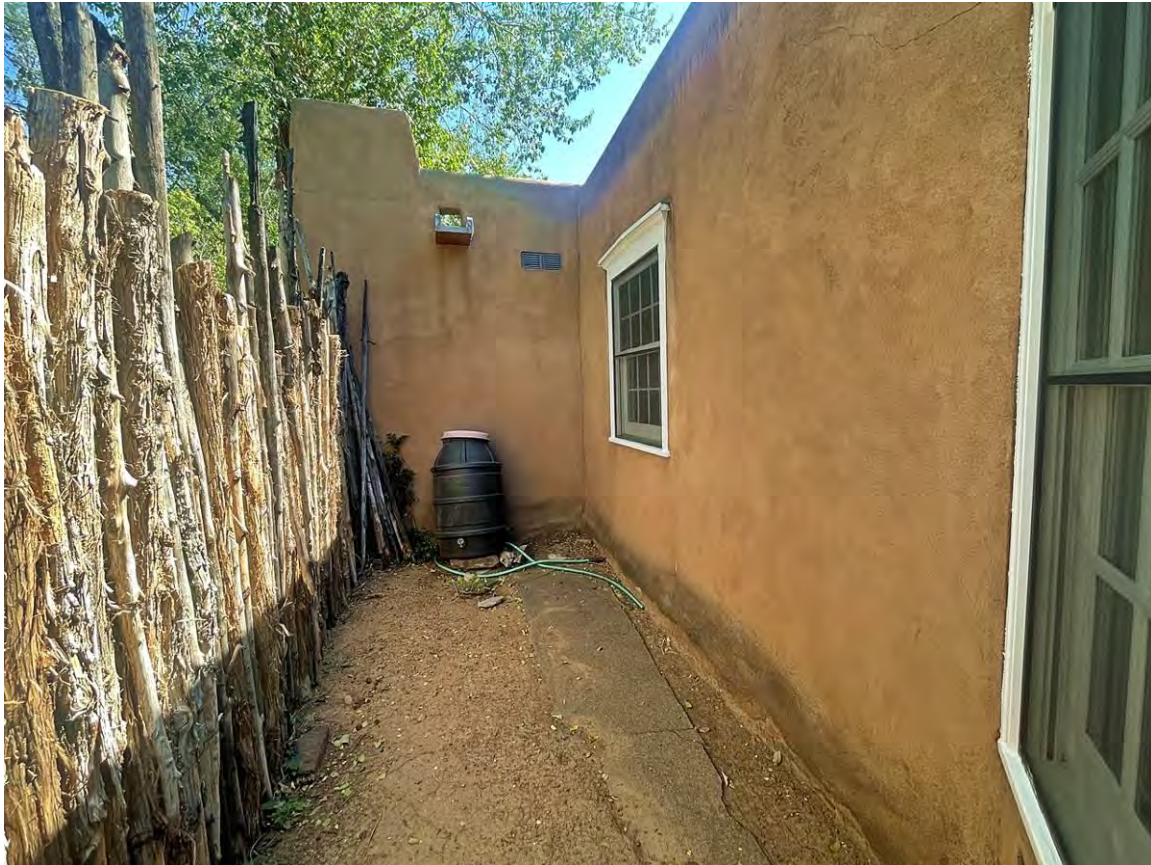
The area east of the bay window was bumped out in the 1980s to extend the wall of the library room to meet a new primary bedroom closet (Photo 12). As seen in the 1987 photograph, the library at the time contained a window and a door (Fig. 12). The north elevation terminates at the primary bedroom closet addition.

**Photo 12: North elevation, east end. Camera facing southeast.**

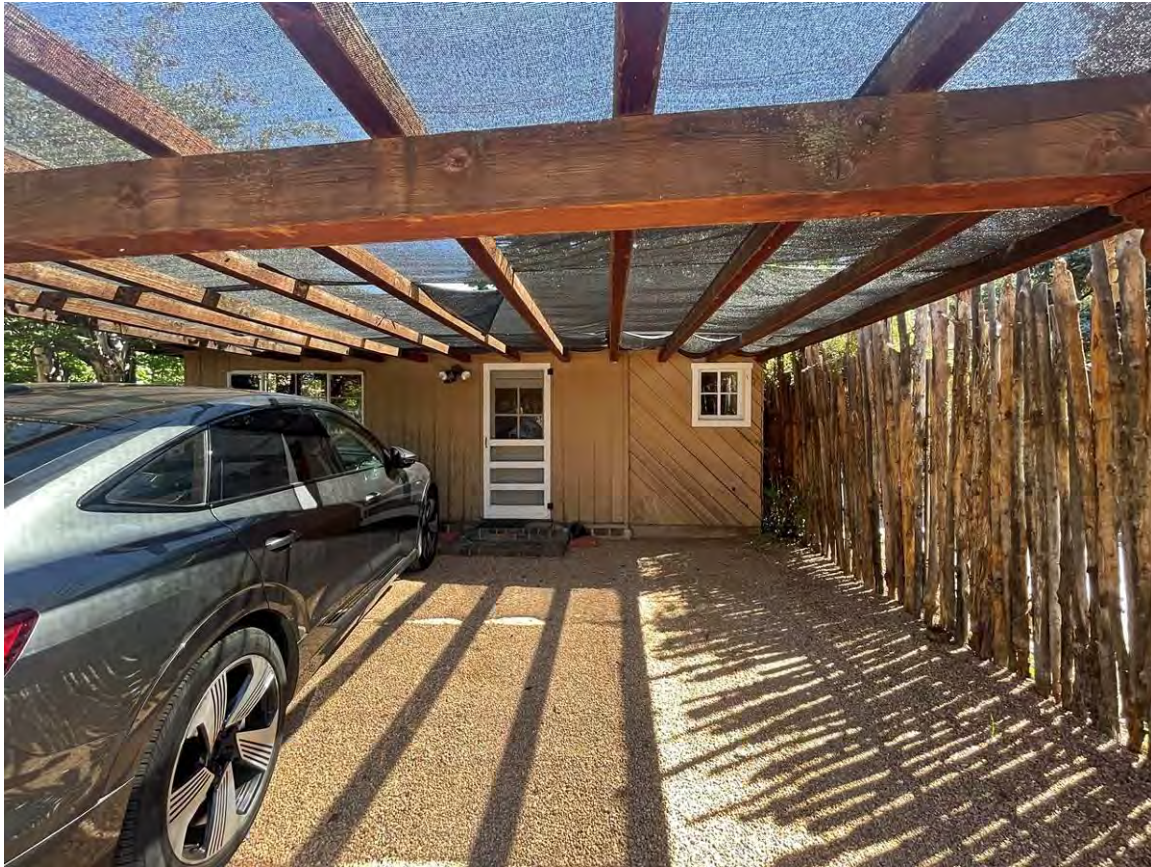
An older wood structure sits at the southeast corner of the property. It is composed of two pieces. The front piece, facing the driveway, likely started as a shed (Photo 13). It has a mixture of diagonal plank and tongue-and-groove board siding. It is entered from this elevation by a ½-light wood door. A barn sash casement window and a steel combination window flank the door. A non-historic wood structure attaches to the building, creating a shaded parking spot. The north side has a pedestrian door and a modern window (Photo 14). The roof appears to have been extended over the façade by

**Photo 13: Guesthouse, west elevation. Camera facing east.**

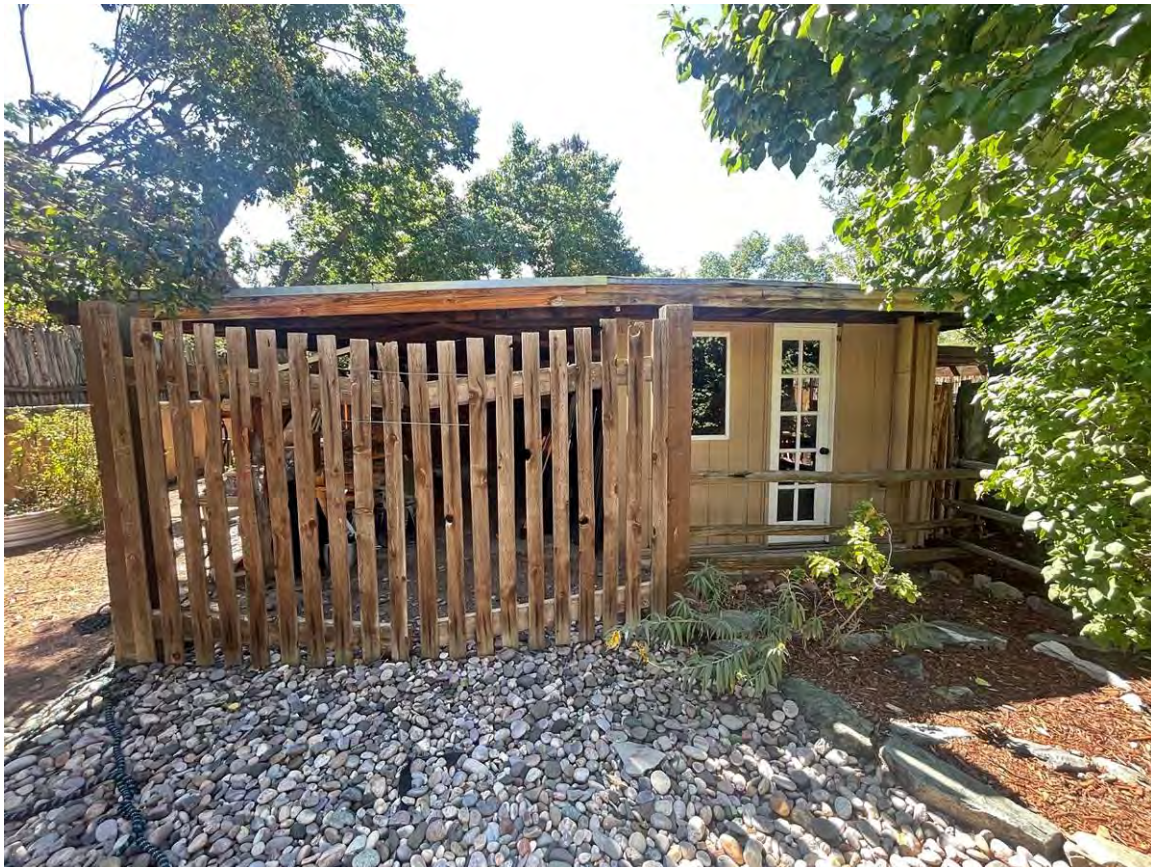
**Photo 14: Guesthouse, north elevation. Camera facing south.**

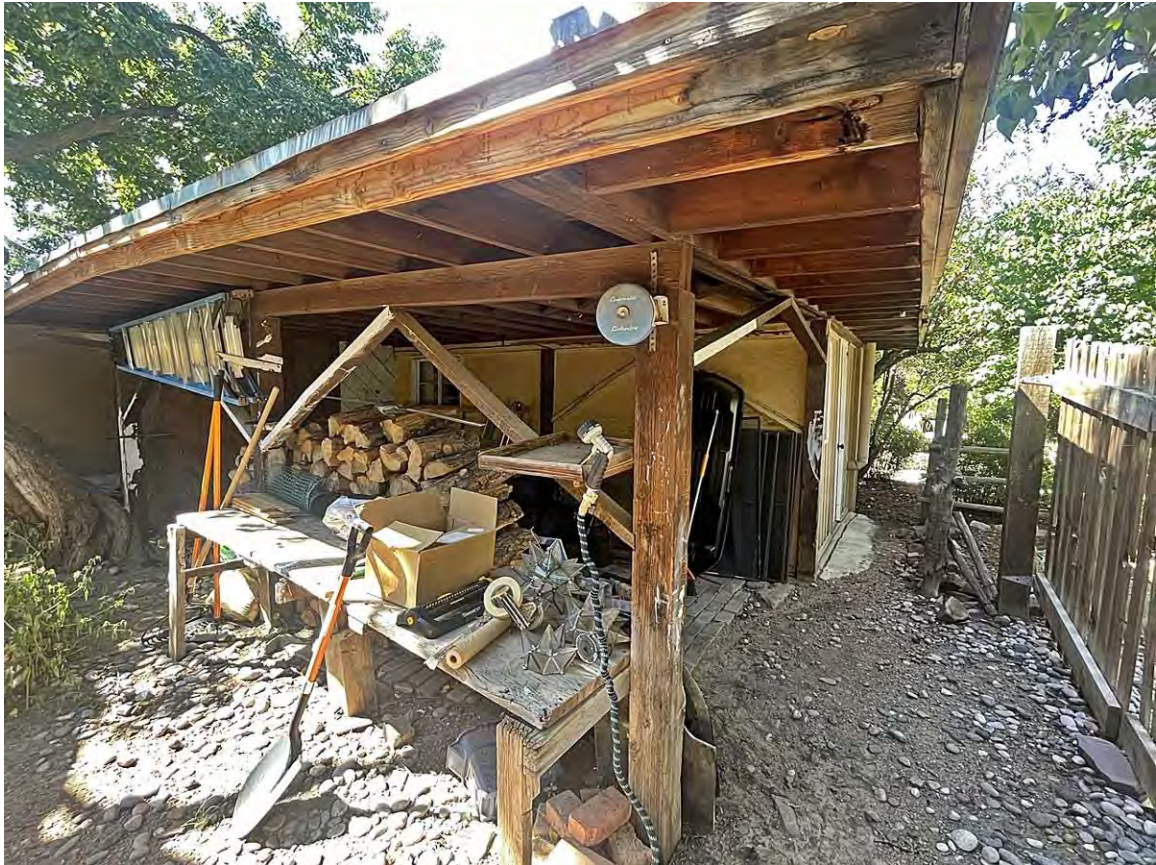
dummy rafters. The east side faces the former carport (Photo 15). It is now used as an outdoor work area.

**Photo 15: Former carport. Camera facing southeast.**

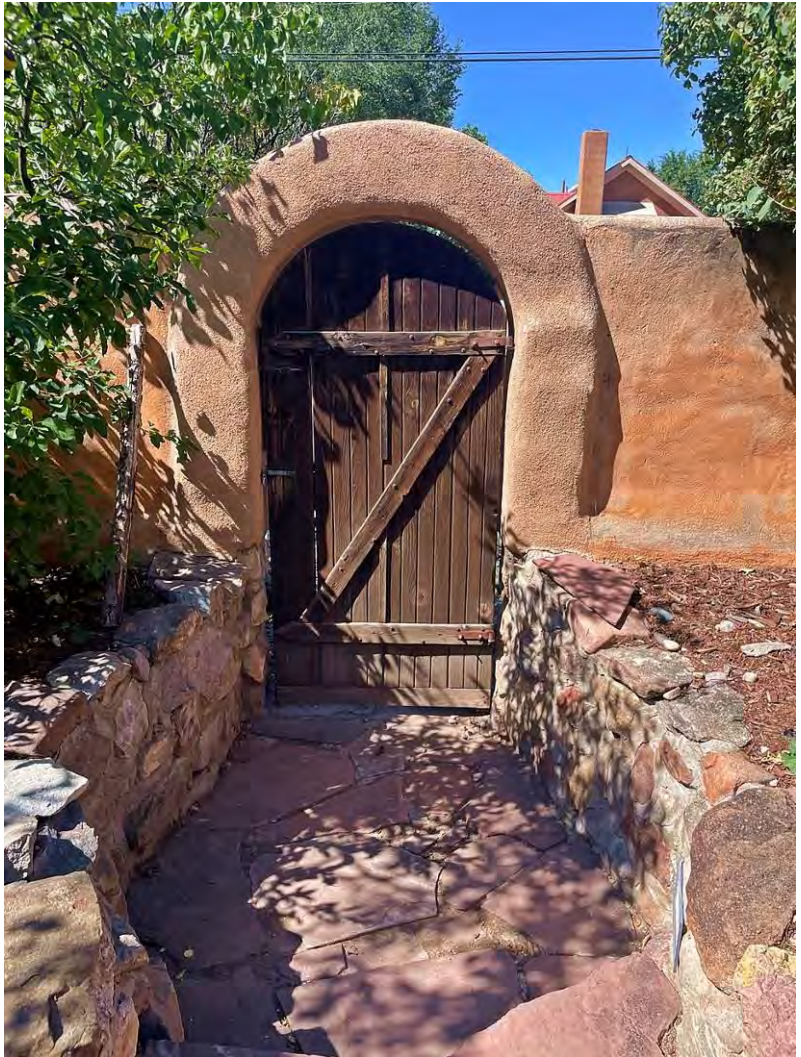
The property has two sections of stucco wall. The first is a roughly 80-foot-long section that runs across the front of the property (Photo 2). It rests on a stone base and serves as a retaining wall. The inside measurement varies between 51” and 53” above the finished grade. It is 12” thick at its top. Near its center is an arched opening that rises 90” above grade, opening to a rock-lined channel flanking a flagstone path leading to the house (Photo 16). The area south of the linear section at the driveway appears to be altered. The wall’s origin is unclear.

**Photo 16: Front wall, entry gate. Camera facing west.**
