**Historic Cultural Properties Inventory Survey
907 Don Miguel Place
Santa Fe, NM**

051600223 (H1869)

**Santa Fe Planning Division
Historic Design Review Board**

August 15, 2006

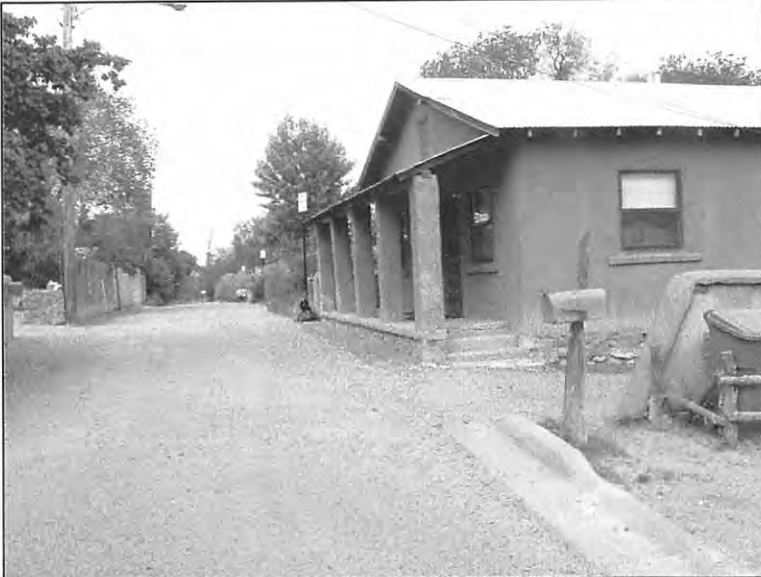
1. View west of Don Miguel Place shows the house of Cruz and Matilda Rios at 909 Don Miguel Place immediately east of 907 Don Miguel Place. Cruz Rios states that his house, built in the 1940s, predates the house on 907 Don Miguel Place (ArcCom 07-20-06).

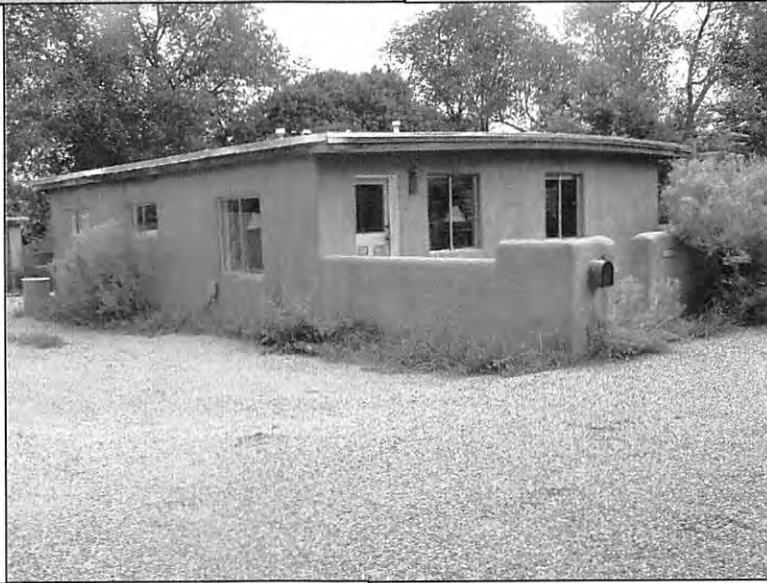
2. View northwest of vernacular dwelling at 903 Don Miguel Place predates 1958, and is immediately west of 907 Don Miguel Place (ArcCom 07-20-06).

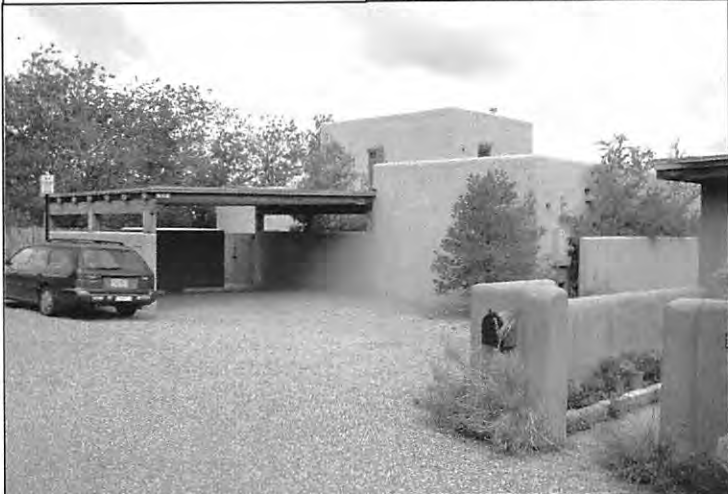
3. View northwest of pueblo-revival dwelling at 901 Don Miguel Place post dates 1958 and is two lots west of 907 Don Miguel Place (ArcCom 07-20-06).
