City of Santa Fe

Plan Number: 2024-009370--HDRB

memo

2024-009370-HDRB, 1030 ½ W. Houghton St., Don Gaspar Area Historic District, non-contributing and no- historic status (accessory building), Seres Architect LLC, agent for Francesca Banci, owner, requests a historic status review with primary facade(s) designation, if applicable, for a residential and an accessory structure.

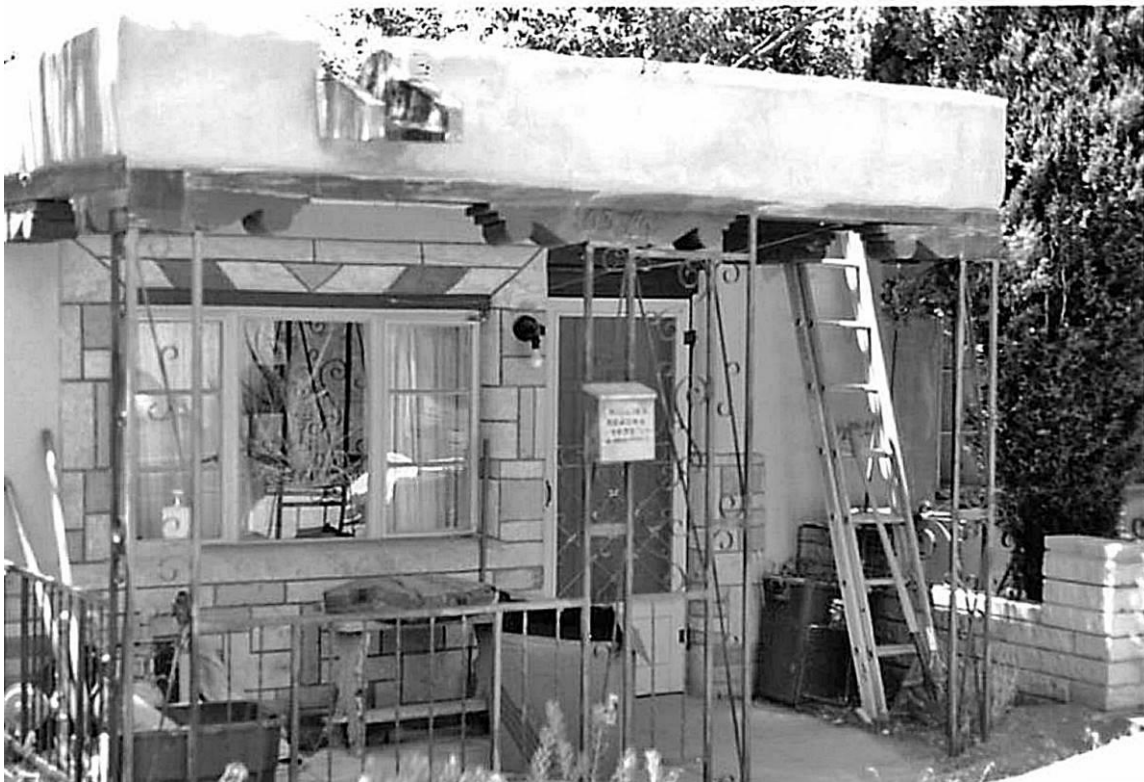
Historically, the porch wall had a Perma-Stone-like treatment (Fig. 1). Before the recent sale, this feature was covered in stucco, resulting in the window now having a pronounced stucco enframing that wasn't there previously.

**Figure 1: Photo from 1995 HBI survey.
 Courtesy NMCRIS.**

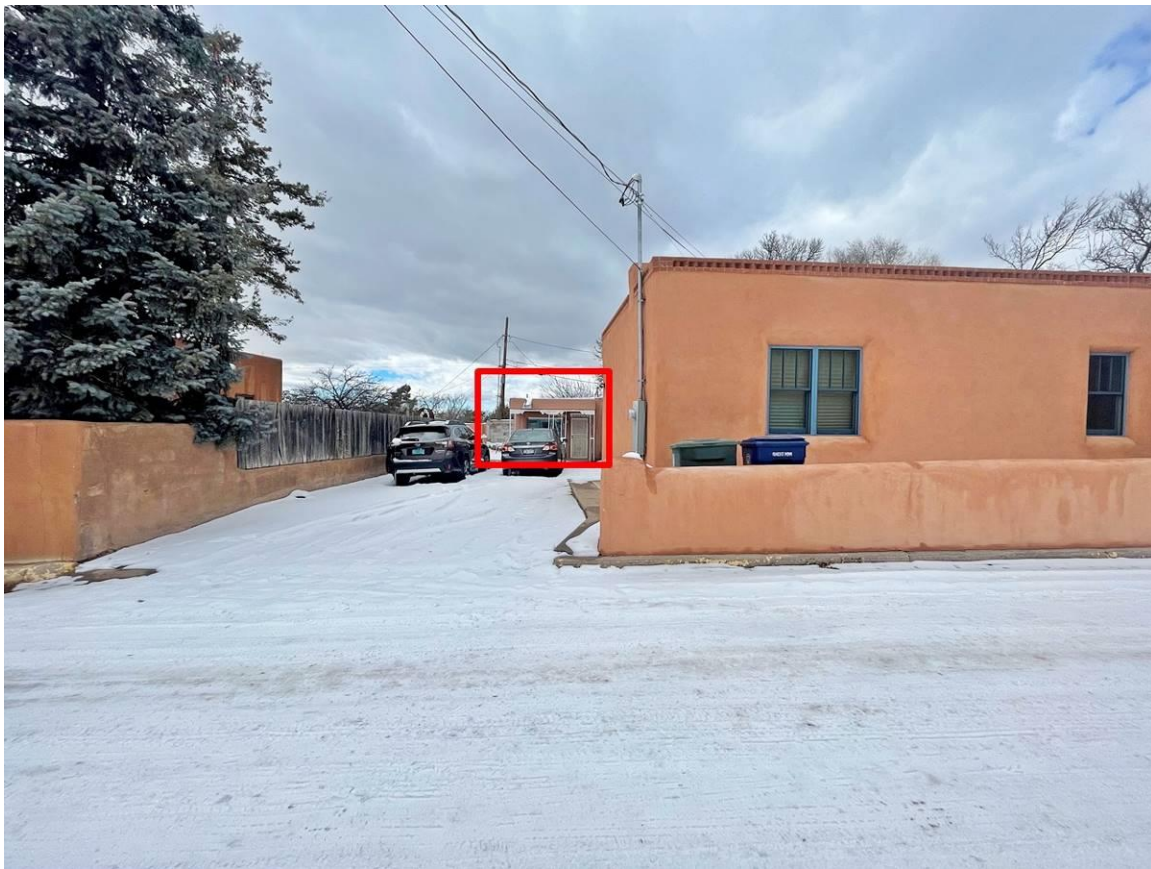
| 11. Brief Description of the Property: The house sits behind the Alberto and Anastacia Rodriguez de Romero home (1030) at the bottom of West Houghton Street in the Don Gaspar Area Historic District and is designated Non-Contributing. While close (15' distance) to the older home and historically connected to that dwelling, it sits on its own parcel. The current property owner owns both lots. The small, rectangular subject parcel includes the house and an adjacent storage building. The southern portion of the house is partially visible from the street, approximately 60' west of its centerline (Photo 2). <i>Continued on Page 5.</i> | | |

Photo 2: View from street. Subject house highlighted. Camera facing west.

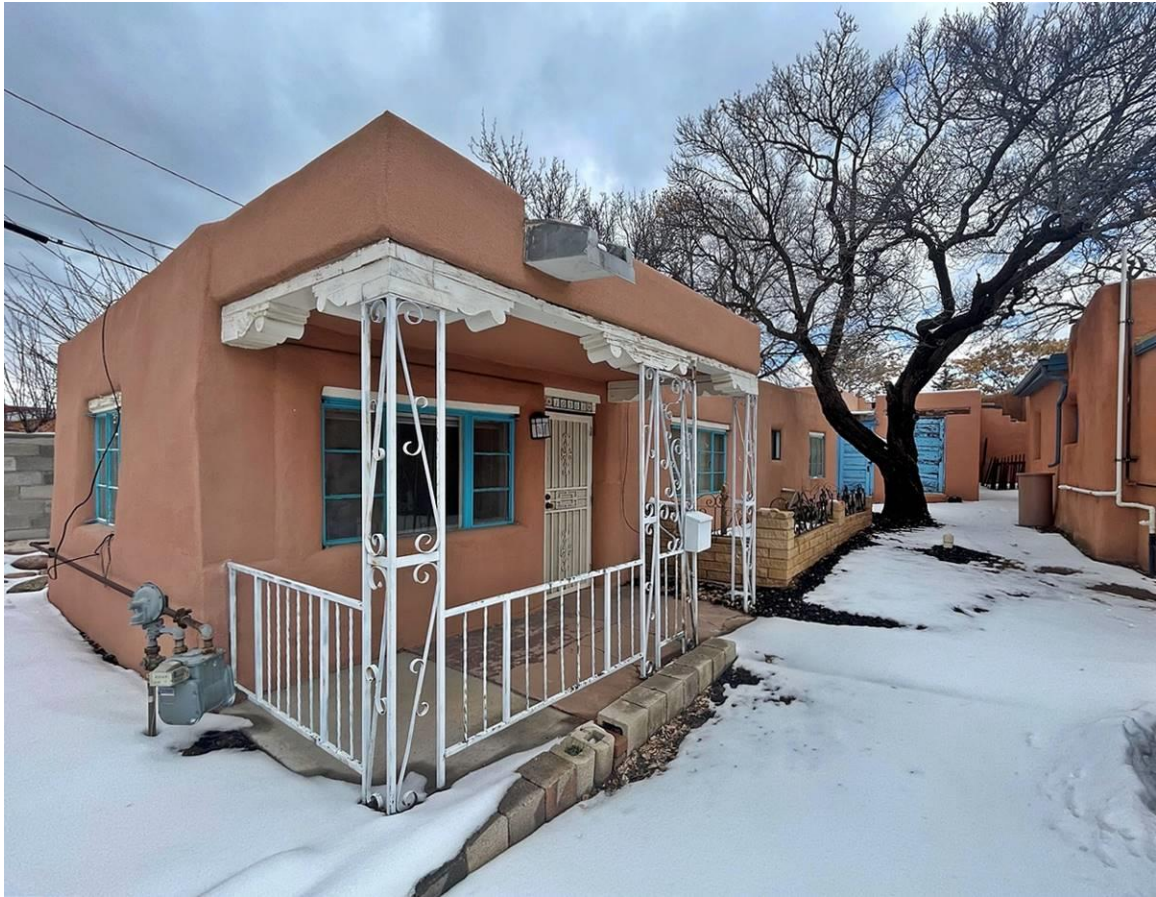
The east elevation faces the driveway with a porch that is of a different height (Photo 3). Panels of wrought-iron balustrade hold the 66-square-foot structure. Its floor is concrete; the ceiling is finished with stucco (Photo 4).

Photo 3: House. South and east elevations. Camera facing northwest.

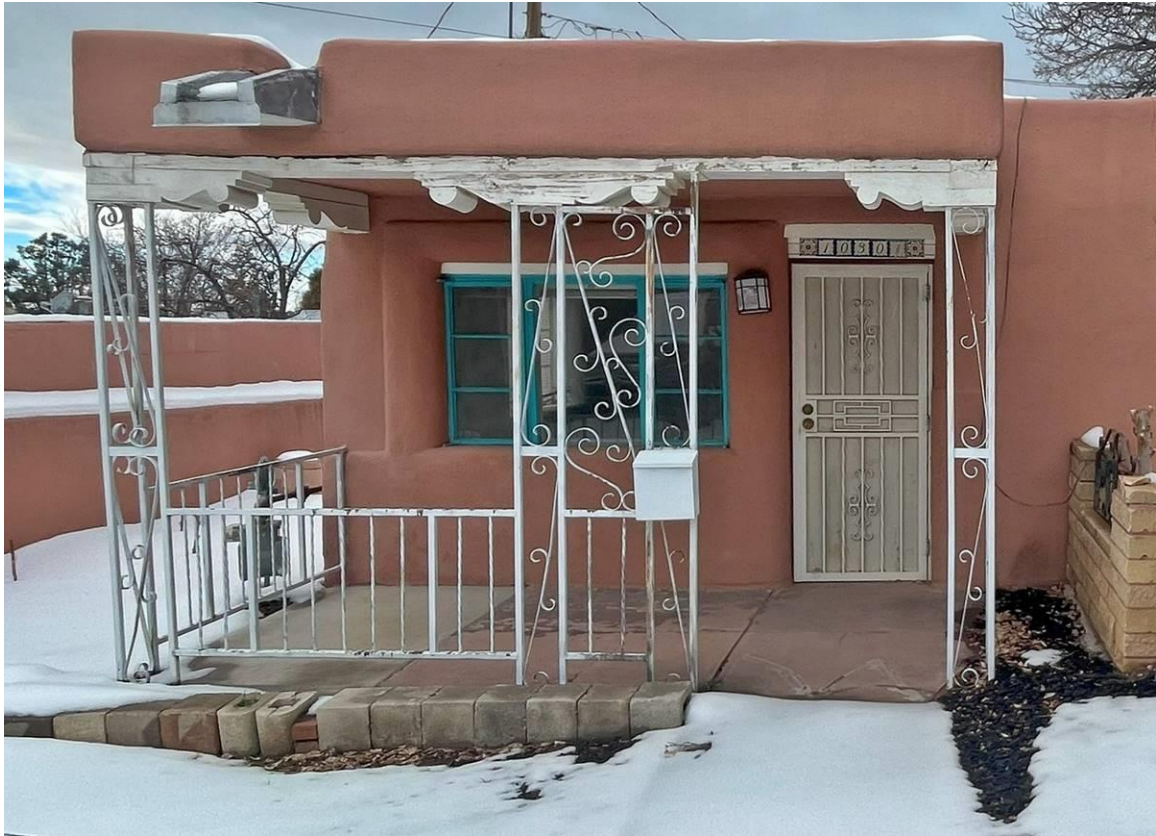
Photo 4: East elevation, porch. Camera facing west.

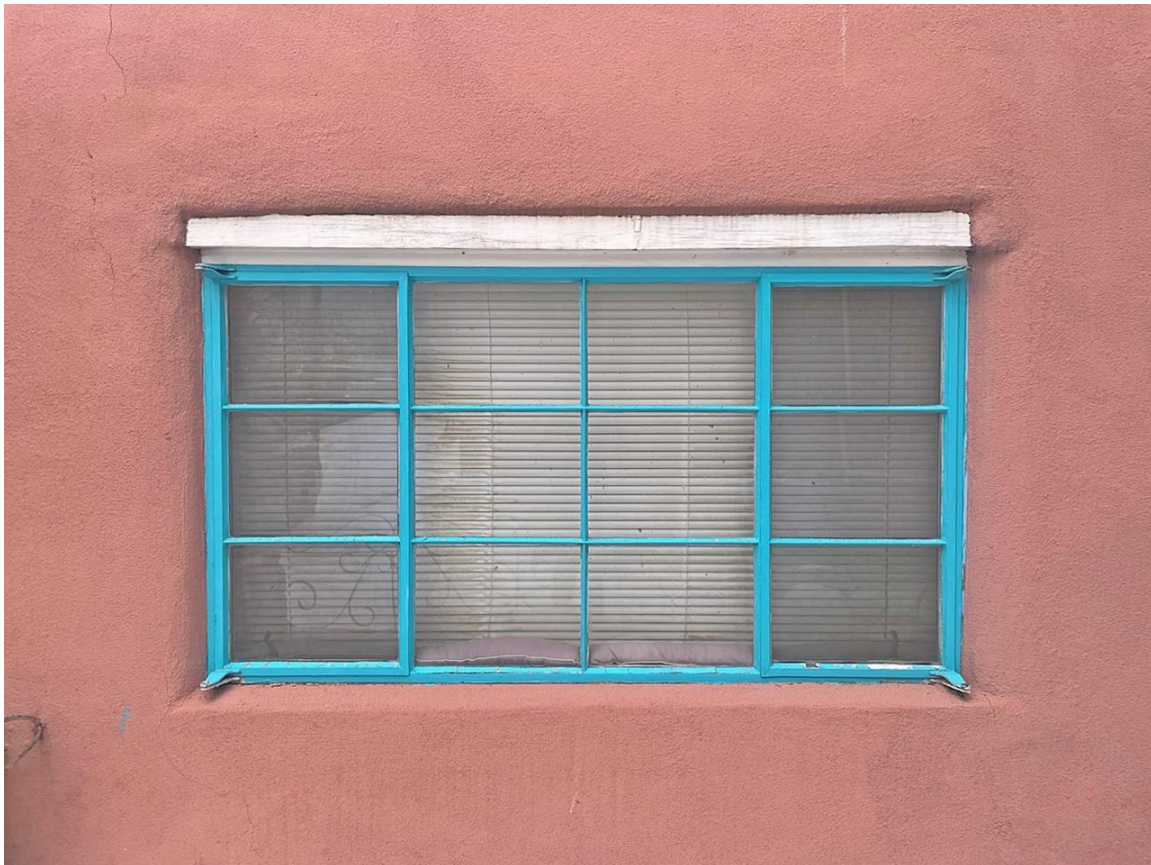
The elevation moves northward with another steel combination window at the bedroom (Photo 5), followed by a newer aluminum sliding unit at the bathroom and a steel window daylighting the kitchen (Photo 6).

Photo 5: East elevation, bedroom window. Camera facing west.

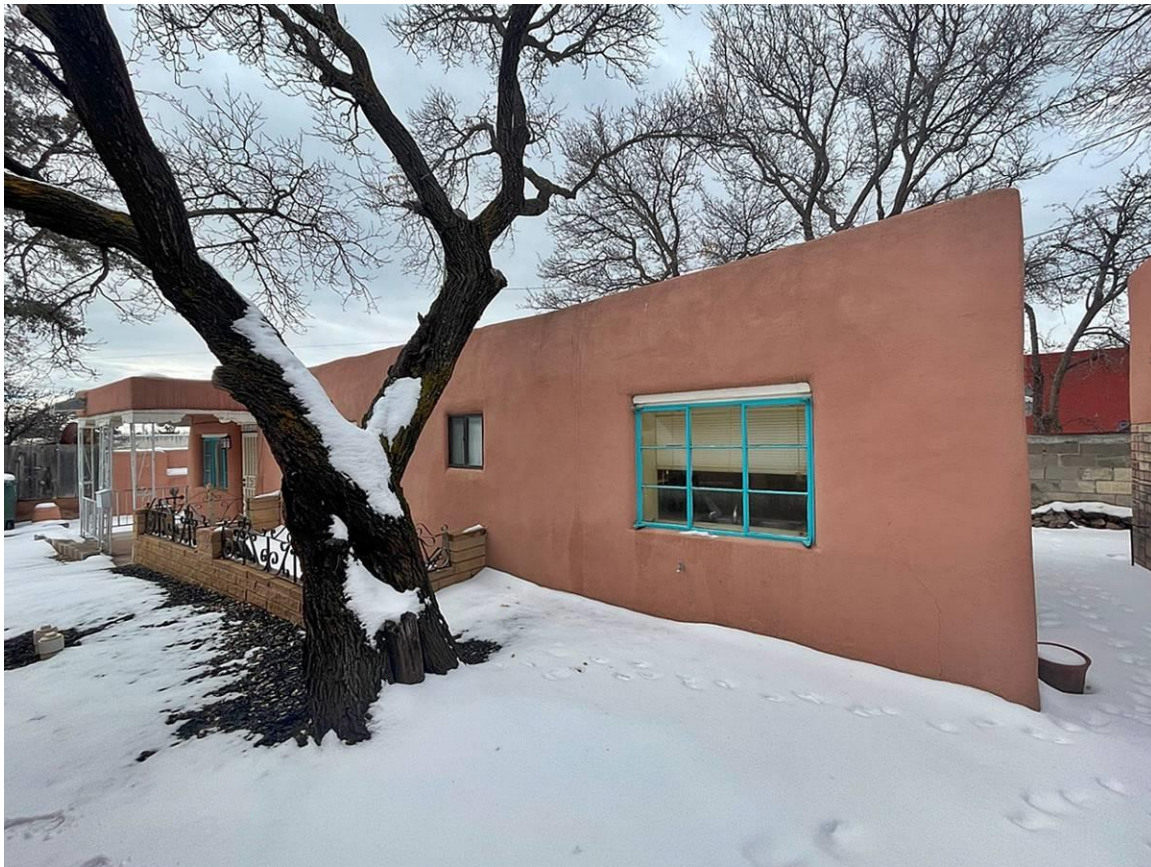
Photo 6: East elevation. Camera facing southwest.

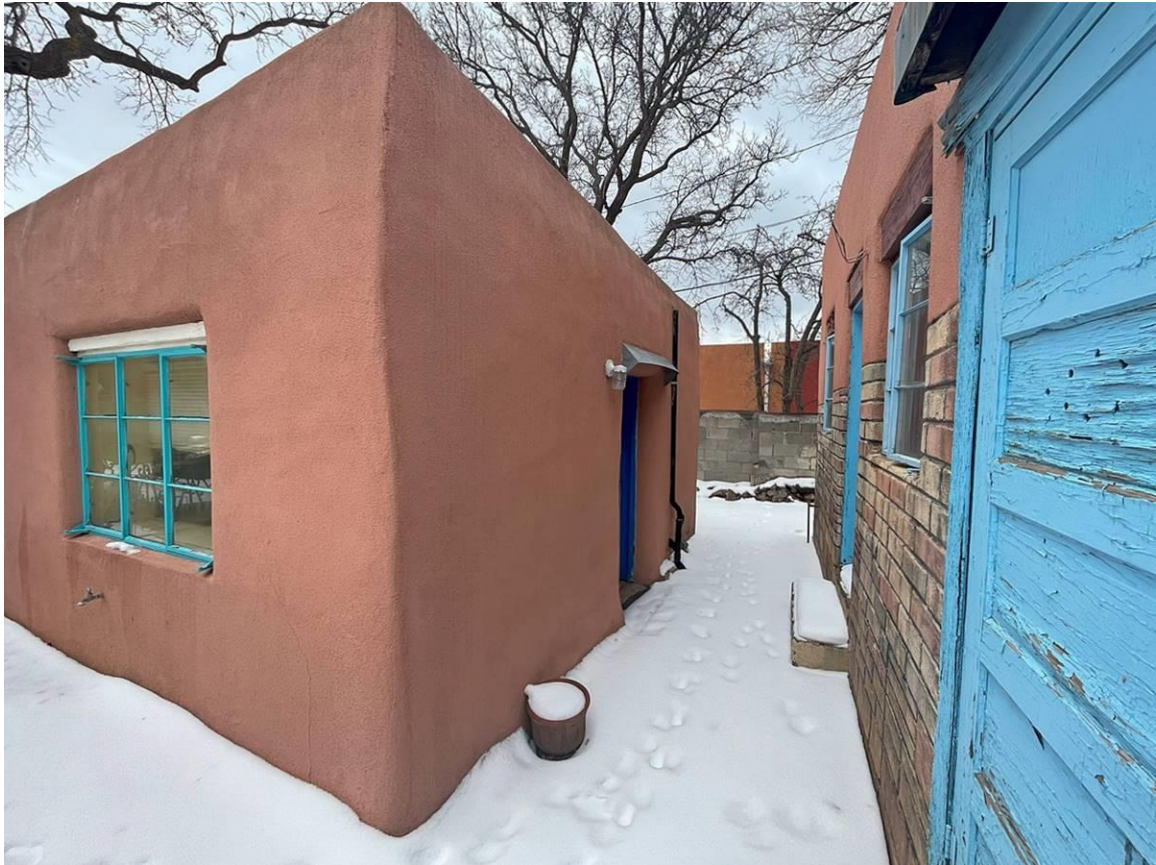
The north side of the building creates a narrow passage between the dwelling and the storage building (Photo 7). The primarily solid wall has an opening near the center holding a door. The ½-light wood panel door leads to the kitchen and appears original.

Photo 7: East and north elevations. Camera facing southwest.

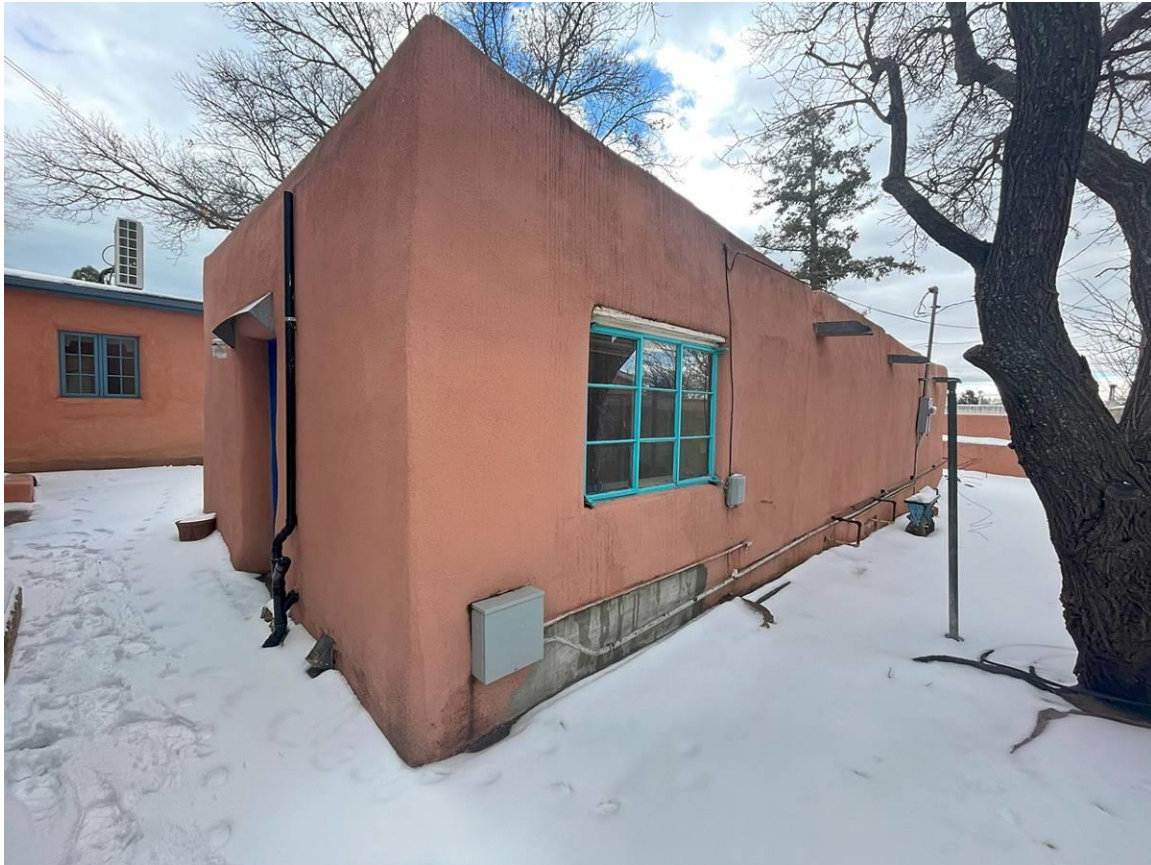
The west elevation, looking upon a block wall, is the utilitarian side of the home. The roof drains over this side through three galvanized gutters; electrical and gas lines run along its base (Photos 9). The elevation contains one window — a steel combination unit at the kitchen.

Photo 9: North and west elevations. Camera facing southeast.

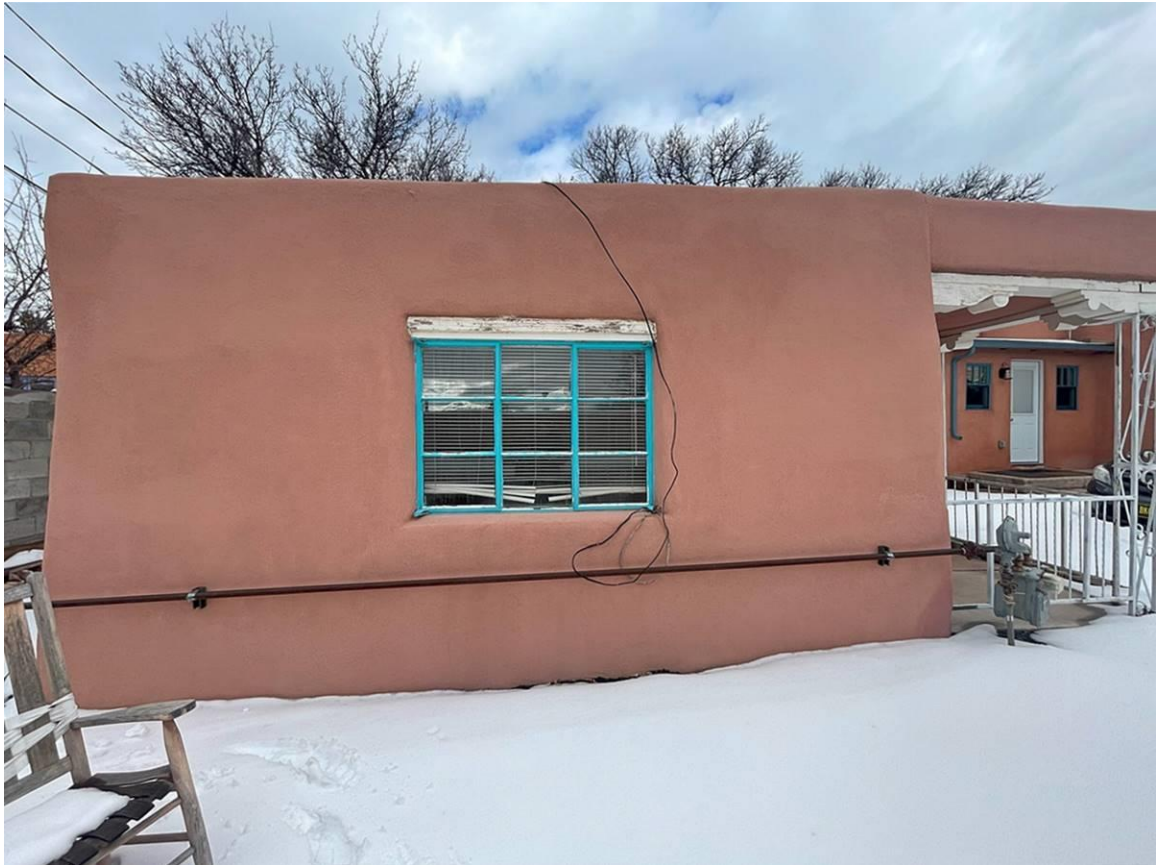
This elevation works as the south living room wall and contains one window. Like the others, it is a standard steel combination unit topped with a wood block lintel (Photo 10). While most of the building has crisp lines, there is a lumpy quality to this elevation and the southwest corner, characteristic of adobe construction (Photo 11).

Photo 10: South elevation. Camera facing north.

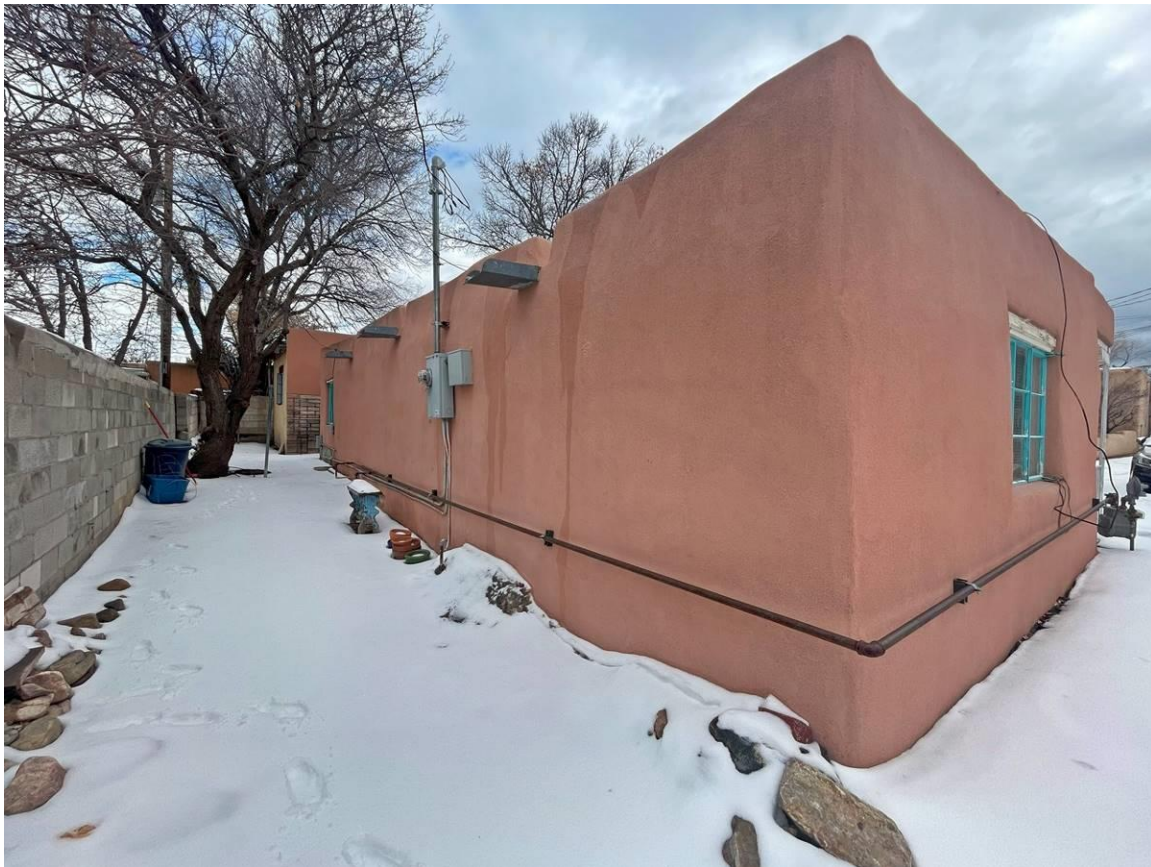
Photo 11: West and south elevations. Camera facing northeast.

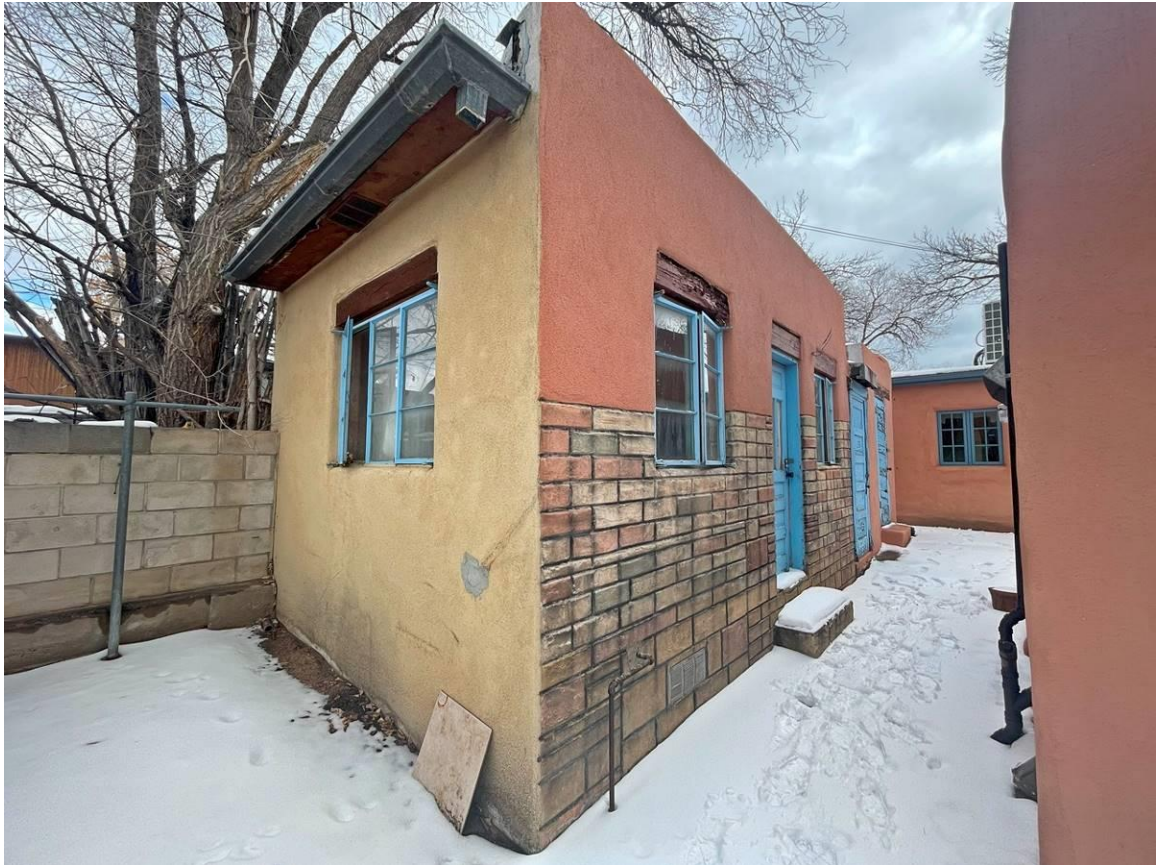
with a five-panel door. The west end of the building has a combination steel window (Photo 13); the east has a 6-light barn sash (Photo 14).

Photo 13: West and south elevations. Camera facing northeast.

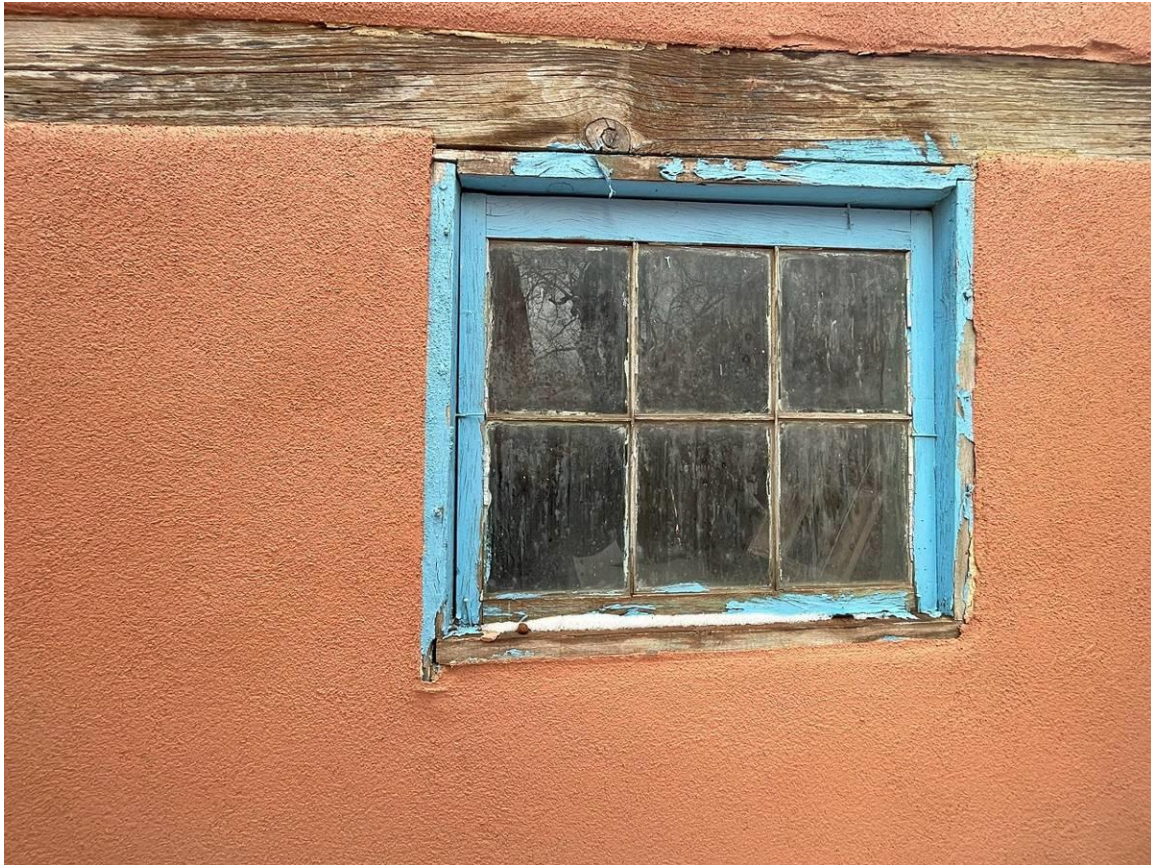
Photo 14: East elevation. Camera facing northwest.
