Historic Cultural Properties Inventory (HCPI) Base Form (FORM 1)

For HPD Office use only: HCPI No. _____ District No. _____ NRHP _____ SRCP _____ Criteria <u> </u> A <u> </u> B <u> </u> C <u> </u> D		
1. Name of property: Rosina Chavez House	2. Location: 423 A West San Francisco Street Downtown and Eastside Historic District Santa Fe	3. Local Reference Number: Santa Fe ID: N/A 4. County: Santa Fe Parcel # 10468150

6. Date of Survey: February 27, 2025		
7. Previous Survey Date(s): <input type="checkbox"/> Yes: No: <input checked="" type="checkbox"/>		
8. Name of Project: HDRB Status Evaluation

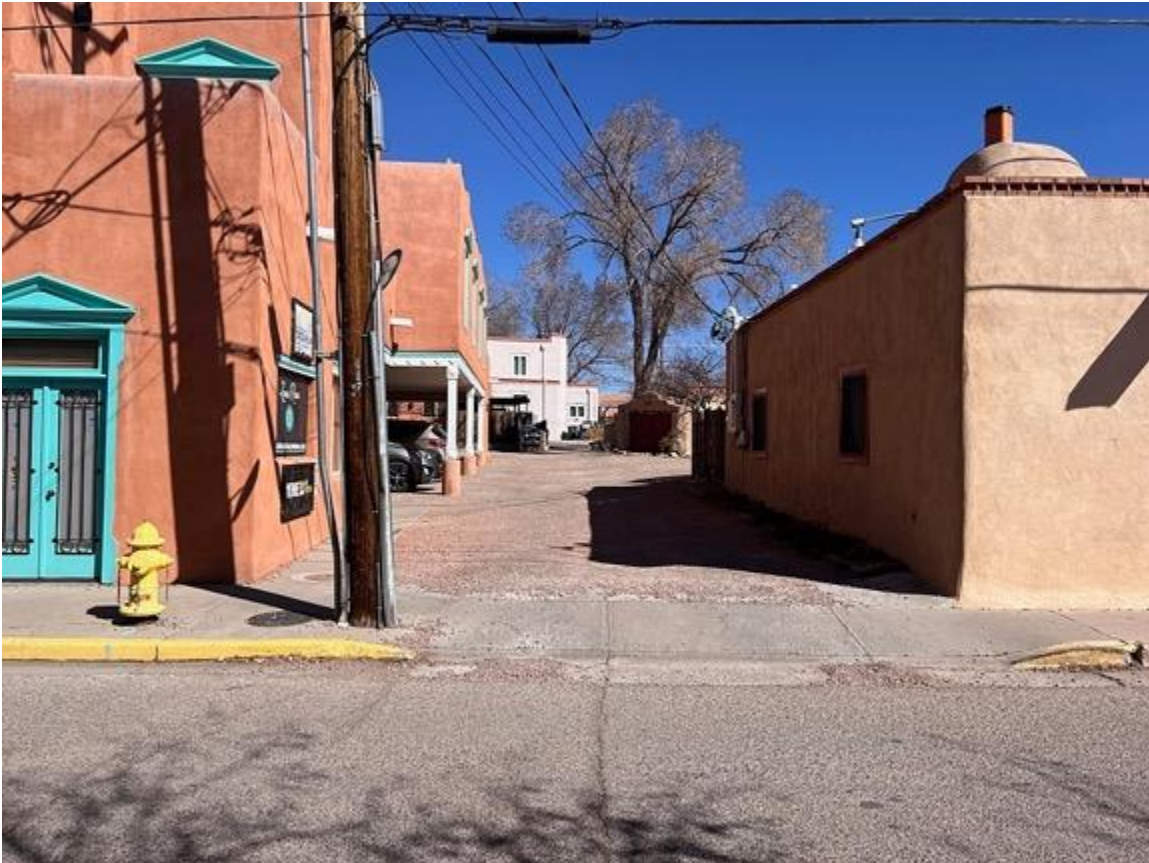
The subject building, recognized in this survey as the Rosina Chavez House (Fig. 1) is located on the north side of West Santa Francisco Street, near its intersection with North Guadalupe Street. It is situated down a 170' long gravel driveway and is out of view (Photo 2). It is surrounded by a mix of buildings that are both historic and modern. Some of these tie directly to its genealogy; others are recent and removed contextual buildings associated with the house.

Photo 2: View down entry drive. Subject property not visible. Camera facing north.

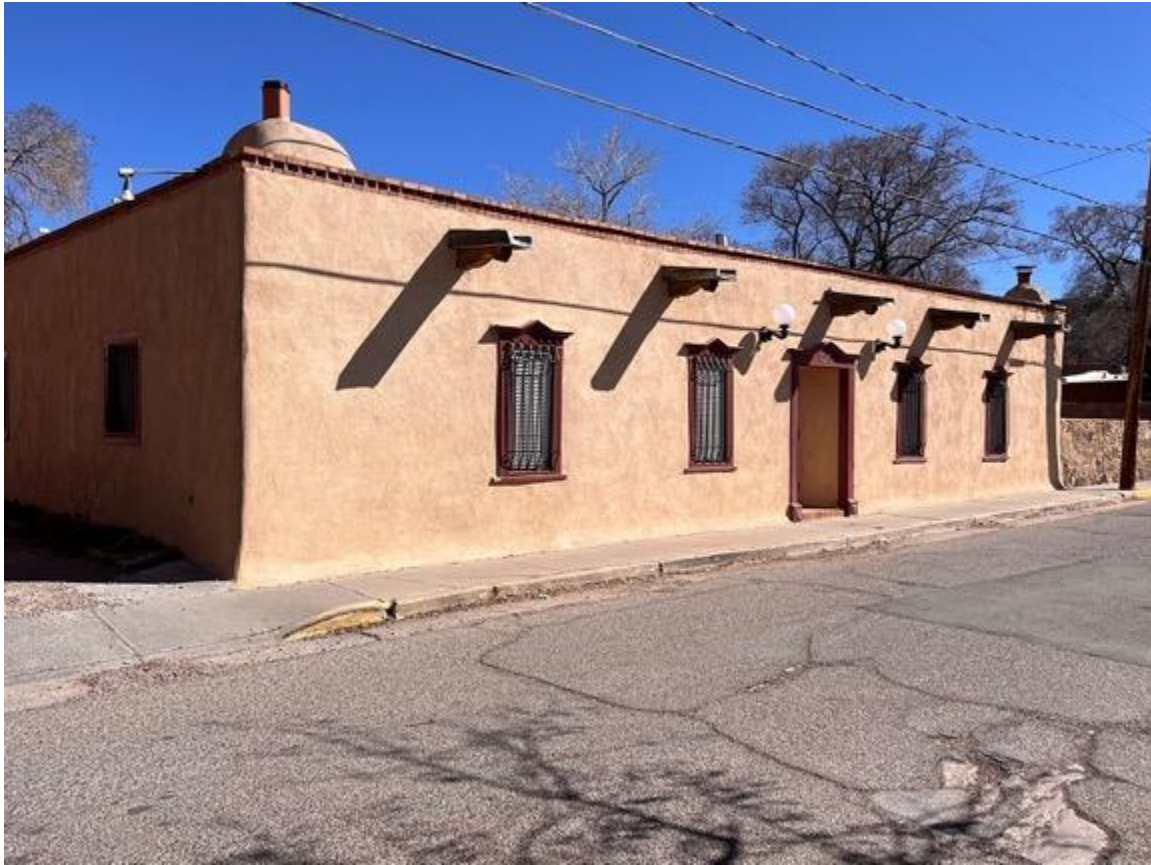
Starting at the street is the renovated Erwin residence, which is contemporaneous with the core block of the subject dwelling, but altered (Photo 3). Further down the driveway on the right (east) is a line of apartments constructed in the 1940s (Photo 4). On the left (west) are modern buildings operated by Zona Rosa Vacation Rentals. At the end of the driveway is a recent structure that destroyed the original Trinidad Chavez house, which was historically part of the subject property.

Photo 3: Altered former Erwin House, also attributed as the Trinidad Chavez House, although this does not appear to be accurate. Camera facing northeast.

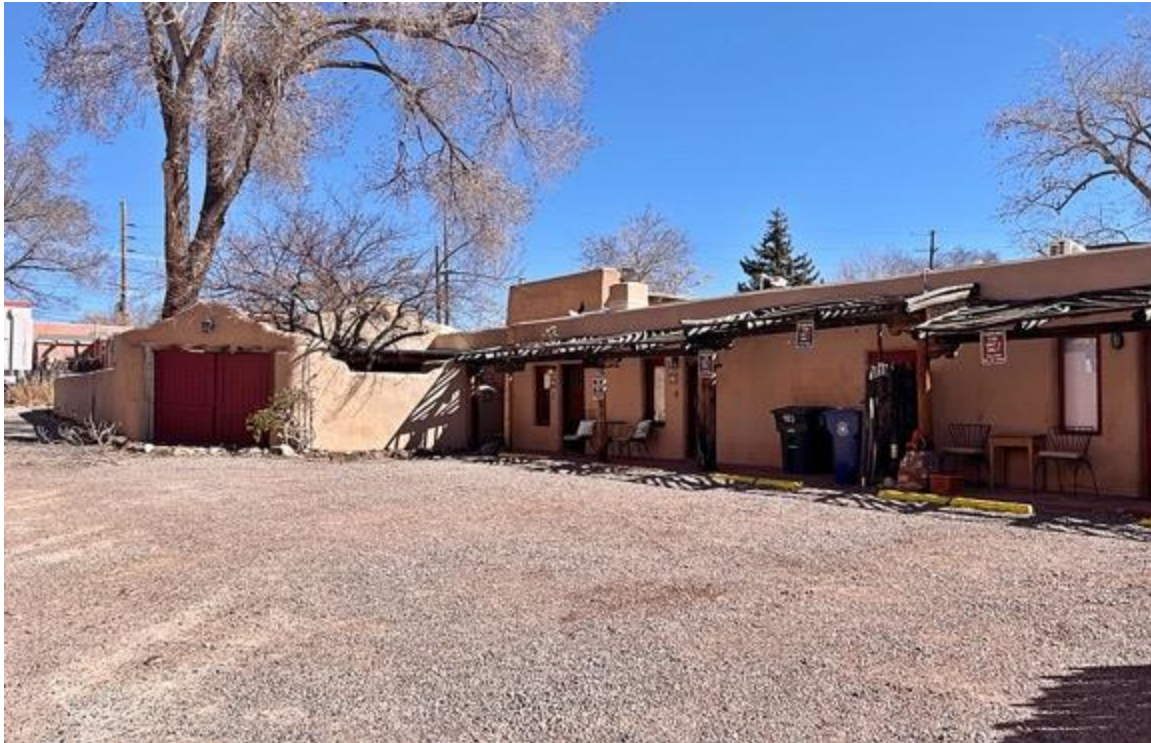
Photo 4: Residence and apartments constructed between 1930 and 1948. Camera facing northeast.

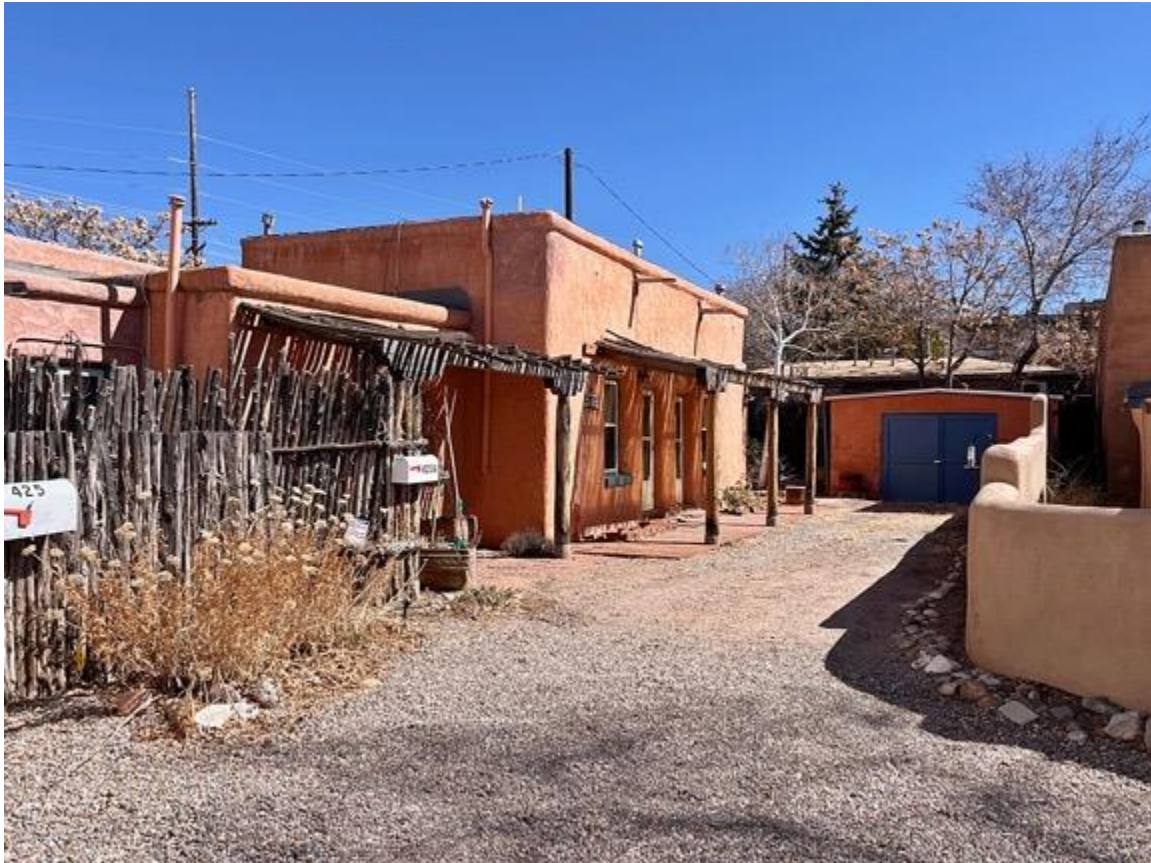
The subject building sits at the east end of the driveway along a narrow 0.08-acre parcel originally part of a larger lot fronting North Guadalupe Street (Photo 5). The building spans approximately 70' along the north lot line as a string of four volumes of different construction periods and materials. The oldest of these, Room 3, potentially dates to the 1880s and is the historical and most architecturally significant piece of the structure.

Photo 5: Subject property. Camera facing northeast.

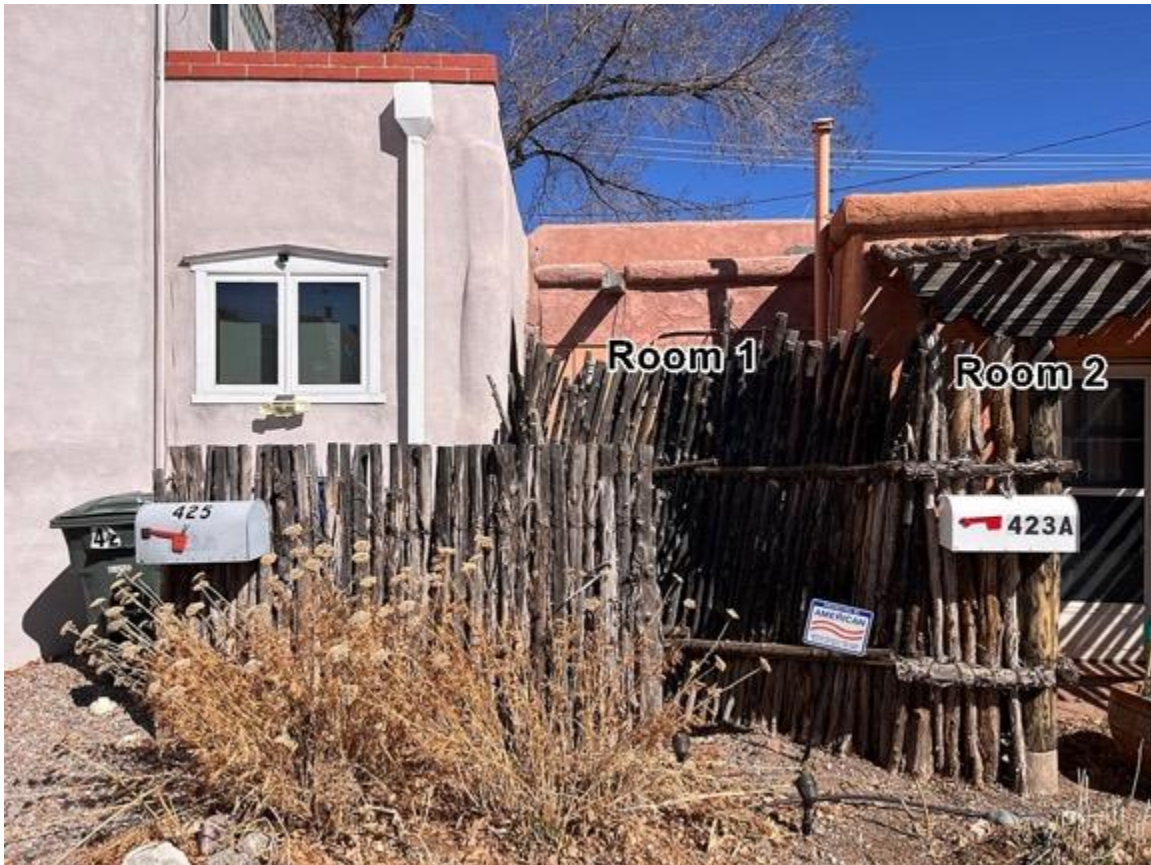
Photo 6: West end of subject building, holding Rooms 1 and 2. White building to the left, replaced the Trinidad Chavez House. Camera facing north.

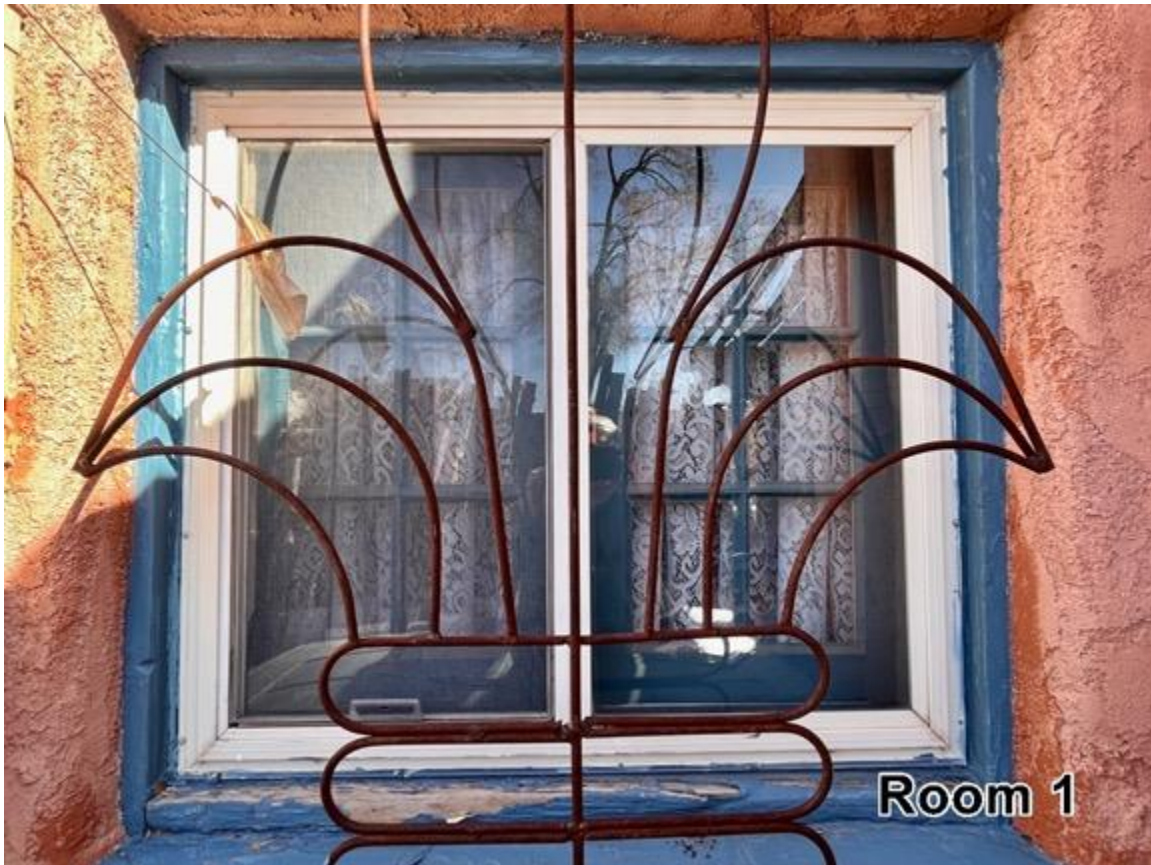
Photo 8: Room 1. Window. Camera facing north.

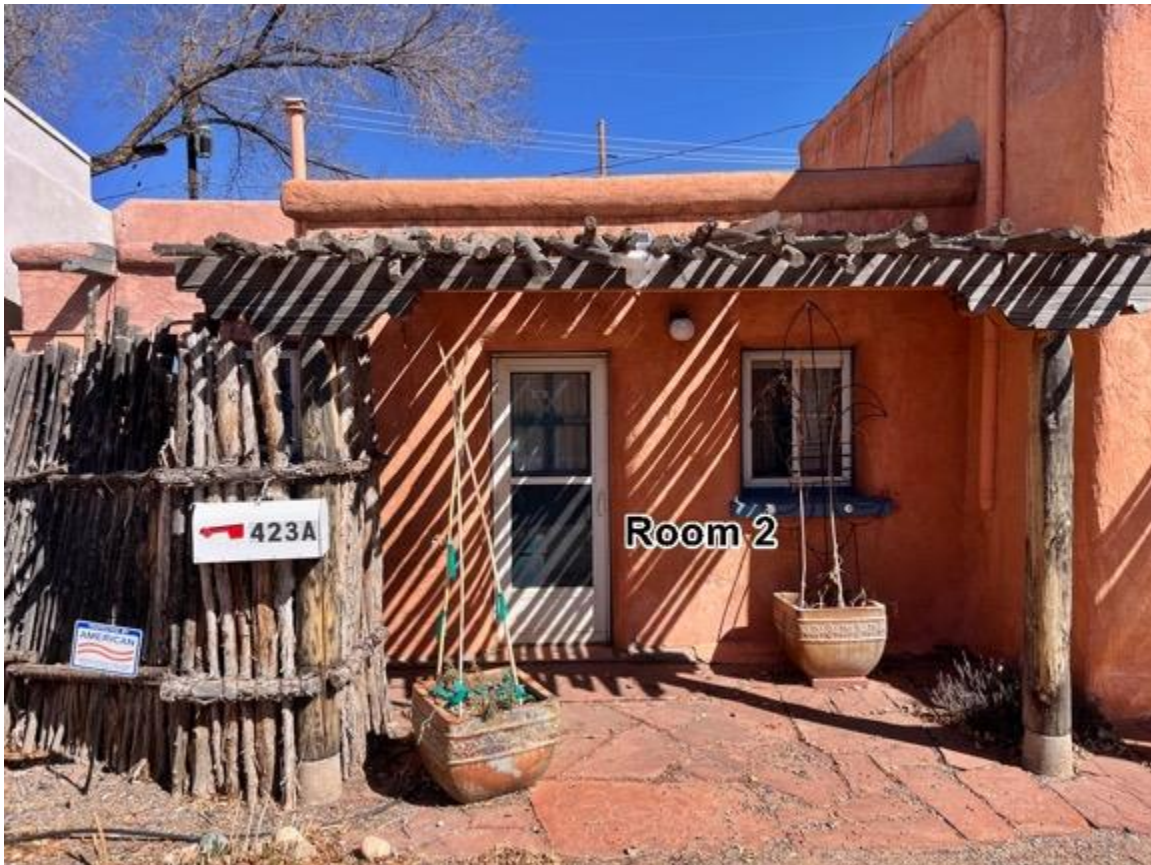
Photo 10: Room 2. Camera facing north.

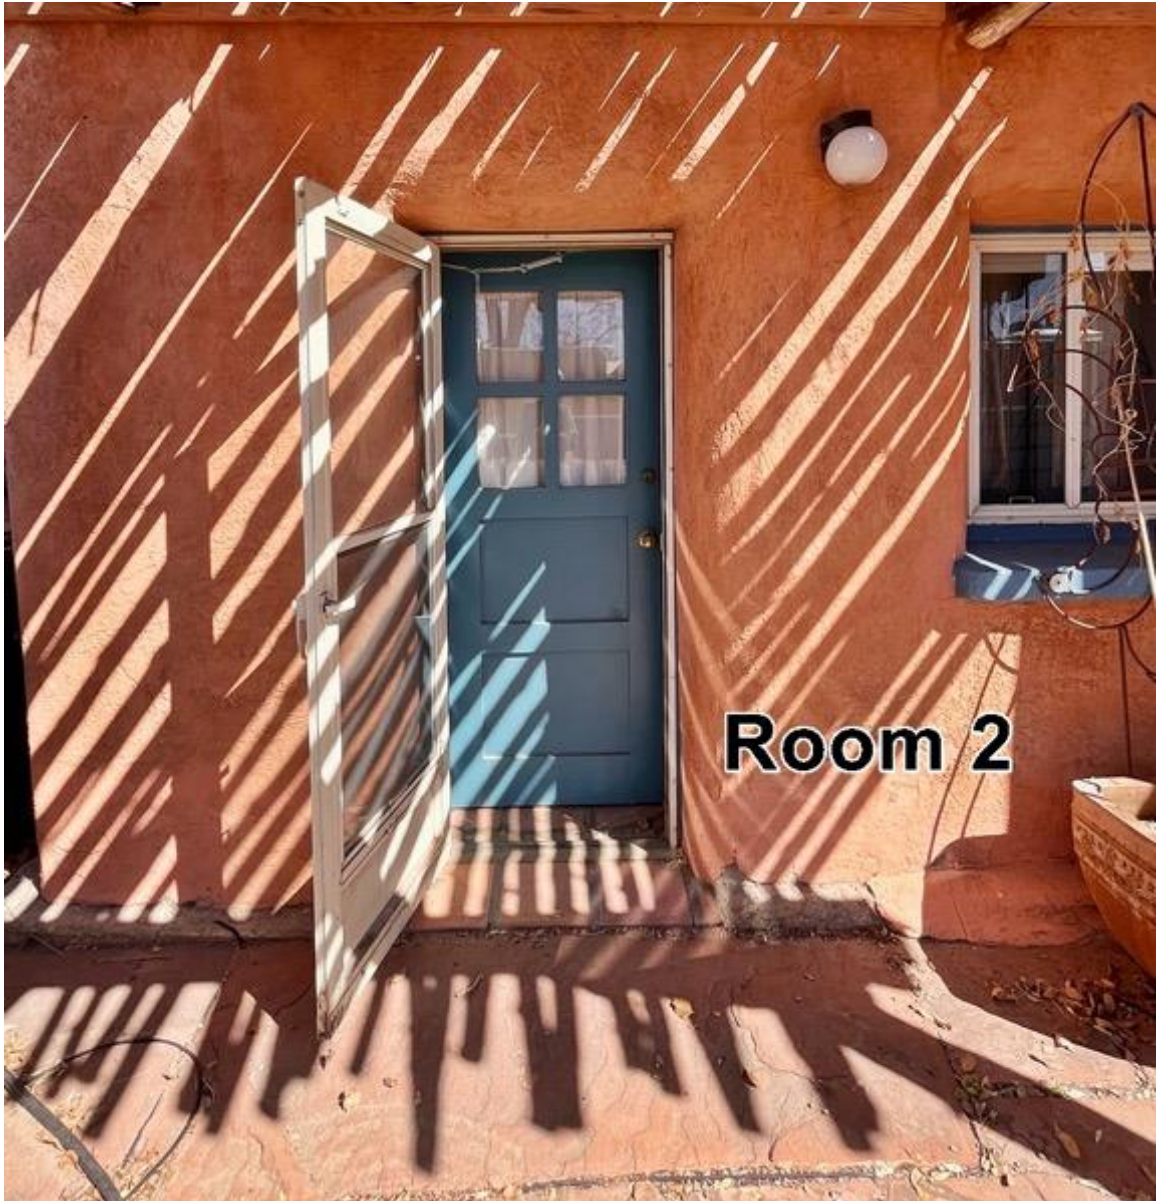
Photo 11: Room 2. Door and window. Camera facing north.

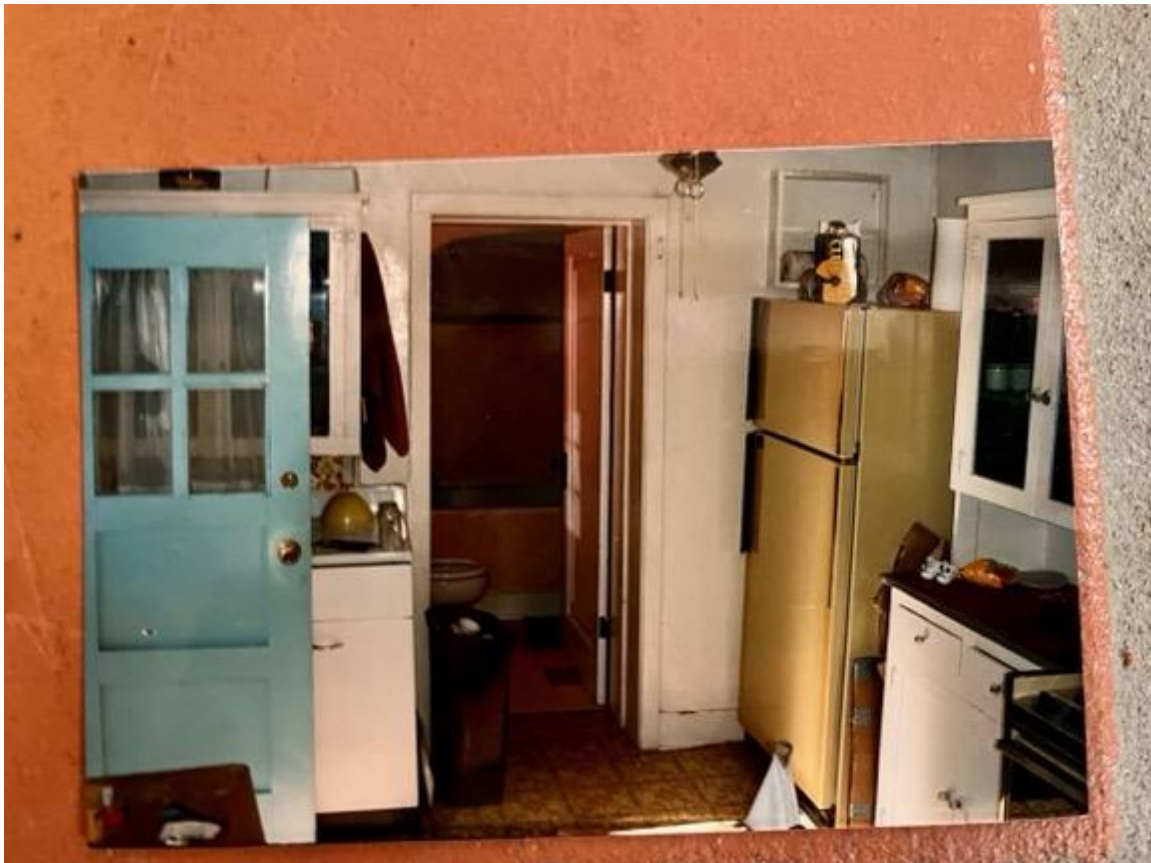
**Photo 12: Room 2. 1990s renovation photograph. Camera facing west.
 Courtesy of Heidi Cost.**

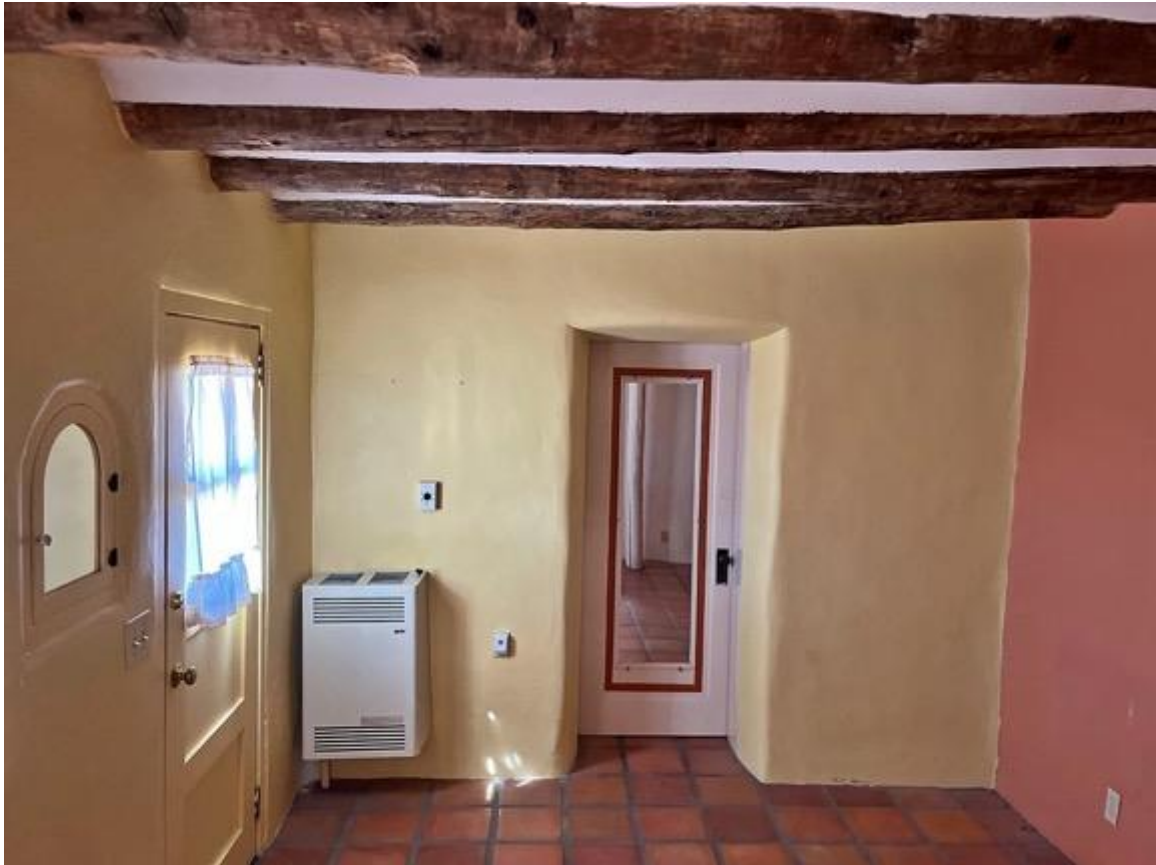
Photo 13: Room 2. Interior. Camera facing west.

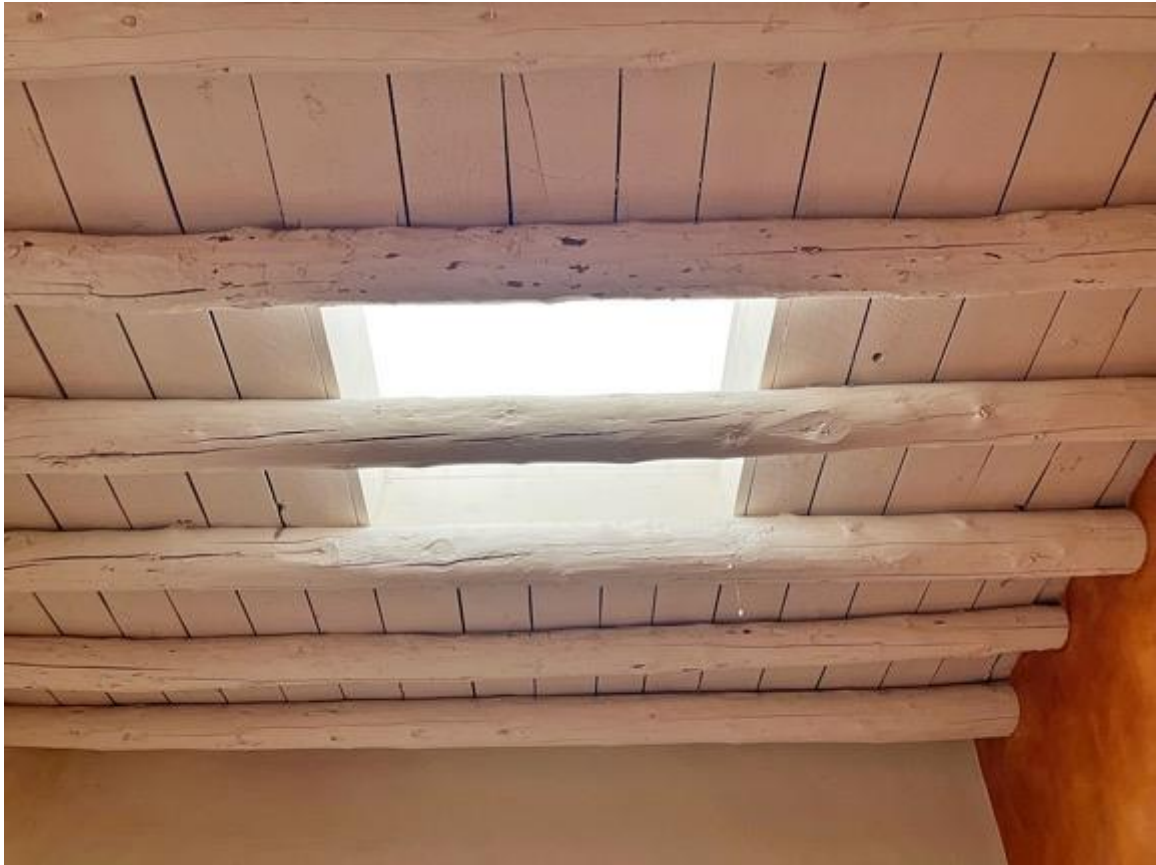
The renovation included removing the interior dividing wall and ceiling (Photo 21). The vigas and rough-sawn boards were painted white, and skylights were added to the roof, resulting in a light, airy, and anachronistic sala-like space (Photo 22). The flooring consists of 3½” wood strips that change color at the point where the core was divided into two rooms (Photo 23).

Photo 22: Room 3. Interior ceiling.

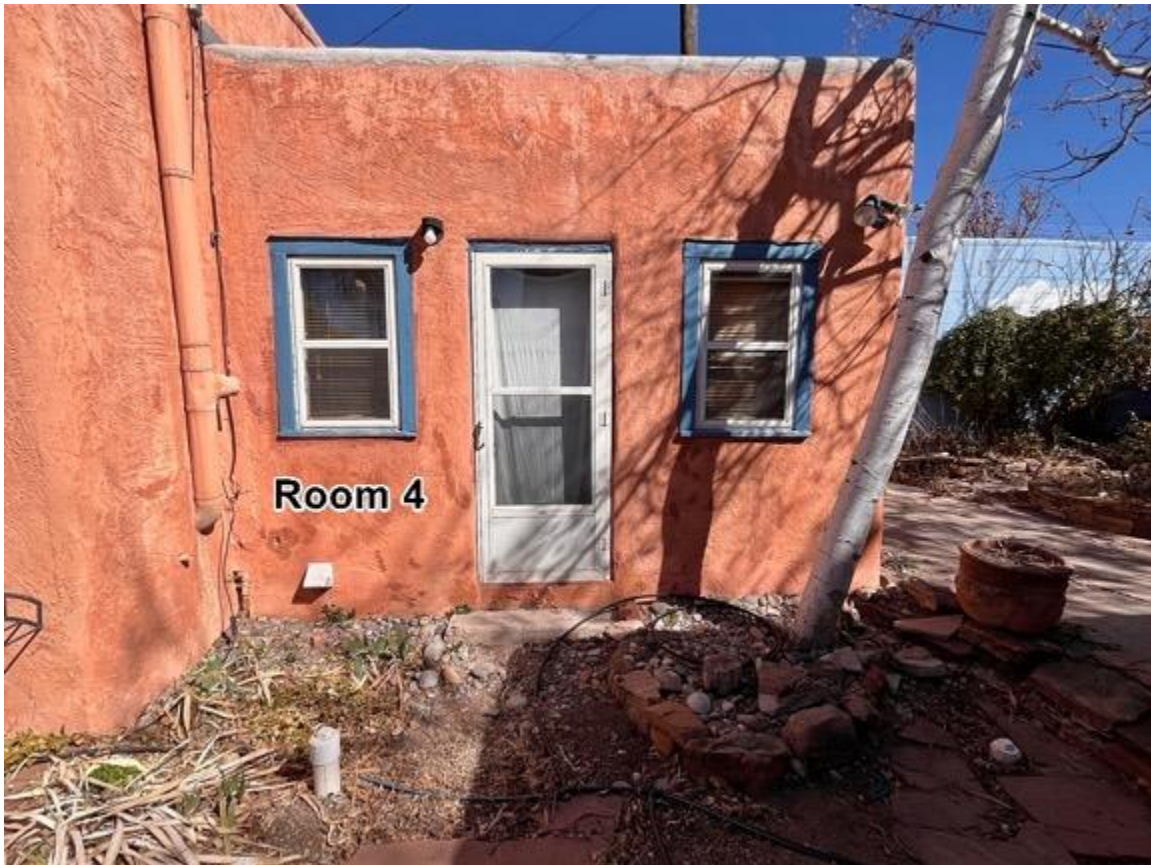
The last room is set back 40” from the core block and has a lower roof height (Photo 24). Constructed after 1948, the volume appears to be made of concrete blocks. The entrance to the outside is through an older four-light, three-panel wood door, which is flanked by 1/1 vinyl sash windows (Photos 24 & 25).

Photo 24: Room 4. Camera facing north.

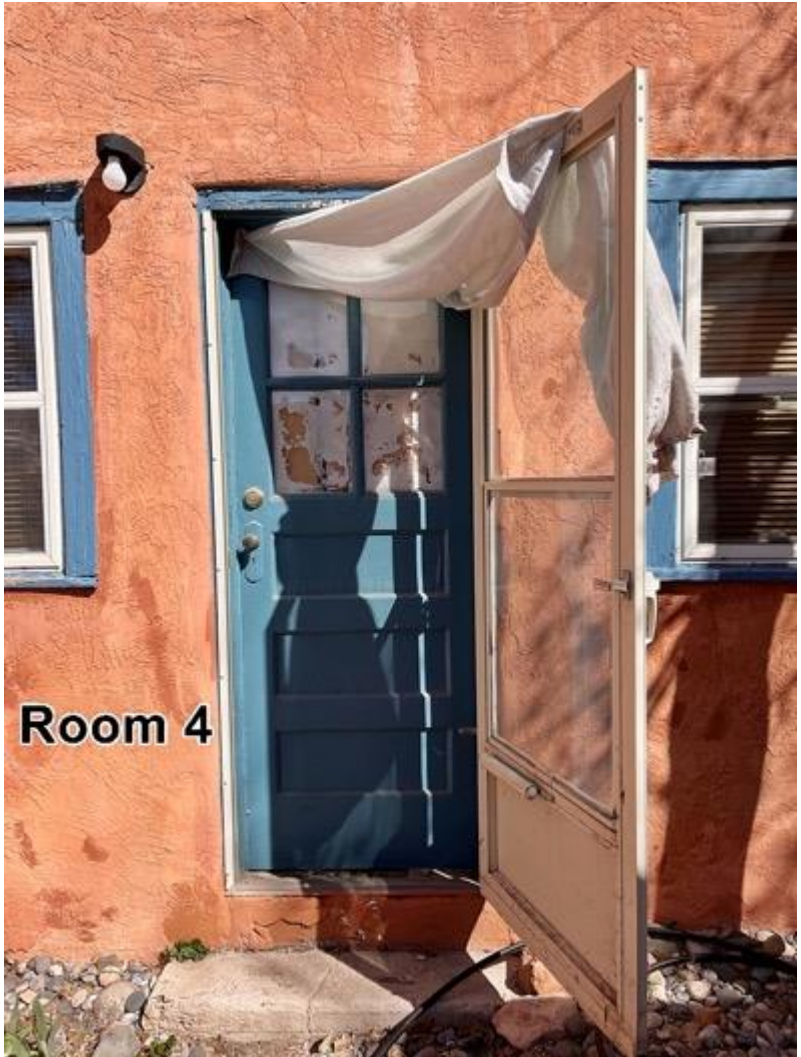
Photo 25: Room 4. Door. Camera facing north.

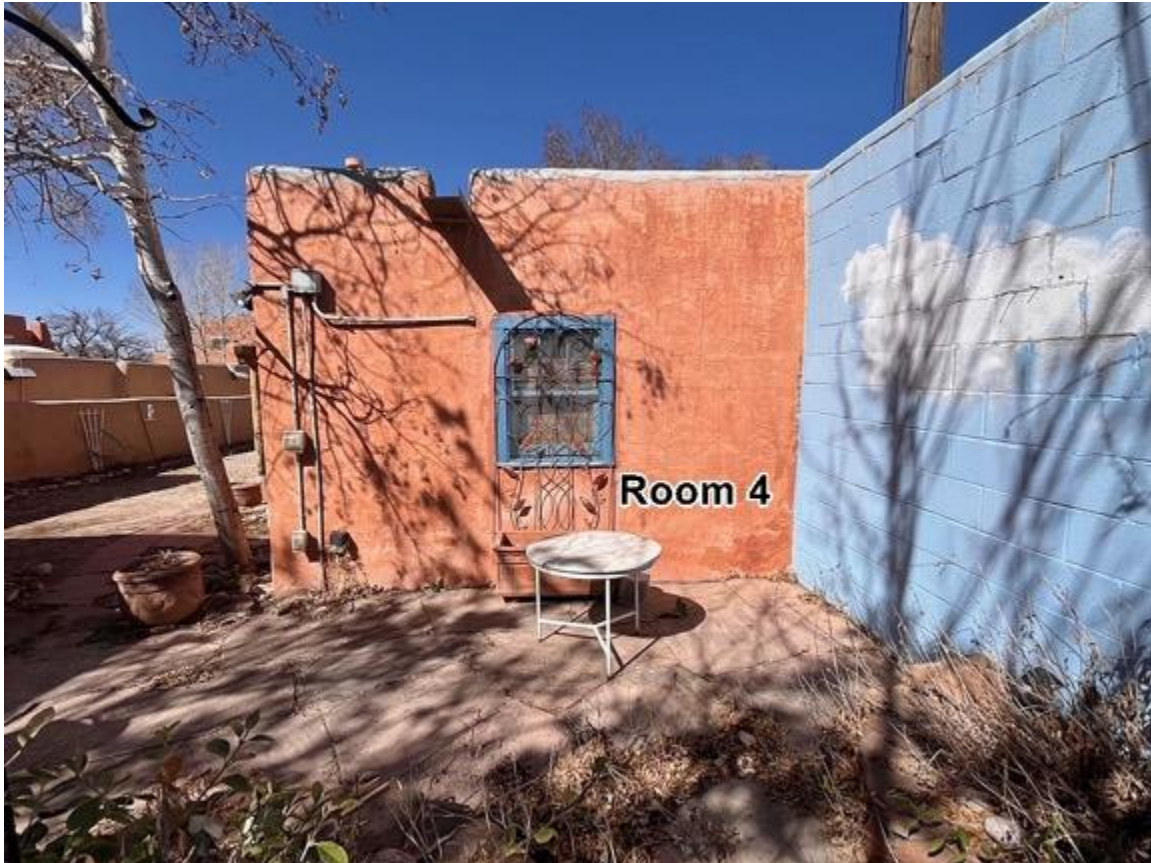
An additional opening on the east elevation contains a 3/1 wood-hung sash window (Photo 26). Both this window and the units on the south elevation are flush with the wall, indicating non-adobe block construction. Its single room measures approximately 114 square feet and has wide board flooring (Photo 27). The southeast corner of the room is occupied by a corner bathroom addition which takes up a significant portion of the space.

Photo 26: Room 4. East elevation. Camera facing west.

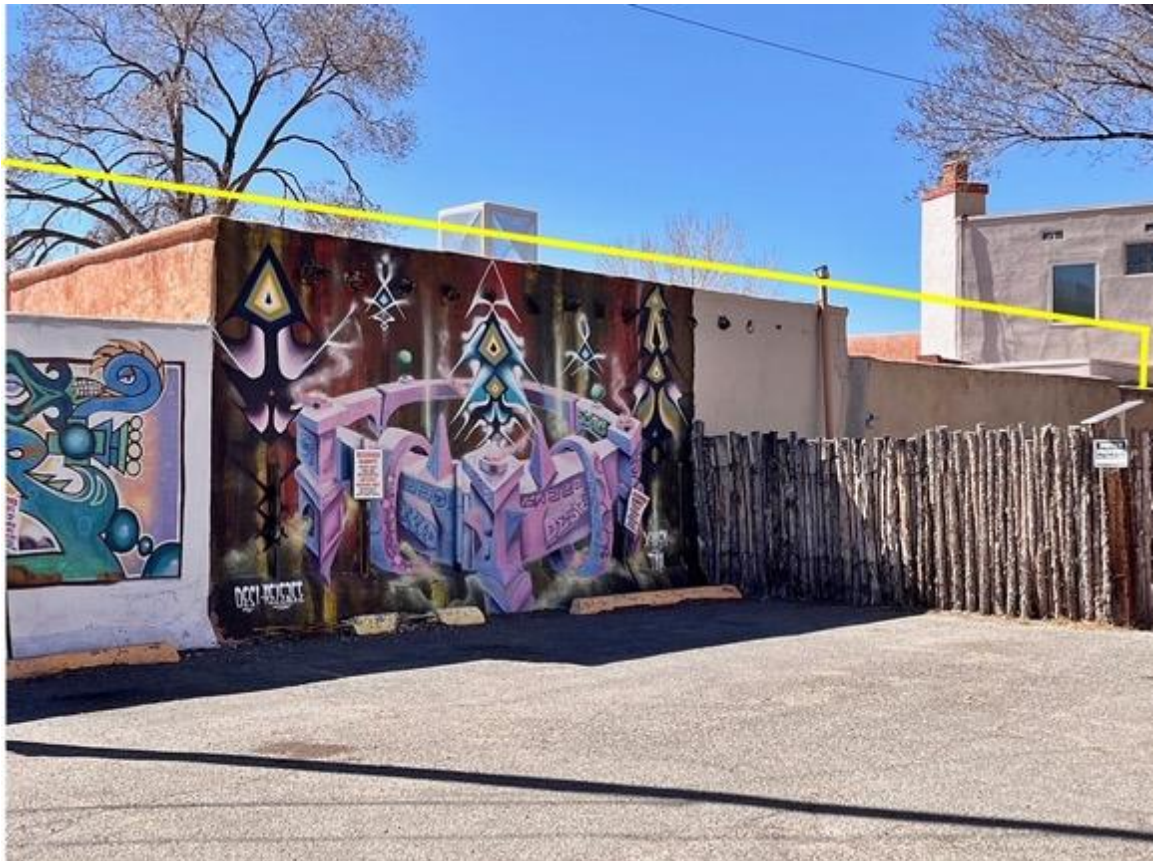
The back side of the building faces a parking lot associated with North Guadalupe Street (Photo 28). None of the rooms have openings on this façade. The exterior walls of Rooms 3 and 4 are covered with murals (Photos 28 & 29). The remaining elevation is a solid painted wall facing a private residence (Photo 30).

Photo 28: Subject building. North elevation at North Guadalupe Street parking lot. Camera facing southwest.

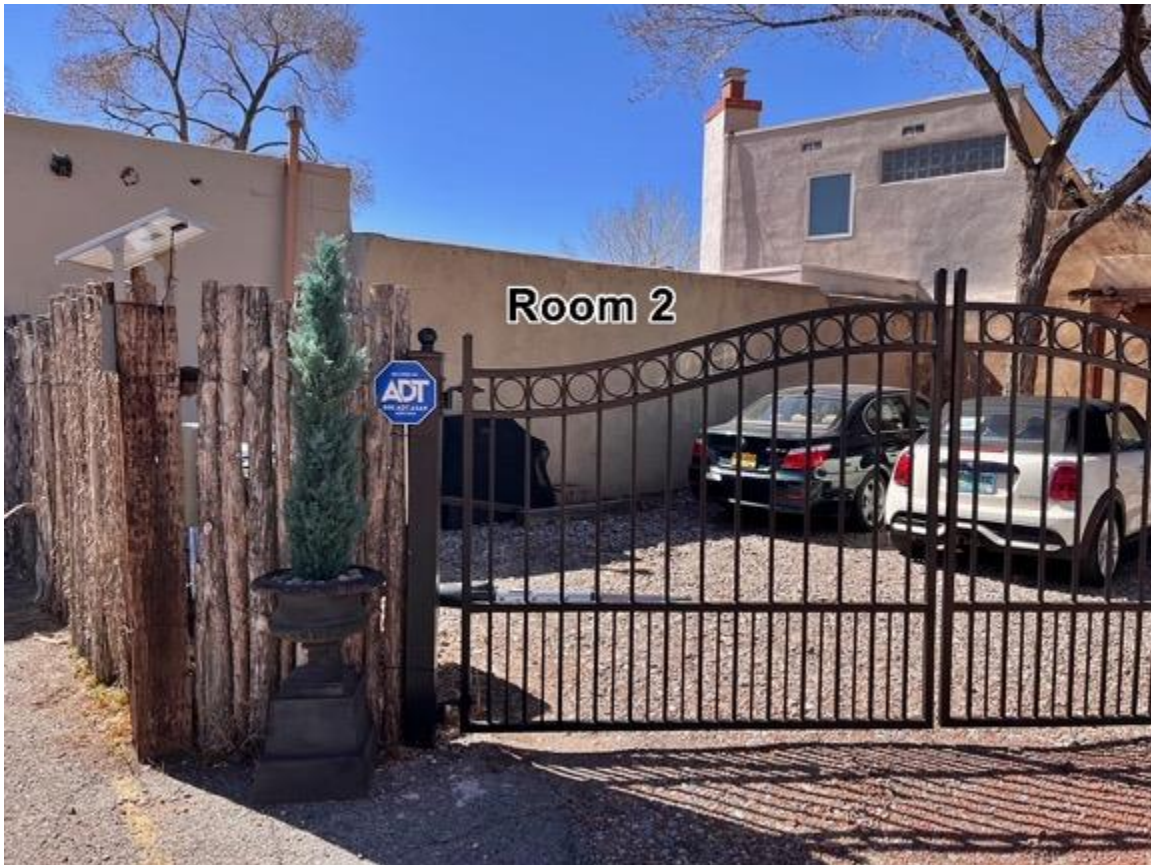
Photo 30: Room 2. North elevation. Camera facing southwest.

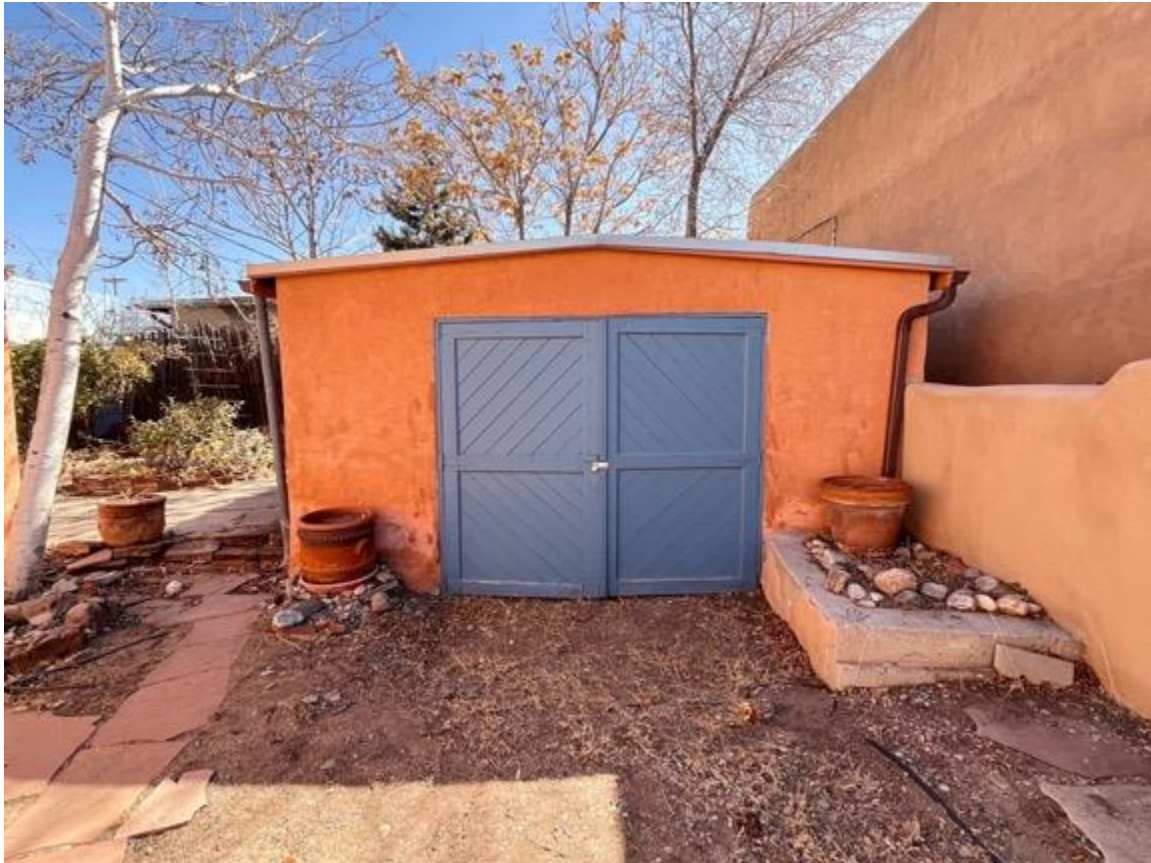
Squeezed into the southeast corner of the property is a garage that, based on Sanborn maps, was erected after 1948 (Photo 31). It faces west with a low-pitch gable roof and is partially dug into the ground. It has two 48 ½” wide, outward-swinging, screw-

Photo 31: Garage. West elevation. Camera facing east.

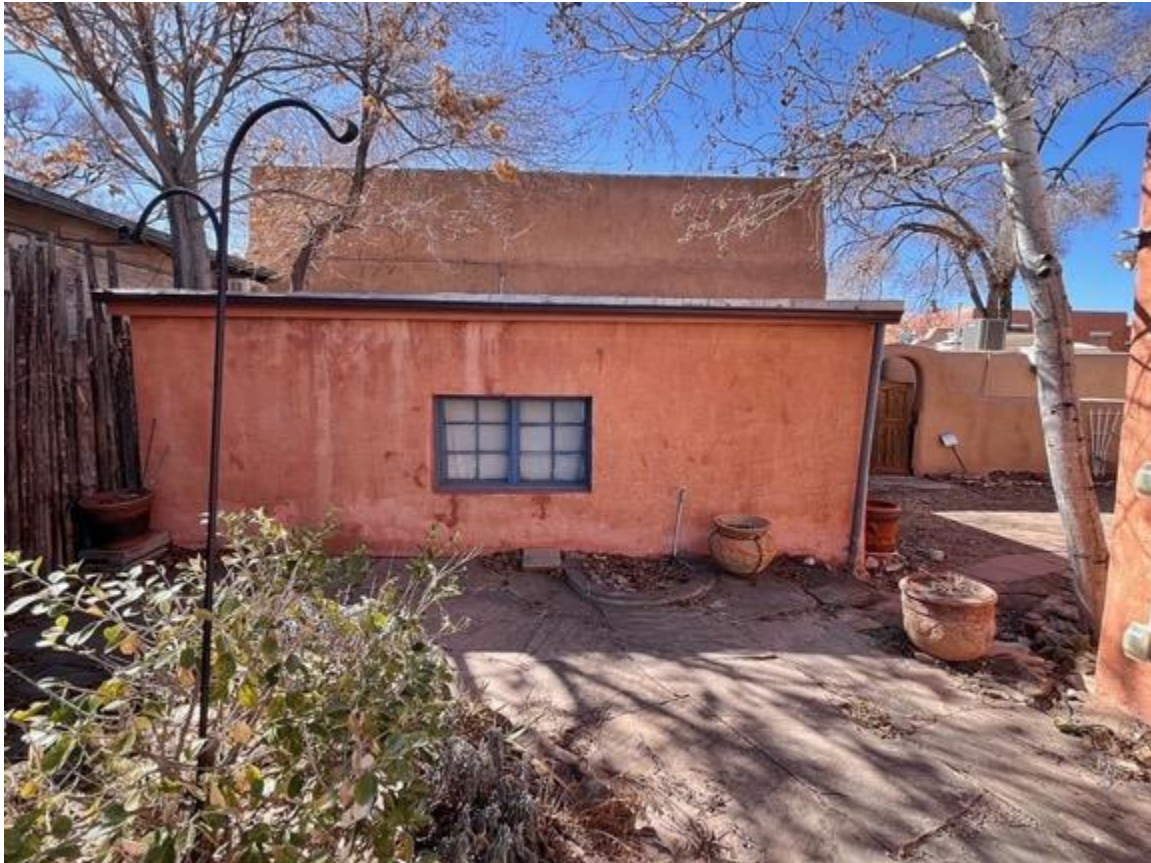
assembled wood doors at the front. There are two 6-light sash windows separated by a mullion on the north elevation (Photos 32 & 33).

Photo 32: Garage. North elevation. Camera facing south.

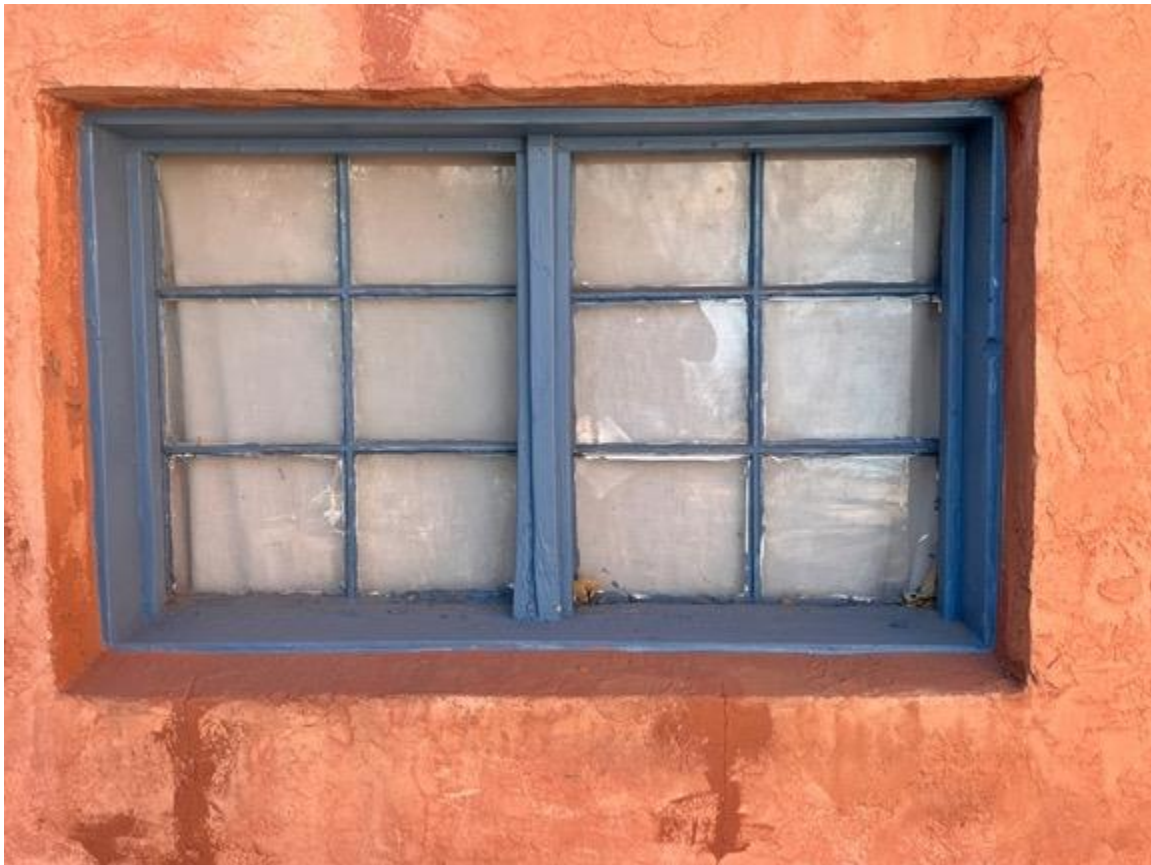
Photo 33: Garage. North elevation. Window. Camera facing south.
