HDRB PACKET  
423 A W. SAN FRANCISCO  
Ellen Yarrell

HISTORIC ASSESSMENT  
 NO. 120525-HA

**423 A West San Francisco Street  
 Canale Selection Summary**

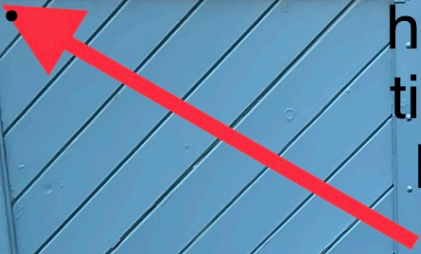
Garage  
West Elevation  
DR #5

Door # 5 on the garage is historic, however most of the wood pieces have been replaced during the 1990's.

This a router end corner on these doors and the router had not been used at this time of early construction Door was redone in the 1990's remodel
