RPA & Associates, LLC.

HISTORIC ASSESSMENT
NO. 050625-HA

JOB	DATE
433 CALLE LA PAZ – MAIN HOUSE, SANTA FE, NM 87505	06/05/2025

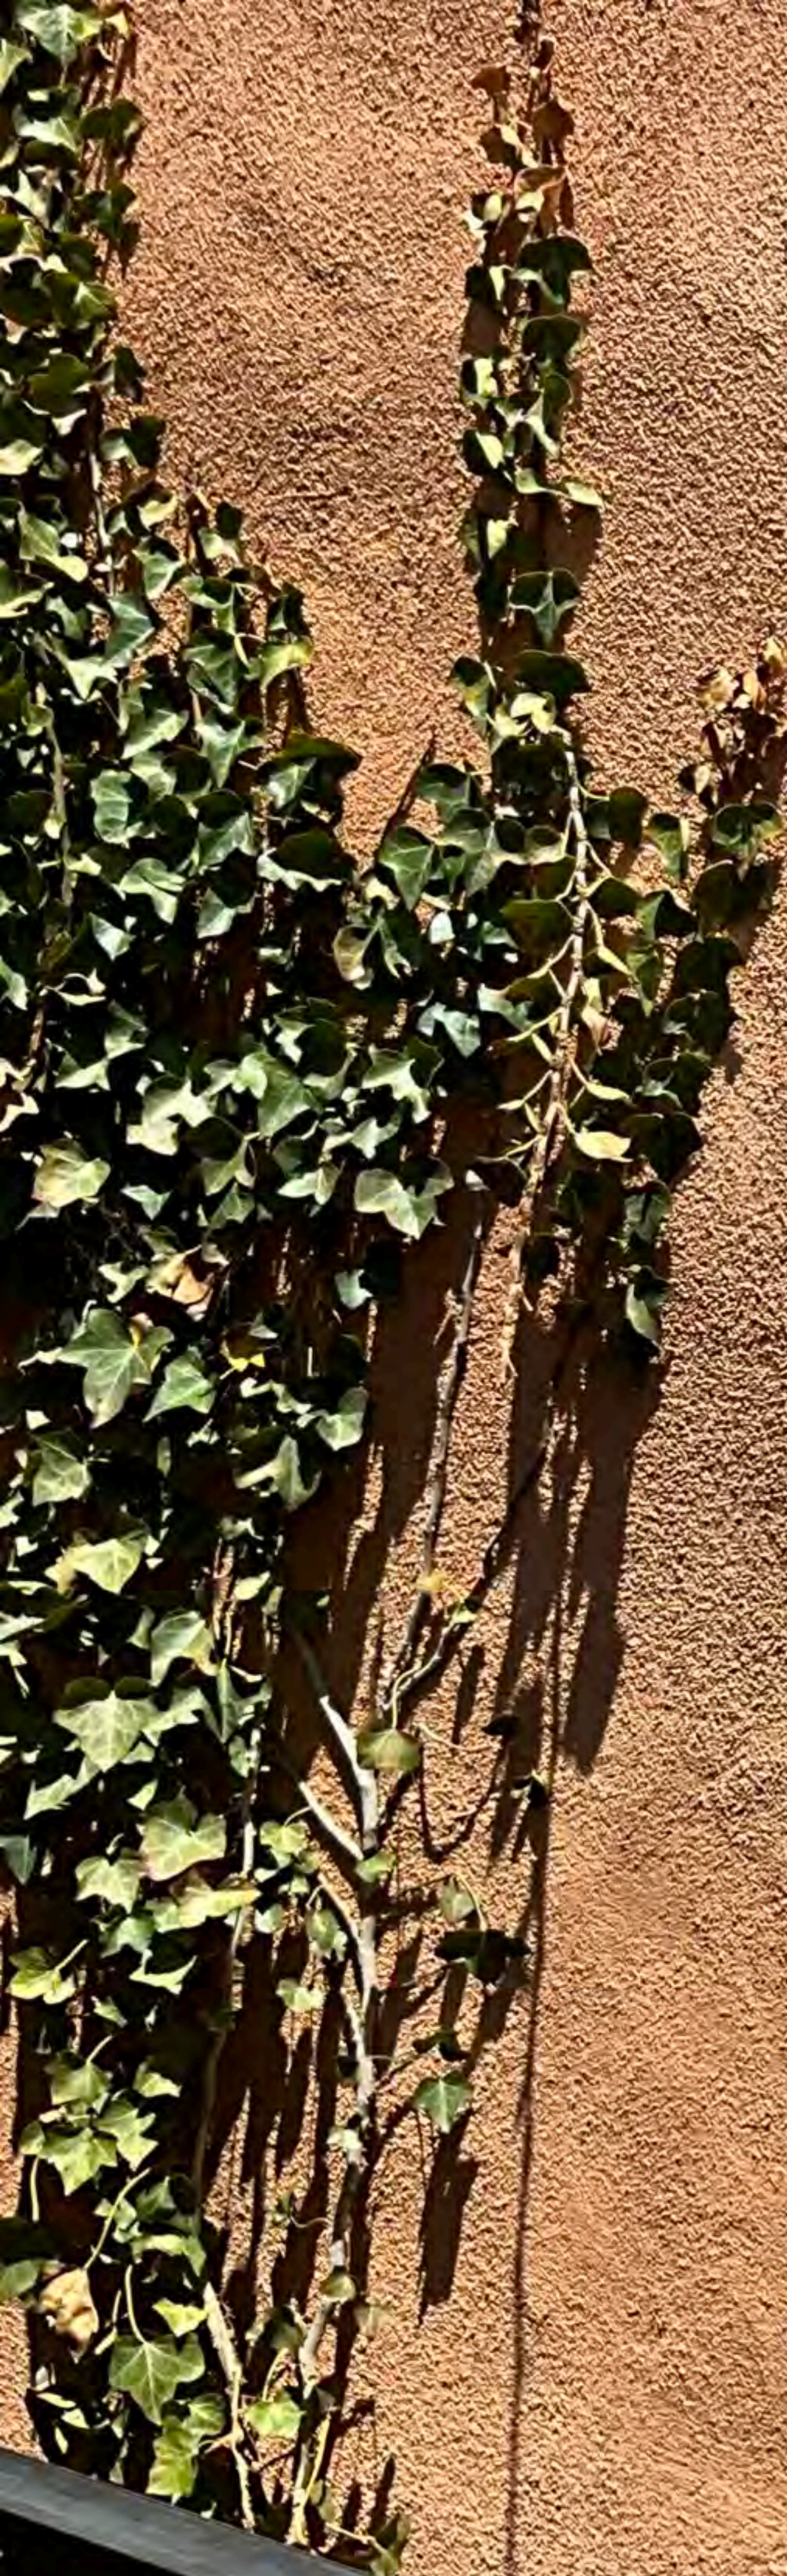
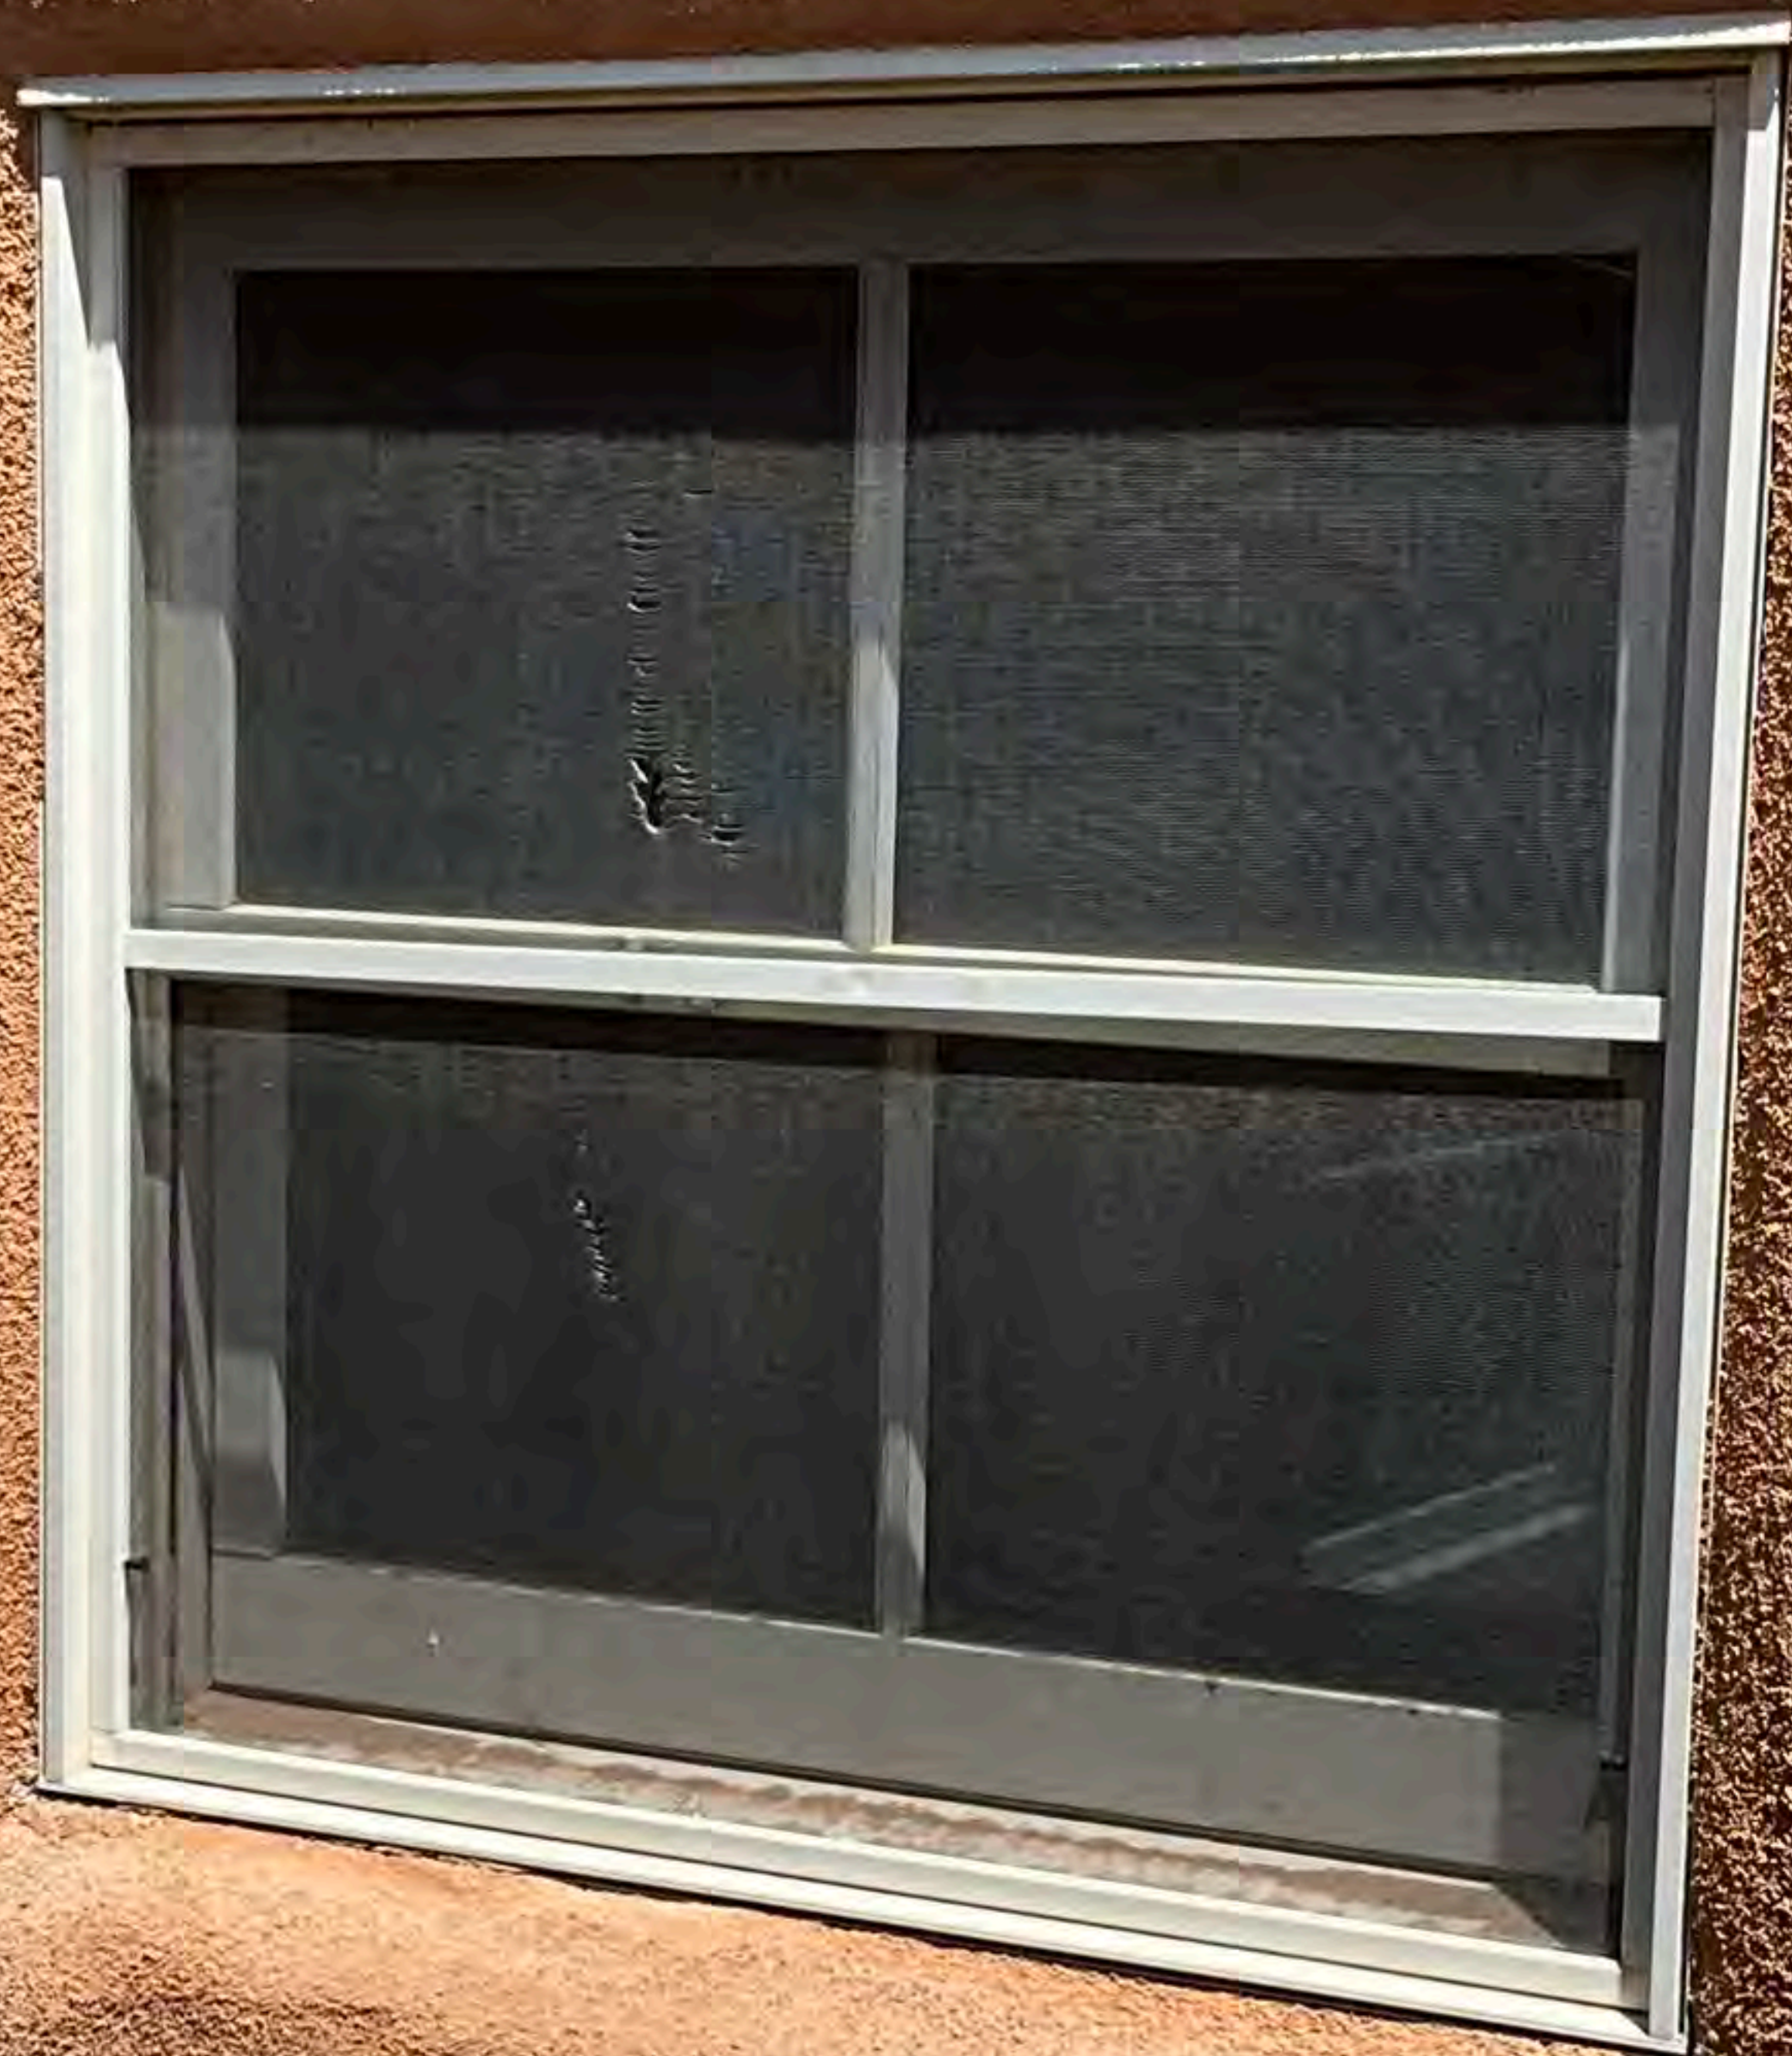
Main House
Window
MH-D

Windows and doors A, C, D, E, DR #1, F and I are non-historic.

If the windows and doors are replaced must be matched to historic requirements and "like and kind" to the existing openings.

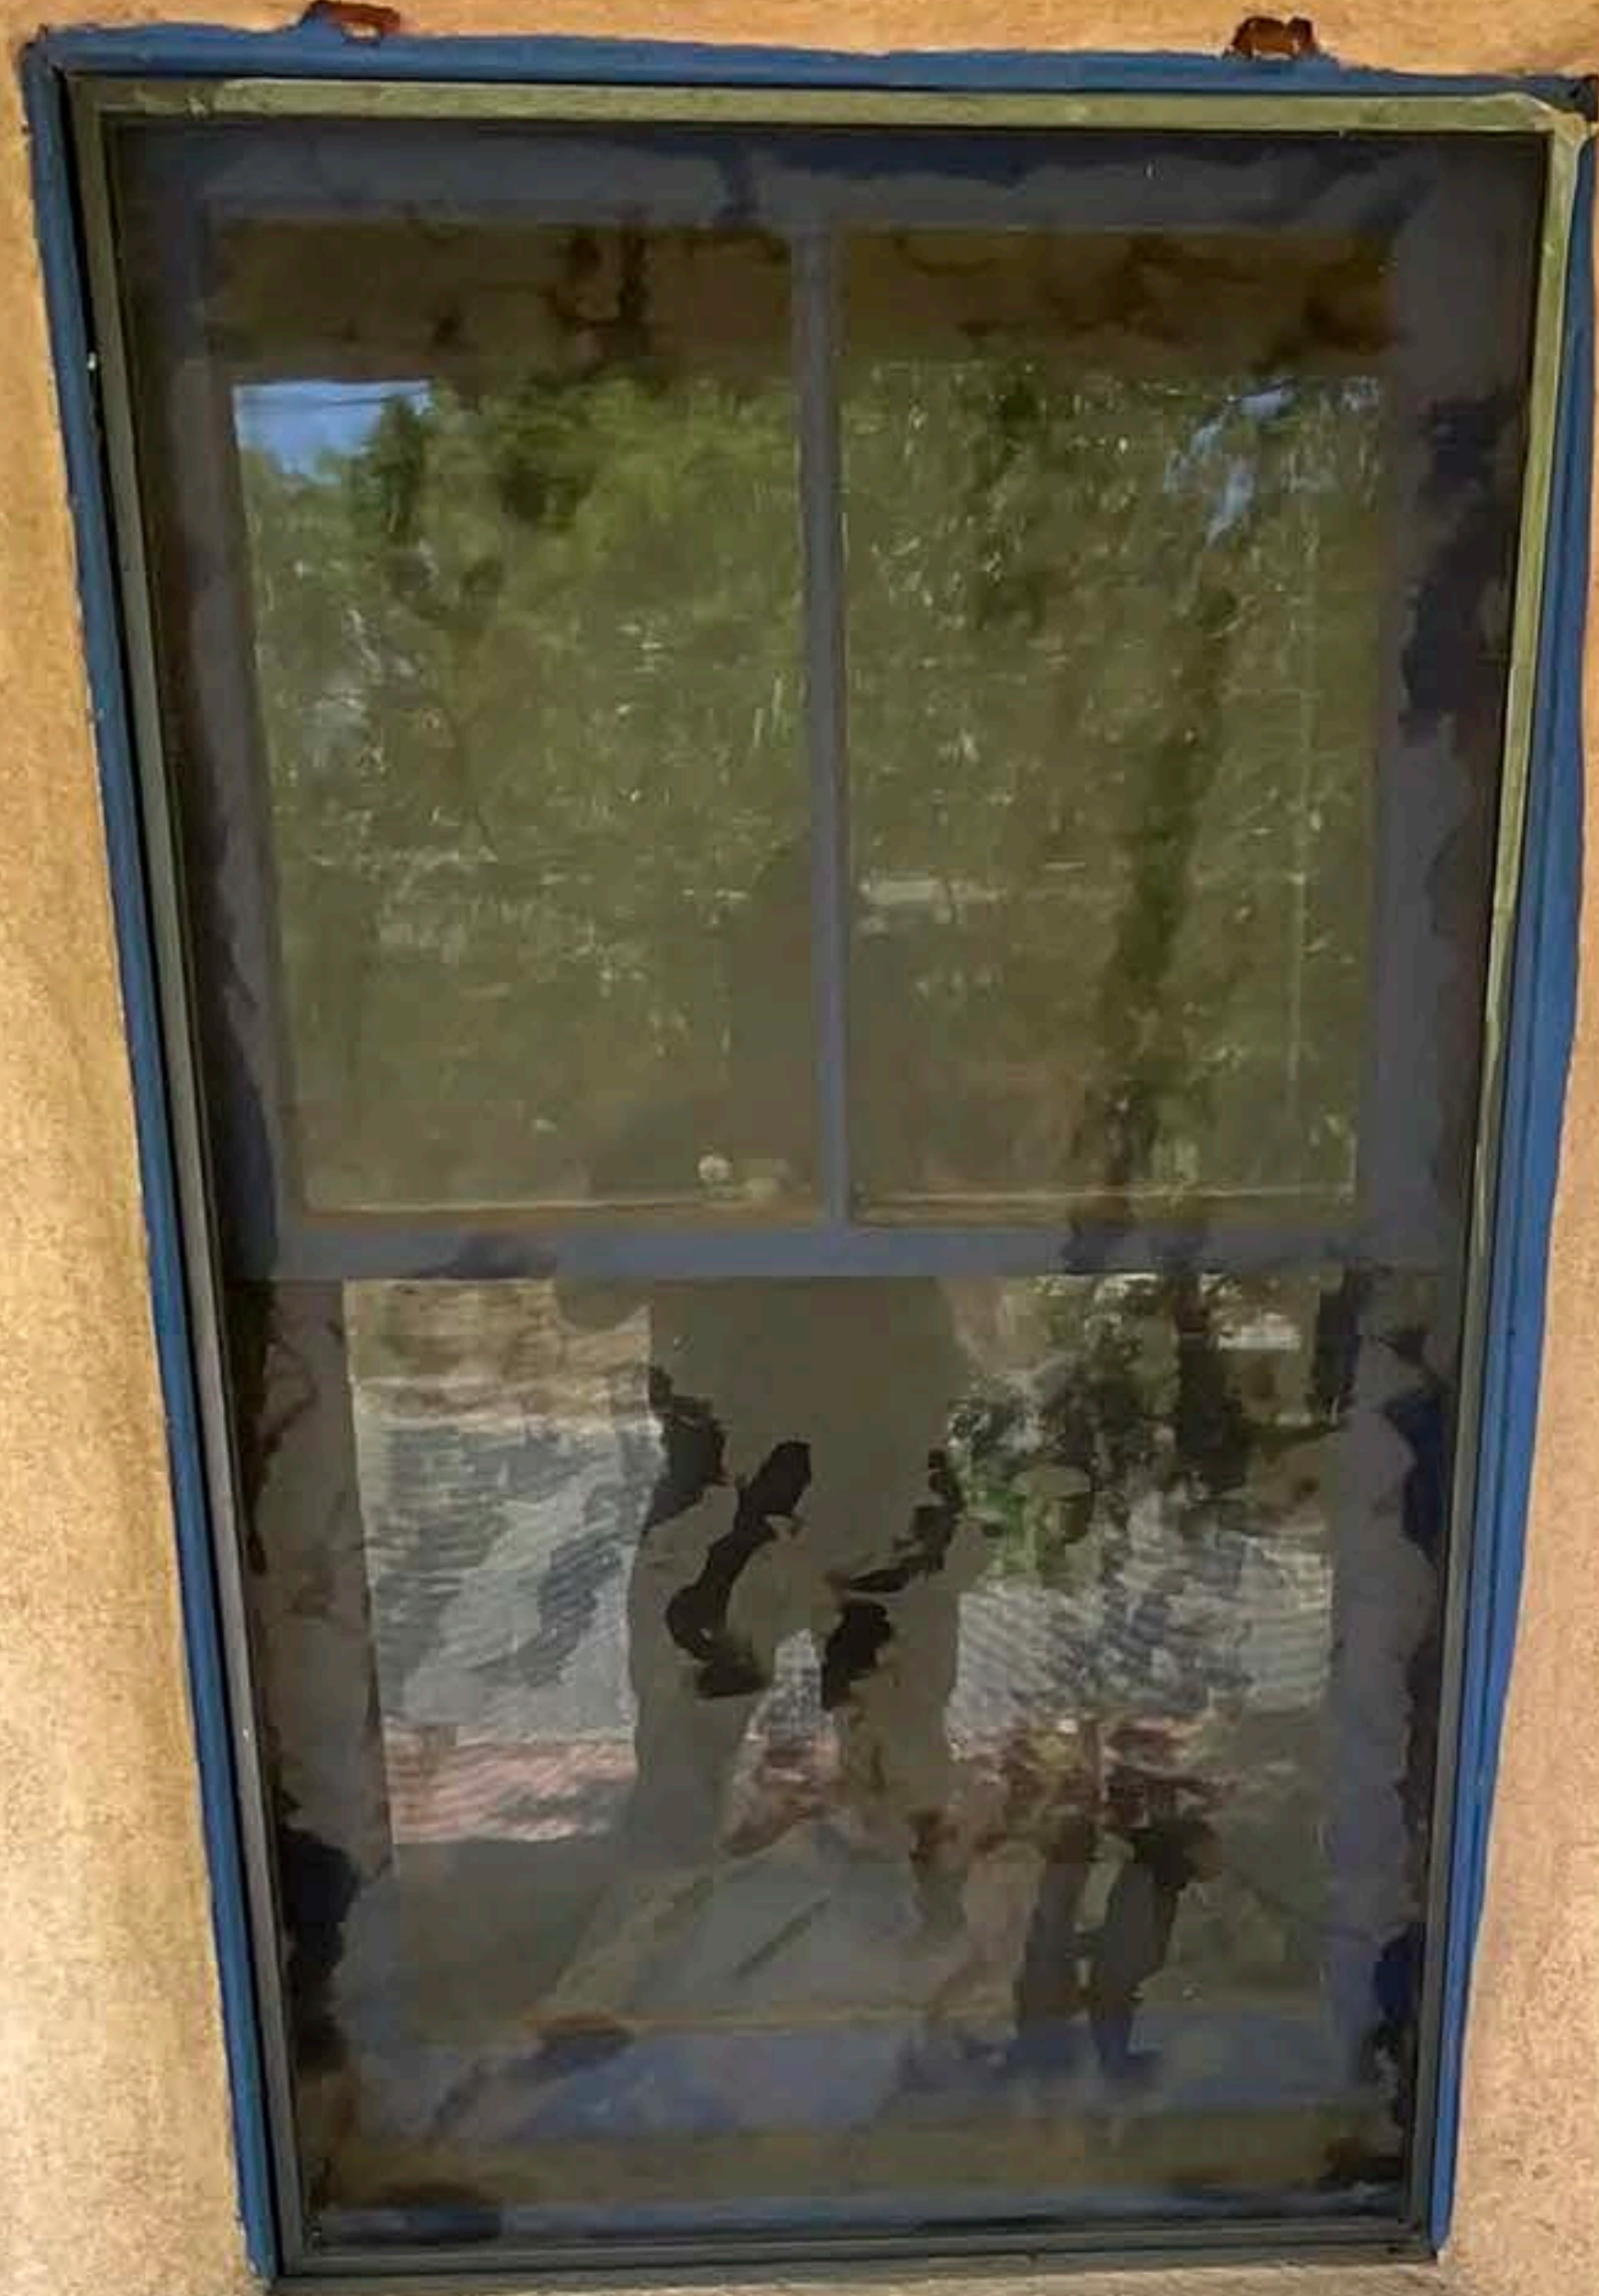
Main House
Window
MH-J

Windows B & H and J are historic however there are signs of water penetration underneath the sills of the water causing structural integrity damage to the adobe. The windows would need to be removed to properly flash the openings to stop the water penetration. The window jambs are the buck in the openings. Removal of the window would destroy the jamb and cause the historic window to be non-reusable and non-restorable.
