NEW MEXICO HISTORIC BUILDING INVENTORY - SANTA FE RESURVEY 1995

IDENTIFICATION	ADDRESS: <u>836 Don Cubero</u>		ID NUMBER: <u>0516 00604</u>
			BUILDING NAME:
	UTM REFERENCE EASTING NORTHING	LEGAL DESCRIPTION:	SANTA FE ID NUMBER: <u>H1683</u>
	ZONE <u>12 13</u>	TNSP <u>17</u> <u>N</u> S RANGE <u>9</u> <u>E</u> W SEC <u>26</u> <u>NE</u> 1/4 <u>SE</u> 1/4	
BUILDING DATA	FIELD MAP <u>Santa Fe Historic Structures Survey, 1983-85/1992</u>		
	DATE OF CONSTRUCTION: ____ ESTIMATE <u>1928</u> ^{by} ACTUAL		
	SOURCE(S) <u>city directory</u> <u>1930 Sanborn</u>		
	ARCHITECTURAL STYLE: <u>Vernacular</u>		
USE:			
HISTORIC: <u>residential</u>			
OTHER _____			
PRESENT: <u>residential</u>			
OTHER _____			
SURROUNDINGS: <u>residential</u>			
RELATIONSHIP TO HISTORIC SURROUNDINGS: <input checked="" type="checkbox"/> SIMILAR _____ NOT SIMILAR			
ASSOCIATED BUILDINGS ON SITE: <input checked="" type="checkbox"/> YES _____ NO			
WHAT TYPE? <u>garage</u>			
IF INVENTORIED, LIST ID NUMBER(S) _____

836 Don Cubero

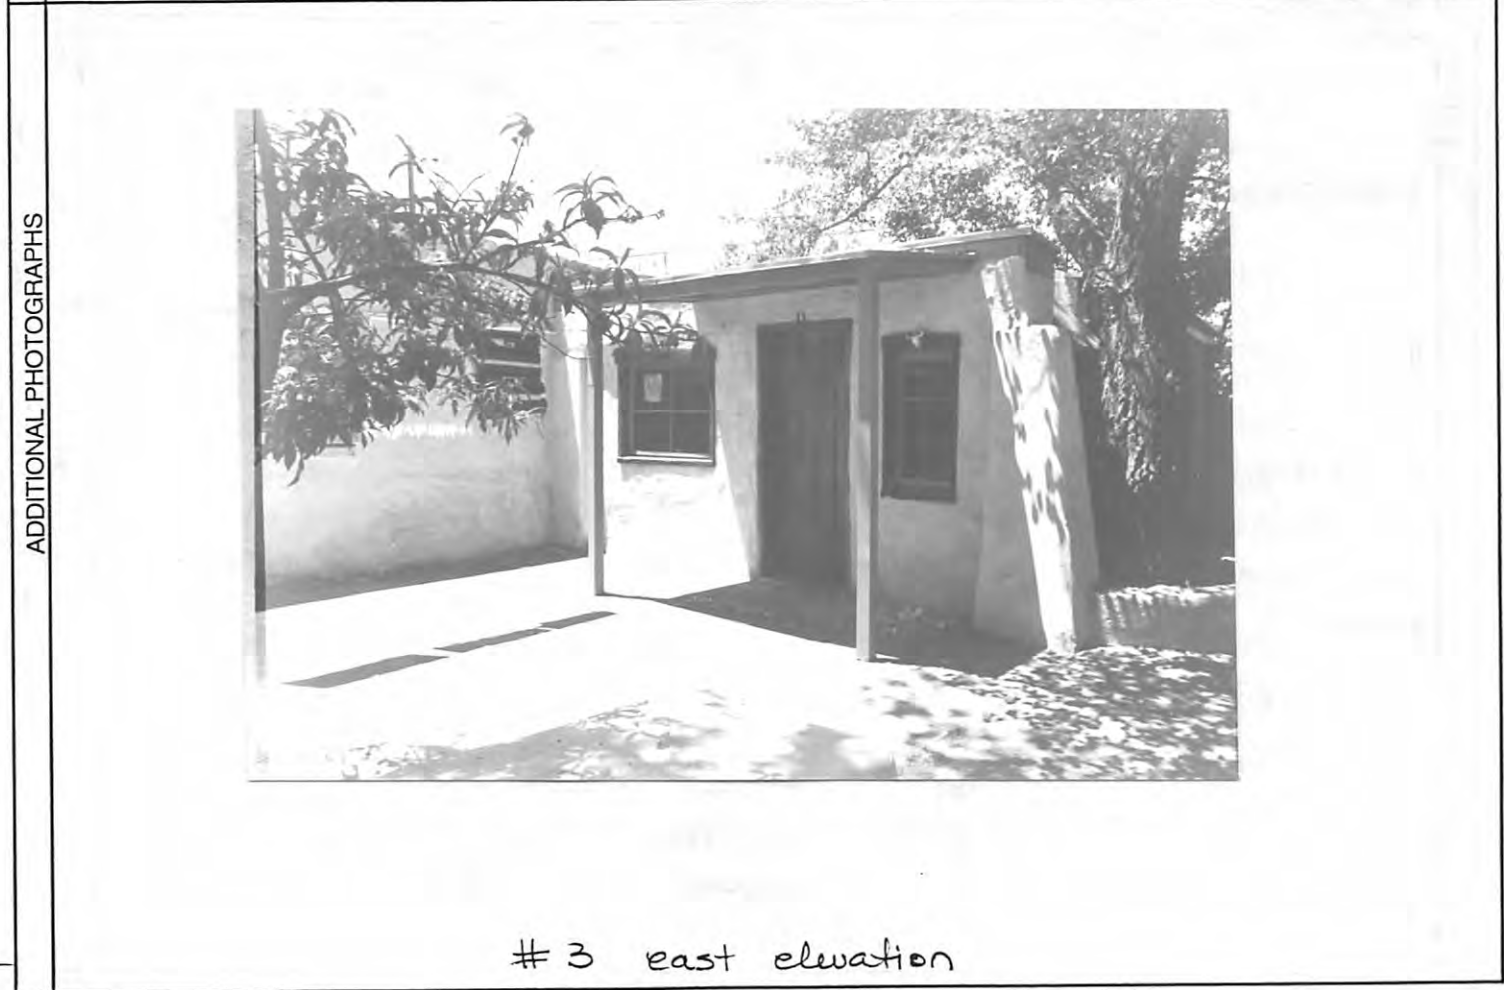
ARCHITECTURAL FEATURES: STYLE, MATERIALS, AND CONDITION	ROOFS & DRAINS	shed roof with wood & metal fascia
	BUILDING WALLS	brown stucco
	FOUNDATIONS	not visible
	DOORS	wood plank
	WINDOWS	wood and metal casements, wood awning window, pedimented lintels and wood frames
	PORCHES OR PORTALES	E - small wood porch with shed roof, 4x4 posts
	BALCONIES	
	COURTYARDS	
	FENCES/WALLS	
	ARCH. DETAILS	
	OTHER	
COMMENTS	Sanborn maps 1948 and 1968 show this as garage.
