**MEMORANDUM**

**RE:** 515 Paseo de Peralta**Date:** June 30, 2025**TO:** Amanda RomeroHistoric Senior Planner  
Land Use Department  
City of Santa Fe**Subject:** HDRB Status Review – 515 Paseo de Peralta**Attachments:**

# Historic Cultural Properties Inventory (HCPI) Base Form (FORM 1)

Date	Issue
MAY, 6th 2025	
Drawn by	Checked by
JUS	JUS
File	Plot Date
515 PdPeralta_A100 Plans 250331.vwx	
Set	Schematic Design Set
Sheet Title	EXISTING FLOOR PLAN w/ STRUCTURAL DEFICIENCIES
<b>S001</b>	
Sheet	of

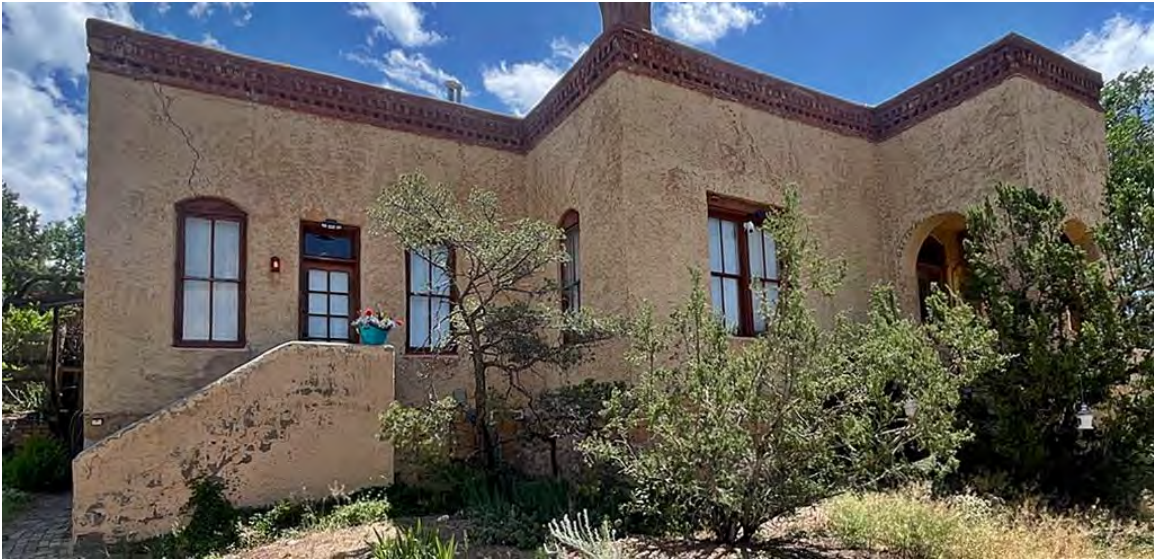
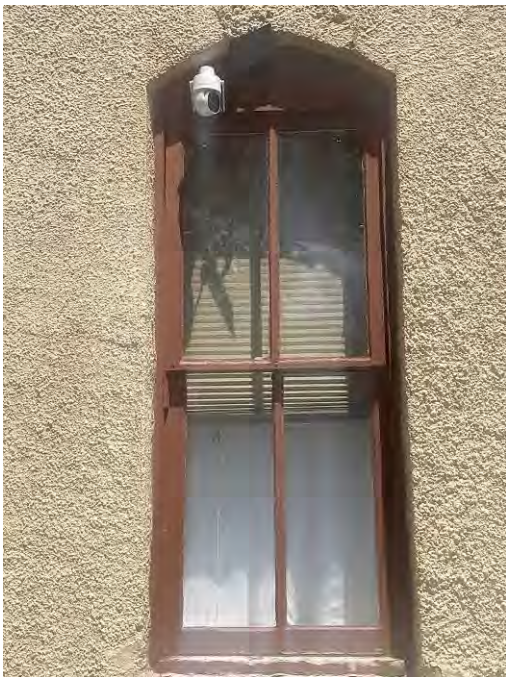
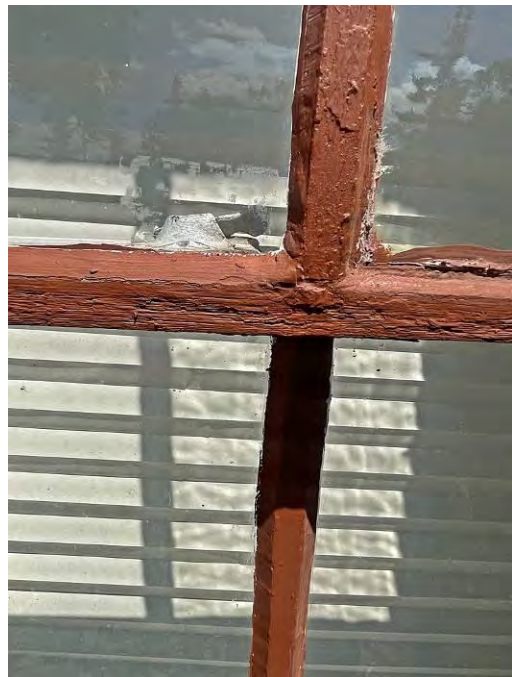
Beginning at the west end, the façade features an entry door flanked by tall sash windows (Photo 4). The window openings are likely original and contain 2/2 double-hung sash units set within the wall and topped with segmental arches—a configuration typical of late 19th-century houses in Santa Fe and elsewhere (Photos 4).

However, based on their appearance, the existing sash may be later, cost-conscious replacements. Although there is moderate paint buildup, the wood elements lack the characteristic “alligatoring” associated with lead-based finishes from the 19th century. The glazing putty is minimal, missing, or obscured by overpainting, and the glass panes appear flat and uniform, lacking the wavy surface typical of earlier cylinder glass.<sup>2</sup>

Moving east, the façade projects about 10 feet and contains a pair of 2/2 wood sash windows separated by a mullion (Photo 4). Distinct from the other openings, these windows are topped with a flat arched header. Below them, an exposed section of the foundation indicates the former location of stairs that once led to the front entry.

**Photo 4: West half of south elevation. Camera facing up and northeast. Typical window (left) and muntin pattern (right).**

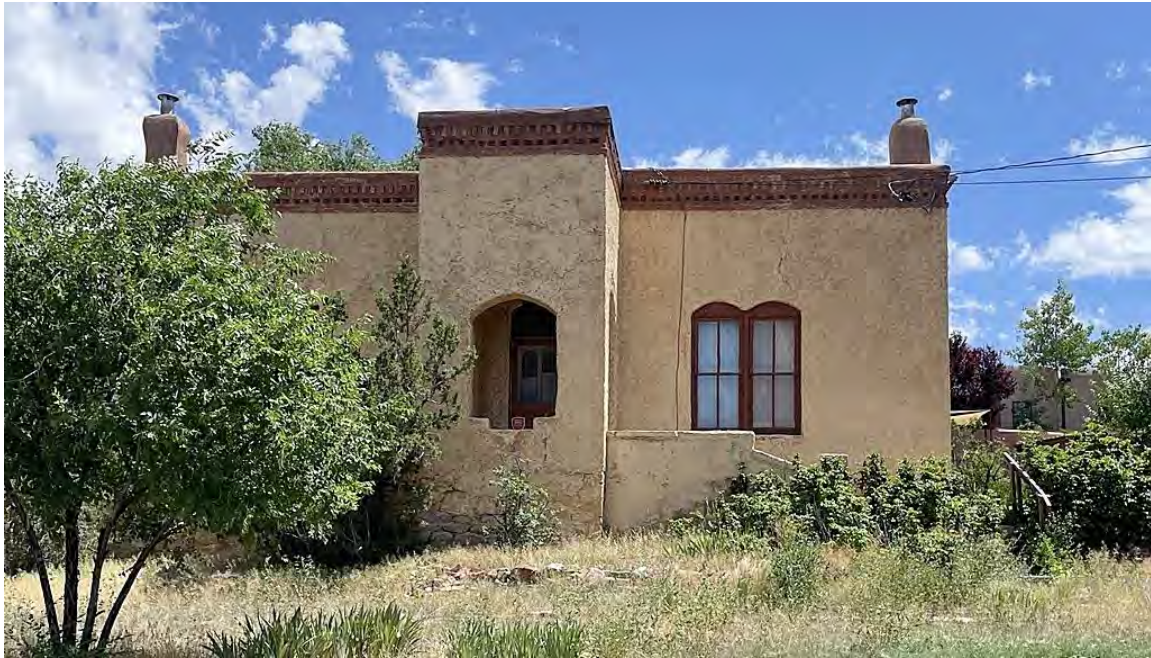
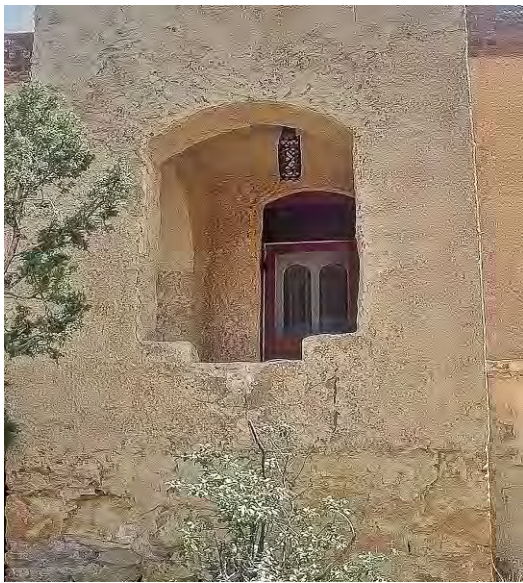
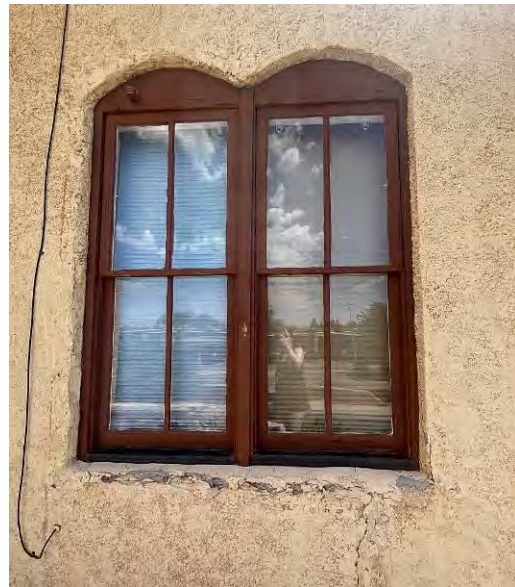
**Photo 5: Entry façade and east half of south elevation. Camera facing up and northeast. Entry porch (left) and altered windows (right).**

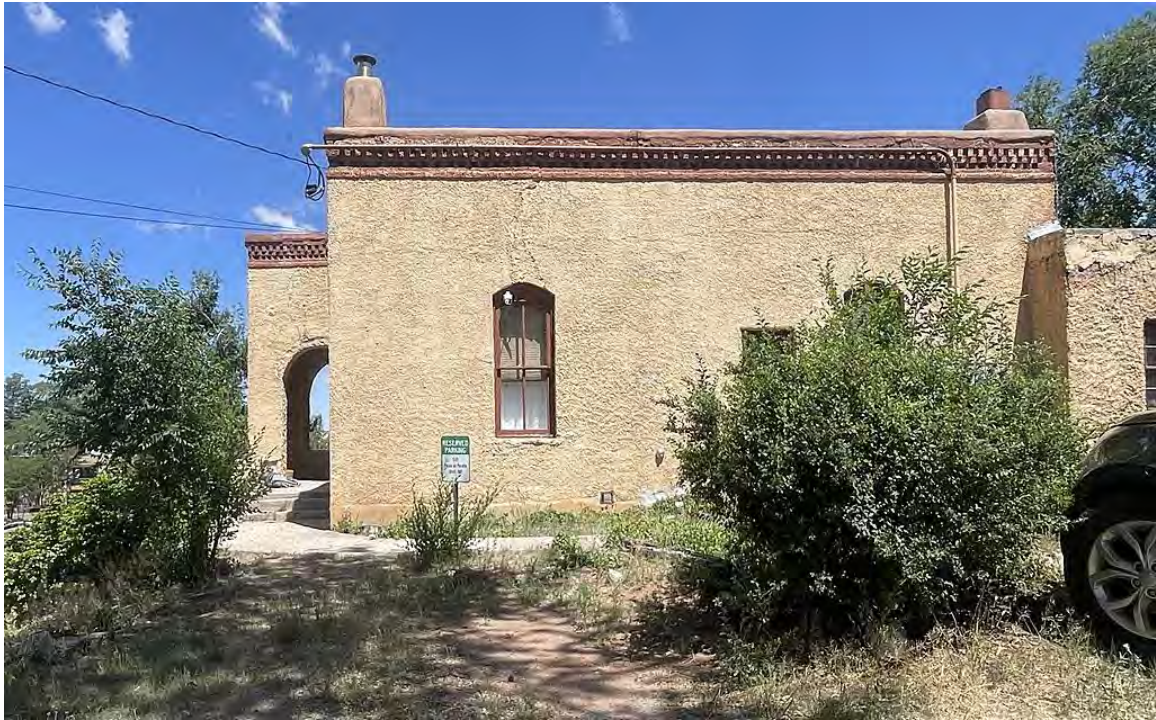
The east elevation, which faces the driveway, extends nearly 60 feet and includes the original house, a garage added before 1930, and a later rock structure which replaced the original garage (Photos 6-9). The historic portion repeats the fenestration of the street façade, with two tall 2/2 wood sash windows set beneath segmental arches (Photo 6). South of the second window is a small opening containing a four-light hopper window, which does not appear in early photographs of the house (Fig. 5).

**Photo 6: East elevation of the original building. Camera facing northwest.**

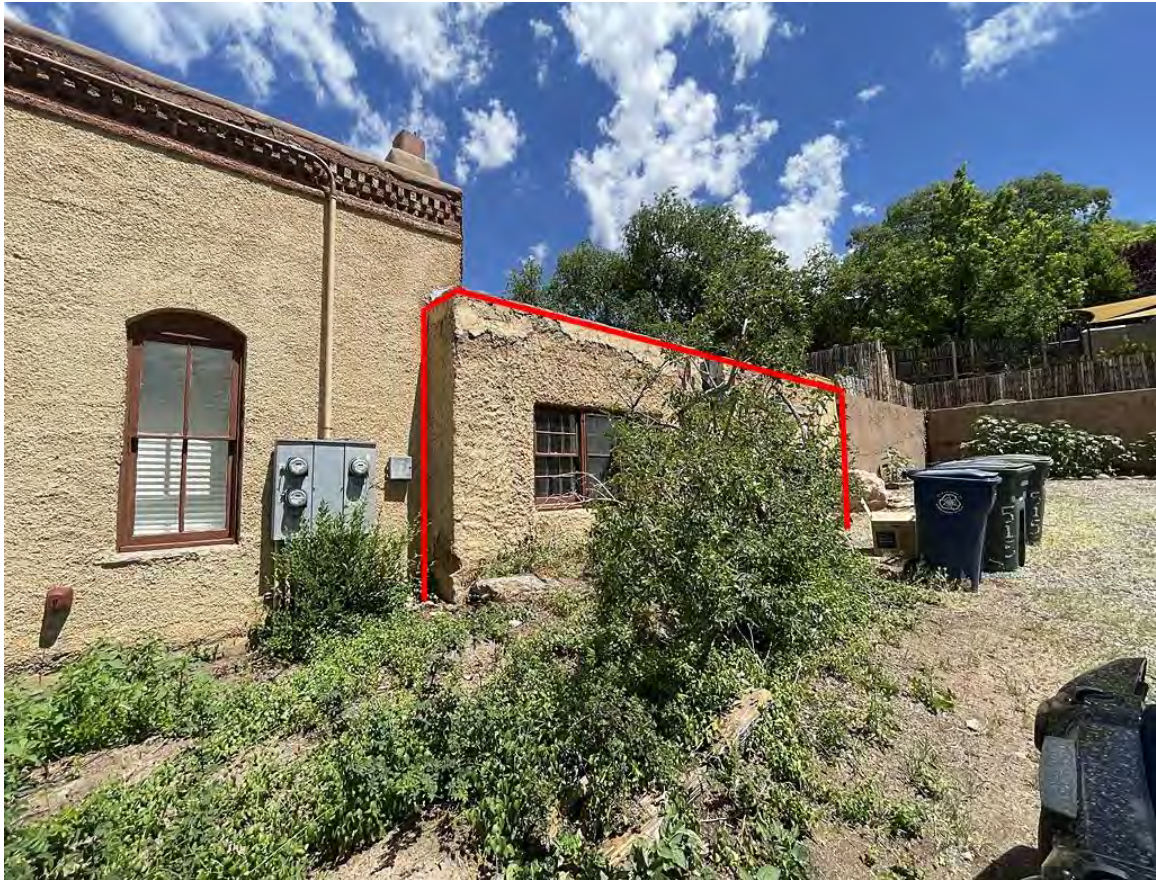
Projecting approximately three feet from the façade is a structure identified as a garage on the 1930 Sanborn Fire Insurance Map (Fig. 6). Constructed of stone and set at a lower elevation, it features a grouping of three 6/6 wood sash windows, some of which are missing muntins (Photos 7 & 8). This section of the elevation appears to be in deteriorated condition.

**Photo 7: East elevation oblique. Two garage additions highlighted. Camera facing north.**

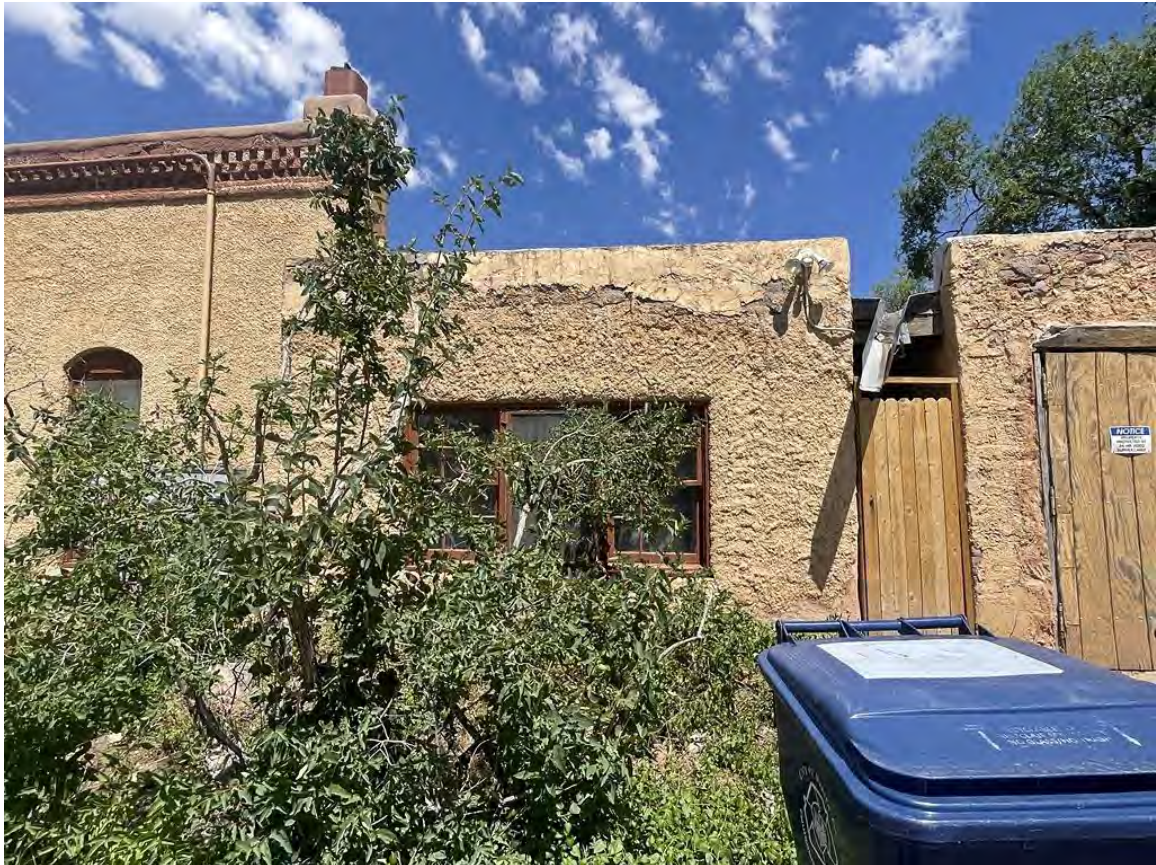
**Photo 8: East elevation. Original garage at center. Camera facing northwest.**

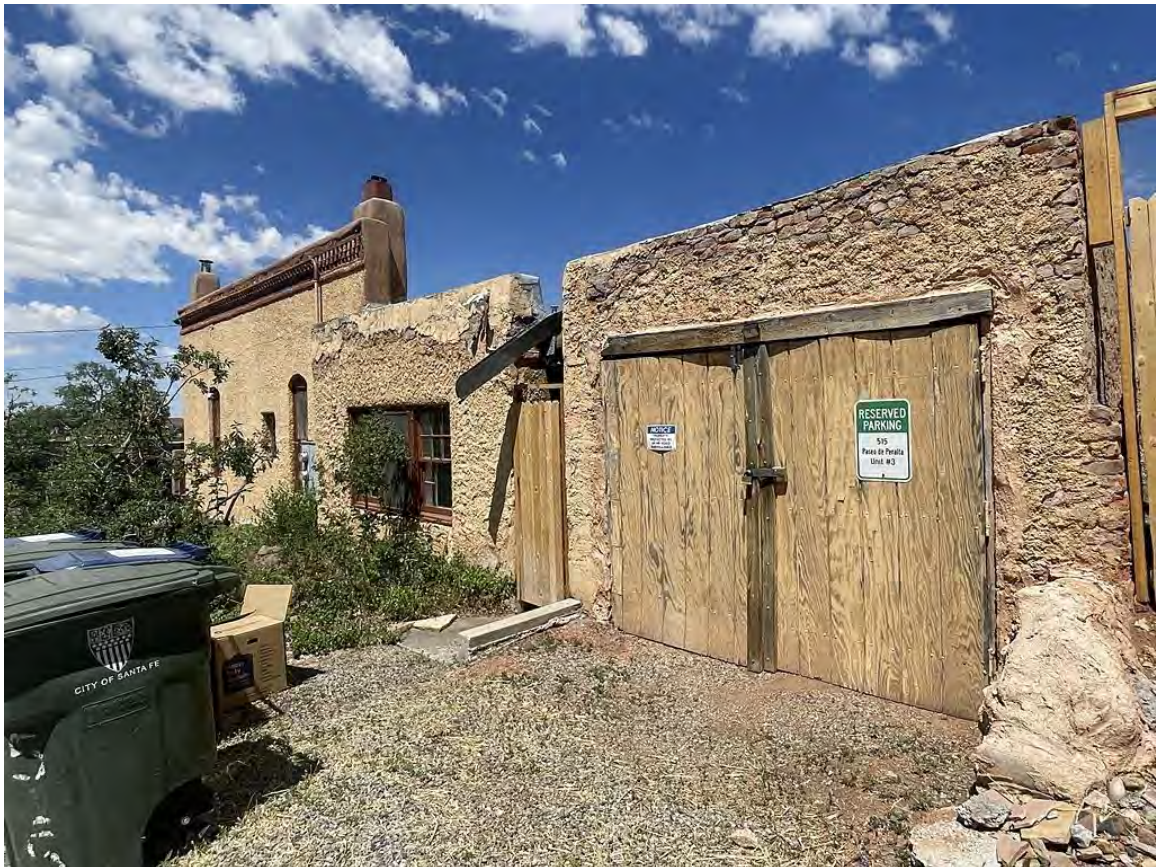
Separated from it by a narrow walkway is the final element of the south elevation: a one-bay stone garage partially built into the hillside (Photos 9 & 10). It is accessed through a pair of non-historic outswing doors constructed of vertical wood boards. Based on the 1943 drawing, this second garage was already in place by that time. It is also in poor condition.

**Photo 9: East elevation oblique. Later garage at right. Camera facing southwest.**

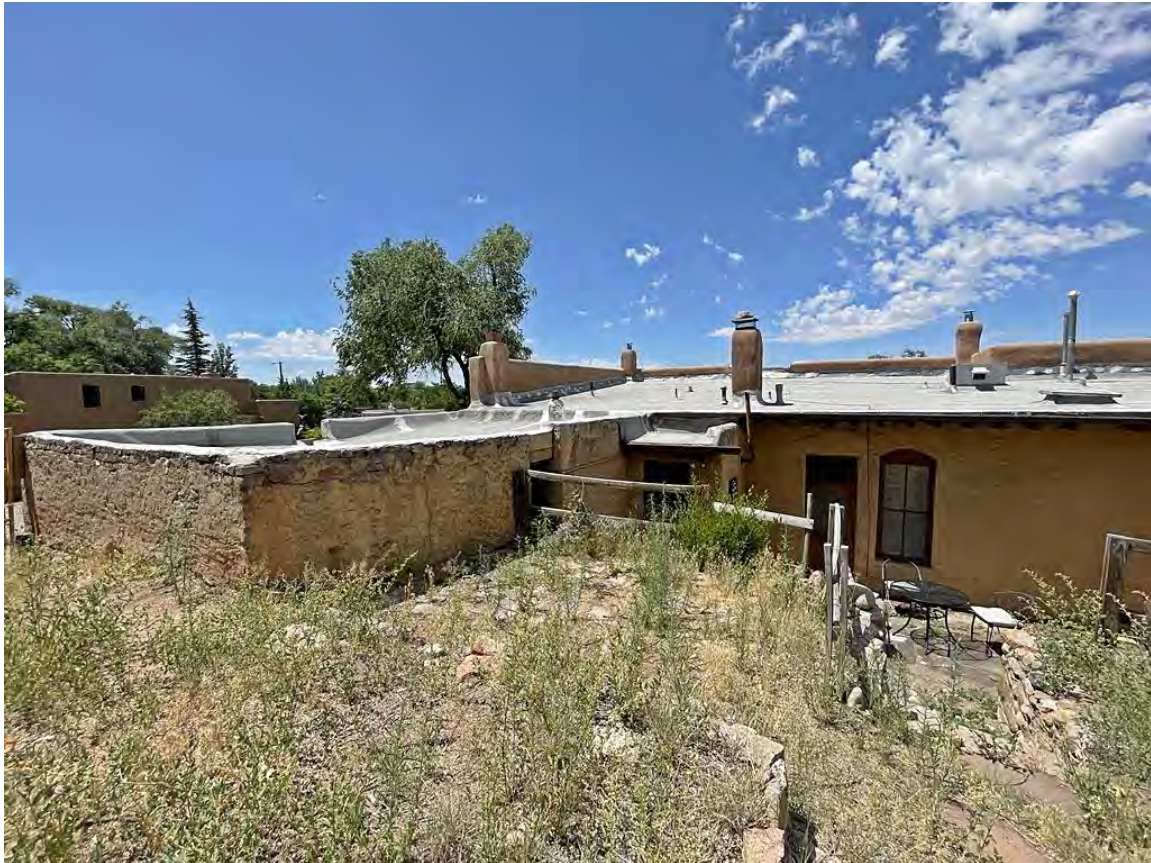
**Photo 10: Combined garages. North and west elevations. Camera facing southeast.**

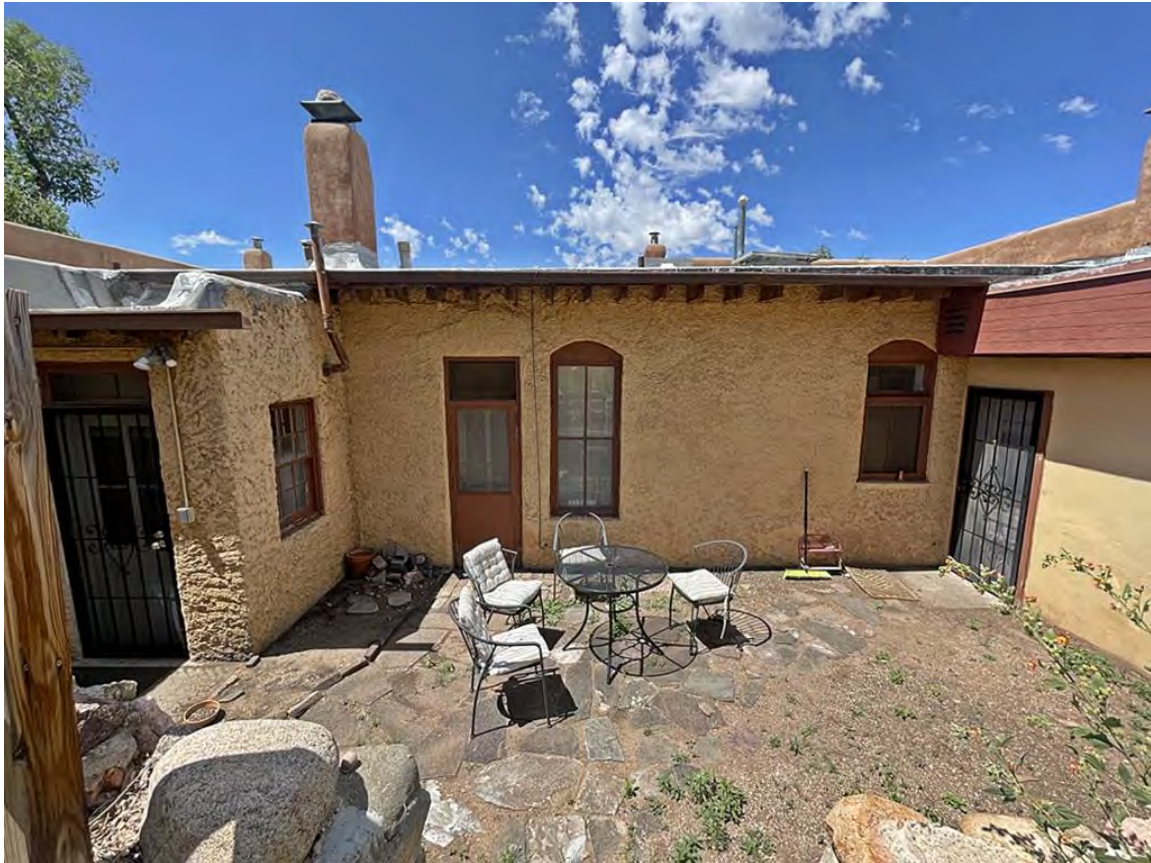
The north elevation, which appears squat in comparison to the street-facing façade, opens onto a flagstone patio (Photo 11). The older central section is covered by a shallow overhang fitted with a modern gutter; the roof slopes in this direction, draining directly into the gutter without a parapet. The functional elements of the apartment

The central portion includes a double-light wood door with transom, protected by a wood screen door. To the west are two older wood sash windows (one converted to a hopper) with segmental-arched heads. Projecting from the east is the original garage, fenestrated on the north with a four-light and wood panel entry door with a transom, and on the west a single 6/6 wood sash window (Photos 11 & 12).

At the far west end is a small addition of uncertain origin (Photos 11 & 12). Based on Sanborn maps and aerial photographs, it was appended to the building sometime between 1948 and 1958 (Fig. 8). However, its exterior detailing appears more modern, characterized by a smoother stucco finish, pronounced fascia, and a sliding aluminum window. It is possible that the current structure replaced an earlier addition. The courtyard-facing door is a half-light over wood panel unit of indeterminate age.

**Photo 11: North elevation. Original garage (left); bedroom addition (right). Camera facing southeast.**

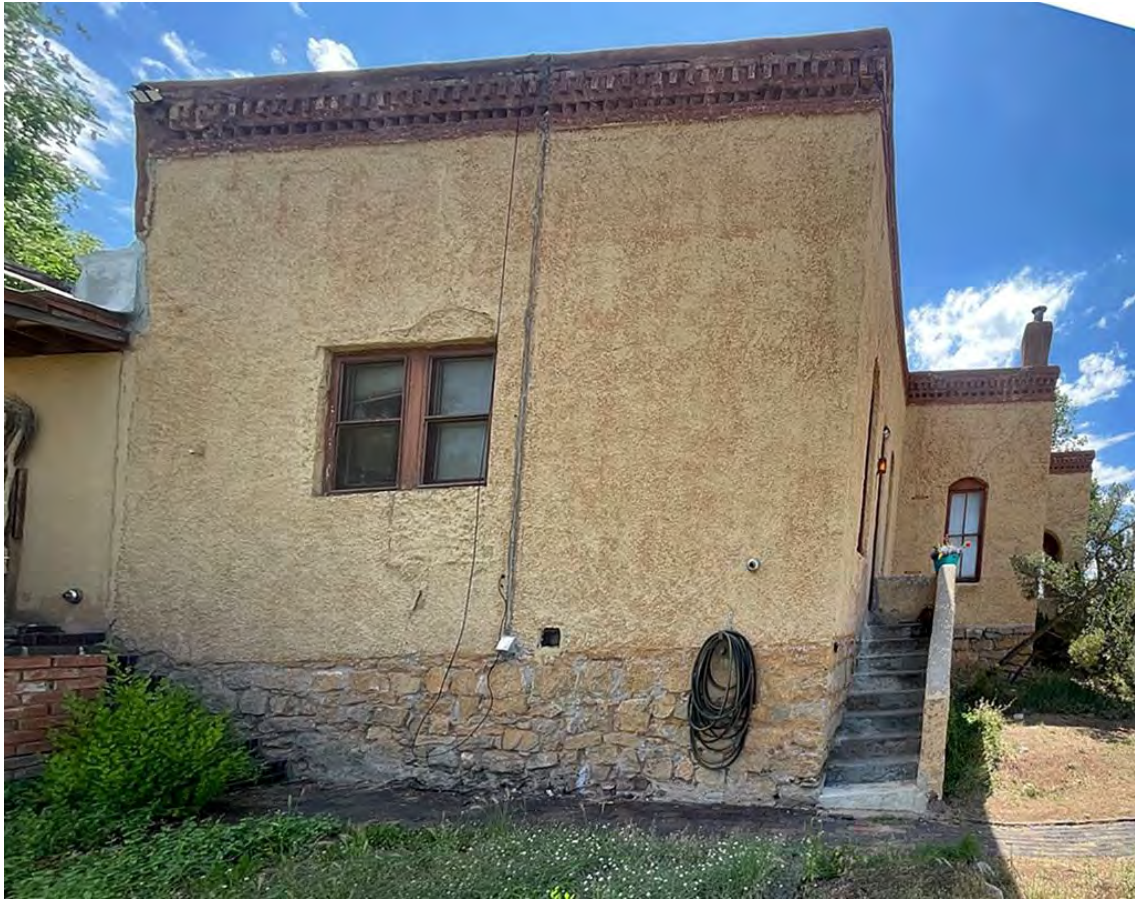
**Photo 13: West elevation of original building. 1940s staircase on the right. Camera facing northeast.**

The older portion of the building contains two 1/1 wood hung-sash windows separated by a mullion (Photo 13). Ghosting visible in the surrounding stucco suggests this was originally a single vertical opening with a segmental-arched window. The adjoining addition contains a single sliding aluminum window (Photo 14).

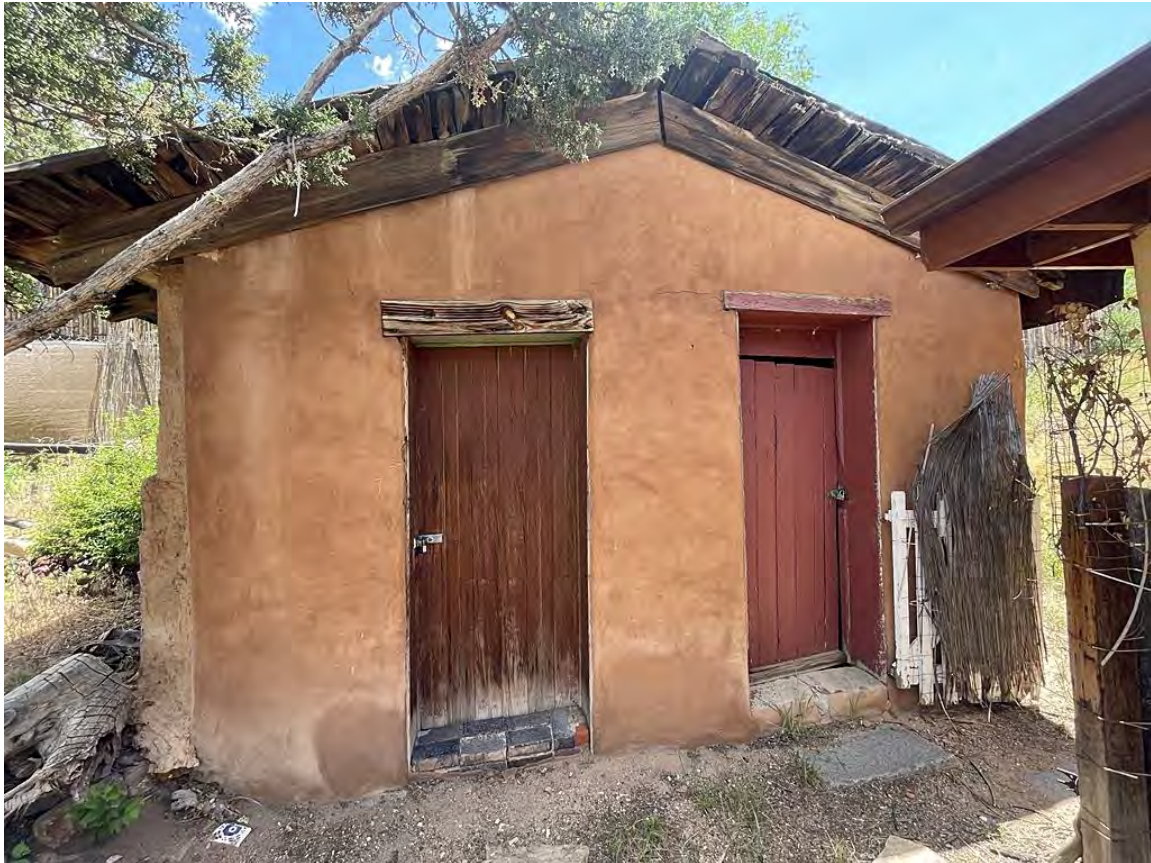
**Photo 16: Shed. South elevation. Camera facing northeast.**

The approximately 195-square-foot shed is located on what was originally Lot 4, north of the alley that once divided the two properties. Constructed in part of adobe, the structure appears on the 1912 King’s Map as a stable (Fig. 2). It is topped with a medium-pitched gable roof clad in weathered boards, over which corrugated metal—now painted black—has been applied (Photo 15). The front (south) elevation is finished with smooth stucco, while the side elevations exhibit much rougher texture (Photo 16).

The north elevation is set into the hillside and incorporates a mix of brick and rubblestone construction. Entry is through the south elevation via a pair of wood plank pedestrian doors (Photo 16).

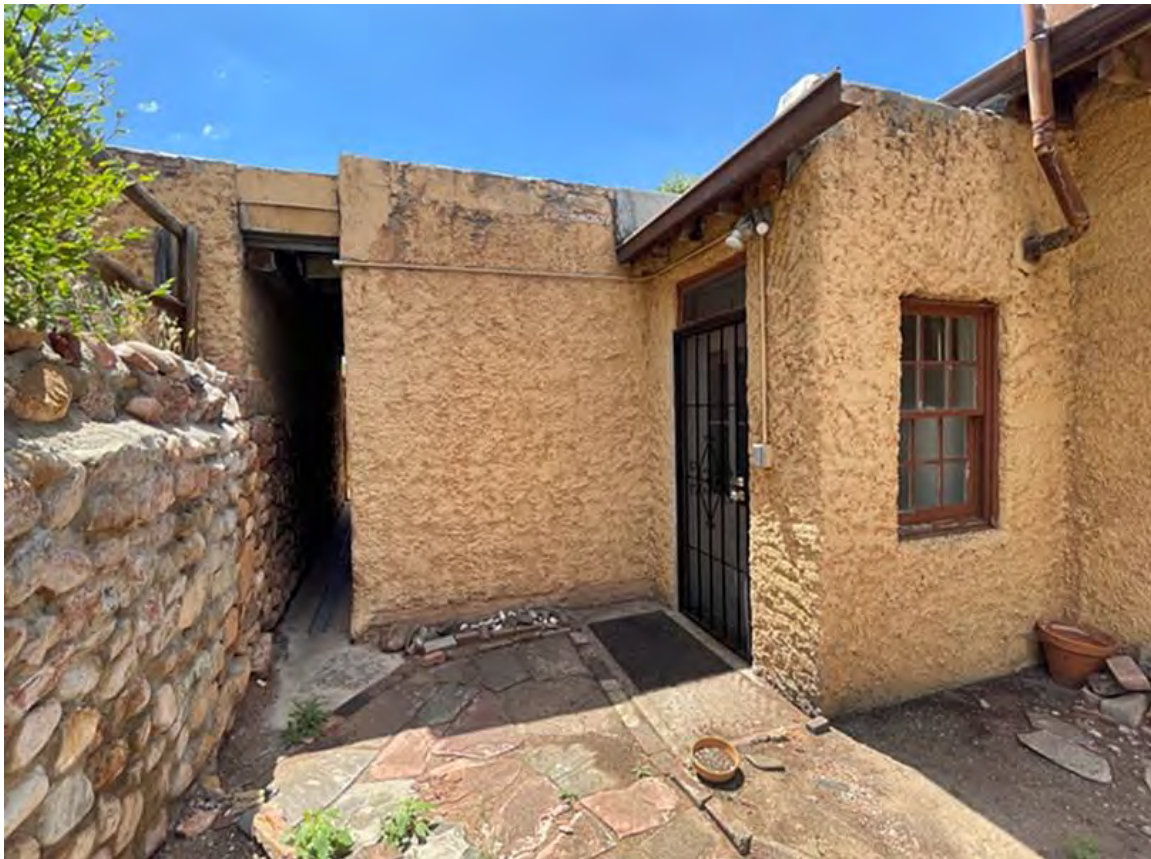
**Photo 20: North retaining wall. Camera facing southeast.**

A separate section of stone retaining wall is located on the north side of the property (Photo 20). It is constructed of river cobbles set in a bed of concrete mortar. This wall is interrupted by a set of steps that lead to higher ground.

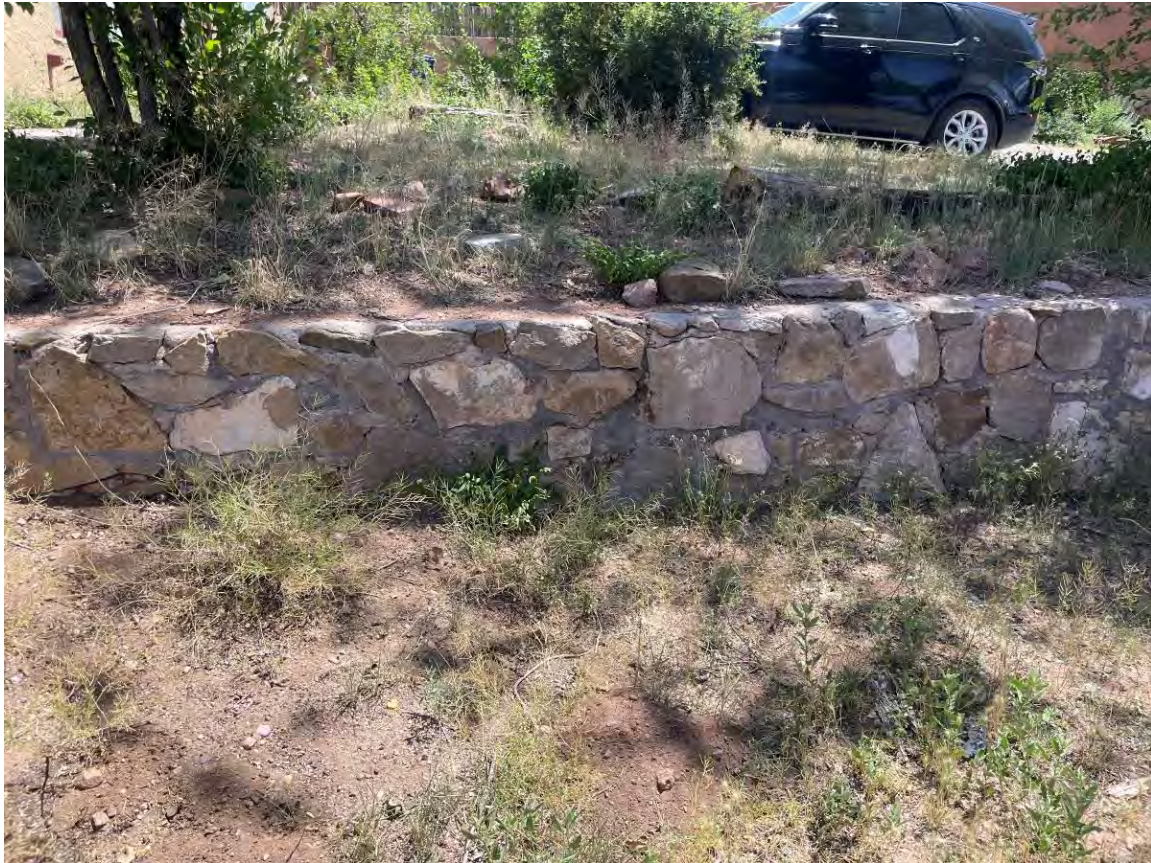
**Photo 21: Minor retaining wall. Camera facing southeast.**

The lot includes additional minor rock retaining walls and stone features that verge on archaeological in character (Photo 21). More recent elements on the property include a low, unstuccoed CMU wall and a coyote fence.

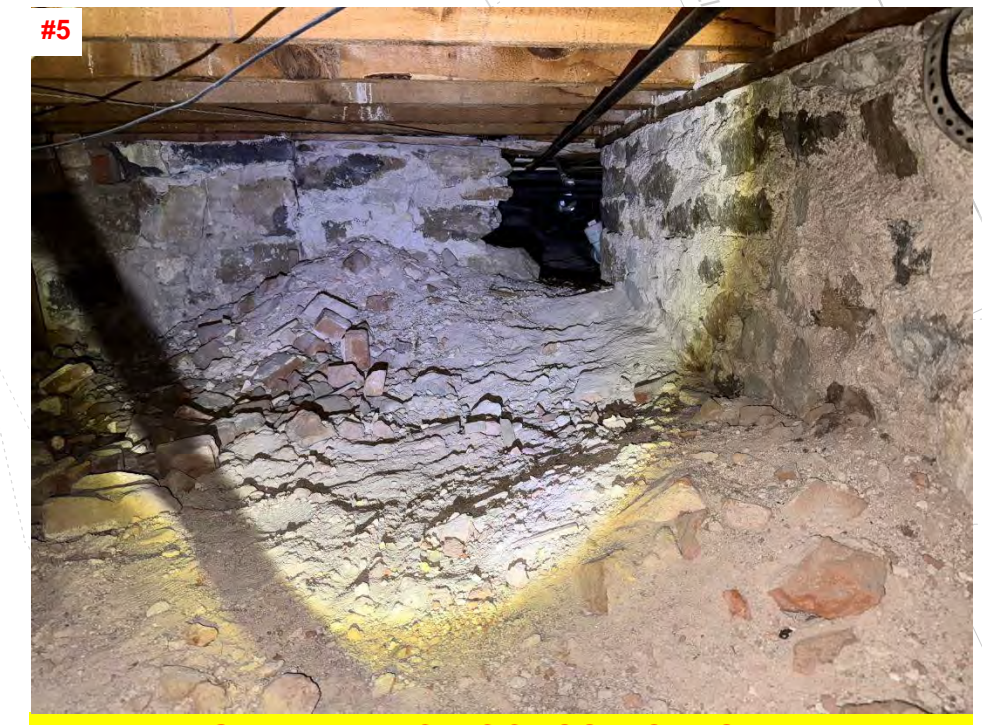
- Tunneling through stone masonry stem walls to accommodate HVAC & plumbing chases were noted to occur in numerous locations throughout the main residence. This alteration will need to be corrected as it has caused localized failures of the wood bearing plates for the floor system.

#5 PLUMBING AND HVAC ACCESS HOLES HAVE BEEN TUNNELED THROUGH THE STONE RUBBLE STEM WALL

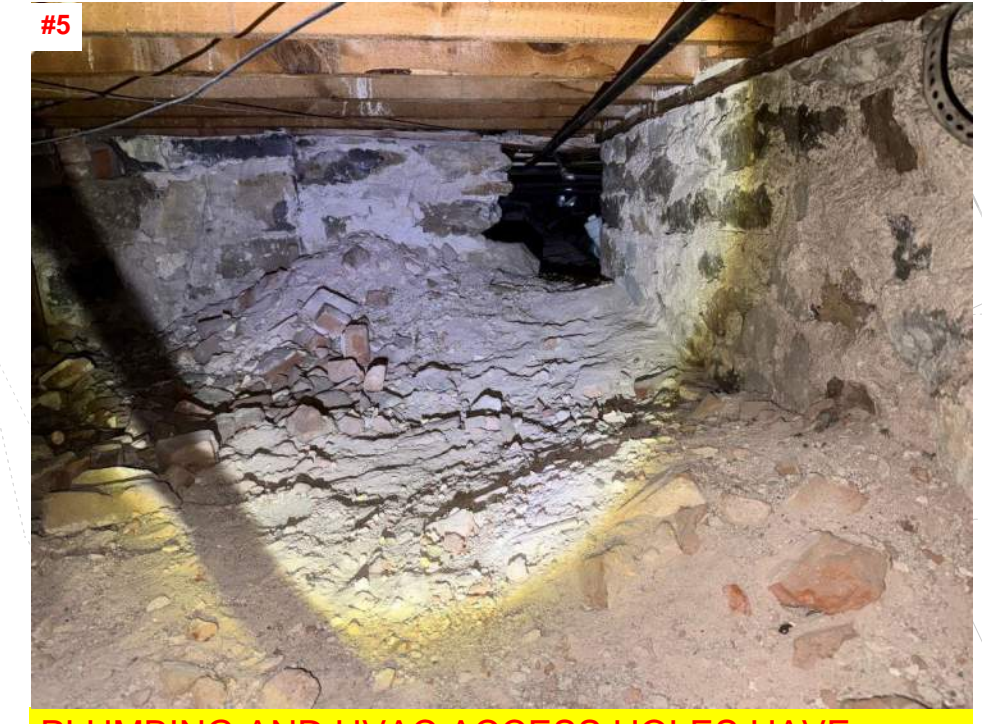
#5 PLUMBING AND HVAC ACCESS HOLES HAVE BEEN TUNNELED THROUGH THE STONE RUBBLE STEM WALL

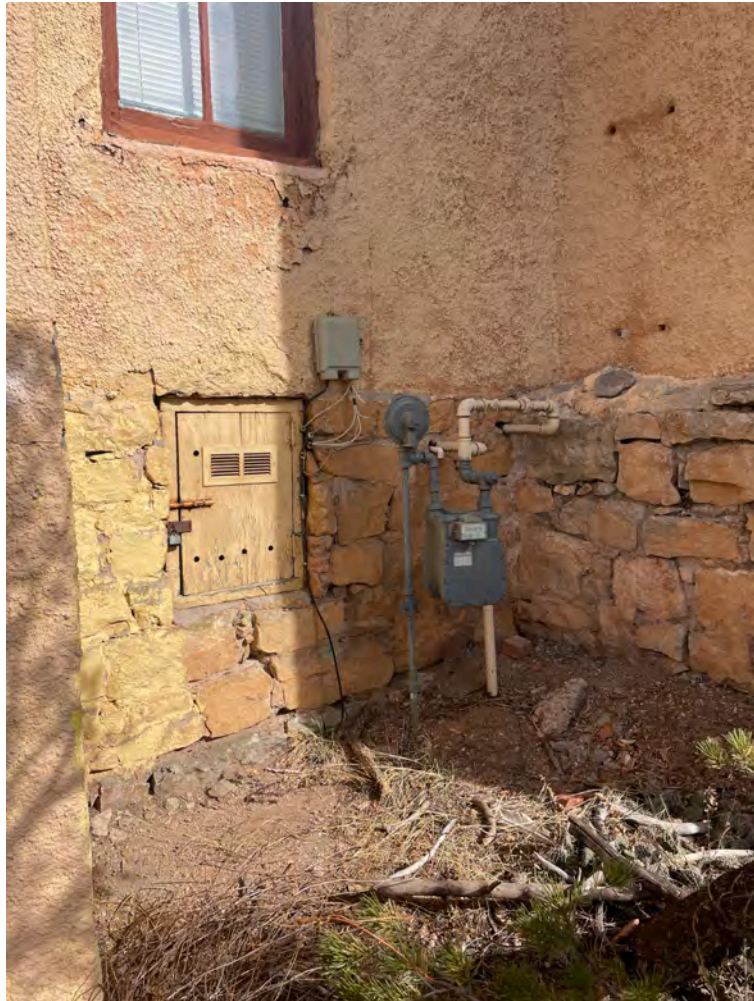
**EXPOSED RUBBLE FOUNDATIONS**

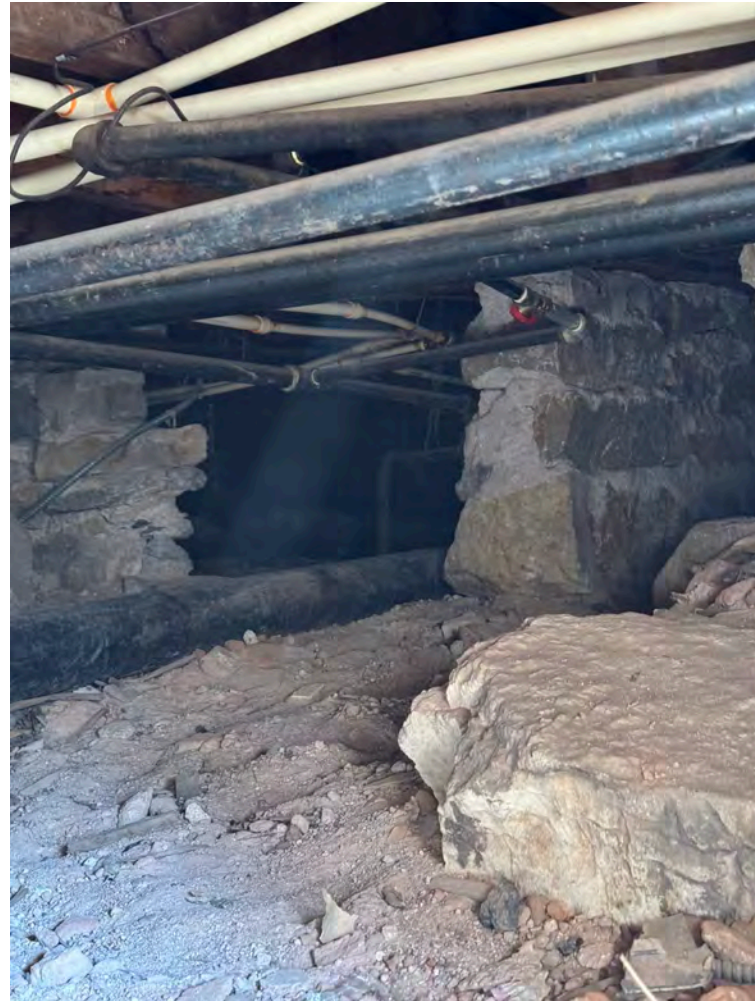
**PREVIOUS INTERVENTIONS**

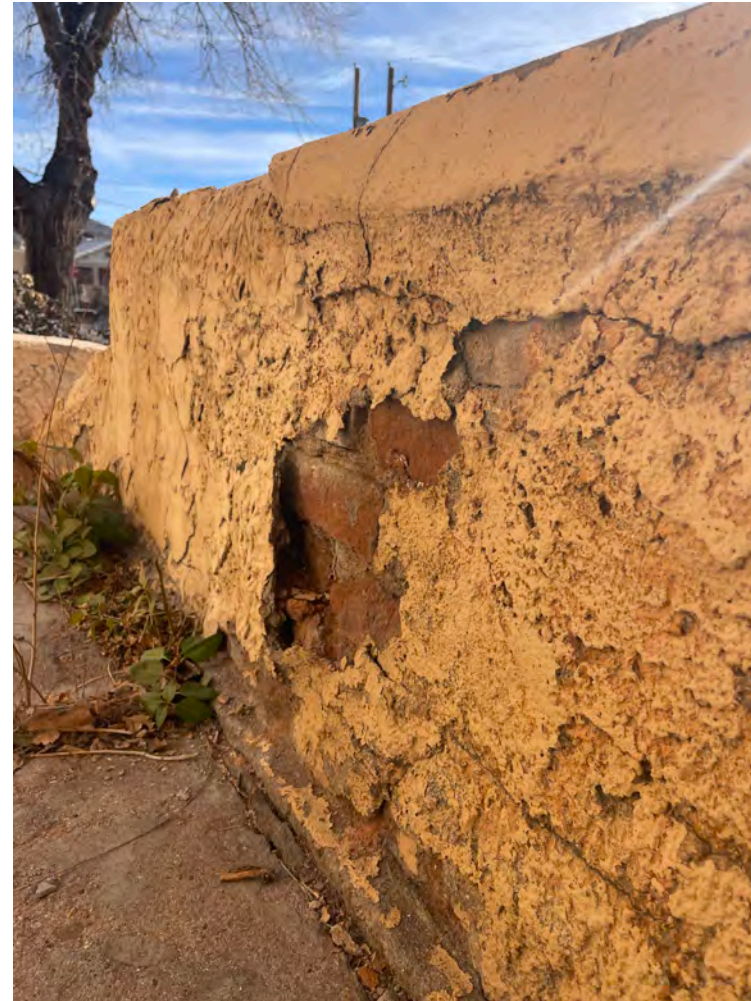
**STUCCO & BRICK BENEATH**

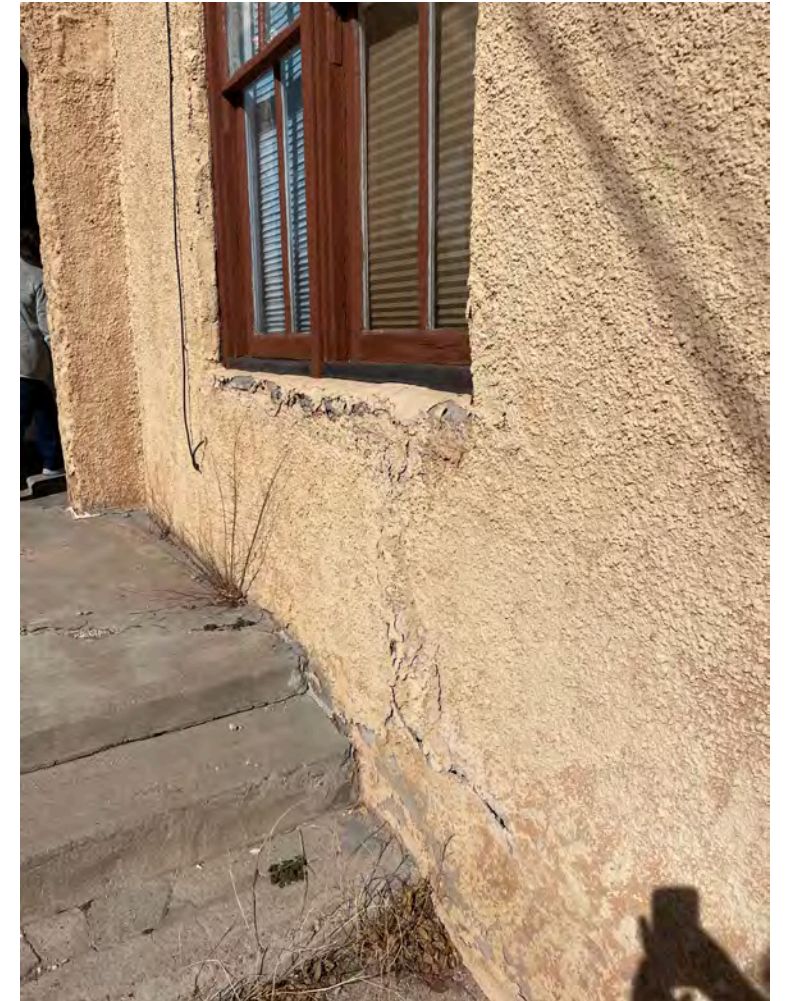
**CAUSE OF CRACKS**

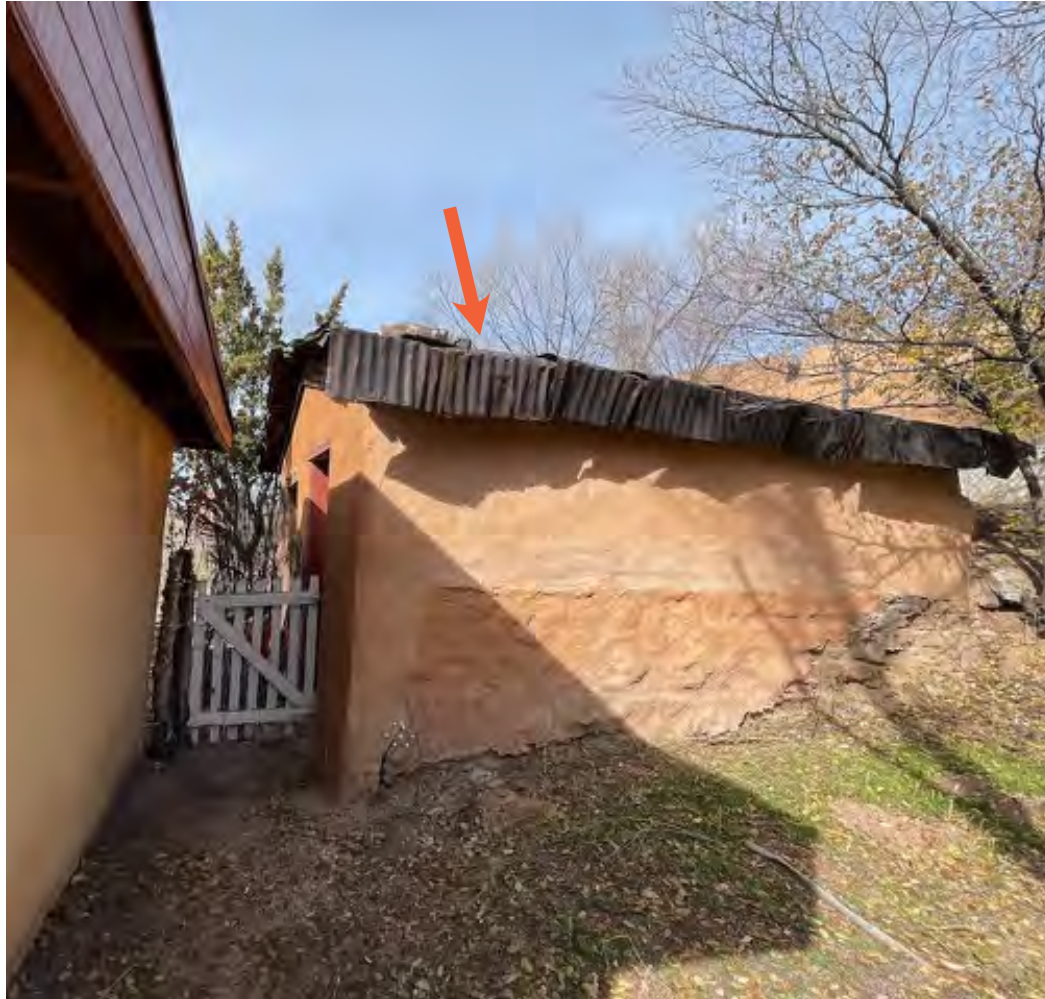
VIEW FROM EAST

ADOBE BRICK DETERIORATING, NO FOUNDATIONS  
(STRUCTURAL CONCERN)

NORTH WALL IS ACTING AS A RETAINING WALL  
(STRUCTURAL CONCERN)

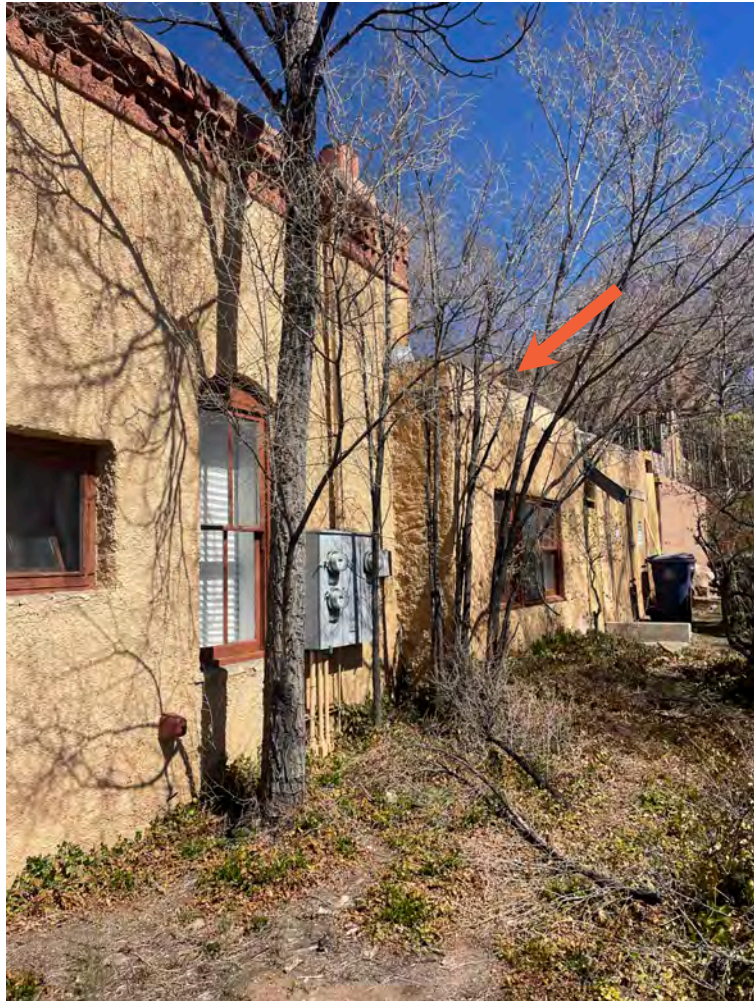
**DISTINCTLY LOWER HEIGHT & WINDOWS**

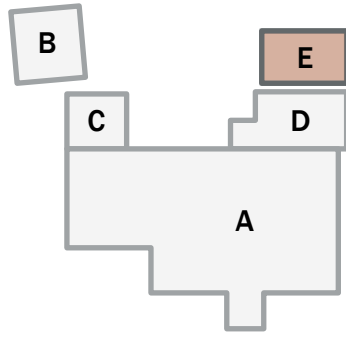
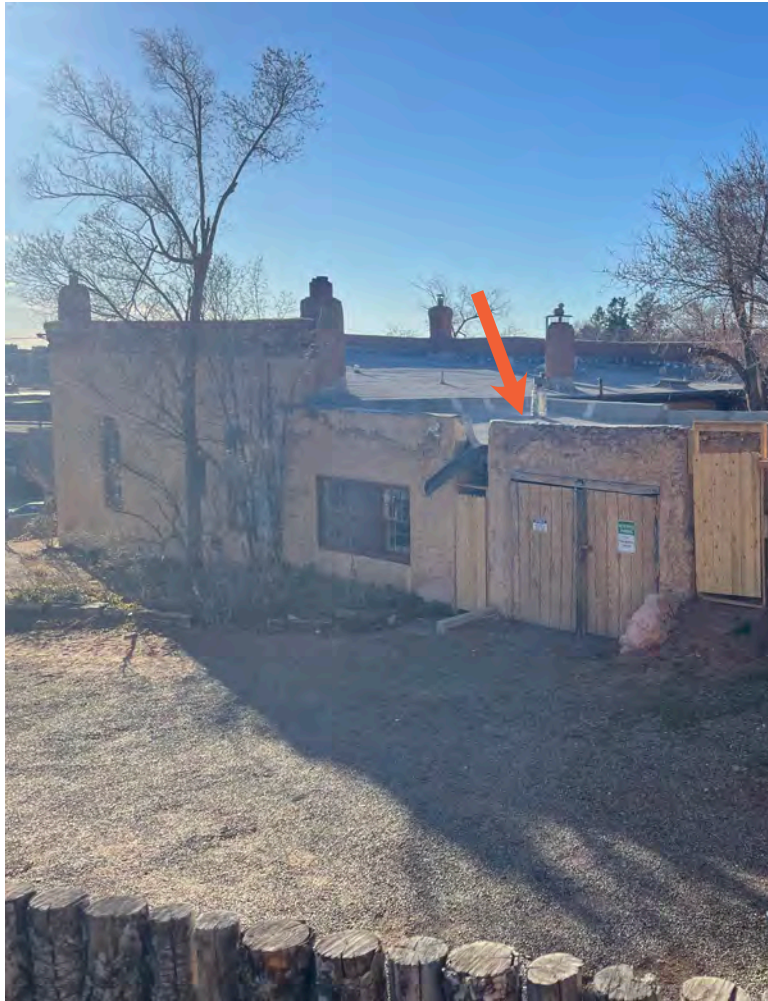
**Concerns — Existing Additions**

**DISTINCTLY LOWER HEIGHT**
