Luchini Trujillo Structural Engineers, Inc.

May 20, 2025

Re: Residence @ 515 Paseo Del Peralta, Santa Fe, New Mexico 87505

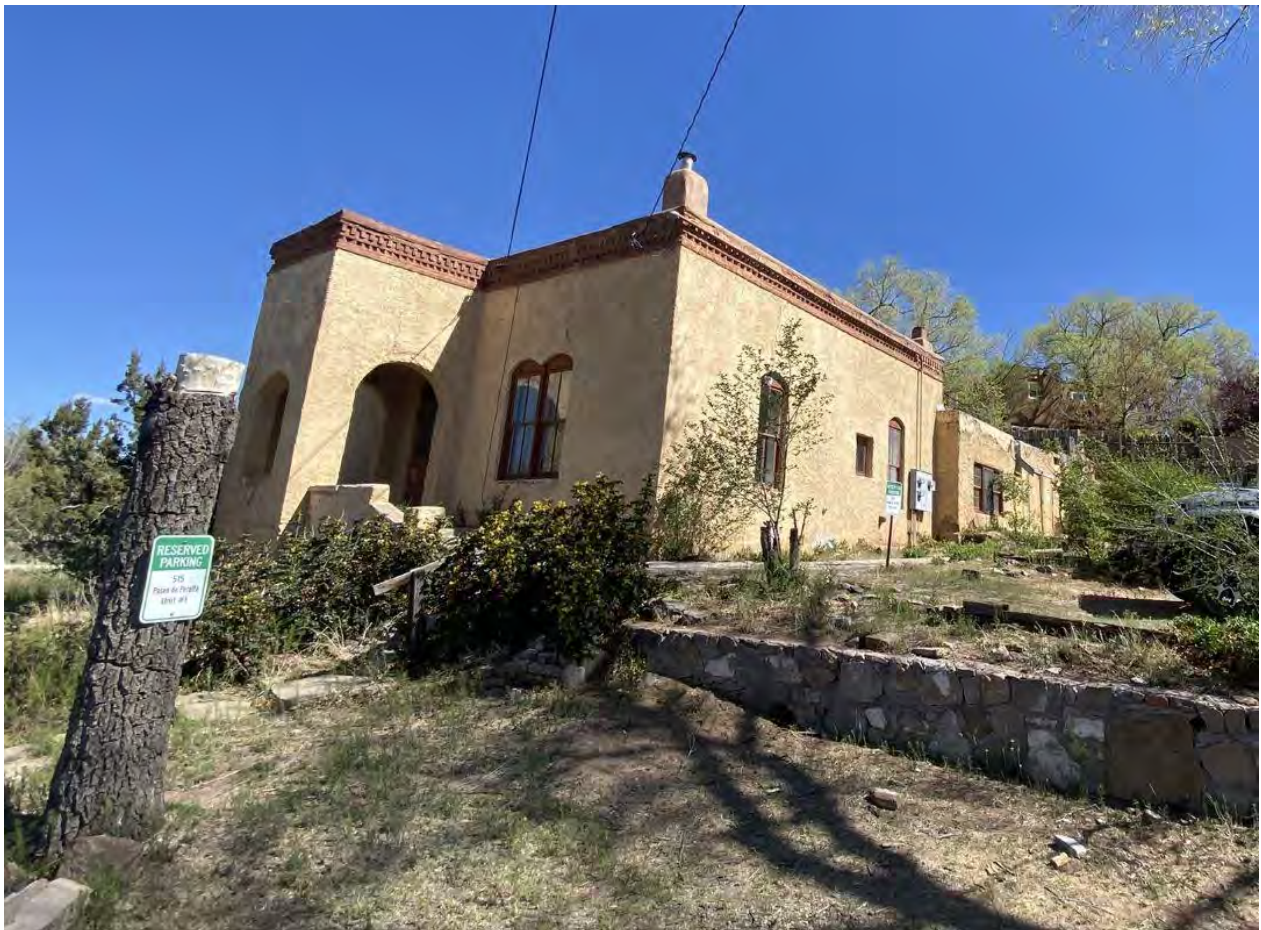
This letter is to acknowledge that I conducted a site visit on April 16, 2025. The purpose of the site visit was to observe the existing condition of the residence and provide an overall opinion regarding its structural integrity. The attached floor plan has been provided by DNCA Architects and is used to identify locations of structural damage herein. The floor plan includes identification of floor framing information and observed structural deficiencies/concerns throughout the property.
