NEW MEXICO HISTORIC BUILDING INVENTORY - SANTA FE RESURVEY 1993

IDENTIFICATION	ADDRESS: <u>121 E. Santa Fe</u>	ID NUMBER: <u>051600030</u>
	BUILDING NAME:	
	UTM REFERENCE EASTING NORTHING ZONE <u>12 13</u>	LEGAL DESCRIPTION: TNSP <u>17</u> (N) S RANGE <u>9</u> (E) W SEC <u>25</u> NW 1/4 NE 1/4
FIELD MAP <u>Santa Fe Historic Structures Survey, 1983-85/1992</u>

NEW MEXICO HISTORIC BUILDING INVENTORY - SANTA FE RESURVEY 1993 (concluded)

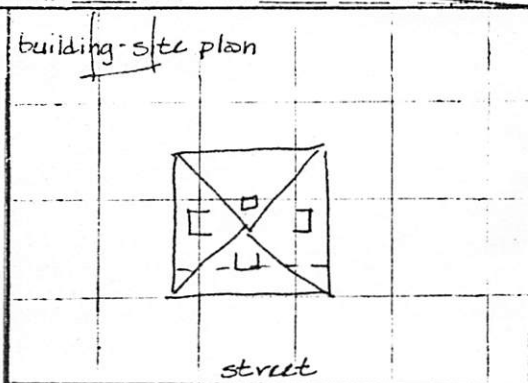
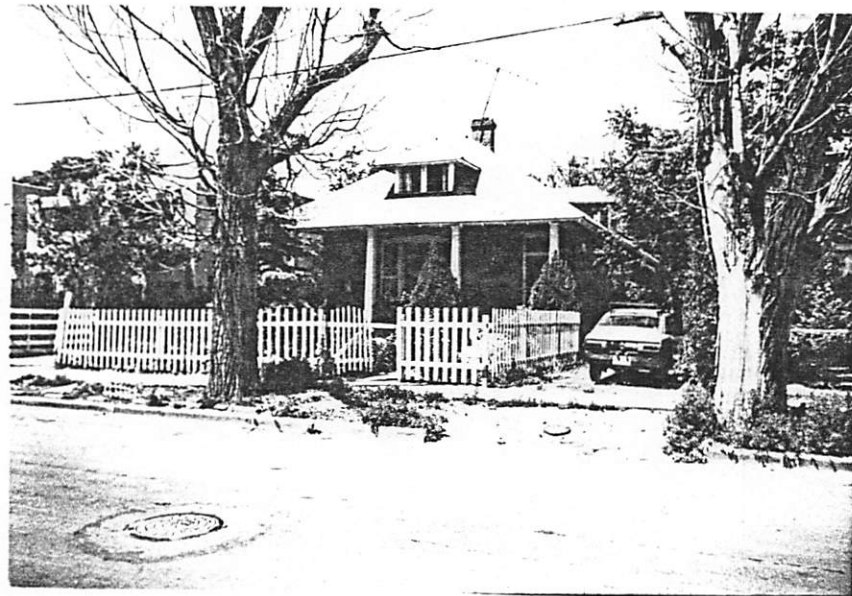
style one Bungalow	foundation material stone
	wall material/surface brick-red

architectural features hip dormers - shingled clapboard porch posts
---

comments slight arches d/A wd triple front window 1936 cd - King ES 1928 cd - Berry FA mgn Bng to Lumber 1912 Kings map - Dunleavy
---
