# Historic Cultural Properties Inventory (HCPI) Base Form (FORM 1)

For HPD Office use only:		District No. _____		NRHP	SRCP	Criteria	A	B	C	D
<b>1. Name of property:</b>  Edward and Mary Vigil House Ed's Appliance Service		<b>2. Location:</b>  925 Canyon Road Downtown and Eastside Historic District - Santa Fe			<b>3. Local Reference Number:</b> Santa Fe ID: H-1117					
<b>5. Property Type:</b> <input checked="" type="checkbox"/> Buildings: 1 house, shed <input checked="" type="checkbox"/> Structures: walls <input type="checkbox"/> Site <input type="checkbox"/> Object

<b>6. Date of Survey:</b> September 8, 2025										
<b>7. Previous Survey Date(s):</b> <input checked="" type="checkbox"/> Yes: November 7, 1984, Michael Belshaw <input type="checkbox"/> No:										
<b>8. Name of Project:</b> HDRB Status Evaluation										
<b>9. Lat/Long:</b> 35.6798765,-105.9246747										
<b>10. Photo Information:</b> Giulia Caporuscio, photographer. Photo 1: View of south elevation from Canyon Road. Camera facing north.

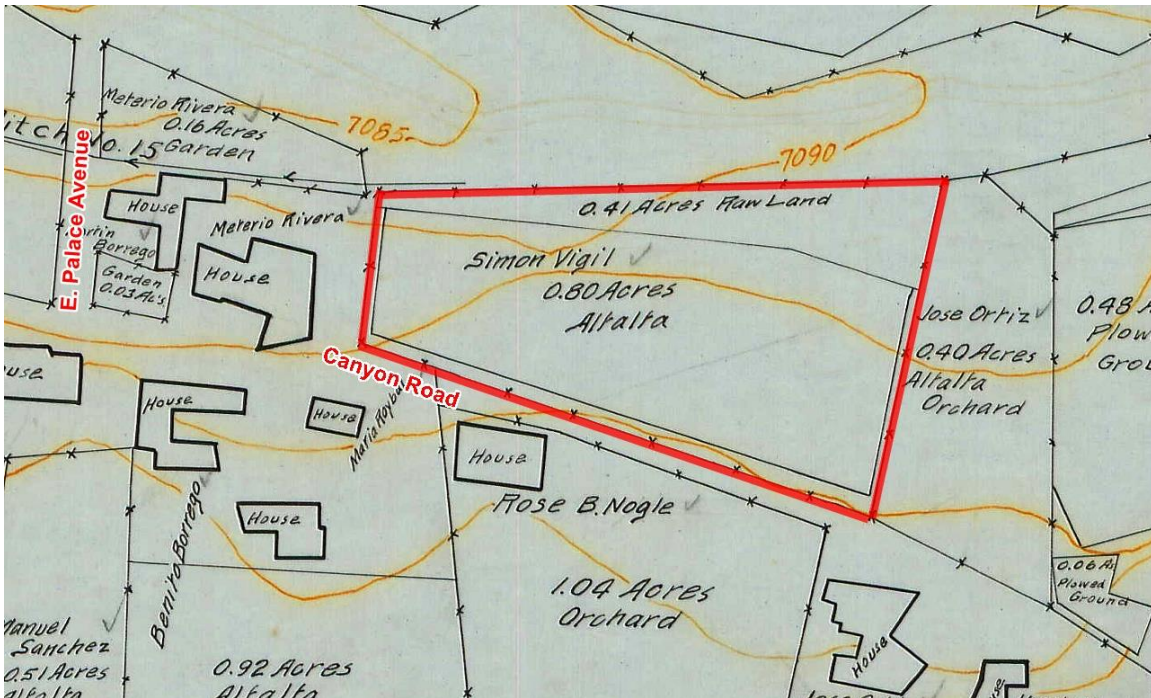
The land that Edward used to build his home was originally an acequia irrigated field owned by his great-grandfather Simon Vigil and perhaps traced further with the Vigil family (Fig. 1). Born in 1833, Simon Vigil initially worked as carpenter, who later became a prosperous sheep rancher and a Santa Fe Trail freighter. He served in the U.S. Army in New Mexico, both in the infantry and cavalry regiments, including the Civil War. According to his obituary, Vigil owned extensive land on the Eastside.<sup>2</sup> The 1897-98 White's map shows the larger property owned by Francisco Sena. It is unclear how or when Simon Vigil acquired the land.

**Figure 1: State Engineer's Office, "Santa Fe Hydrological Survey," [series of maps] (Santa Fe: State Engineer's Office, 1914 (published 1919). Land under the ownership of Simon Vigil.**

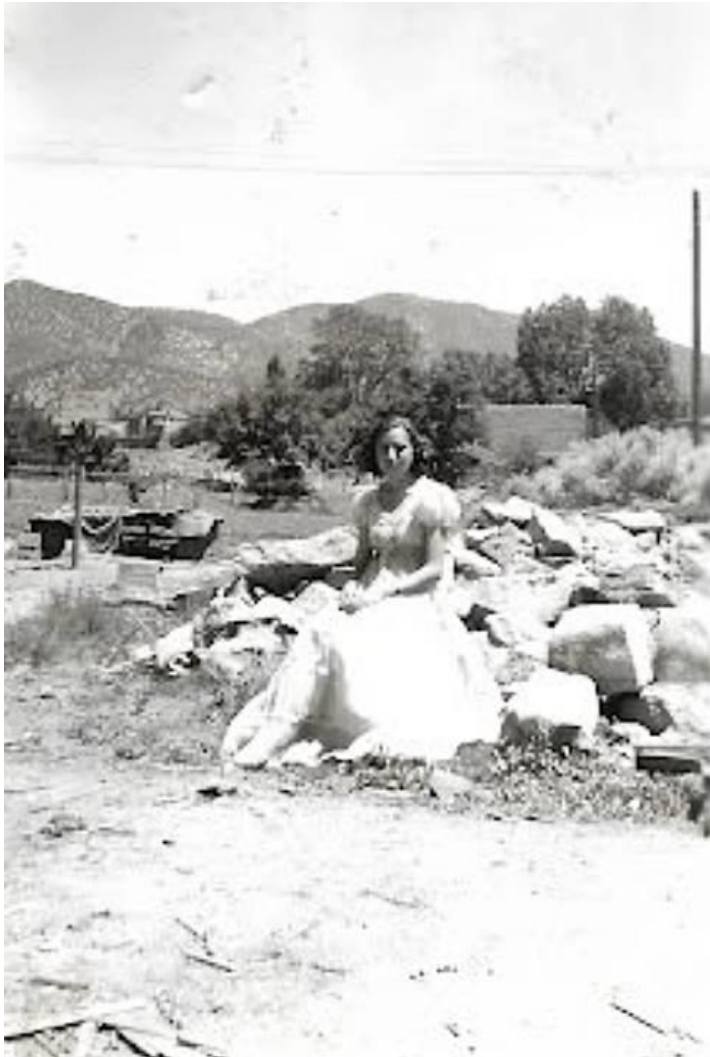
**Figure 3: c.1950s. Unidentified Vigil family members posed at the site that would become 925 Canyon Road. The house at 943 Canyon Road is visible in the background. Courtesy of Frank Vigil.**

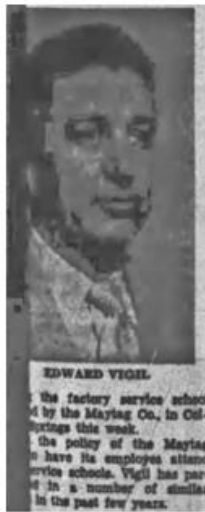
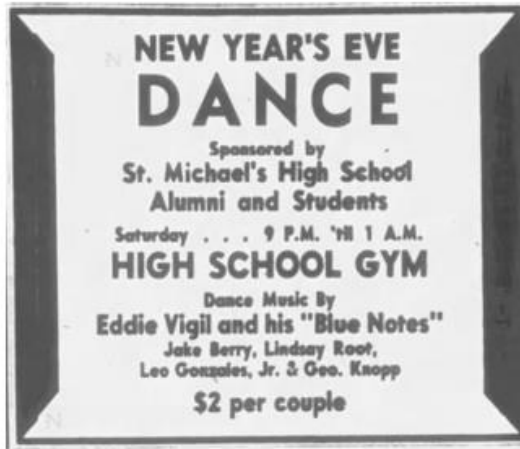
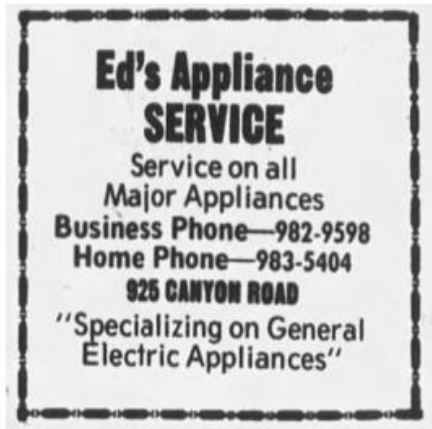
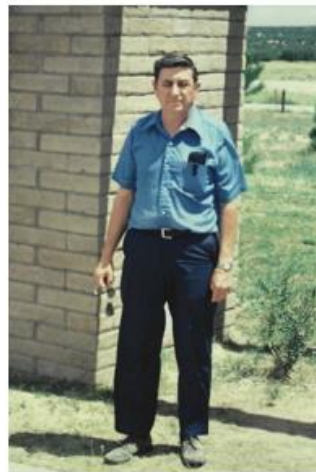
In the early 1950s, Edward had gone to work at the Maytag Shop, a dealership on Lincoln Avenue operated by the McCauley family. Maytag was then one of the most trusted appliance brands in the country, promoting itself as "the dependability people." The company developed a strong network of independent dealerships, with local shops offering both sales and factory-trained service. Edward attended Maytag's factory service school in Colorado, gaining specialized training in appliance repair.<sup>6</sup> During this period, he formed a popular dance band, the Blue Notes (sometimes billed as Eddie Vigil and his "Blue Notes"), in which he played guitar; the group remained active into the 1960s (Fig. 4).

**Figure 4: Edward Vigil materials, clockwise from top left: newspaper portrait of Vigil, Santa Fe New Mexican, 1954; Blue Notes' advertisement for New Year's Eve dance, Santa Fe New Mexican, 1955; advertisement for Ed's Appliance Service, Santa Fe New Mexican, 1973; photograph of Vigil c. 1970s, courtesy Russel Asbury.**

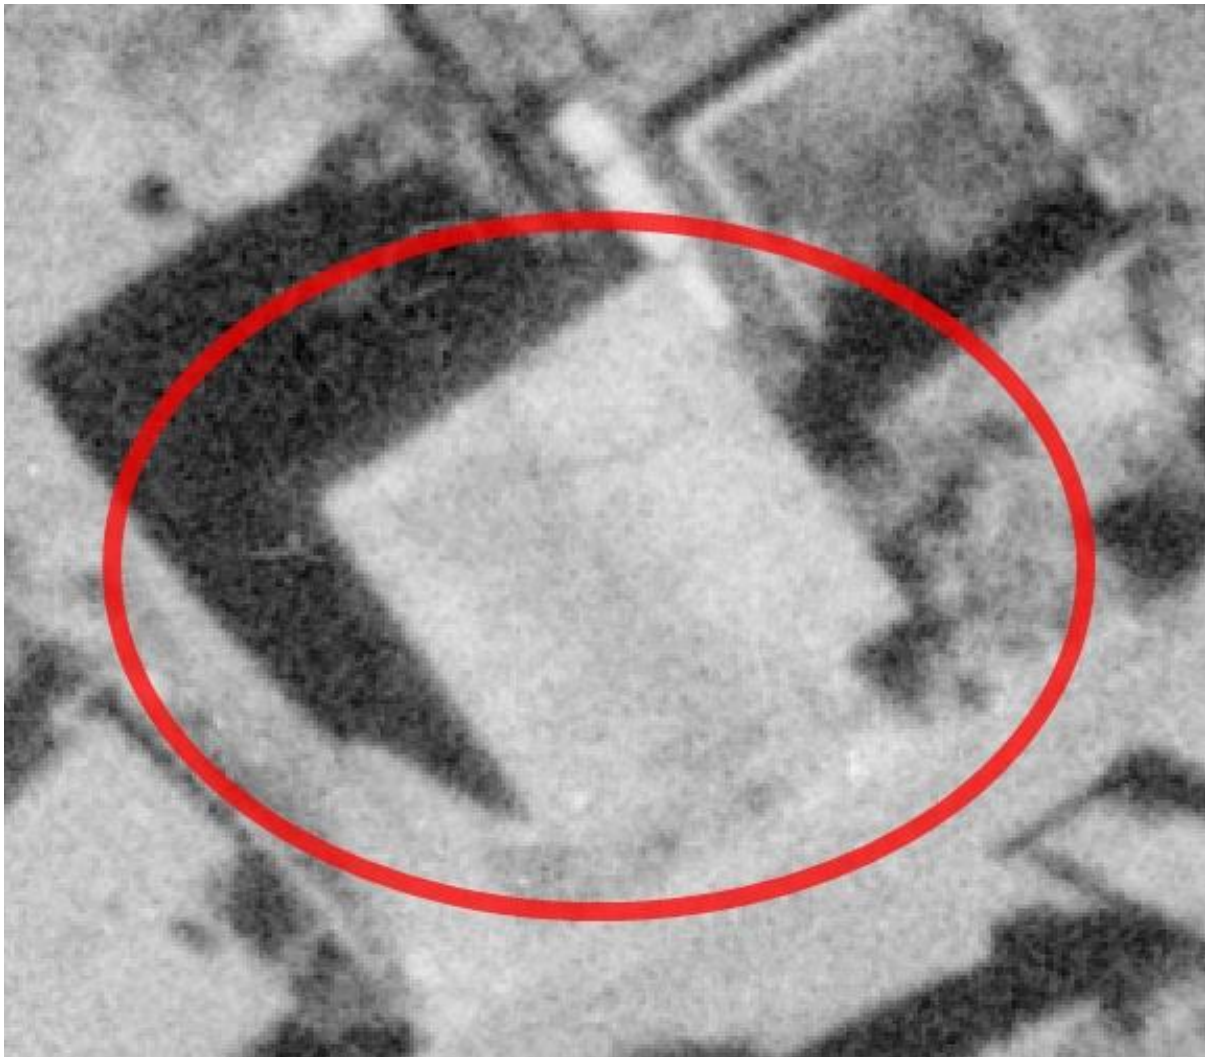
In the 1950s, Edward Vigil, a Maytag repairman, began building a house on an empty lot along Canyon Road, near his family home. Born Eduardo Isidro Vigil in 1924, Edward had his hands full with work and little money to spare. With help from his father, Jacobo (Jake) Vigil, and other relatives, he managed to raise the foundation and walls, but could not take the project any further. He capped the structure with a temporary roof and boarded the window openings with plywood to keep children out. According to his nephew, Frank Vigil, the unfinished house stood in this state for five to six years.<sup>1</sup> This explains its presence on a 1958 aerial photograph (Fig. 5), but its absence from city directories until the early 1960s.

**Figure 5: November 10, 1958, aerial photograph. Apparently unfinished house.**

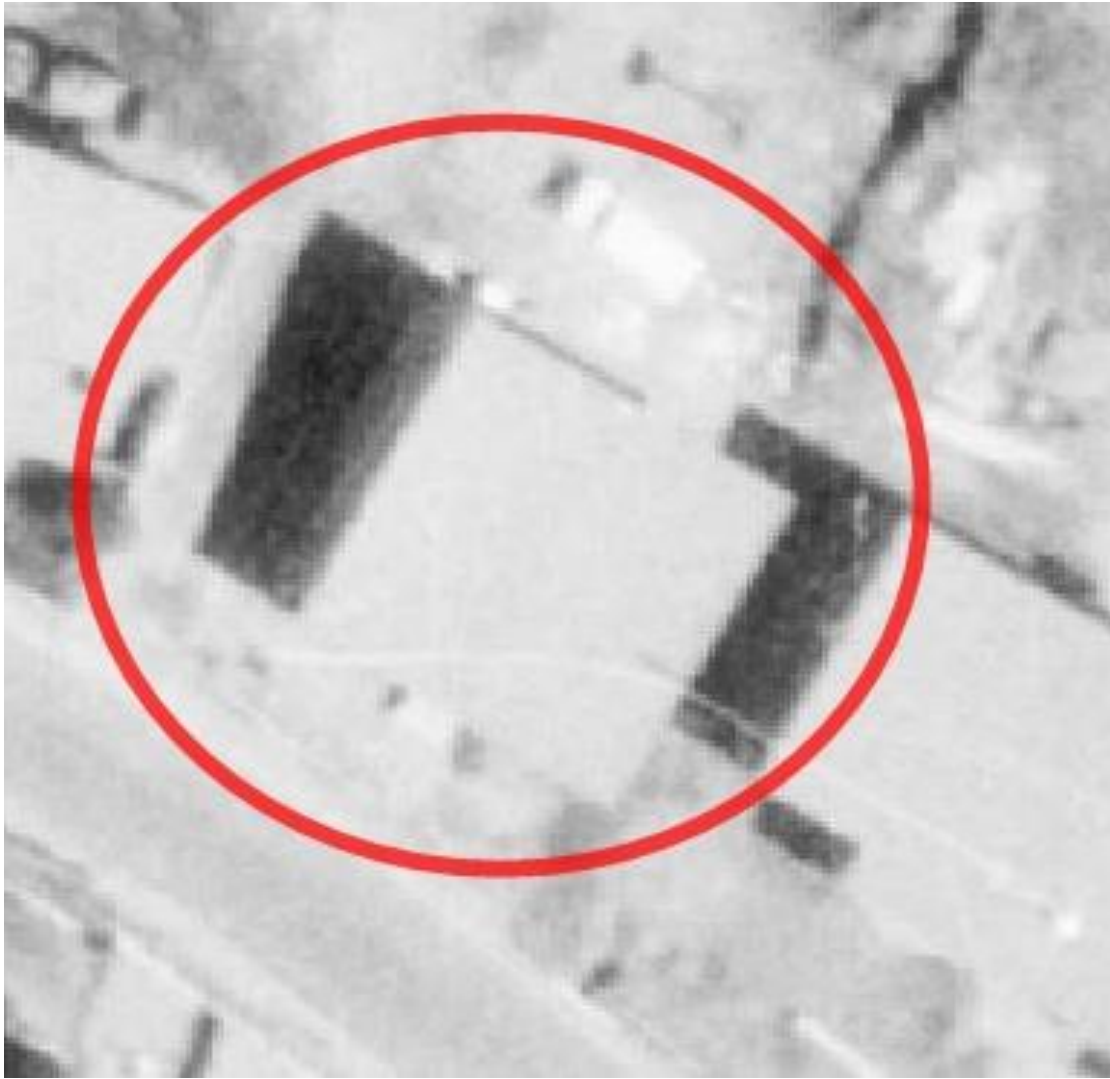
**Figure 6: May 2, 1966, aerial photograph. Completed home without west addition or porches.**

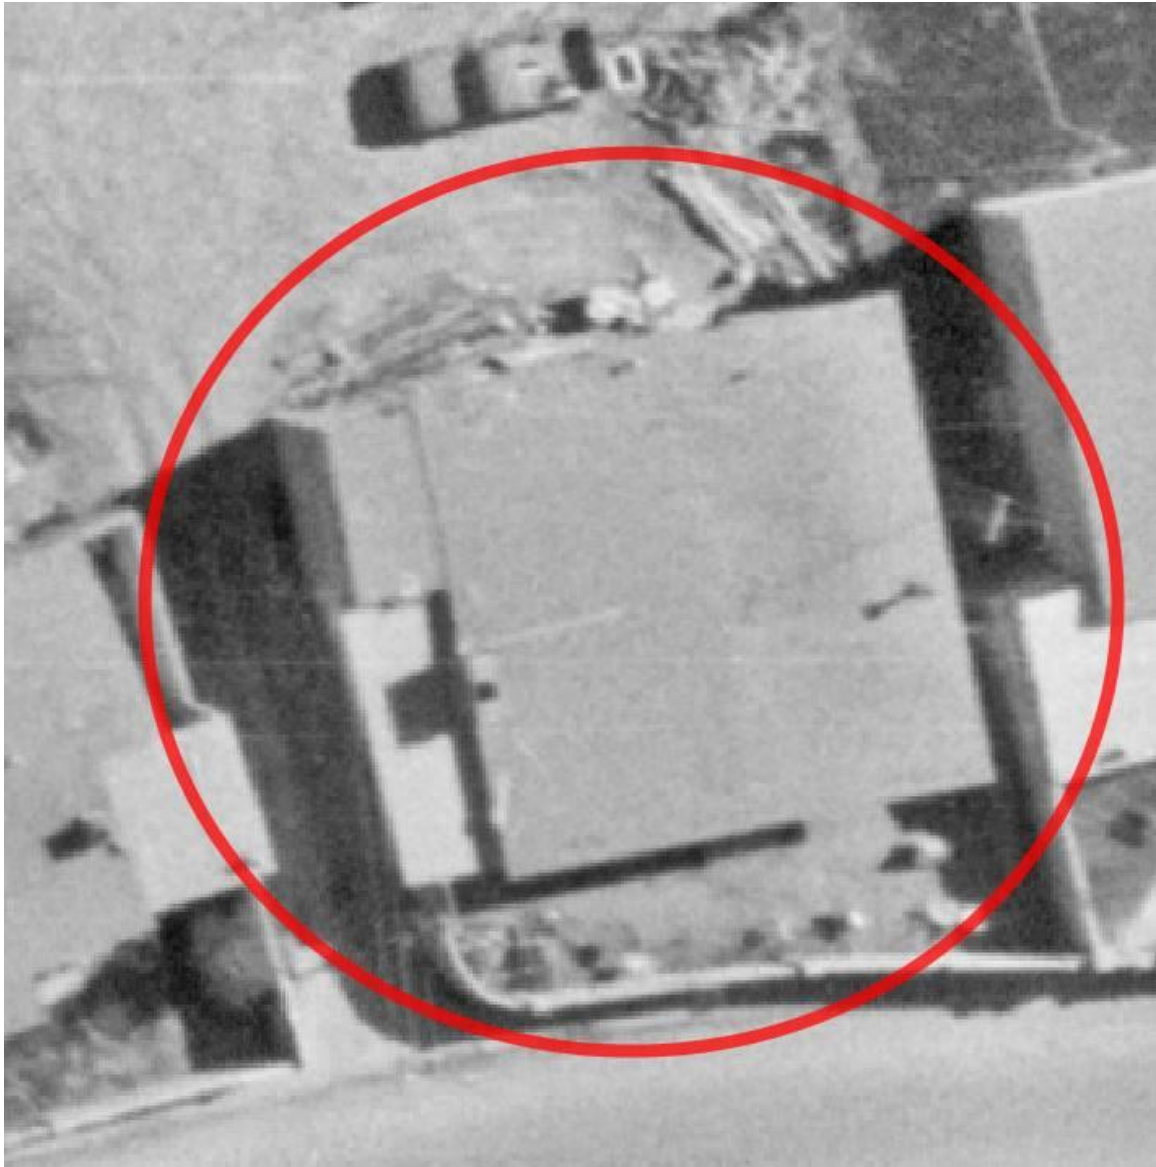
**Figure 7: May 11, 1973, aerial photograph. West elevation addition and porch and front wall in place.**

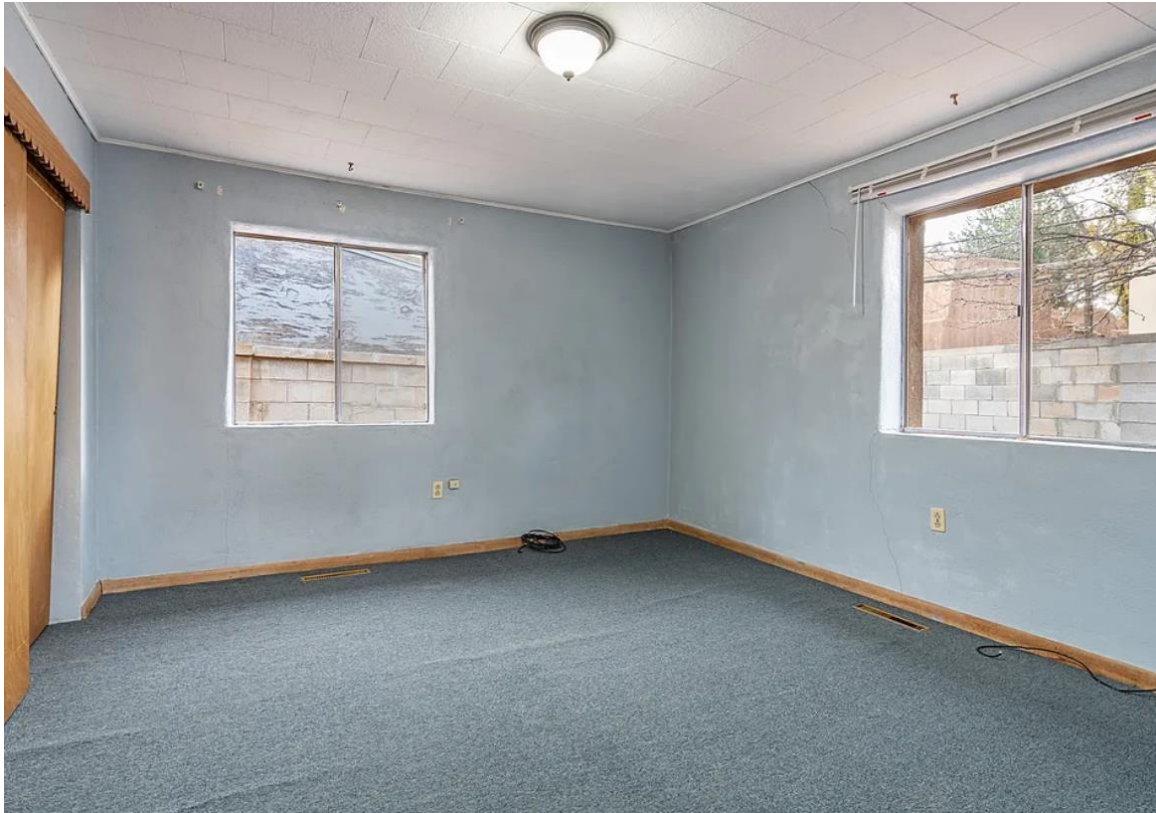
The interior was not accessed during the survey, but a review of recent real estate photographs provides a sense of its surviving midcentury finishes. For example, the front bedroom reflects the modest residential design of the period: the space is finished with wall-to-wall carpet and small rectangular floor registers, a simplified wood baseboard trim, and aluminum sliding windows with minimal hardware. The ceiling is clad in square acoustical tile, fitted with a modern light fixture (Fig. 8). Along one wall is

**Figure 8: Southeast bedroom. 2025 real estate listing photo. Photographer unknown.**
