MEMORANDUM

RE: 515 Paseo de Peralta

Subject: HDRB Demolition Review – 515 Paseo de Peralta

File: 515 PdPeralta_A100 Plans 250331.vwx
Set: Schematic Design Set
Sheet Title: EXISTING FLOOR PLAN w/ STRUCTURAL DEFICIENCIES

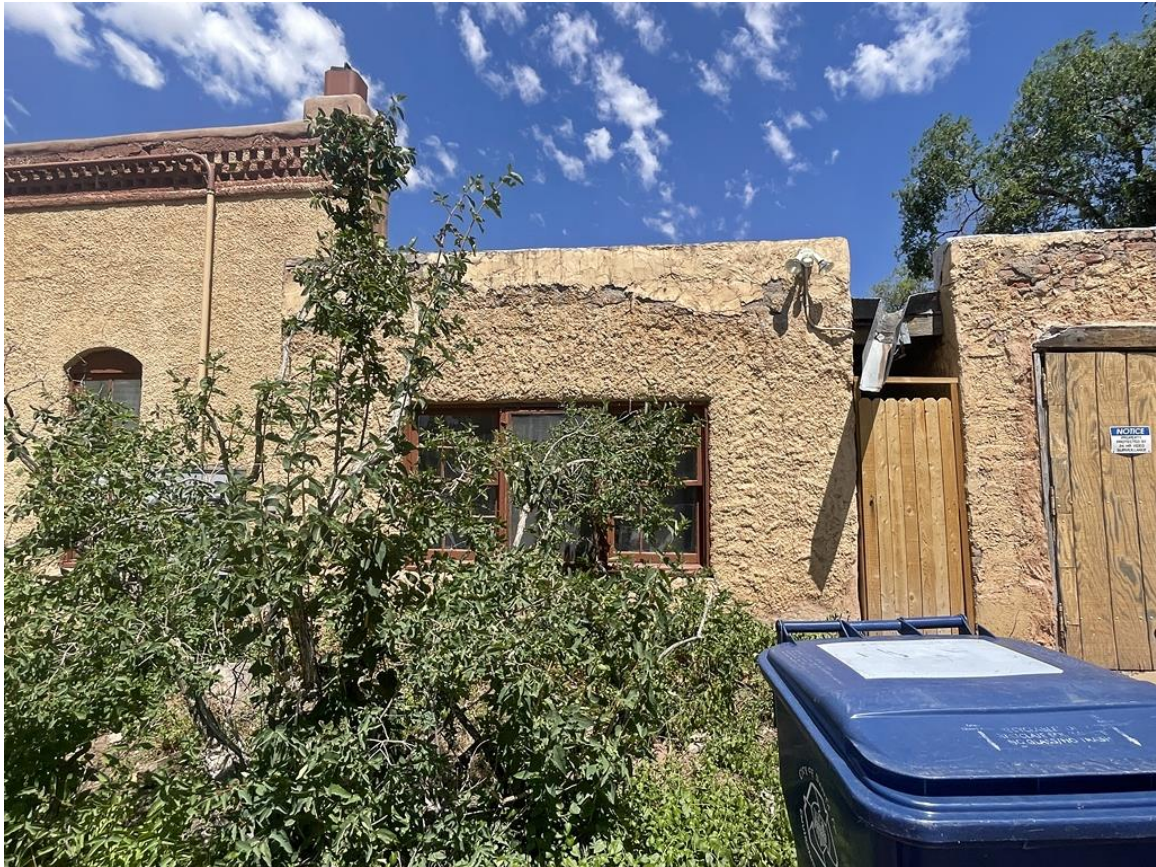
Projecting approximately three feet from the façade is a structure identified as a garage on the 1930 Sanborn Fire Insurance Map (Fig. 6). Constructed of stone and set at a lower elevation, it features a grouping of three 6/6 wood sash windows, some of which are missing muntins (Photos 7 & 8). This section of the elevation appears to be in deteriorated condition.

Photo 8: East elevation. Original garage at center. Camera facing northwest.

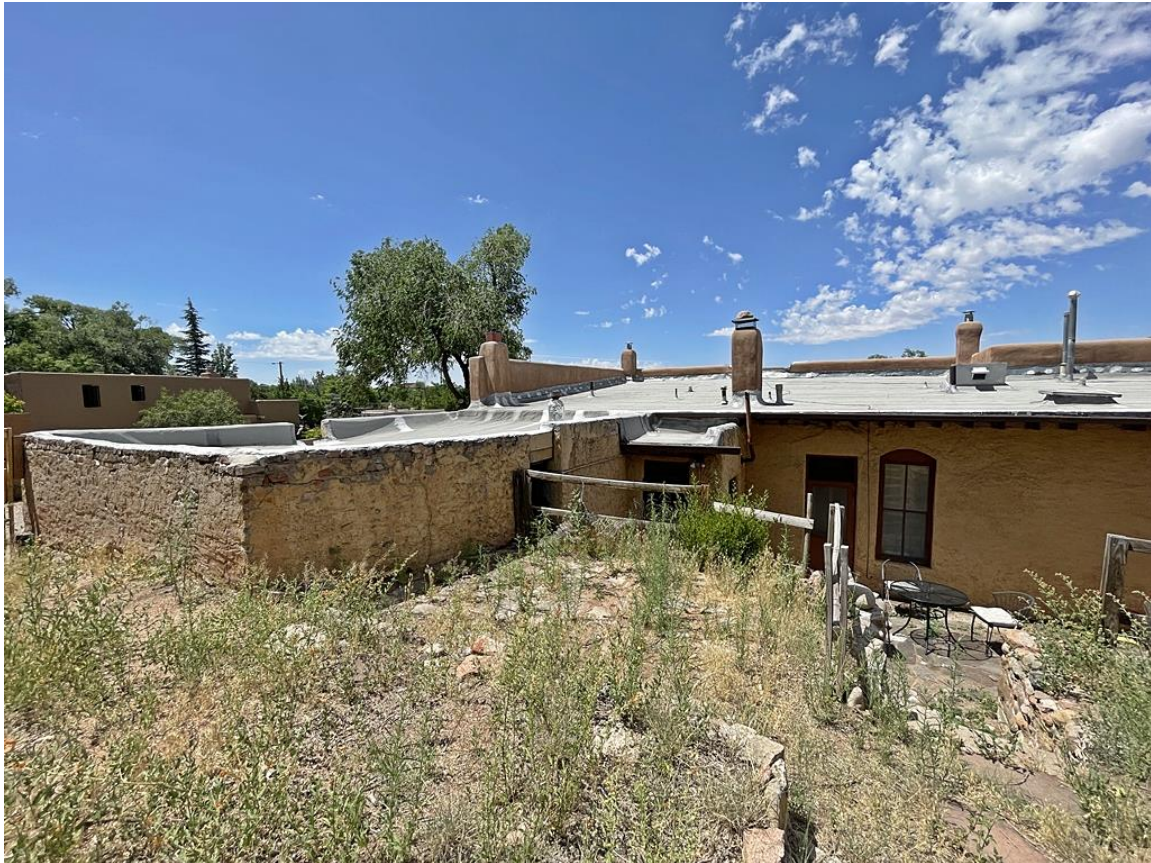
Separated from it by a narrow walkway is the final element of the south elevation: a one-bay stone garage partially built into the hillside (Photos 9 & 10). It is accessed through a pair of non-historic outswing doors constructed of vertical wood boards. Based on the 1943 drawing, this second garage was already in place by that time. It is also in poor condition.

Photo 10: Combined garages. North and west elevations. Camera facing southeast.

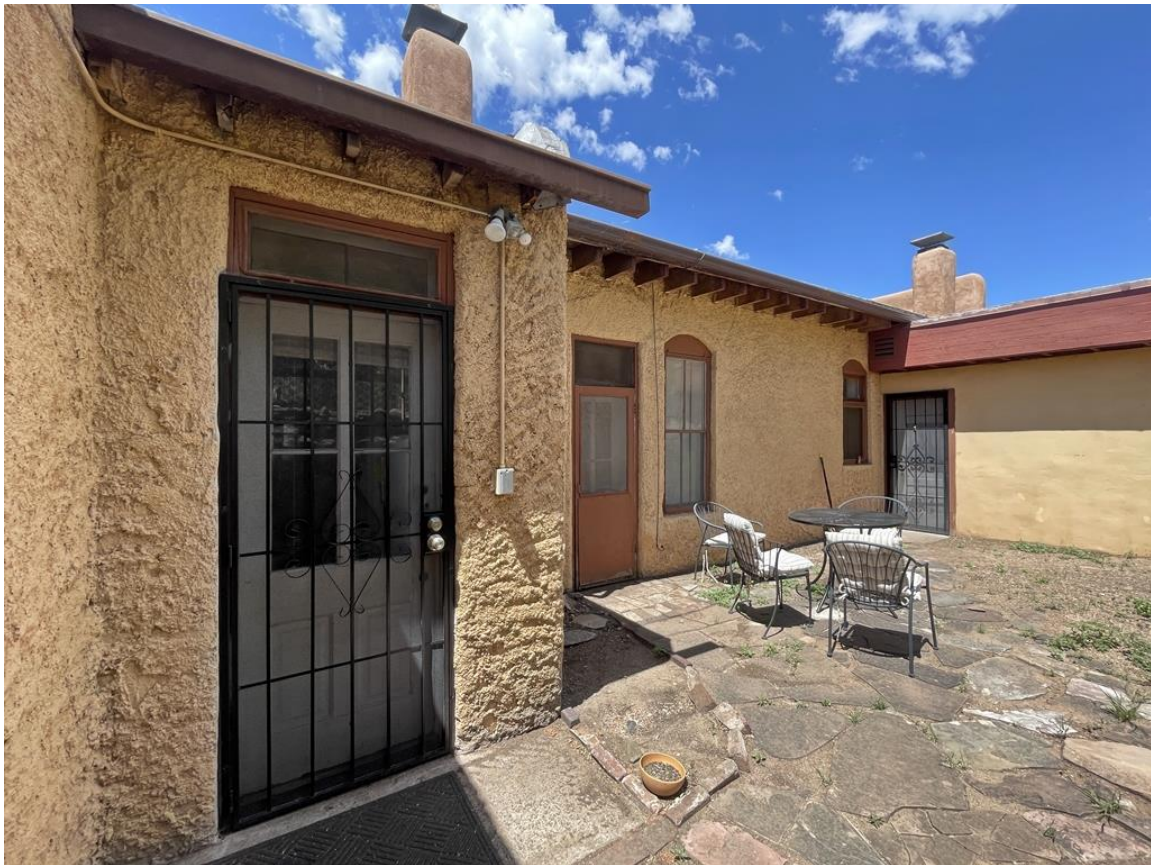
The central portion includes a double-light wood door with transom, protected by a wood screen door. To the west are two older wood sash windows (one converted to a hopper) with segmental-arched heads. Projecting from the east is the original garage, fenestrated on the north with a four-light and wood panel entry door with a transom, and on the west a single 6/6 wood sash window (Photos 11 & 12).

Photo 12: North elevation. Original garage (left); bedroom addition (right). Camera facing southeast.

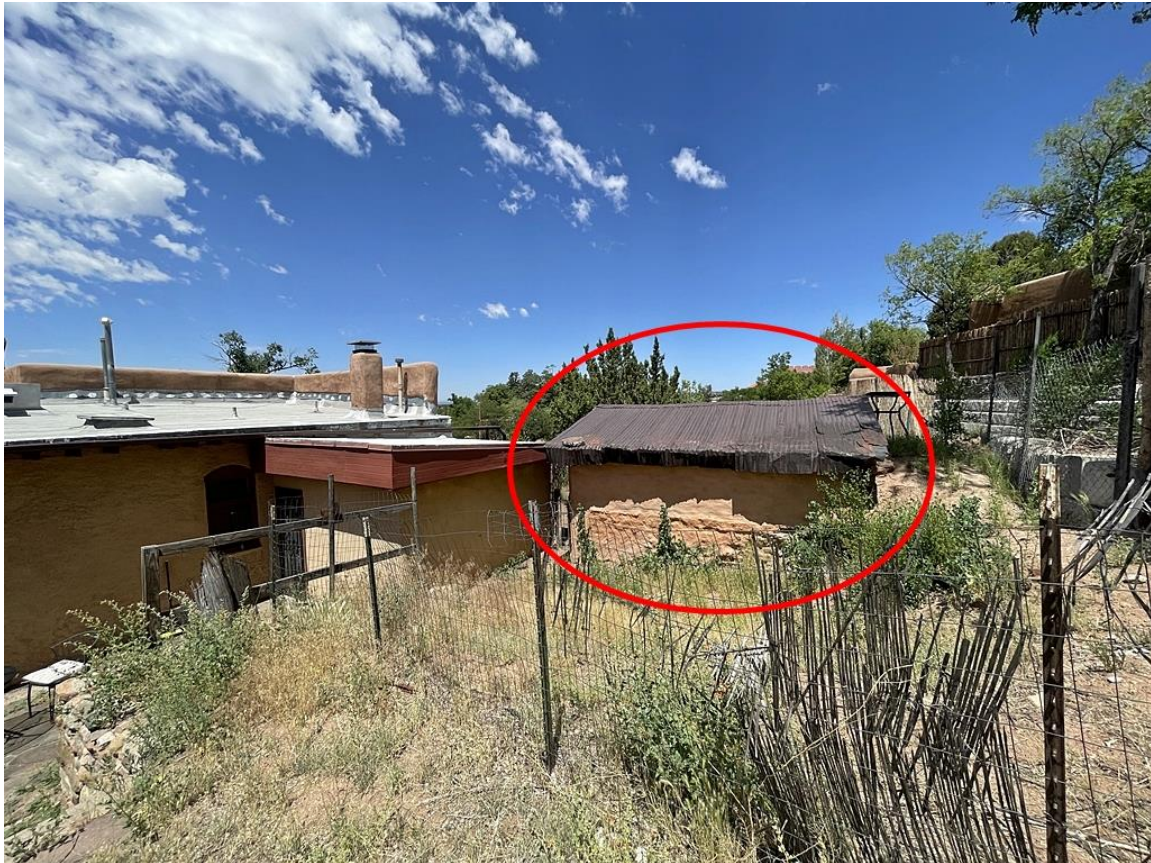
Photo 15: Shed. East elevation. Camera facing northwest.

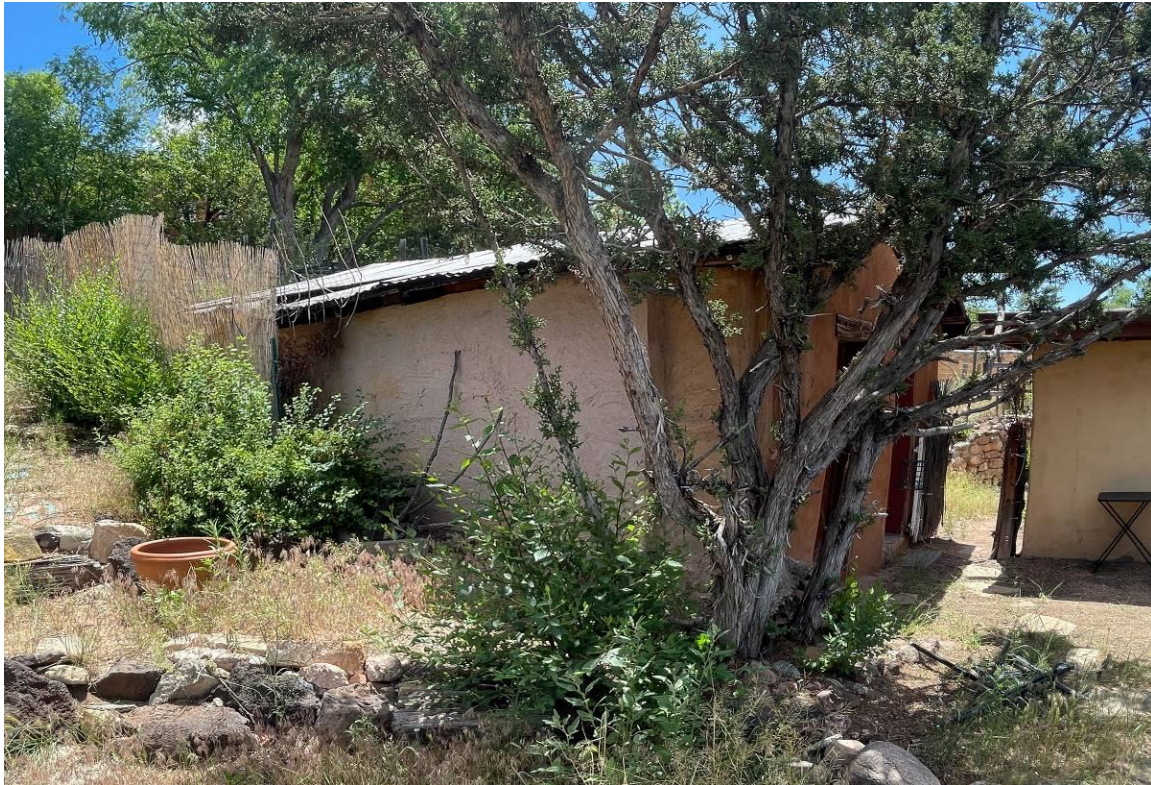
Photo 17: Shed. West elevation. Camera facing northeast.

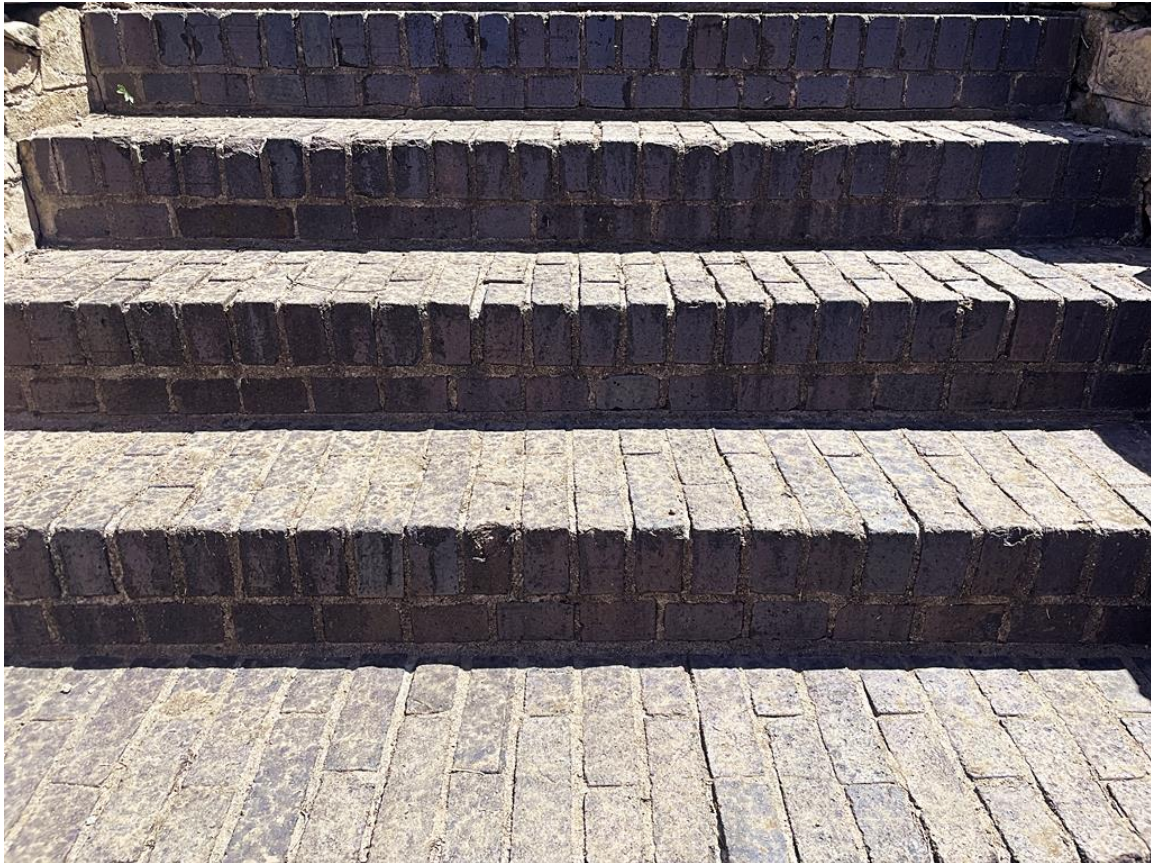
Photo 19: Brick stairs of street entry. Camera facing down.

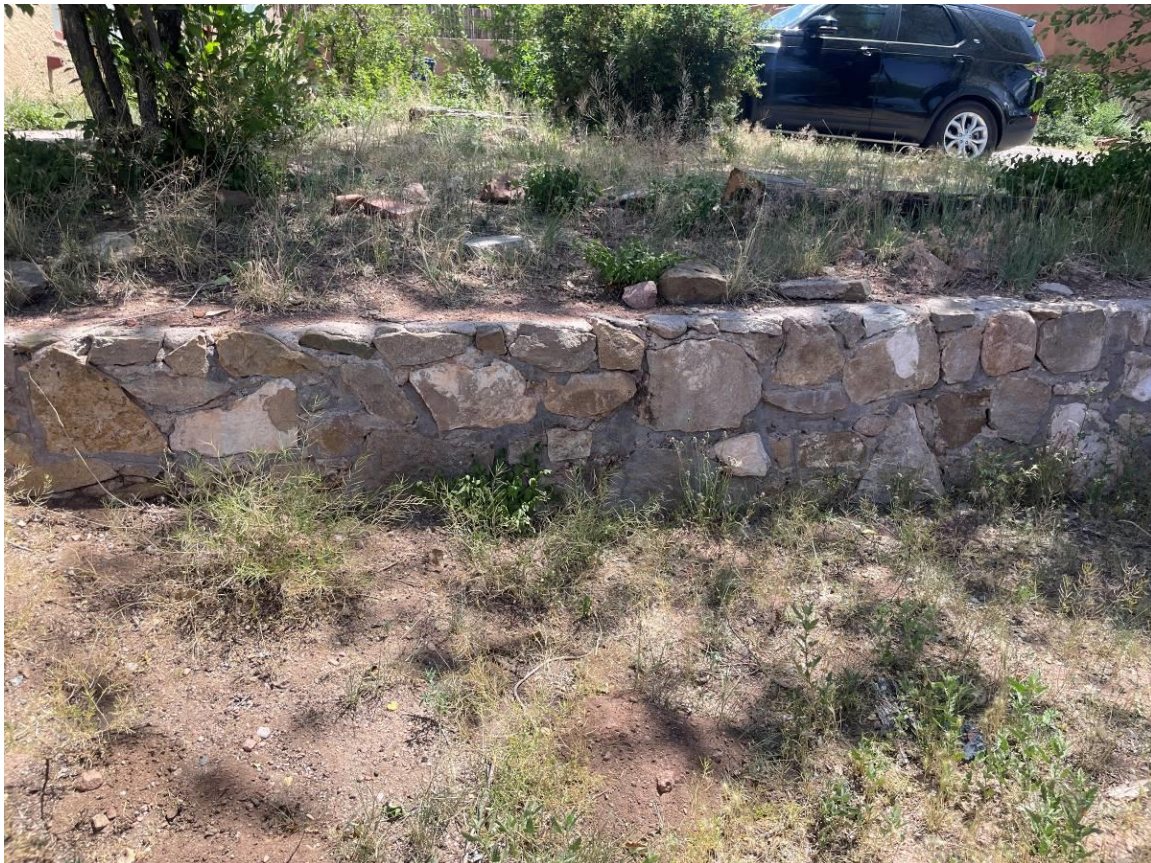
The lot includes additional minor rock retaining walls and stone features that verge on archaeological in character (Photo 21). More recent elements on the property include a low, unstuccoed CMU wall and a coyote fence.

Photo 21: Minor retaining wall. Camera facing southeast.

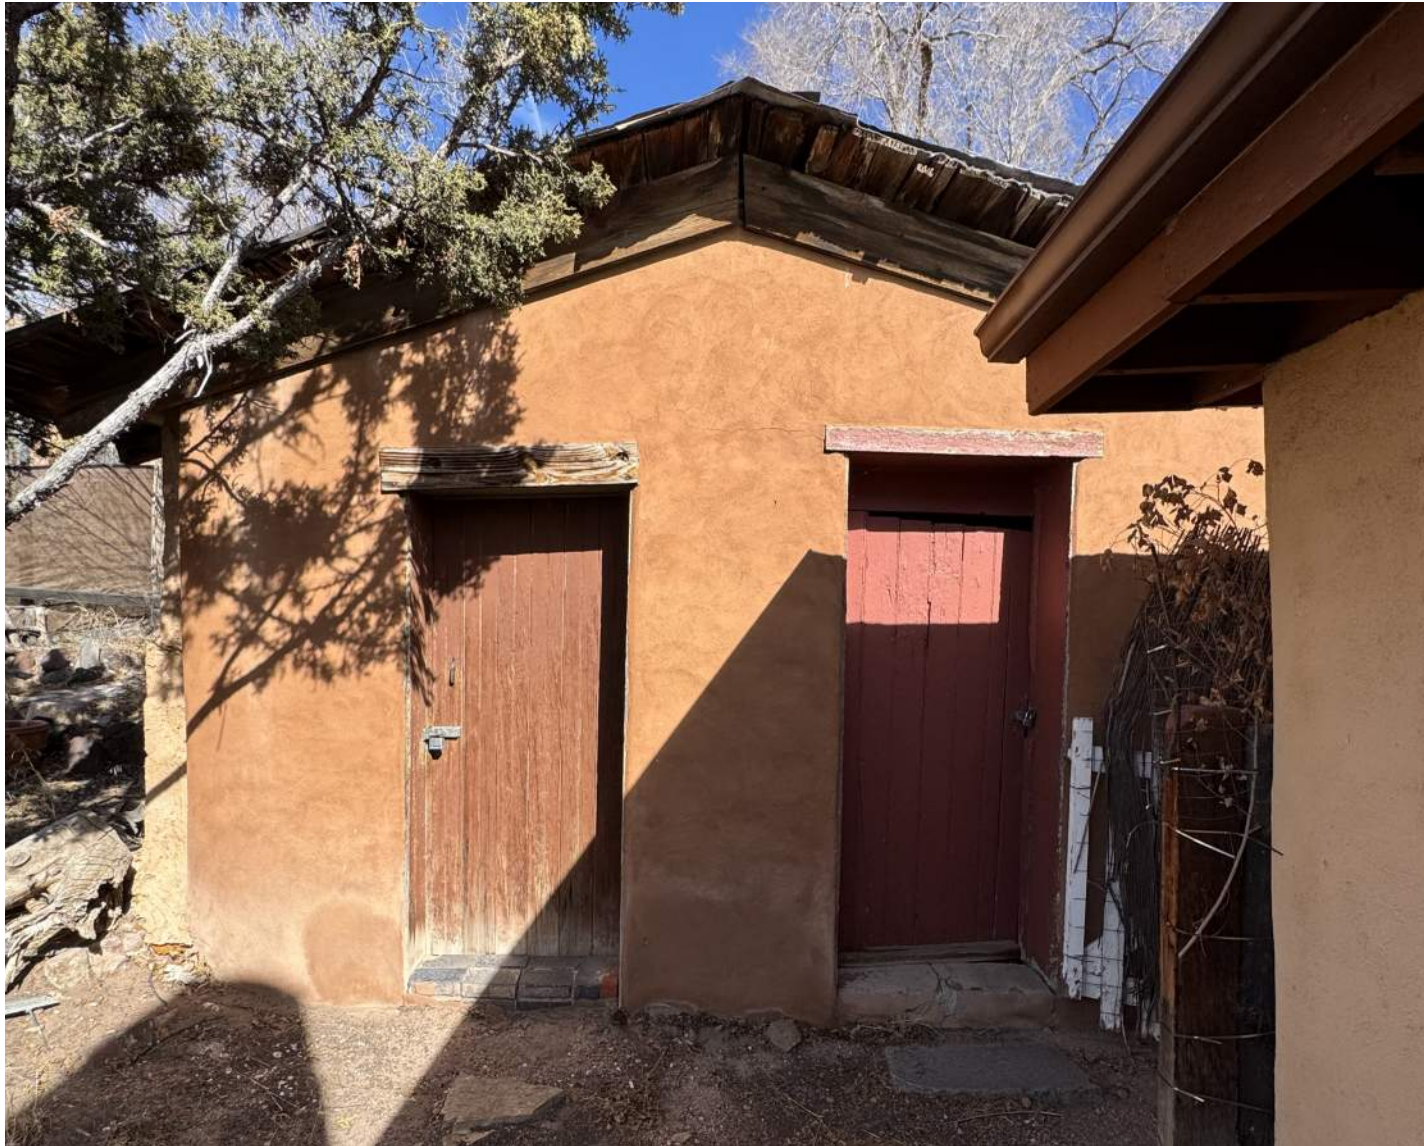
SOUTH ELEVATION

- No foundation or waterproofing
- Unreinforced adobe bricks are retaining up to 6 ft of soil and show significant deterioration
- Structurally unsound, not habitable
- Per structural report, complete reconstruction with foundations and new walls would be required to ensure safe and legal occupation

DEMOLITION PROPOSED

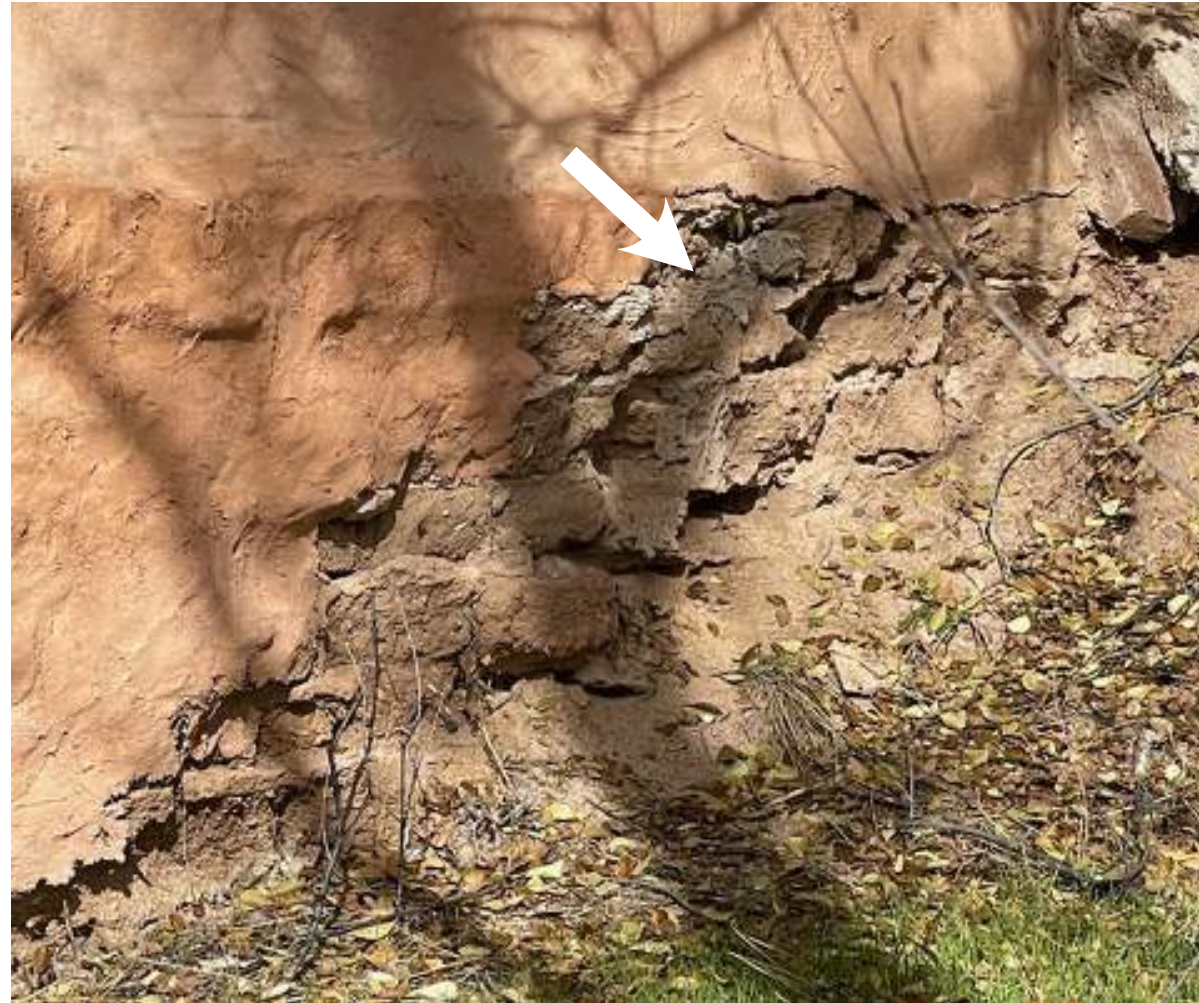
ADOBE BRICK DETERIORATING, NO FOUNDATIONS

#2 A PORTION OF THE SHED WALLS ARE CONSTRUCTED WITH ADOBE. SIGNIFICANT DETERIORATION OF THE ADOBE BLOCK FROM MOISTURE INTRUSION WAS OBSERVED, AND NO FOUNDATION WAS DETECTED.

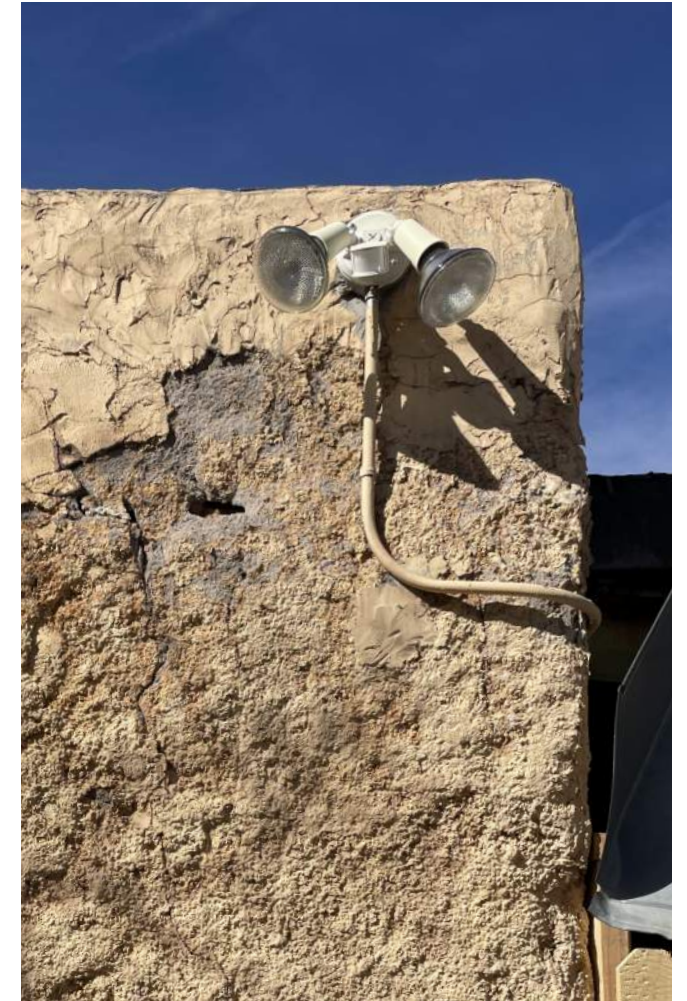
- 210 sf
- Constructed by 1930
- Originally a garage, converted to bedroom during 1950s
- Adobe and stucco addition with shed roof
- Roofline is 6 ft lower than original brick house
- Windows are distinct - horizontal with small panes
- Deteriorated condition

STUCCO DETERIORATION

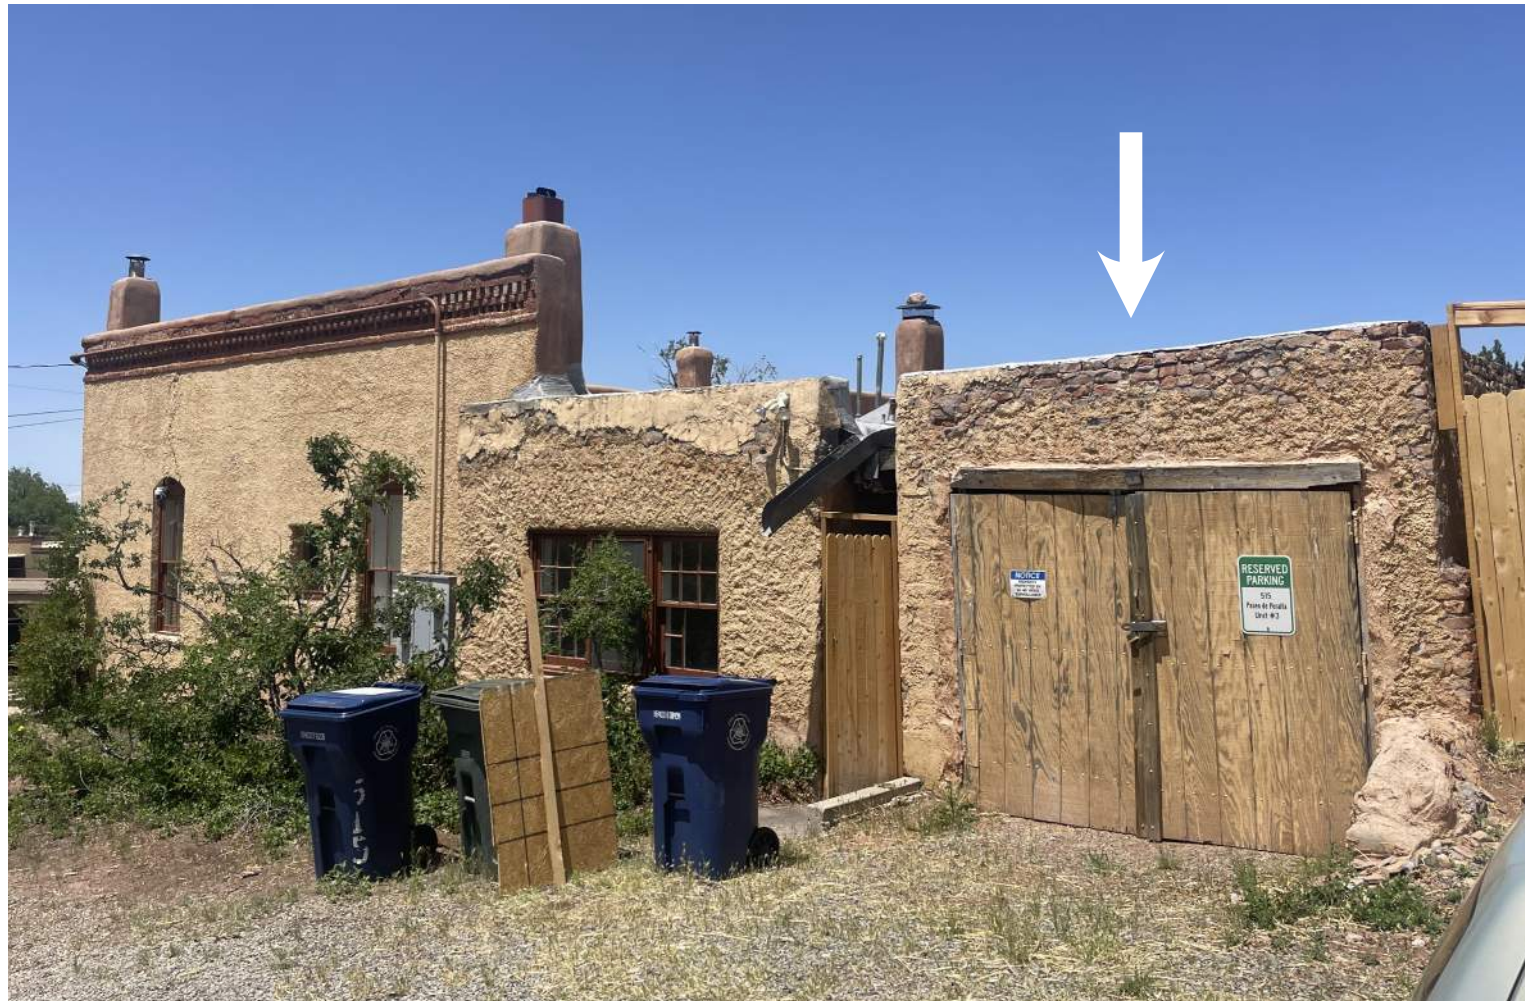
EAST ELEVATION

- No foundation or waterproofing
- Unreinforced walls are retaining up to 6 ft of soil and show significant deterioration
- Stone site wall shows water damage and visibly leans
- Structurally unsound, not habitable
- Per structural report, complete reconstruction with foundations and new walls would be required to ensure safe safe and legal occupation

DEMOLITION PROPOSED

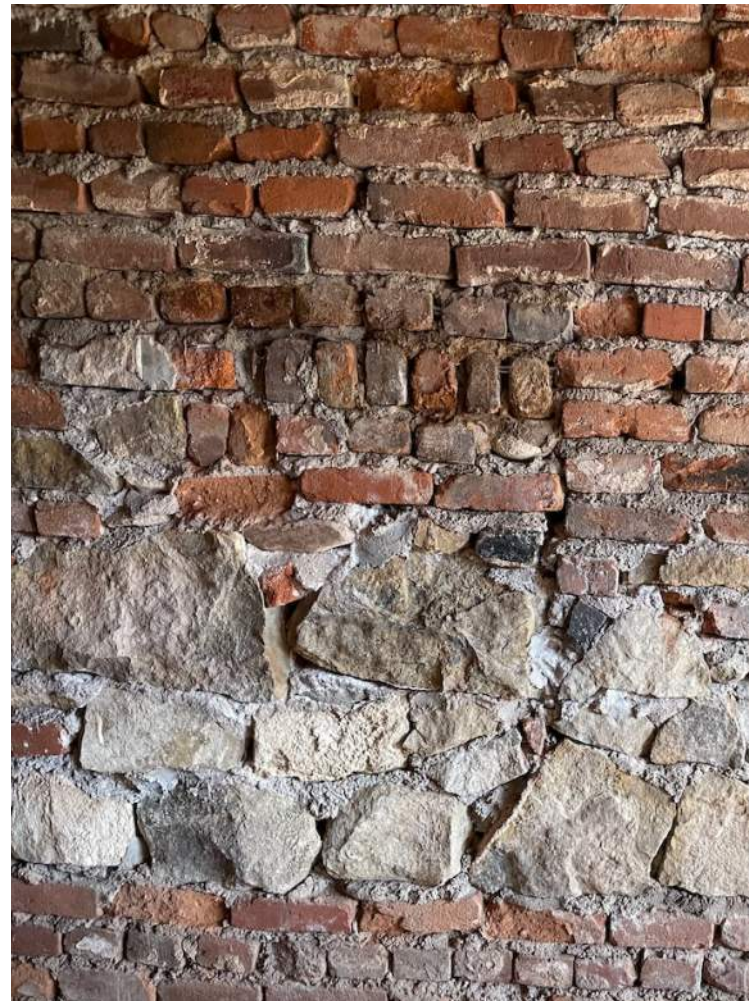
DETERIORATING BRICK

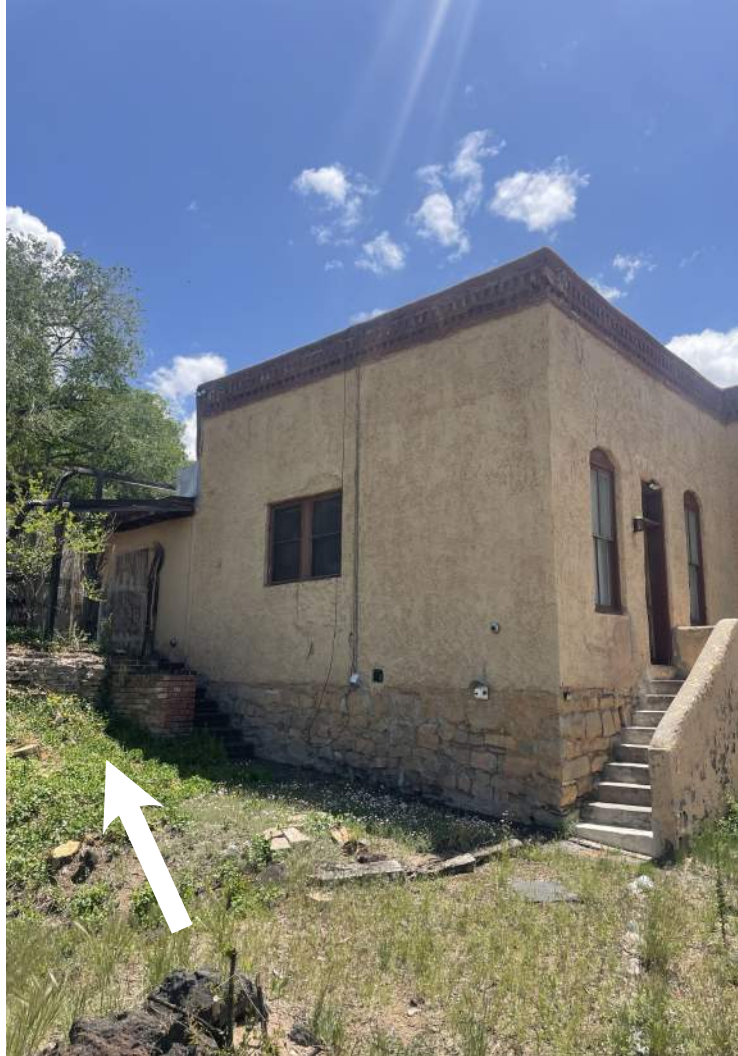
SITE WALL AT WEST ELEVATION

- Ground-level retaining walls and stairs
- Exposed brick and stone
- Brick and low stone retaining walls added after historic house
- Lack of foundations / waterproofing has caused structural instability

DEMOLITION PROPOSED

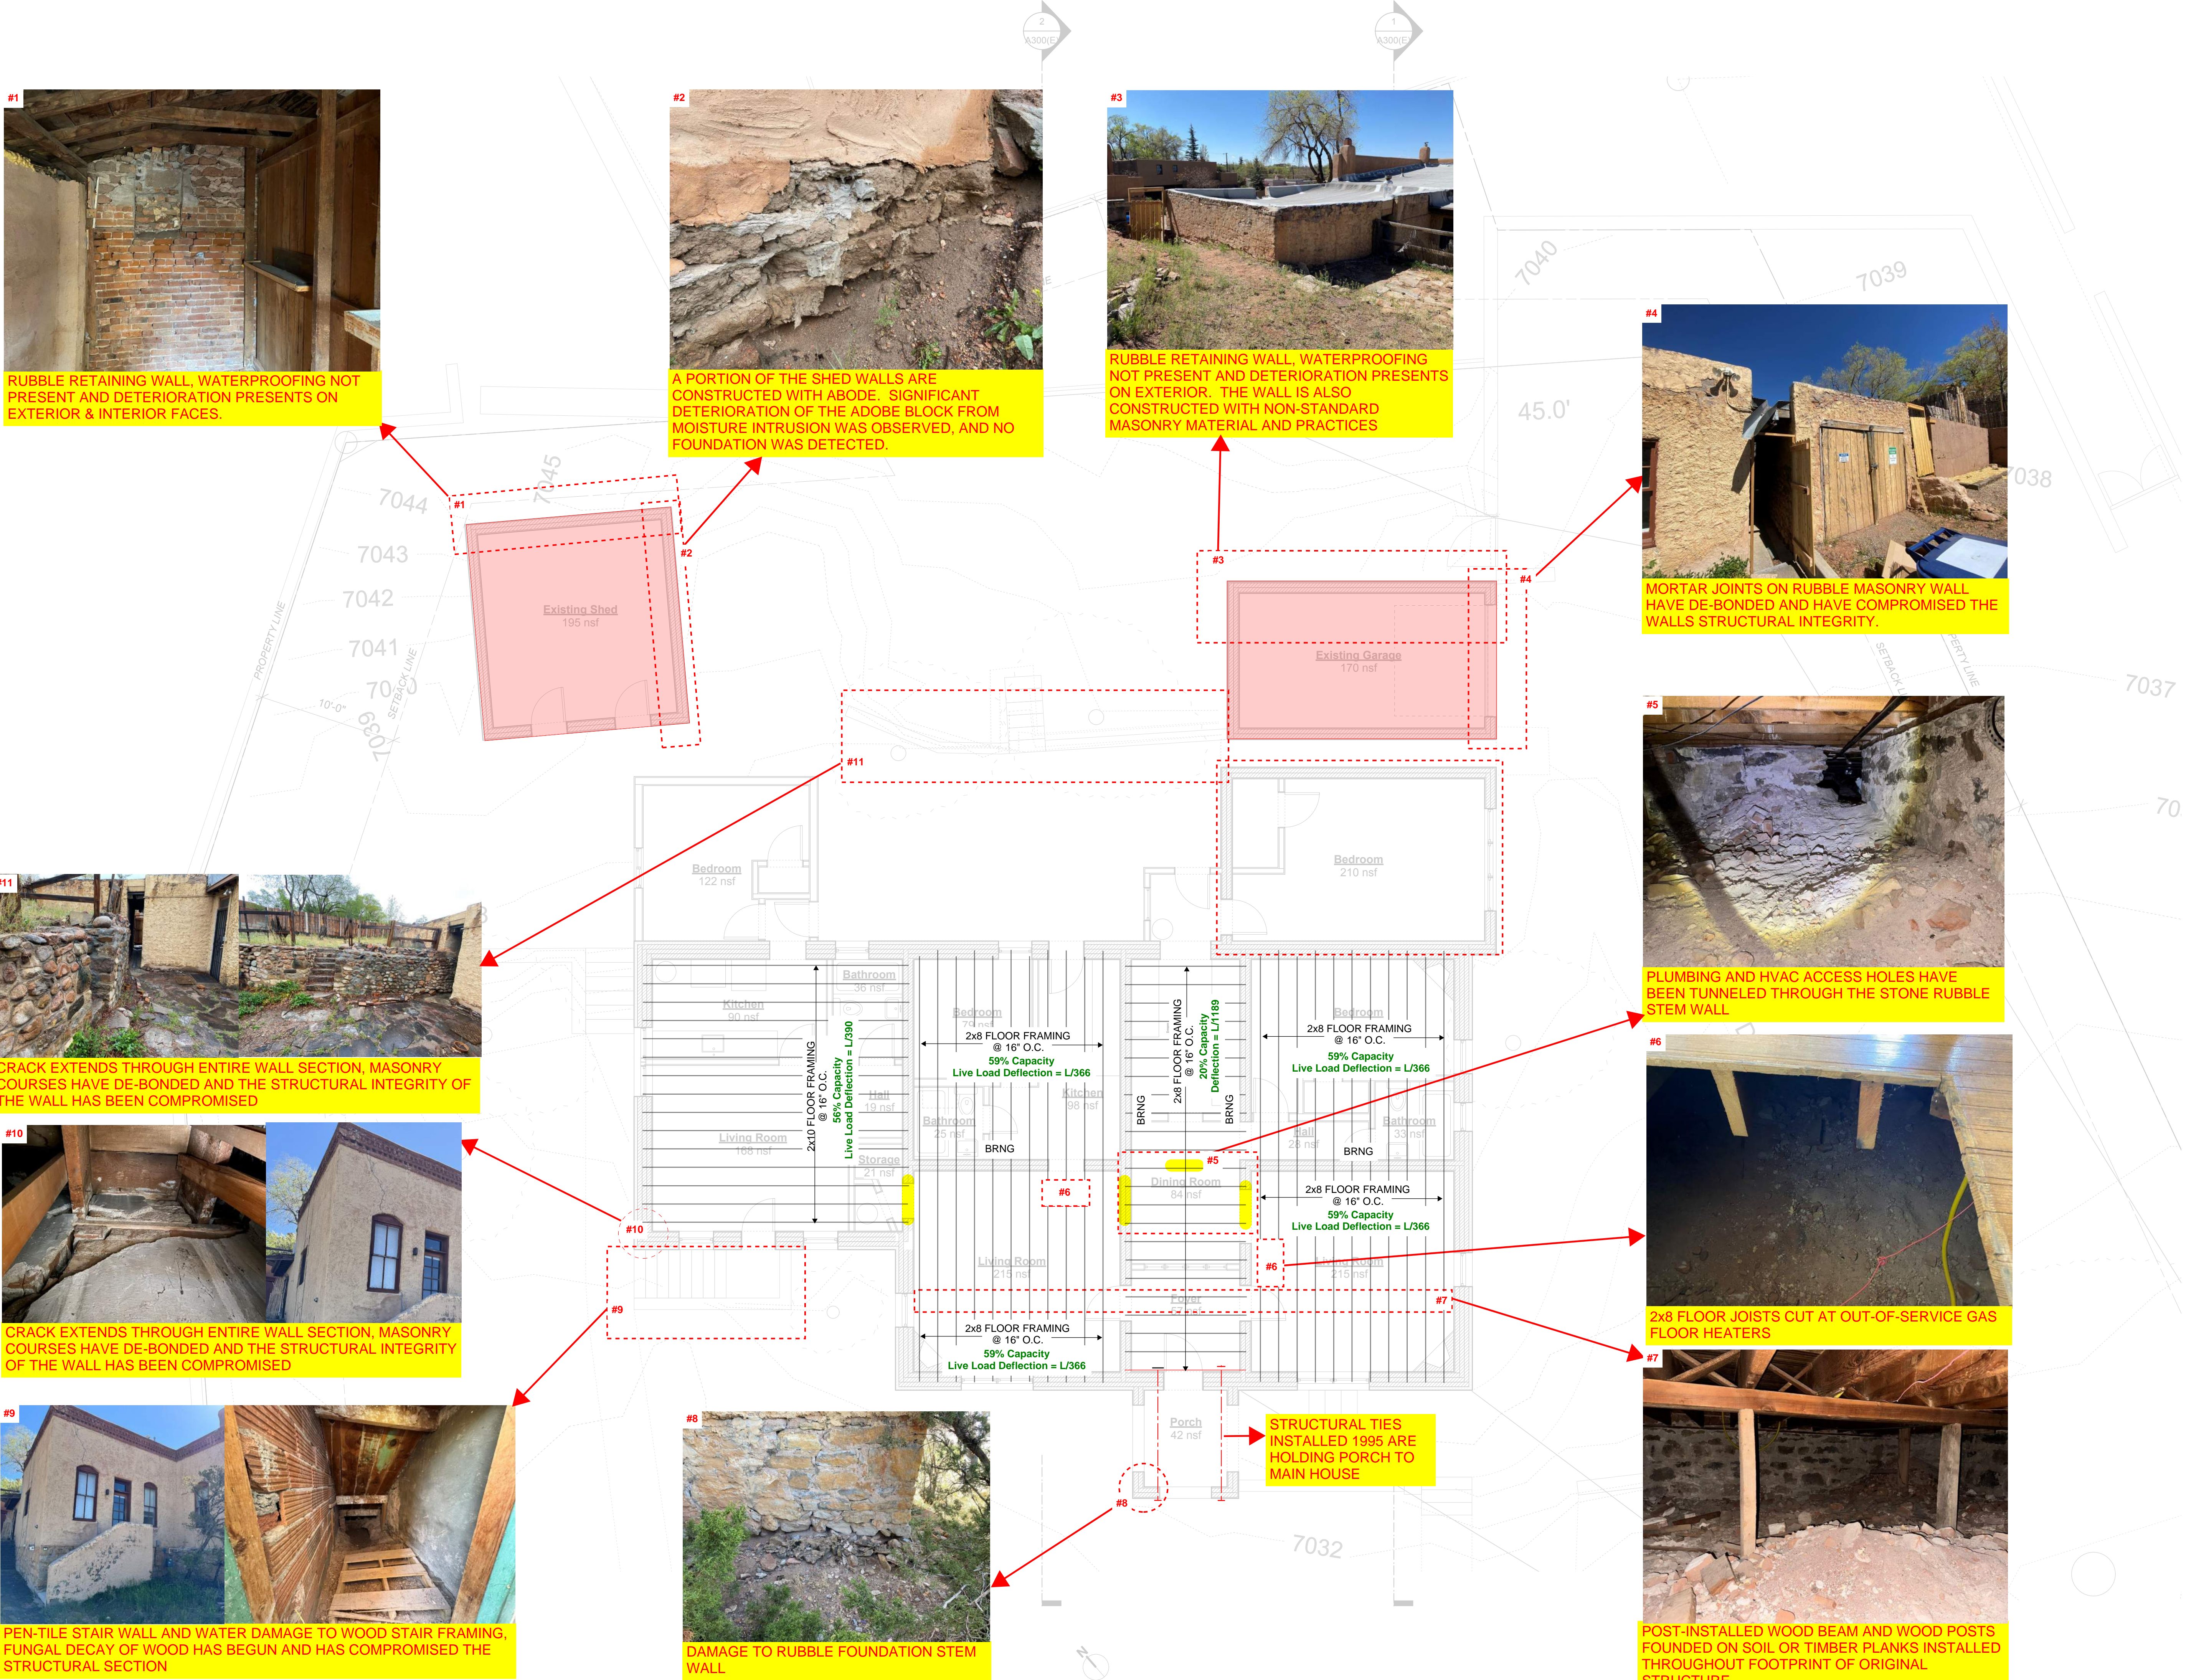
#8 DAMAGE TO RUBBLE FOUNDATION STEM WALL
