NEW MEXICO HISTORIC BUILDING INVENTORY - SANTA FE RESURVEY 1993

IDENTIFICATION	ADDRESS: <u>912 Don Gaspar</u>	ID NUMBER: <u>0516 00322</u>	
	UTM REFERENCE EASTING NORTHING ZONE <u>12 13</u>	LEGAL DESCRIPTION: TNSP <u>17</u> (N) S RANGE <u>9</u> (E) W SEC <u>25</u> NW 1/4 SE 1/4	BUILDING NAME: <u>Lynn House</u> SANTA FE ID NUMBER: <u>41842</u>
	FIELD MAP <u>Santa Fe Historic Structures Survey, 1983-85/1992</u> DATE OF CONSTRUCTION: <u>1893</u> by <u>owner</u> ESTIMATE <u>1930</u> ACTUAL SOURCE(S) <u>Sanborn map</u>

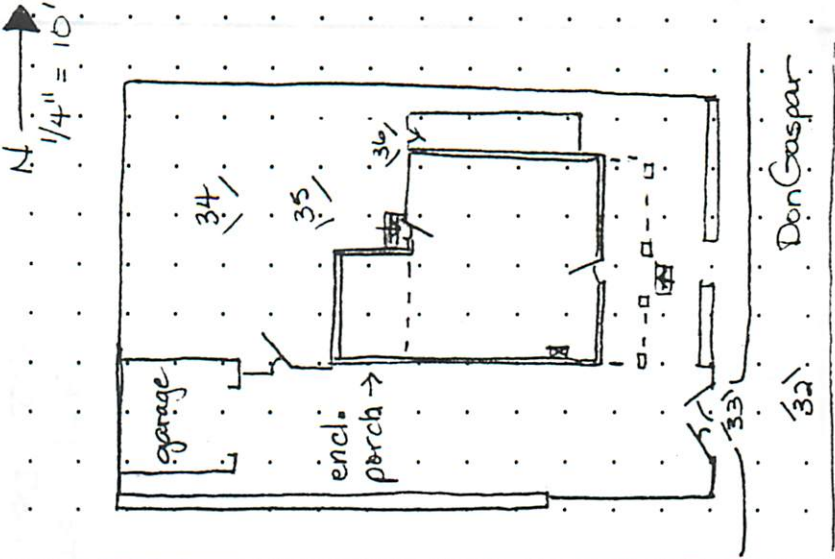
<p>#32 east elevation</p>	
ARCHITECTURAL STYLE: <u>Hipped Box</u>			
USE: HISTORIC: <u>residential</u> OTHER _____ PRESENT: <u>residential</u> OTHER _____			
SURROUNDINGS: <u>residential</u>			
BUILDING DATA	RELATIONSHIP TO HISTORIC SURROUNDINGS: <input checked="" type="checkbox"/> SIMILAR <input type="checkbox"/> NOT SIMILAR	SITE PLAN
