# City of Santa Fe, New Mexico

# memo

**2023-007597-HDRB. 410 Don Gaspar Ave.** Downtown and Eastside Historic District. Contributing (office and garage buildings). Jennifer Jenkins, JenkinsGavin, Inc., agents for the State of New Mexico General Services Division, request demolition of the of the office building (previously a residence) and garage. Exceptions are requested to Sections 14-5.2(M)(3)(b), Contributing, Significant and Landmark Buildings for consideration of the loss of Historic Status, and 14-5.2(M)(4) Demolition of Historic and Landmark Structures within the State Capital Outlay Projects section of the code.

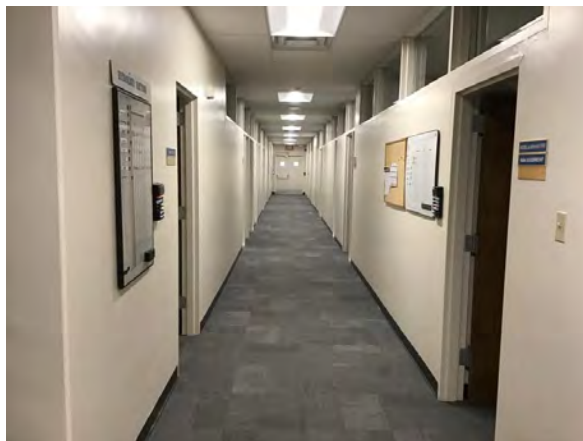
## Project 01-001-00018.2003 · ADA Compliance - Tactile and Braille Signage

The buildings lacks ADA-compliant tactile and Braille signage.

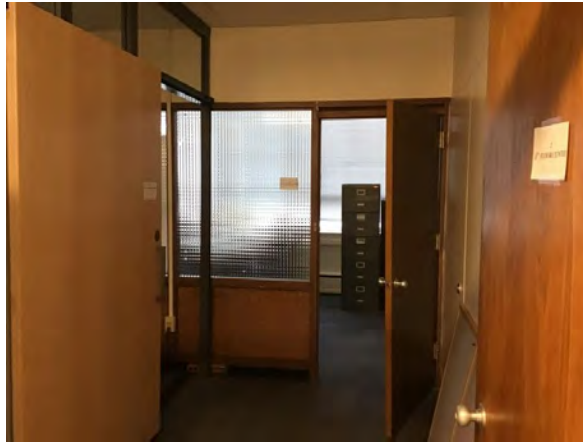
# Project 01-001-00018.2008 · Interior Renovation

The building has a combination of traditional and open office spaces. Many of the first-floor offices are small and awkward due to the subdivision of larger areas into smaller individual offices. Various wall systems and finish materials create an incongruous hodgepodge of office spaces. The second floor is more cohesive regarding materials and finishes, but offices are small and cramped. Office furniture impedes clear pathways. The basement finishes are old and past their usable life span. The rooms in the basement are randomly furnished and finished.

Description	Cost Code	Quantity	Unit	Adjustment	Cost	Subtotal Cost
1	Renovate interior	2.1118	31,843.0	SF	1.00	\$127.28	\$4,052,977
Maximum Allowable Construction Cost							\$4,052,977
<b>Total Project Cost</b>							<b>\$5,430,989</b>

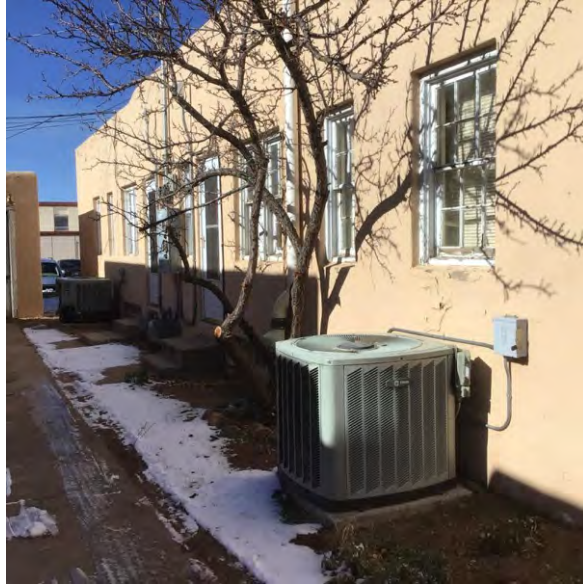
# Project 01-001-00019.2001 · Landscaping Upgrades

The landscaping is neglected. Trees and bushes are not pruned.

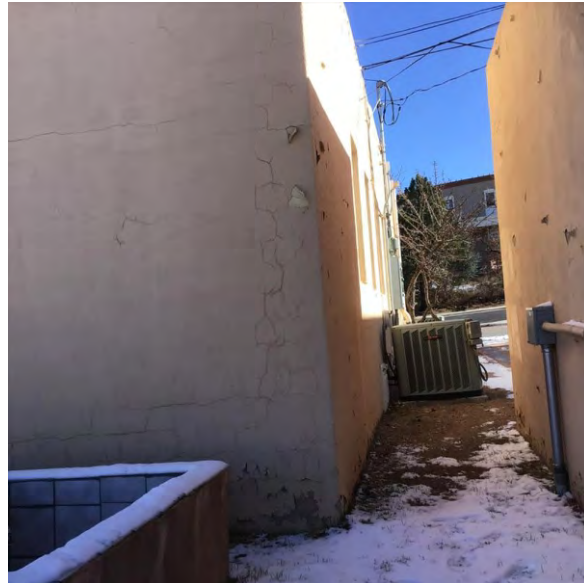
# Project 01-001-00019.2004 · Security Upgrades

The building has no security alarm or surveillance system.

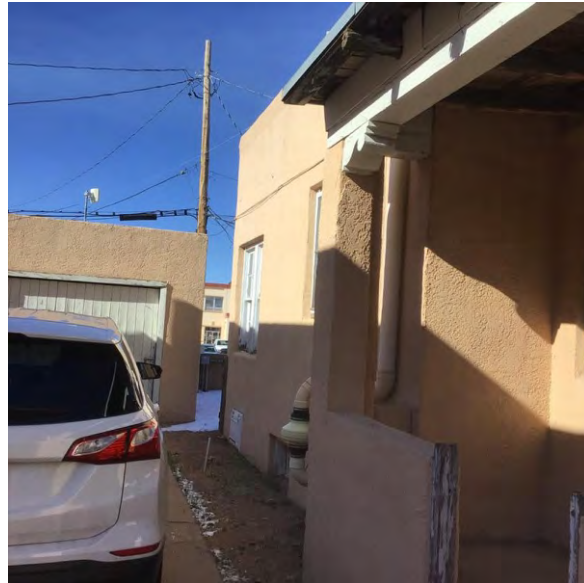
# Project 01-001-00020.2004 · Security Upgrades

There is no security alarm or cameras in the building.

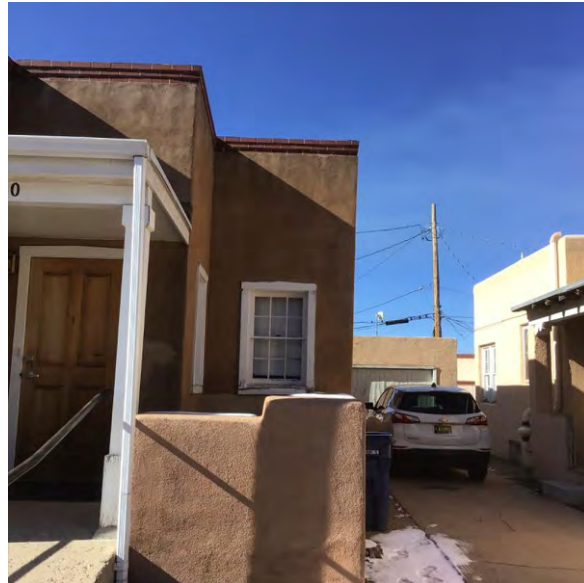
# Project 01-001-00014.2004 · Security Upgrades

The building has no security alarm or surveillance system.

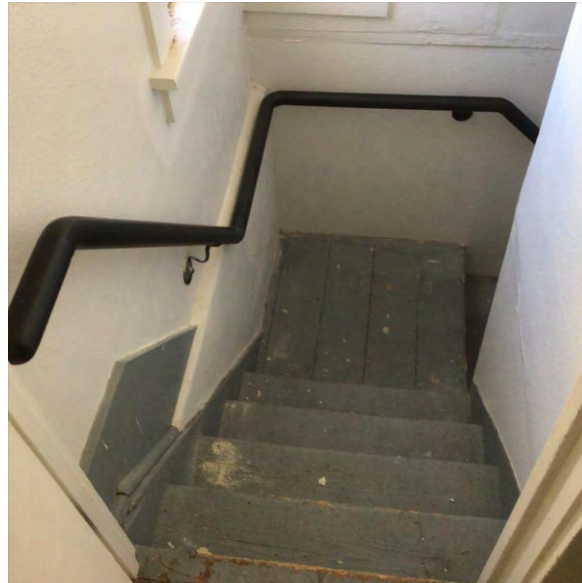
## Project 01-001-00014.2005 · ADA Compliance: Interior

Offices and support rooms do not have ADA-required signage. A compliant drinking fountain is absent. The break room sink is not compliant. Vertical and horizontal bars are missing in the restroom. Insulation is missing from the restroom sink. Stairs and handrails leading to the basement are not compliant. All doors within the Casita are 2'-8" or 2'-6" wide and are not ADA compliant.

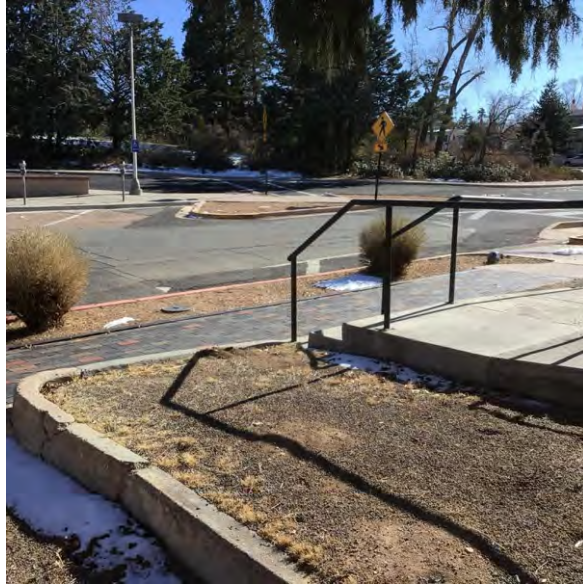
## Project 01-001-00015.2002 · ADA Compliance: Site Work

The sidewalks are old, worn, weed-infested, and have settled, creating uneven walks that are not ADA compliant. The ramp at the building entrance is noncompliant. The ramp does not provide a 5' x 5' turn around space in two locations, handrails are noncompliant, and edge protection is absent.

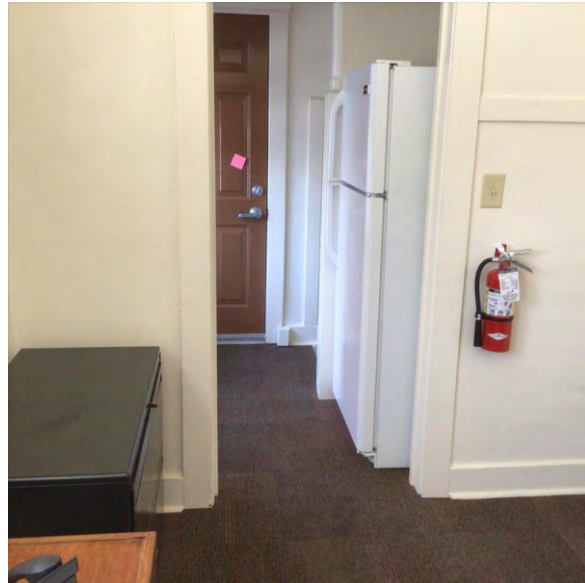
# Project 01-001-00015.2006 · Hardous Materials Study

Because the building is 90 years old, hazardous materials may be present. Commission a hazardous materials study.
