Historic Cultural Properties Inventory (HCPI) Base Form (FORM 1)

For HPD Office use only:		District No. _____		NRHP	SRCP	Criteria	A	B	C	D
1. Name of property: Catherine D. Janney/ Waldo and Ernestine Anton/ Henry and Virginia Wicks House		2. Location: 521 Calle Corvo Downtown and Eastside Historic District – Santa Fe		3. Local Reference Number: Santa Fe ID: H-632		4. County: Santa Fe Parcel # 13018752

8. Name of Project: HDRB Status Evaluation										
9. Lat/Long: 35.6819669,-105.9329764										
10. Photo Information: Giulia Caporuscio, photographer. Photo 1: View of south elevation. Facing northwest.

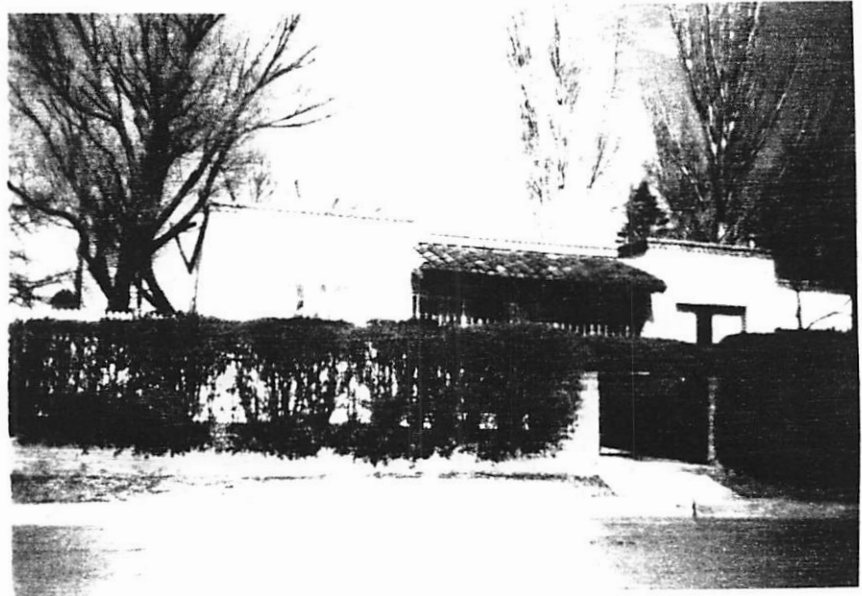
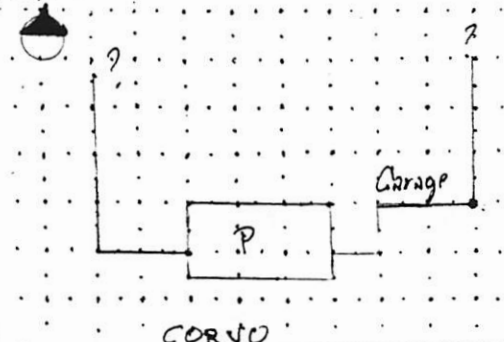
condition excellent fair good deteriorating

degree of remodeling minor moderate major described

style Territorial Rev foundation material NV wall material/surface Adobe Stucco

architecture features
 Roof - Shed over porch. Sp. tile. Rafter exp
 Elsewhere - Flat - Brick parapet. - Strchr
 hdr, strchr. 5 mtl Pluor
 Windows - dbl 6/8 Picture Turquoise trim.
 Bullnose frame Under porch (8 lite csm⁺, picture
 8 lite csm⁺)
 Door - wd panel
 Porch. Corbels + lintel supp by wall.
 Wrought iron grill.

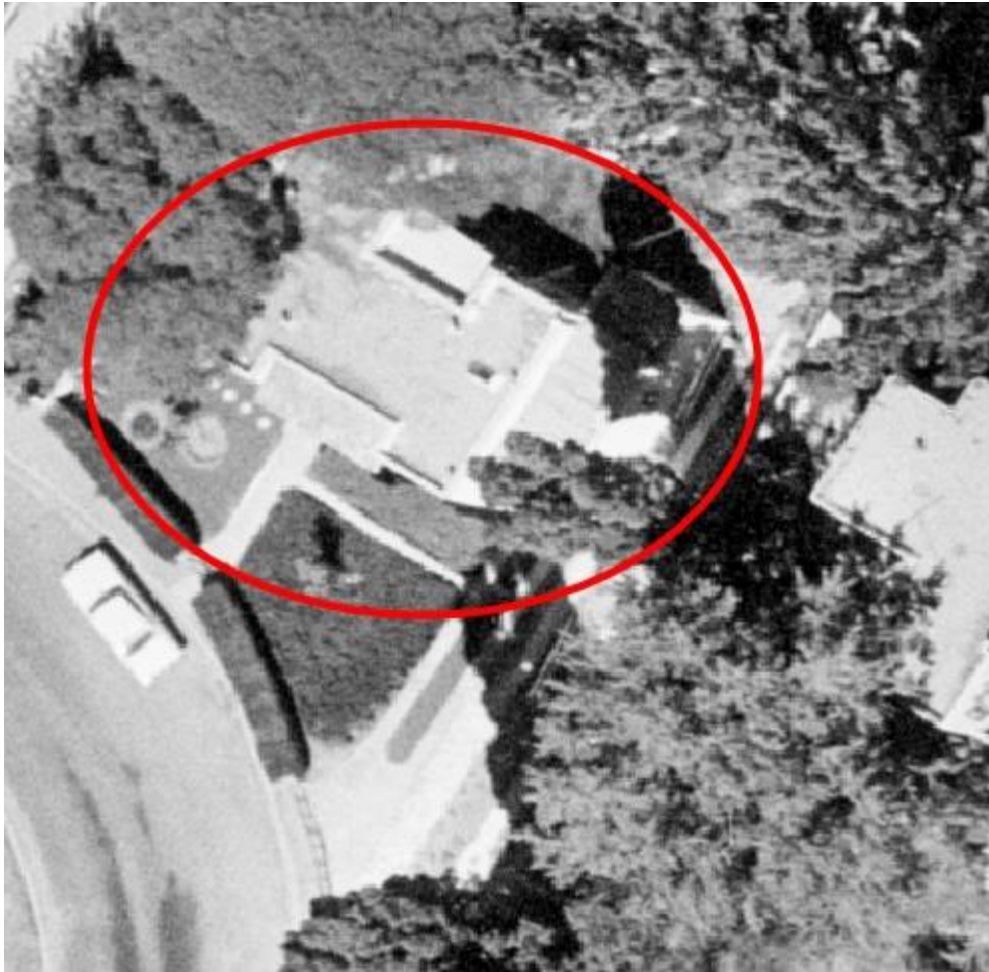
Figure 4: September 11, 1978, aerial photograph.

A roughly three-foot-high, two-foot-wide adobe wall extends along the front property line (Photo 2). Near the center, a steel entry gate opens onto a brick walkway leading to the main entrance. Comparison with a 1978 aerial photograph and the 1984 HBI suggests that the wall is relatively recent, replacing what had historically been a hedge (Figs. 4 & 5). The rear patio walls are also of modern construction.
