Status Review Request

310 Lomita St, Santa Fe, NM 87505

Historic Cultural Properties Inventory (HCPI) Base Form (FORM 1)

1. Name of property: Robert and Agnes McBride House	2. Location: 310 Lomita Street Don Gaspar Area Historic District – Santa Fe	3. Local Reference Number: Santa Fe ID: H-2551 4. County: Santa Fe Parcel # 11624320

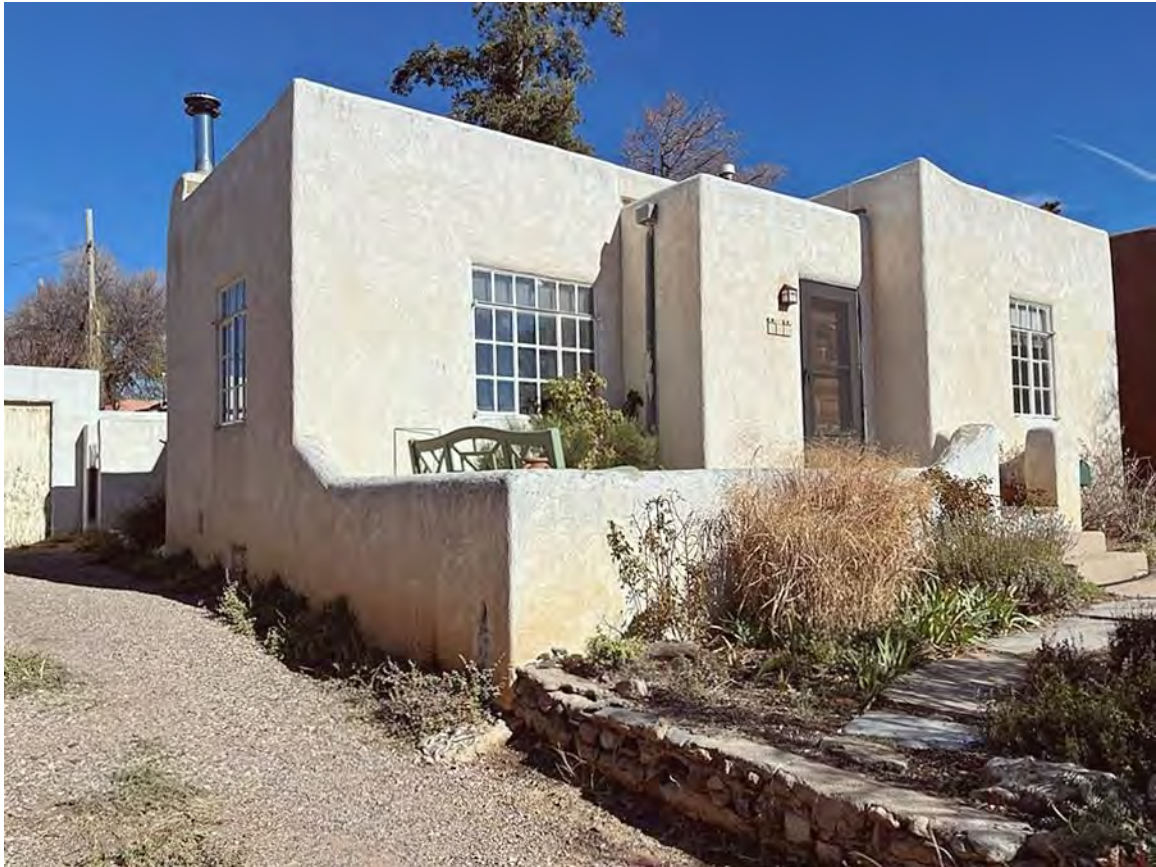
The house is approached by a short run of concrete steps rising from the sidewalk to the front entry. The south elevation exhibits the greatest architectural articulation, with a sequence of additive volumes creating a characteristic Pueblo Revival façade (Photos 1 & 3). On the west side, a recessed wall plane contains a 24-light steel combination window (Photo 4). This unit, likely original to the house, consists of fixed and casement

Photo 3: South (front) façade composition. Camera facing northeast.

Built in 1941 as part of the Linda Vista Addition, the house retains its original massing, footprint, and overall Pueblo Revival façade composition. The steel combination windows appear original, and the stepped planar arrangement of the south elevation continues to express the design intent of its builder, S. L. Kirk. Aside from door replacements and minor site changes, the building has experienced little alteration, and its essential historic character remains intact. For these reasons, the house is recommended as Contributing, with the articulated south elevation designated as the primary façade.

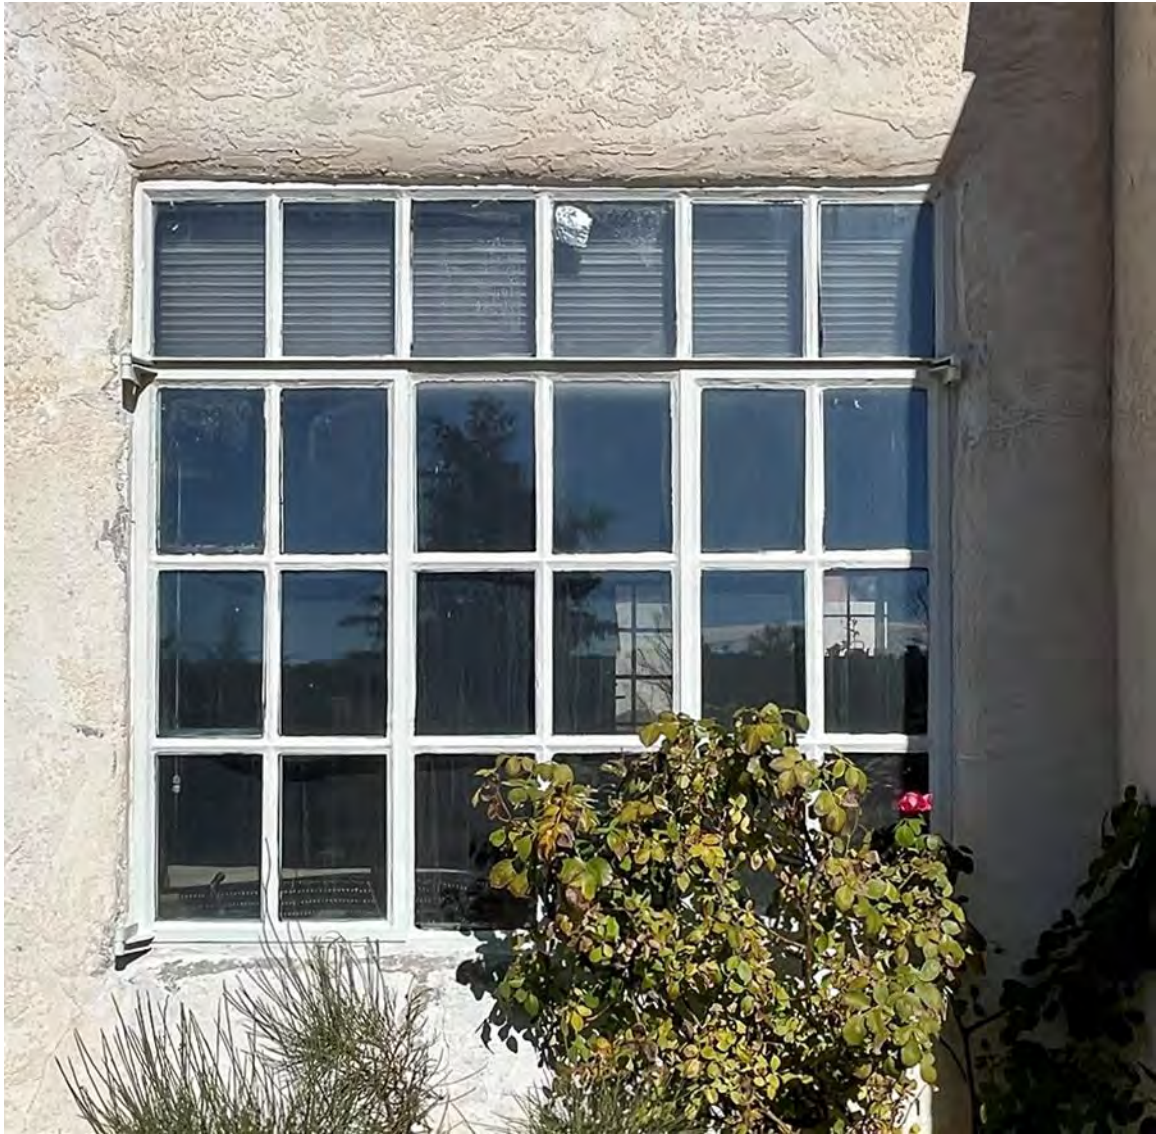
Photo 4: South (front) façade. Living room window. Camera facing north.

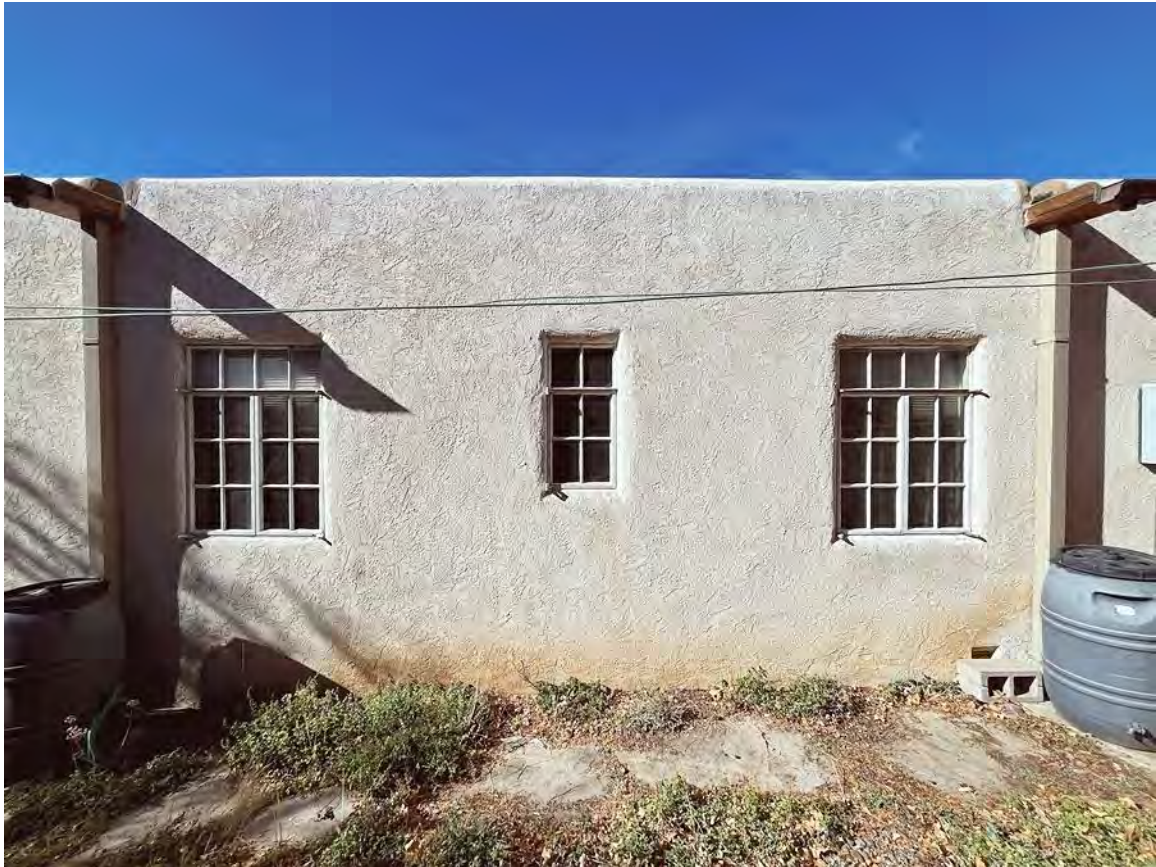
Facing the neighboring property, the east elevation presents as a continuous flat wall plane, fenestrated by two sets of paired six-light steel casement windows serving the bedrooms, with a smaller opaque casement lighting the bathroom between them (Photo 7). The parapet along this elevation contains two openings fitted with modern wood trough canales.

Photo 7: East elevation. Camera facing west.

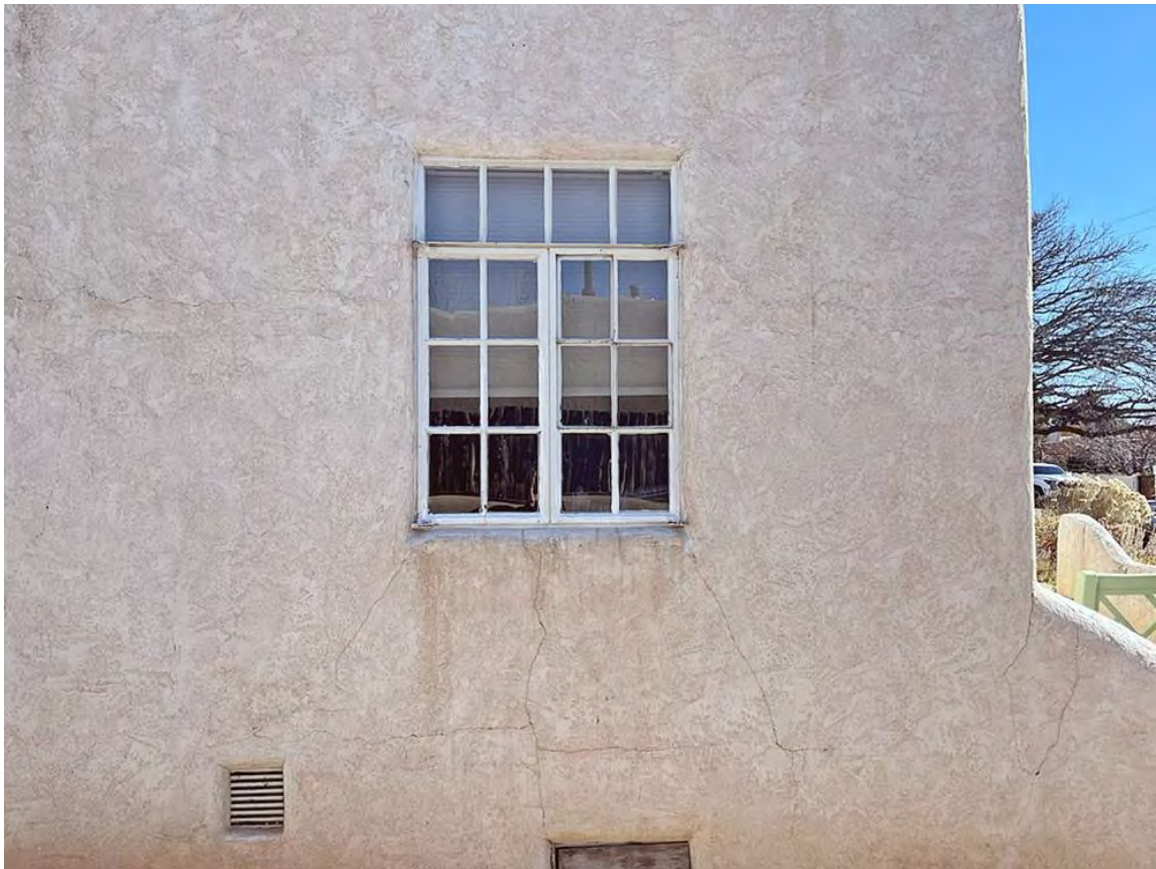
Set along the driveway, the west elevation is defined by a shallow wall recess containing paired six-light steel casement windows lighting the kitchen (Photo 10), with an additional casement serving the living room (Photo 11). A crawl-space hatch is located below the living-room window. At the northwest corner of the living room, a stuccoed

Photo 11: West elevation, south end. Camera facing east.
