PROJECT 2025-011108-HDRB, 532 Calle Corvo, Downtown and Eastside Historic District,
DESC: Non-contributing, John Padilla, agent for Susan McShane Salomone, owner, requests status review with primary façade(s) designation if applicable.

CASE NUMBER: 2025-011108--HDRB

PROJECT TYPE: Historic Status Review

Historic Cultural Properties Inventory (HCPI) Base Form (FORM 1)

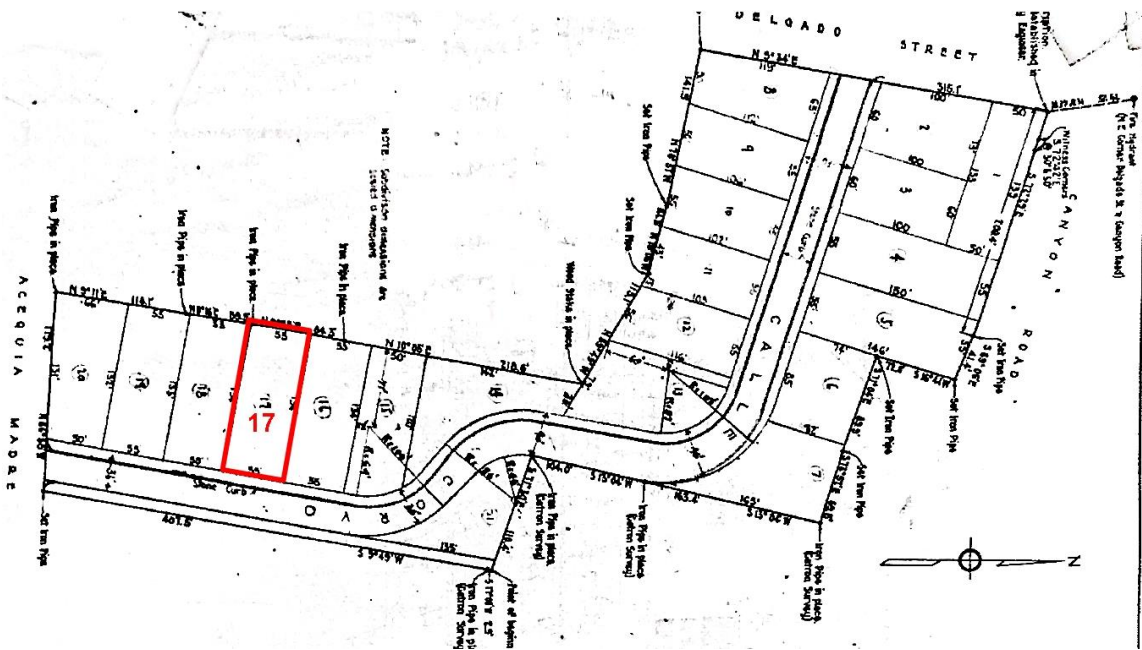
In 1937, he created the first Hughes Subdivision, consisting of 20 lots laid out along a gently curving road between Delgado Street and Acequia Madre—then known as East Manhattan Street. Following a contemporary trend of using picturesque Spanish names for new streets, Hughes named the road *Calle Corvo*, loosely translated as “curving” or “bent street.” The subdivision was replatted the following year as the Second Hughes Addition (Fig. 1).

Figure 1: Hughes Second Addition, 1938. Floyd Haak. Subject lot highlighted.

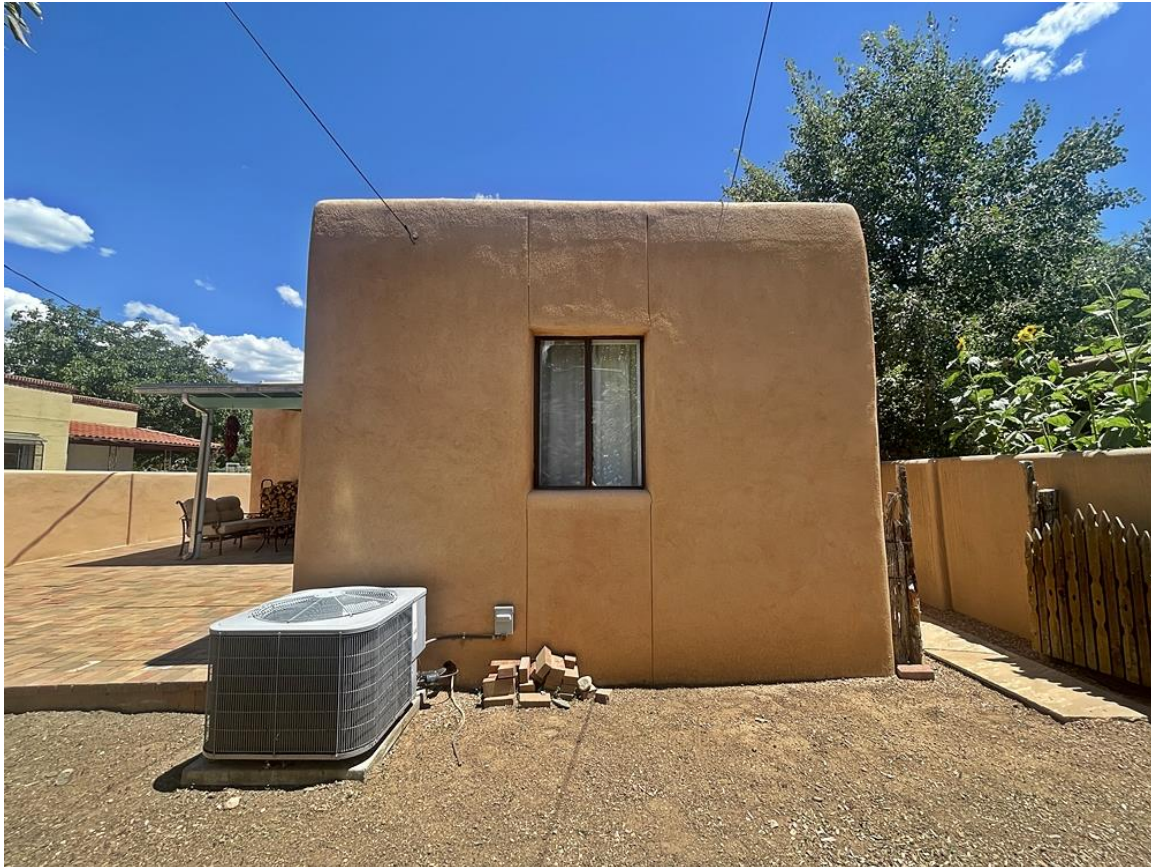
Beyond this is a primary bedroom addition, constructed—based on aerial photographs—between 1958 and 1966 (Figs. 4 & 5). This rectangular volume projects approximately 13 feet and features privacy-oriented fenestration: high-set horizontal windows and a vertical aluminum sliding unit placed in the short west-facing wall (Photo 11).

Photo 11: West elevation. Primary bedroom addition. Camera facing east.
